Building and Timber Pest Inspection Report

Inspection Date: Fri, 13 Feb 2026

Property Address: 102 Minorca Cct, Spring Farm NSW 2570,
Australia

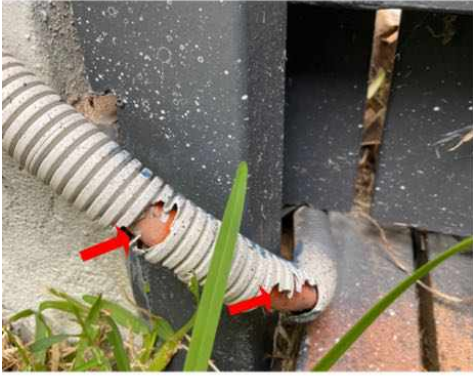
Building: Building 1
Location: Front walls
Finding: Electrical solar wiring exposed above ground
Information: Electrical cables have been installed above ground and are not buried or protected as required. This appears to be non-compliant with NSW safety regulations and poses a risk of electric shock or damage. These cables ducting has already been damaged by lawn mowing activities.

This needs urgent rectification.

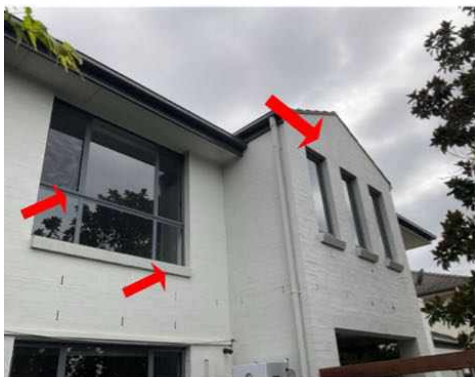
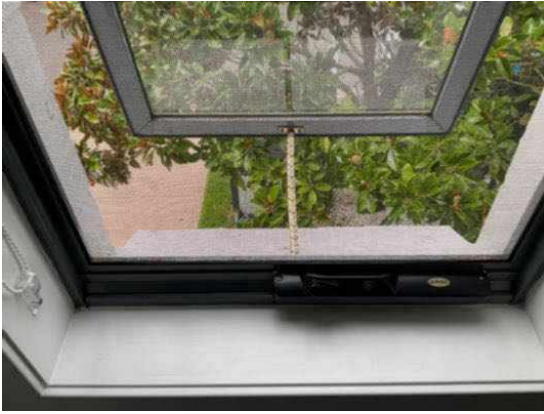
Building:	Building 1
Location:	Many upstairs windows
Finding:	Window opening restrictors missing.
Information:	The Building Code of Australia rules require all openable windows (where the internal floor is more than 2m above the ground outside) in residential rooms to be fitted with a suitable screen or restrictor. Windows located 1.7m above the floor level do not require protection.

Window restrictors are required where people who are vulnerable to the risk of falling have access to windows. This means all windows above ground level which do not have another fall prevention safety measure in place, such as a balcony or balustrade should have a restrictor.

These need to be added urgently for the safety of all persons.

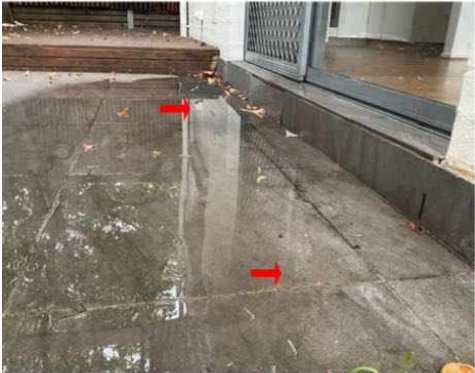
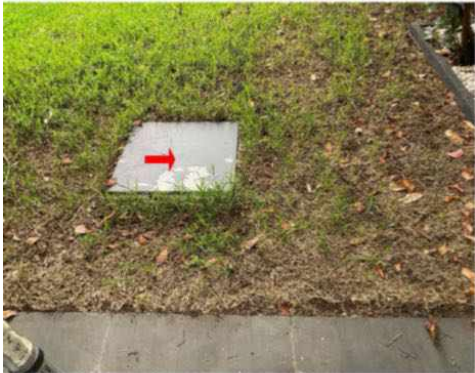
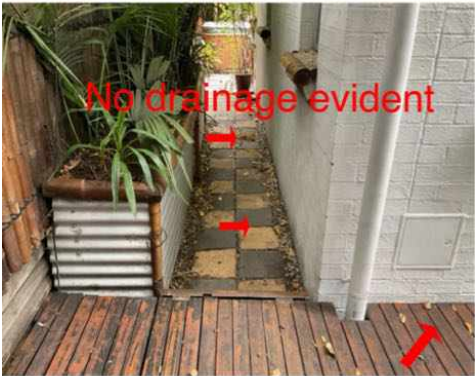
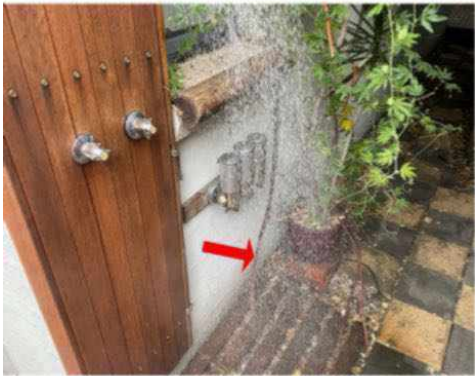
Building:	Building 1
Location:	West Wall - pergola and other areas
Finding:	Site drainage - Inadequate
Information:	The site drainage in these areas was found to be inadequate at the time of inspection, creating potential for subsequent water damage to associated building elements.

1. Water was found to pool on the pergola tiling and may run under or around the house slab.
2. The air conditioner and hot water system overflow run against the house walls.
3. The front downpipe is damaged.
4. The two rear drains are full of debris.
5. The spa pergola roof drainage is substandard and runs on top of the ground.
6. The rear shower had no drain.

It is important that water does not lie against the base of walls; surrounding paths and ground levels should be sloped to drain water away from walls. Downpipes should not discharge stormwater onto lower walls or plinths. Stormwater should be carried away by large, regularly cleaned drains. Ground levels may need to be lowered to expose a buried DPC.

Where site drainage is inadequate, installation of an Agricultural (Aggie) Drain may be required. A qualified plumber should be appointed to further inspect the property and perform any remedial works as necessary. Secondary defects are likely to occur if left unmanaged.

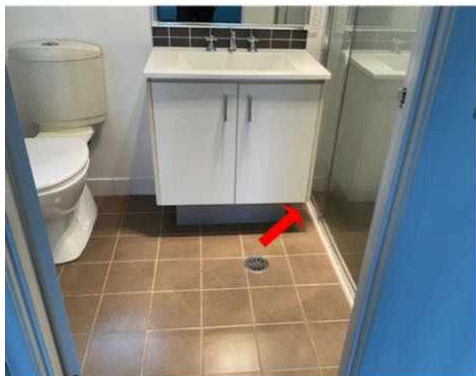
Building: Building 1
 Location: Ensuite
 Finding: Shower screen - Leaking
 Information: Leaking was evident to the shower screening at the time of inspection. It is suspected

that the leaking has occurred as a result missing sealant. Leaking from the shower , where left unattended, is likely to lead to water damage to adjoining flooring and walls. Such damage can lead to water damage and necessitate extensive remedial works being required. Active water leaks may also create an environment that is susceptible to the formation and development of mould.

Appointment of a sealant expert is required to repair or replace this missing sealant. Such works should be performed as soon as possible to ensure that no further damage occurs.

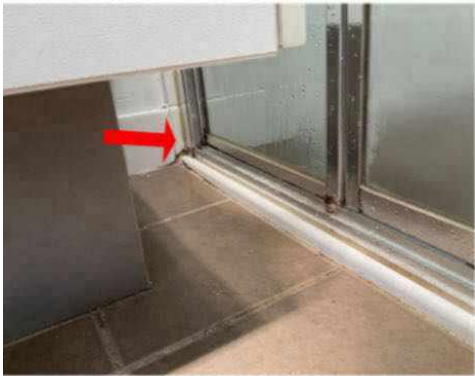
Finding 3.06

Building:	Building 1
Location:	Kitchen, laundry and bathroom
Finding:	Sealant and grouting - Missing or damaged and hole in plumbing
Information:	It was noted on inspection that sealant or grout is degraded to these pictured areas.

Different materials and floor areas move at different rates, generally causing cracking to grout or sealant at this point. A flexible sealant is required to allow for expected expansion and contraction, while keeping the joint water tight and protective of all associated building materials.

Flexible and mould resistant materials should be applied to affected areas to prevent any subsequent water damage that is likely to occur. Regular maintenance and replacement of damage or missing or damaged sealant and grout is highly recommended to the wet areas, as this is a regular wear and tear defect. Sealant and grouting in areas that come into regular contact with water should be maintained for the long term care of your property.

A sealant specialist or tiling contractor should be appointed to complete these works as soon as possible

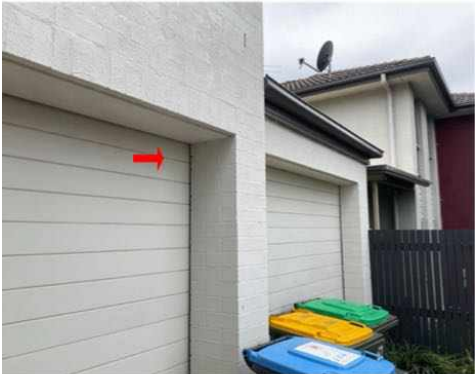
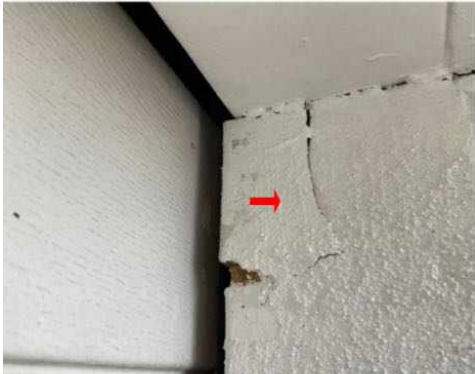
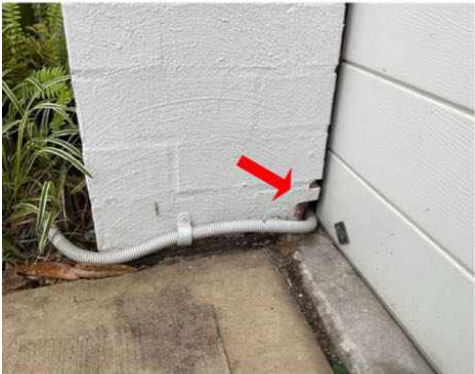
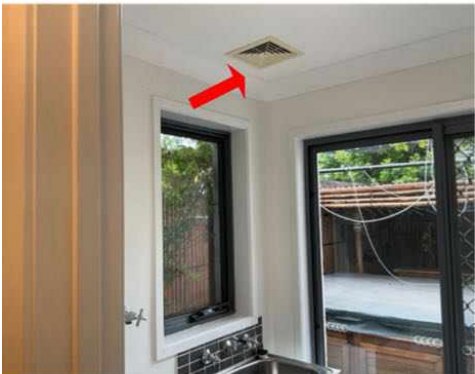
Building: Building 1
 Location: Pictured external areas
 Finding: Building elements - Damaged
 Information: Evidence of damaged areas were identified at the time of the inspection. These include

-
- 1. Some brickwork showed minor damage.
- 2. The oven had unusual noises emitting from it.
- 3. The laundry exhaust fan did not appear to work.

A carpenter would be the trade responsible for rectification of these areas when convenient.

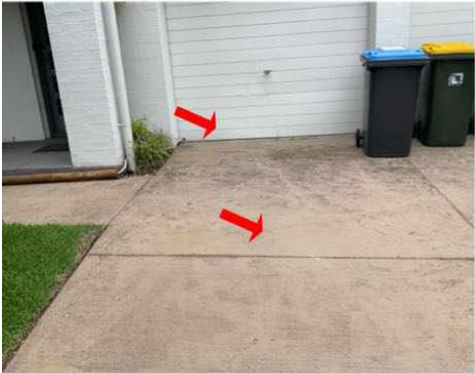
Building:	Building 1
Location:	Yard - front
Finding:	Crack in concrete slabs - Category 1
Information:	Cracks coded as Category 1 was identified in these pictured slabs. A Category 1 crack is described as a fine but noticeable crack, with the slab at an otherwise reasonable level. To be considered Category 1, the approximate width of the crack is less than 1.0mm, or a less than 10mm change in offset when a 3m straight edge is placed over the defect.

Category 1 cracks should be monitored for a period of 12 months. At the end of the monitoring period, identified cracks that are rated greater than Category 2 are considered defects, and require rectification.

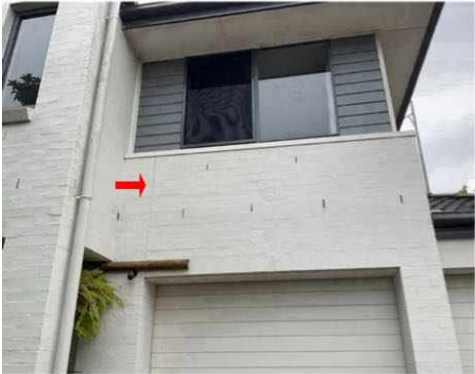
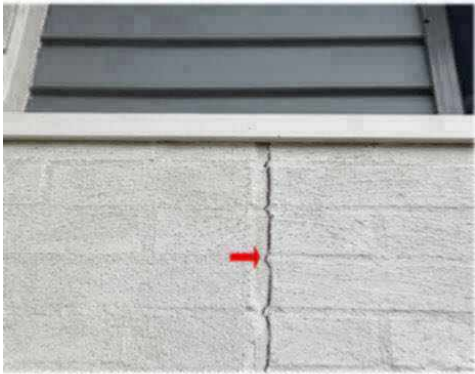
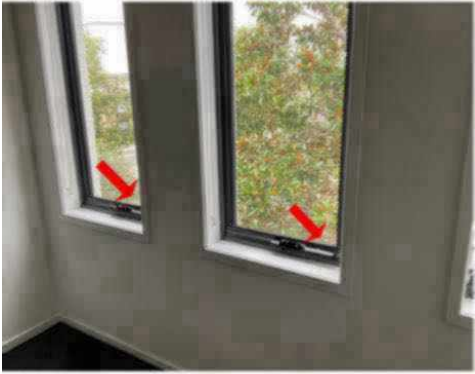
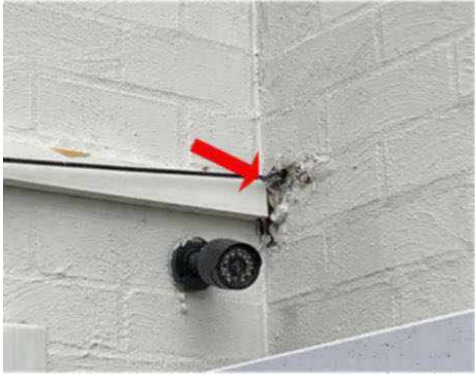
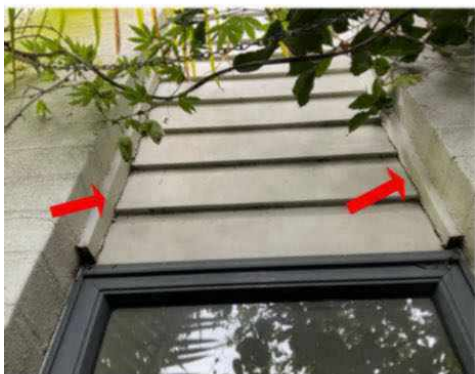
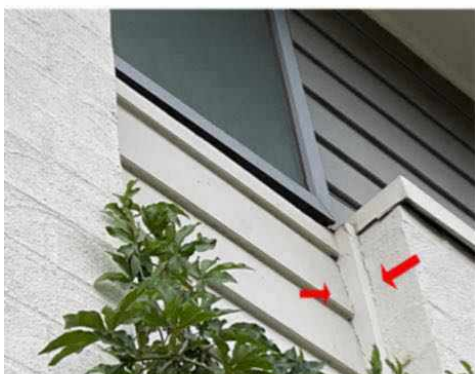
Building: Building 1
Location: Many exterior walls
Finding: Sealant (external) - missing
Information: It was noted on inspection that areas of external sealant was missing to small areas of the external walls.

A sealant specialist or skilled handy person should be appointed to complete these works as soon as possible

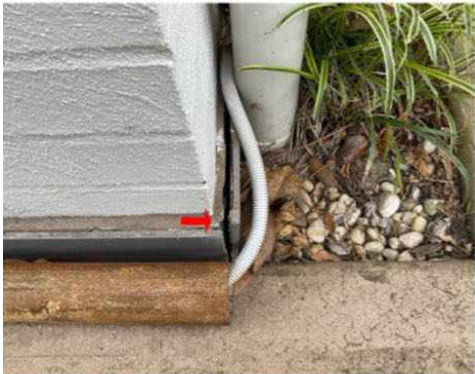
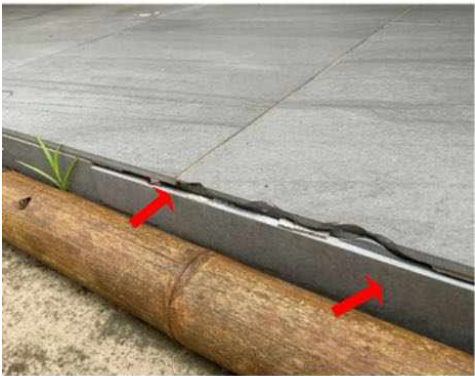
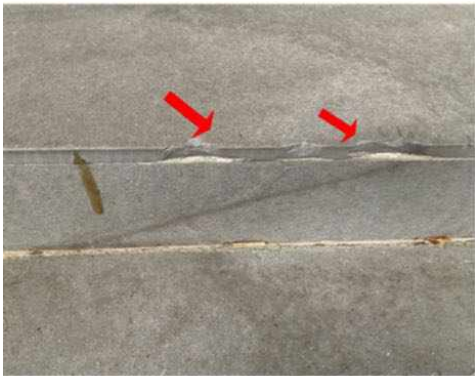
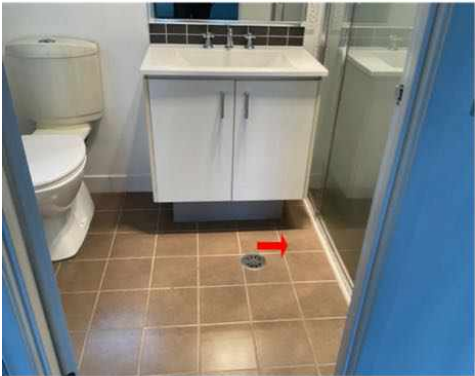
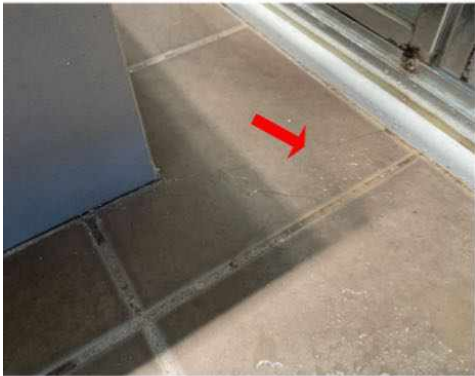
Finding 3.13

Building: Building 1
 Location: External areas and bathroom
 Finding: Tiles cracked and loose.
 Information:

Cracked tiles were evident in these pictured areas at the time of inspection. It is suspected that this cracking has occurred as a result of minor settlement or impact damage.

Cracked tiles throughout the household detract from the overall appearance of the affected areas. In wet areas of kitchens and bathrooms, it can lead to water damage of adjoining walls and floors.

Replacement of cracked tiles is recommended as soon as possible. A tiling contractor may be appointed to perform these works. Where cracks become more numerous, contact a licensed building inspector for further investigation.

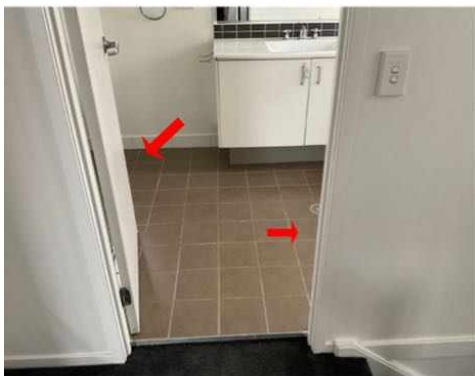
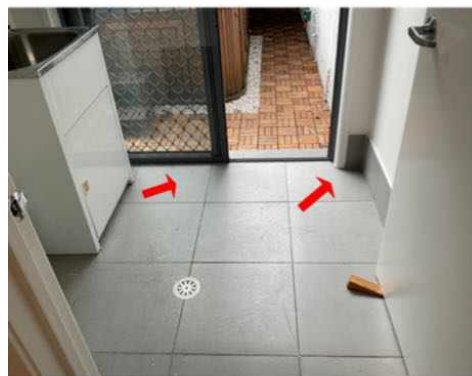
Finding 3.14

Building:	Building 1
Location:	Pictured bathroom & laundry areas
Finding:	Tiles - Drummy
Information:	Drummy tiled areas were identified at the time of inspection. The term 'drummy' refers to tiles that have become detached from their fixing, despite otherwise being in relatively good condition. Such defects are generally caused by physical or moisture damage to the area. Drummy tiled areas may also be a direct result of poor workmanship during the construction process.

Tiled areas may swell and shrink with changes in air humidity if the area has sustained moisture damage. Any exposure to moisture is capable of causing tiled areas to become drummy and/or cracked over a prolonged period of time. Drummy tiled areas generally require removal and replacement of affected tiles, with adequate sealant and grouting.

Specialist trades are available for these types of services. A registered builder may be required to undertake works if damage is extensive or if secondary building defects have resulted. Otherwise, it is advised that a tiling contractor be appointed to perform works as necessary. Immediate action is recommended to ensure that no further damage is sustained in the affected area.

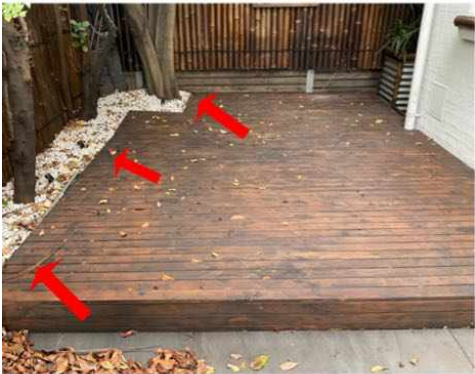
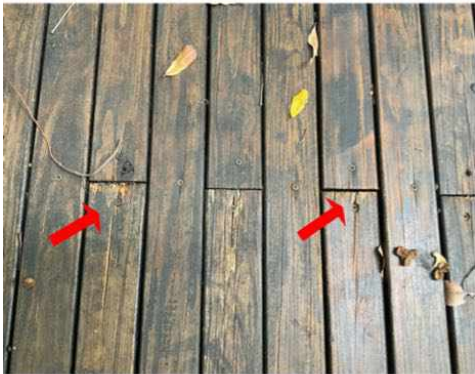
Building: Building 1
Location: Some deck areas
Finding: Lack of support
Information: Some side deck areas shows a lack of support which is highly likely to result in further defects over time. Additional support is required to these areas.

Some decking boards also show minor weathering.

A carpenter can report these areas when convenient.

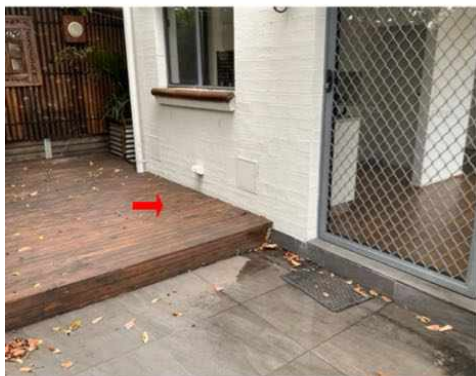
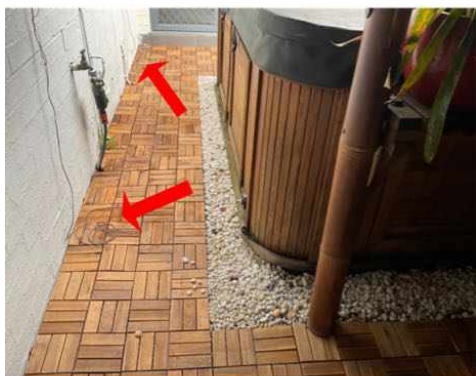
If the slab edge is not properly exposed there is a high risk of termite attack. Sometimes, in order to determine the type of slab, a suitably qualified person such as an architect or builder may be required to consult the construction plans.

Where the slab edge cannot be properly inspected, it is highly recommended that termite or timber pest inspections be carried out every 6-12 months to aid protection of the property against infestation.

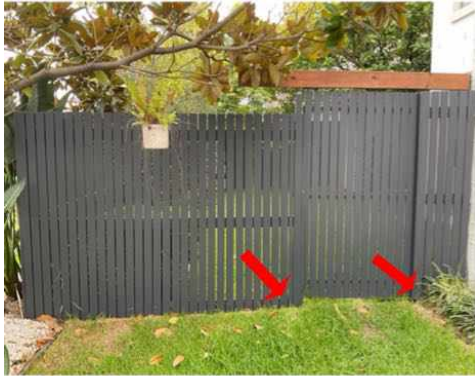
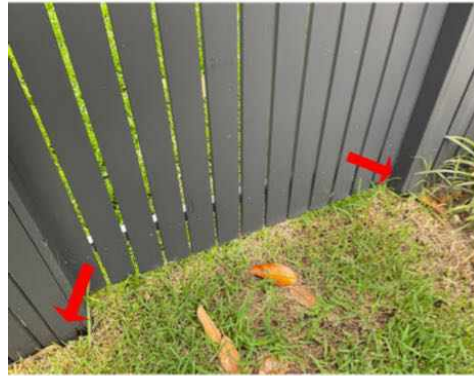
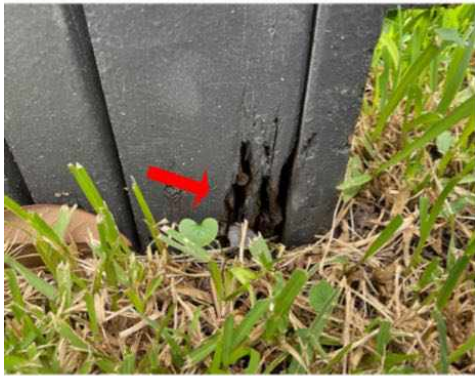
Finding 7.01

Building: Building 1
 Location: Front fence
 Finding: Fungal decay - present (localised)
 Information: Fungal decay also known as wood decay or wood rot generally refers to the deterioration of timber elements when in contact with excessive levels of moisture for a prolonged period of time.

In this case, the affected timber fence is in a decaying state and will need replacement in the future by a carpenter or licensed builder.

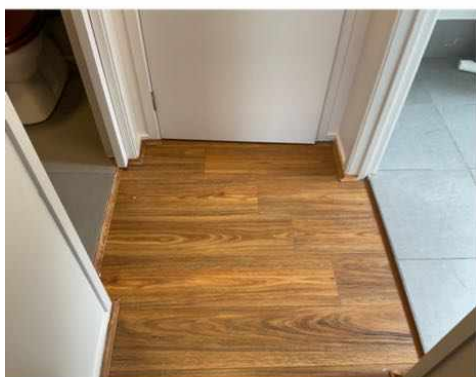
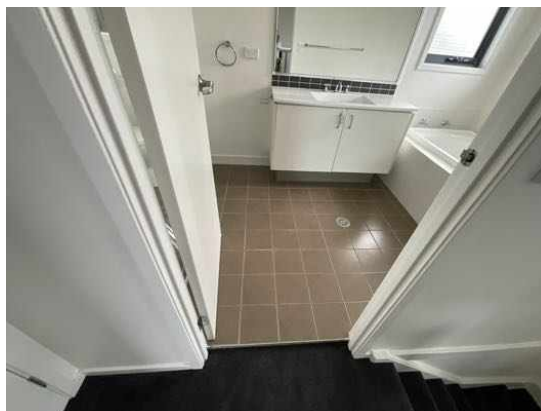
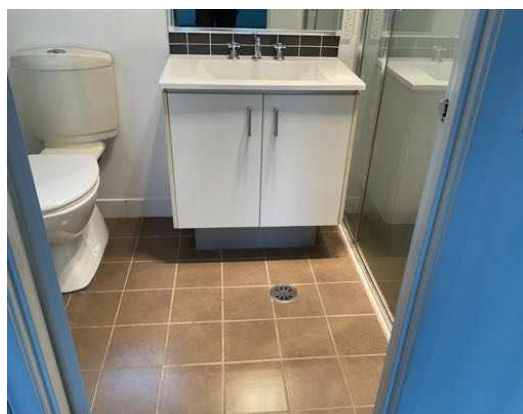
Building: Building 1
 Location: Bathrooms and laundry
 Finding: Waterproofing membranes - Information Only
 Information: Internal Water Proofing Membranes, are crucial in preventing water ingress into the property is important to know that the Membrane System used is to Australian Standards and has been installed correctly.

With older property's where this information is unavailable all wet areas should be monitored. If any leaks, water staining, peeling or bubbling of the paint become evident to any adjacent walls or ceilings below a licensed builder or waterproofing specialist is recommended to investigate further.

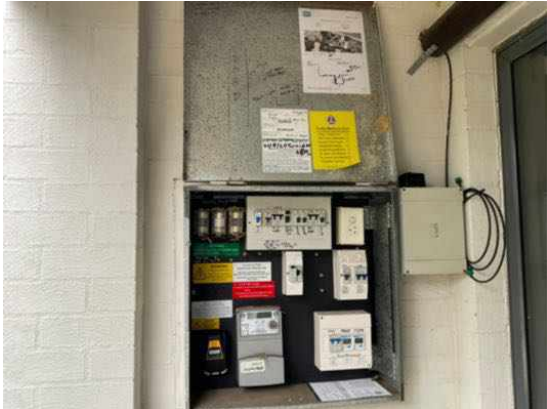
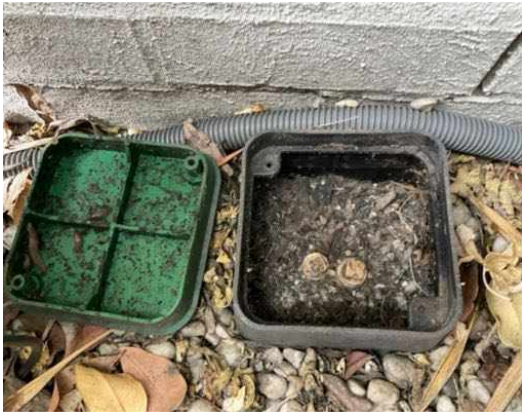
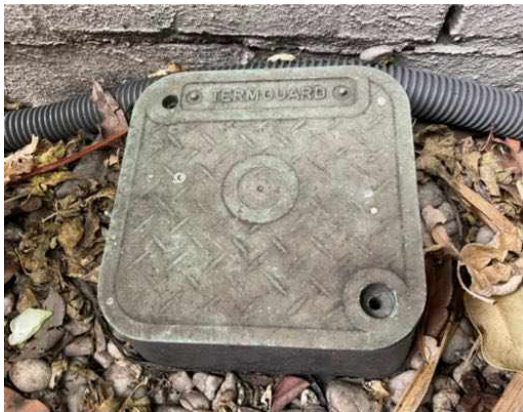
A durable notice should be placed in the switchboard unit to indicate current termite barriers. At the time of inspection, the durable notice was evident and it appeared as though a chemical termite management system has been installed, with evidence to suggest preventative works took place in May 2025.

The client may consider gaining further advice from a pest controller as to the costs and procedures involved with upkeep of this 'chemical' application. It is recommended that obtaining such advice be a short-term priority.
