# Building and Timber Pest Inspection Report

Inspection Date: Thu, 26 Feb 2026

Property Address: 14 Wavell Ave, Carlingford NSW 2118,  
Australia

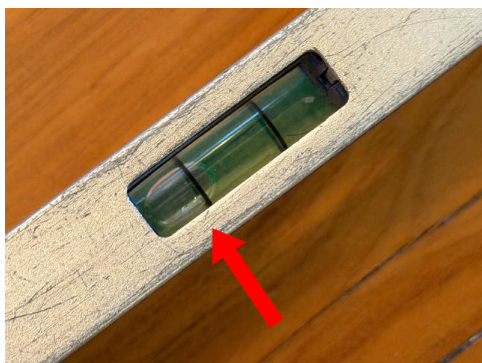
Information: The internal flooring in this area is out of level and uneven. Uneven flooring is likely to indicate minor defects such as expected movement of the foundations of the property, but may also indicate subsidence of the associated subfloor stumps.

It is advised that the flooring be closely monitored to identify any further movement. Where flooring remains relatively unchanged for an extended period of time (i.e. several months), it is likely that this defect has been caused by expected movement of the foundations of the property.

However, where flooring is uneven further, potentially invasive inspection of the subfloor structures and stumps in this area is required. In this case, works to repair are likely to be required, and would be carried out by a registered builder specialising in re-stumping.

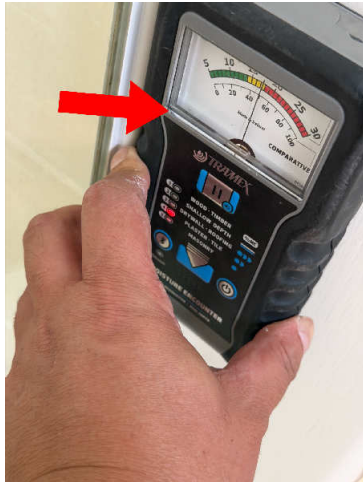
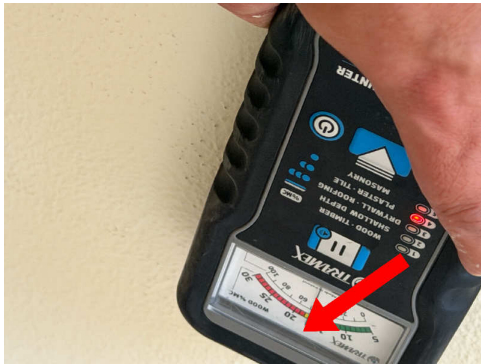
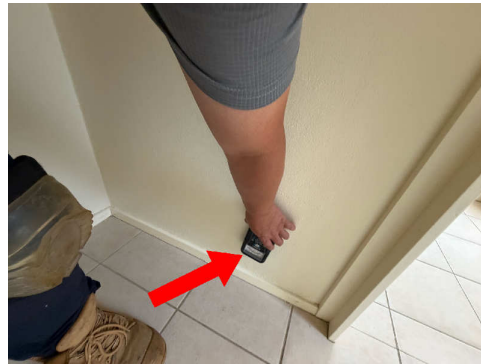
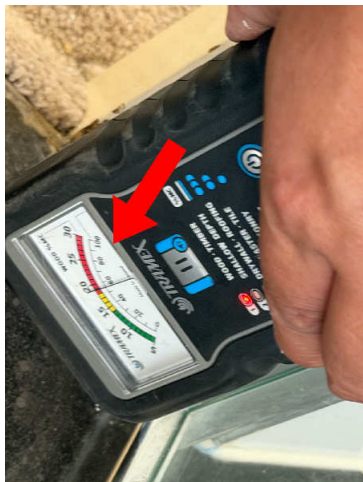
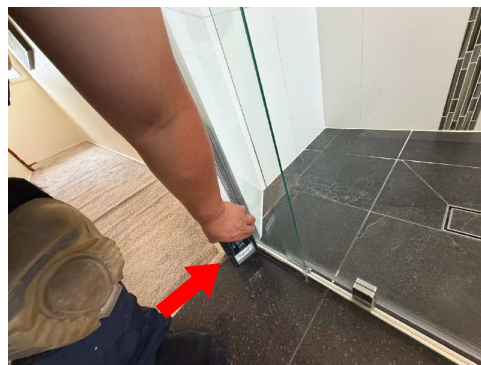
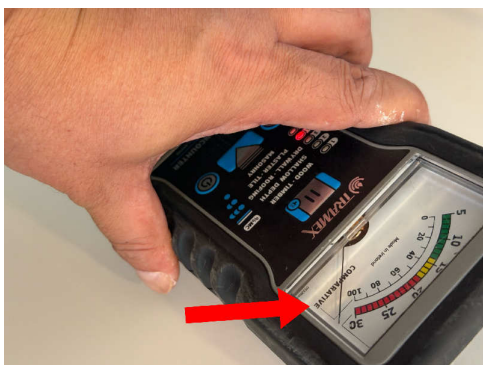
### Finding 3.02

Building:	Main Building
Location:	Bathroom 1 & Bathroom 3
Finding:	Shower damp - Monitor
Information:	Damp is evident to the wall outside of the shower area.

This defect is quite common, and is suspected to have been caused by moisture permeating or leaching through the grouting and perhaps gaps in the sealant prior to repair.

Monitoring the area is advised and if any visual signs of excessive moisture appear (peeling paint, mould) then consultation with a qualified plumber or bathroom specialist would be advised to identify the cause of damp and to perform remedial works as required.

Always ensure that sealant and grout is in good condition to prevent any moisture issues occurring in the future.

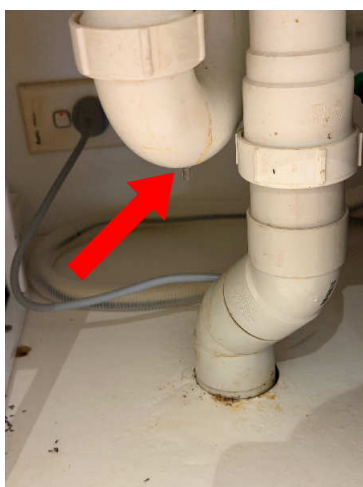
### Finding 3.03

Finding: Trap - Leaking

Information: The trap under sink in this area was found to be leaking at the time of inspection.

While this defect only seems minor, if left unmanaged, it is likely to result in the development of rust, water damage and/or extensive water usage.

It is advised that a handyman or licensed plumber be appointed to perform remedial works on the affected trap. Such works should be performed prior to the development of secondary defects to ensure adequate functionality of all associated building elements.

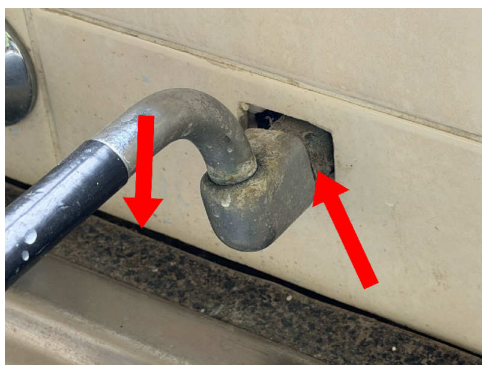
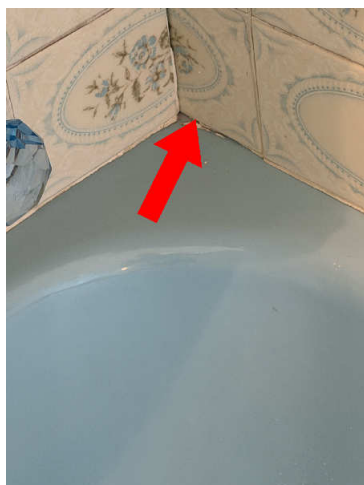
Finding: Sealant and grouting - Missing or damaged

Information: It was noted on inspection that sealant or grout is degraded in multiple locations of the property.

Different materials and floor areas move at different rates, generally causing cracking to grout or sealant at this point. A flexible sealant is required to allow for expected expansion and contraction, while keeping the joint water tight and protective of all associated building materials.

Flexible and mould resistant materials should be applied to affected areas to prevent any subsequent water damage that is likely to occur. Regular maintenance and replacement of damage or missing or damaged sealant and grout is highly recommended to the wet areas, as this is a regular wear and tear defect. Sealant and grouting in areas that come into regular contact with water should be maintained for the long term care of your property.

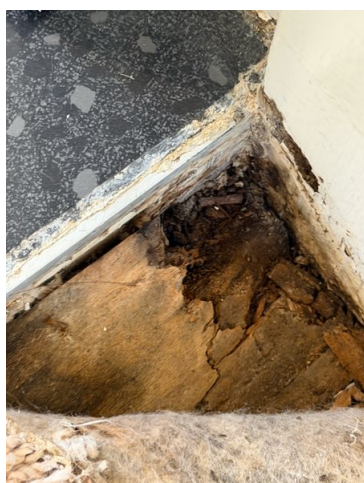
Finding: Wood rot

Information: Localised wood rot was noted to the timber at the floor. The affected area shows signs of moisture-related deterioration.

Monitoring and timely repair or replace are recommended to prevent further deterioration.

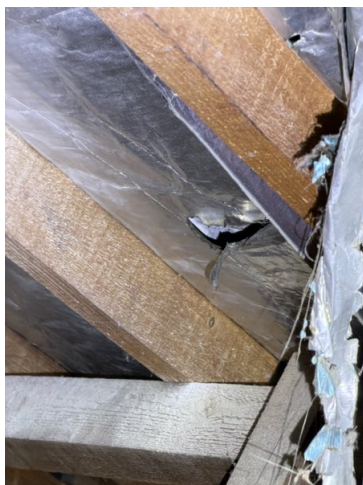
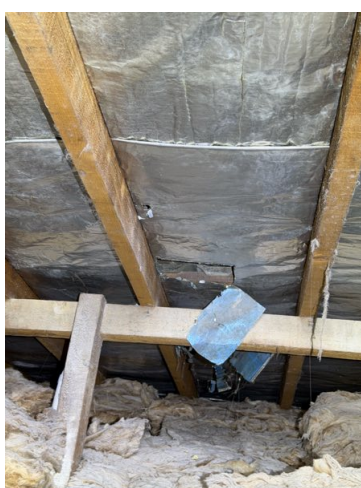
Finding: Sarking - Damaged

Where sarking is damaged, both insulation and moisture protection of the property are inhibited. This creates a loss of energy and thus negatively impacts the energy efficiency of the property, allowing potential for moisture ingress from condensation or leaking roof tiles.

It is important to repair any holes or damaged sections of sarking to ensure that the building material is fully functional. A register builder or qualified carpenter should be consulted to provide further advice on this defect and to perform rectification works at client discretion.
