# Building and Timber Pest Inspection Report

Inspection Date: Mon, 30 Mar 2026

Property Address: 55 Daintree Way, West Wodonga VIC 3690,  
Australia

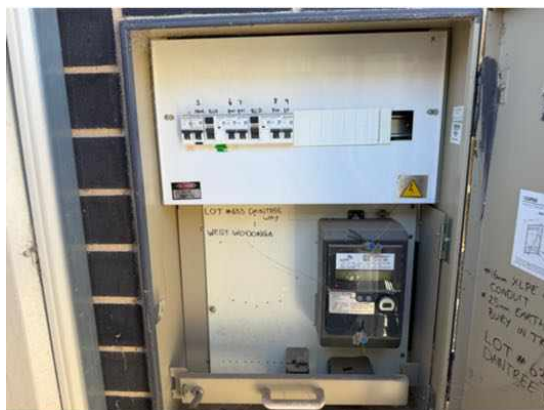
### Finding 6.01

Building: Main Building  
Location: Switchboard  
Finding: Termite Management System - no evidence of a chemical installation  
Information: No durable notice (evidence of termite treatment) was identified in the switchboard at the time of inspection. Recommend consulting with the building company to confirm what type of termite barrier is installed (if any), and provide future termite management plan.

12 monthly termite inspections, conducted by a qualified termite inspector are also advised. Recommend engaging a licensed pest controller, to provide further advice.

No durable notice was identified in the switchboard at the time of inspection. Recommend consulting with the building company to confirm what type of termite barrier is installed (if any), and provide future termite management plan. 12 monthly termite inspections, conducted by a qualified termite inspector are also advised. Recommend engaging a licensed pest controller, to provide further advice.

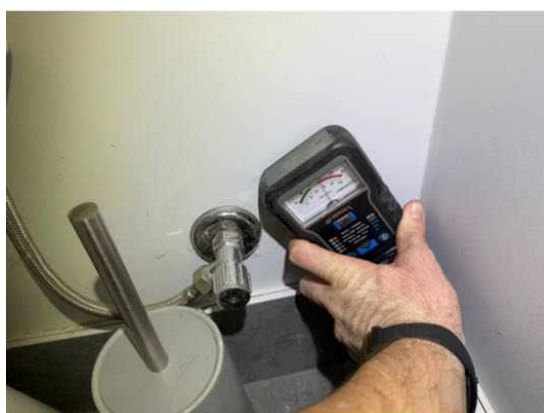
### Finding 6.02

Building:	Main Building
Location:	Ensuite Toilet
Finding:	Toilet - Elevated moisture reading
Information:	Slightly elevated moisture reading appeared to be present at, but not limited to beneath the toilet plumbing at the time of inspection.

Recommend client to monitor the area. Should further moisture or water damage become apparent, a licensed plumber should be engaged promptly, to identify the cause & provide remedial works where necessary.

Slightly elevated moisture reading was present at, but not limited to beneath the toilet plumbing. Recommend client to monitor the area. Should further moisture become apparent, a licensed plumber should be engaged promptly, to identify the cause & provide remedial works where necessary.

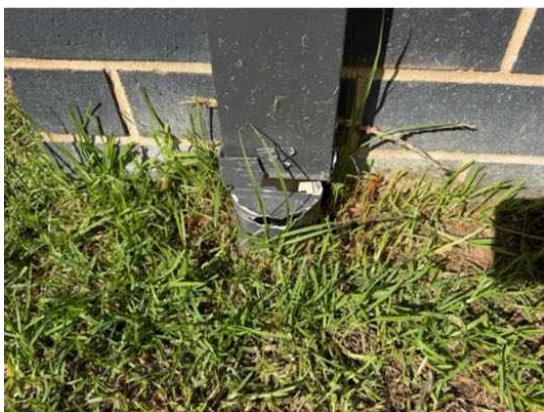
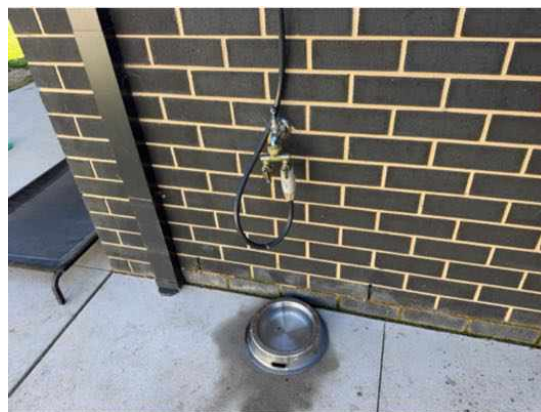
### Finding 6.03

Building:	Main Building
Location:	All external areas
Finding:	Potential Water pooling - against property
Information:	Potential areas of water pooling around the perimeter of the property were identified. Where insufficient drainage of taps, or broken down-pipes are present, water pooling is likely to occur, and can create areas conducive to timber pests.

Recommend consulting with a licensed plumber to provide further advice.

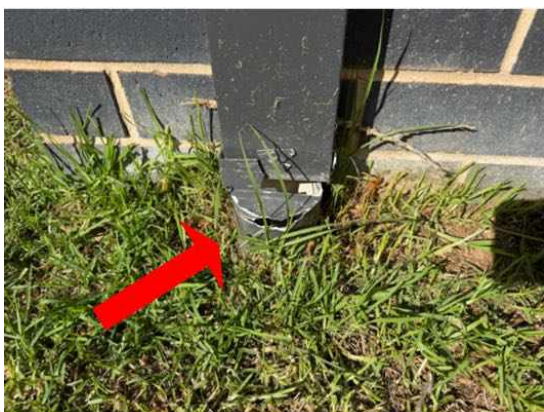
### Finding 6.04

Building:	Main Building
Location:	Front Elevation
Finding:	Down pipe - Minor Damage
Information:	Minor damage was identified to the base of the front down-pipe. Damaged down pipes can cause the area at the base to become damp, creating an environment conducive to termite activity. Recommend engaging a licensed plumber to provide minor remedial works where necessary.

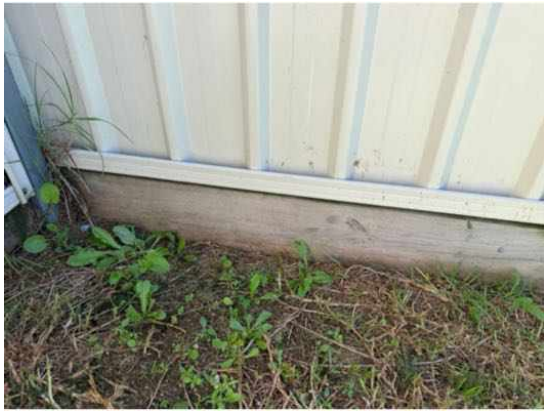
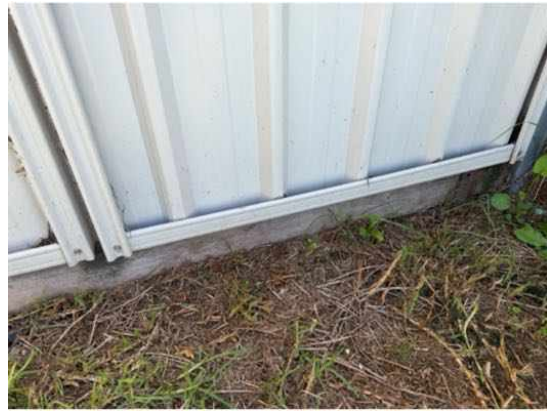
### Finding 6.05

Building:	Main Building
Location:	All External Areas
Finding:	Timber in direct ground contact - conducive to termites
Information:	Where timber materials are in direct contact with the ground and consequently moisture, they become conducive to termite activity. The landscaping timbers create an environment conducive to termite activity.

Where feasible, any timbers in direct contact with the ground should be inspected frequently to reduce the risk of termite infestation & detect any early signs of termite activity.

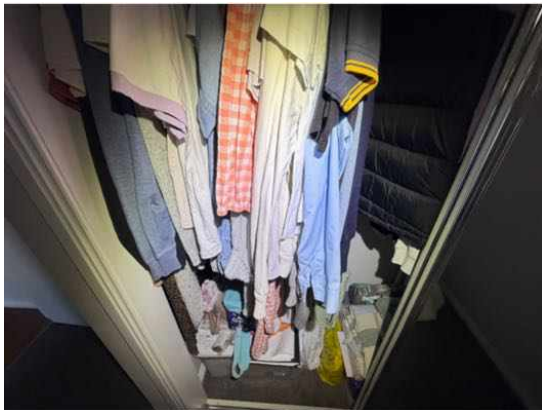
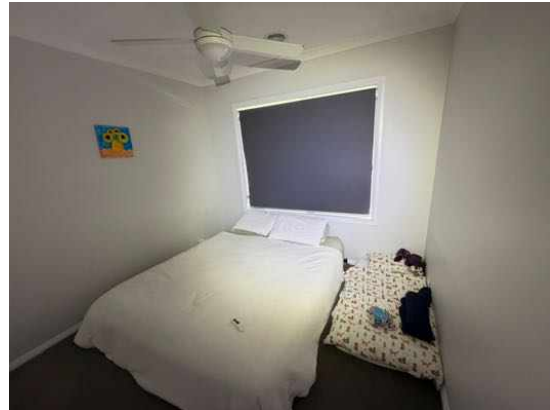
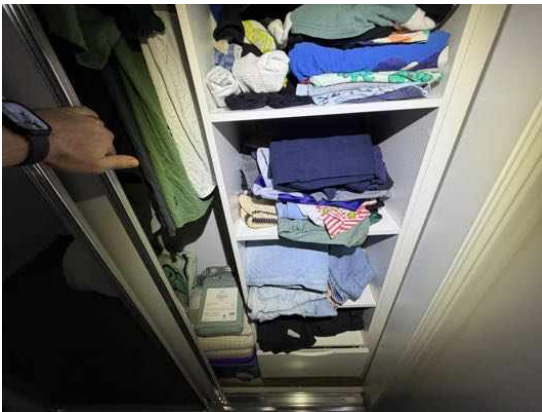
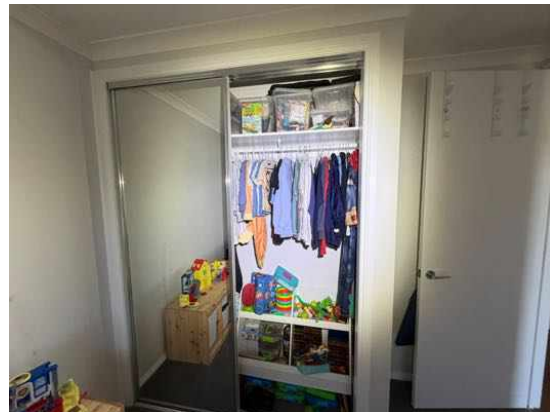
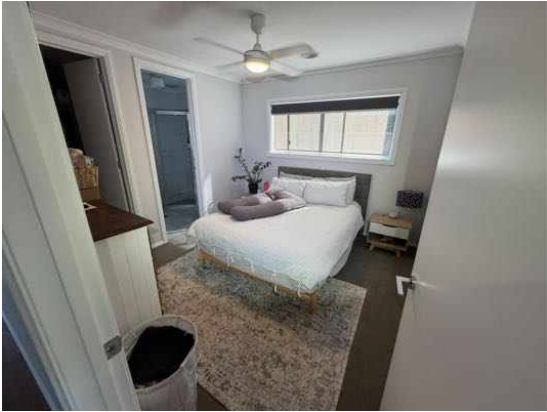
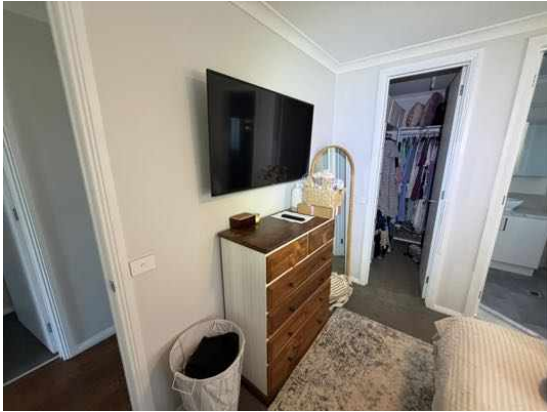
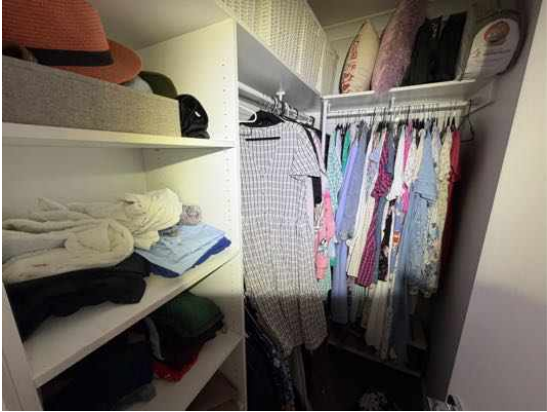
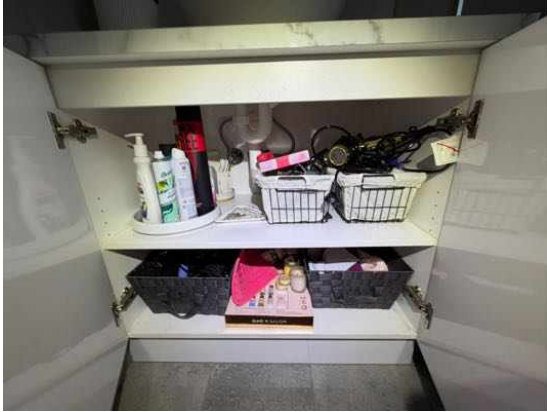
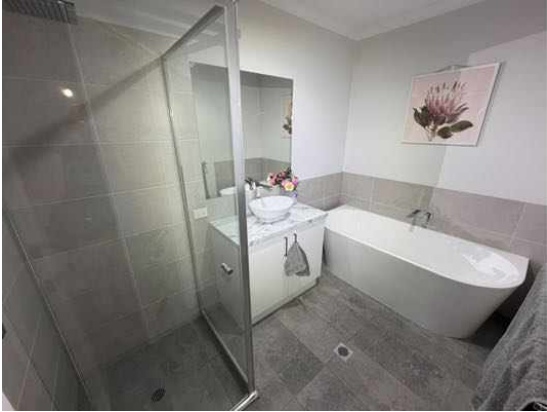
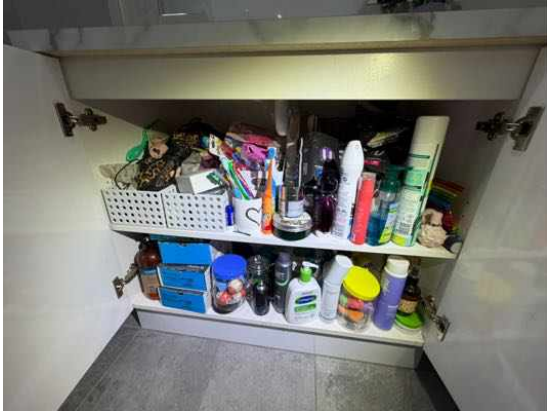
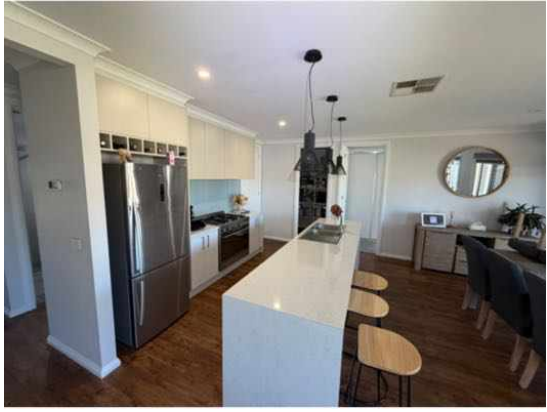
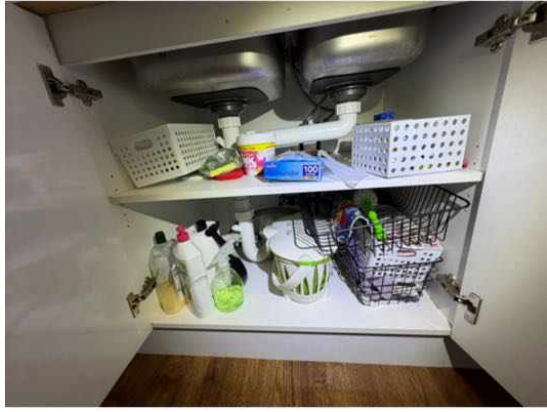
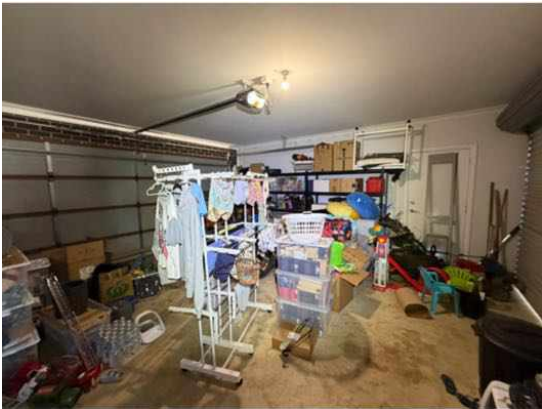
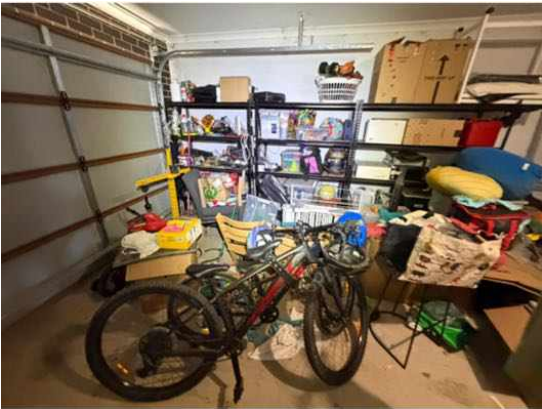
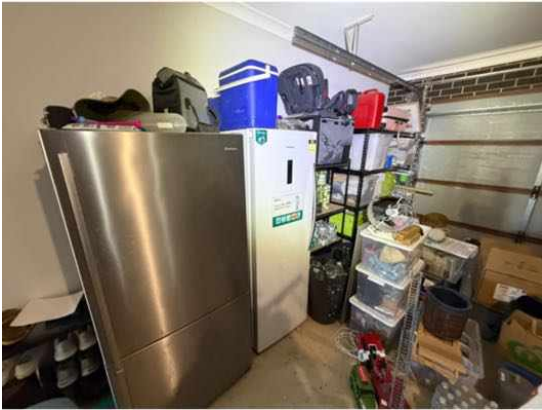
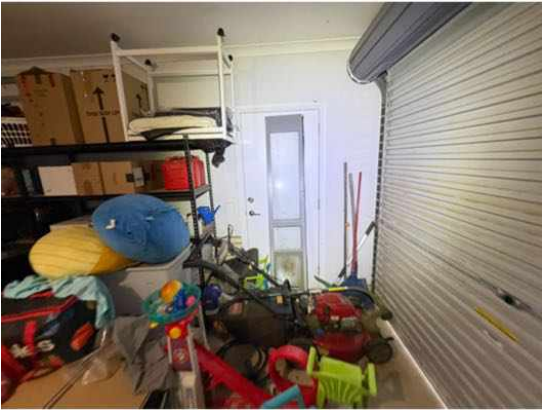
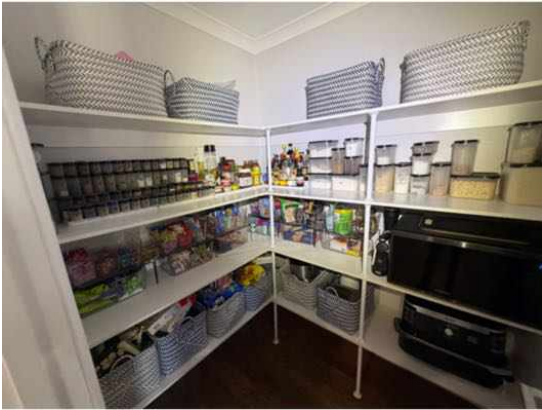
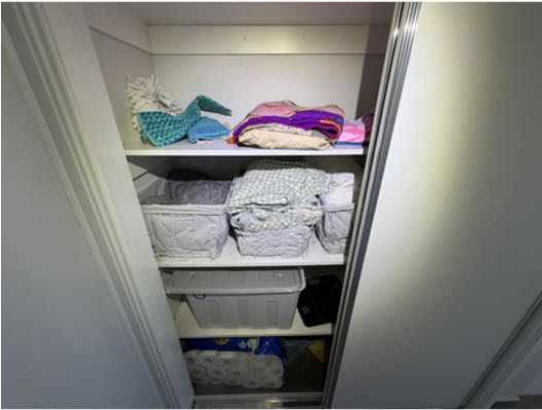
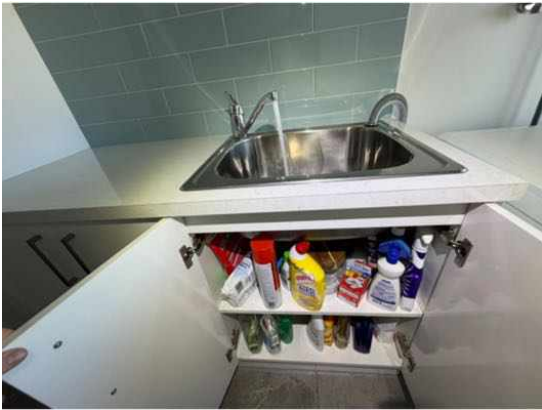
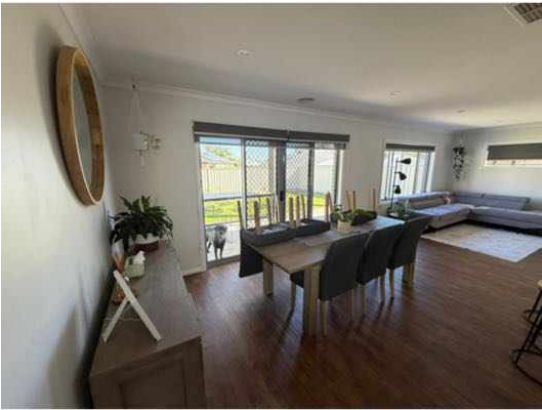
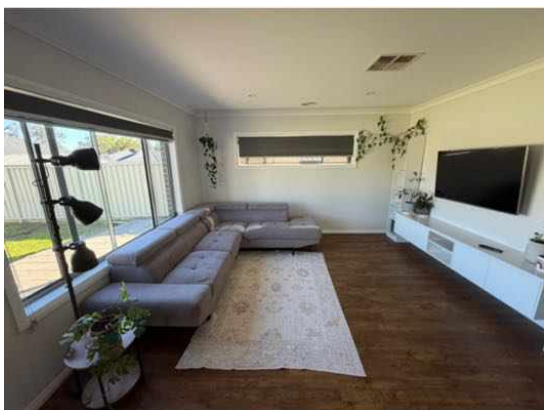
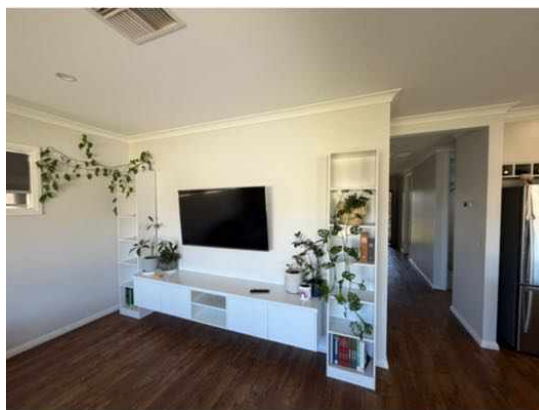
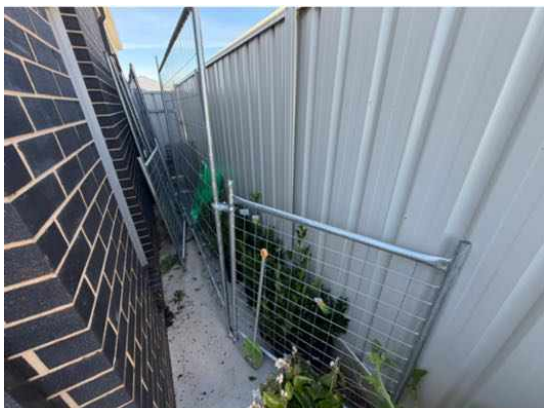
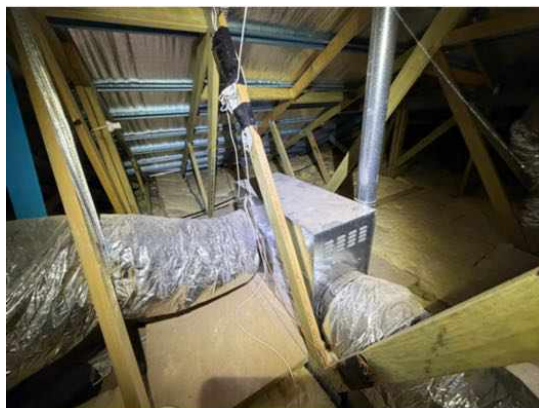
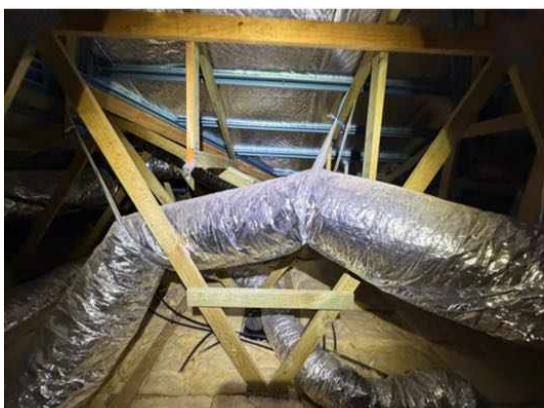
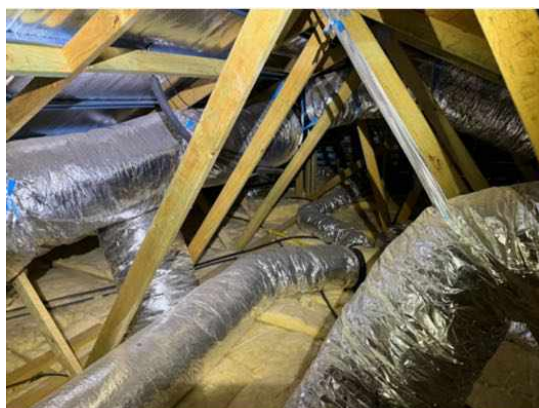
#### Noted Item

Building: Main Building  
Location: All Areas  
Finding: Additional Photos - Obstructions and Limitations  
Information: These photographs are an indication of the obstructions and limitations which impeded full inspection of the property at the time of inspection. These obstructions can hide an array of defects and should be removed to allow full inspection to be carried out. A re-inspection is recommended once the areas are made accessible.

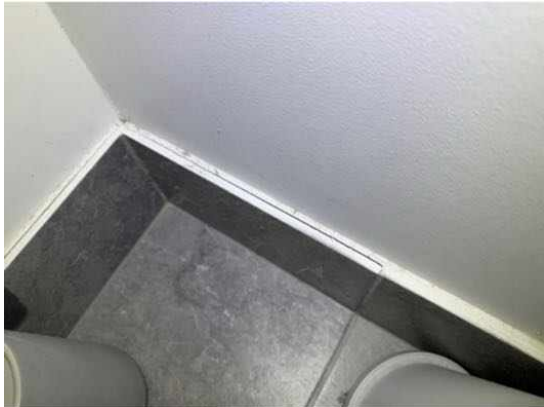
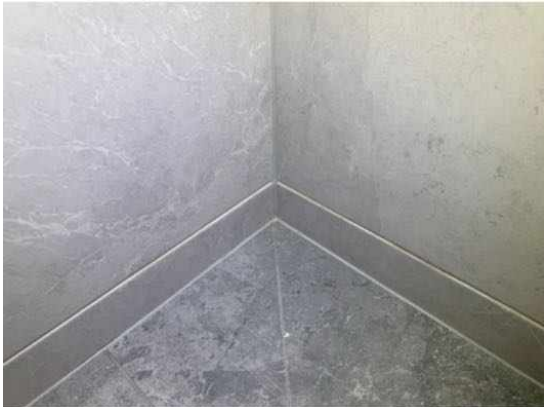
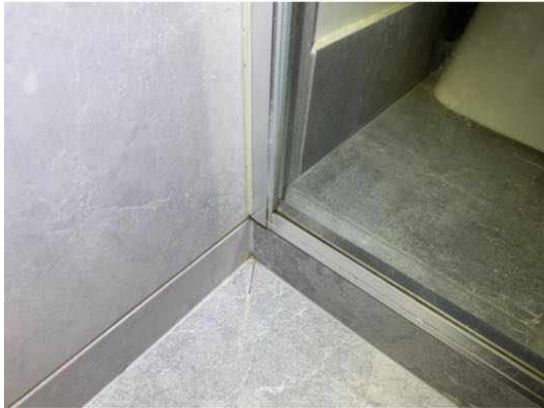
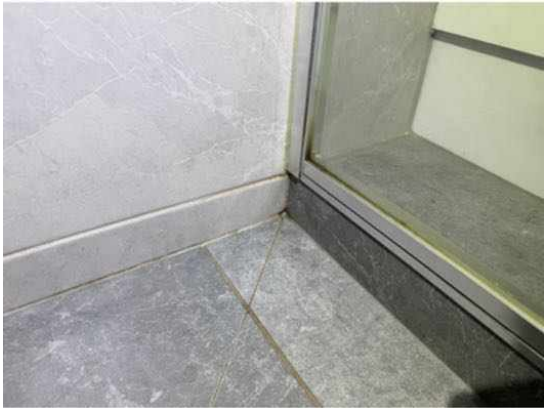
### Noted Item

Building: Main Building  
 Location: Tiled Areas  
 Finding: Sealant and grouting - Monitor & General Maintenance  
 Information: It appears that the sealant and grouting in the tiled areas are slightly weathered, a common defect in houses of a similar age.

It is noted for the clients information that sealant and grouting in areas that come into regular contact with water should be maintained.

Should the sealant deteriorate further, a tiling contractor should be engaged to provide maintenance works where necessary to ensure all wet areas are sufficiently sealed.
