# Building and Timber Pest Inspection Report

Inspection Date: Fri, 13 Mar 2026

Property Address: 9A Lewis St, South Wentworthville NSW  
2145, Australia

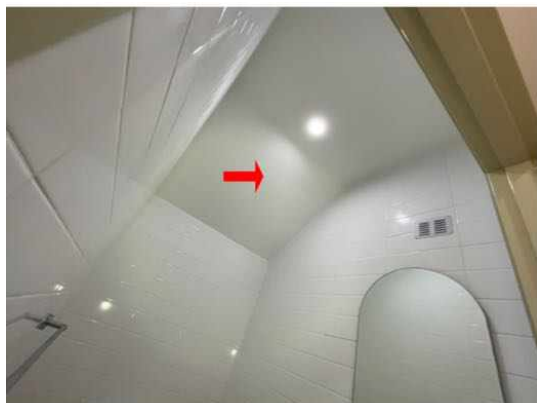
#### Finding 1.01

Building:	Main Building
Location:	Powder room
Finding:	Exhaust fan - Missing
Information:	An exhaust fan has not been installed in this area. Missing exhaust fans may lead to the development of more significant defects such as moisture damage to surrounding building materials from inadequate ventilation. Inadequate ventilation in internal areas creates an environment that is conducive to the formation and development of mould and other respiratory hazards. It is highly advised that a licensed electrician be appointed to retrospectively install an exhaust fan. Failure to perform works to aid the ventilation of the area may lead to the development of these secondary defects.

Exhaust fan was found to be missing from the powder room, requiring urgent replacement by a licensed electrician.

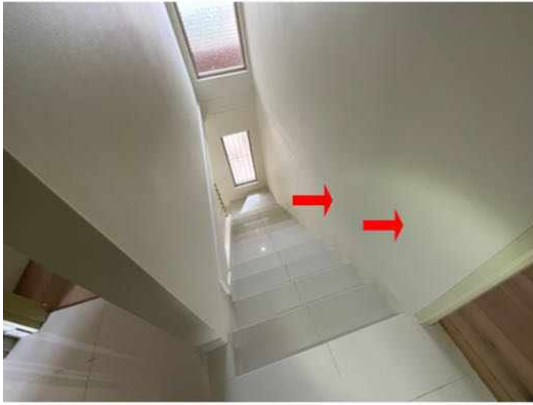
#### Finding 1.02

Building:	Main Building
Location:	Staircase
Finding:	Handrail — Missing
Information:	A complying handrail was found to be missing in this area at the time of inspection.  According to NCC 2022 Volume 2 -Housing Provisions  Part 9.5 - Stairways and ramps  Clause 9.5.2.2 - Handrails  "A stairway must have at least one handrail if it has 4 or more risers."  A licensed builder must be appointed urgently for rectifications.

Complying handrails were found to be missing from the staircase, requiring urgent rectifications by a licensed builder.

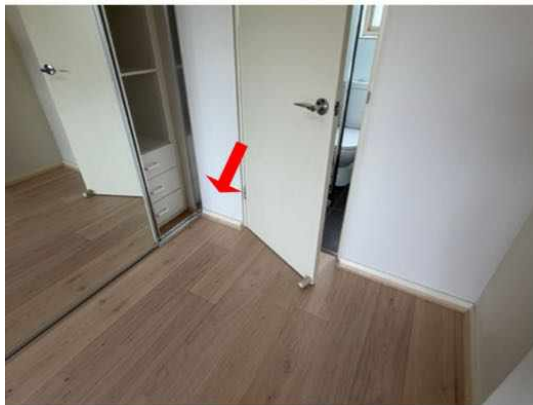
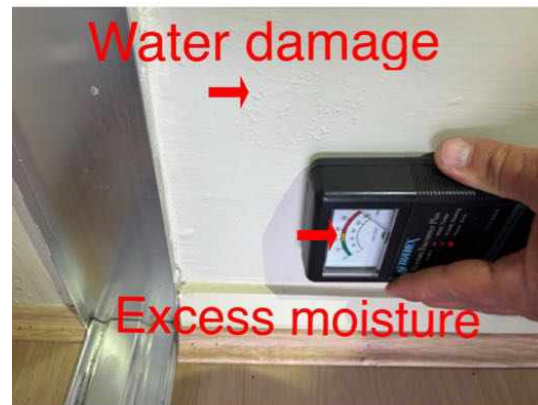
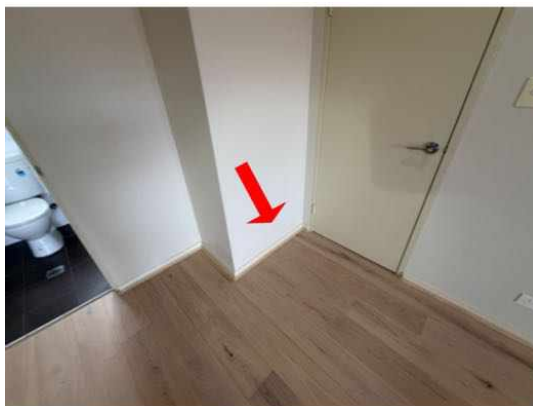
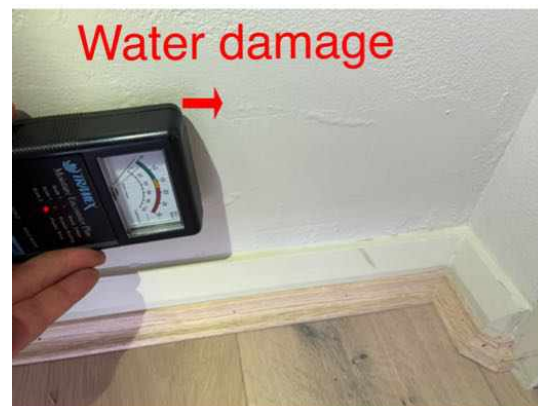
Building: Main Building  
 Location: Bathroom, ensuite  
 Finding: Waterproofing damage - Suspected

Information: Excessive moisture was detected in these areas at the time of inspection. Internal water leaks can be detrimental to surrounding building elements. The potential cause in this area is damage to the waterproofing membrane inside the both showers.

Attracting termites, corrosion, mould, decay and water damage are potential outcomes where a minor water leak is left unattended. More serious defects may also result, such as electrical hazards, or water damage to structural building elements.

In extreme cases, structural damage may develop due to a prolonged water leak. It is highly advised that this issue be addressed immediately by a bathroom specialist as a matter of relative urgency.

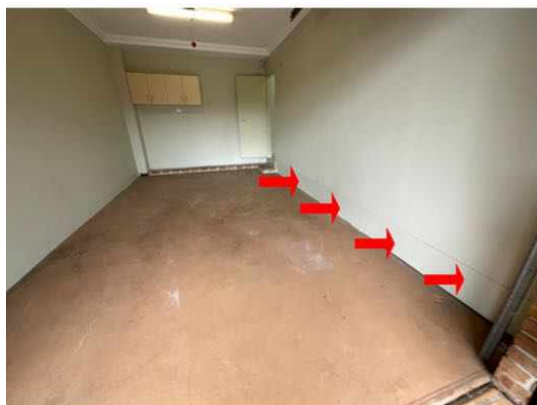
### Finding 3.01

Since damp is affecting surfaces below the DPC, no action is required at this stage. Regular monitoring must be carried out for any future changes.

Consultation with a licensed builder may be considered for any recommended remedial works. It is advised the render under the DPC to be stripped back to the substrate.

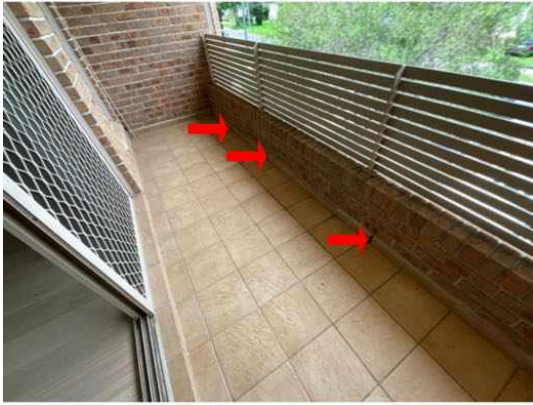
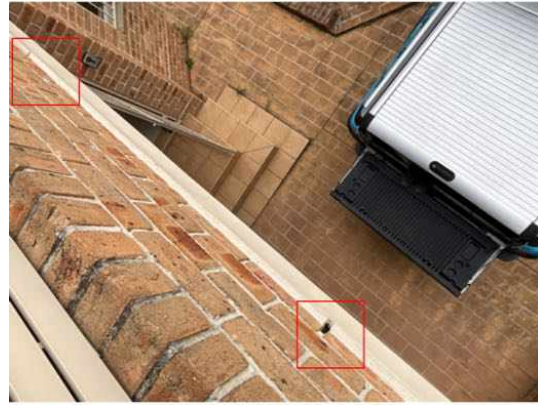
### Finding 3.02

Building:	Main Building
Location:	Balcony, Stormwater tank
Finding:	Stormwater drain - Not connected
Information:	The roof plumbing is not adequately connected to stormwater drainage on the site. This disconnection negatively impacts the functional capacity of the roof plumbing.

Where roof plumbing doesn't drain adequately, the area at the base perimeter can become excessively damp, potentially creating an environment that is susceptible to rust and corrosion of surrounding building elements, as well as attracting termites and other pests.

It is highly recommended that a plumber be appointed to further inspect the area and to install adequate drainage equipment where necessary.

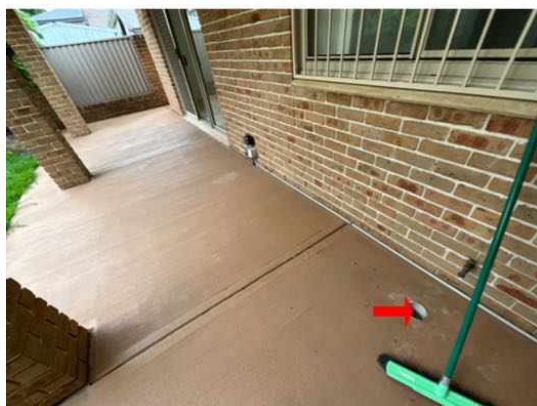
### Finding 3.03

Building:	Main Building
Location:	Alfresco
Finding:	Plumbing - Point of connection non-compliant
Information:	At the time of inspection it was noted that connections between above ground pipe work and below ground sewer/storm water systems were incomplete.

Additionally, where sewer pipes are concerned, gases can escape from unsealed connections which can pose a serious health risk.

Engagement of a certified plumber is strongly recommended to ensure all connection points are sealed in accordance with the plumbing construction guidelines.

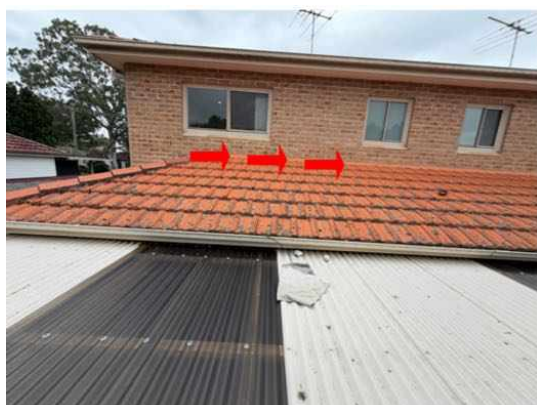
### Finding 3.04

Building:	Main Building
Location:	Flashing
Finding:	Roof plumbing - Flashing cracked
Information:	Water leaks generally occur when a particular area of the property is not weather or water tight. Cracks were evident to the roof flashing in this area at the time of inspection.

Regardless of the location, if left unmanaged, even minor leaks can lead to serious damage of associated building elements, potentially resulting in the need for replacement of building materials. Damage to ceilings, wood rot, mould and other hazards, such as electrical hazards, may also arise if left unmanaged.

Further inspection and repair by a roof specialist or a licensed roof plumber is advised to adequately rectify the potential leak.

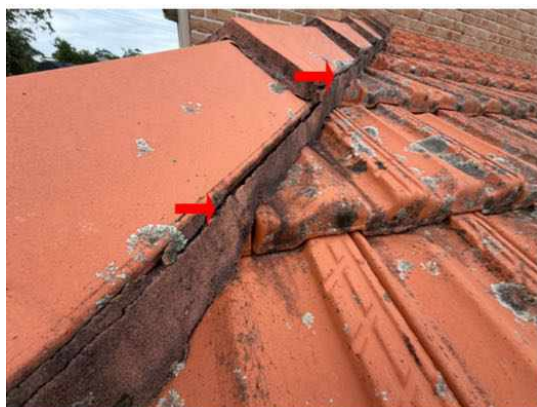
### Finding 3.05

Building:	Main Building
Location:	Roof Exterior
Finding:	Roof tiles - Weathered
Information:	Upon inspection of the exterior roofing, the majority of roof tiles were considered to be

in a fair condition. While weathering of the tiles is consistent with the age of the property, maintenance works are required.

Isolated areas of mortar have come loose and minor cracking is also present. Re-pointing and re-sealing the may be considered as an interim solution by the client to help preserve and extend the life span of the tiles.

Where left unmanaged, deteriorating roof tiles are likely to lead to a number of secondary defects, including minor water leaks and weather exposure to internal roofing structures.

Consultation with a licensed roofing contractor is highly advised to gain advice on cost of remedial works that may be required in the short to medium term. Remedial works are likely to increase the longevity of the exterior roofing structure.

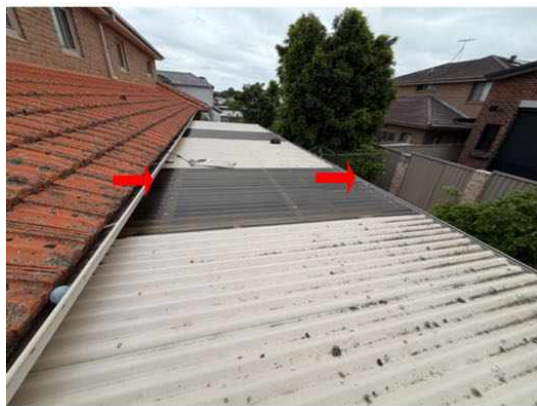
### Finding 3.06

Building:	Main Building
Location:	Gutters >
Finding:	Gutters - Debris
Information:	Roof plumbing structures, such as guttering and downpipes, should be free of all debris to prevent blockages. Blockages of the guttering and downpipes will lead to pooling and accumulated water overflows, which is likely to subsequently flood eaves and exterior walls.

Blocked gutters are likely to lead to high levels of moisture in the affected areas. Such moisture will not only cause rust and decay of the associated building materials, but can also provide conditions that are conducive to termite and timber pest activity. Blockages in gutters should therefore be removed immediately to ensure dry conditions are maintained.

Consult a Licensed Plumber for further specific advice on remedial works that may be

required. In the interim, it is highly advised that blocked gutters be removed by the homeowner or a general handyperson as a matter of urgency.

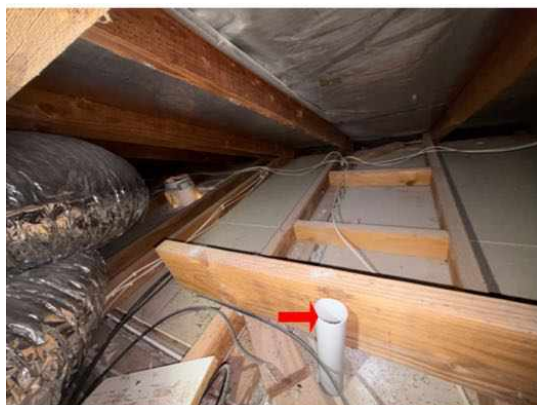
### Finding 3.07

Building:	Main Building
Location:	Roof Void
Finding:	Sewer vent pipe - Suspended in the roofvoid
Information:	The pipe vent was found to lead directly into the roof space, rather than venting to the exterior of the building.

A licensed plumber should be appointed as soon as possible to provide further consultation on the scope of these works and to provide quotations for any necessary works.

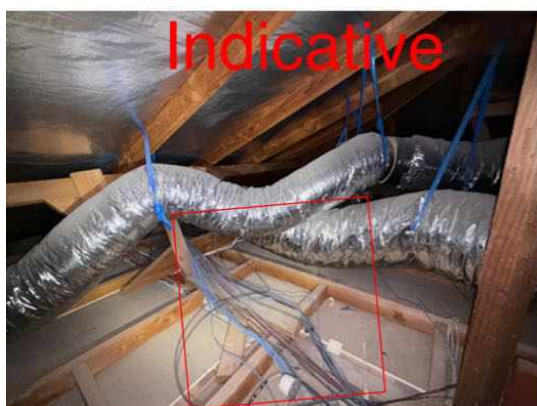
### Finding 3.08

Building:	Main Building
Location:	Roof Void
Finding:	Insulation - Missing
Information:	Upon inspection of the roof void it was noted that insulation is not present.

property as there is a lack of Insulation (or uneven coverage of insulation) which works as a barrier to heat transfer. This helps to keep out unwanted heat in summer and preserves warmth inside your home in winter. It can also help soundproof your home from unwanted airborne noise transfer.

Where insulation is absent, the area does not meet current Australian Standards. Installation of adequate insulation is required and should be conducted as soon as possible.

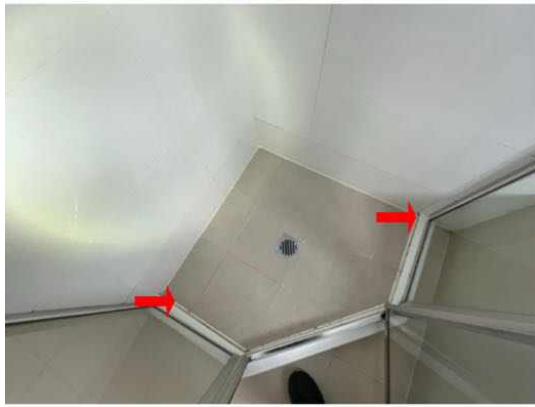
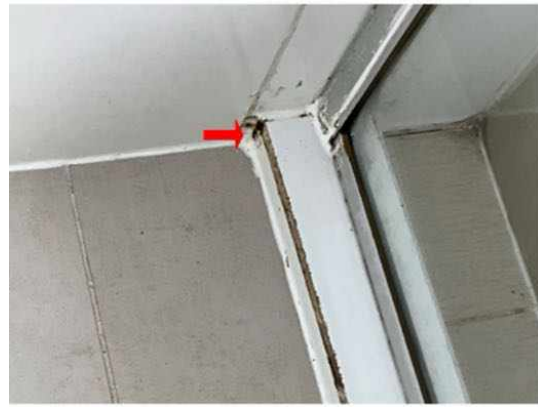
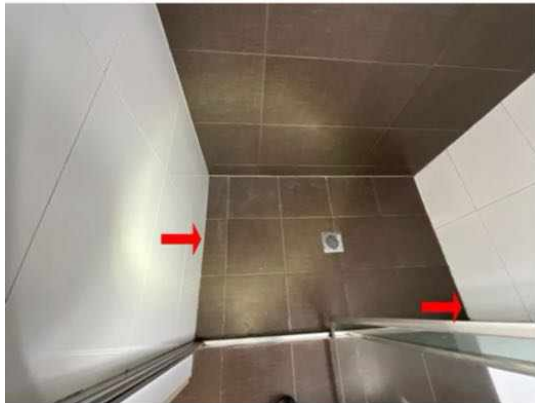
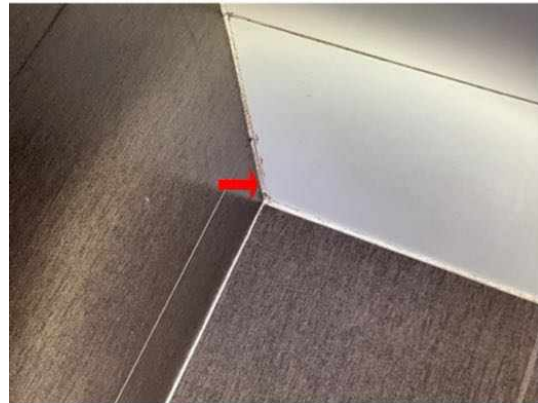
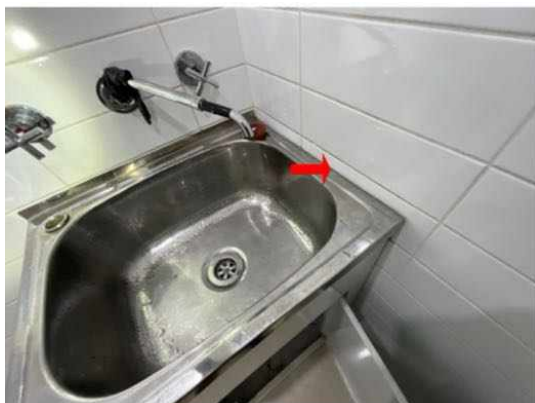
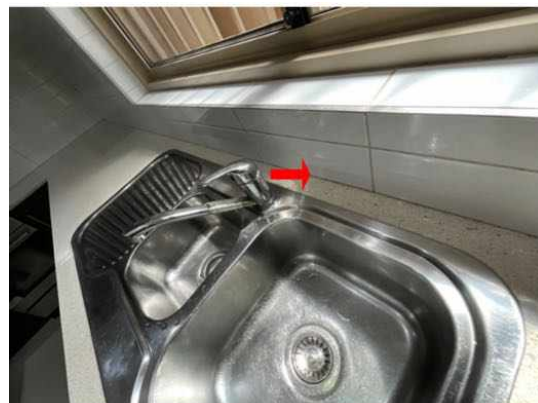
### Finding 3.09

Building: Main Building  
 Location: All Wet Areas  
 Finding: Sealant and grouting - Missing or damaged  
 Information:

It was noted on inspection that sealant or grout is degraded to this area.

Different materials and floor areas move at different rates, generally causing cracking to grout or sealant at this point. A flexible sealant is required to allow for expected expansion and contraction, while keeping the joint water tight and protective of all associated building materials.

Flexible and mould resistant materials should be applied to affected areas to prevent any subsequent water damage that is likely to occur. Regular maintenance and replacement of damage or missing or damaged sealant and grout is highly recommended to the wet areas, as this is a regular wear and tear defect. Sealant and grouting in areas that come into regular contact with water should be maintained for the long term care of your property.

A sealant specialist should be appointed to complete these works as soon as possible.

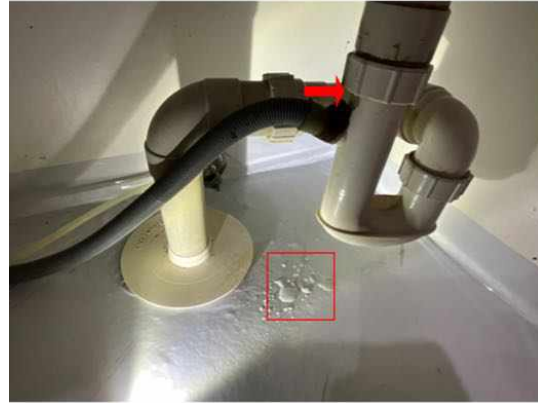
### Finding 3.10

Finding: Water leak - Active

Information: Generally, water leaks occur when a particular area of the property is not weather or water tight. As the surrounding area was found to be damp at the time of inspection, the leak is considered ongoing and hence requires urgent action.

Regardless of the location, even minor leaks that are left unmanaged can lead to serious damage of associated building elements and result in the need for replacement of building materials. Mould and other hazards such as electrical hazards may also arise if the leak is left to develop.

It is highly advised that the cause of the leak be identified and resolved immediately by a licensed plumber to prevent any further damage. Depending on the extent of the damage previously sustained, repair and/or replacement of any affected building materials may be required.

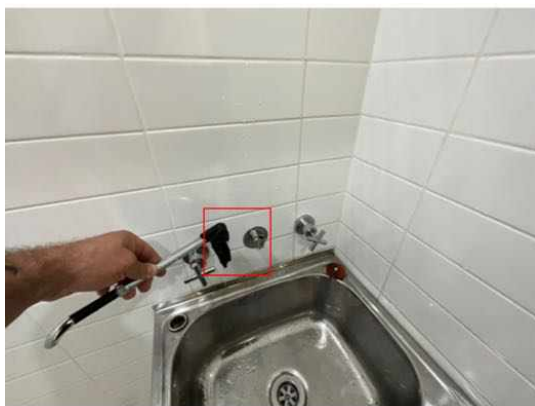
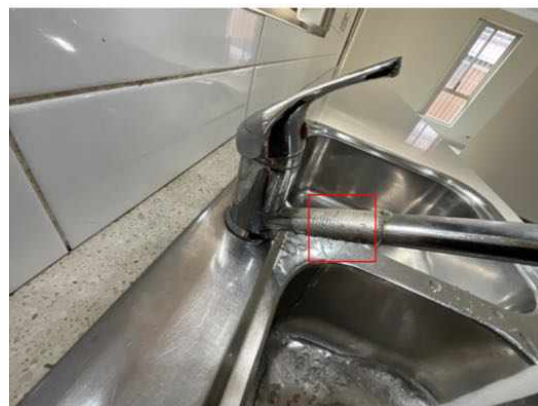
### Finding 3.11

Building: Main Building  
 Location: Laundry, kitchen  
 Finding: Plumbing fitting or fixture - Damaged  
 Information: The fitting in this area is damaged and requires replacement.

If left unmanaged, the fitting may further deteriorate, causing potential for the development of other minor secondary defects.

A licensed plumber should be appointed to perform these rectification works at discretion of the client.

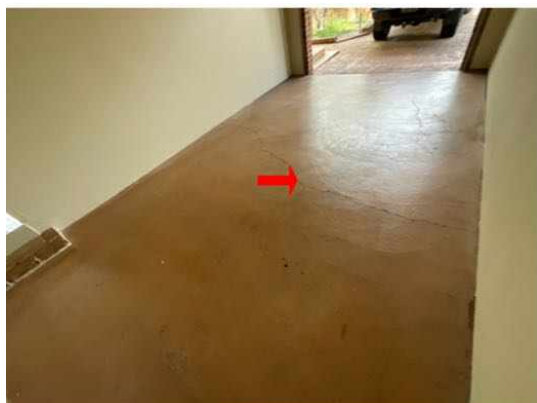
### Finding 3.12

Finding: Crack in concrete slab - Category 2  
 Information: A crack coded as Category 2 was identified in the slab. A Category 2 crack is described as a distinct crack, with the slab being noticeably curved or changed in level.

To be considered Category 2, the approximate width of the crack is less than 2.0mm, or a change in offset of less than 15mm when a 3m straight edge is placed over the defect.

Category 2 cracks to slabs should be monitored for a period of 12 months. At the end of the monitoring period, cracks rated greater than Category 2 are considered defects that require rectification.

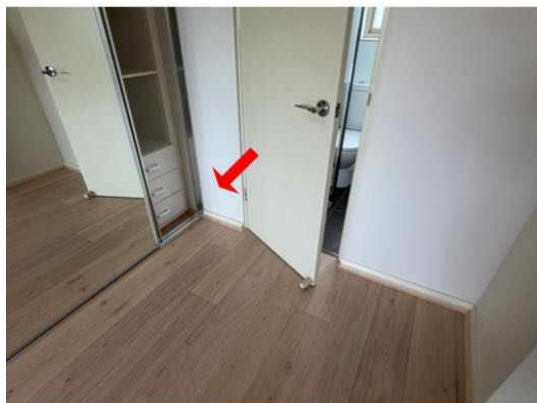
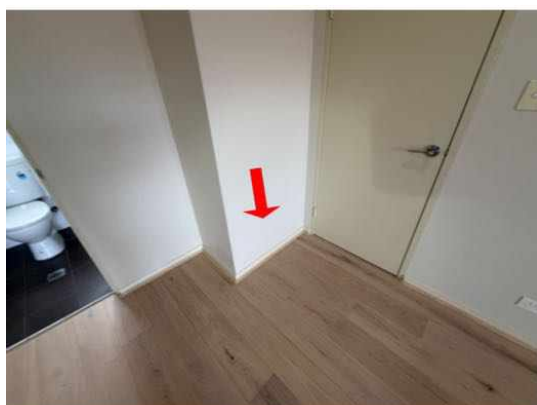
Building: Main Building  
 Location: Bathroom, ensuite  
 Finding: Waterproofing damage - Suspected  
 Information: Excessive moisture was detected in these areas at the time of inspection. Internal water leaks can be detrimental to surrounding building elements. The potential cause in this area is damage to the waterproofing membrane inside both showers.

Attracting termites, corrosion, mould, decay and water damage are potential

outcomes where a minor water leak is left unattended. More serious defects may also result, such as electrical hazards, or water damage to structural building elements.

In extreme cases, structural damage may develop due to a prolonged water leak. It is highly advised that this issue be addressed immediately by a bathroom specialist as a matter of relative urgency.

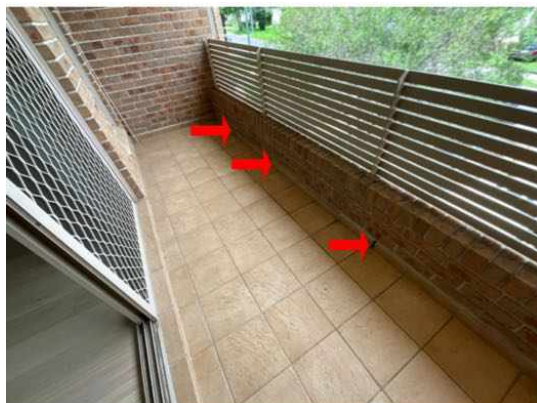
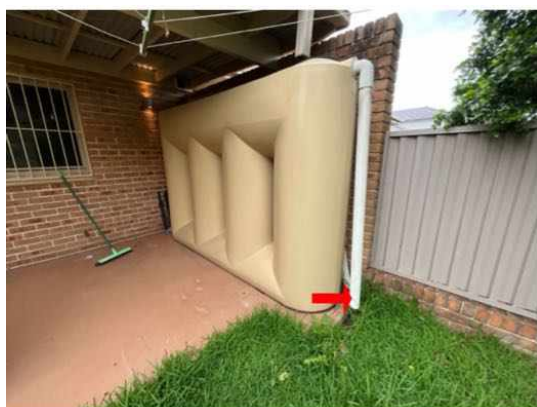
### Finding 6.02

Building:	Main Building
Location:	Slab penetrations
Finding:	Service penetrations
Information:	Services into home can allow for concealed termite entry without additional or adequate termite protection.

Where roof plumbing doesn't drain adequately, the area at the base perimeter can become excessively damp, potentially creating an environment that is susceptible to rust and corrosion of surrounding building elements, as well as attracting termites and other pests.

It is highly recommended that a plumber be appointed to further inspect the area and to install adequate drainage equipment where necessary.

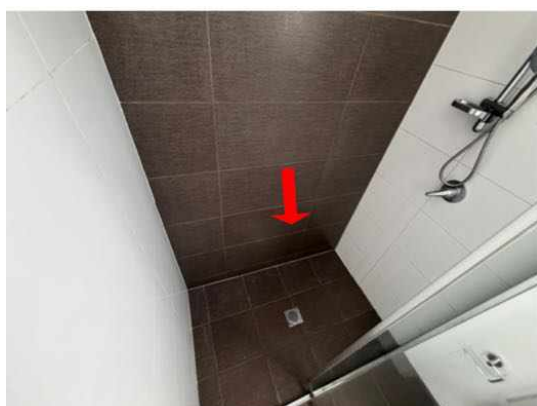
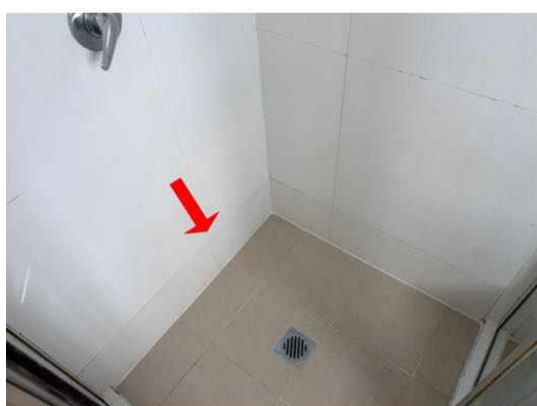
#### Finding 6.04

Building:	Main Building
Location:	Bathroom, ensuite
Finding:	Shower damp - Sealant and grout
Information:	Damp is evident to the lower 400mm of wall to the shower alcove. This defect is quite common, and is suspected to have been caused by moisture permeating or leaching through the grouting and sealant in this area, which shows evidence of deterioration. Leaking pipes within the wall is also a possible cause however this seems unlikely in this instance as there is no moisture build up around the taps or transferring to the other side of the wall. There appears to be no sealant around the tap spindles which may be a small contributing factor.

Damp (or structural damp) refers to the presence of unwanted moisture in the structure of a building, either as the result of intrusion from outside, or condensation

from within the structure. In the shower area, internal water leaks, degraded materials or other sources of excessive moisture are generally the cause of damp.

Unmanaged damp in the shower recess is likely to facilitate the formation and development of mould and fungi growth, decaying associated building materials and compromising their structural integrity of associated elements. It is important to address damp conditions, as the World Health Organisation notes that excess moisture leads - on almost all indoor materials - to growth of microbes such as moulds, fungi and bacteria, which subsequently emit spores and other matter into the indoor air. Exposure to these contaminants is associated with a wide range of respiratory and other health-related problems. Damp conditions also create a conducive environment for termite infestation.

Consultation with a bathroom sealant specialist is advised immediately to identify the cause of damp and to perform remedial works as required.

Always ensure that sealant and grout is in good condition to prevent any moisture issues occurring in the future.

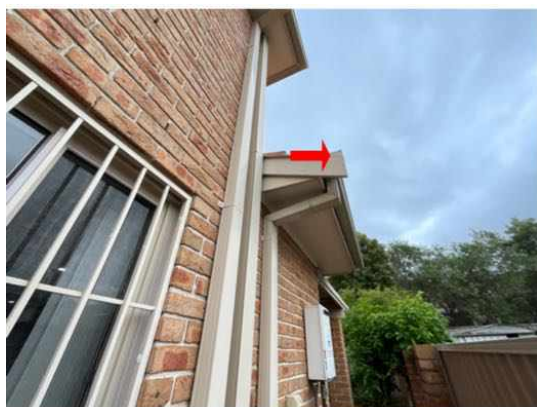
### Finding 7.01

Building:	Main Building
Location:	LHS
Finding:	Wood rot/decay
Information:	This building element shows evidence of wood rot. Wood rot, also known as Fungal Decay, occurs when timbers and other cellulose building materials are exposed to damp conditions on an ongoing basis. This could be the result of exposure to weathering over a prolonged period of time, or the attraction of excessive moisture from other abutting building materials. Contributing factors also include poor air ventilation in the area.

Wood rot is often associated with general damp problems and is evidenced by a `musty` smell or mould and mildew occurring on surfaces. If left unmanaged, damp conditions can lead to further health problems and the decay of timbers will continue.

Early intervention and regular maintenance, particularly of exterior timbers, will prolong the useful life of these building elements. Prior to any works being performed, the cause of the moisture that has created the visible wood rot should be identified and addressed in a suitable manner. Replacement of affected timbers may then be a necessary step in protecting surrounding building elements from such deterioration.

A licensed plumber may be appointed to assess the cause of excessive moisture and to provide advice on any remedial works as required. A licensed carpenter may also be required to replace affected building materials.
