Building Inspection Report

Inspection Date: Fri, 27 Feb 2026

Property Address: 16 Avenue Rd, Prospect SA 5082, Australia

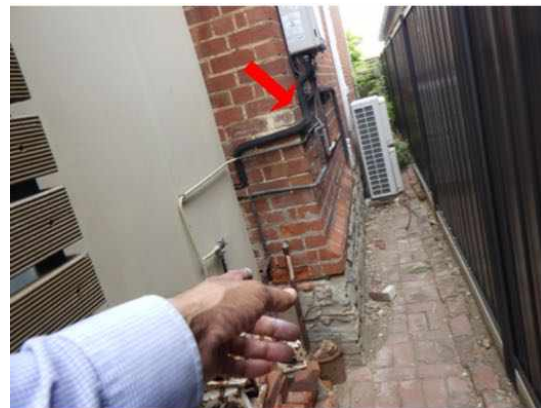
Defects 1.01

Building:	Building 1
Location:	All External Areas
Finding:	External Area – Rear- Suspected Gas Leak
Information:	At the time of inspection, evidence consistent with a suspected gas leak was observed at the rear external wall area, in close proximity to the hot water system/unit. The presence of a potential gas leak represents a serious safety risk, including the risk of fire, explosion, or health hazards to occupants.

Failure to promptly address this issue may result in serious injury, property damage, or further regulatory non-compliance.

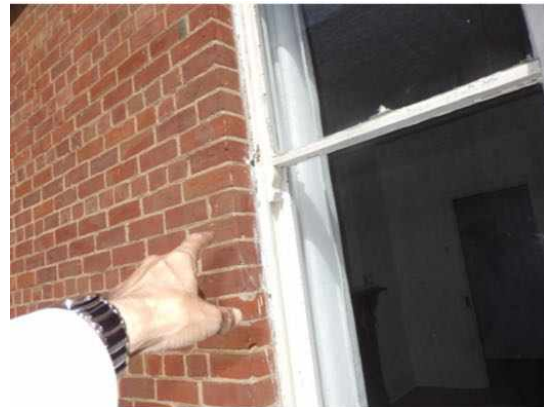
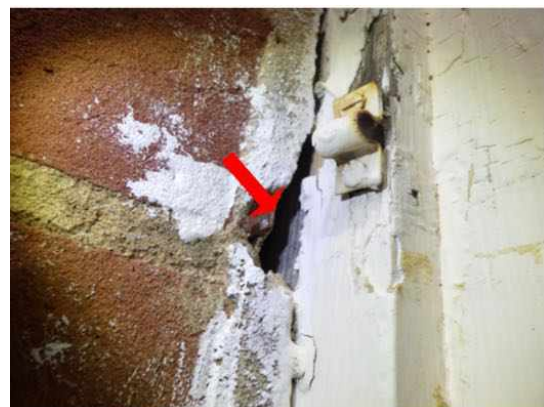
Defects 2.01

Finding: External Walls & Window Frame Assemblies - Significant Gaps Observed

Information: At the time of inspection, it was noted that significant gaps are present between the external wall cladding and several window frame assemblies at various locations around the property. These gaps indicate poor detailing, movement, deterioration of materials, or inadequate installation and sealing.

Such conditions may arise due to age-related degradation, environmental exposure, or physical damage. If left unrectified, these gaps may allow water and air ingress, potentially leading to secondary defects, including moisture damage, deterioration of adjacent building elements, and reduced thermal and weatherproof performance.

Repair and/or replacement of the affected components is recommended to reinstate the integrity and performance of the building envelope. All building elements play an essential role in the operation and overall performance of the structure, and defects of this nature may adversely impact durability and habitability.

It is advised that a suitably qualified and licensed tradesperson be engaged as soon as practicable to assess and rectify the affected areas to prevent further deterioration or consequential damage.

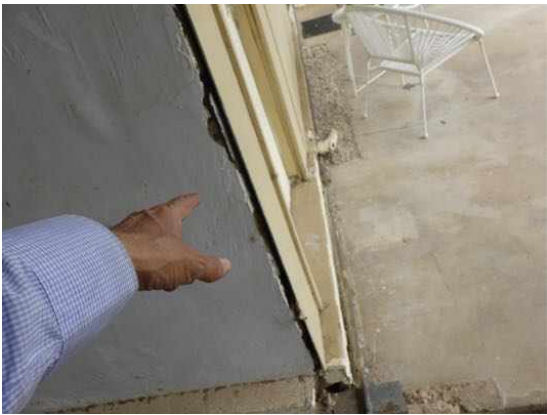
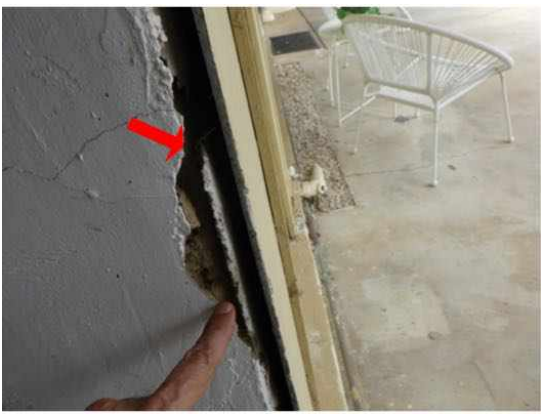
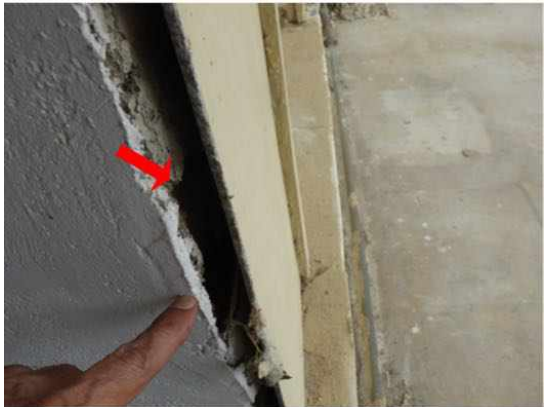
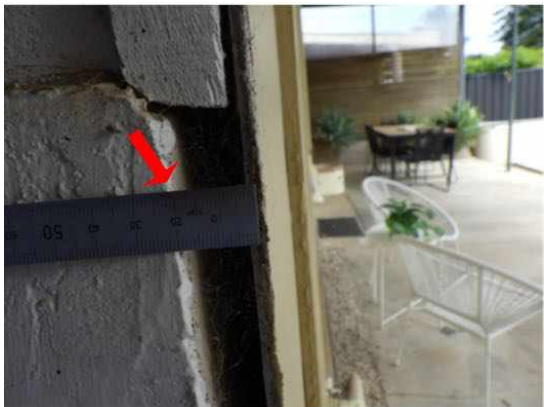
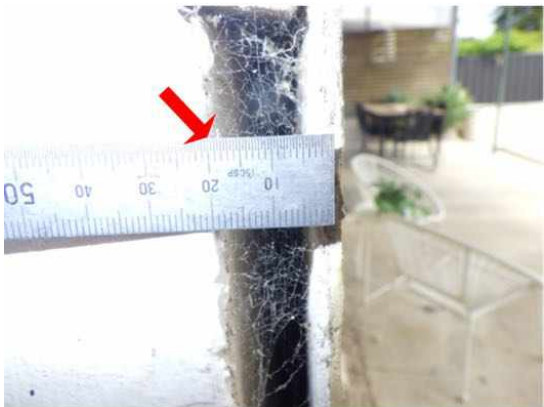
Defects 2.02

Building: Building 1
Location: All External Areas
Finding: External Walls – Rear - Significant Gaps at Joints / Loose from Original Fixing
Information: At the time of inspection, it was observed that the rear external wall cladding exhibits significant gaps at several joint locations, and sections appear loose from their original fixing. These conditions indicate inadequate installation, movement, deterioration of materials, or possible fixing failure.

Breakage and separation of building elements can occur due to age-related deterioration, environmental exposure, or physical damage. If left unaddressed, such defects may allow moisture ingress and contribute to secondary issues, including structural degradation and reduced performance of the building envelope.

Repair and/or replacement of the affected wall sections is recommended to restore the integrity and performance of the external wall system. All building elements form an integral part of the overall structure, and defects of this nature may adversely affect the building’s durability and weather resistance.

It is advised that a suitably qualified and licensed tradesperson be engaged as soon as practicable to assess, repair, or replace the affected areas to prevent further deterioration or consequential damage.

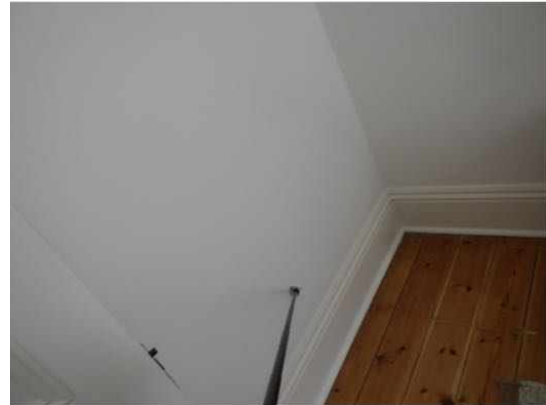
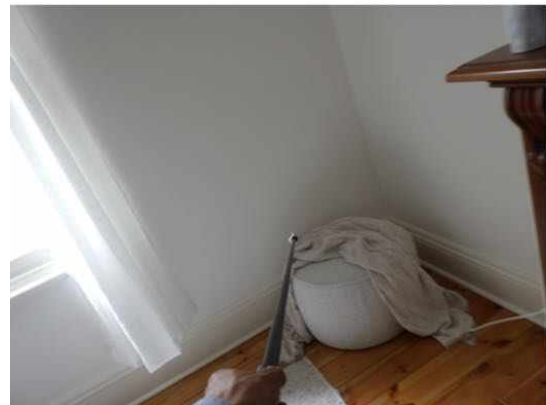
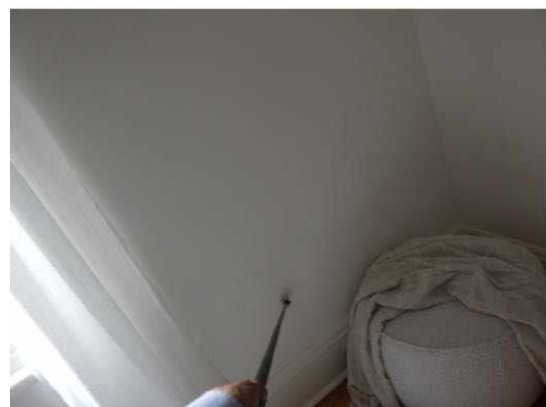
Defects 2.04

Building:	Building 1
Location:	All Areas
Finding:	Internal walls - Damp at lower base
Information:	At the time of inspection it was noticed that high moisture readings were noted in few sections of internal walls around the property at lower base.

Unmanaged damp facilitates the formation and development of mould, fungi growth and wood rot, decaying associated building materials and compromising their structural integrity. Damage to finishes is also likely to occur, including lifting, bubbling, peeling and staining of paint, plaster and wallpaper.

should be addressed first prior to repairing the appearance and other defects which have resulted from the rising damp. If the original cause is not resolved, further cases of damp are likely to ensue, resulting in secondary defects.

Consultation with a qualified plumber is advised immediately to identify the cause of damp and perform remedial works as required. Where excessive mould growth is present, further inspection by a specialist environmental health inspector should also be considered.

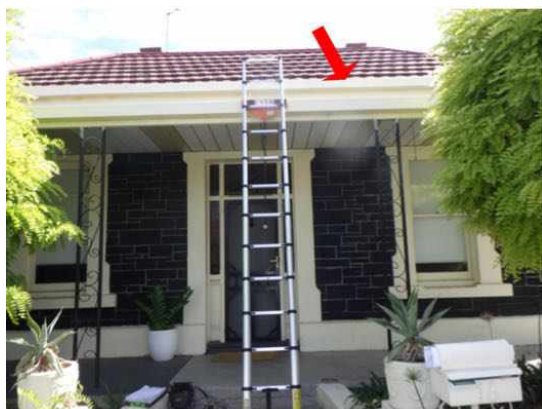
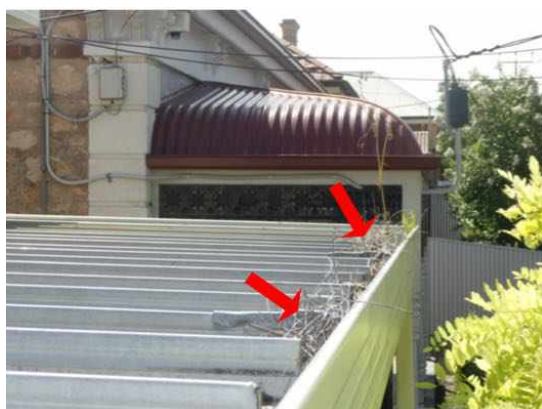
Defects 3.01

Blocked gutters are likely to lead to high levels of moisture in the affected areas. Such moisture will not only cause rust and decay of the associated building materials, but can also provide conditions that are conducive to termite and timber pest activity. Blockages in gutters should therefore be removed immediately to ensure dry conditions are maintained.

Consult a Licensed Plumber for further specific advice on remedial works that may be required. In the interim, it is highly advised that blocked gutters be removed by the homeowner or a general handyperson as a matter of urgency.

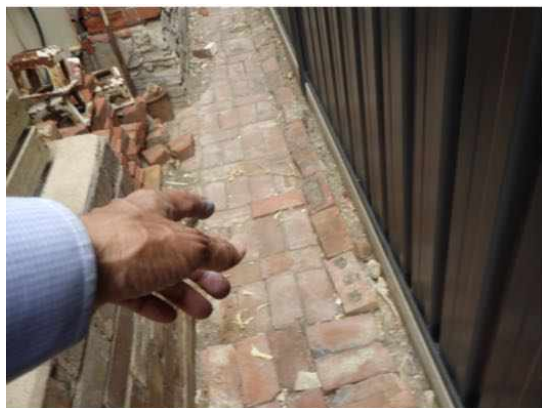
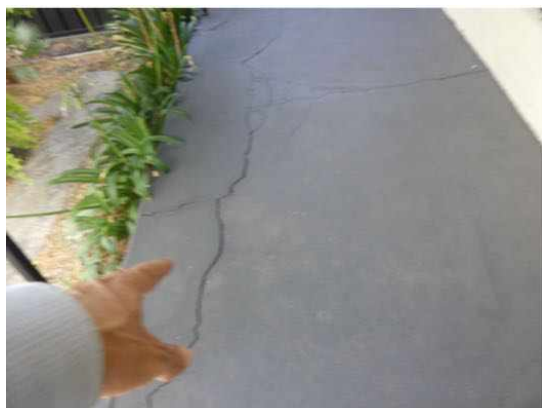
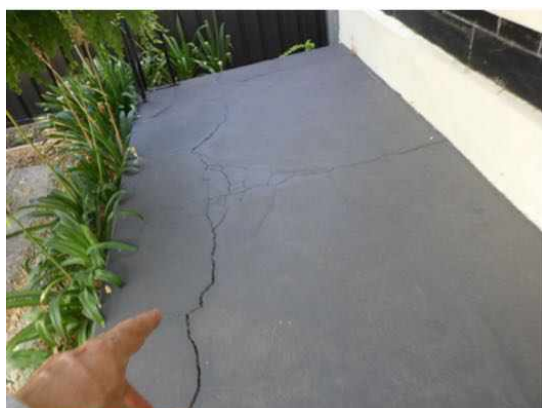
Defects 3.03

Information: Sections of the external paved area are uneven, creating a potential trip hazard. It appears as though the area has been subject to rough installation, or that paving sections have lifted due to movements in the foundation of the property.

Where paving creates a trip hazard, personal injury may ensue if due caution is not taken by all persons within this area.

Re-paving of the area is required as soon as possible to remedy this situation. Further consultation with a specialist concreter is advised.

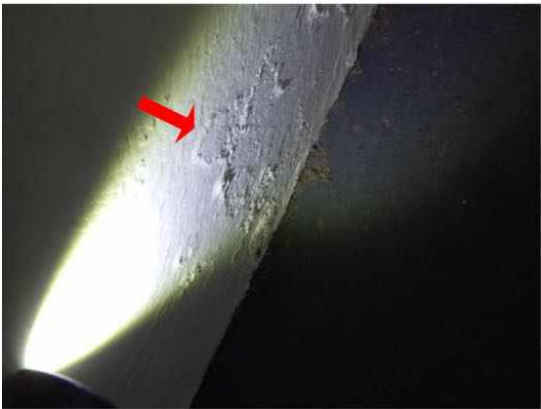
Defects 3.04

Building:	Building 1
Location:	All External Areas
Finding:	Plaster - Drummy
Information:	Sections of plaster sheeting in this area appear to be drummy. The term 'drummy' is used to describe plaster which, whilst solid, has become detached from its original fixing.

The most common causes of plaster failure are physical damage and moisture damage. Moisture causes plaster to swell and shrink as the humidity of the air changes, or as a consequence of leaks, which can be enough to create drumminess or cracking.

Drummy plaster generally needs chemical re-adhesion or to be screwed back to the substrate, with minor consequent patching and painting required.

Ensure that the general environment is free of moisture and humidity to aid in the prevention of drummy plaster and plaster damage. Appointment of a qualified plasterer is advised in order to complete remedial works as necessary.

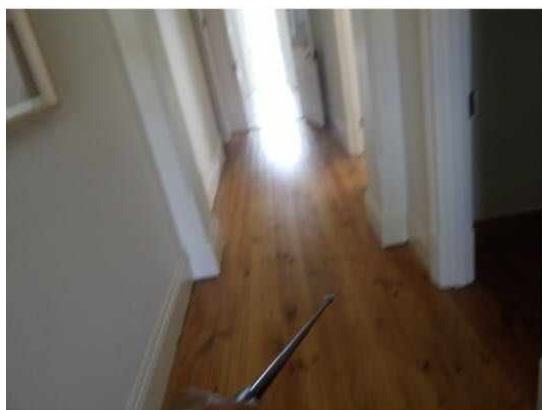
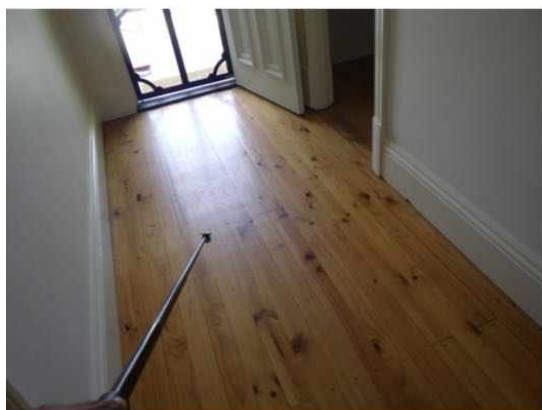
Defects 3.05

Bouncy floors generally indicate that the floorboards or the subfloor structures are coming loose from the joists that they are installed on. Bouncy flooring may also be the result of gaps between flooring and stumps or joist structures, which require packing.

The client is advised to seek quotations for required repairs from a Registered Builder specialising in re-stumping. The potential resolution may range from packing gaps in subfloor structures through to replacement of subfloors stumps and refixing of flooring.

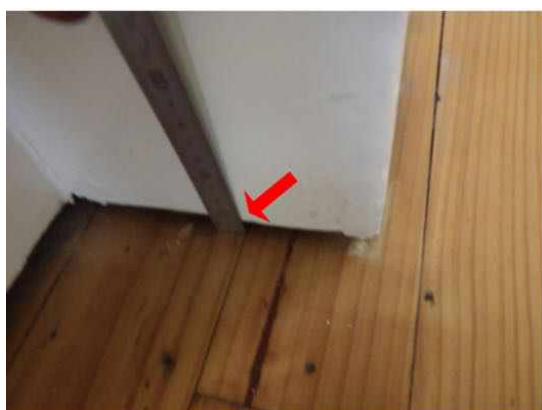
Defects 3.06

Building: Building 1
Location: All Internal Areas
Finding: Timber flooring - Gaps to edges
Information: Considerable gaps were noticeable around door jambs and edges of flooring. These gaps serve the purpose of allowing the flooring material to expand and contract, which is expected due to moisture levels and humidity.

While purposeful, these gaps make the adjoining building elements prone to water penetration, creating potential for the development of secondary damage.

While beading is used in most places to cover this gap around smaller corners, it is recommended that these gaps be filled with a coloured caulking compound. Such works should be performed by a qualified carpenter or general handyperson, and should be completed at the discretion of the client.

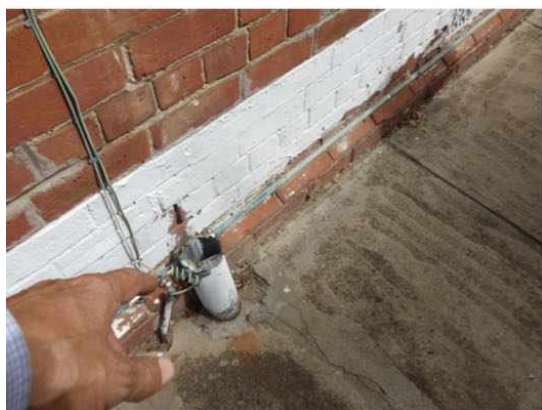
Defects 3.07

Building:	Building 1
Location:	All Areas
Finding:	Building element - Damaged
Information:	At the time of inspection it was noticed that rear flyseen door frame assembly and pipe were damaged

Breakage occurs generally when the building materials have either aged and decayed, or as a result of damage (accidental or deliberate).

Repair and/or replacement of broken elements is advised to ensure that additional secondary defects do not arise as a consequence. Such works are necessary, as all building elements play a key role in the operation and function of the overall structure and its performance.

A relevant tradesperson should be appointed to repair or replace the affected building element prior to any subsequent damage being caused.

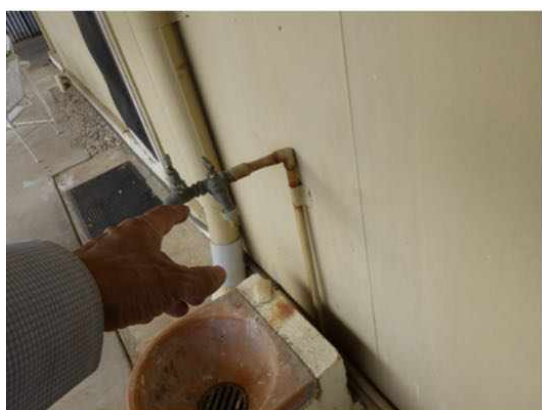
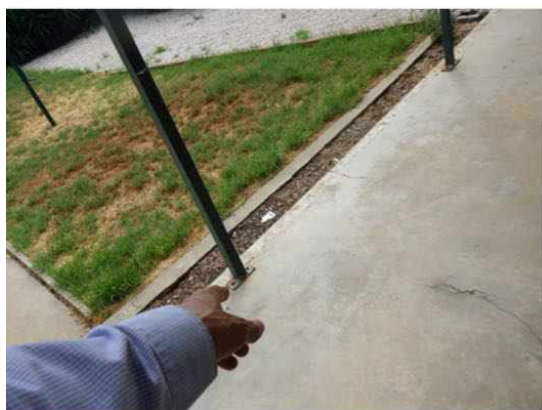
Defects 3.08

Building:	Building 1
Location:	All External Areas
Finding:	Building element - Rusted or corroded
Information:	This building element shows evidence of rusting and corrosion, which is likely to have developed as a result of excessive exposure to moisture and or inadequate coatings.

As surface rust provides no protection to the underlying iron, the deteriorating condition is likely to worsen if not addressed in the short-term future.

Where possible, the use of galvanized (treated) metals or aluminium coated metals aid in rust prevention, as does regular general maintenance. Rust formation can be controlled with coatings, such as paint, that isolate the iron from the environment.

Rusting and corrosion should be managed by ideally removing or limiting the affected surface from exposure to moisture. A registered builder may be appointed to replace any building elements that have been severely affected by rust or water damage.

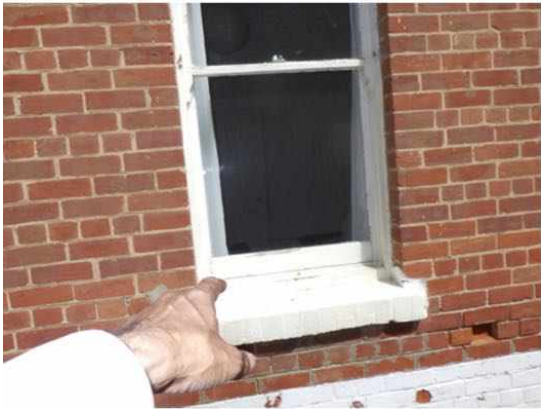
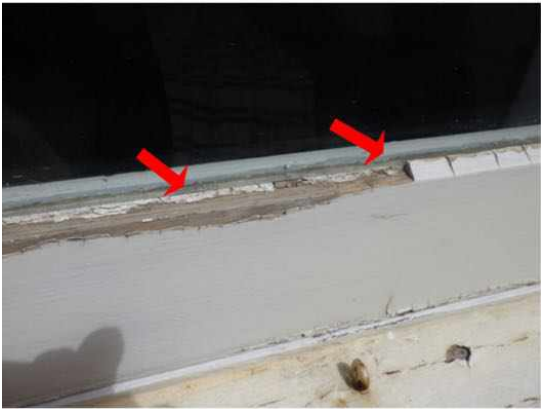
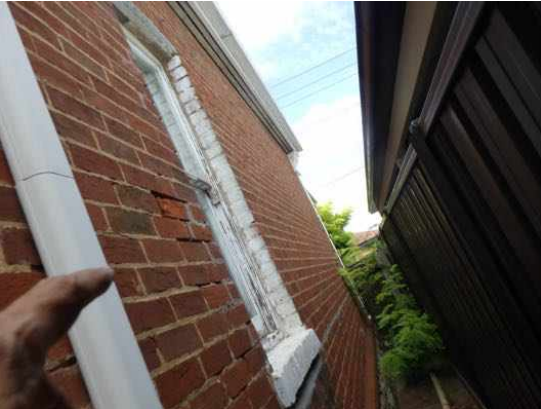
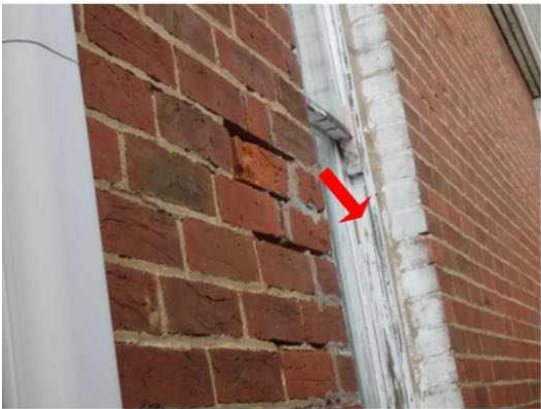
Defects 3.09

Building:	Building 1
Location:	All External Areas
Finding:	External painting deteriorated
Information:	Much of the external paintwork including but not limited to windows, fascias, guttering, veranda and other external fitments have been neglected and require attention to prepare and re-paint.

Whilst incomplete or missing paint finish is generally an appearance defect, it can also lead to the development of secondary building defects over time. Incomplete areas of paint finish expose the area to moisture, potentially accelerating the deterioration of underlying building materials.

Degraded paint finishes should be sanded back, filled, leveled and painted, as applicable. Where inadequate or missing paint protection has led to the deterioration of the associated building element, repair and/or replacement of this building element may be required.

A painting contractor should be appointed as soon as possible to perform necessary works to aid the appearance of the affected area and to ensure the area is protected against further deterioration. Alternatively, the homeowner following manufacturer instructions may perform these works.

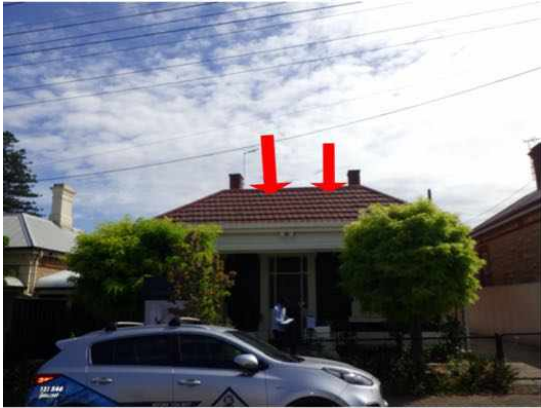
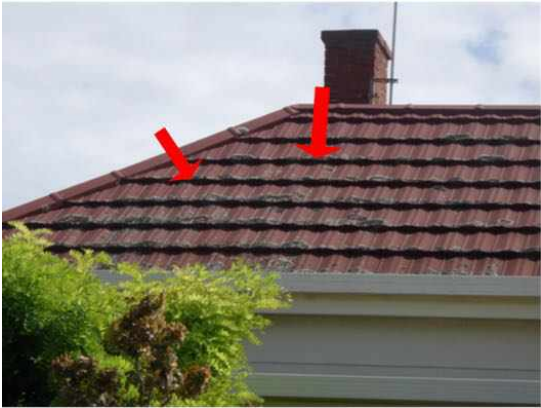
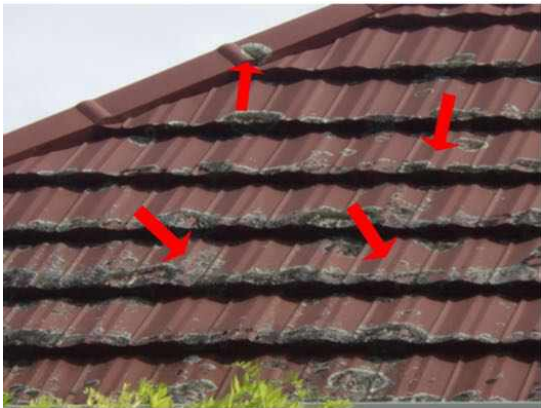
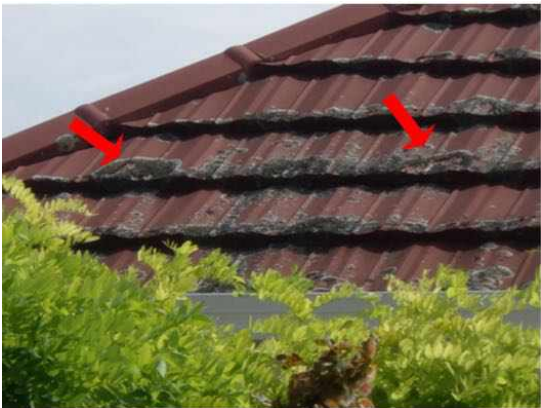
Defects 3.10

Building: Building 1
Location: All Internal Areas
Finding: Roof sheets - Weathered
Information: Upon inspection of the exterior roofing, the majority of roof sheets were assessed to be in fair condition. General weathering was noted, which appears consistent with the age of the property.

While no significant defects were observed at the time of inspection, ongoing maintenance works are required to maintain the serviceability and weatherproof performance of the roof covering and to reduce the risk of future deterioration.

Where left unmanaged, deteriorating roof sheets are likely to lead to a number of secondary defects, including minor water leaks and weather exposure to internal roofing structures.

Consultation with a roofing contractor is highly advised to gain advice on cost of remedial works that may be required in the short to medium term. Remedial works are likely to increase the longevity of the exterior roofing structure.

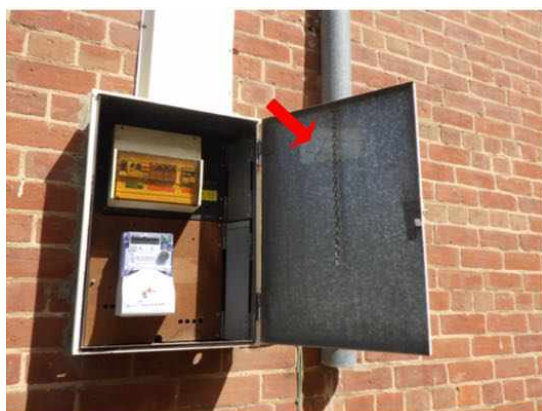
Building: Building 1
 Location: All External Areas >
 Finding: Termite Management System - No evidence of a chemical installation
 Information: The application of a post-construction chemical termite barrier is highly recommended for all properties, particularly if live termite activity has been found on the site previously. Such barriers are highly effective in preventing termite attack on any timber building elements throughout the property.

A durable notice should be placed in the switchboard unit to indicate current termite barriers. At the time of inspection, it appeared as though no termite management system has been installed, with no evidence to suggest preventative works taking place.

The client may consider gaining further advice from a pest controller as to the costs and procedures involved with this application. It is recommended that obtaining such advice be a short-term priority.

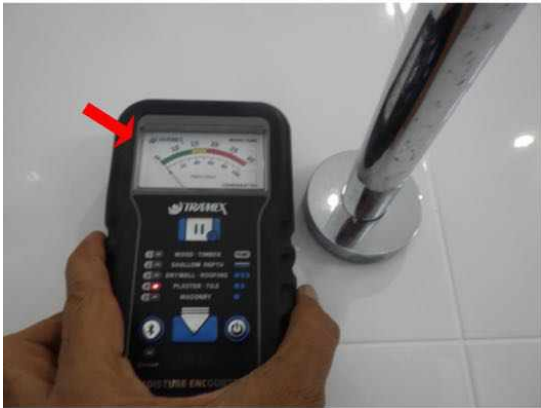
Building: Building 1
 Location: Bathroom
 Finding: Shower Alcove - No Damp & Evidence of renovation
 Information: At the time of inspection it was noticed that damp is not evident to the shower alcove.

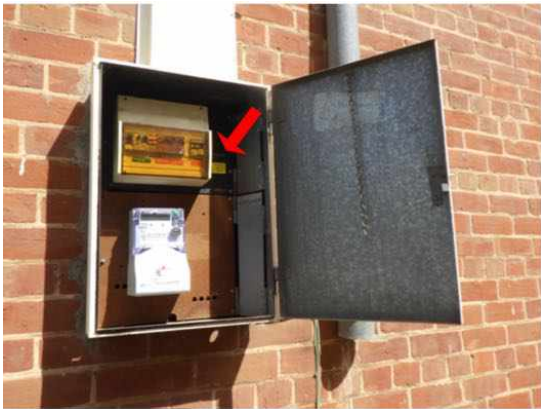
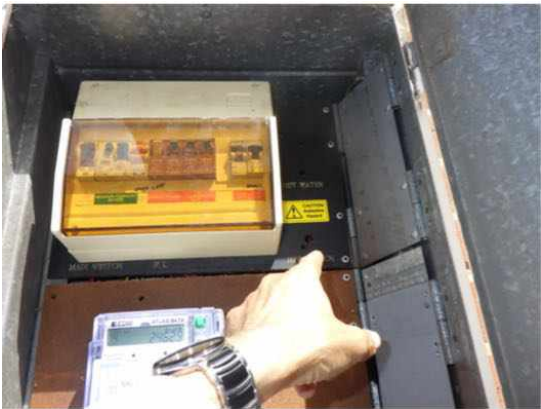
Building: Building 1
Location: All External Areas
Finding: Asbestos - Suspected ACM Identified on Site
Information: Reporting on Asbestos is outside the Scope of this Report. This suspected defect is highlighted as a caution only. We suspect, based on our experience in the building industry, that there is a higher risk of the identified building element containing asbestos.

As Asbestos Reporting is outside the scope of this report, we advise that you consider a separate Asbestos Inspection and Condition Audit, which can include the taking of samples for definitive confirmation of the presence of Asbestos.

In the interim, the client is advised to act with caution, especially when considering any damage to building materials general wear and tear renovations extensions demolition and general maintenance activities due to the suspected presence of Asbestos.

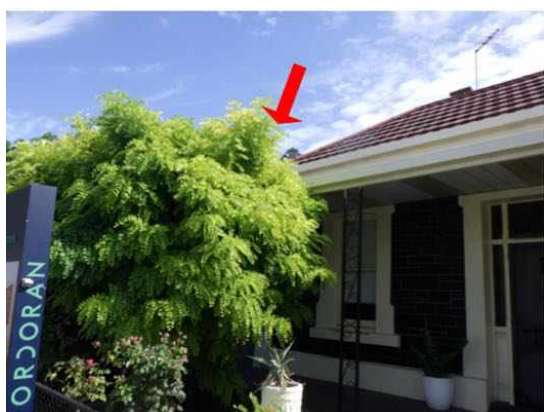
Building: Building 1
Location: All External Areas
Finding: Trees - Overhanging and filling gutters
Information: Overhanging trees often result in excessive amounts of leaf debris accumulating in gutters.

Gutters are a critical part of the building's management of storm water and rain. It is therefore important that they be kept clear to prevent secondary damage to associated building elements, including exterior and interior walls, ceiling linings and any adjoining building elements. Where gutters are blocked, pooling of rainwater is likely to occur, fast-tracking rust and corrosion of the roof plumbing elements.

It is highly advised that all overhanging tree branches be removed as soon as possible to prevent any further damage. Repair and/or replacement of sections of damaged guttering may also be required where the extent of the damage necessitates.

Such works should be performed by the homeowner; however, appointment of a landscape contractor or an arborist may be required. Consultation with a licensed roof plumber is required where guttering has been damaged.
