Building and Timber Pest Inspection Report

Inspection Date: Wed, 18 Mar 2026

Property Address: 12/3-7 Windermere Ave, Northmead NSW
2152, Australia

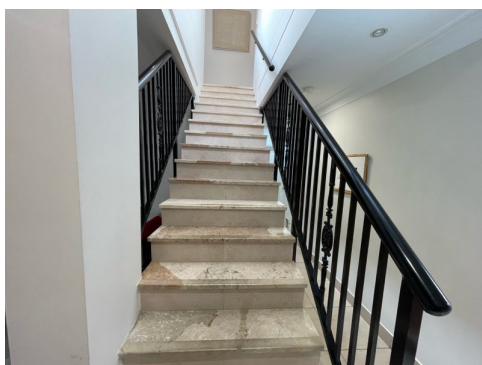
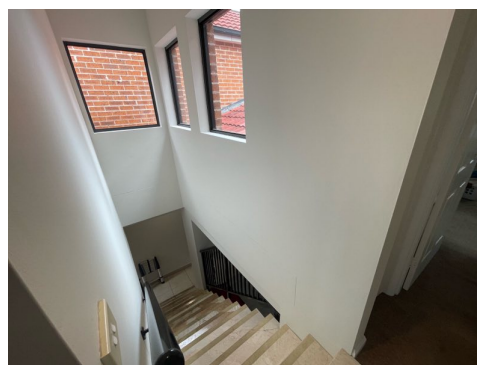
Information: During the inspection, the stair riser heights were found to be uneven. Variations in riser height were noted along the staircase, resulting in a lack of consistency between steps. Stairs are required to provide a predictable walking pattern, and irregular step heights can affect safe use.

Uneven stair risers present a safety hazard, as they increase the risk of misstep, trip, or fall when ascending or descending the staircase. This is particularly relevant where occupants may rely on a consistent step rhythm. The defect therefore represents a hazardous condition requiring attention.

A suitably qualified contractor should be engaged to assess the staircase and carry out rectification works so that the stair geometry is made uniform and safe for normal use. Until repaired, care should be taken when using the stairs.

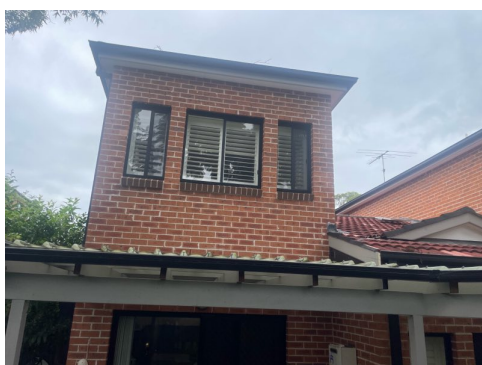
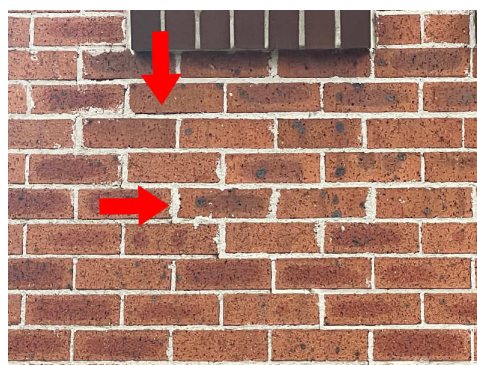
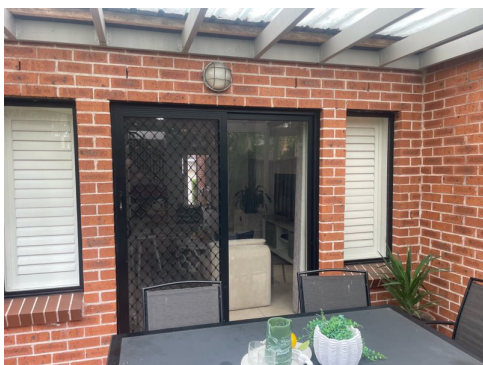
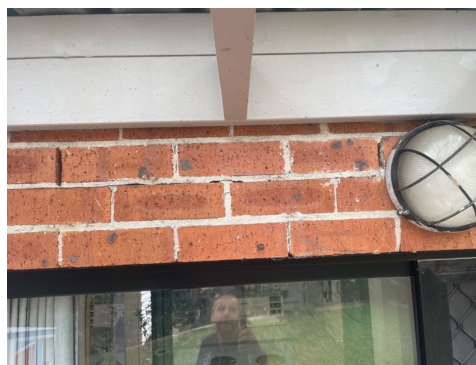
Finding 2.01

Finding: Brickwork – Cracked Mortar Joints / Repointed / Bowed Lintel

Information: During the inspection, irregular and inconsistent mortar joints were observed to the brickwork at the upper level. Sections of the mortar appeared to have been repointed previously, indicating past repair works. Cracking to the mortar joints was also noted above the window openings, and the lintel above the ground-floor rear window appeared bowed.

The condition of the brickwork at the rear elevation may indicate past or ongoing movement, localised masonry distress, or deformation of the supporting lintel. Repointed mortar can sometimes conceal earlier cracking or separation, while a bowed lintel may reduce adequate support to the masonry above the opening and contribute to further cracking. Openings within brick walls are common stress points, and the observed distortion and cracking in this location are considered significant.

A qualified structural engineer should be engaged to assess the rear elevation brickwork, window openings, and supporting lintel to determine the cause, extent, and significance of the defect. Any necessary remedial works should then be undertaken by a suitably qualified contractor in accordance with the engineer's recommendations.

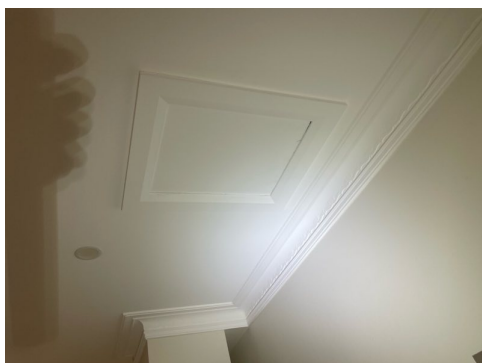
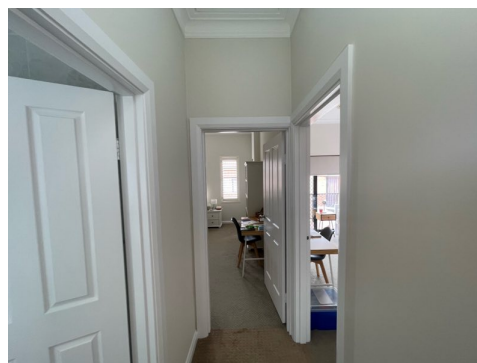
Finding 2.02

Building:	Main Building
Location:	Ground Level, Level 1
Finding:	Roof Access Manhole – Substandard Size / Restricted Position / Inspection Limitation

Information: During the inspection, the roof access manhole was found to be of substandard size and was also located in a position that did not allow safe or practical entry. Access was further restricted by obstructions directly beneath the opening and inadequate clearance for safe movement at the point of entry. As a result, the roof void could not be accessed or inspected internally.

This condition represents an inspection limitation under the scope of a visual building inspection in accordance with AS 4349, as safe access could not be achieved. The limited size and poor location of the manhole increase the difficulty of entry and may prevent proper assessment of concealed roof framing, sarking, insulation, ventilation, and any signs of defects, damage, or water ingress within the roof space.

A suitably qualified contractor should be engaged to provide compliant and safe access to the roof void if internal inspection is required. Until such access is made available, no comment can be offered on the condition of the concealed roof space areas that were inaccessible at the time of inspection.

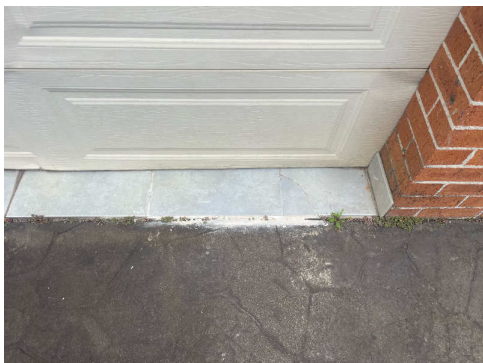
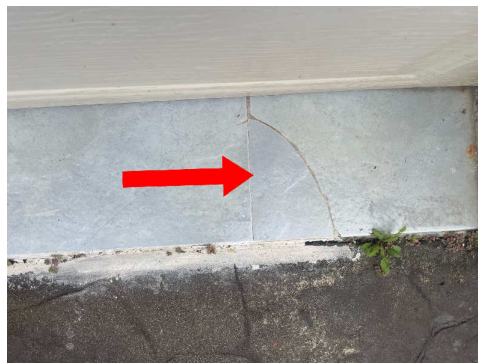
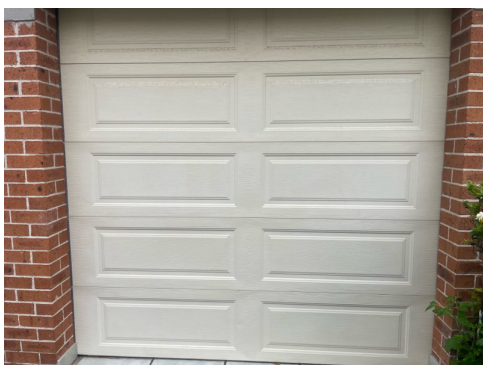
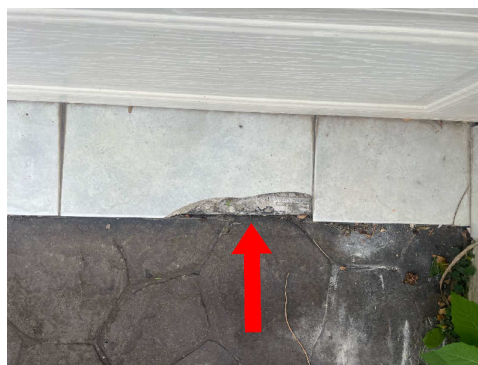
Finding 3.01

Finding: Tiles - Cracked or damaged

Information: Cracking was evident to the tiling in this area at the time of inspection. While the cracking appears to be minor, this area is frequently exposed to water, allowing potential for water penetration into adjoining sections of walls or flooring.

If left unmanaged, water penetration to these areas may lead to subsequent water damage, which is likely necessitate repair work to affected building elements.

A tiling contractor should be appointed to ensure that no further water damage occurs. The re-application of silicone and grouting throughout remaining tile work is also advised, to further protect the area against water penetration.

Where water penetration has led to water damage, appointment of a relevant tradesperson may be required to repair damaged building elements.

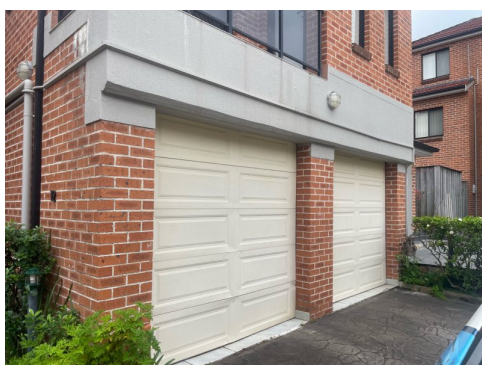
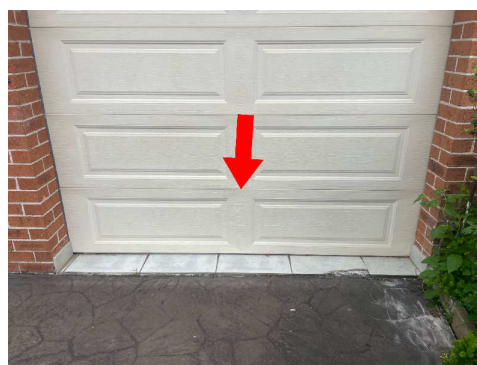
Finding 3.02

Building: Main Building
Location: Garage
Finding: Garage door - Superficial markings

Information: The garage roller door has a number of marks and dents likely to have resulted from impact damage be it accidental or deliberate impact at sometime.

Garage roller doors can fail when the building materials have aged but may be indicative of impact damage (accidental or deliberate). While superficial markings detract from the aesthetics of the building element, the functionality has not been hindered in any way.

Repair and/or replacement of the two garage doors would improve the condition of the garage but certainly not an urgent item

A qualified roller door installer or supplier should be engaged to check out the operation and overall condition of the doors to determine if repair is an option otherwise replacement may need to be considered.

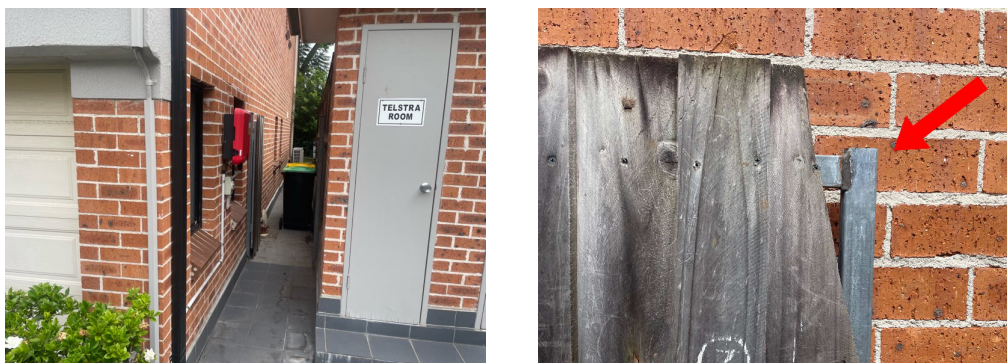
Finding 3.03

Information: The door was observed to have sustained significant damage, including impact marks and rupturing of the surface material. The defect was readily visible and has affected both the appearance and integrity of the door.

A damaged and ruptured door may not operate correctly, can compromise security and privacy, and detracts from the overall presentation of the property. If left unmanaged, the damage may worsen with continued use.

This matter is considered a repair defect. It is recommended that a suitably qualified carpenter or builder assess the extent of the damage and carry out repairs or replacement of the affected door to restore full function and appearance.

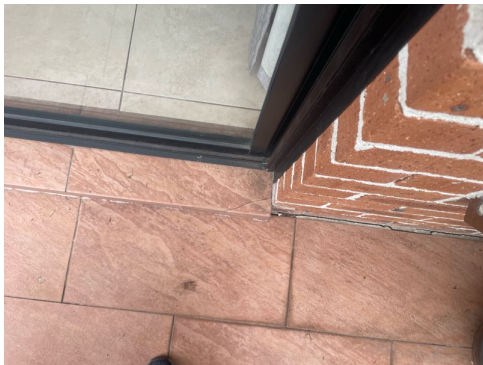
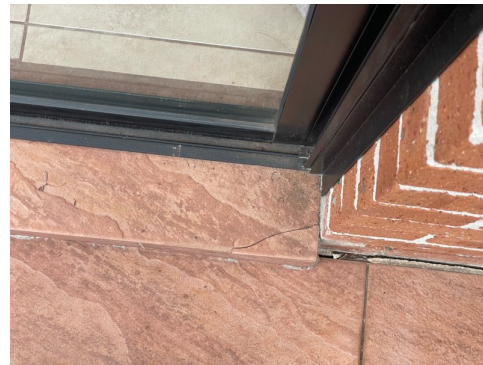
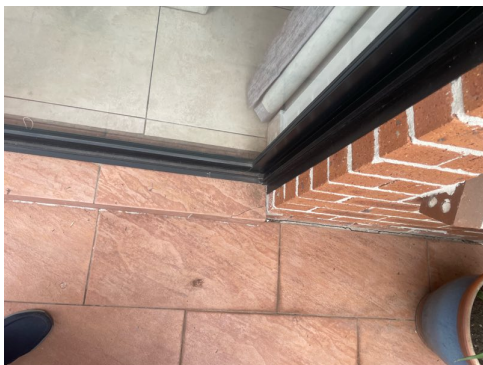
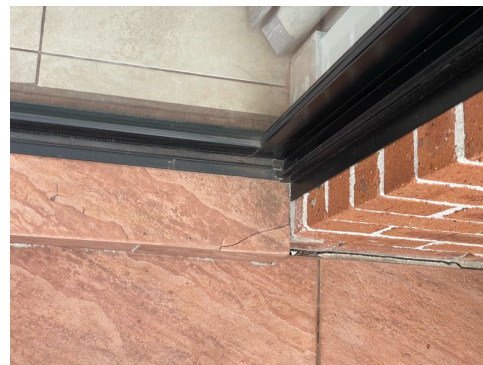
Finding 3.04

Finding: Tiles - Cracked or damaged

Information: Cracking was evident to the tiling in this area at the time of inspection. While the cracking appears to be minor, this area is frequently exposed to water, allowing potential for water penetration into adjoining sections of walls or flooring.

If left unmanaged, water penetration to these areas may lead to subsequent water damage, which is likely necessitate repair work to affected building elements.

A tiling contractor should be appointed to ensure that no further water damage occurs. The re-application of silicone and grouting throughout remaining tile work is also advised, to further protect the area against water penetration.

Where water penetration has led to water damage, appointment of a relevant tradesperson may be required to repair damaged building elements.

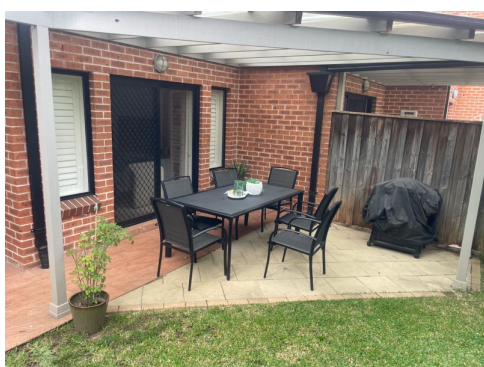
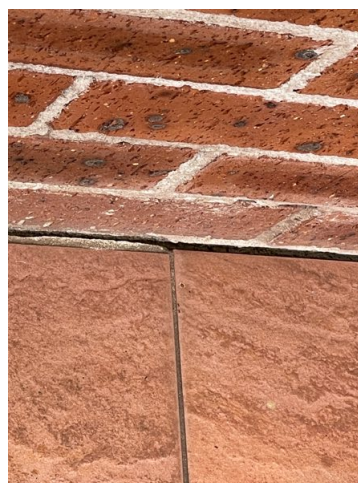
Finding 3.05

Building: Main Building
Location: Exterior walls - rear
Finding: Gaps in perimeter pavement

Gaps in the external concrete paving were identified at the time of inspection. Gaps in the slab are significant and are likely to lead to the development of secondary defects if left unmanaged, such as the creation of a trip hazard and water entry points.

With reactive clay soils, it is extremely important to ensure that all stormwater flows including roof and ground flows, contained and continually maintained. High moisture also creates an environment that is conducive to termite attack.

A licensed Plumber should be appointed immediately to ensure that the stormwater pipework is intact and adequate, and all gaps to concrete, driveways and paths should be sealed by a licensed builder or a general handy person to keep moisture from entering.

A licensed concreter may be required to replace pavements that are beyond repair.

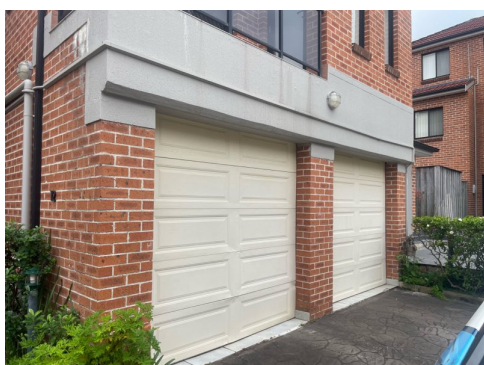
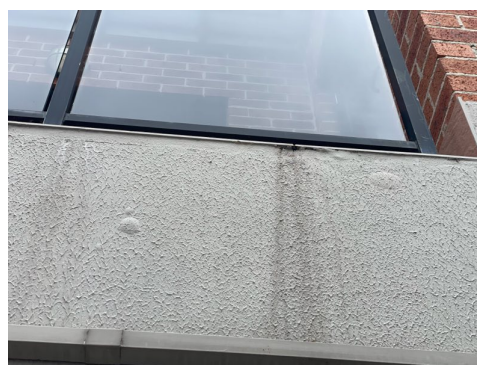
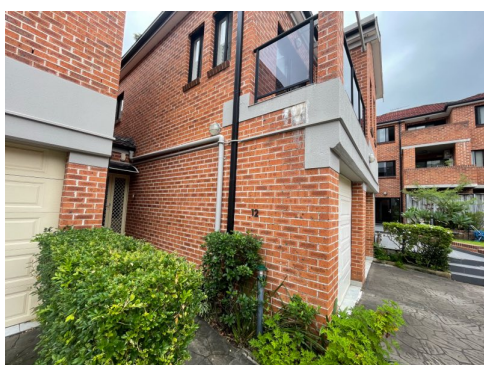
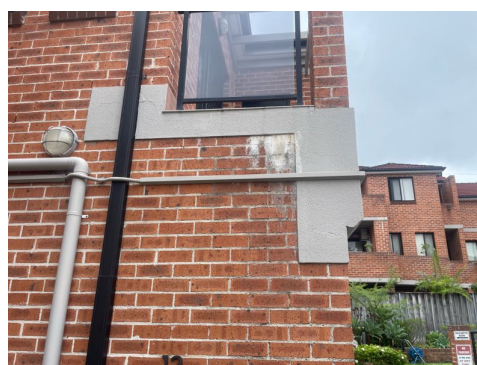
**Finding 3.06**

Building:	Main Building
Location:	Front Elevation
Finding:	External Paint Coating – Deterioration and Bubbling

During the inspection, paint bubbling and blistering were observed to affected external painted surfaces. This condition is commonly associated with moisture ingress behind the paint film or deterioration of the external paint system.

Paint bubbling typically occurs when moisture becomes trapped beneath the coating due to factors such as inadequate surface preparation, failure of the paint membrane, aging or weathered paint, defective sealing to joints or penetrations, or moisture penetration from adjacent building elements. Over time, this condition compromises the protective function of the paint finish and may accelerate deterioration of the underlying substrate.

If left unaddressed, ongoing moisture exposure may lead to further paint failure, surface degradation, and potential damage to wall materials. It is recommended that the affected areas be investigated by a qualified painter or relevant trade to identify the moisture source, rectify any contributing defects, and reinstate the external paint system in accordance with acceptable trade practices.

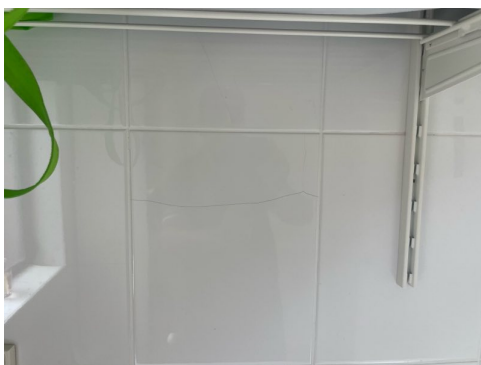
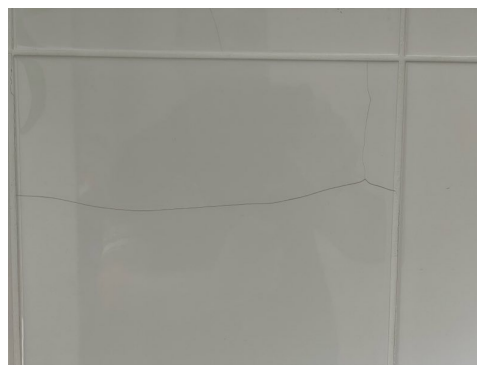
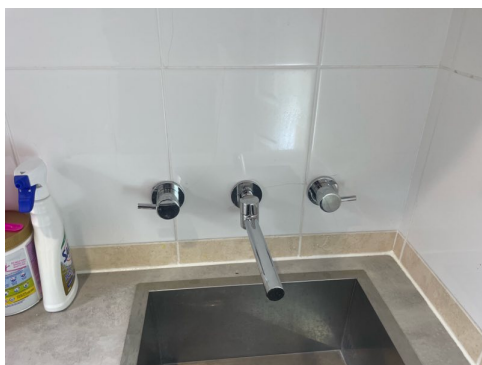
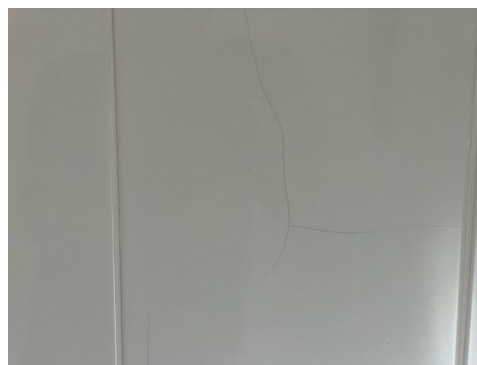
Finding 3.07

Building:	Main Building
Location:	Laundry Ground Level
Finding:	Tiles - Cracked or damaged
Information:	<p>Cracking was evident to the tiling in this area at the time of inspection. While the cracking appears to be minor, this area is frequently exposed to water, allowing potential for water penetration into adjoining sections of walls or flooring.</p> <p>If left unmanaged, water penetration to these areas may lead to subsequent water damage, which is likely necessitate repair work to affected building elements.</p> <p>A tiling contractor should be appointed to ensure that no further water damage occurs. The re-application of silicone and grouting throughout remaining tile work is also advised, to further protect the area against water penetration.</p> <p>Where water penetration has led to water damage, appointment of a relevant tradesperson may be required to repair damaged building elements.</p>

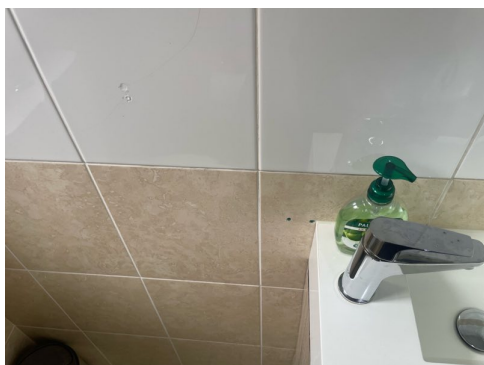
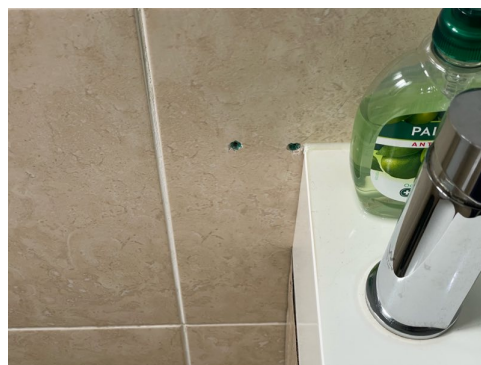
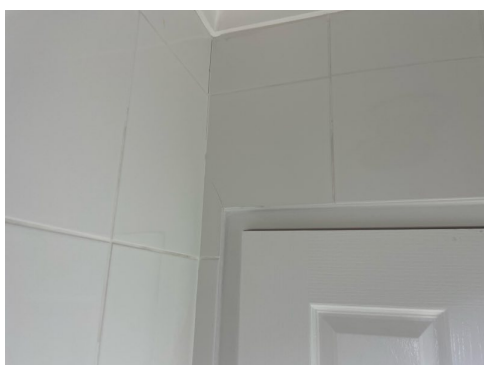
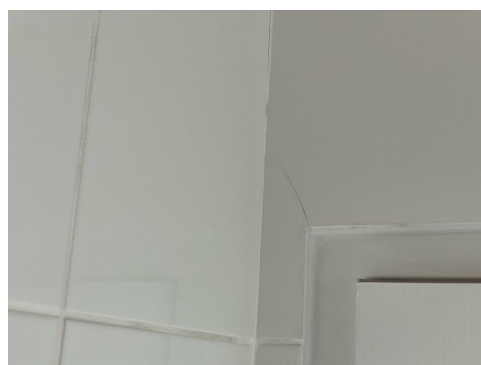
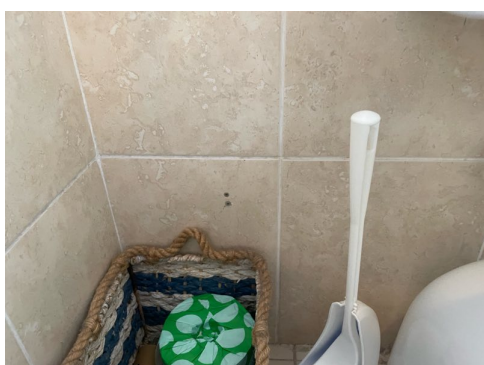
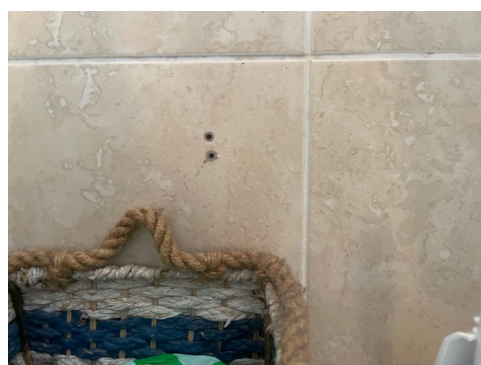
Finding 3.08

Finding: Tiles - Cracked or damaged

Information: Cracking was evident to the tiling in this area at the time of inspection. While the cracking appears to be minor, this area is frequently exposed to water, allowing potential for water penetration into adjoining sections of walls or flooring.

If left unmanaged, water penetration to these areas may lead to subsequent water damage, which is likely necessitate repair work to affected building elements.

A tiling contractor should be appointed to ensure that no further water damage occurs. The re-application of silicone and grouting throughout remaining tile work is also advised, to further protect the area against water penetration.

Where water penetration has led to water damage, appointment of a relevant tradesperson may be required to repair damaged building elements.

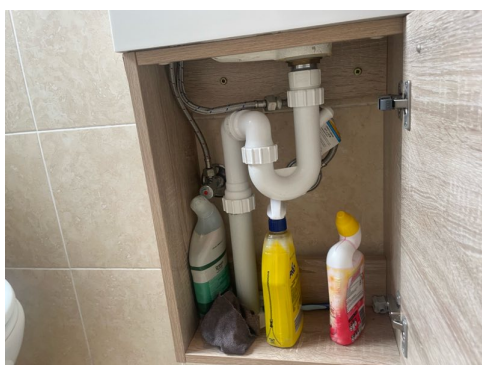
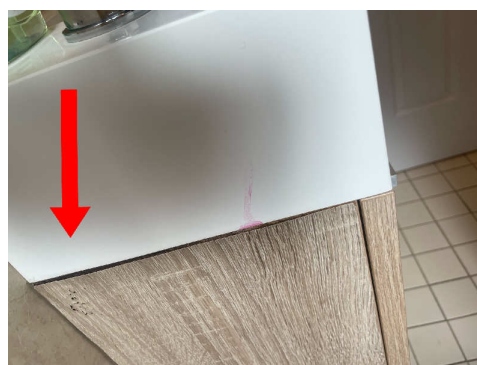
Finding 3.09

Finding: Bathroom Vanity – Damaged (Scratches, Water Staining, Wear & Tear, Broken Shelf)

Information: The bathroom vanity was observed to be in a damaged condition at the time of inspection, including visible scratches to the vanity surfaces, water staining, general wear and tear, and a broken internal shelf. This condition affects both presentation and serviceability of the fixture.

The observed staining and deterioration may be consistent with ongoing moisture exposure (splashing, minor leakage, or poor drying/ventilation) combined with normal use over time. Where laminated or painted finishes are scratched, worn, or water stained, the protective coating can be compromised, which may allow moisture absorption and lead to swelling, delamination, and progressive deterioration of the cabinet materials.

It is recommended that the client arrange further assessment and repair or replacement of the affected vanity components as required to restore function and reduce the risk of further deterioration. If water staining is active or worsening, it is also recommended that the plumbing and surrounding junctions (basin waste, taps, silicone seals, and adjacent wall/floor interfaces) be checked to confirm there is no ongoing leak contributing to the damage.

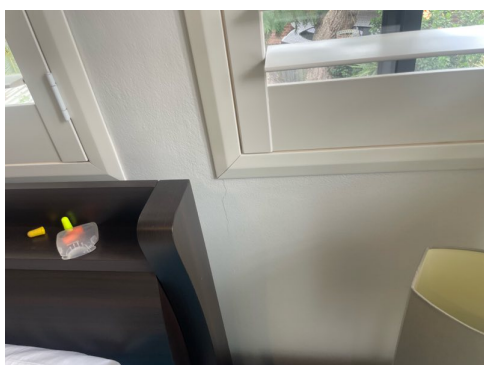
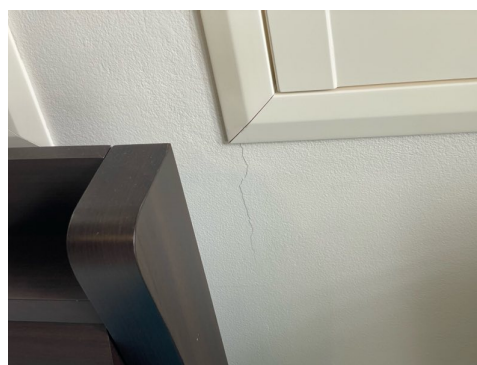
Finding 3.10

Finding: Cracking - Damage Category 0 - Hairline (less than 1mm)

Information: Hairline cracks are very minor in nature and generally are only ever an appearance defect. While such cracking may be noticeable in some cases, it is quite common and does not indicate any structural damage.

Cracking of this nature can generally be repaired with minor sanding, filling and/or repainting. Such works should be performed by a qualified painter or a general handyman.

Monitoring of all cracking should be conducted frequently. Always contact a building inspector should cracks widen, lengthen, or become more numerous.

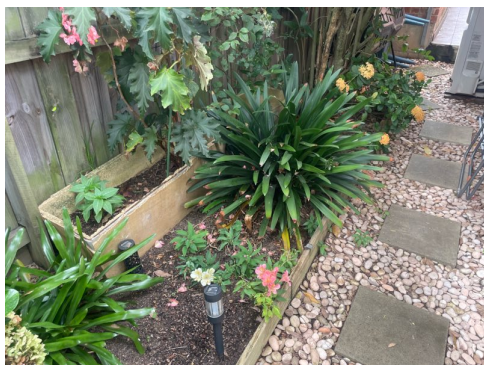
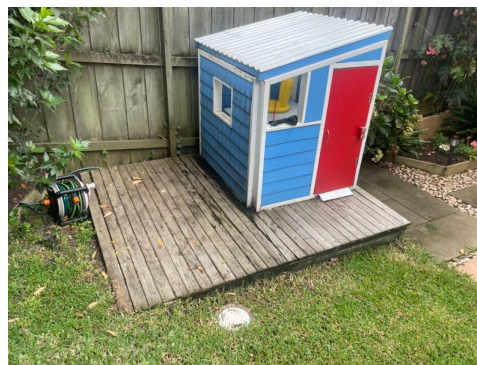
Building:	Main Building
Location:	Yard
Finding:	In ground contact
Information:	Any timbers in direct ground contact provide opportunity for concealed termite entry and are likely to be subject to premature rot and decay as the soil retains moisture or damp conditions against the timbers.

Remove untreated timber that is in direct contact with external grounds. Consider replacement with more durable materials i.e. treated timber or non timber elements. Frequent pest inspections are advised to readily identify any termite activity in these areas.

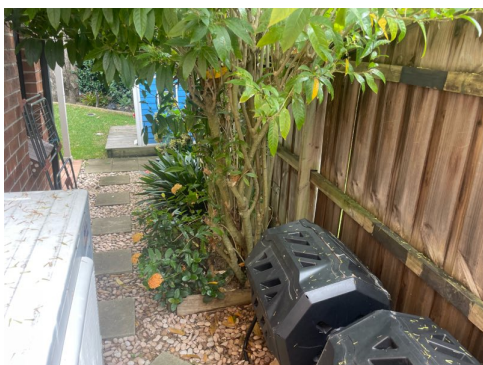
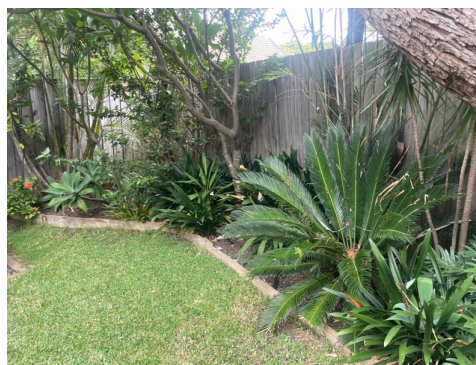
Finding 6.04

Building:	Main Building
Location:	Yard
Finding:	Large trees/stumps within 30m of house
Information:	There are a number of large trees/stumps within 30m of the house which may contain natural termite activity. It is important to monitor these areas to ensure no natural activity is allowed to progress into the main house. Regular inspections are recommended. Consider test drilling any large trees. A pest controller can be contacted to carry out such testing at the owners discretion.
