Building and Timber Pest Inspection Report

Inspection Date: Tue, 3 Feb 2026

Property Address: 14 Gladstone Wy, Edgeworth NSW 2285,
Australia

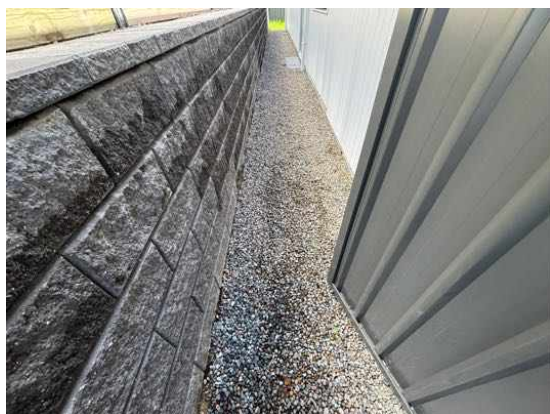
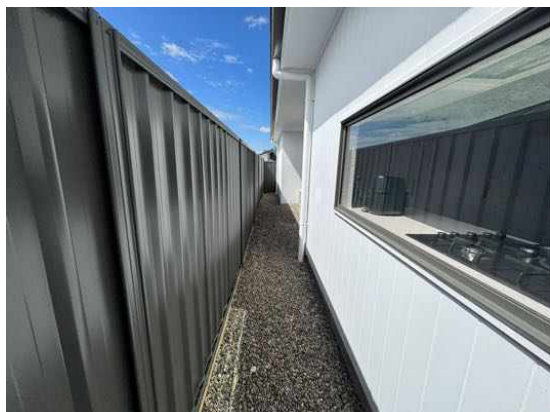
Building: Main Building
Location: All External Areas
Finding: Obstructions and Limitations - External Areas
Information: The attached photographs provide a visual representation of the obstructions and limitations that impeded a full inspection of the external areas of the property at the time of assessment. These obstructions, which may include vegetation, stored items, debris, or other physical barriers, can obscure potential defects and prevent a thorough evaluation of the property's condition. Obstructions of this nature can conceal a wide range of issues, such as structural damage, water ingress, pest infestations, or deteriorating building materials, which may not be visible during the initial inspection.

It is essential that these obstructions be cleared to allow for a comprehensive inspection of the external areas. Removing these barriers will enable a more accurate assessment of the property's condition and allow any hidden defects to be identified and addressed promptly. Failure to do so could result in undetected issues worsening over time, potentially leading to more costly repairs in the future.

Therefore, it is strongly recommended that the obstructions be removed and a re-inspection be scheduled once the affected areas are made fully accessible. This will ensure a complete evaluation of the property's exterior and provide the client with a clear understanding of any potential issues that may have been concealed during the initial inspection.

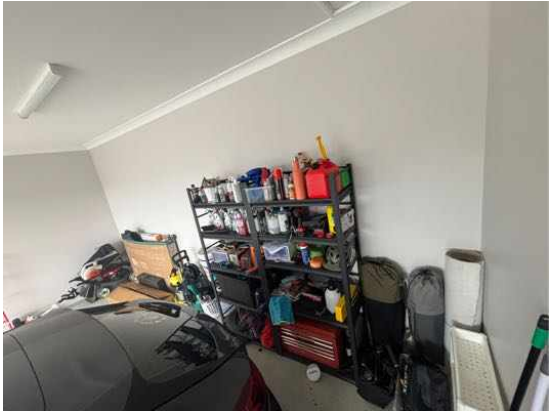
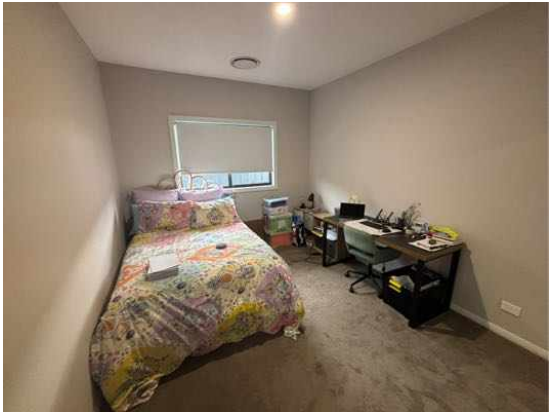
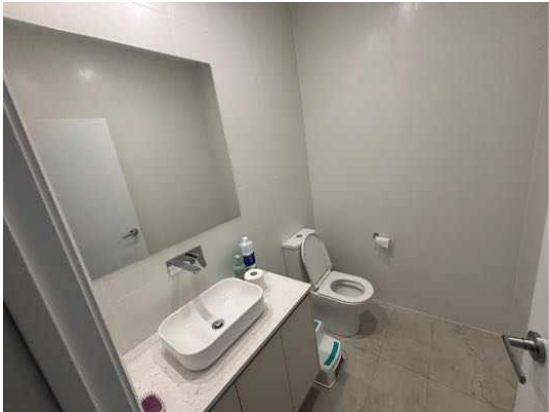
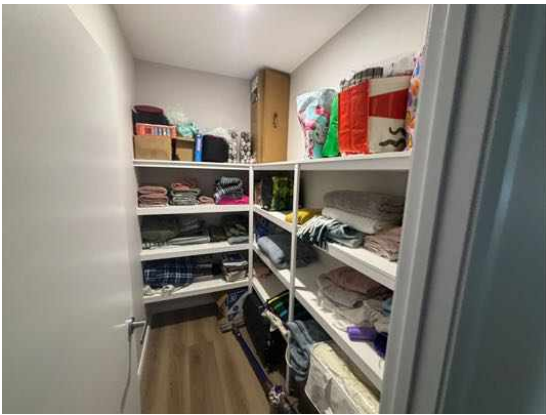
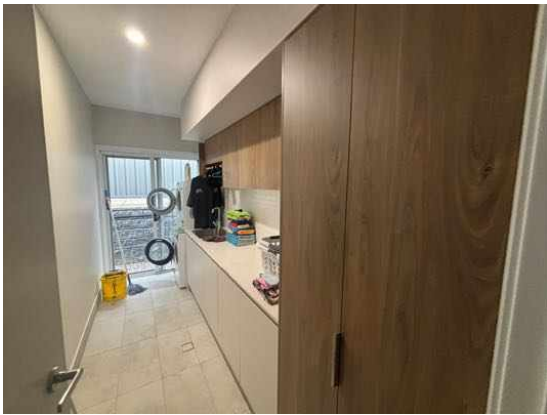
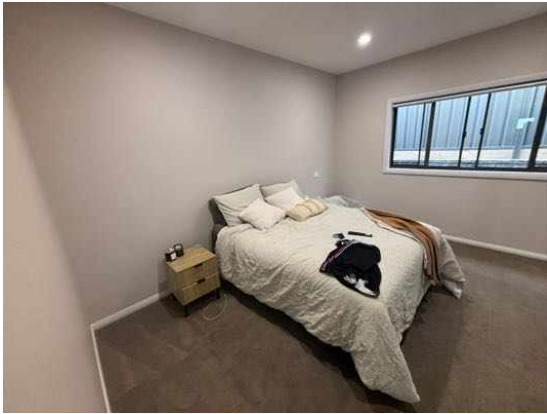
Information: The accompanying photographs provide clear evidence of the obstructions and limitations that restricted a comprehensive inspection of the internal areas of the property at the time of assessment. These obstructions, which may include furniture, personal belongings, stored items, or structural elements such as wall coverings and built-ins, significantly hindered the ability to thoroughly evaluate these areas. It is important to note that such obstructions can potentially conceal a wide array of defects, ranging from hidden structural damage, water leaks, pest infestations, or electrical issues, to deteriorating materials that may not be visible during the initial inspection.

The presence of these impediments means that critical areas of the property were not accessible, and therefore, any underlying defects that may affect the integrity and safety of the property could remain undetected. These hidden defects, if left unaddressed, could worsen over time and may result in costly repairs or pose potential safety hazards to the occupants.

It is highly recommended that all obstructions be cleared to facilitate a complete and thorough inspection of the internal areas. Once the obstructions have been removed and full access is available, a re-inspection should be carried out to ensure that any

previously concealed issues can be properly identified and rectified. This follow-up inspection will provide a more accurate assessment of the property's internal condition and help the client make informed decisions about any necessary repairs or maintenance.

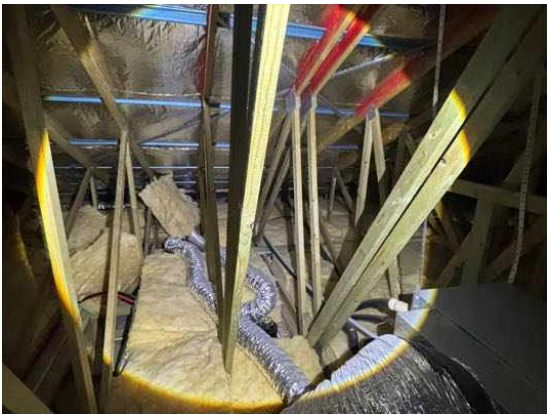
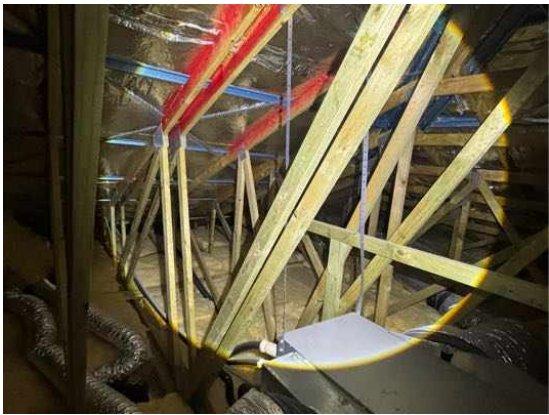
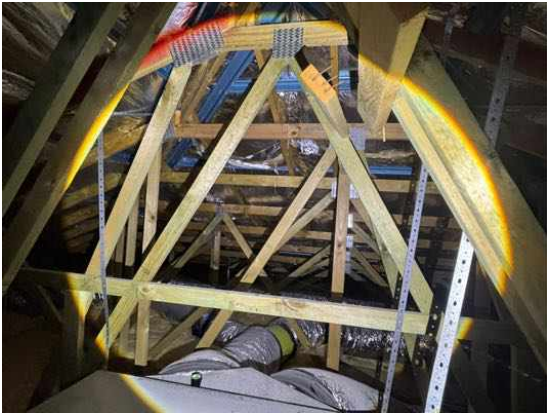
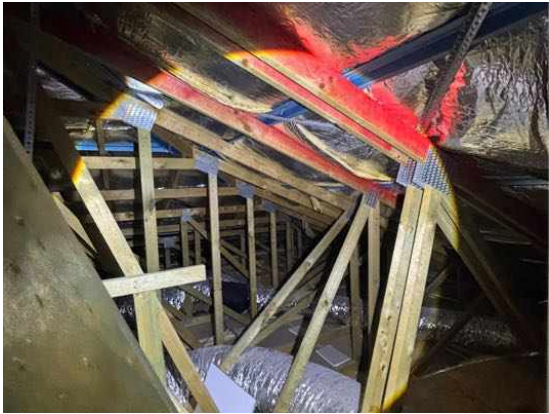
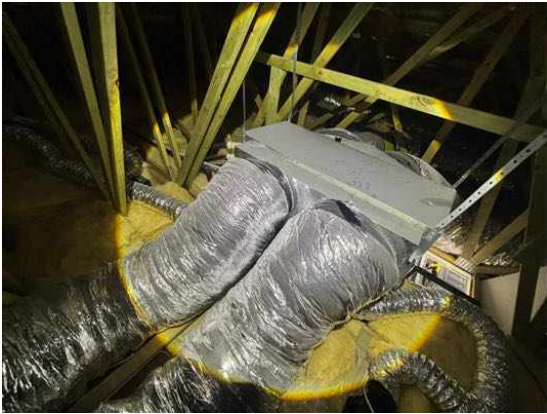
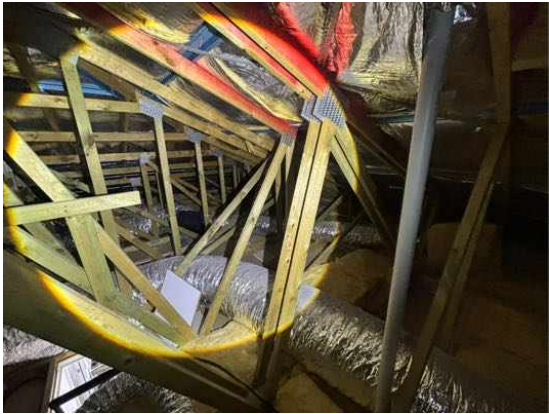
Building:	Main Building
Location:	Roof Void
Finding:	Obstructions, Limitations, and General Roof Space Condition
Information:	The photographs provided document both the general condition and the obstructions and limitations that were present in the roof cavity of the main building at the time of inspection. These obstructions—such as insulation materials, stored items, structural elements, or electrical wiring—restricted safe and adequate access to key areas within the roof space. As a result, a comprehensive inspection of all components could not be completed.

Obstructions of this nature may conceal a variety of potential defects, including damaged framing, compromised insulation, evidence of moisture ingress, pest activity, or electrical hazards. While no major issues were observed in the visible areas, the presence of these limitations means that some defects may remain undetected.

It is recommended that these barriers be removed or repositioned to facilitate full and safe access to the roof space. Once clear, a follow-up inspection should be conducted to allow for a thorough assessment of all concealed areas. This will help ensure that the condition of the roof cavity is accurately evaluated and any hidden issues are appropriately identified and addressed.

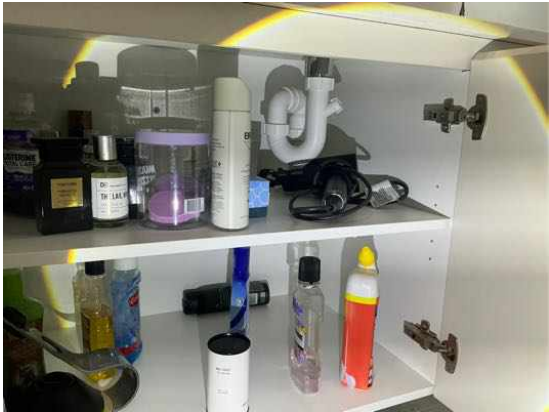
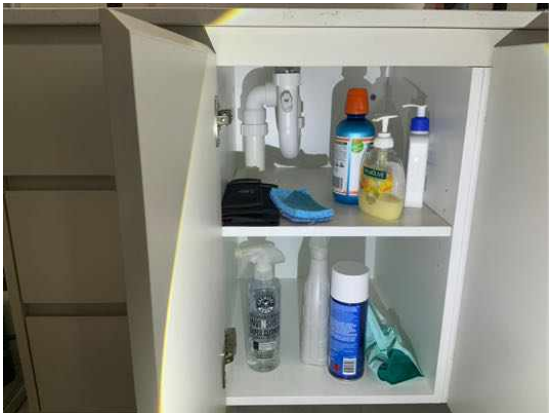
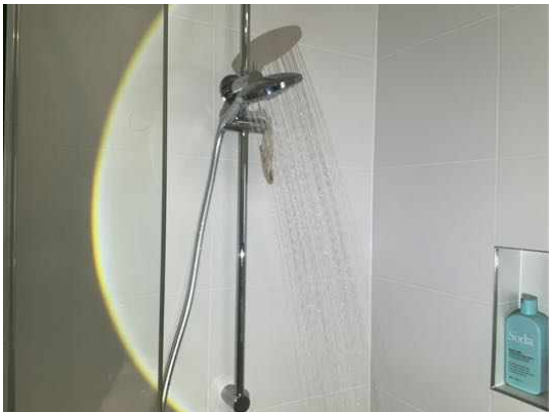
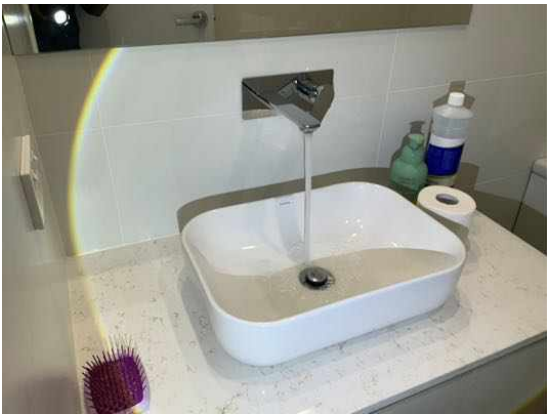
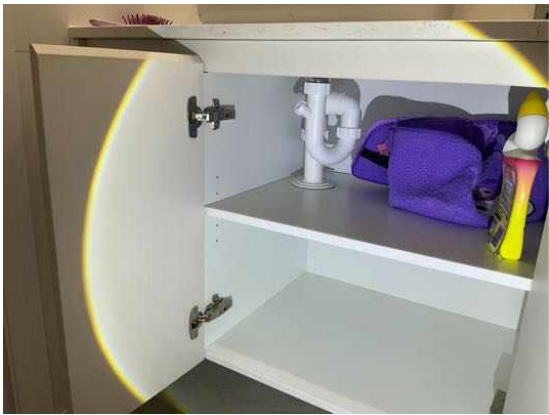
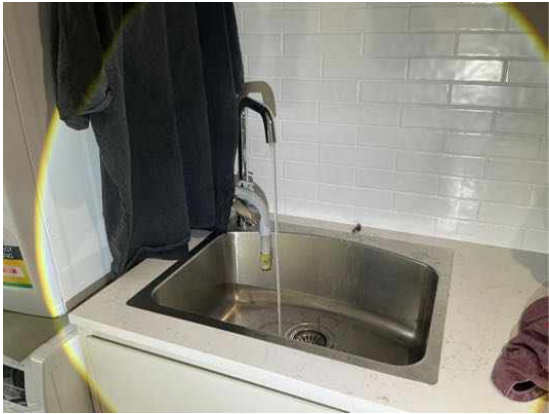
Building: Main Building
 Location: All Areas
 Finding: FYI - Taps, Drainage & Toilets Tested and Cabinetry Obstructions
 Information: During the inspection, all accessible taps, drainage systems, and toilets were tested for water flow and drainage efficiency, and checked for any visible signs of leakage. At the time of the inspection, no issues were noted in these areas. Unless highlighted in a separate defect statement, no immediate remedial work appears necessary. Supporting images may be found in the additional photos section for reference.

It is important to note that while a visual inspection of cupboards and cabinetry beneath sinks and vanities was undertaken, stored personal items and fixtures presented obstructions that limited full visibility of the internal areas. As per standard inspection practices, inspectors are not permitted to move or disturb personal belongings during the inspection process. Therefore, only visible and accessible sections were inspected, and concealed water damage or plumbing defects may not have been detected.

Given this, a re-inspection is recommended after all obstructions have been cleared to allow for a comprehensive assessment of these areas. Regular maintenance and monitoring of plumbing and drainage systems is also advised to ensure ongoing functionality and early detection of potential issues.

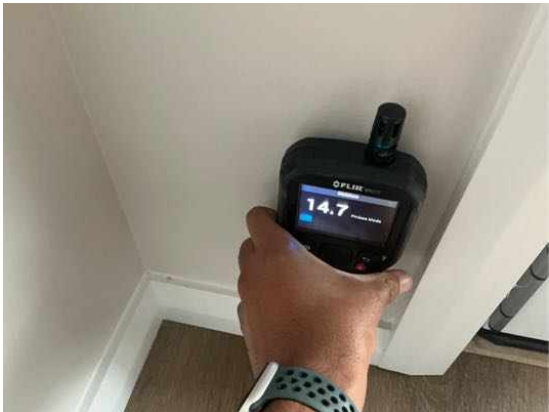
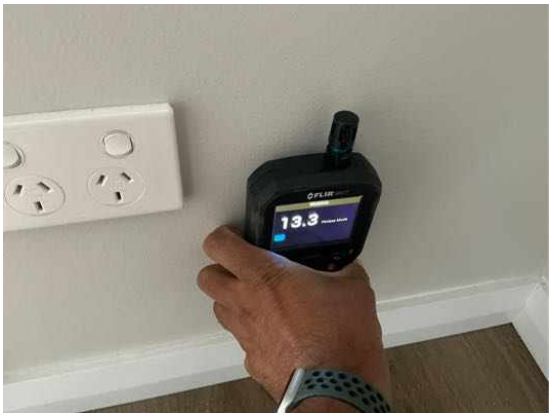
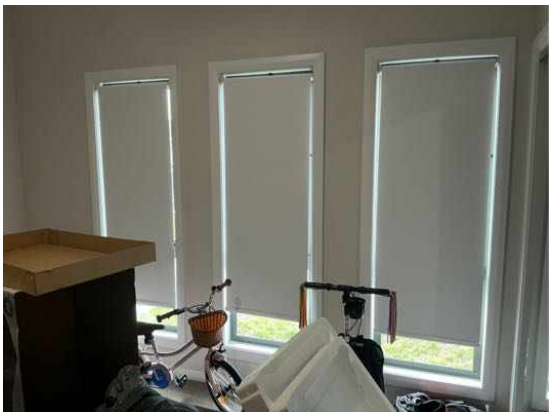
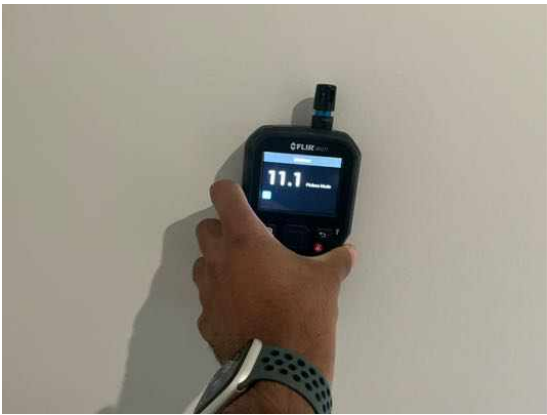
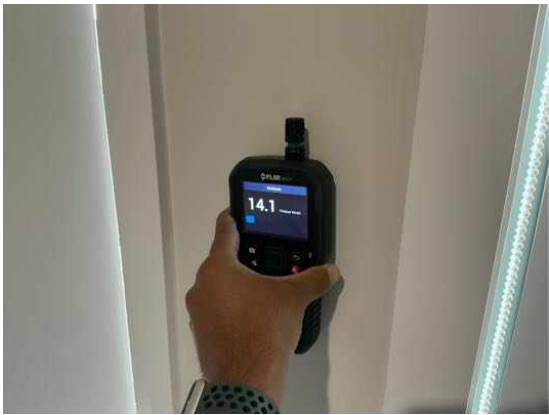
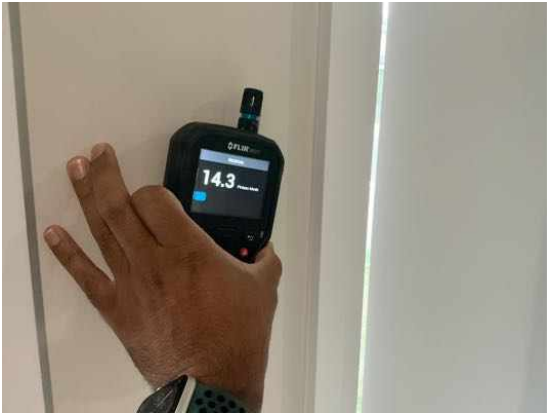
Finding: Additional Photos - Moisture Meter Readings

Information: Additional moisture meter reading photos have been provided for the property to offer further clarity on areas tested during the inspection. These photos are intended to give a visual reference for the specific locations where moisture levels were measured. These readings were taken at the time of the inspection to assess any potential moisture-related issues within the property. Any defects related to moisture that were identified during the inspection have been separately mentioned in the defect statements within the report.

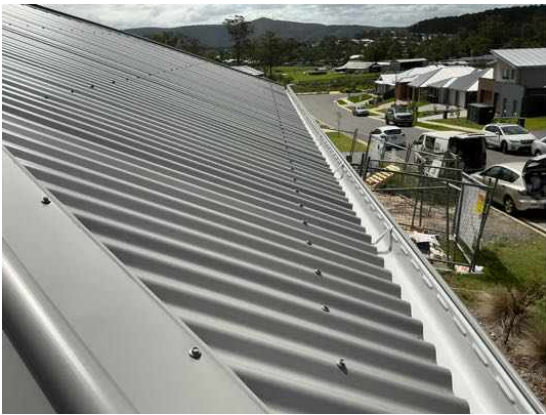
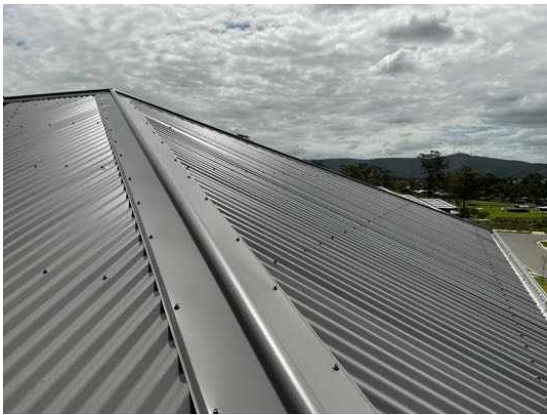
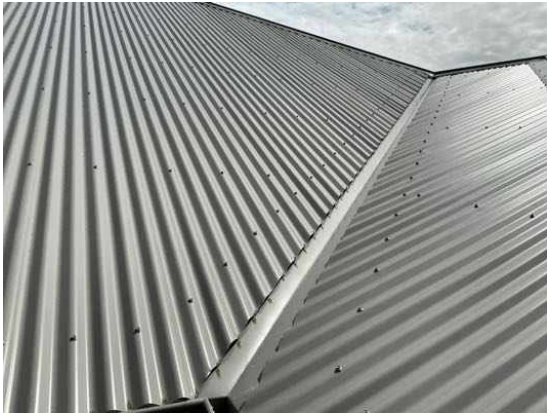
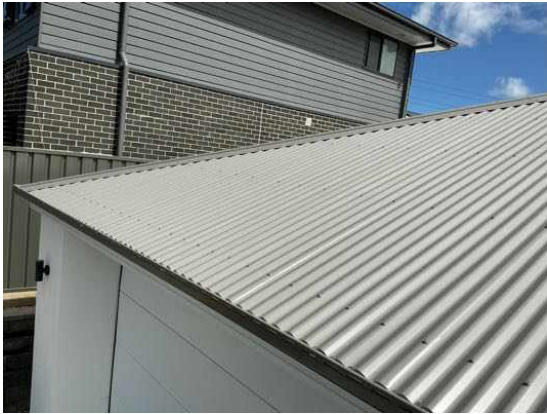
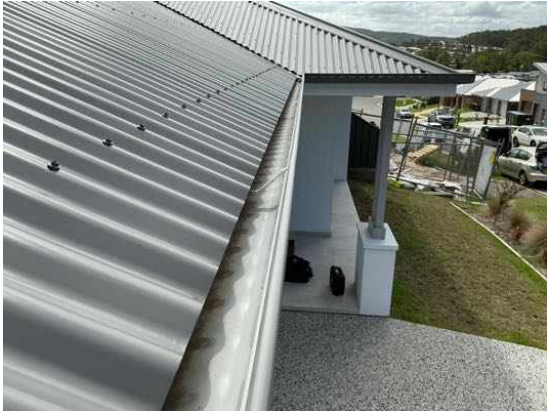
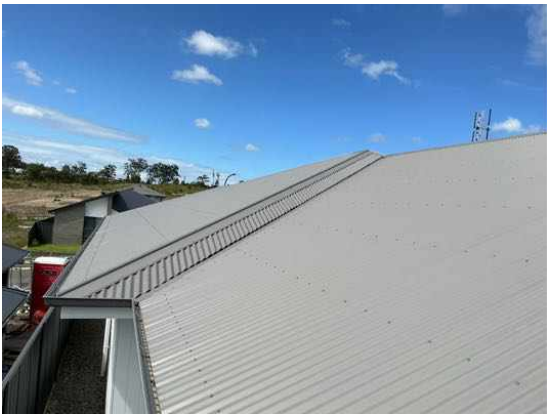
Building: Main Building
Location: Roof Exterior
Finding: Additional Roof Photos
Information:

As part of the information provided, please note that the attached roof photos represent the condition of the roof at the time of inspection. These photos are for visual reference only and do not constitute a detailed roofing assessment. Any defects or issues identified with the roof are mentioned separately in the defect statements. It is strongly recommended that the client engage a qualified roofer to conduct a thorough inspection of the roof, ensuring that any potential issues, such as leaks, structural integrity, or wear and tear, are properly identified and addressed.
