Building and Timber Pest Inspection Report

Inspection Date: Thu, 19 Feb 2026

Property Address: 13 Page St, Pagewood NSW 2035, Australia

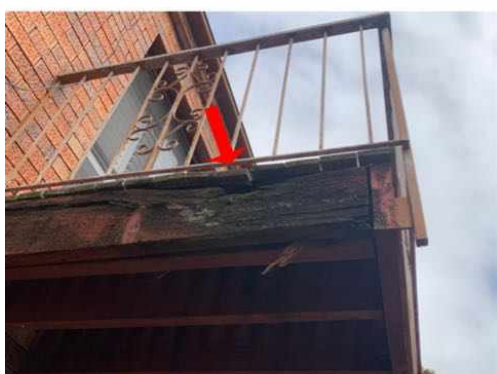
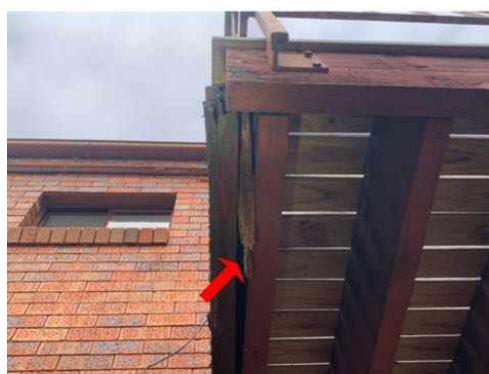
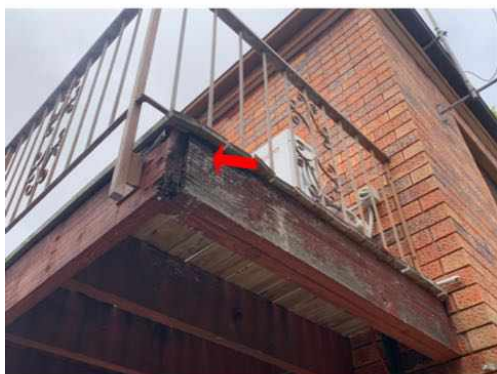
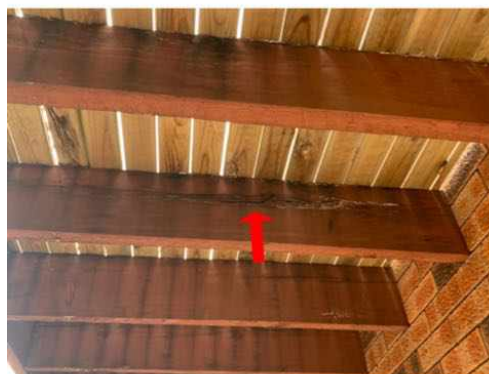
Building: Main Building
Location: Balcony
Finding: Beams - Wood rot
Information: Wood rot was found to be affecting the timber balcony beams in this area. Wood rot, also known as Fungal Decay, occurs when timbers and other cellulose building materials are exposed to damp conditions on an ongoing basis.

It is likely that this wood rot has developed as a result of frequent exposure to rain and other weather conditions which make un-maintained (ie regular painting) fascias and window frames susceptible to accelerated deterioration.

Early intervention and regular maintenance will prolong the useful life of these building elements. Prior to any works being performed, the cause of the moisture that has created the visible wood rot should be identified and addressed in a suitable manner.

Replacement of affected balcony timbers may then be a necessary step in protecting surrounding building elements from such deterioration. A qualified carpenter or registered builder may also be required to replace affected building materials.

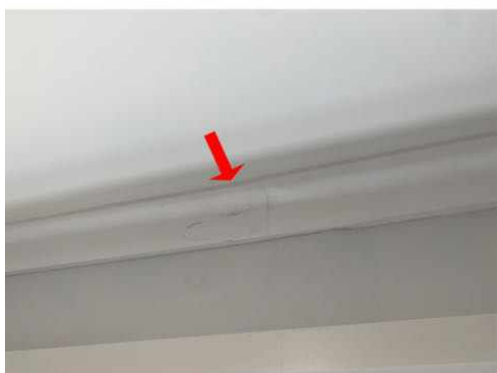
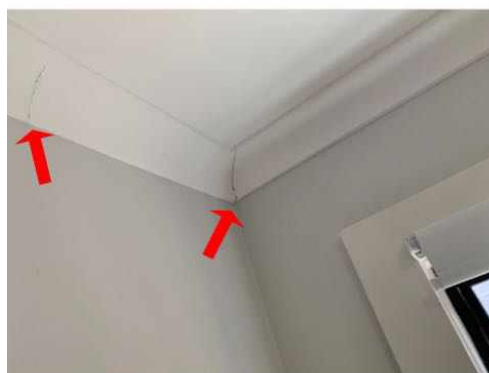
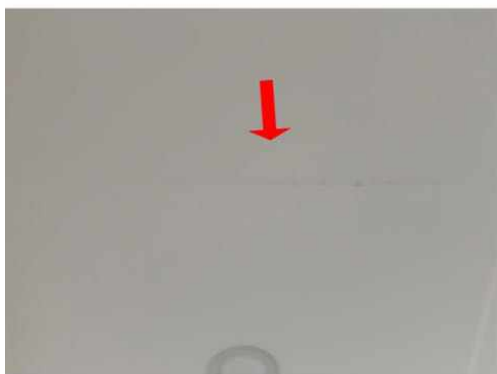
Finding 3.01

Building:	Main Building
Location:	Lounge Room / Hallway
Finding:	Ceiling Lining / Cornice Cracking - Damage Category 1 - Fine (up to 1mm)
Information:	Although fine cracks are quite noticeable, they are often only considered to be an appearance defect, and usually do not indicate any structural damage. Generally, the cause of a fine crack is indicative of a separation between building materials and finishes (e.g. paint, plaster, etc.) along joins.

Cracking of this nature can generally be repaired with minor sanding, filling and/or repainting. Such works should be performed by a qualified painter or a general handyman.

Monitoring of all cracking should be conducted frequently. Always contact a building inspector should cracks widen, lengthen, or become more numerous.

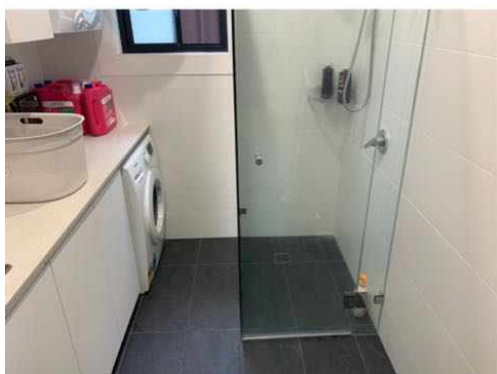
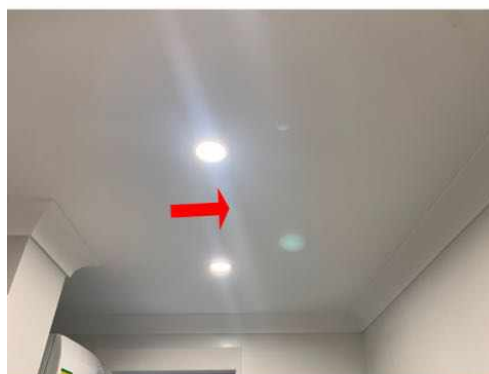
Finding 3.02

Building:	Main Building
Location:	Laundry
Finding:	Exhaust fan - Missing
Information:	An exhaust fan has not been installed in this area. Missing exhaust fans may lead to the development of more significant defects such as moisture damage to surrounding building materials from inadequate ventilation.

Inadequate ventilation in internal areas creates an environment that is conducive to the formation and development of mould and other respiratory hazards.

It is advised that a licensed electrician be appointed to retrospectively install an exhaust fan. Failure to perform works to aid the ventilation of the area may lead to the development of these secondary defects.

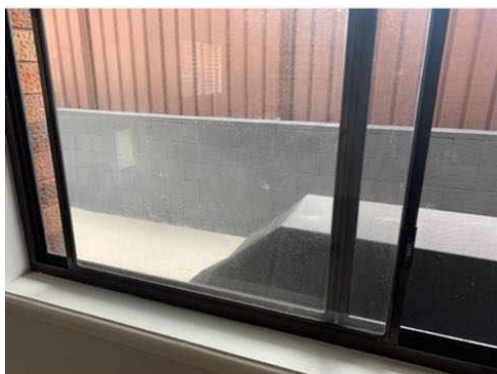
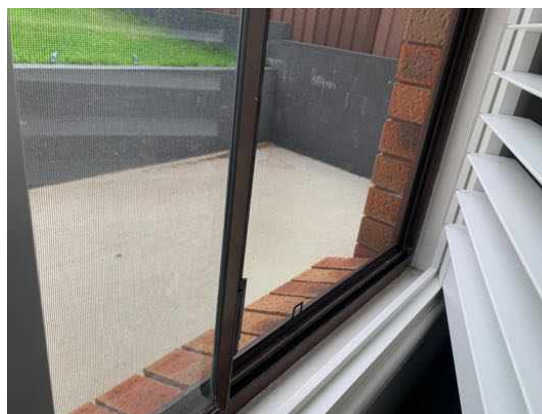
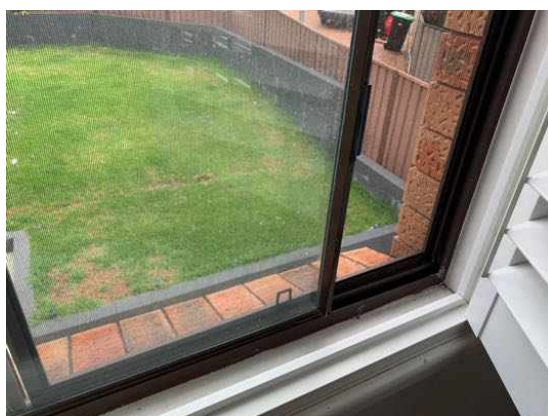
Finding 3.03

Building:	Main Building
Location:	Lounge Room 2 / Master Bedroom
Finding:	Window - Stiff to slide
Information:	The window in this area was jammed and difficult to operate at the time of the inspection. Windows provide ventilation to the adjoining area and should be at a fully

operational level to ensure user comfort. Restricted function of the window may also pose as a potential safety hazard if required for emergency egress from the building.

Generally, factors such as general age of the building element and a lack of maintenance are the usual causes for this type of defect.

Replacement of window hardware or frame may be required, as well as minor repairs and cleaning. A registered builder or general handy person will be required to repair the window.

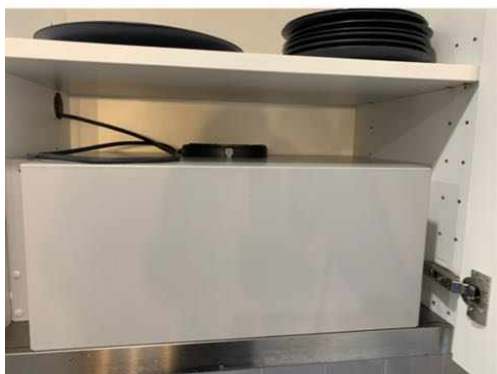
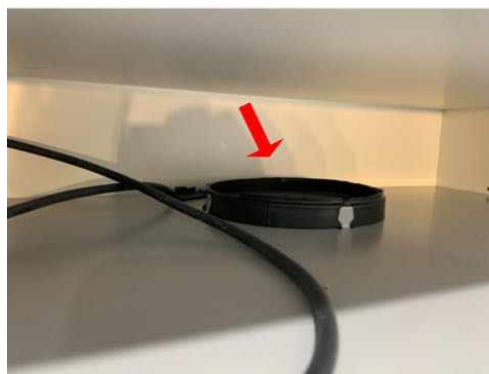
Finding 3.04

Building:	Main Building
Location:	Kitchen
Finding:	Rangehood - Vented into cupboard
Information:	The rangehood flue was found to lead directly into the kitchen cupboard, rather than venting to the exterior of the building.

The positioning of this flue is likely to lead to a build-up of grease and grime in the surrounding area within the cupboard, and / or potential moisture related issues.

Without re-direction to the exterior of the building, the rangehood is not considered fully operational and is deemed a minor defect. It is therefore preferable that the flue be re-directed to vent into the external environment.

A licensed plumber should be appointed as soon as possible to provide further consultation on the scope of these works and to provide quotations for any necessary works.

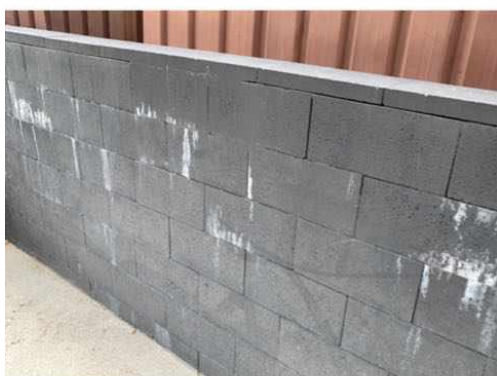
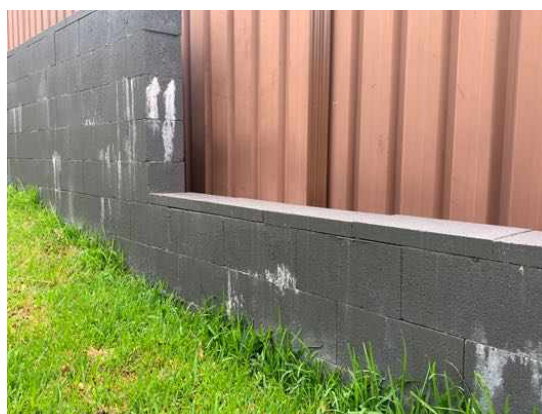
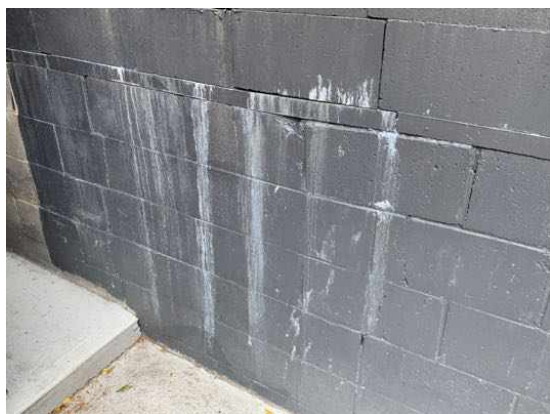
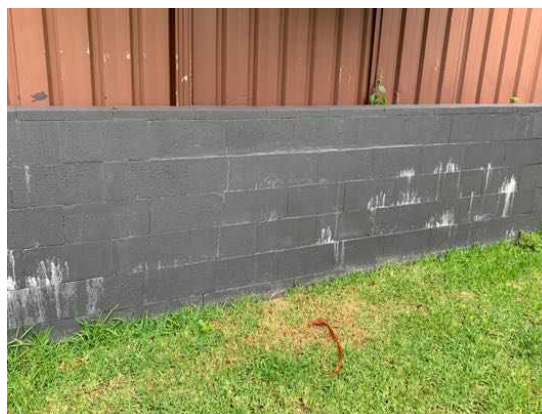
Finding 3.05

Building: Main Building
 Location: Yard - Back
 Finding: Blockwork - Efflorescence
 Information: Efflorescence appears to be affecting the blockwork in this area. Efflorescence typically occurs when excess salts within the cement mortar is leached to the surface due to water transfer.

It is typically seen as white salt deposits on the surfaces of mortar between blocks. While detracting from the overall appearance of the affected area, efflorescence is not likely to develop into secondary damage if left unmanaged.

Generally, soluble salt deposits can be removed by dry brushing with a stiff-bristled brush. Repeated dry brushing is an ideal treatment for eliminating this forming of efflorescence. A cleaning contractor or general handyperson may be appointed to perform these works at the discretion of the client.

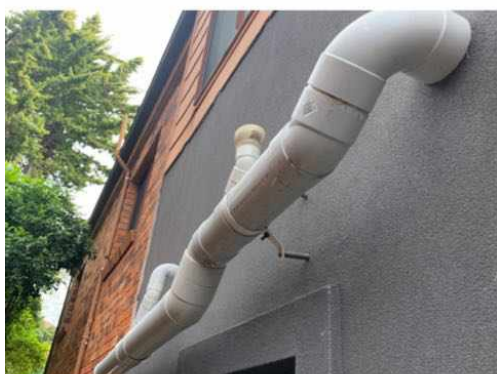
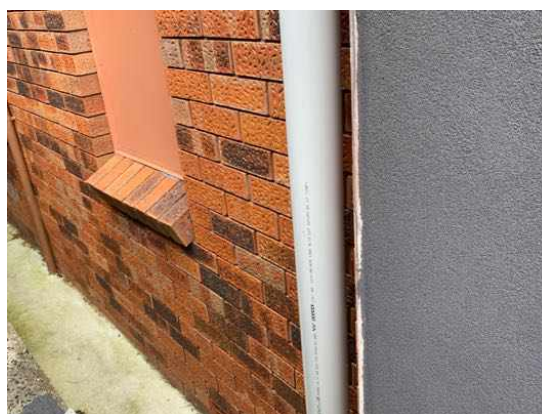
Finding 3.06

Building:	Main Building
Location:	Exterior walls - left side
Finding:	Roof plumbing - Painting required
Information:	The gutters and downpipes have not been painted. Painting all exterior plumbing work is necessary to adequately seal the building materials, preventing accelerated rust and deterioration.

Where roof plumbing is not protected by paint, frequent exposure to UV and rainwater is likely to result in premature ageing and the development of secondary building defects.

It is highly advised that a painting contractor be appointed to paint the sections of roof plumbing that have not been painted. Such works will increase the longevity of the roof plumbing and all associated building materials.

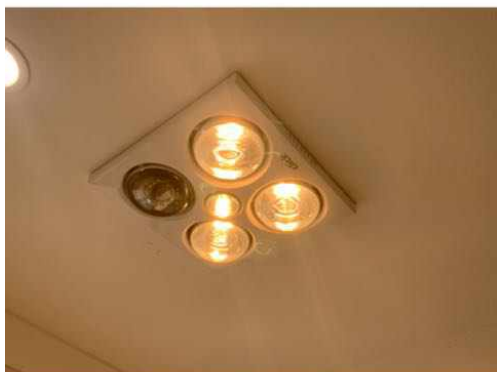
Finding 3.07

Building:	Main Building
Location:	Bathroom
Finding:	Light fitting - Not operating
Information:	The light fittings in these areas were noted to be not operating at the time of

inspection. It is suspected that this could be a simple globe replacement, however, if this does not rectify the problem, then there could be a further issue with the fitting and / or transformer.

Repair and/or replacement of the faulty building element is recommended. It is highly recommended that the relevant tradesperson be engaged to perform any necessary works.

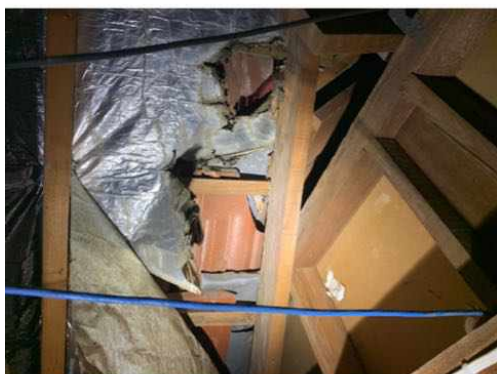
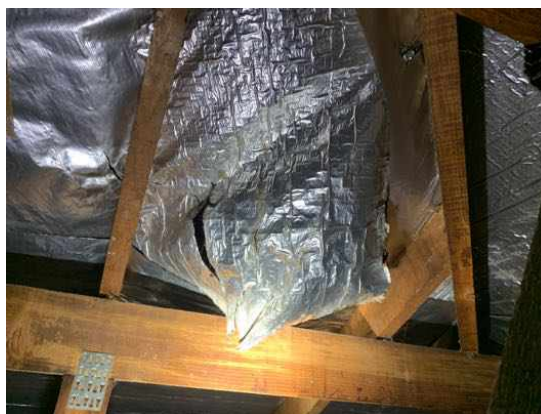
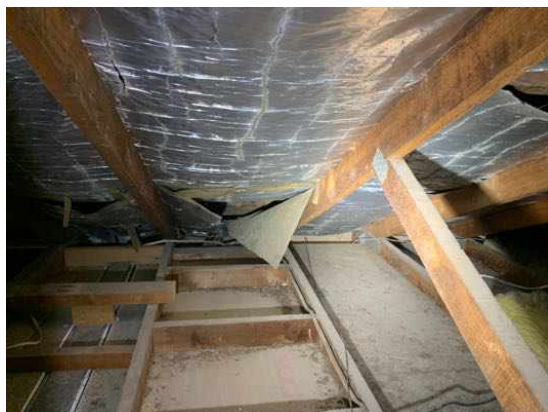
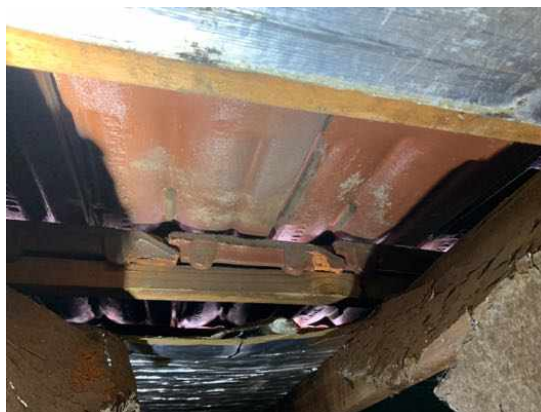
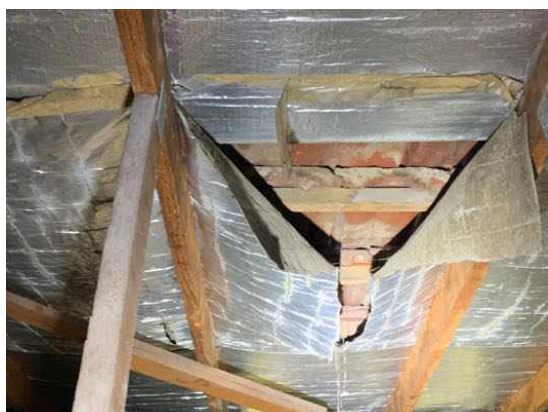
Finding 3.08

Building:	Main Building
Location:	Roof Void - lower & upper
Finding:	Sarking - Damaged
Information:	Sarking, a laminated aluminium foil applied to the interior of the roof covering, assists in insulating the property and acting as a vapour-barrier to the roof void and, subsequently, to the household.

Where sarking is damaged, both insulation and moisture protection of the property are inhibited. This creates a loss of energy and thus negatively impacts the energy efficiency of the property, allowing potential for moisture ingress from condensation or leaking roof tiles.

It is important to repair any holes or damaged sections of sarking to ensure that the building material is fully functional. A registered builder or qualified carpenter should be consulted to provide further advice on this defect and to perform rectification works at client discretion.

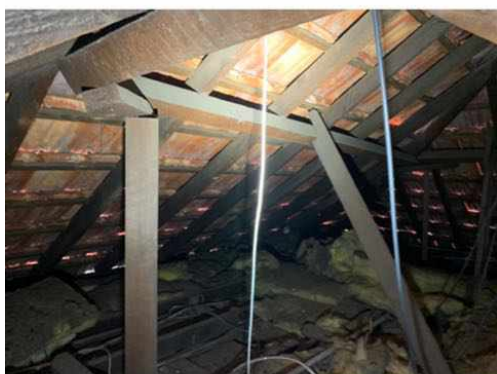
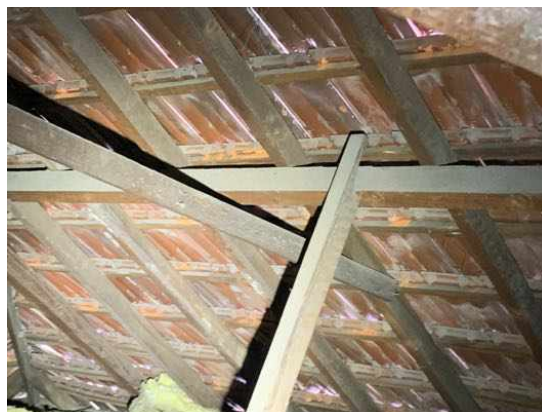
Finding 3.09

Building:	Main Building
Location:	Roof Void (lower / front) - Part
Finding:	Sarking - Missing
Information:	Sarking is missing under the roof sheeting. Sarking acts as an insulator that helps with noise reduction and protects against water penetration. Sarking plays a key role in the operation and function of the overall roofing structure and its performance.

Although not a requirement at the time of construction, replacement of any missing building element is advisable (although this can be quite expensive to do after the time of construction). Where sarking is missing, regular inspections of the roof tiles for cracking and potential moisture penetration is required.

Sarking may be retrospectively fitted by a registered builder at the discretion of the client.

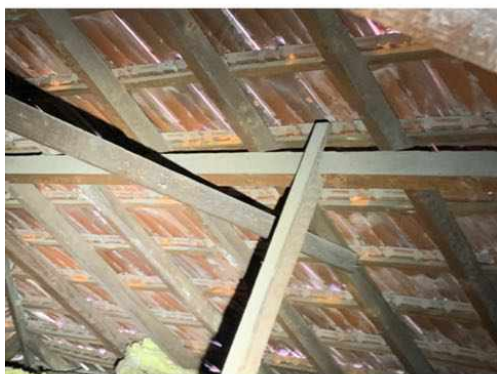
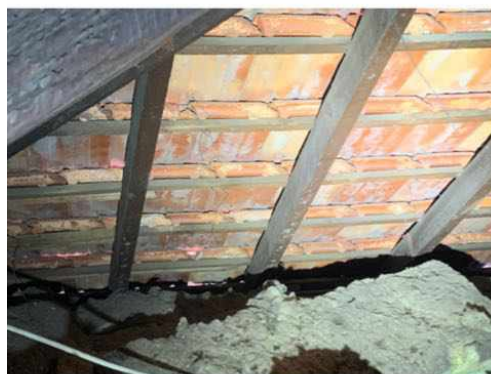
Finding 3.10

Building:	Main Building
Location:	Roof Void (lower / front) - Part
Finding:	Roof tiles - Weathered
Information:	Upon inspection of the exterior roofing, the majority of roof tiles were considered to be in a fair condition. While weathering of the tiles is consistent with the age of the property, maintenance works are required.

Isolated areas of mortar have come loose in the valleys and minor cracking is also present. Re-pointing and re-sealing may be considered as an interim solution by the client to help preserve and extend the life span of the tiles.

Where left unmanaged, deteriorating roof tiles are likely to lead to a number of secondary defects, including minor water leaks and weather exposure to internal roofing structures.

Consultation with a roofing contractor is highly advised to gain advice on cost of remedial works that may be required in the short to medium term. Remedial works are likely to increase the longevity of the exterior roofing structure.

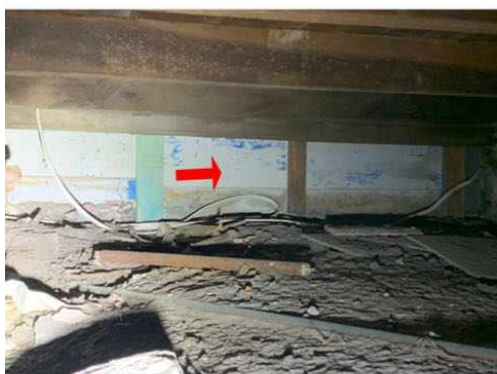
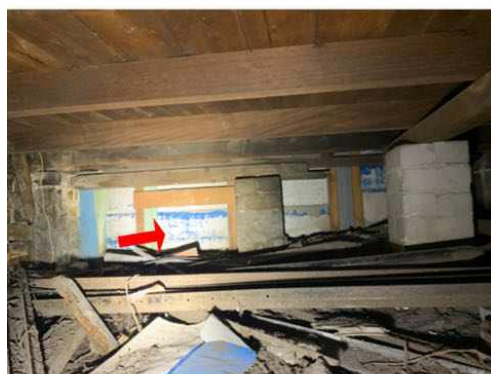
Finding 3.11

Building:	Main Building
Location:	Subfloor
Finding:	Wall sarking - Missing
Information:	Although some building elements may seem irrelevant or unnecessary, all building elements play a key role in the operation and function of the overall structure and its performance.

Replacement of any missing building element should be conducted as soon as possible to ensure that no damage or functional issues occur to associated building materials.

The appropriate tradesperson should be appointed as soon as possible to replace the missing building element.

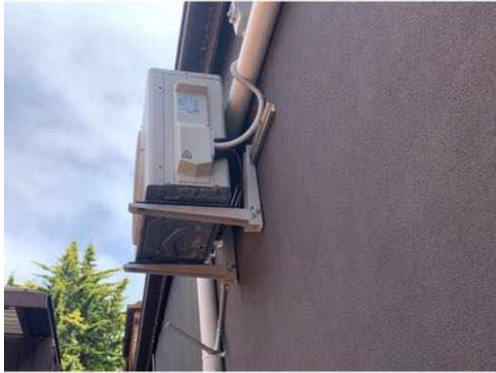
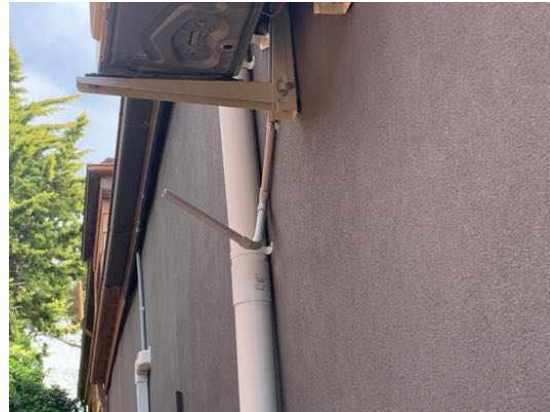
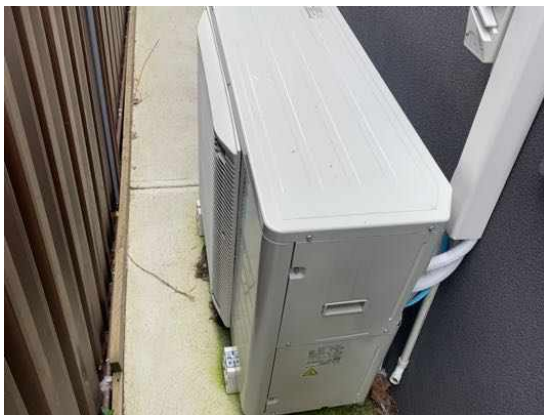
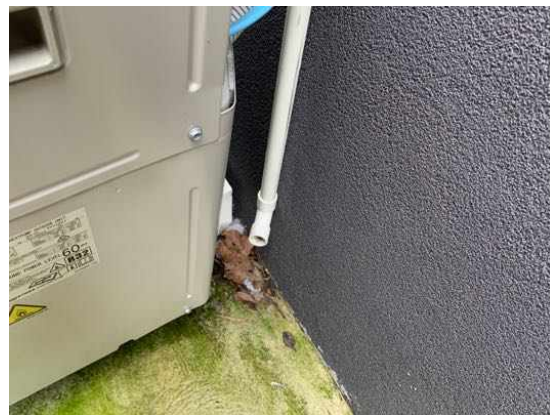
Finding 6.02

Building:	Main Building
Location:	Exterior walls - left side
Finding:	Air conditioner - Disconnected overflow
Information:	The Air Conditioner (A/C) overflow was found to be disconnected from storm water drainage and is creating excessive moisture in the surrounding area.

Such leaking creates an environment which is conducive to an array of defects, including water damage to associated building elements and the attraction of termite or timber pest infestation.

It is highly recommended that a licensed plumber be appointed to connect the A/C

overflow in order to prevent such an environment from being created. These minor works should be carried out as soon as possible.

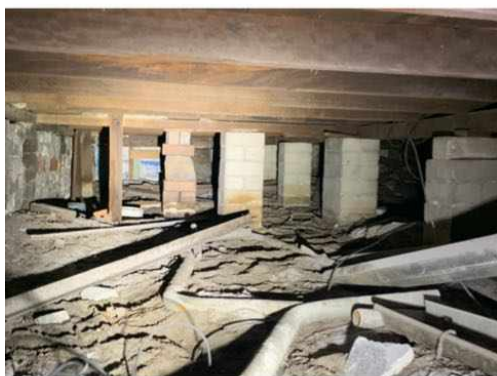
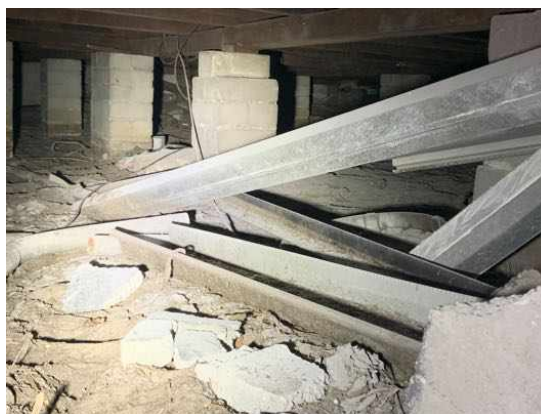
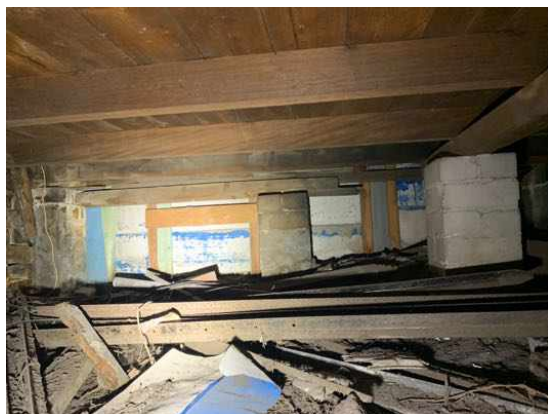
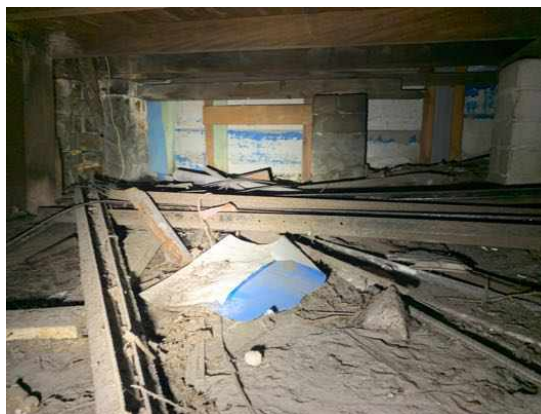
Information: An array of debris was found in the subfloor area at the time of inspection. Debris in this area restricts subfloor ventilation and creates potential for concealed pest entry. Stored timbers and other materials may also make the area susceptible to termite activity and wood rot.

A clear and empty subfloor will be better ventilated and easier to maintain in a dry condition. The removal of any timber debris is vital in minimising the risk of termite or wood borer activity.

Debris in the subfloor should be removed as soon as possible. Depending on the location and amount of debris and stored items, the homeowner may elect to undertake this task. Alternatively there are a large number of rubbish removal subcontractors that could undertake these works.

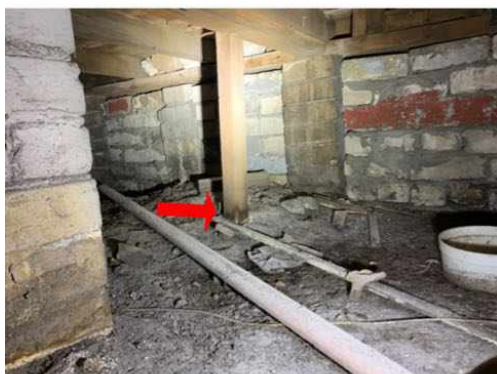
Finding 6.05

Building:	Main Building
Location:	Subfloor
Finding:	In ground contact
Information:	Any timbers in direct ground contact provide opportunity for concealed termite entry and are likely to be subject to premature rot and decay as the soil retains moisture or damp conditions against the timbers.

Remove untreated timber that is in direct contact with external grounds. Consider replacement with more durable materials i.e. treated timber or non timber elements. Frequent pest inspections are advised to readily identify any termite activity in these areas.

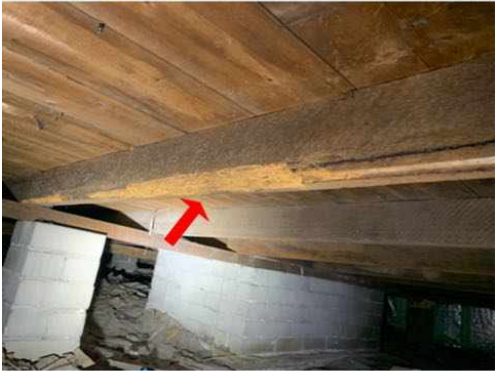
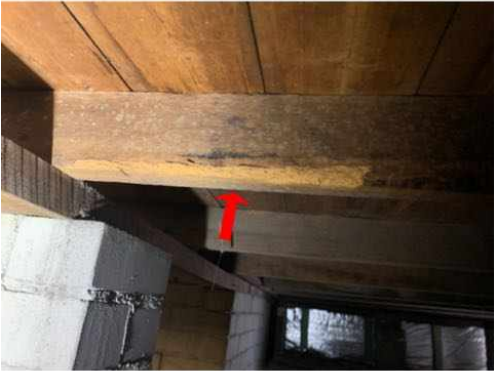
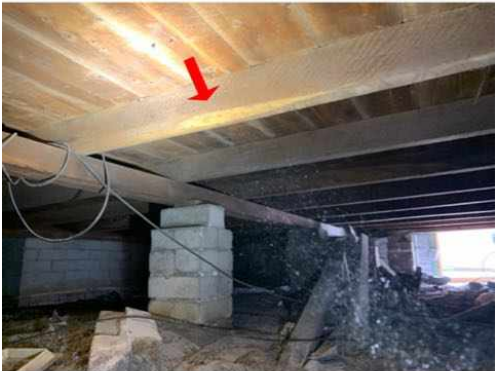
Building:	Main Building
Location:	Subfloor
Finding:	Evidence of wood borer activity identified
Information:	Wood borers small beetles that colonise in exposed timber elements are a common timber pest that are regularly mistaken for termites. Although wood borer activity is generally not detrimental to the affected timber they may lead to serious damage and necessitate replacement of certain building elements if left unattended.

The other commonly known borer the Anobium borer is more likely to attack floorboards and may cause severe structural damage to flooring areas.

As no live wood borer activity was identified treatment is not required at this time. Replacement of affected timbers may be considered by the client for superficial reasons.

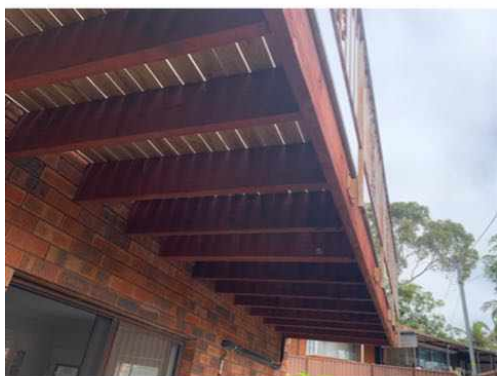
Building: Main Building
 Location: Balcony
 Finding: External Timber Balcony or Deck - Structural Stability
 Information: Although the balconies appeared to be in adequate condition, the load capacity of the external balcony or deck could not be verified during the inspection.

It is highly recommended that a Structural Engineer further assess the external timber balcony or deck to inform the client of its load capacity. Regular maintenance inspections by competent practitioners is needed.

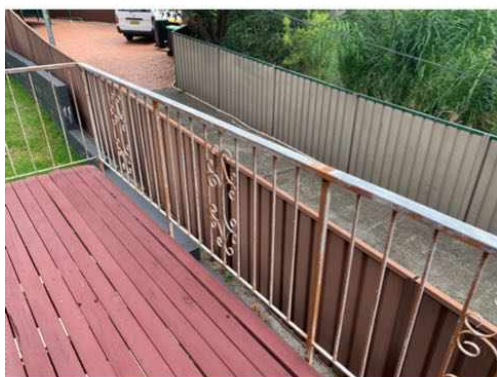
Building: Main Building
 Location: Balcony
 Finding: Balustrade - Suspected Non-Compliance
 Information: The fabricated metal balustrade was measured and found to be less than the present building regulation requirement of 1000mm high where there is a potential of a fall greater than 1000mm.

A registered builder should be contacted to discuss possible rectification solutions.

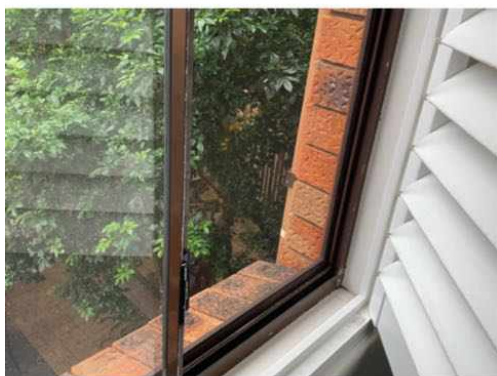
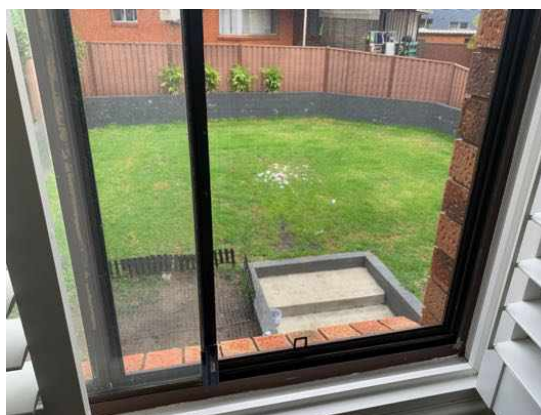
Building:	Main Building
Location:	Bedrooms
Finding:	Window Child Safety Restraints
Information:	Although not the standard at the time of construction, the current National Construction Code (NCC) states that windows are required to have restraints as per the below:

A window contractor or general handyman engaged by strata experienced in the fitting of these restraints could be engaged to carry out and complete these works.

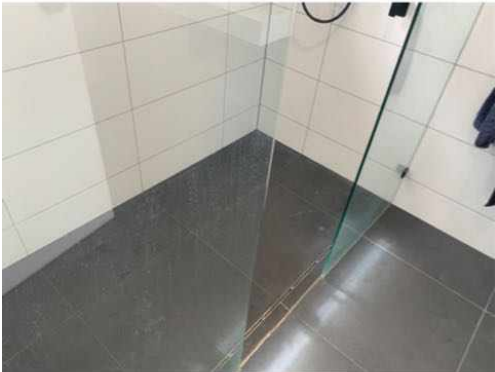
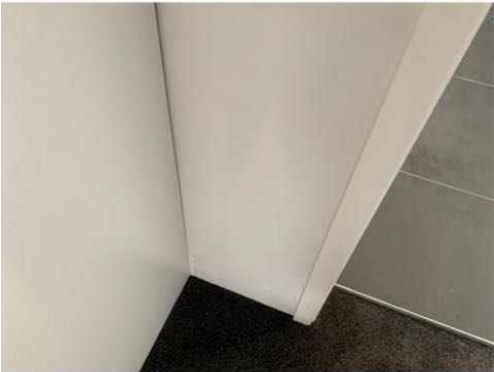
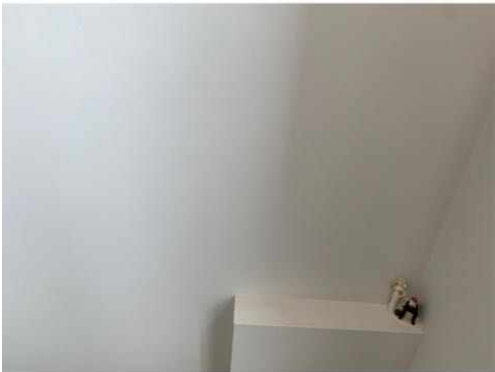
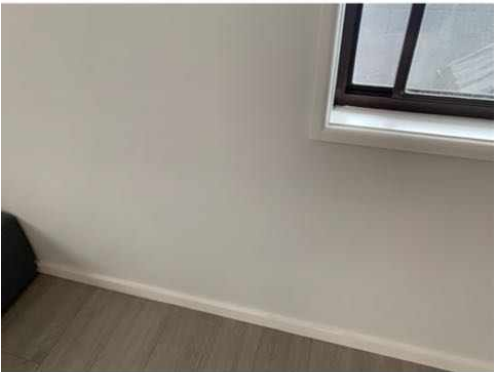
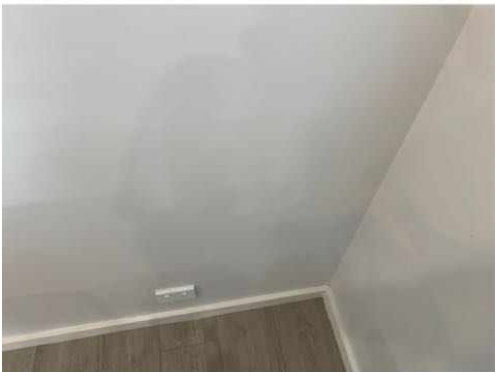
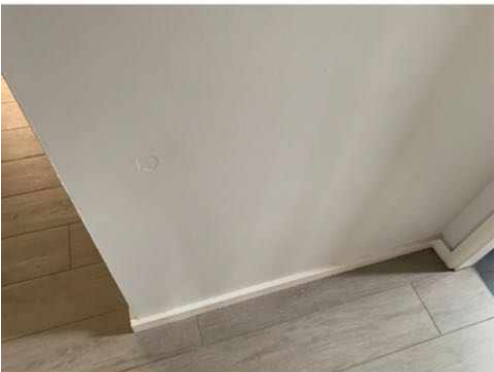
Building:	Main Building
Location:	Walk In Robe / Ground Floor Walls
Finding:	Moisture Readings - No Damp Detected
Information:	During the inspection a moisture meter was used to measure and evaluate the presence of damp to the rear of the shower recess walls (where possible) and the lower ground floor walls.

The assessed areas showed no signs of leakage or damp, however, if the property has not been occupied for an extended period and bathrooms not used, then these readings do not warrant against a future issue occurring.
