## Building Inspection Report

Inspection Date: Tue, 24 Mar 2026

Property Address: 2605/36 Walker St, Rhodes NSW 2138,  
Australia

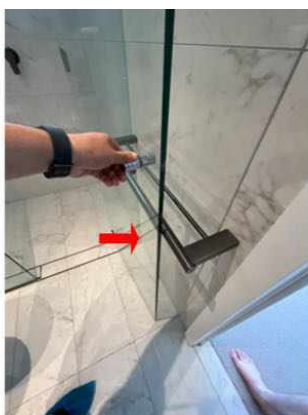
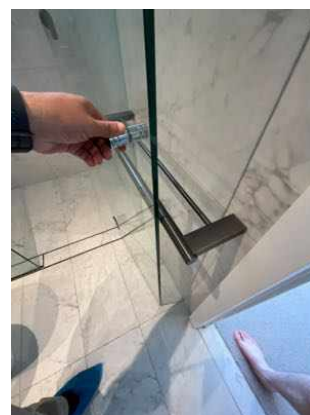
#### Defects 1.01

Building: Main Building  
 Location: Ensuite  
 Finding: shower screen door hitting fixed towel rail/bar  
 Information: The shower screen door was found to make contact with the fixed towel rail/bar upon opening. This indicates poor placement or alignment of fittings.

This condition is considered a potential safety hazard. Ongoing impact may lead to loosening of fittings or damage to the shower glass, which carries a risk of glass breakage and injury to occupants.

It is recommended that a licensed glazier or bathroom renovator further evaluate and rectify this issue. Adjustment of the shower screen door alignment or relocation of the towel rail is required to prevent contact and ensure safe operation.

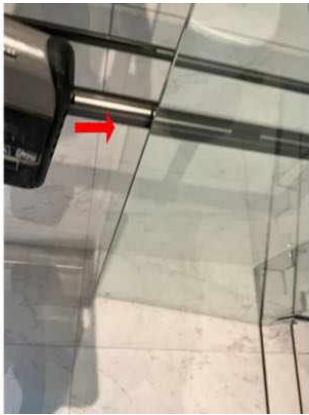
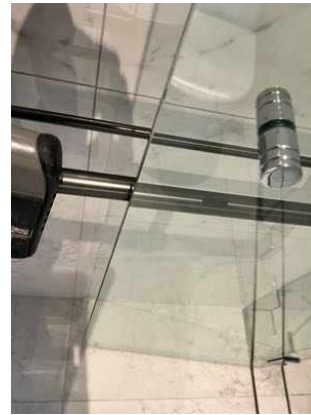
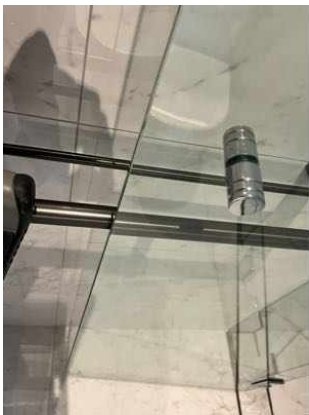
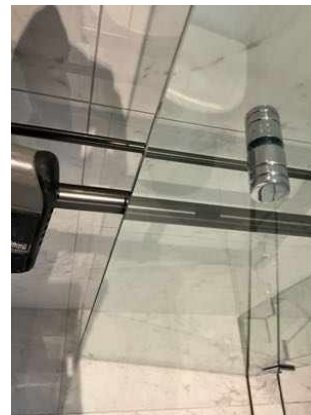
#### Defects 1.02

Building: Main Building  
 Location: Bathroom  
 Finding: shower screen door hitting fixed towel rail/bar  
 Information: The shower screen door was found to make contact with the fixed towel rail/bar upon opening. This indicates poor placement or alignment of fittings.

This condition is considered a potential safety hazard. Ongoing impact may lead to

loosening of fittings or damage to the shower glass, which carries a risk of glass breakage and injury to occupants.

It is recommended that a licensed glazier or bathroom renovator further evaluate and rectify this issue. Adjustment of the shower screen door alignment or relocation of the towel rail is required to prevent contact and ensure safe operation.

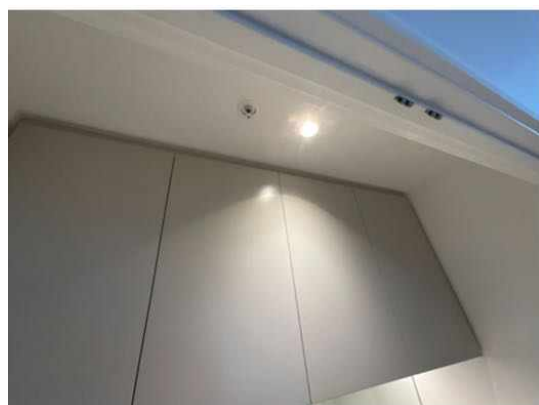
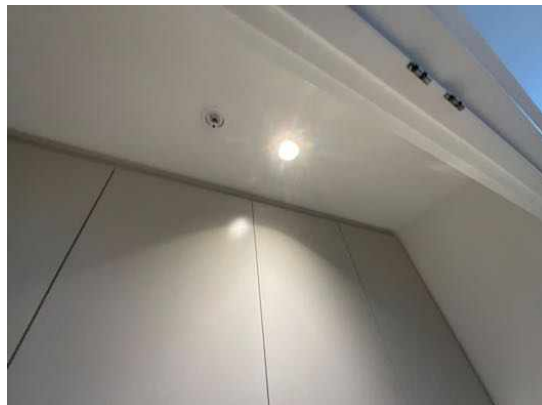
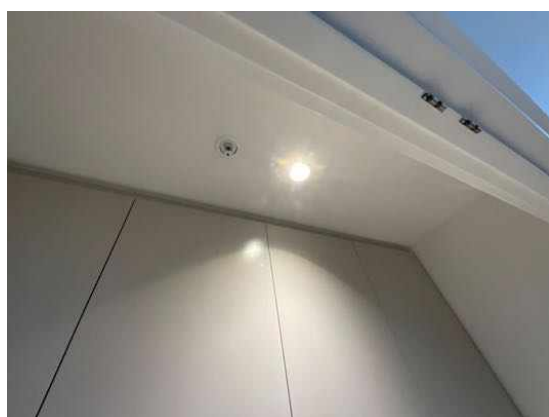
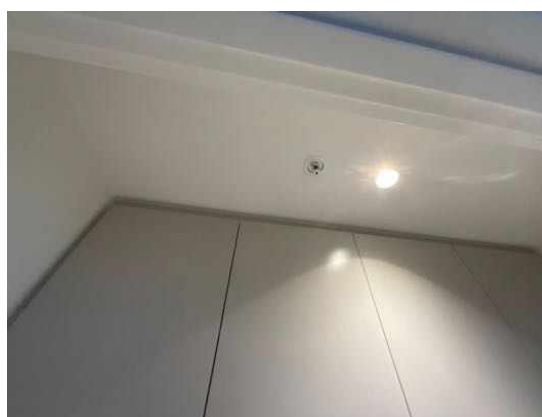
### Defects 3.01

Building:	Main Building
Location:	Laundry
Finding:	No exhaust fan
Information:	The laundry lacks an exhaust fan, leading to inadequate ventilation and potential issues with moisture buildup.

1. Mold and mildew growth: Without proper ventilation, moisture accumulates in the bathroom, creating an environment conducive to mold and mildew growth, which can pose health risks and damage surfaces.
2. Odor retention: The absence of an exhaust fan can lead to lingering odors in the bathroom, causing discomfort for occupants and potential embarrassment.
3. Damage to building materials: Excessive moisture can damage paint, wallpaper, and even structural elements like drywall and wood, leading to costly repairs and renovations.

A licensed electrician or general contractor can install an exhaust fan in the bathroom. Additionally, a building inspector or HVAC technician may be consulted to ensure proper ventilation requirements are met and to recommend the appropriate fan size and placement.

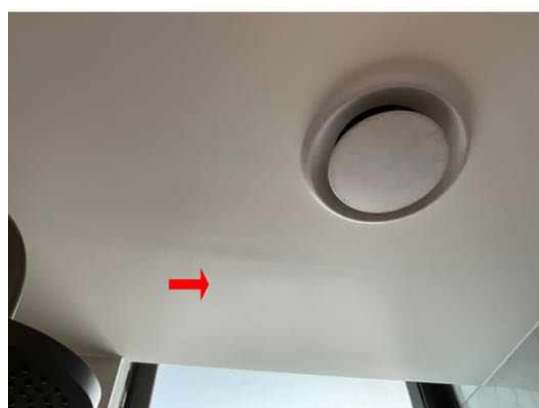
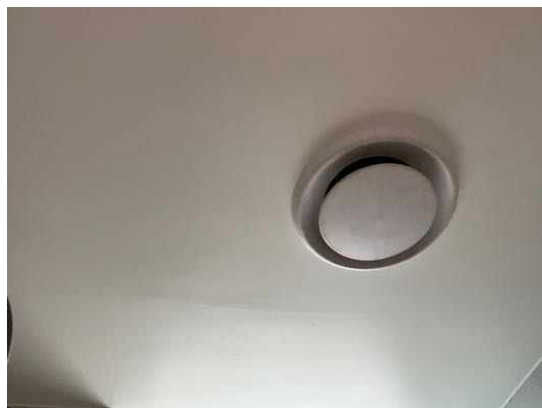
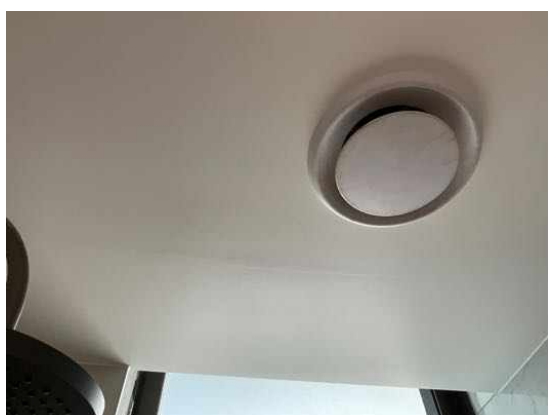
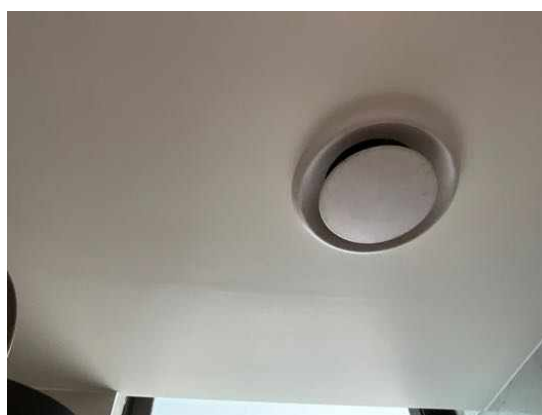
**Defects 3.02**

Building: Main Building  
Location: Ensuite

**Finding:** Sagging Ceiling Lining

**Information:** The ceiling lining exhibits visible sagging/deformation, which is indicative of potential failure of the fixing system and/or deterioration of the plasterboard. This condition may be associated with inadequate fixing, moisture ingress, or age-related material fatigue. The defect is considered significant as it may compromise the structural integrity of the ceiling lining.

- Risk of sudden collapse of the ceiling lining, posing a safety hazard to occupants
- Potential presence of underlying issues such as roof leaks or moisture damage
- Progressive deterioration if not addressed in a timely manner

It is recommended that a licensed builder or qualified plasterer be engaged to assess and rectify the issue. Further investigation may be required to identify any underlying causes (e.g. roof leaks), and repairs should be carried out in accordance with relevant Australian Standards.

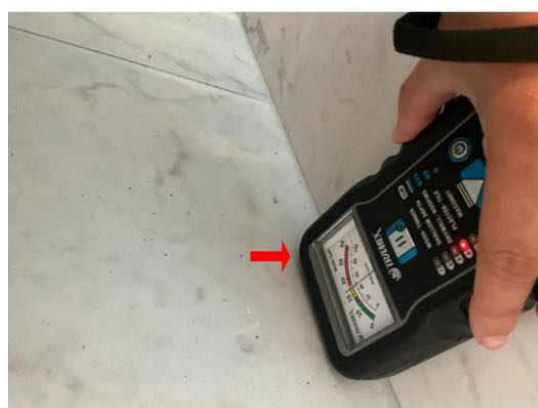
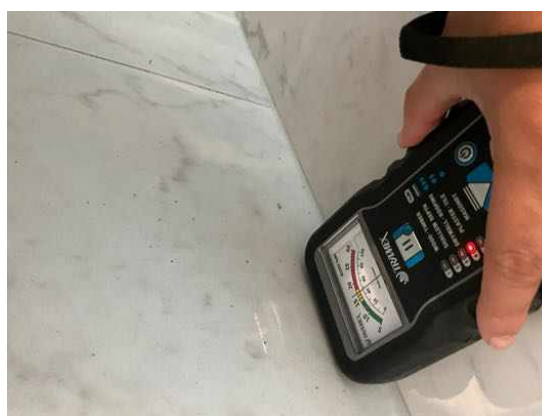
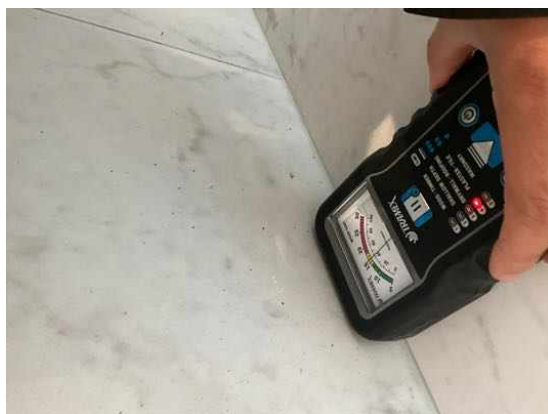
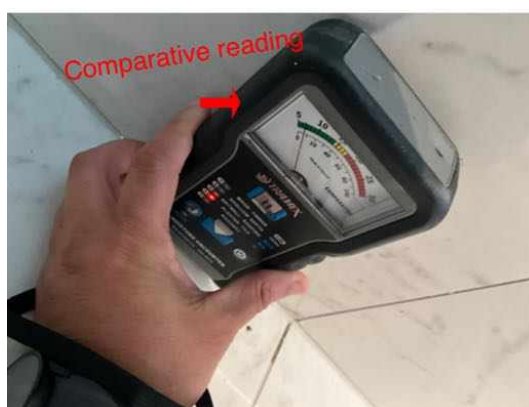
**Defects 3.03**

Building: Main Building  
Location: Ensuite  
Finding: Shower - Damp  
Information: Damp is evident to the lower 300mm of wall to the shower alcove. This defect is quite common, and is suspected to have been caused by moisture permeating through the grouting in this area, which shows evidence of deterioration. Leaking pipes within the adjoining wall is also a possible cause.

Damp (or structural damp) refers to the presence of unwanted moisture in the structure of a building, either as the result of intrusion from outside, or condensation from within the structure. In the shower area, internal water leaks or other sources of excessive moisture are generally the cause of damp.

Unmanaged damp in the shower recess is likely to facilitate the formation and development of mould and fungi growth, decaying associated building materials and compromising their structural integrity. It is important to address damp conditions, as the World Health Organisation notes that excess moisture leads - on almost all indoor materials - to growth of microbes such as moulds, fungi and bacteria, which subsequently emit spores and other matter into the indoor air. Exposure to these contaminants is associated with a wide range of respiratory and other health-related problems.

Consultation with a qualified plumber or bathroom specialist is advised immediately to identify the cause of damp and to perform remedial works as required. Where excessive mould growth is present, further inspection by a specialist environmental health inspector should also be considered.

Always ensure that sealant and grout is in good condition to prevent any moisture issues occurring in the future.

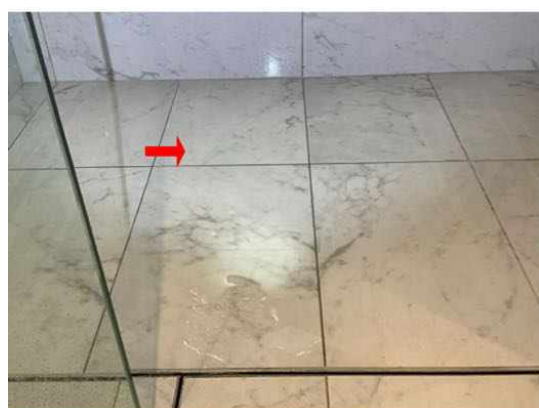
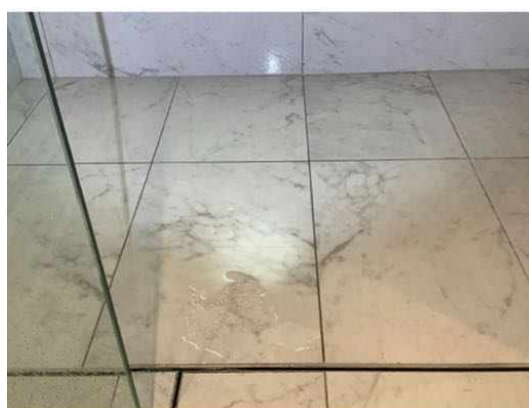
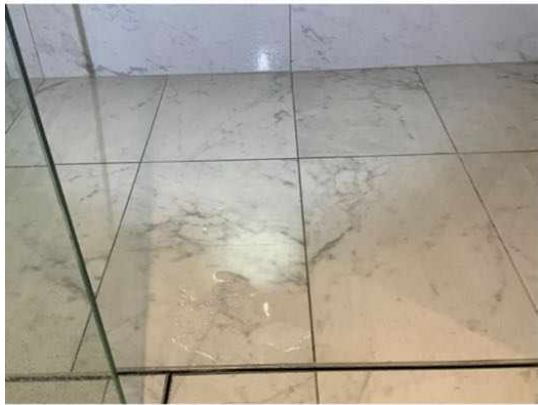
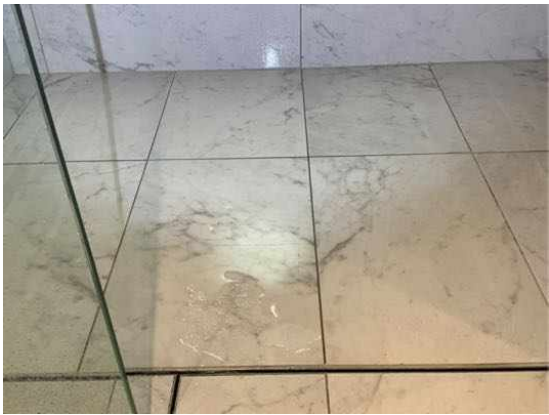
### Defects 3.04

Building:	Main Building
Location:	Ensuite
Finding:	Shower base - Water pooling
Information:	Evidence of water pooling around the floor waste in the shower recess was noticed at the time of inspection. It is suspected that this excessive moisture is attributed to insufficient fall in the shower floor tiles.

This pooling is minor overall but is still considered unsatisfactory, as standard tiling practices would not permit this situation to occur. Pooling water around floor wastes can create a slip hazard in extreme cases and create conditions that are conducive to mould growth over time. Where left unmanaged, the degradation of sealant and grouting is also likely to occur, possibly necessitating further repair works.

Remedial works may involve some sections of tiling and flooring repair and replacement. A tiling contractor or bathroom specialist should be appointed to provide further advice on reparation options and to perform works as necessary.

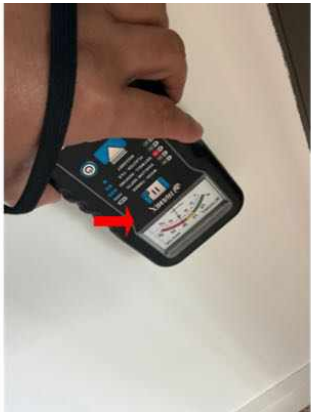
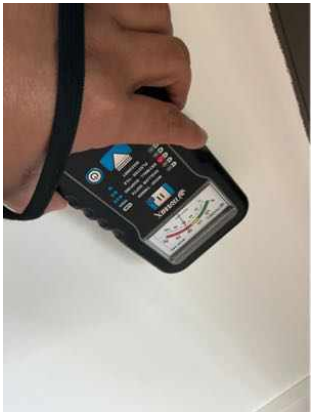
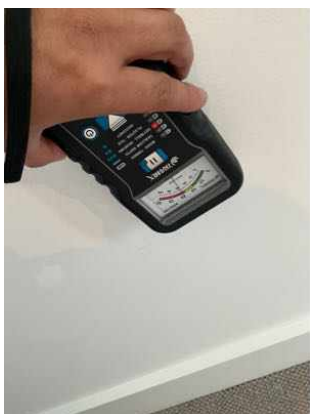
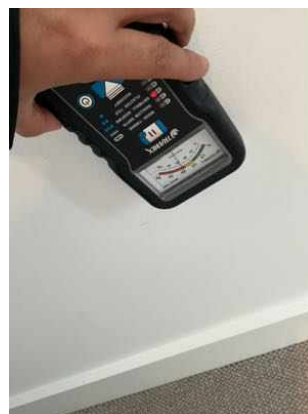
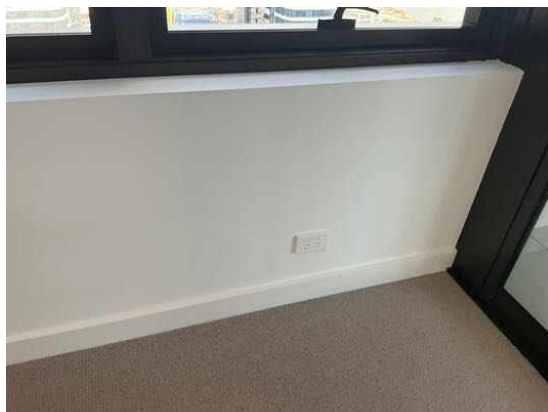
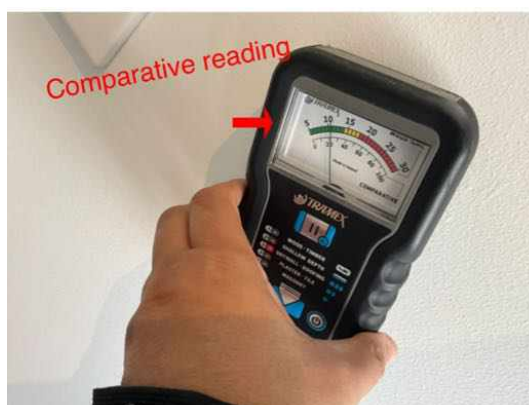
**Defects 3.05**

Building: Main Building  
Location: Bedroom - Master  
Finding: Evidence of excessive moisture - Drywall  
Information: Excessive moisture is present at the time of , indicating a potential water leakage issue within the wall.

The prolonged presence of moisture can lead to mold growth, deteriorate the structure, and create an environment conducive to health hazards. Additionally, it may compromise the adhesive holding the tiles, leading to their detachment.

A licensed plumber or a qualified contractor specializing in water damage remediation should investigate the source of the moisture, fix any leaks, and address the damage. Additionally, replacing affected tiles and ensuring proper waterproofing are crucial to preventing future issues.

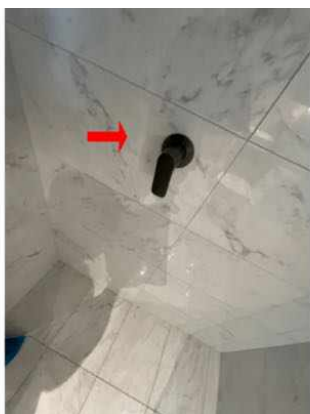
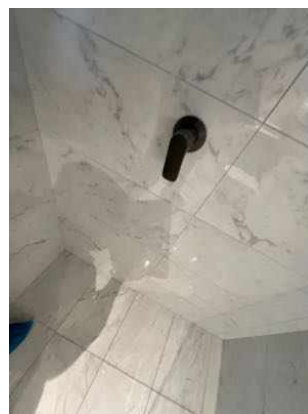
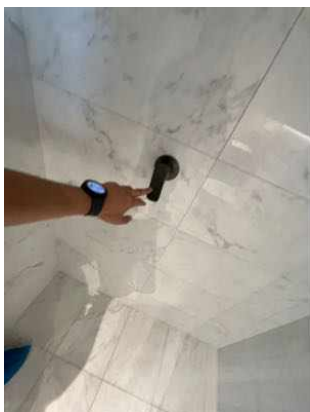
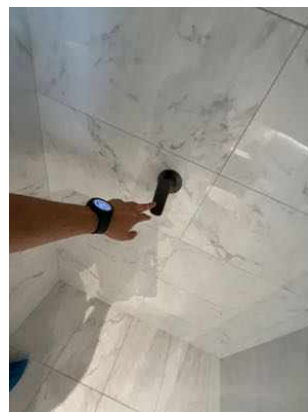
### Defects 3.06

Building: Main Building  
 Location: Bathroom  
 Finding: Water Hammer in Plumbing Fitting  
 Information: Water hammering noise was detected when operating the plumbing fixture, suggesting a sudden pressure surge within the pipework.

- May lead to long-term damage of internal plumbing components.
- Can cause wear and tear at joints and fittings.
- Potential for leaks or water damage if left unresolved.

A licensed plumber should be engaged to investigate and rectify the issue. Solutions may include installing water hammer arrestors, securing pipework, or adjusting water pressure.

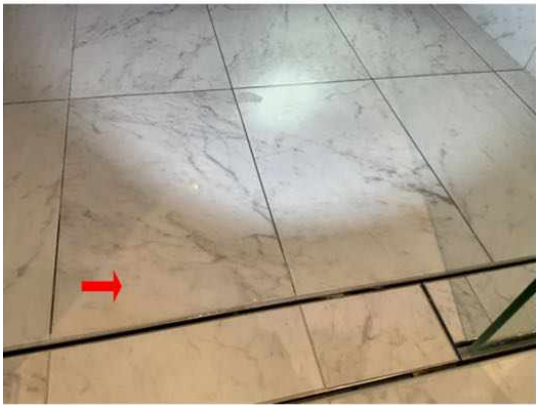
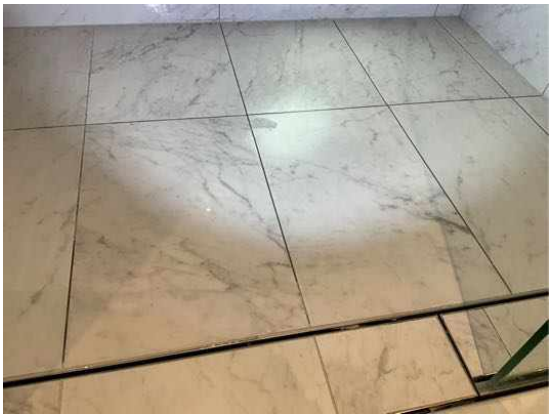
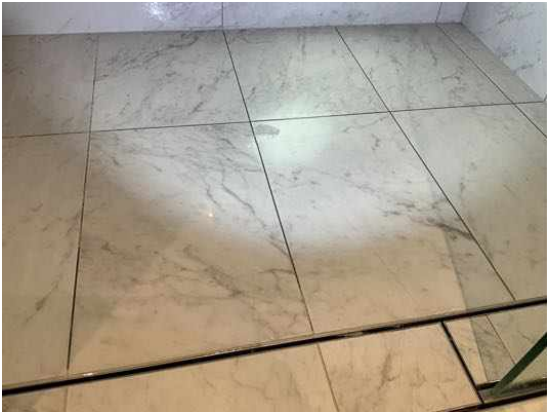
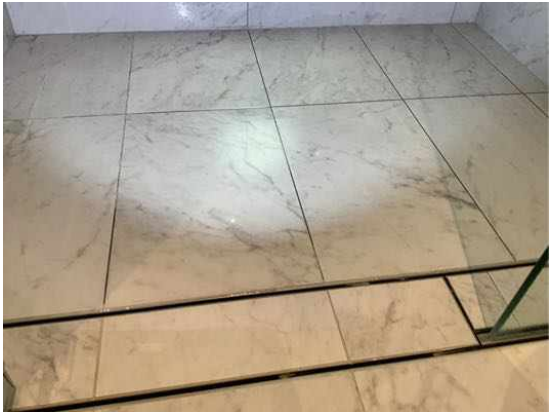
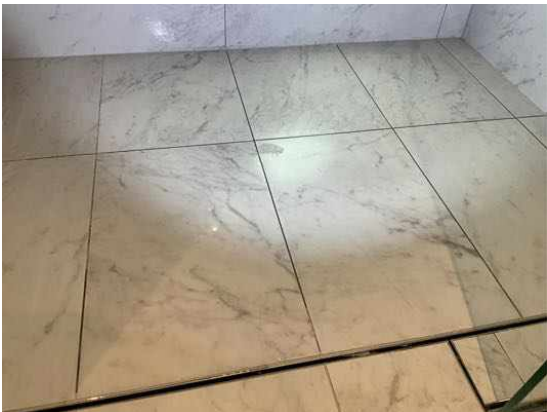
### Defects 3.07

Building:	Main Building
Location:	Bathroom
Finding:	Shower base - Water pooling
Information:	Evidence of water pooling around the floor waste in the shower recess was noticed at the time of inspection. It is suspected that this excessive moisture is attributed to insufficient fall in the shower floor tiles.

This pooling is minor overall but is still considered unsatisfactory, as standard tiling practices would not permit this situation to occur. Pooling water around floor wastes can create a slip hazard in extreme cases and create conditions that are conducive to mould growth over time. Where left unmanaged, the degradation of sealant and grouting is also likely to occur, possibly necessitating further repair works.

Remedial works may involve some sections of tiling and flooring repair and replacement. A tiling contractor or bathroom specialist should be appointed to provide further advice on reparation options and to perform works as necessary.
