Building and Timber Pest Inspection Report

Inspection Date: Tue, 17 Feb 2026

Property Address: 23 Ronald Ave, Greenwich NSW 2065,
Australia

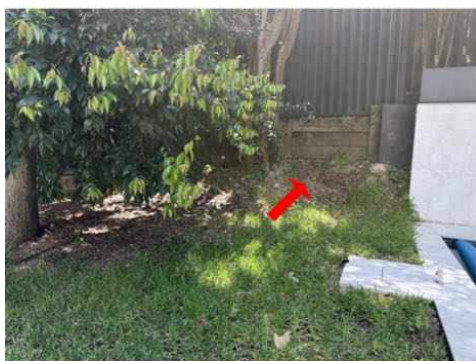
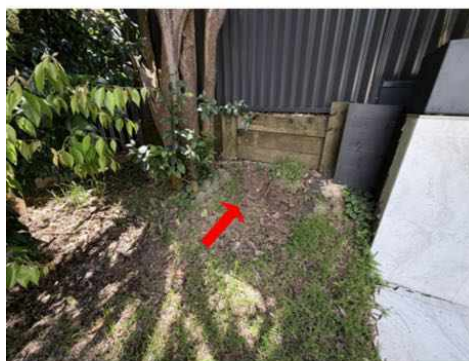
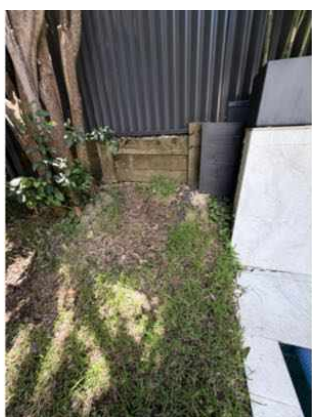
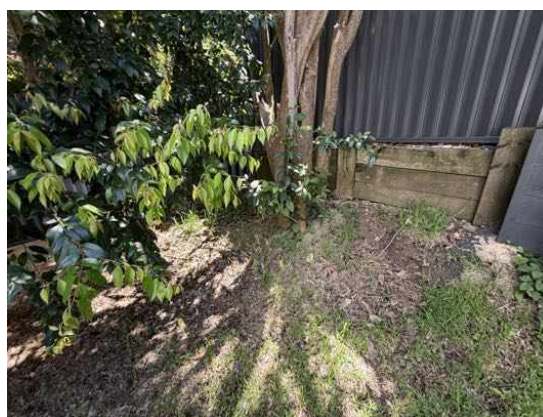
Finding 1.01

Building: Main Building
Location: Pool Area
Finding: Soil Erosion
Information: Soil erosion from inadequate retaining wall to the back fence and neighbouring property is found.

The soil appears to be washing away at the back of the retaining wall.

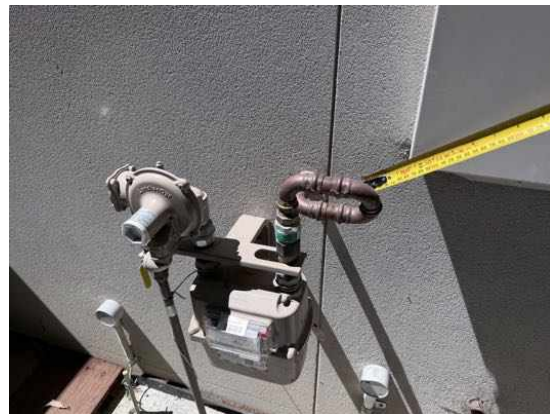
Finding 1.02

Building: Main Building
Location: Exterior walls - left side
Finding: Gas Meter Distance to Electrical Meter
Information: The gas meter and regulator is required a minimum 500mm away from the electrical meter.

Relocation of the gas meter is required.

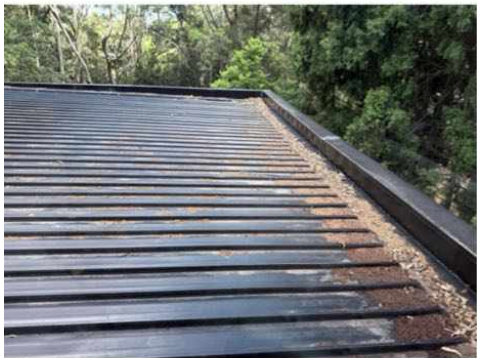
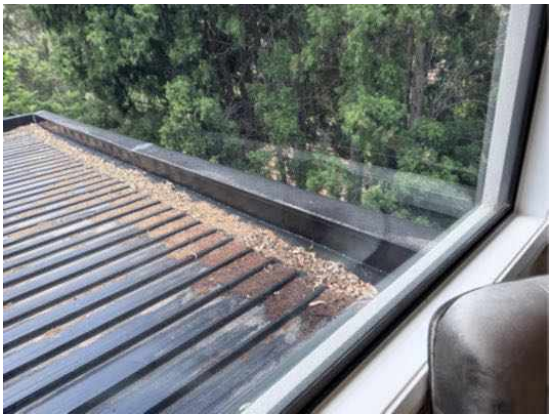
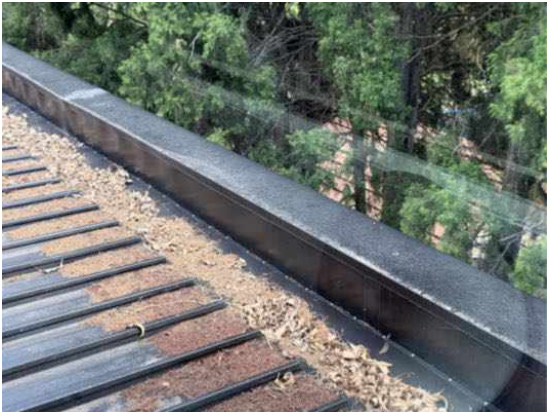
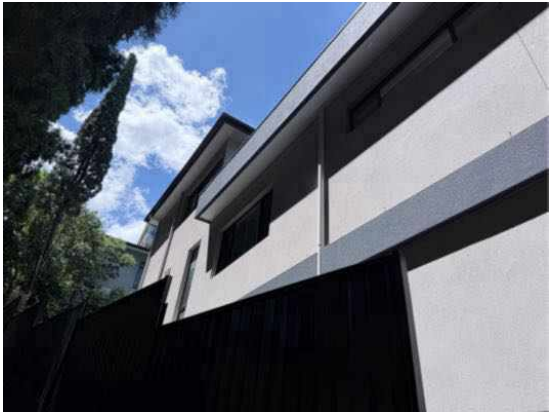
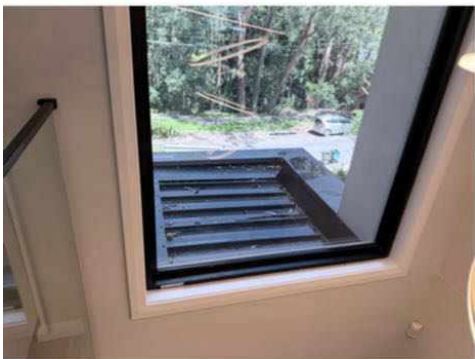
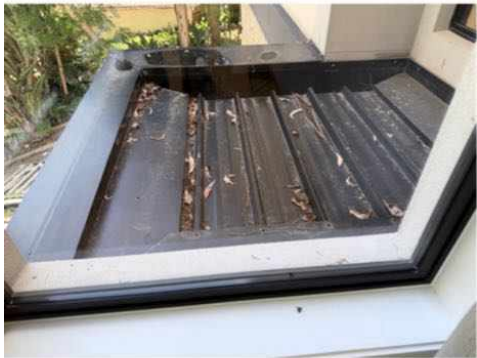
Finding 2.01

Building: Main Building
Location: Roof Exterior
Finding: Overflow of Roof Box Gutter Missing
Information: No overflow provision has been installed to the box gutter.

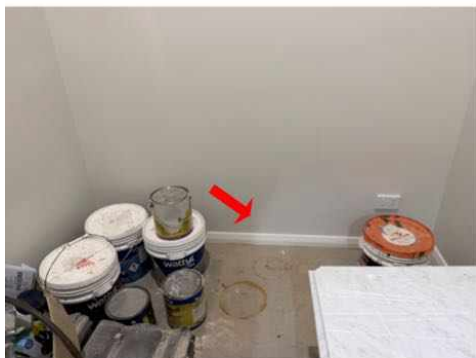
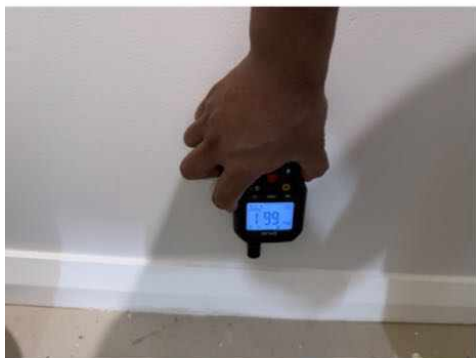
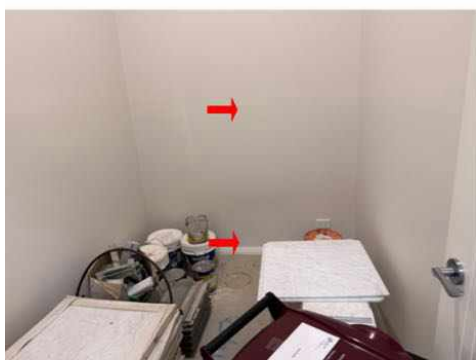
Finding 2.02

Building:	Main Building
Location:	Store Room
Finding:	Damp - Rising
Information:	Rising damp describes the upward movement of water in low sections of building elements (e.g. walls) by capillary action - the movement of water through porous materials such as bricks, sandstone or mortar.

Rising damp is generally managed by the installation of a damp proof course during construction. A Damp Proof Course (DPC) is an impermeable barrier at the base of the wall above ground level. However, many 19th Century buildings have no damp course installed, or the materials have failed. The DPC may have been omitted as a consequence of poor workmanship, or it may have been bridged where materials built up against the side of the house allow moisture ingress above the DPC level.

The first step in addressing rising damp is to diagnose the cause. The identified cause should be addressed first before addressing the appearance and other defects which have resulted from the rising damp. If the original cause is not resolved, further cases of damp are likely to ensue, resulting in secondary defects.

Consultation with a qualified plumber is advised immediately to identify the cause of the damp and perform remedial works as required.

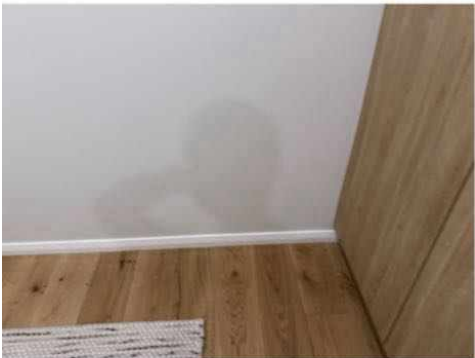
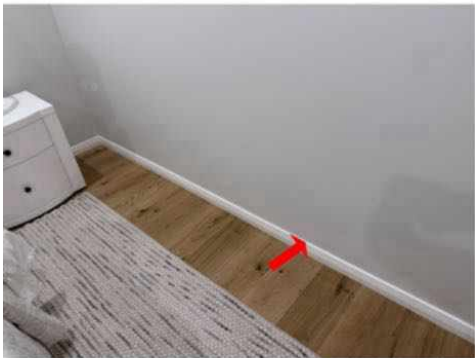
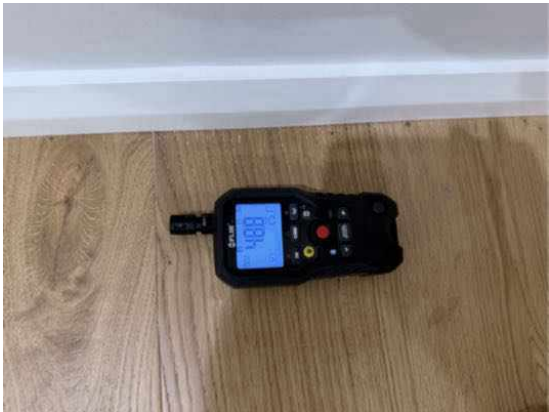
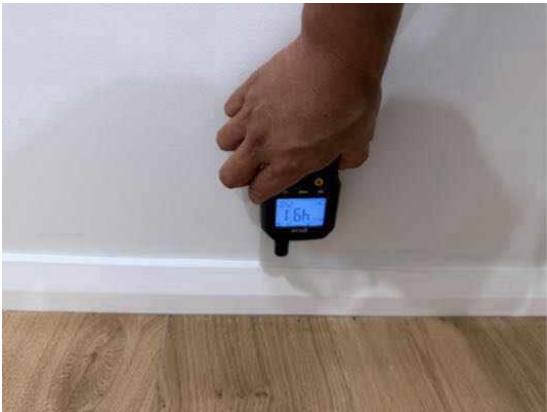
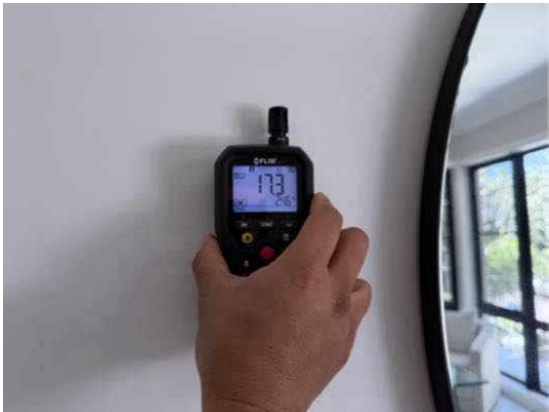
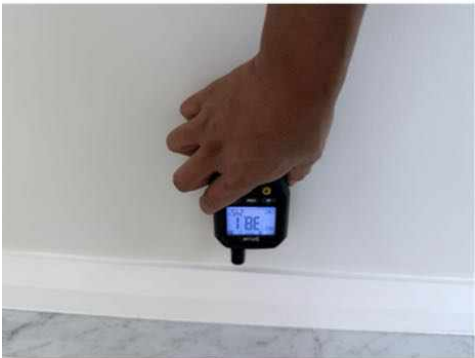
Finding 2.03

Building:	Main Building
Location:	Bedroom
Finding:	Exterior walls - Lateral damp
Information:	Lateral penetrating damp refers to the sideways movement of moisture, predominantly from the surrounding ground, which tends to affect basement walls and other earth-retaining walls. The implications of unmanaged damp range from mould fungi growth, wood rot and decaying building materials, to finishes including lifting, bubbling, peeling and staining of paint, plaster and wallpaper.

It is important to address damp conditions as the World Health Organisation notes that excess moisture leads - on almost all indoor materials - to the growth of microbes such as moulds, fungi and bacteria, which subsequently emit spores and other matter into the indoor air. Exposure to these contaminants is associated with a wide range of respiratory and other health-related problems. Additionally, the development of damp in timber building elements also provides an environment that is conducive to termite / timber pest attack.

Immediate consultation with a licensed plumber is advised to address the cause of the

damp and to perform remedial works as necessary.

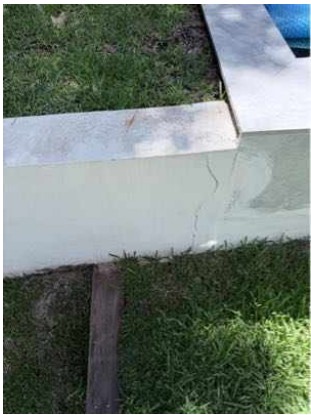
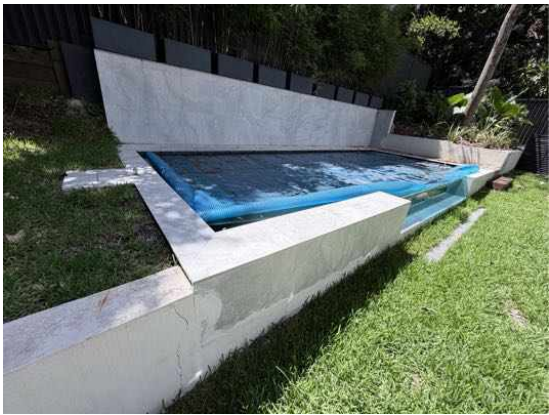
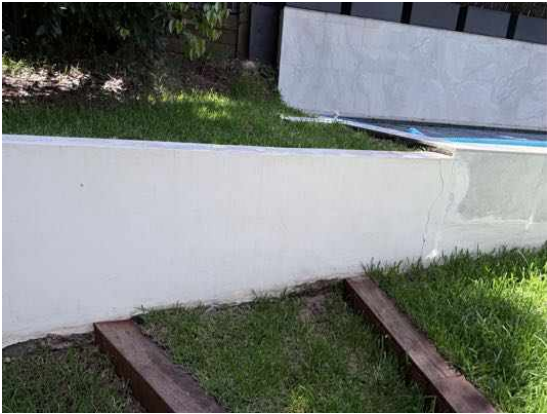
Finding 2.04

Building:	Main Building
Location:	Pool Area
Finding:	Retaining wall - Defective
Information:	Crack is observed to the retaining wall of greater than 2mm. The retaining wall is measured to be leaning outwards indicating a movement in the retaining wall.

The retaining wall in this area was found to be defective at the time of inspection. Generally, defective retaining walls are caused by poor original design or material use. However, deteriorated retaining walls may also be a result of substandard construction, poor site drainage or unmanaged stormwater flows.

If left unmanaged, the retaining wall may become a safety hazard if it continues to destabilise. Where retaining walls further rot and decay, an environment is created that is conducive to termite and pest infestation.

Significant repair and replacement should be expected. Where retaining walls are considered structural walls, a structural engineer / surveyor should be consulted regarding required remedial works. Otherwise, a landscaper or retaining wall installer may be appointed to repair or replace the wall, at the discretion of the client.

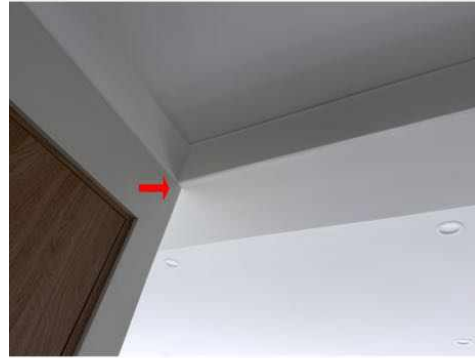
Finding 3.03

Building:	Main Building
Location:	Stair Landing
Finding:	Cracking - Damage Category 0 - Hairline (less than 1mm)
Information:	Hairline cracks are very minor in nature and generally are only ever an appearance defect. While such cracking may be noticeable in some cases, it is quite common and does not indicate any structural damage.

Cracking of this nature can generally be repaired with minor sanding, filling and/or

repainting. Such works should be performed by a qualified painter or a general handyman.

Monitoring of all cracking should be conducted frequently. Always contact a building inspector should cracks widen, lengthen, or become more numerous.

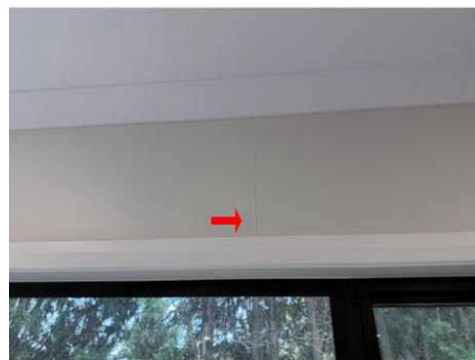
Finding 3.04

Building:	Main Building
Location:	Bedroom - Master
Finding:	Cracking - Damage Category 0 - Hairline (less than 1mm)
Information:	Hairline cracks are very minor in nature and generally are only ever an appearance defect. While such cracking may be noticeable in some cases, it is quite common and does not indicate any structural damage.

Cracking of this nature can generally be repaired with minor sanding, filling and/or repainting. Such works should be performed by a qualified painter or a general handyman.

Monitoring of all cracking should be conducted frequently. Always contact a building inspector should cracks widen, lengthen, or become more numerous.

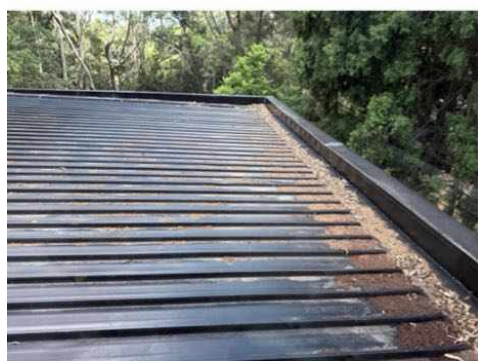
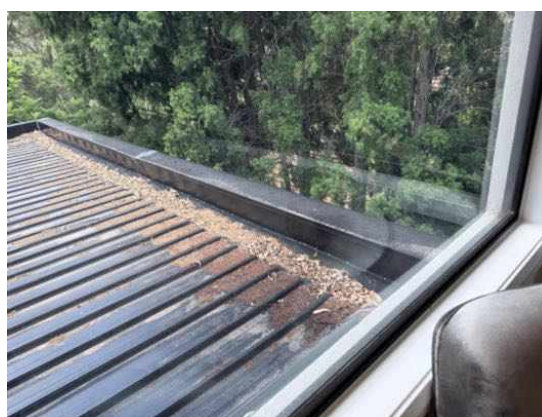
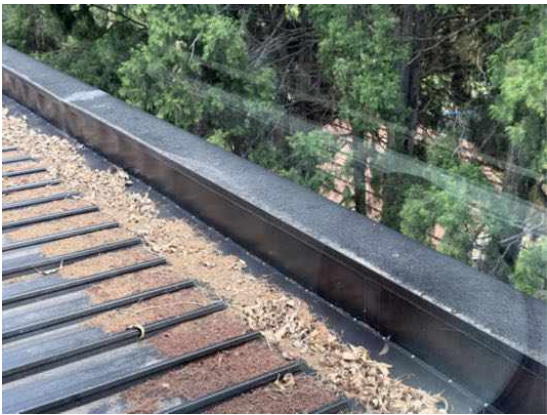
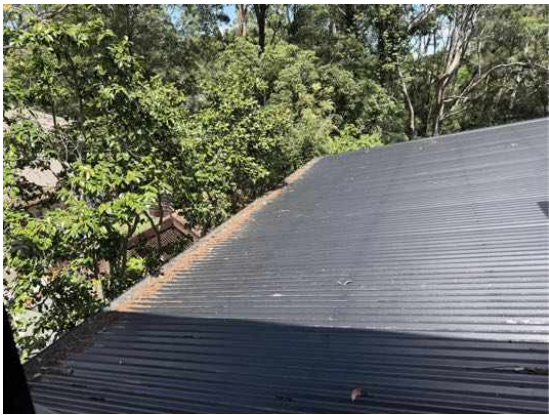
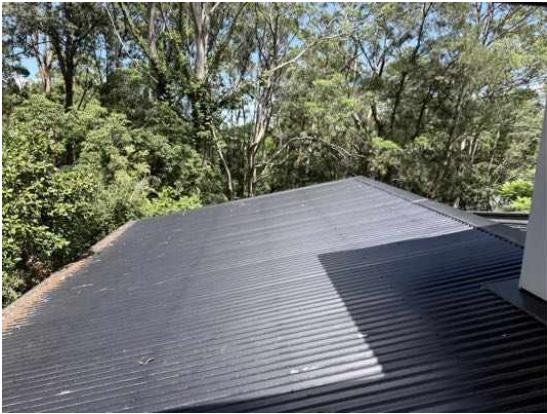
Finding 3.05

Gutters are a critical part of the building's management of storm water and rain. It is therefore important that they be kept clear to prevent secondary damage to associated building elements, including exterior and interior walls, ceiling linings and any adjoining building elements. Where gutters are blocked, pooling of rainwater is likely to occur, fast-tracking rust and corrosion of the roof plumbing elements.

It is highly advised that all overhanging tree branches be removed as soon as possible to prevent any further damage. Repair and/or replacement of sections of damaged guttering may also be required where the extent of the damage necessitates.

Such works should be performed by the homeowner; however, appointment of a landscape contractor or an arborist may be required. Consultation with a licensed roof plumber is required where guttering has been damaged.

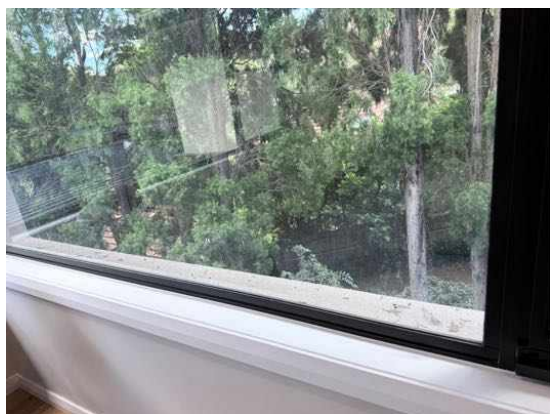
Finding 3.06

Building: Main Building
Location: Bedroom - Master
Finding: Window Not Cleaned
Information: Construction render and concrete splashes on the windows has not been cleaned.

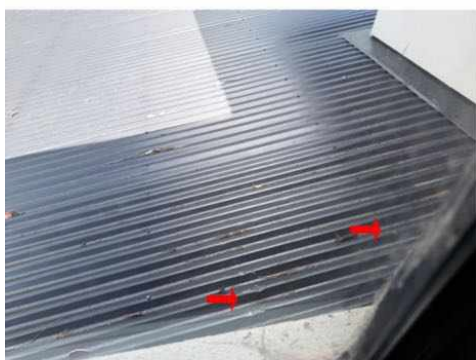
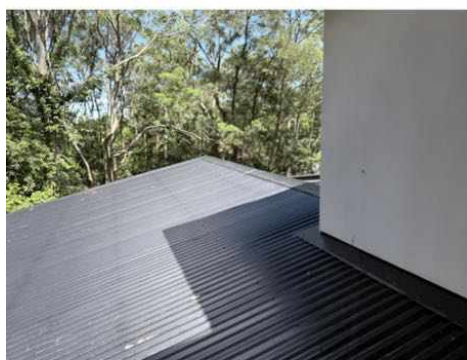
Finding 3.07

Building:	Main Building
Location:	Roof Exterior
Finding:	Roof Sheeting Dented
Information:	Dents is observed on the roof sheets.

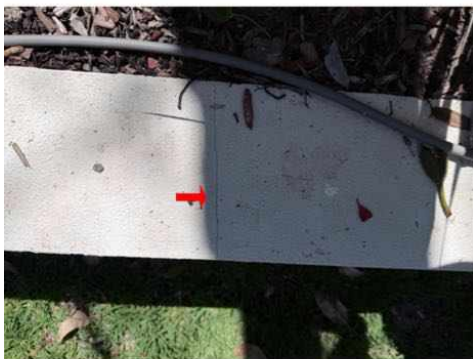
Building:	Main Building
Location:	Yard - Back
Finding:	Cracking - Damage Category 1 - Fine (up to 1mm)
Information:	Although fine cracks are quite noticeable, they are often only considered to be an appearance defect, and usually do not indicate any structural damage. Generally, the cause of a fine crack is indicative of a separation between building materials and finishes (e.g. paint, plaster, etc.) along joints.

Cracking of this nature can generally be repaired with minor sanding, filling and/or repainting. Such works should be performed by a qualified painter or a general handyman.

Monitoring of all cracking should be conducted frequently. Always contact a building inspector should cracks widen, lengthen, or become more numerous.

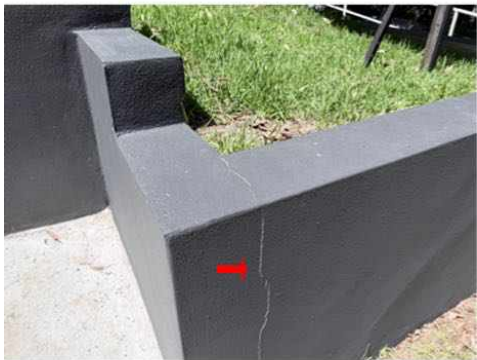
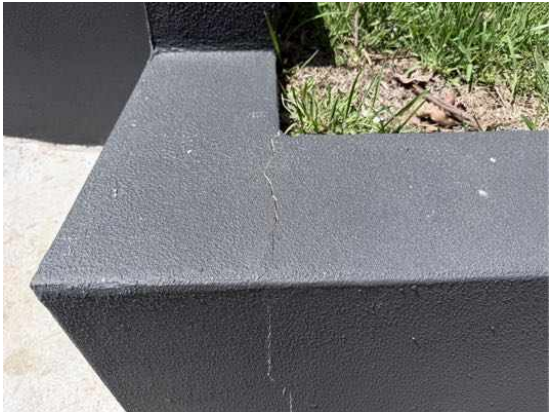
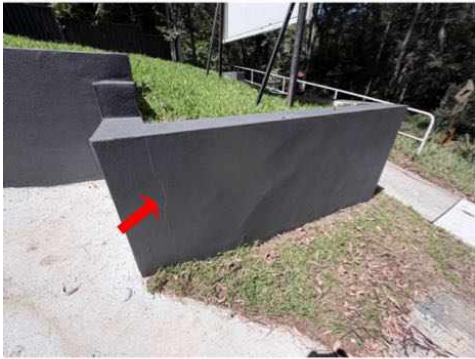
Building: Main Building
Location: Yard - Front
Finding: Cracking - Damage Category 1 - Fine (up to 1mm)
Information: Although fine cracks are quite noticeable, they are often only considered to be an appearance defect, and usually do not indicate any structural damage. Generally, the cause of a fine crack is indicative of a separation between building materials and finishes (e.g. paint, plaster, etc.) along joints.

Cracking of this nature can generally be repaired with minor sanding, filling and/or repainting. Such works should be performed by a qualified painter or a general handyman.

Monitoring of all cracking should be conducted frequently. Always contact a building inspector should cracks widen, lengthen, or become more numerous.

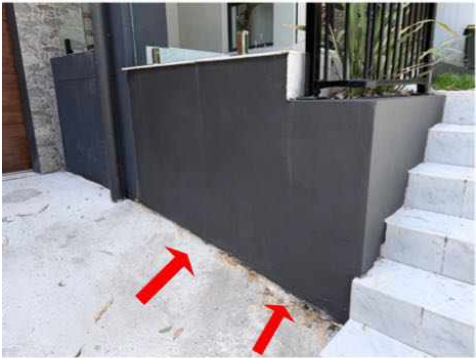
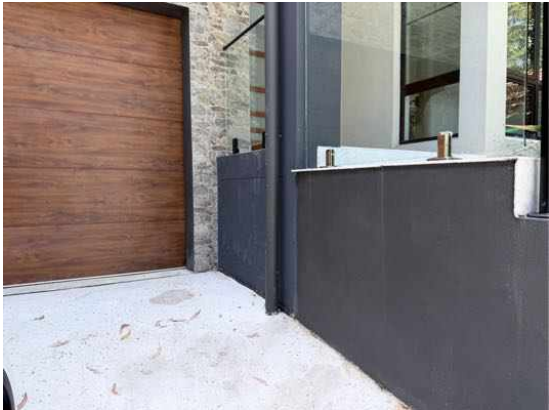
Finding 3.14

Building: Main Building
Location: Yard - Front
Finding: Water leak - External
Information: Water leaks were found to be present to exterior plumbing work. Leaks are generally caused by deterioration of the plumbing elements over time, due to exposure to weather conditions, but may have also been caused by minor impact damage.

Such leaking creates damp conditions in the affected area, causing potential for water pooling and subsequent water damage if left unattended. These conditions may also attract termite attack, particularly if the area is subject to minimal levels of sun throughout daylight hours.

It is highly advised that a licensed plumber be appointed to rectify any water leaks that may be present. Areas of repair and replacement of plumbing fittings and fixtures may be required and, as such, a quotation should be sought.

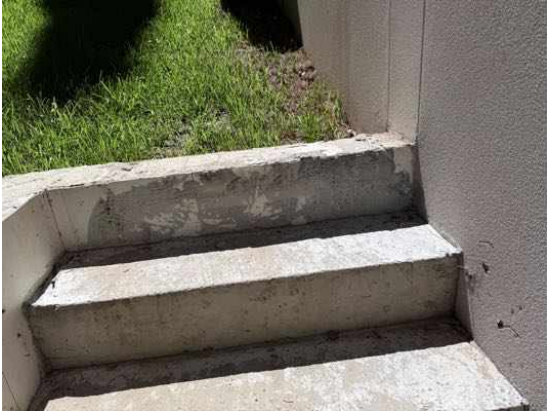
Noted Item

Building: Main Building
Location: Exterior walls - left side
Finding: Tiling and Finishing to Stair - Incomplete
Information: The tiling and finishing to the external stair appears to be incomplete.
