# Building and Timber Pest Inspection Report

Inspection Date: Thu, 29 Jan 2026

Property Address: lot 174/83-93 Dalmeny Ave, Rosebery NSW  
2018, Australia

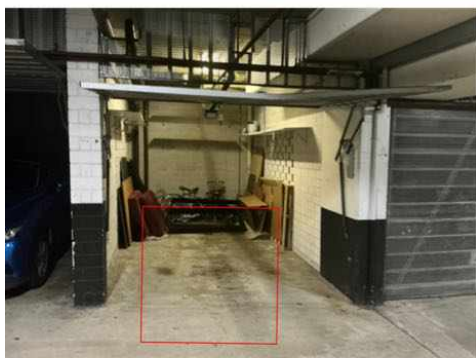
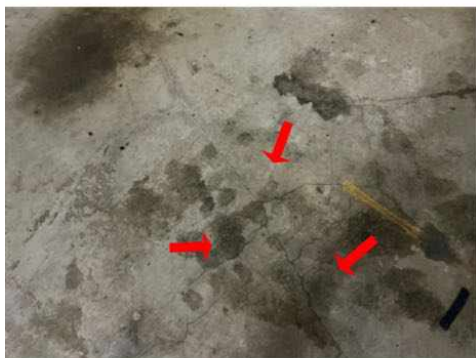
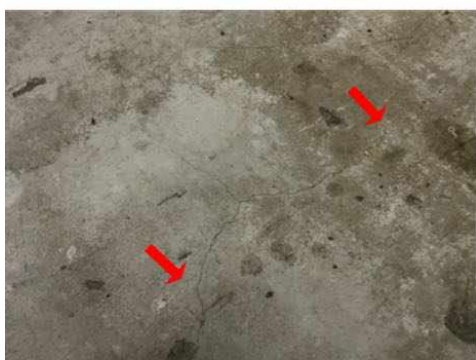
Building: Main Building  
Location: Garage floor  
Finding: Cracking - external concrete -Damage Category 2 - Noticeable (up to 5mm)  
Information: Noticeable cracks are a common occurrence as a result of many primary defects. Such causes may include age, general wear and tear, expected building movement, general expansion/contraction of building materials in different weather conditions, and/or minor failings in the installation or application of building materials.

Monitoring of all cracking should be conducted frequently. Always contact a building inspector should cracks widen, lengthen, or become more numerous. Additionally, your building inspector should also be contacted if associated building elements such as doors and windows become more difficult to operate over time.

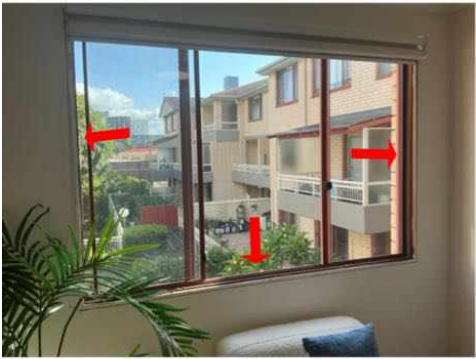
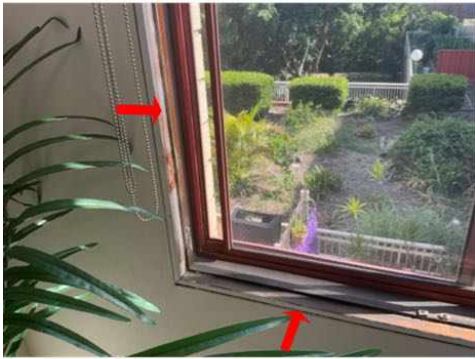
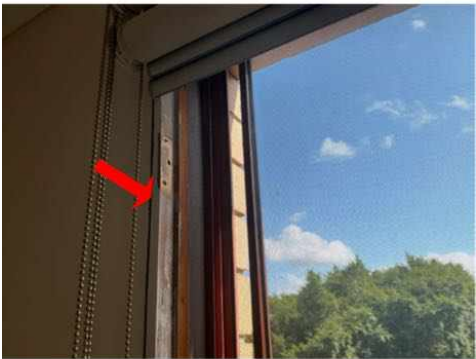
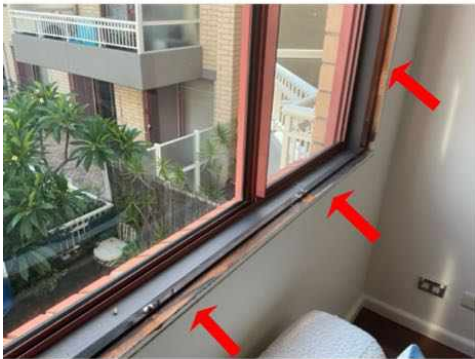
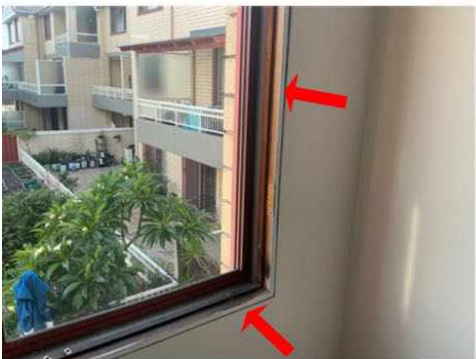
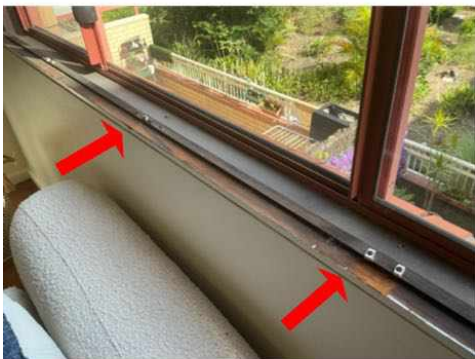
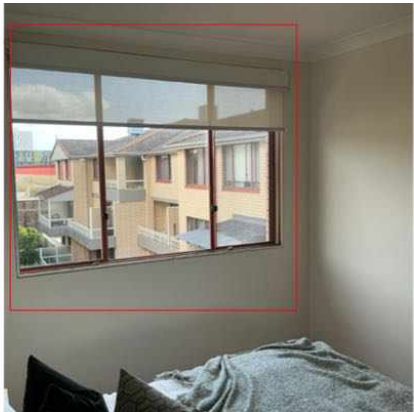
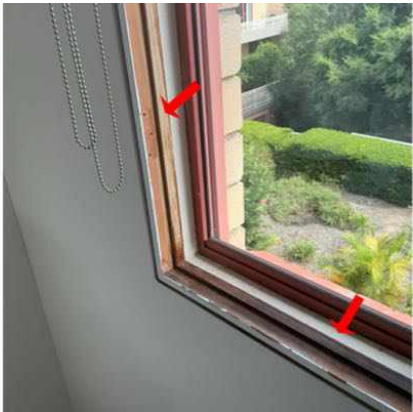
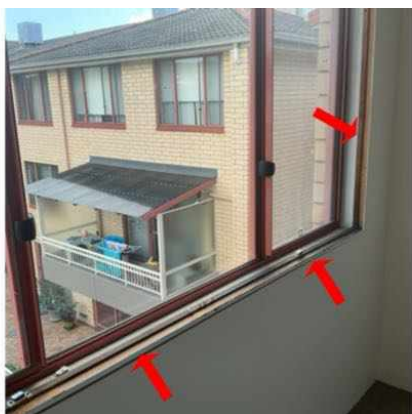
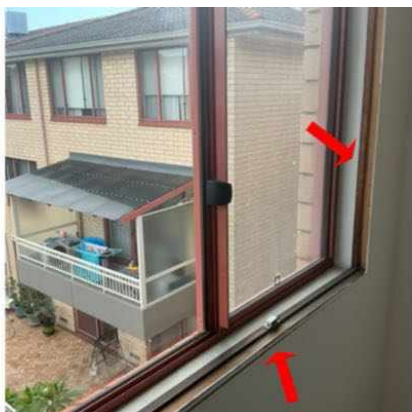
### Finding 3.02

Building:	Main Building
Location:	Window recesses in lounge room and upstairs bedrooms.
Finding:	Incomplete or substandard works- frameworks for former blinds in disrepair. Requires removal resealing, painting.
Information:	The works to this area appear to be incomplete or have been completed to a substandard level.

Works that have not been completed to a satisfactory level create potential for the development of building defects and may impede on the safety and integrity of the overall structure.

It is highly recommended that a handyman be appointed to complete these works and ensure the safety of the area and the longevity of all associated building elements.

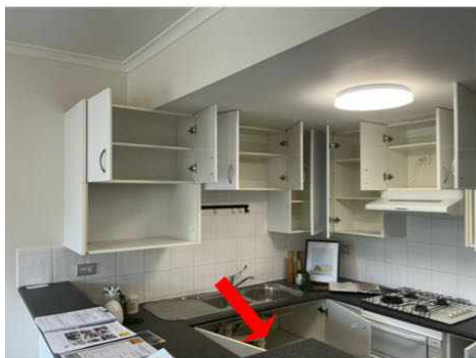
### Finding 3.03

Building:	Main Building
Location:	Vanity- Under kitchen sink
Finding:	Building element- broken/ damaged. - Shelving under kitchen sink
Information:	Breakage occurs generally when the building materials have either aged and decayed, or as a result of damage (accidental or deliberate).

Repair and/or replacement of broken elements is advised to ensure that additional secondary defects do not arise as a consequence. Such works are necessary, as all building elements play a key role in the operation and function of the overall structure and its performance.

A relevant tradesperson should be appointed to repair or replace the affected building element prior to any subsequent damage being caused.

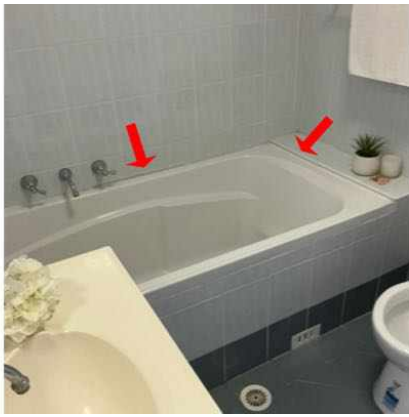
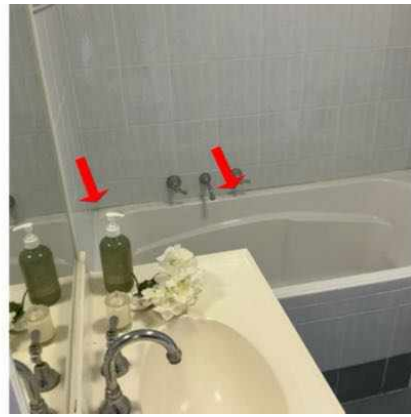
### Finding 3.04

Building:	Main Building
Location:	Bedroom ensuite
Finding:	Sealant and grouting - Missing or damaged
Information:	It was noted on inspection that sealant or grout is degraded to the tiled shower alcove and or other areas of the bathroom.

Different materials and floor areas move at different rates, generally causing cracking to grout or sealant at this point. A flexible sealant is required to allow for expected expansion and contraction, while keeping the joint water tight and protective of all associated building materials.

There appears to be excessive mould to the sealant and grout which will likely require scraping out and replacement.

Flexible and mould resistant materials should be applied to affected areas to prevent any subsequent water damage that is likely to occur. Regular maintenance and replacement of damage or missing or damaged sealant and grout is highly recommended to the wet areas, as this is a regular wear and tear defect. Sealant and grouting in areas that come into regular contact with water should be maintained for the long term care of your property.

A sealant specialist or tiling contractor should be appointed to complete these works as soon as possible

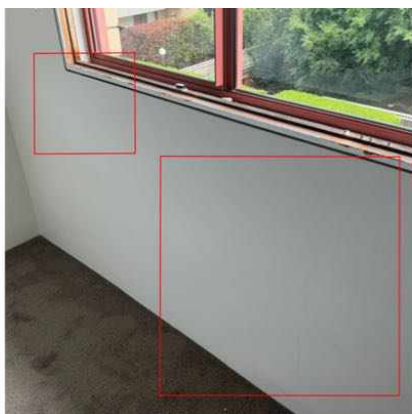
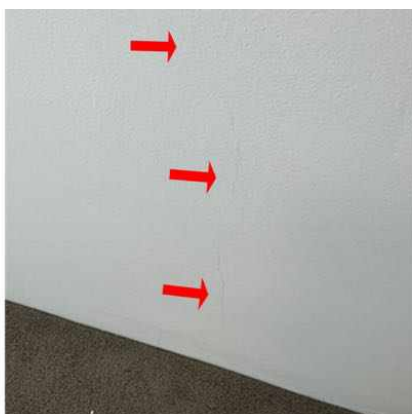
### Finding 3.05

Building: Main Building  
 Location: Smaller bedroom (western side)  
 Finding: Cracks to internal render - Category 1  
 Information: It has been observed that cracking to internal rendered surfaces has occurred. The degree of damage falls within Category 1, described as fine cracks that do not need repair and which are less than 1.0mm in width limit.

Damage of this category is not considered a defect for rectification. Always contact your building inspector should cracks widen, lengthen, or become more numerous.

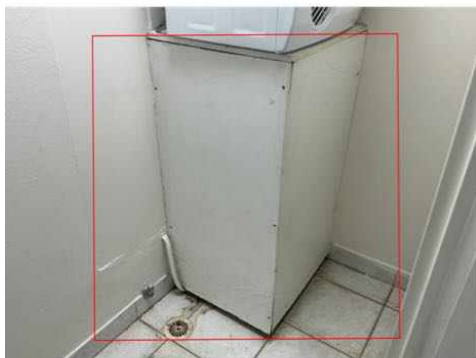
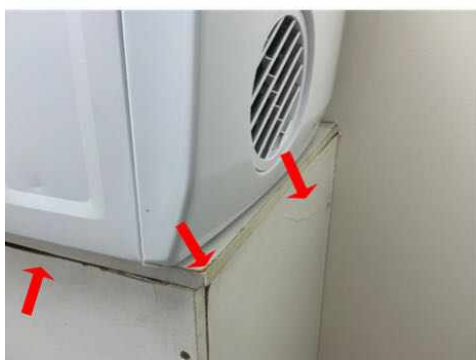
### Finding 3.06

Building:	Main Building
Location:	Laundry
Finding:	Building element - Broken or Damaged- Laundry cabinet
Information:	Breakage occurs generally when the building materials have either aged and decayed, or as a result of damage (accidental or deliberate).

Repair and/or replacement of broken elements is advised to ensure that additional secondary defects do not arise as a consequence. Such works are necessary, as all building elements play a key role in the operation and function of the overall structure and its performance.

A relevant tradesperson should be appointed to repair or replace the affected building element prior to any subsequent damage being caused.

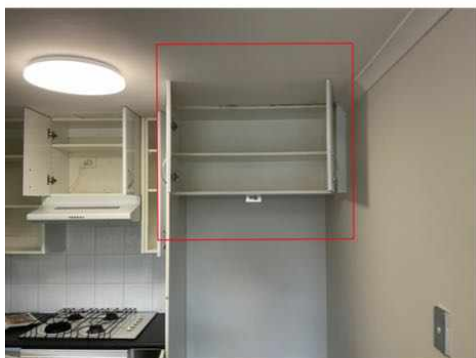
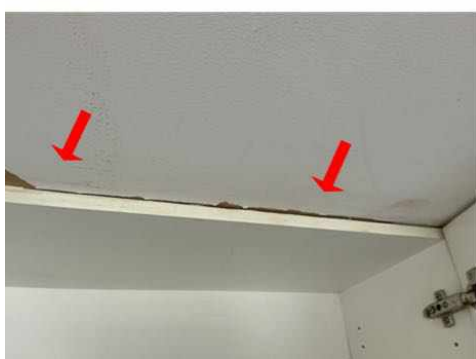
### Finding 3.07

Building:	Main Building
Location:	Kitchen cupboard, above fridge cavity
Finding:	Paint finish - Substandard
Information:	The paint finish in this area was found to have been completed to a substandard level. Substandard painting is generally classified as an appearance defect. However, the substandard appearance may also be indicative of poor surface preparation and substandard workmanship.

If this applies, further areas of poor and incomplete finishes could develop over time. Furthermore, substandard paint finishes in areas exposed to moisture, e.g. external areas or wet areas, could lead to deterioration of underlying building materials.

Substandard paint finishes should be sanded back, filled, leveled and repainted, as applicable. Where inadequate paint protection has led to the deterioration of the associated building element, repair and/or replacement of this building element may be required.

A painting contractor should be appointed as soon as possible to perform necessary works to aid the appearance of the affected area and to ensure that the area is protected against further deterioration. Alternatively, the homeowner following manufacturer instructions may be able to provide this service.

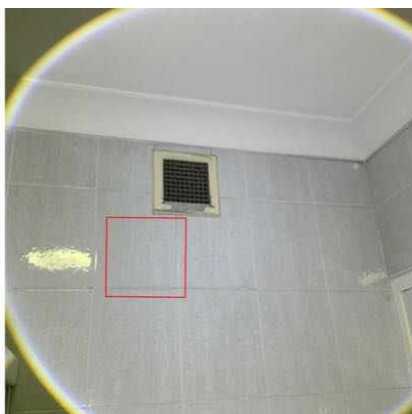
### Finding 3.08

Building:	Main Building
Location:	Bedroom ensuite
Finding:	Tile cracked or damaged- (wet areas)
Information:	Cracking was evident to the tiling in this area at the time of inspection. While the cracking appears to be minor, this area is frequently exposed to water, allowing potential for water penetration into adjoining sections of walls or flooring.

If left unmanaged, water penetration to these areas may lead to subsequent water damage, which is likely necessitate repair work to affected building elements.

A tiling contractor should be appointed to ensure that no further water damage occurs. The re-application of silicone and grouting throughout remaining tile work is also advised, to further protect the area against water penetration.

Where water penetration has led to water damage, appointment of a relevant tradesperson may be required to repair damaged building elements.

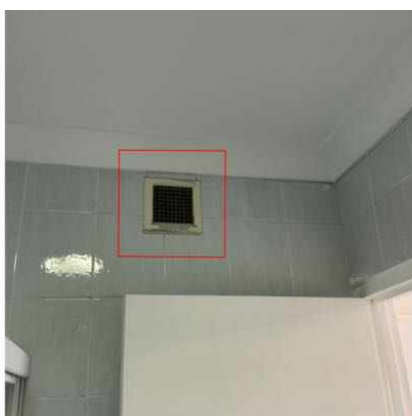
### Finding 3.09

Building:	Main Building
Location:	Bedroom ensuite
Finding:	Exhaust fan - Not functioning
Information:	An exhaust fan is not functioning properly in this area. Missing exhaust fans may lead to the development of more significant defects such as moisture damage to surrounding building materials from inadequate ventilation. Inadequate ventilation in internal areas creates an environment that is conducive to the formation and development of mould and other respiratory hazards. It is highly advised that a licensed electrician be appointed to retrospectively install an exhaust fan. Failure to perform works to aid the ventilation of the area may lead to the development of these secondary defects.

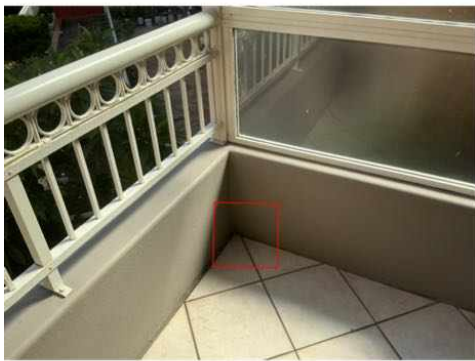
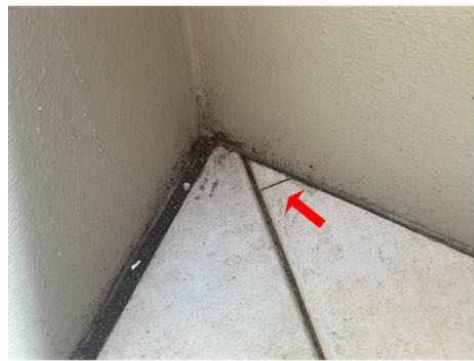
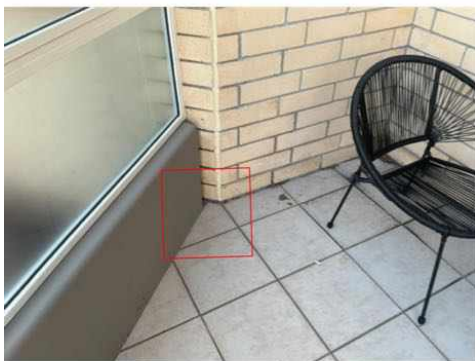
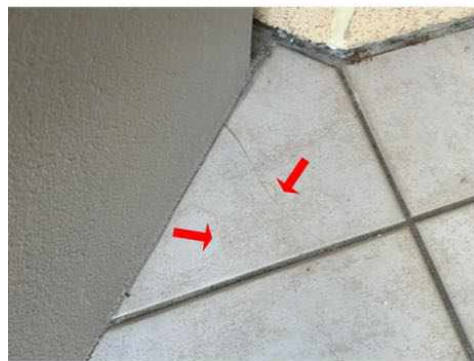
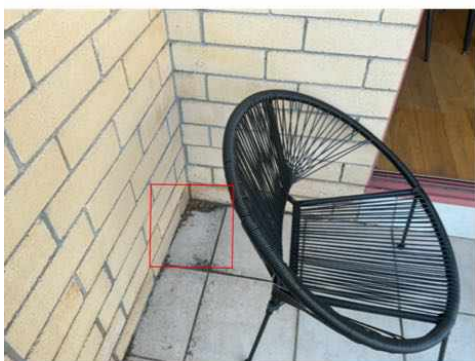
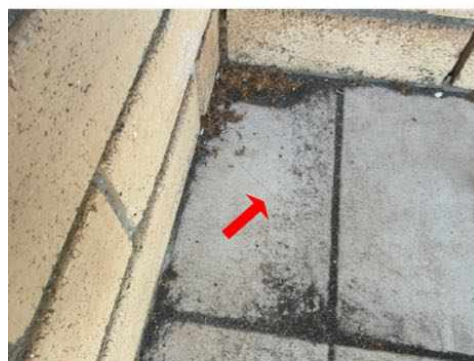
### Finding 3.10

Building:	Main Building
Location:	Balcony
Finding:	Cracked floor tiles
Information:	Cracking in the floor tiles was evident in this area at the time of inspection. It is suspected that this cracking has occurred as a result of minor settlement or shrinkage of the slab.

Cracked tiles throughout the household detract from the overall appearance of the affected areas however it is unlikely to create or lead to any secondary defects.

While not considered a matter of urgency, replacement of cracked floor tiles is recommended at the clients discretion. A tiling contractor may be appointed to perform these works. Where cracks become more numerous, contact a licensed building inspector for further investigation.

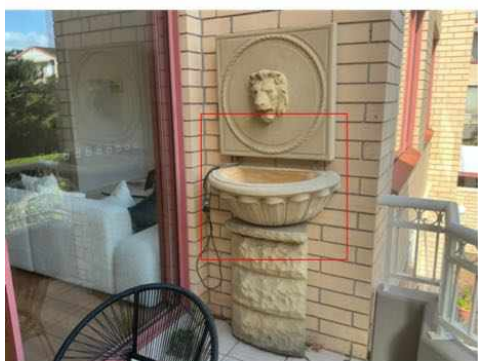
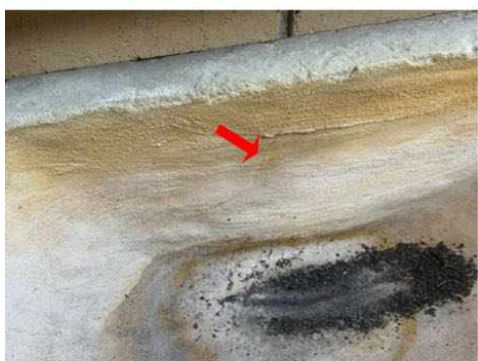
### Finding 3.11

Building: Main Building  
Location: Balcony

Finding: Basin - Cracked  
 Information: Cracking was evident to the basin at the time of inspection, which is suspected to have been by minor impact damage. While the cracking appears to be minor, any further impact damage sustained by the basin may lead to additional cracking.

As the cracking provides potential ingress for water, secondary water damage may occur to associated cabinetry, walls or flooring, if the cracking is left unmanaged.

Consultation with a plumber regarding basin repair or replacement is required. Remedial works may be required to protect against any further damage.

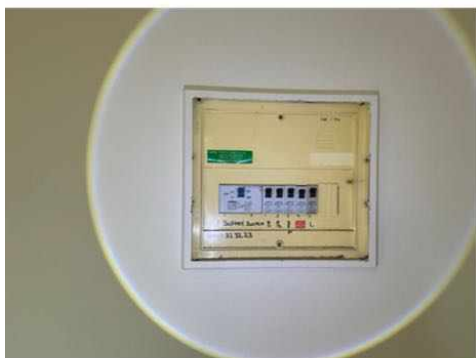
Building:	Main Building
Location:	Switch board or under kitchen sink
Finding:	Termite Management System - no evidence of a chemical installation
Information:	The application of a post-construction chemical termite barrier is highly recommended for all properties, particularly if live termite activity has been found on the site previously. Such barriers are highly effective in preventing termite attack on any timber building elements throughout the property.

A durable notice should be placed in the switchboard unit to indicate current termite barriers. At the time of inspection, it appeared as though no termite management system has been installed, with no evidence to suggest preventative works taking place.

The client may consider gaining further advice from a pest controller as to the costs and procedures involved with this application. It is recommended that obtaining such advice be a short-term priority.

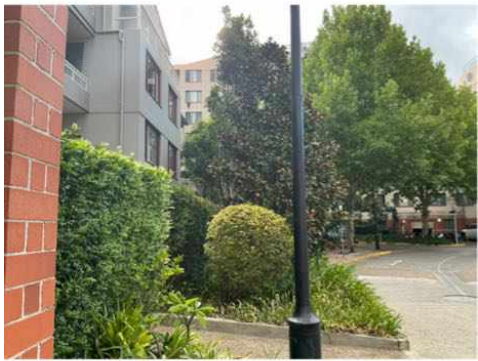
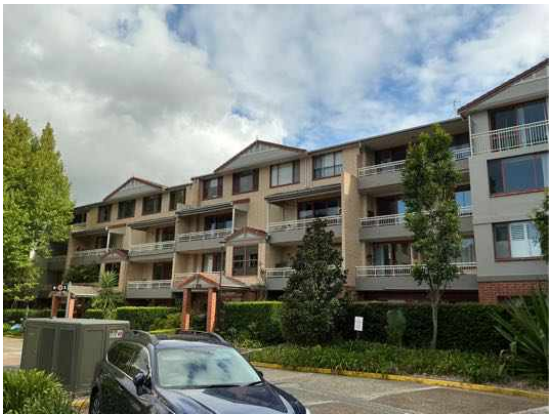
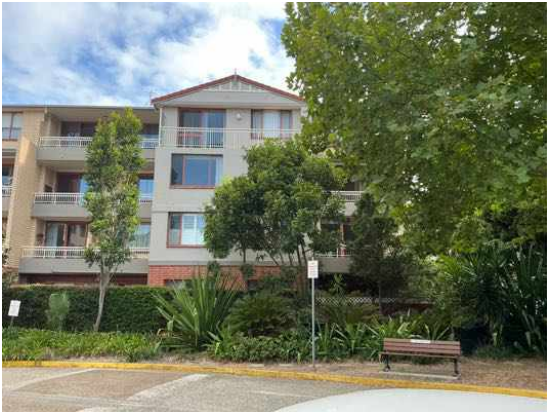
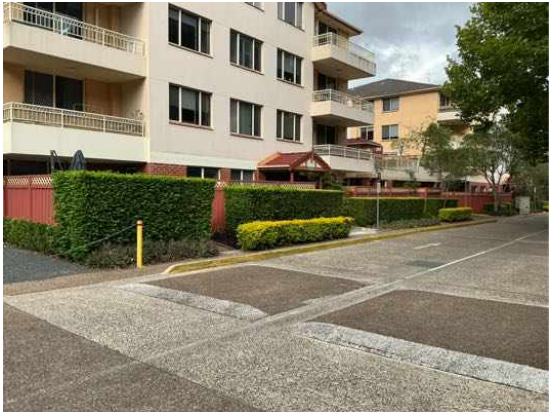
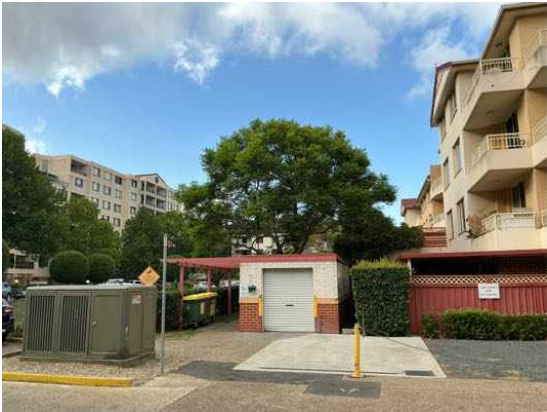
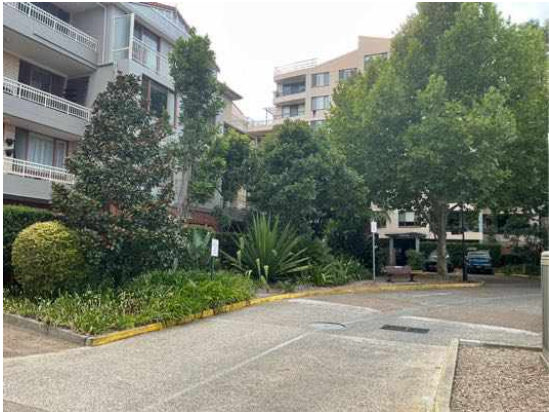
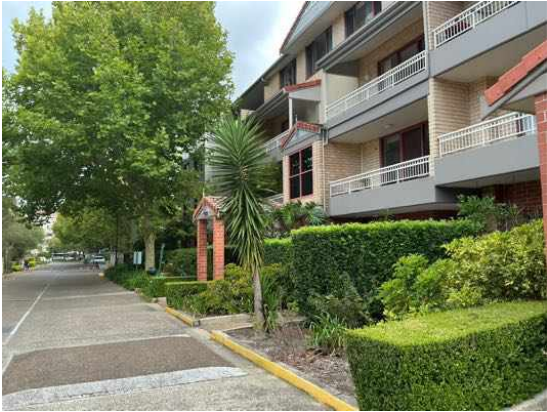
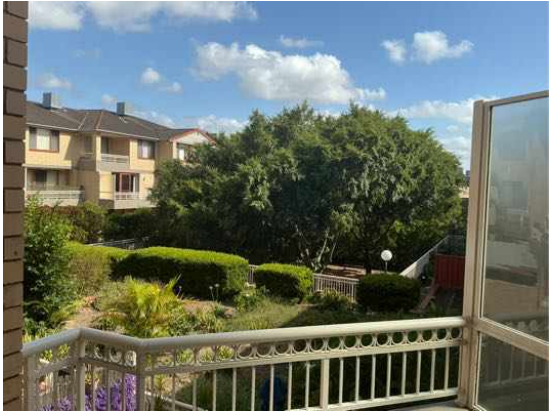
## Finding 6.02

Building:	Main Building
Location:	All Areas
Finding:	Trees to be inspected within the property.
Information:	Trees can be conducive to termite activity and nesting. Trees over 100mm on the property, should be drilled and tested for termite activity.

Regular inspections every 6-12 months- or advised by the termite management system installer.
