# Building and Timber Pest Inspection Report

Inspection Date: Wed, 28 Jan 2026

Property Address: 45 Fitzwilliam Rd, Vaucluse NSW 2030,  
Australia

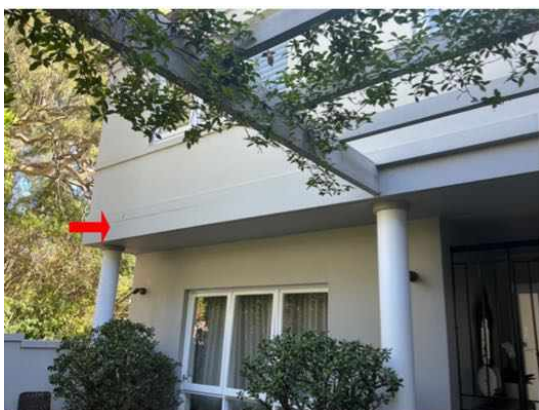
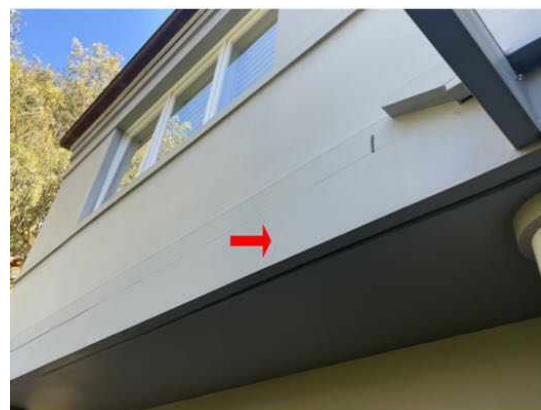
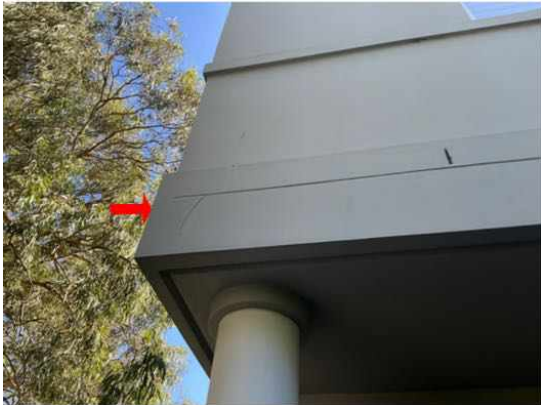
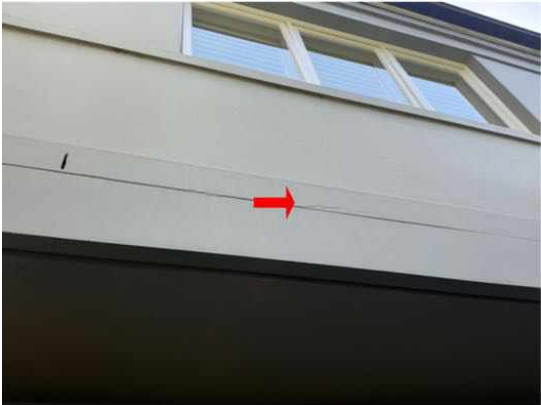
#### Finding 3.01

Building:	Main Building
Location:	Exterior walls - front
Finding:	Cracking - Damage Category 1 - Fine (up to 1mm)
Information:	Although fine cracks are quite noticeable, they are often only considered to be an appearance defect, and usually do not indicate any structural damage. Generally, the cause of a fine crack is indicative of a separation between building materials and finishes (e.g. paint, plaster, etc.) along joins.

Monitoring of all cracking should be conducted frequently. Always contact a building inspector should cracks widen, lengthen, or become more numerous.

Cracking of this nature can generally be repaired with minor sanding, filling and/or repainting. Such works should be performed by a qualified painter or a general handyman.

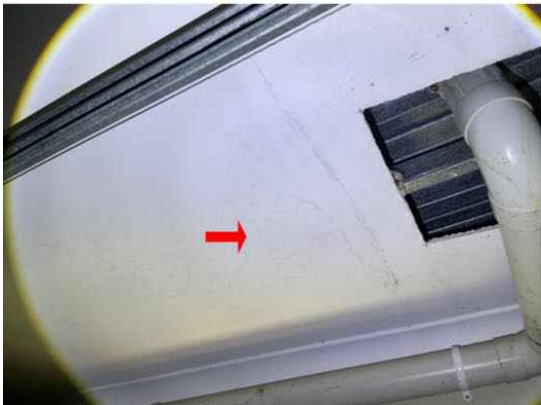
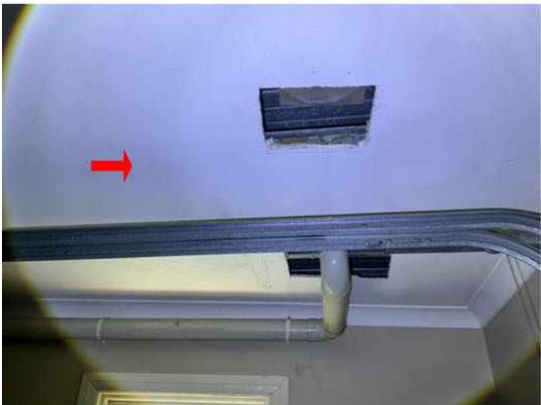
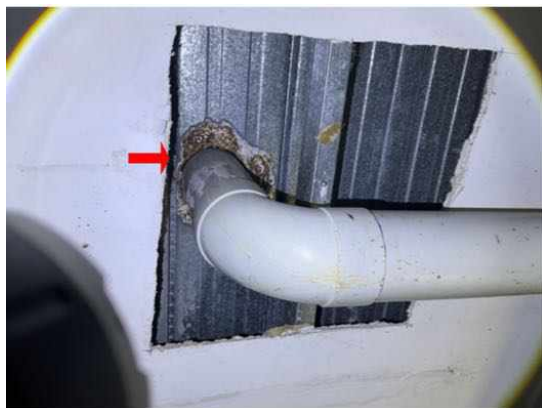
**Finding 3.02**

Building: Main Building  
Location: Garage  
Finding: Ceiling - Water stained  
Information: Water staining to ceiling linings in this area was evident at the time of inspection. Water staining indicates that surfaces have been exposed to excessive moisture over time. The minerals and other elements in the water lead to staining, which may graduate to corrosion and deterioration if left unmanaged.

While mostly an appearance defect, water staining can be indicative of more serious defects, which may be currently concealed by interior ceilings.

Where water staining is active, a licensed plumber must be consulted to identify the cause of the staining and to provide advice on any reparation works that may be required. Replacement of any damaged structures is advised.

Conversely, where water staining is old and inactive, affected building materials may be repaired or replaced at client discretion.

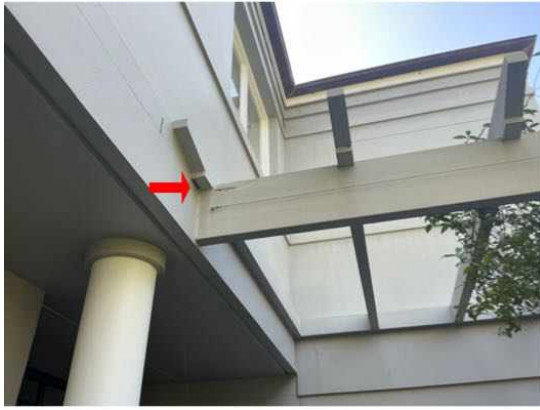
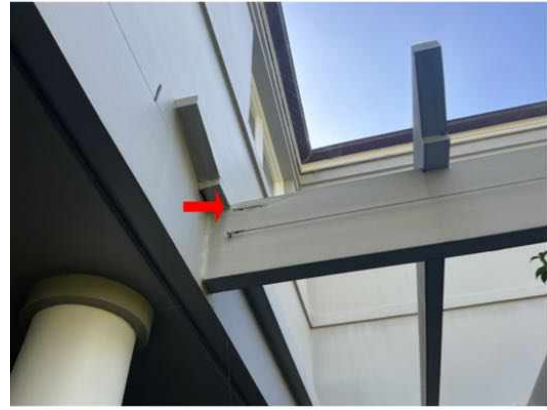
### Finding 6.01

Building:	Main Building
Location:	Yard - Front
Finding:	Fungal decay - present (localised)
Information:	Fungal decay also known as wood decay or wood rot generally refers to the deterioration of timber elements when in contact with excessive levels of moisture for a prolonged period of time.

The development of fungal decay is accelerated by temperatures in the range of 5degreeC to 40degreeC as well as the presence of oxygen. Generally fungal decay develops on timber elements that are in use in an external environment which are exposed to rain penetration.

In this case although the affected timber element is in a decaying state the extent of any visible damage appears to be localised to a specific area and is yet to spread to other parts of the building element or affect adjoining structures. The fungal decay is therefore likely to be of a relatively superficial nature with minimal impact on the structural integrity or tensile strength of the timber element.

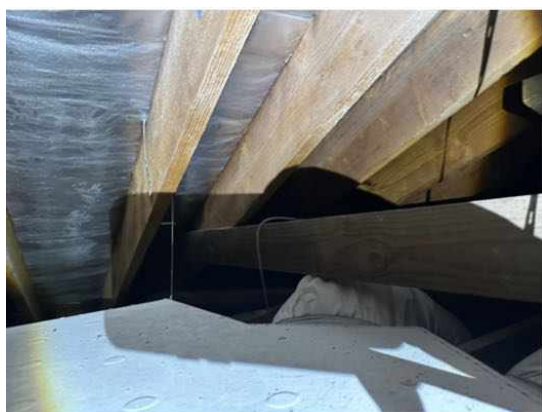
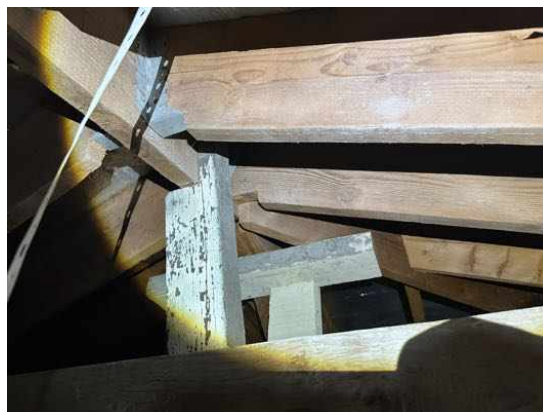
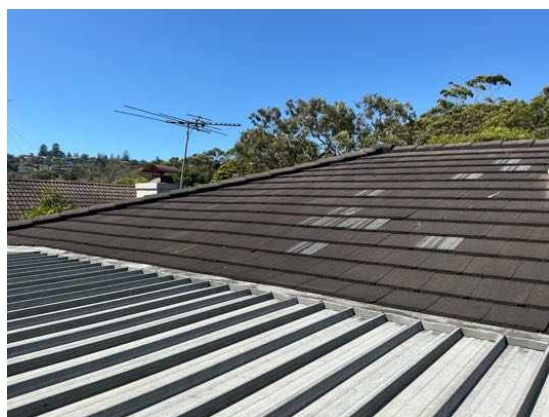
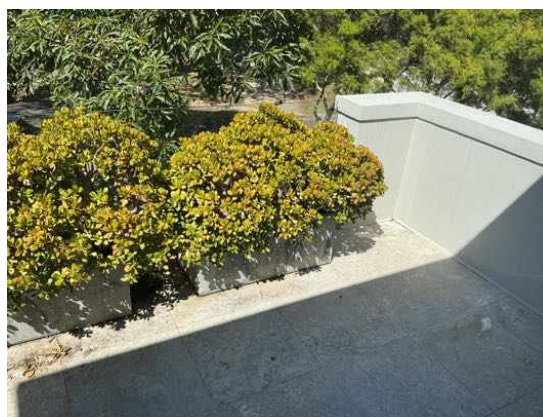
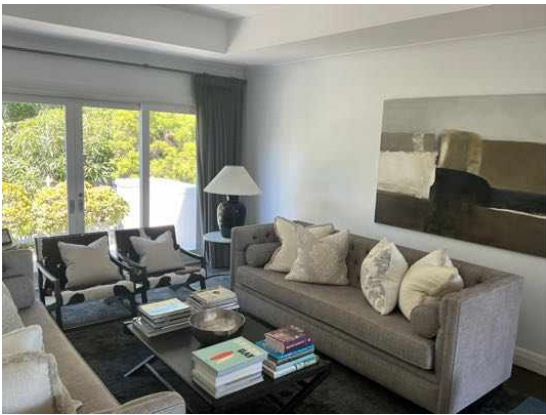
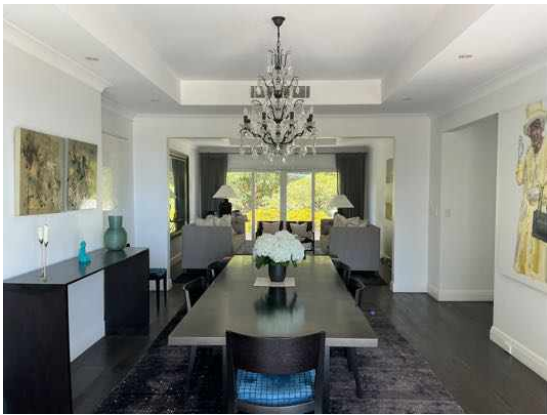
Building: Main Building  
Location: All Areas  
Finding: Additional Photos - Obstructions and Limitations  
Information: These photographs are an indication of the obstructions and limitations which impeded full inspection of the property at the time of inspection. These obstructions can hide an array of defects and should be removed to allow full inspection to be carried out. A re-inspection is recommended once the areas are made accessible.
