# Building and Timber Pest Inspection Report

Inspection Date: Fri, 6 Mar 2026

Property Address: 4 Strathmore St, Wodonga VIC 3690,  
Australia

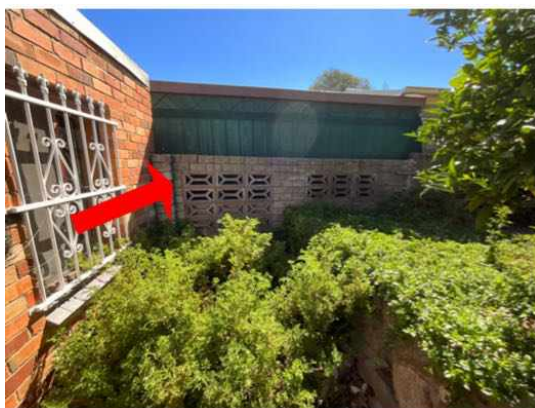
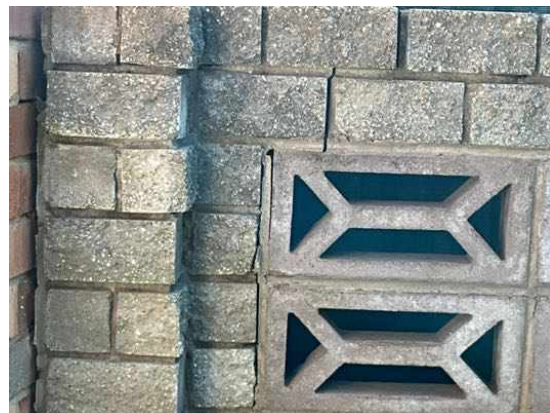
Building: Building 1  
 Location: Yard - Back  
 Finding: Brickwork- Step cracking  
 Information: Step cracking was identified to the brickwork in this area at the time of inspection. Step cracking, which is similar to other forms of cracking, has a variety of possible causes. However, the most common is the subsidence of adjacent footings.

Step cracking is a relatively common defect, and is most likely to occur adjacent to windows, doors and other openings. Mortar failure in the gaps between affected bricks indicates the stresses and tensions affecting the wall.

Minor step cracking can be used as a warning sign to address factors causing stress to the wall, which can include the effect of surrounding trees, water leaks, soil erosion, or even the presence of reactive soils in the surrounding area.

If cracks increase in size or number contact a Licensed builder immediately to make all needed repairs.

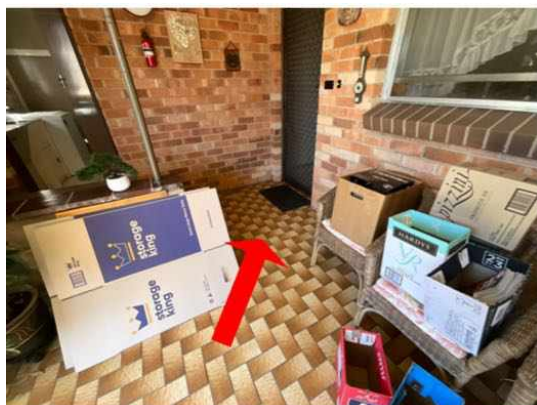
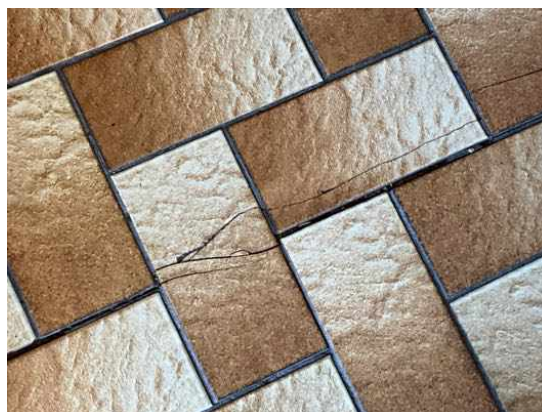
#### Finding 3.02

Building:	Building 1
Location:	Verandah
Finding:	Cracked floor tiles
Information:	Cracking in the floor tiles was evident in this area at the time of inspection. It is suspected that this cracking has occurred as a result of minor settlement or impact damage.

Cracked tiles throughout the household detract from the overall appearance of the affected areas however it is unlikely to create or lead to any secondary defects.

While not considered a matter of urgency, replacement of cracked floor tiles is recommended at the clients discretion. A tiling contractor may be appointed to perform these works. Where cracks become more numerous, contact a licensed building inspector for further investigation.

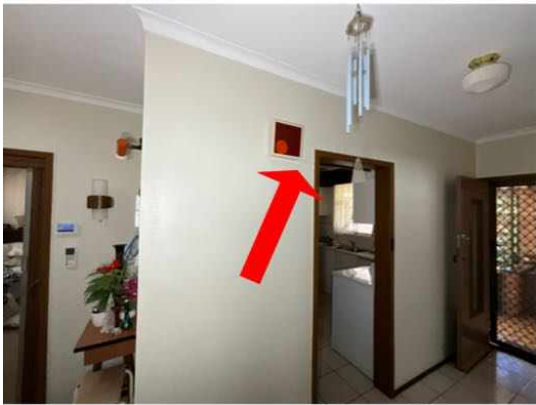
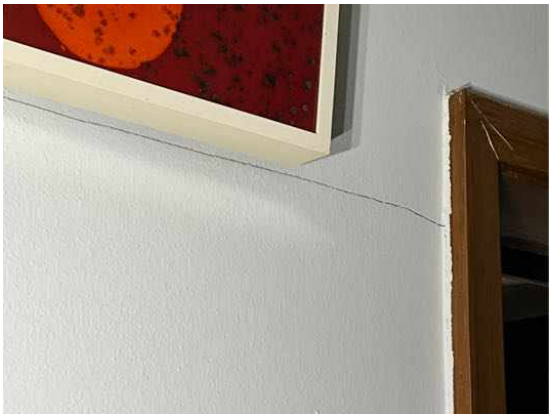
### Finding 3.03

Building:	Building 1
Location:	Hall
Finding:	Cracking - Damage Category 1 - Fine (up to 1mm)
Information:	Although fine cracks are quite noticeable, they are often only considered to be an appearance defect, and usually do not indicate any structural damage. Generally, the cause of a fine crack is indicative of a separation between building materials and finishes (e.g. paint, plaster, etc.) along joints.

Cracking of this nature can generally be repaired with minor sanding, filling and/or repainting. Such works should be performed by a qualified painter or a general handyman.

Monitoring of all cracking should be conducted frequently. Always contact a building inspector should cracks widen, lengthen, or become more numerous.

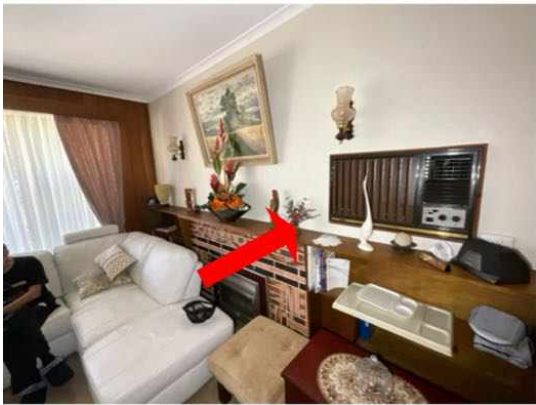
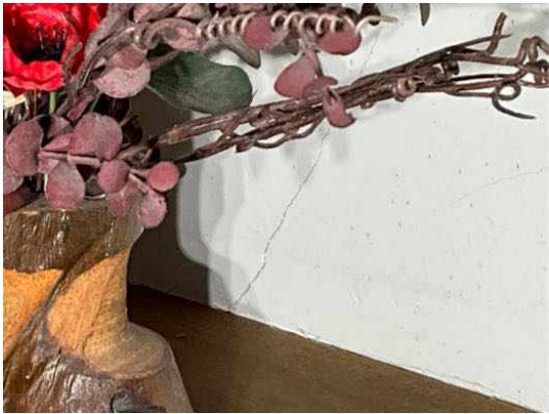
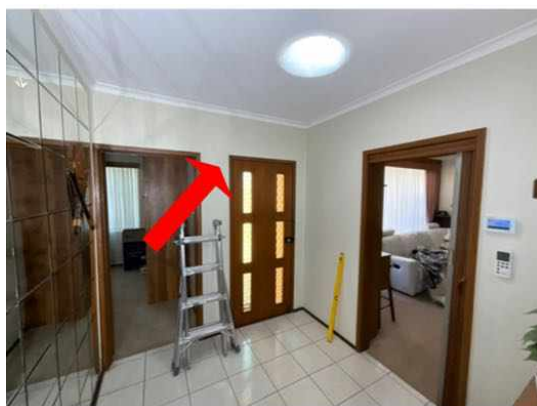
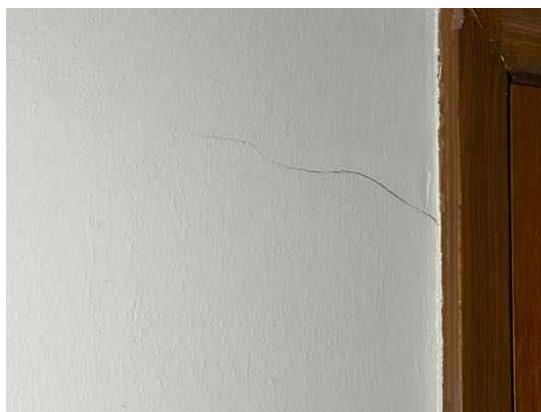
**Finding 3.04**

Building: Building 1  
 Location: Living Room, hall  
 Finding: Cracking - Damage Category 1 - Fine (up to 1mm)  
 Information: Although fine cracks are quite noticeable, they are often only considered to be an appearance defect, and usually do not indicate any structural damage. Generally, the cause of a fine crack is indicative of a separation between building materials and finishes (e.g. paint, plaster, etc.) along joins.

Cracking of this nature can generally be repaired with minor sanding, filling and/or repainting. Such works should be performed by a qualified painter or a general handyman.

Monitoring of all cracking should be conducted frequently. Always contact a building inspector should cracks widen, lengthen, or become more numerous.

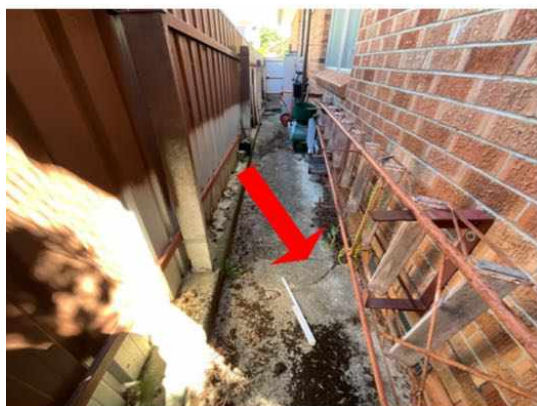
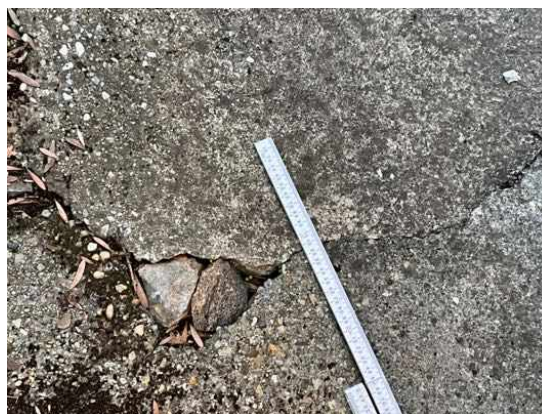
### Finding 3.05

Building:	Building 1
Location:	Yard - Side
Finding:	Cracking - External Concrete Paving Damage Category 3 - Wide Cracks (2mm - 4mm)
Information:	Wide cracks were identified in external concrete paving. Wide cracks are significant and are likely to lead to the development of safety hazards and secondary defects if left unmanaged.

General age and expected deterioration of the paved areas is a common cause of this type of cracking. However, expansion and contraction of the slab may also have occurred due to environmental factors. Such factors include variable moisture and weather conditions, the presence of trees and their roots having a settling or lifting effect on the soil, or the effect of load bearing, e.g. heavy vehicles over a sustained period of time.

Cracking to this degree may also be due to poor original installation of the concrete. Factors such as poor compaction of the sub surface and/or inadequate reinforcing of the slab may create cracking and other secondary defects. Wide cracks may also have a more significant structural cause, such as subsidence of soils.

Where the crack is located adjacent to structural elements of the building, the advice of a Structural Engineer is advisable before undertaking repairs. Significant repair and likely replacement of the concrete paving is probable.

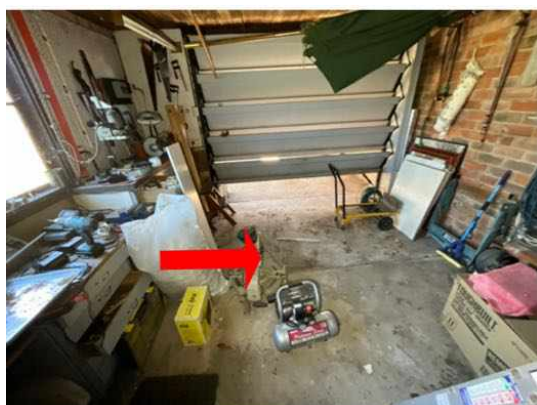
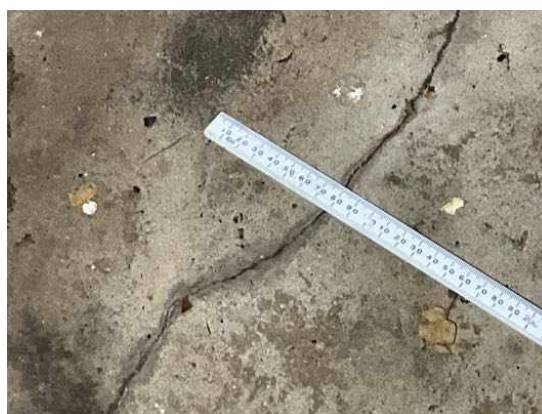
### Finding 3.06

Building: Building 1  
 Location: Garage  
 Finding: Crack in concrete slab - Category 1  
 Information: A crack coded as Category 1 was identified in the slab. A Category 1 crack is described as a fine but noticeable crack, with the slab at an otherwise reasonable level.

To be considered Category 1, the approximate width of the crack is less than 1.0mm, or a less than 10mm change in offset when a 3m straight edge is placed over the defect.

Category 1 cracks should be monitored for a period of 12 months. At the end of the monitoring period, identified cracks that are rated greater than Category 2 are considered defects, and require rectification.

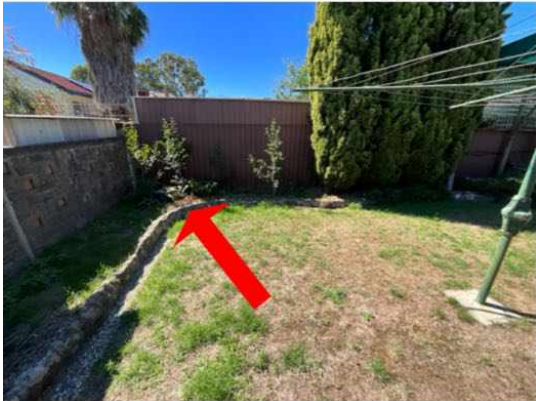
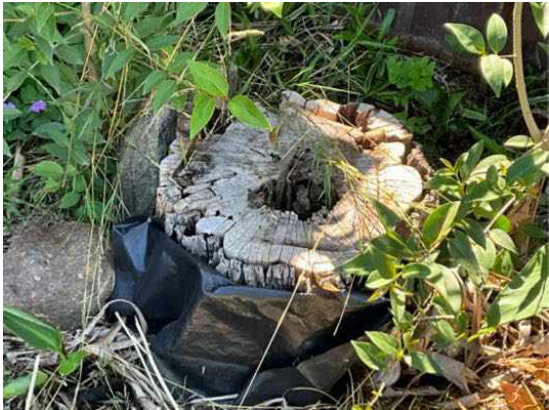
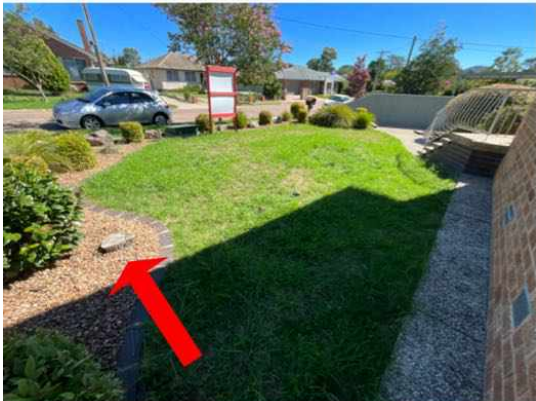
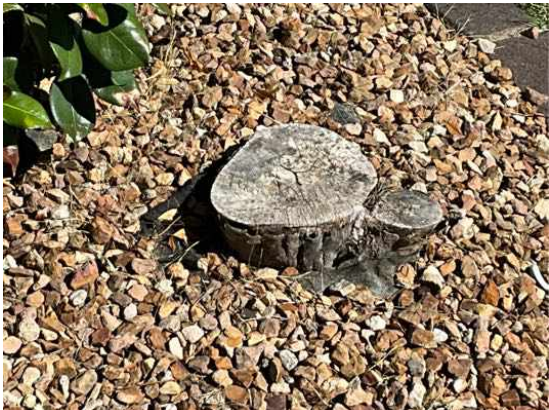
Building: Building 1  
Location: Yard - Back  
Finding: Tree Stump in Ground  
Information: Any tree stumps in the yard not removed during the tree removal process provides the opportunity for Termite infestation and is likely to be subject to decay from damp conditions against the stump.

All tree stumps should be removed by professional tree removal services where possible. Meanwhile regular inspections are advised to identify any termite activity in the areas identified.

Services for tree stump removal should be contacted as soon as possible to reduce the risk of timber pest attack.

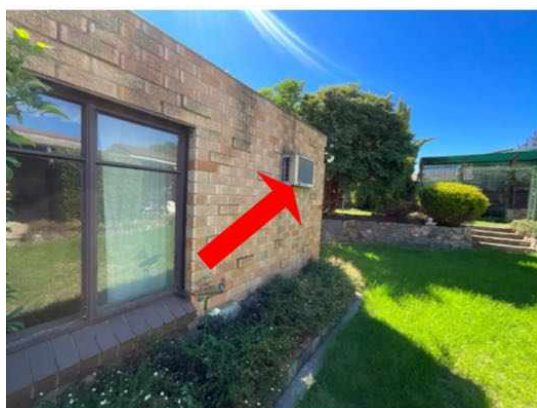
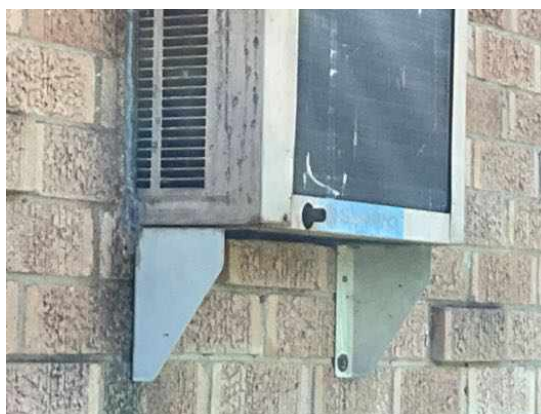
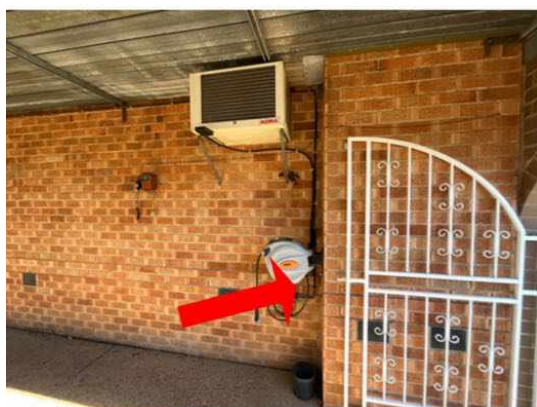
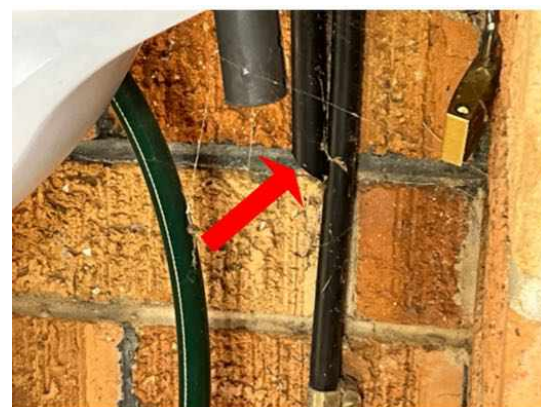
**Finding 6.01**

Finding: Air conditioner - Disconnected overflow  
 Information: The Air Conditioner (A/C) overflow was found to be disconnected from storm water drainage and is creating excessive moisture in the surrounding area.

Such leaking creates an environment which is conducive to an array of defects, including water damage to associated building elements and the attraction of termite or timber pest infestation.

It is highly recommended that a licensed plumber be appointed to connect the A/C overflow in order to prevent such an environment from being created. These minor works should be carried out as soon as possible.

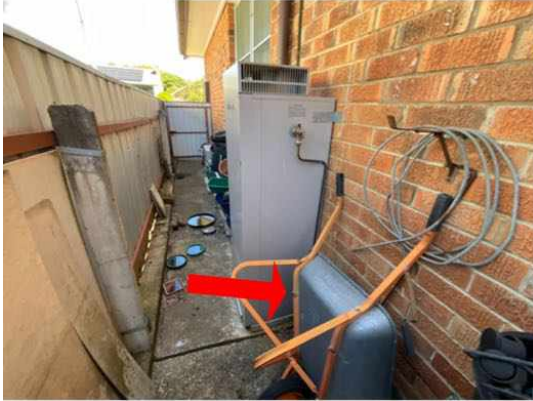
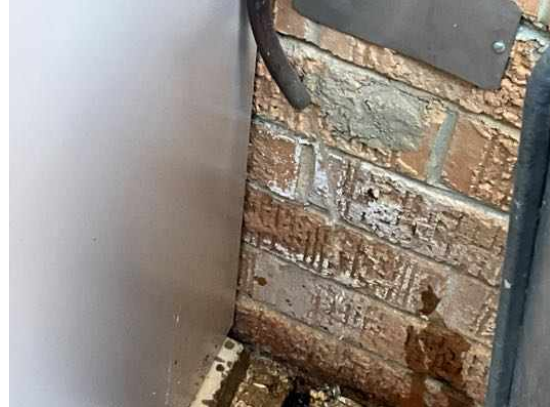
## Finding 6.02

Building: Building 1  
 Location: Yard - Side  
 Finding: HWS Overflow - Not Connected  
 Information: The Hot Water System (HWS) overflow was found to be disconnected from storm water drainage and is creating excessive moisture in the surrounding area.

These damp conditions can lead to secondary defects such as rot, rust or corrosion of associated building elements, the formation of fungal decay, or even the creation of potential slip hazards. When coupled with poor site drainage, pooling of water may

also attract termite activity to this area.

It is highly recommended that a licensed plumber be appointed to connect the HWS overflow in order to prevent such an environment from being created. These minor works should be carried out as soon as possible.

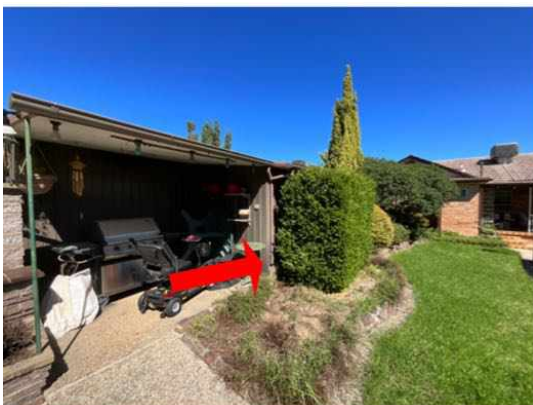
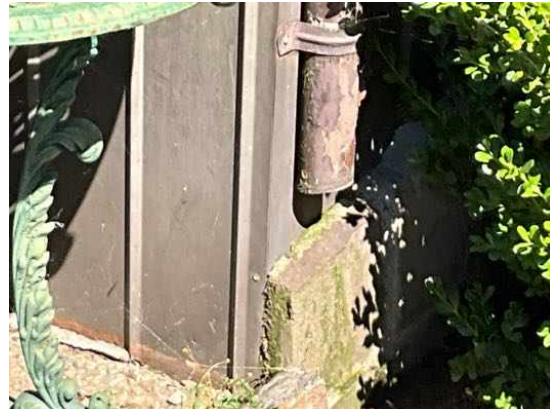
### Finding 6.03

Building:	Building 1
Location:	Shed
Finding:	Stormwater drain - Not connected
Information:	The roof plumbing is not adequately connected to stormwater drainage on the site. This disconnection negatively impacts the functional capacity of the roof plumbing.

Where roof plumbing doesn't drain adequately, the area at the base perimeter can become excessively damp, potentially creating an environment that is susceptible to rust and corrosion of surrounding building elements, as well as attracting termites and other pests.

It is highly recommended that a plumber be appointed to further inspect the area and to install adequate drainage equipment where necessary.

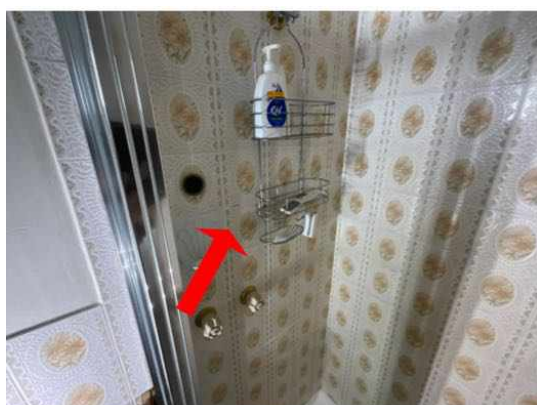
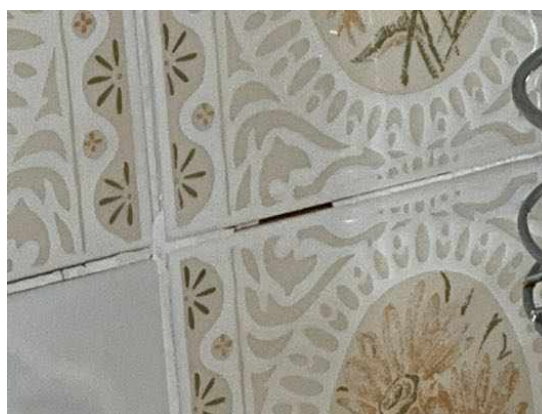
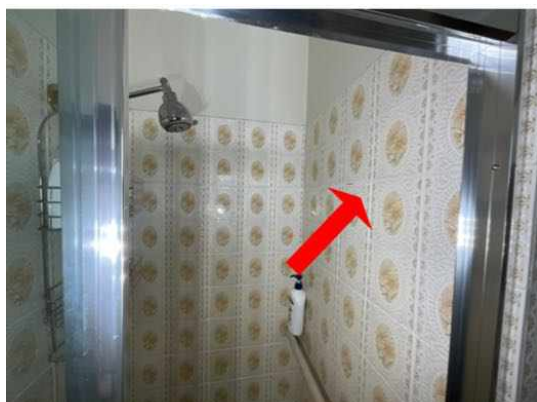
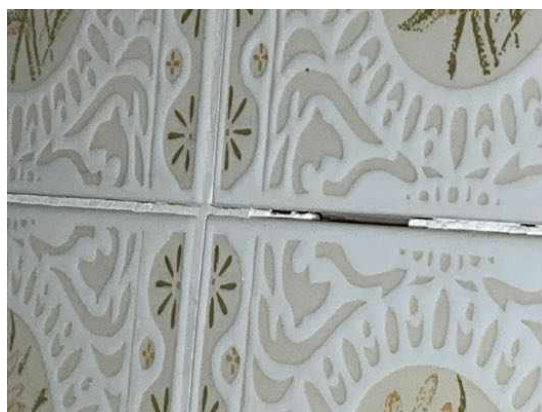
### Finding 6.04

Building: Building 1  
 Location: Bathroom  
 Finding: Inadequate sealant or Grout  
 Information: This area has a lack of effective Sealant or Grout. This is allowing the ingress of water to the structure inside the wall.

The presence of water encourages Termite attack, Mould and Fungal Decay.

A Tiler or General Handy person must be contacted as soon as possible to effect repairs and prevent further deterioration.

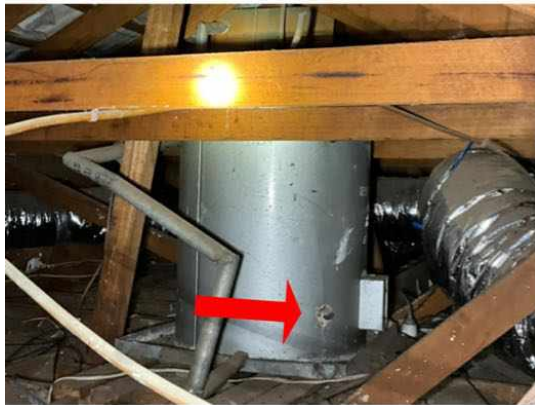
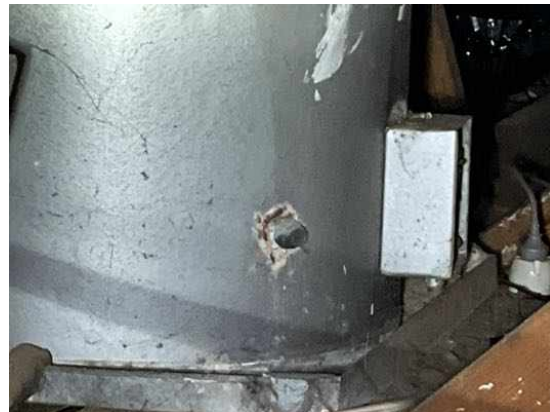
### Finding 6.05

Building: Building 1  
 Location: Roof Void  
 Finding: Gravity-Fed HWS - Disconnected  
 Information: It was noted at the time of inspection that a disconnected gravity-fed hot water system (HWS) remains in this area.

Despite this plumbing structure being unused, it is likely to be storing residual water, and is therefore susceptible to rust and corrosion. If allowed to continue, rust and corrosion is likely to lead to damage to adjoining building elements, and may also make the area susceptible to termite or timber pest activity.

While it is a costly exercise to remove the disused gravity-fed HWS, it is advisable in the short-term future to prevent any further damage to the area. Further consultation with a licensed plumber is required to gain further advice on removal of the structure.

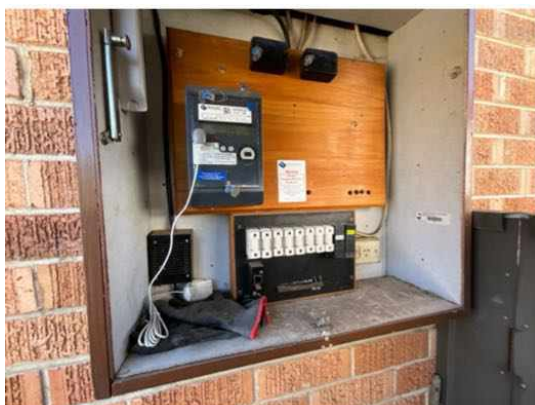
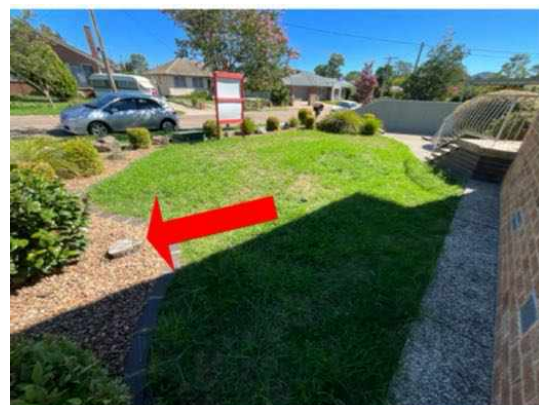
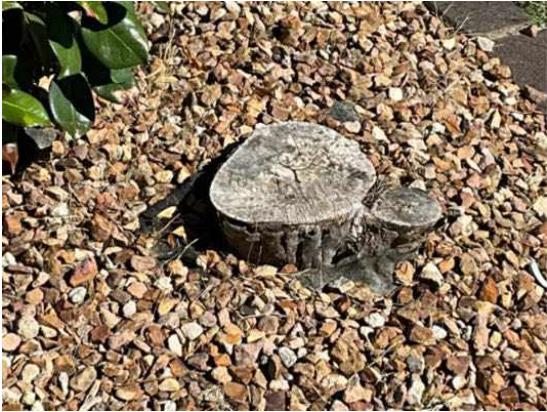
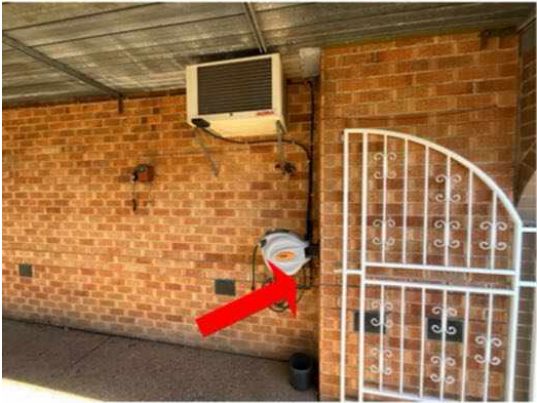
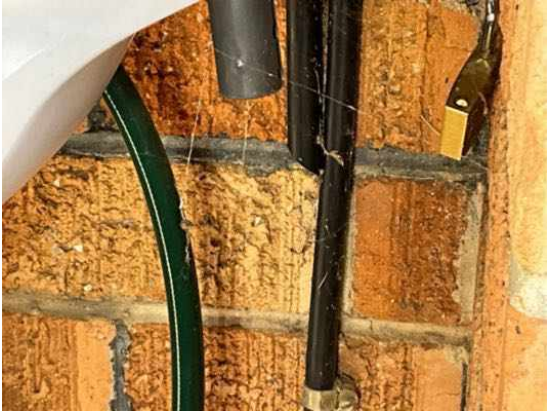
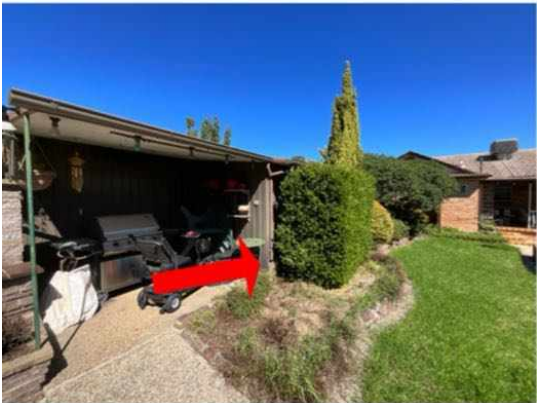
### Finding 6.06

Building:	Building 1
Location:	All External Areas
Finding:	Termite Management System - no evidence of a chemical installation
Information:	The application of a post-construction chemical termite barrier is highly recommended for all properties, particularly if live termite activity has been found on the site previously. Such barriers are highly effective in preventing termite attack on any timber building elements throughout the property.

A durable notice should be placed in the switchboard unit to indicate current termite barriers. At the time of inspection, it appeared as though no termite management system has been installed, with no evidence to suggest preventative works taking place.

The client may consider gaining further advice from a pest controller as to the costs and procedures involved with this application. It is recommended that obtaining such advice be a short-term priority.

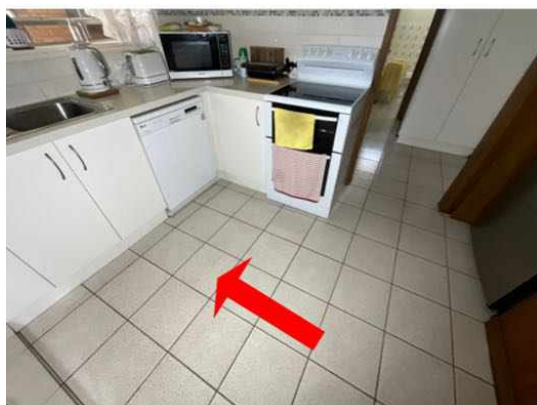
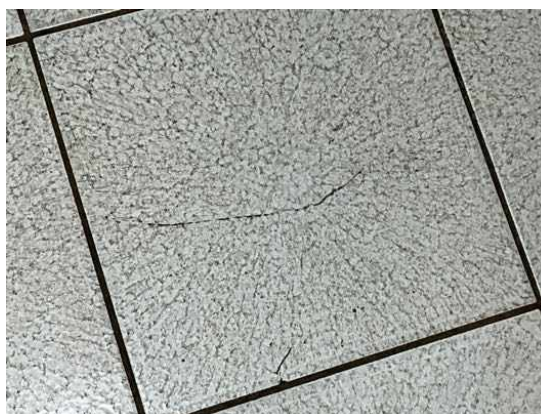
Building: Building 1  
 Location: Kitchen  
 Finding: Cracked floor tiles  
 Information: Cracking in the floor tiles was evident in this area at the time of inspection. It is suspected that this cracking has occurred as a result of minor settlement or impact damage.

Cracked tiles throughout the household detract from the overall appearance of the affected areas however it is unlikely to create or lead to any secondary defects.

While not considered a matter of urgency, replacement of cracked floor tiles is recommended at the clients discretion. A tiling contractor may be appointed to perform these works. Where cracks become more numerous, contact a licensed building inspector for further investigation.

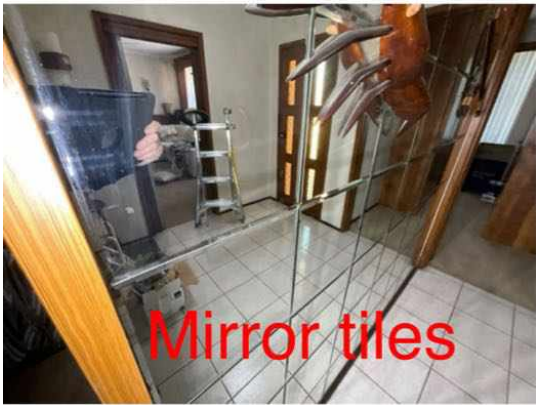
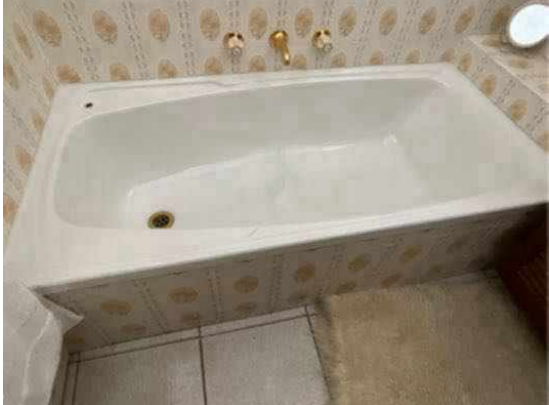
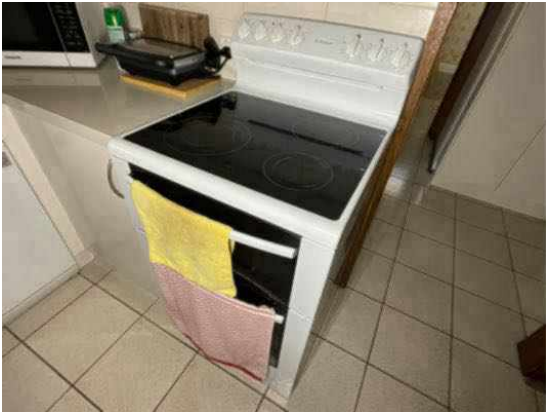
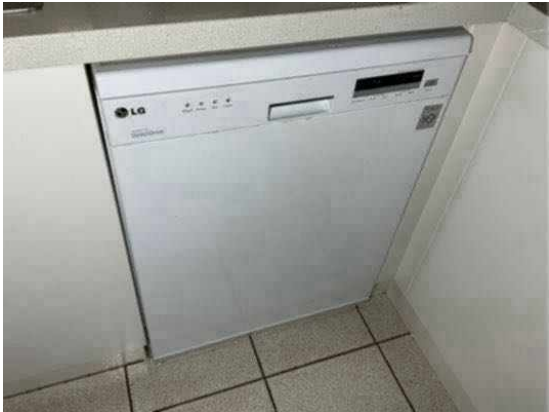
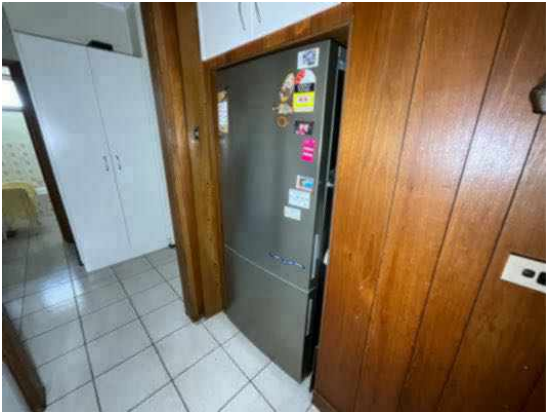
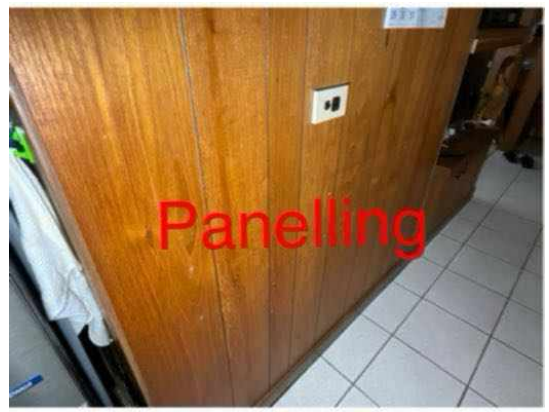
Building: Building 1  
 Location: All Areas  
 Finding: Additional Photos - Obstructions and Limitations  
 Information: These photographs are an indication of the obstructions and limitations which impeded full inspection of the property at the time of inspection. These obstructions can hide an array of defects and should be removed to allow full inspection to be carried out. A re-inspection is recommended once the areas are made accessible.
