Building Inspection Report

Inspection Date: Tue, 7 Apr 2026

Property Address: 3/59 Wills Rd, Woollooware NSW 2230,
Australia

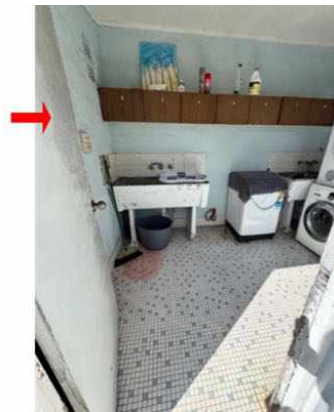
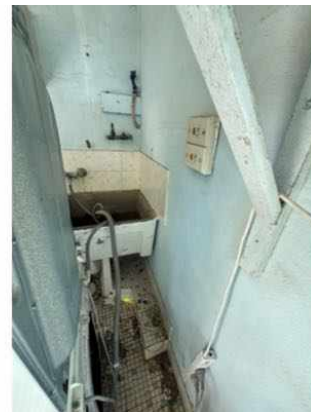
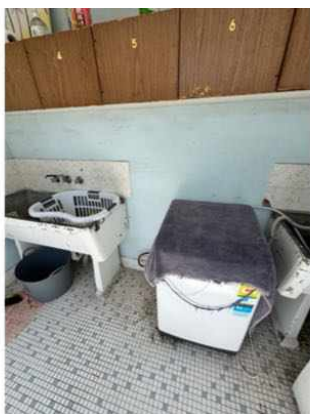
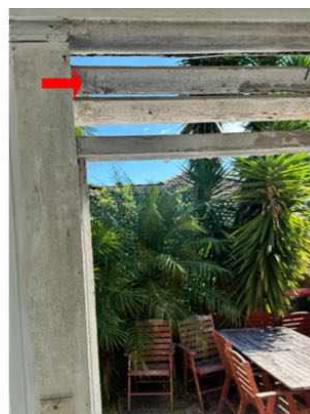
Defects 1.01

Location: Shared Laundry

Finding: Mould - Present

Information: Where evidence of mould growth was noted, there may be environmental, biological or health issues associated with the report. A specialist inspection by a suitably qualified environmental health inspector is warranted, where mould is extensive or where any queries regarding air quality spores or other related issues apply.

Generally, the client is advised to ensure that the general environment is free of moisture and humidity to aid in the prevention of mould formation and development. Any mould found during the inspection should be cleaned immediately by a cleaning contractor or the homeowner as applicable.

Please note that severely affected building elements may require replacement by a registered builder or qualified carpenter.

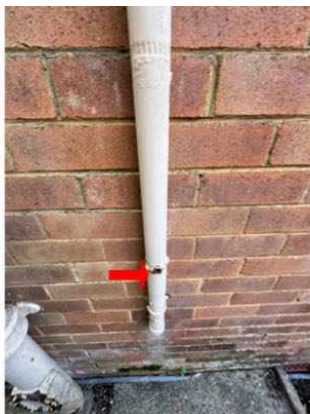
Defects 3.01

Building: Main Building
Location: Exterior walls - left side
Finding: Building element - Damaged

Information: Breakage occurs generally when the building materials have either aged and decayed, or as a result of damage (accidental or deliberate).

Repair and/or replacement of broken elements is advised to ensure that additional secondary defects do not arise as a consequence. Such works are necessary, as all building elements play a key role in the operation and function of the overall structure and its performance.

A relevant tradesperson should be appointed to repair or replace the affected building element prior to any subsequent damage being caused.

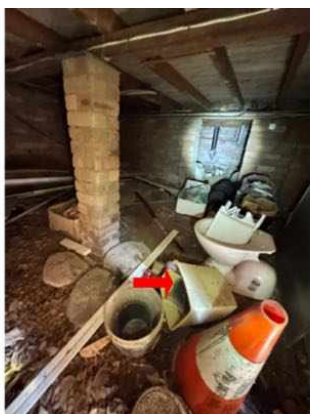
Defects 3.02

Location: Subfloor

Finding: Subfloor - Debris

Information: An array of debris was found in the subfloor area at the time of inspection. Debris in this area restricts subfloor ventilation and creates potential for concealed pest entry. Stored timbers and other materials may also make the area susceptible to termite activity and wood rot.

A clear and empty subfloor will be better ventilated and easier to maintain in a dry condition. The removal of any timber debris is vital in minimising the risk of termite or wood borer activity.

Debris in the subfloor should be removed as soon as possible. Depending on the location and amount of debris and stored items, the homeowner may elect to undertake this task. Alternatively there are a large number of rubbish removal subcontractors that could undertake these works.

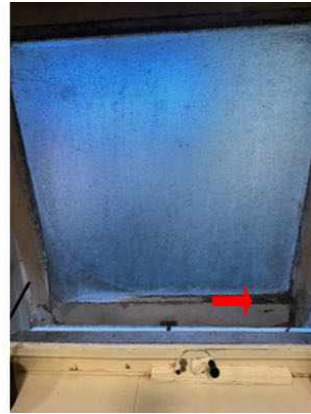
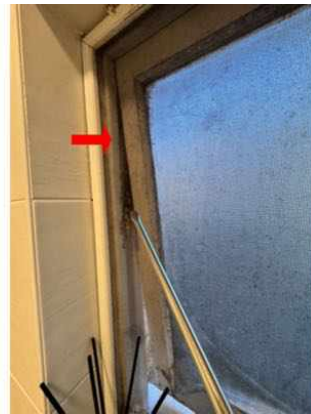
Defects 3.03

| Location: | Bathroom |
| Finding: | Windows - Wood rot |
| Information: | Wood rot was found to be affecting external windows. Wood rot, also known as Fungal Decay, occurs when timbers and other cellulose building materials are exposed to damp conditions on an ongoing basis. |

It is likely that this wood rot has developed as a result of frequent exposure to rain and other weather conditions. It is suspected that failure to maintain the window frames over a prolonged period has resulted in them deteriorating at an accelerated rate, increasing their susceptibility to the development of wood rot. Leaks in roof plumbing or associated pipework may have also contributed to the formation of the wood rot in this area.

Early intervention and regular maintenance will prolong the useful life of these building elements. Prior to any works being performed, any associated pipework or roof plumbing should be inspected by a licensed plumber for faults or leaks.

Repair and/or replacement of affected window frames may be a necessary step in protecting surrounding building elements from such deterioration. Remedial works should be performed by a qualified carpenter or registered builder as soon as possible to prevent any further damage.

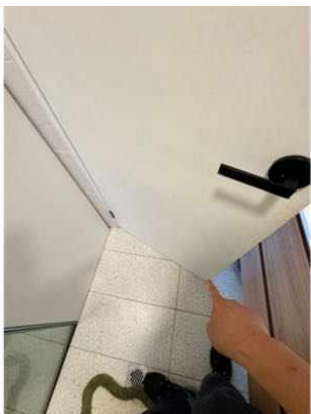
Defects 3.04

| Location: | Bathroom |
| Finding: | Door stop - Missing |
| Information: | The door stop is missing or is inadequate to stop the door handle from damaging the wall. Although some building elements may seem irrelevant or unnecessary, all building elements play a key role in the operation and function of the overall structure and its performance. |

Re-installation or replacement of the door stop is advised as soon as possible to prevent any subsequent damage to the door or associated structures. A general handyman may be appointed to perform these works at client discretion.

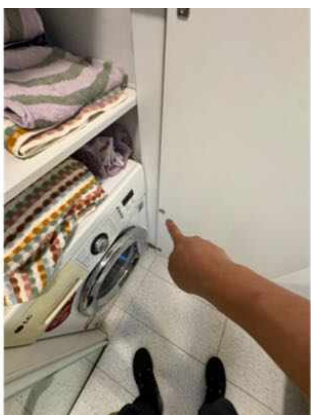
Defects 3.05

| Location: | Bathroom |
| Finding: | Cabinetry - Missing hinges |
| Information: | A cupboard doors is not level and detract from the operational state of the cabinetry. Upon further inspection, it was noted that the hinges to the cupboard doors have deteriorated over time and, as a result, have missed from their original fixing. To improve operation of the affected cupboard doors, a general handyman may be appointed to replace the faulty hinges. Such works should be completed at discretion of the client. |

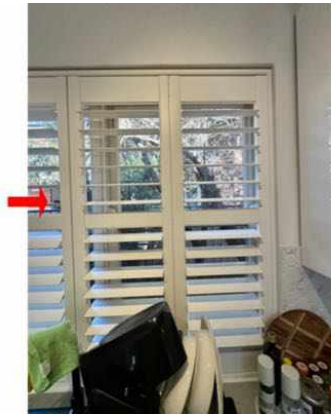
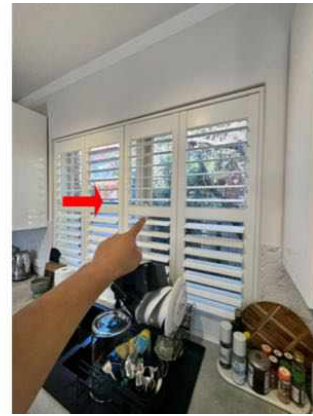
Defects 3.06

| Location: | Kitchen |
| Finding: | shutter - Loose |
| Information: | The shutter in this area is loose and requires adjustment to tighten. If left unmanaged, the fitting may further deteriorate, causing potential for the development of other minor secondary defects. A relevant tradesperson should be appointed to perform these rectification works at |

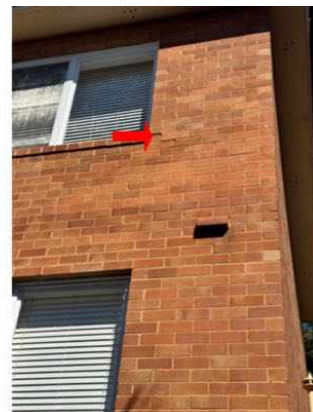
Defects 3.07

| Location: | Exterior walls - right side |
| Finding: | Brickwork - Step cracking |
| Information: | Step cracking was identified to the brickwork in this area at the time of inspection. Step cracking, which is similar to other forms of cracking, has a variety of possible causes. However, the most common is the subsidence of adjacent footings. |

Step cracking is a relatively common defect, and is most likely to occur adjacent to windows, doors and other openings. Mortar failure in the gaps between affected bricks indicates the stresses and tensions affecting the wall.

Where step cracking is extensive or severe, the client is advised to consult a structural engineer. Minor step cracking can be used as a warning sign to address factors causing stress to the wall, which can include the effect of surrounding trees, water leaks, soil erosion, or even the presence of reactive soils in the surrounding area.

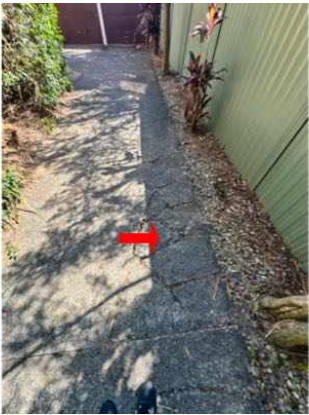
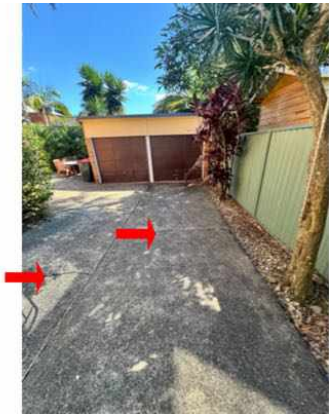
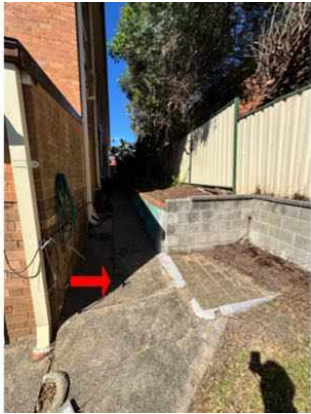
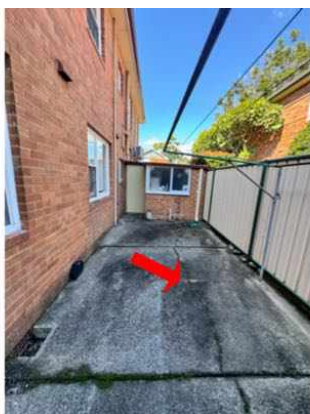
Defects 3.08

Location: Driveway
Finding: Crack in concrete slab - Category 2
Information: A crack coded as Category 2 was identified in the slab. A Category 2 crack is described as a distinct crack, with the slab being noticeably curved or changed in level.

To be considered Category 2, the approximate width of the crack is less than 2.0mm, or a change in offset of less than 15mm when a 3m straight edge is placed over the defect.

Category 2 cracks to slabs should be monitored for a period of 12 months. At the end of the monitoring period, cracks rated greater than Category 2 are considered defects that require rectification.

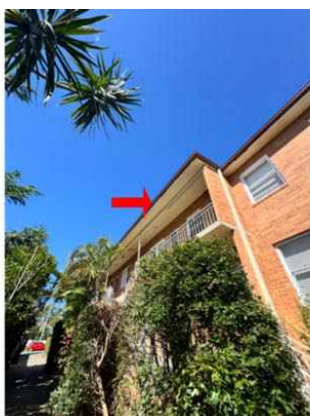
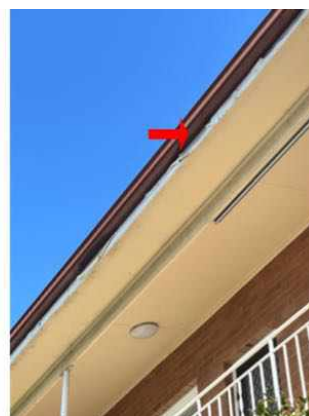
Defects 3.09

| Location: | Roof Exterior |
| Finding: | External painting deteriorated |
| Information: | Much of the external paintwork including but not limited to windows, fascias, guttering, veranda and other external fitments have been neglected and require attention to prepare and re-paint. |

Whilst incomplete or missing paint finish is generally an appearance defect, it can also lead to the development of secondary building defects over time. Incomplete areas of paint finish expose the area to moisture, potentially accelerating the deterioration of underlying building materials.

Degraded paint finishes should be sanded back, filled, leveled and painted, as applicable. Where inadequate or missing paint protection has led to the deterioration of the associated building element, repair and/or replacement of this building element may be required.

A painting contractor should be appointed as soon as possible to perform necessary works to aid the appearance of the affected area and to ensure the area is protected against further deterioration. Alternatively, the homeowner following manufacturer instructions may perform these works.

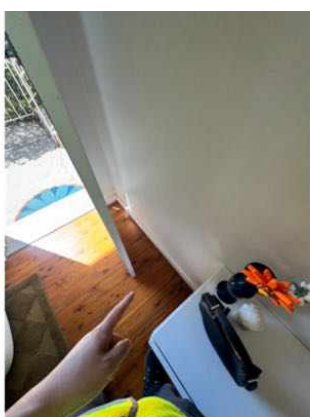
Defects 3.10

| Location: | Entry |
| Finding: | Door stop - Missing |
| Information: | The door stop is missing or is inadequate to stop the door handle from damaging the wall. Although some building elements may seem irrelevant or unnecessary, all building elements play a key role in the operation and function of the overall structure and its performance. |

Re-installation or replacement of the door stop is advised as soon as possible to prevent any subsequent damage to the door or associated structures. A general handyman may be appointed to perform these works at client discretion.

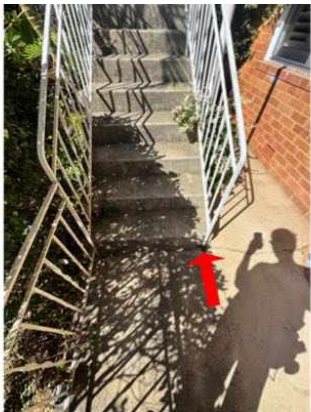
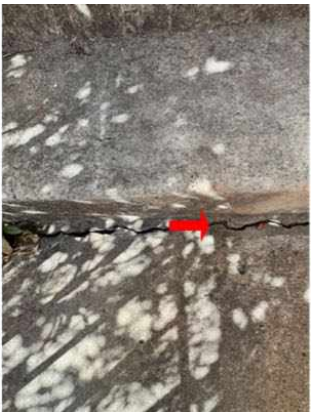
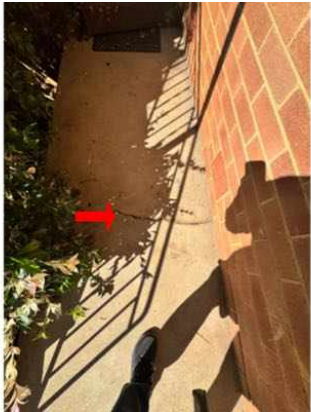
Defects 3.11

| Location: | Entry |
| Finding: | Crack in concrete slab - Category 2 |
| Information: | A crack coded as Category 2 was identified in the slab. A Category 2 crack is described as a distinct crack, with the slab being noticeably curved or changed in level. |

To be considered Category 2, the approximate width of the crack is less than 2.0mm, or a change in offset of less than 15mm when a 3m straight edge is placed over the defect.

Category 2 cracks to slabs should be monitored for a period of 12 months. At the end of the monitoring period, cracks rated greater than Category 2 are considered defects that require rectification.
