## Building Inspection Report

Inspection Date: Fri, 27 Feb 2026

Property Address: 523/1-39 lord Sheffield circuit, Penrith,  
NSW 2750

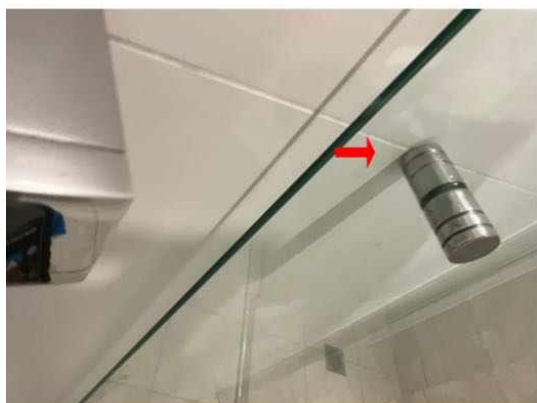
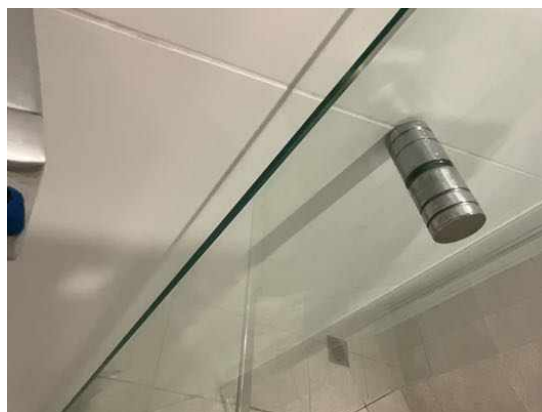
#### Defects 1.01

Building: Main Building  
 Location: Bathroom  
 Finding: shower screen door hitting tiles  
 Information: The shower screen door makes contact with the adjacent tiles when opened. This indicates inadequate clearance between the shower screen and the wall. The door's operation is impeded and presents a safety concern.

- Potential for impact damage to the wall and shower screen.
- Increased risk of glass breakage, posing a personal injury hazard.
- Ongoing stress may lead to hardware failure or misalignment of the door.

This condition does not comply with the intent of AS 4349.1-2007, Appendix C – Significant Items, under “Defects in the condition of secondary and finishing elements,” specifically where normal use may cause failure or injury.

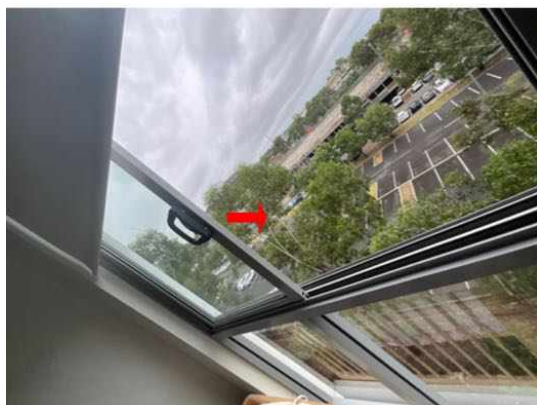
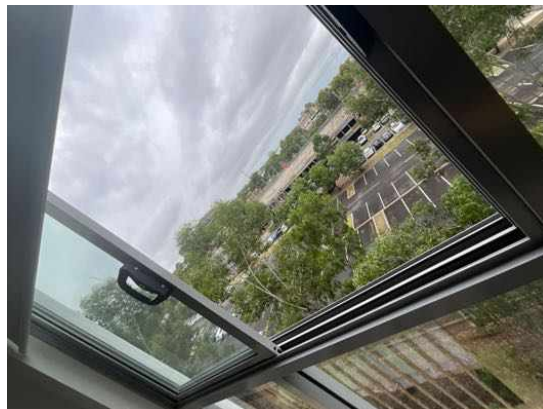
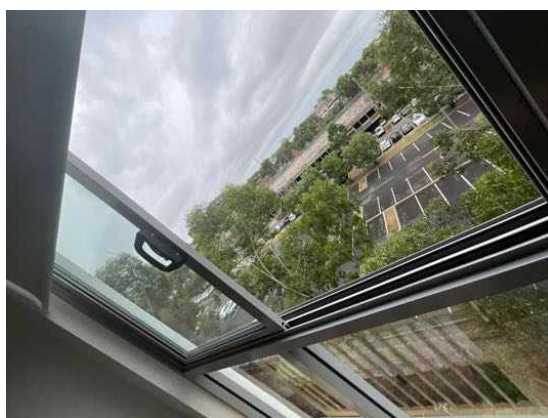
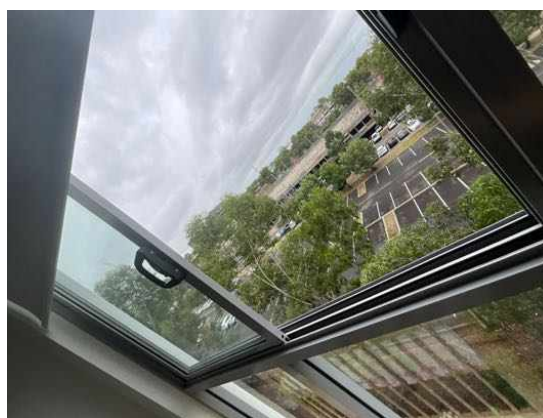
#### Defects 1.02

Building: Main Building  
 Location: All Areas  
 Finding: Window child lock missing  
 Information: The window in question lacks a child lock mechanism, which poses a potential safety risk to young occupants in the premises. As per Australian Standards windows accessible to children should be equipped with appropriate child safety locks to

prevent accidental opening, reducing the risk of falls and ensuring compliance with safety regulations.

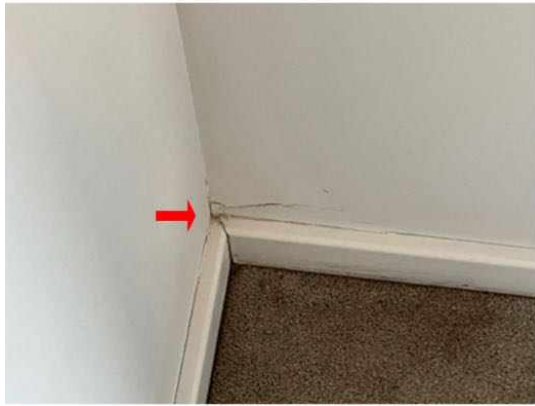
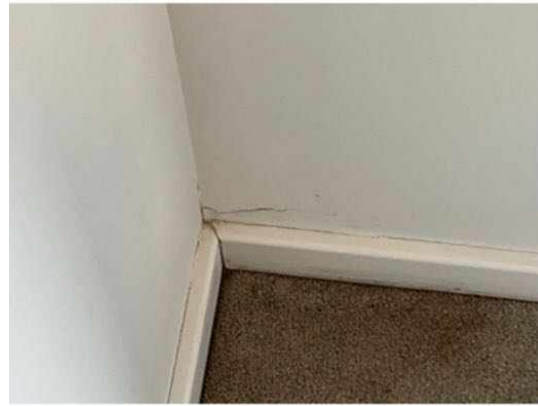
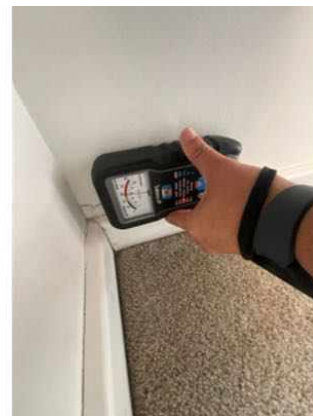
### Defects 2.01

Building:	Main Building
Location:	Bedroom 2
Finding:	Water damage
Information:	The area has sustained water damage resulting in potential structural issues. This damage compromises both the aesthetic and functional aspects.

To fix this issue, you should consider contacting a professional:

1 **\*\*Plumber:\*\*** If the water damage is due to plumbing issues, a plumber can fix leaks and ensure there are no further water-related problems.

2 **\*\*General Contractor:\*\*** If the damage is extensive and affects the surrounding area, a general contractor can coordinate the repair work, including any related structural or cosmetic repairs.

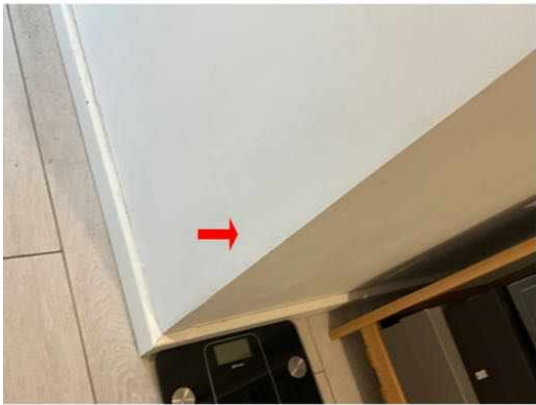
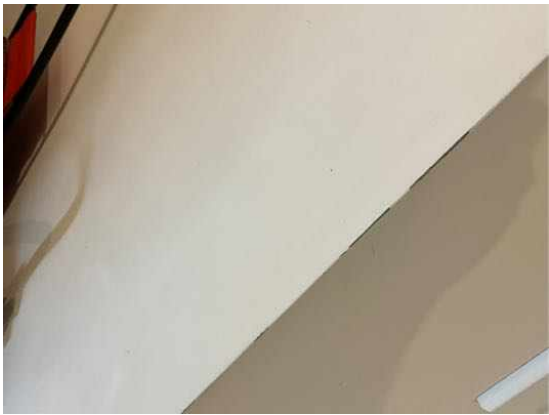
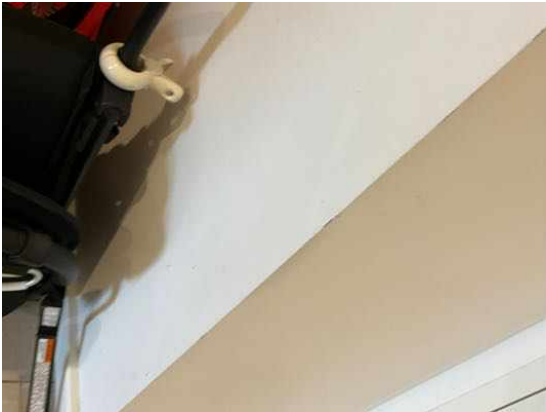
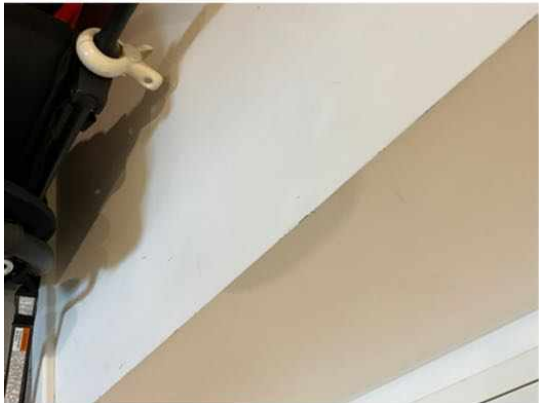
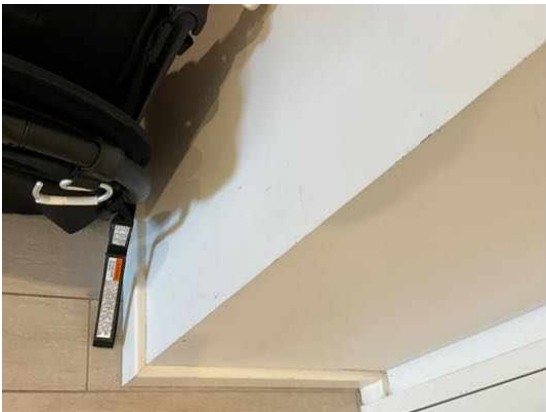
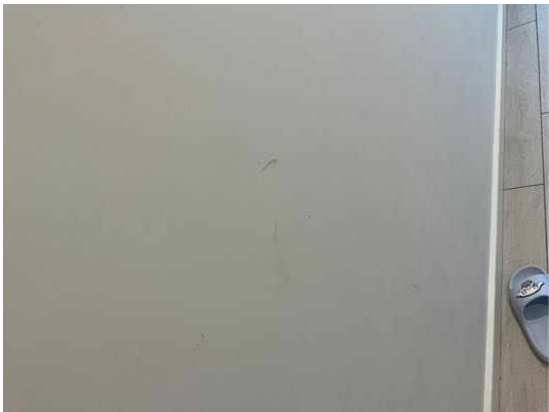
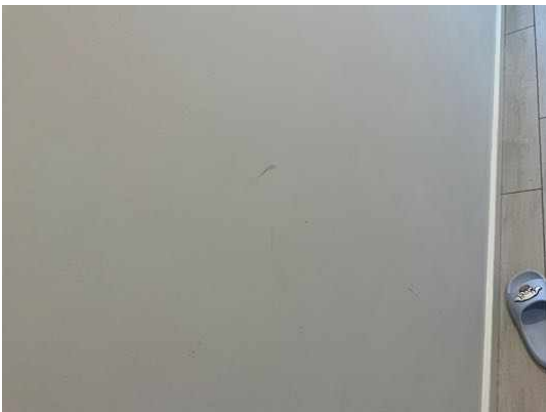
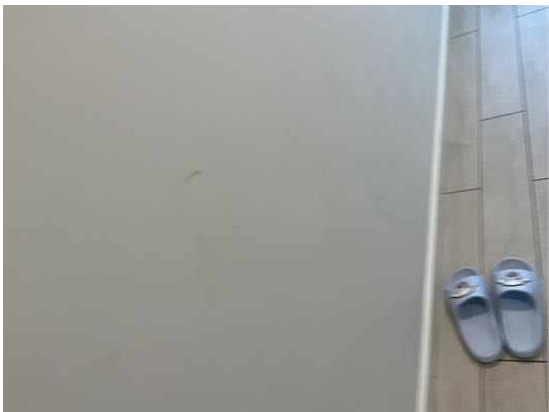
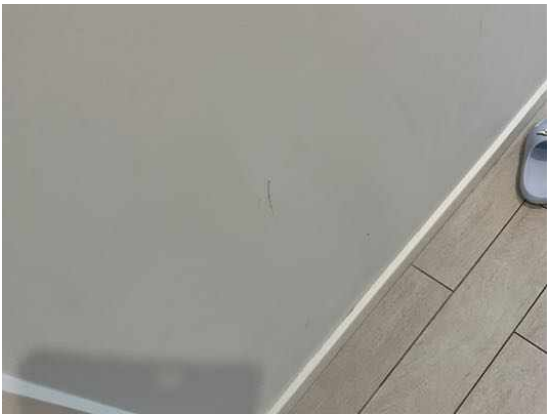
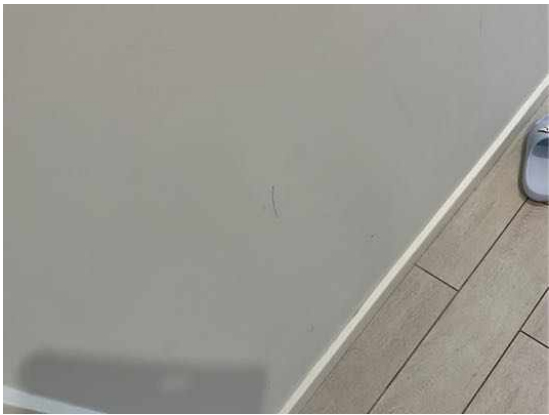
## Defects 3.02

Building:	Main Building
Location:	All Areas
Finding:	Paint surface - Scratches
Information:	Scratches have been identified on the paint surface, detracting from the overall appearance and quality of the painted surface.

1. Aesthetic Degradation: Scratches mar the appearance of the painted surface, diminishing its visual appeal and potentially lowering property value.
2. Corrosion Vulnerability: Exposed areas of bare metal due to scratched paint are susceptible to corrosion, leading to structural damage and compromised durability.
3. Environmental Hazards: Scratched paint can release hazardous chemicals into the environment, posing risks to both human health and the ecosystem.

A qualified painter should address the issue promptly to repair the scratched paint. Depending on the severity of the scratches, repair options may include sanding, priming, and repainting the affected area to restore the integrity and appearance of the paint surface.

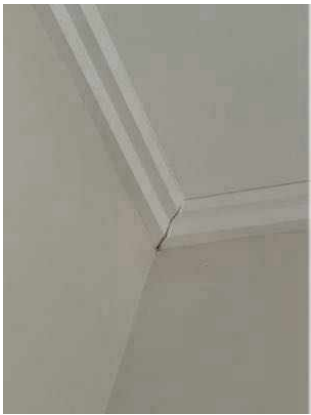
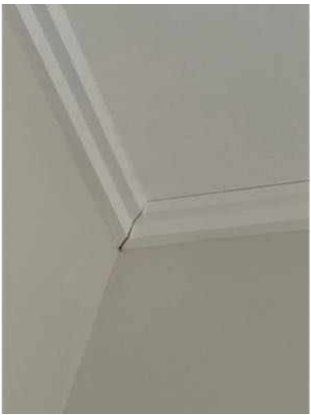
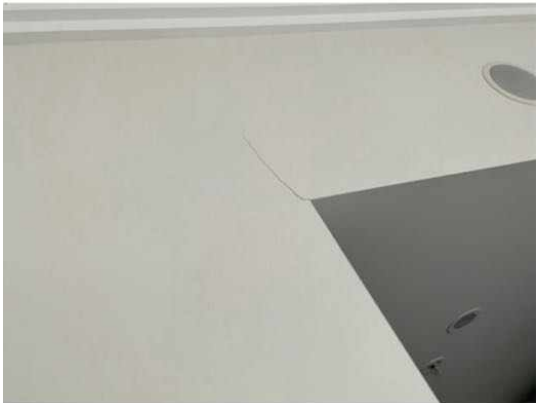
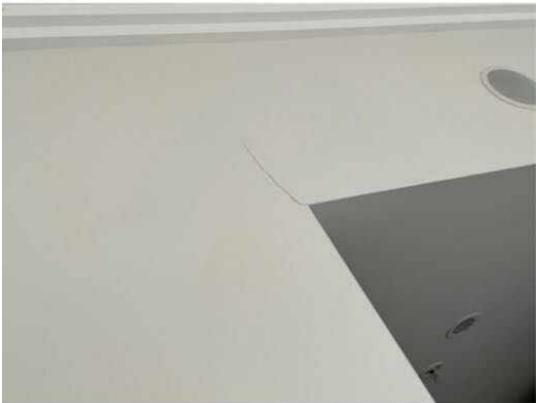
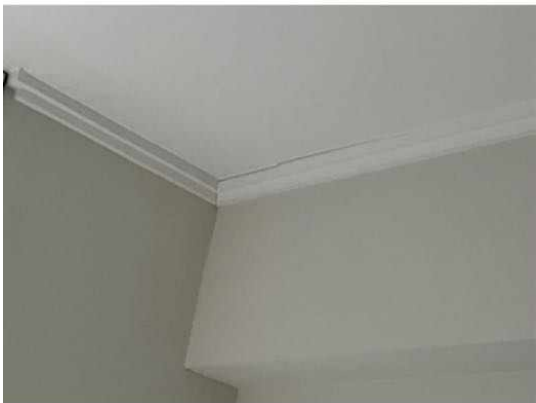
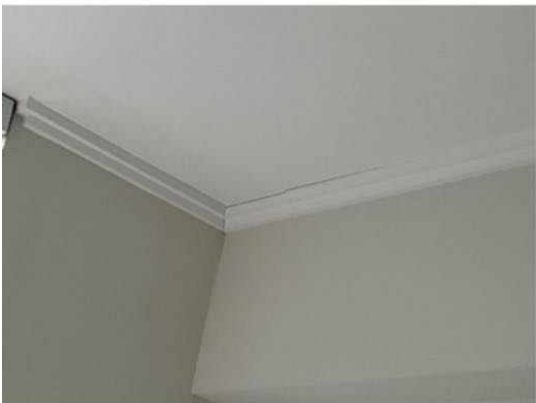
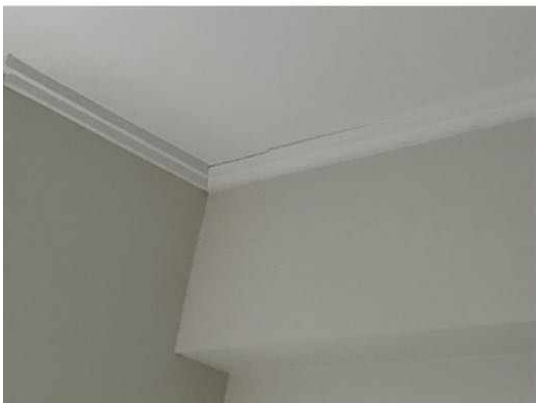
**Defects 3.03**

Building: Main Building  
Location: All Areas  
Finding: Gyprock - Crack ( Fine ) - walls and ceiling  
Information: Fine cracks have appeared in the gyprock of the ceiling and walls, suggesting potential issues with settling or structural movement.

The fine cracks in the gyprock pose a risk of further widening, compromising the aesthetic appeal of the space, and potentially indicating underlying structural problems.

A skilled plasterer or a contractor specializing in drywall repairs should assess the extent of the cracks and address them promptly. Identifying and fixing the root cause of the issue, whether related to settling or structural concerns, is essential to prevent further damage and maintain the integrity of the ceiling.

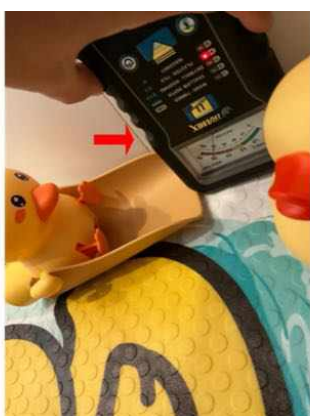
Defects 3.04

Building:	Main Building
Location:	Ensuite
Finding:	Shower - Damp
Information:	Damp is evident to the lower 300mm of wall to the shower alcove. This defect is quite common, and is suspected to have been caused by moisture permeating through the grouting in this area, which shows evidence of deterioration. Leaking pipes within the adjoining wall is also a possible cause.

Unmanaged damp in the shower recess is likely to facilitate the formation and development of mould and fungi growth, decaying associated building materials and compromising their structural integrity. It is important to address damp conditions, as the World Health Organisation notes that excess moisture leads - on almost all indoor materials - to growth of microbes such as moulds, fungi and bacteria, which subsequently emit spores and other matter into the indoor air. Exposure to these contaminants is associated with a wide range of respiratory and other health-related problems.

Consultation with a qualified plumber or bathroom specialist is advised immediately to identify the cause of damp and to perform remedial works as required. Where excessive mould growth is present, further inspection by a specialist environmental health inspector should also be considered.

Always ensure that sealant and grout is in good condition to prevent any moisture issues occurring in the future.

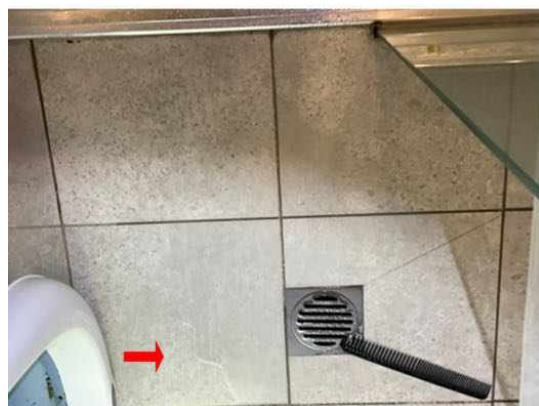
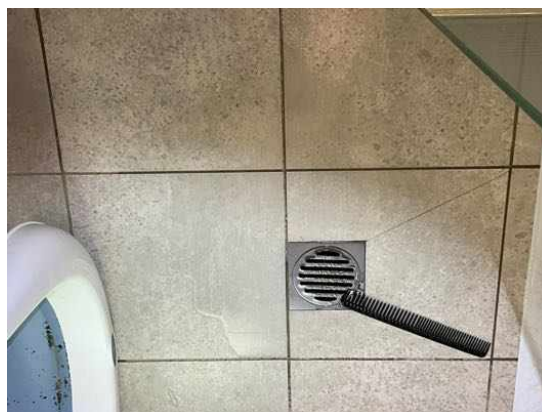
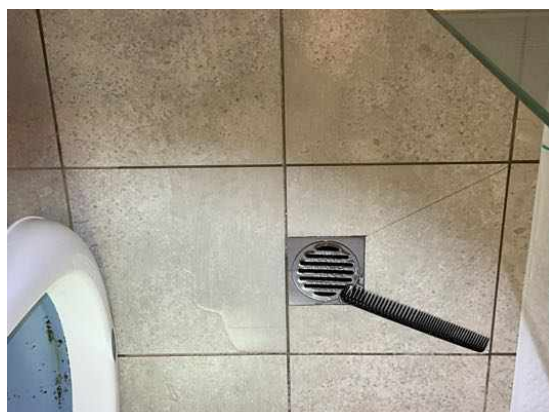
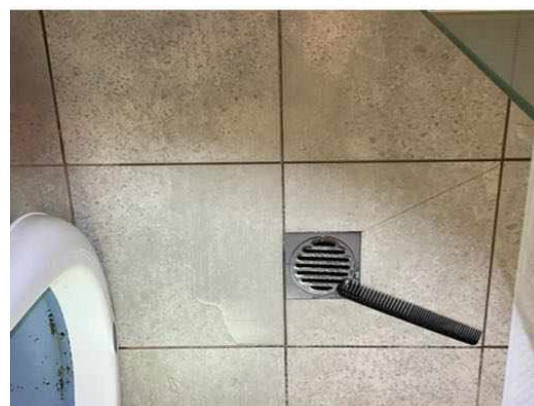
### Defects 3.05

Building:	Main Building
Location:	Ensuite
Finding:	Shower base - Water pooling
Information:	Evidence of water pooling around the floor waste in the shower recess was noticed at the time of inspection. It is suspected that this excessive moisture is attributed to insufficient fall in the shower floor tiles.

This pooling is minor overall but is still considered unsatisfactory, as standard tiling practices would not permit this situation to occur. Pooling water around floor wastes can create a slip hazard in extreme cases and create conditions that are conducive to mould growth over time. Where left unmanaged, the degradation of sealant and grouting is also likely to occur, possibly necessitating further repair works.

Remedial works may involve some sections of tiling and flooring repair and replacement. A tiling contractor or bathroom specialist should be appointed to provide further advice on reparation options and to perform works as necessary.

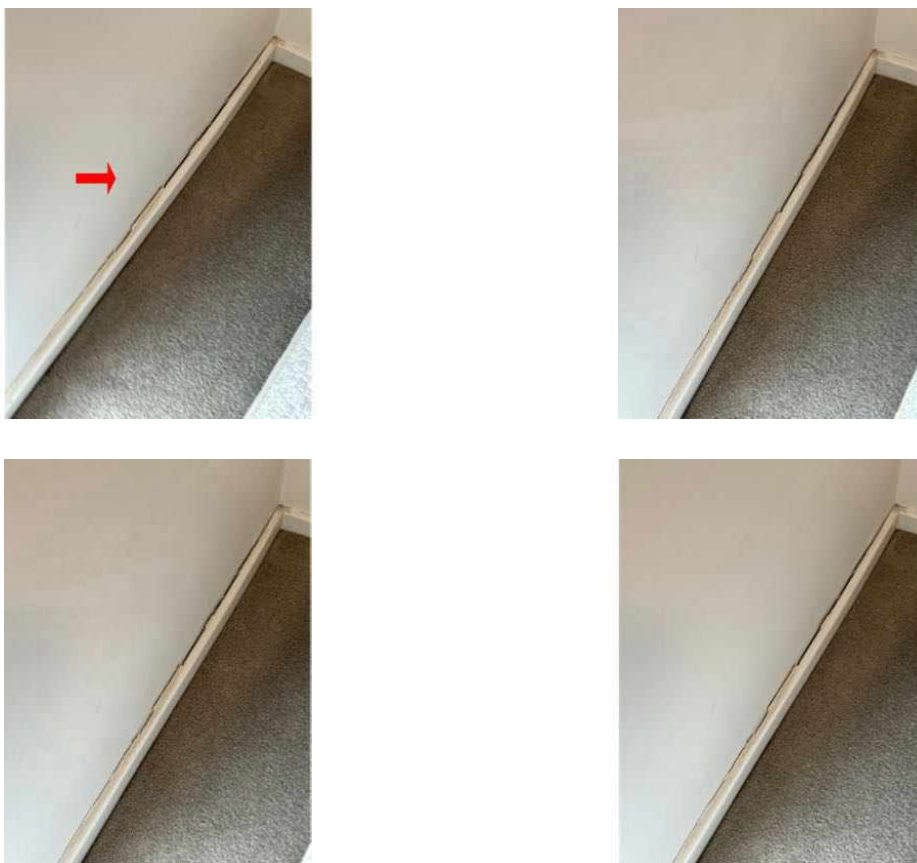
### Defects 3.06

Building: Main Building  
 Location: Bedroom 2  
 Finding: Skirting board: gaps  
 Information: Gapping was observed between the skirting board and wall surface. This appears to be caused by poor installation or seasonal expansion/contraction of materials.

- Minor aesthetic concern.
- May allow dust, insects, or moisture ingress if left unsealed.
- If movement continues, it may indicate underlying settlement or moisture-related issues in adjacent flooring or wall structures.

- A qualified carpenter or handyman should be engaged to reseal, reattach, or replace the affected skirting board section.
- If moisture or structural movement is suspected, further inspection by a licensed builder may be warranted.

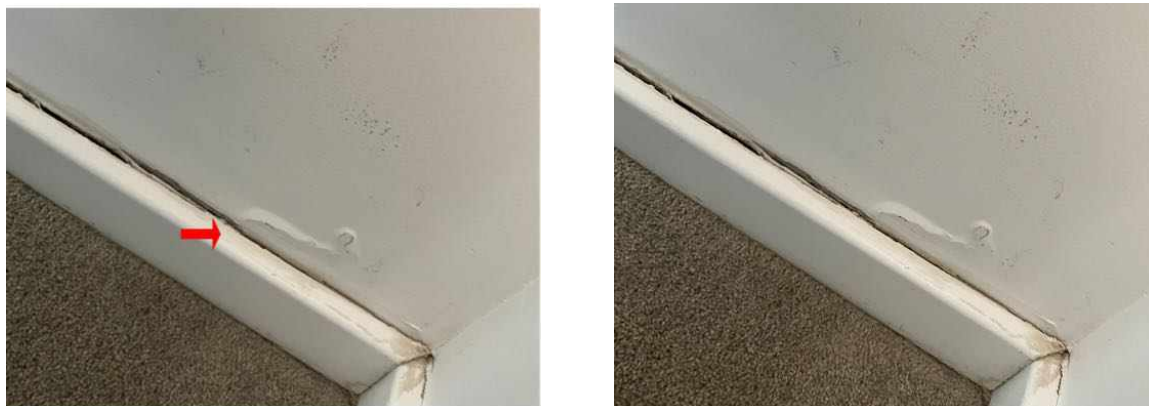
### Defects 3.07

Finding: Paint Bubble

Information: A visible paint bubble (or blister) was identified on the surface. The deformation appears as a raised area in the paint film, typically resulting from adhesion failure between the paint and substrate, possibly due to moisture, poor surface preparation, or incompatible paint layers.

As per AS 4349.1-2007, this is considered a minor defect. However, if moisture is the cause, it may indicate an underlying issue such as water ingress or high humidity, which could worsen over time and lead to mould growth or plasterboard deterioration if left unattended.

Minor Defect — unless associated with active moisture ingress, in which case it may be upgraded depending on extent and cause.

A licensed painter or plasterer should assess the cause of the blister. If moisture is present, the source must be identified and rectified before repairs. Once dry, the affected area should be scraped back, sealed, patched, and repainted. Further investigation may be required if there is suspicion of plumbing or roofing leaks above the ceiling.

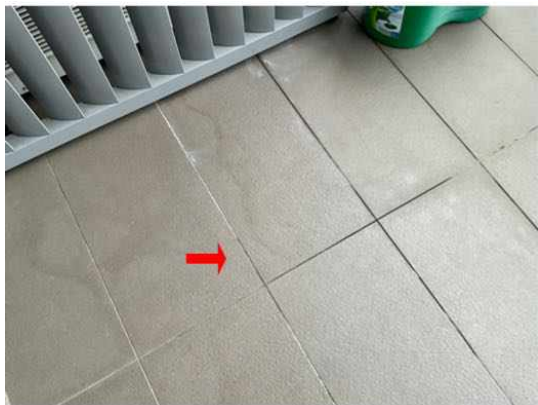
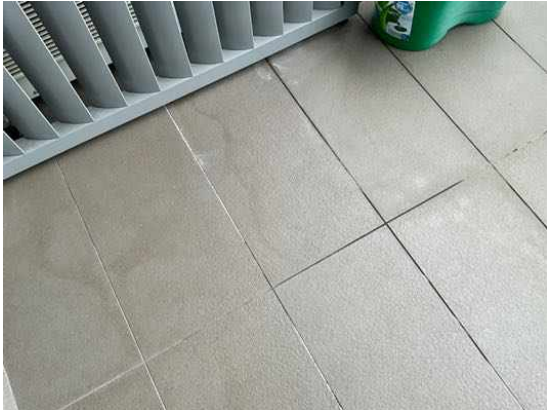
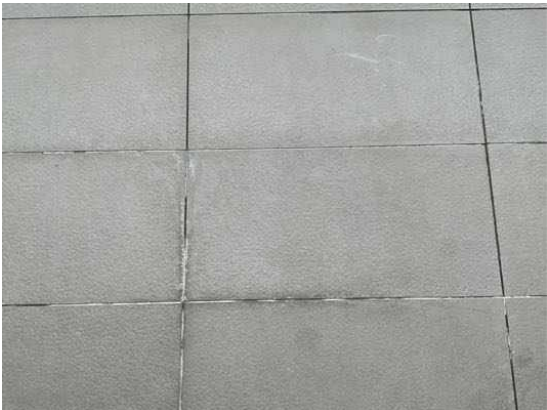
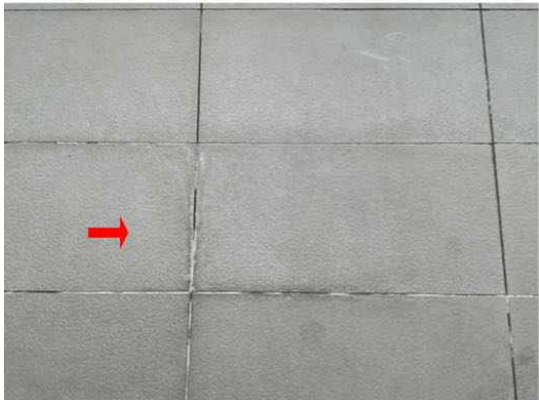
### Defects 3.08

Building:	Main Building
Location:	Balcony
Finding:	Balcony - Efflorescence and Moisture Staining to External Tiled Floor
Information:	White crystalline deposits (efflorescence) and visible moisture staining were observed across grout lines and tile surfaces. This condition is commonly associated with the movement of moisture through the tile bed or substrate, which dissolves soluble salts and deposits them on the surface as water evaporates.

- Indicates potential waterproofing failure or inadequate drainage.
- May lead to tile delamination, deterioration of grout and adhesive, and long-term moisture damage to the substructure.
- In severe or persistent cases, dampness may migrate into internal areas, potentially leading to mould growth or structural deterioration.
- Surface may become slippery, increasing the risk of slips and falls.

- Engage a licensed waterproofing contractor to conduct moisture testing and assess the integrity of the waterproofing membrane.
- If failure is confirmed, rectification may require tile removal and reapplication of a compliant waterproofing system, followed by re-tiling by a qualified tiler.
- If moisture ingress is suspected to affect internal structural components, an invasive

inspection by a registered building consultant or structural engineer is recommended.
