# Building and Timber Pest Inspection Report

Inspection Date: Tue, 10 Feb 2026

Property Address: 4/124 Nellie St, Nundah QLD 4012,  
Australia

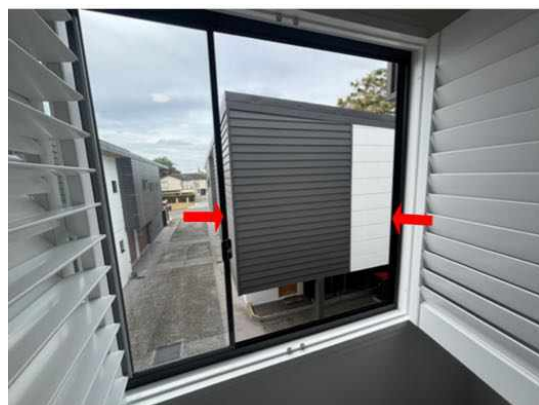
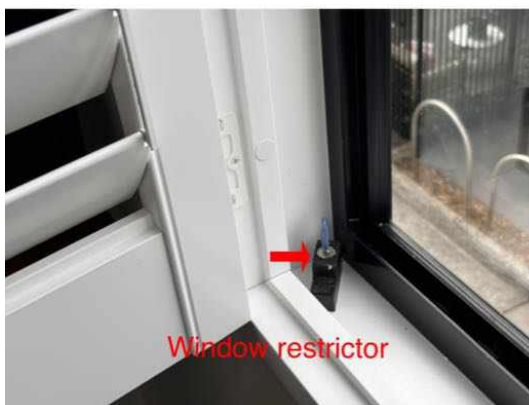
#### Finding 1.01

Building:	Main Building
Location:	Bedroom 2
Finding:	Bedroom 2 - window opens more than 125mm
Information:	At the time of the inspection, it was noted that the window in bedroom 2 was not restricted to prevent them from opening more than 125mm. The windows could be opened to its full width. The keyed window restrictor was on the window sill. Permanent screens were not fitted to the window.

The Australian Building Codes Board (ACCB) altered the Building Code of Australia (BCA) in 2013. The new requirements relate to childcare centres, bedrooms within buildings two stories or more, and bedrooms within single story buildings on steep sloping blocks where the fall to the ground is greater than 2m.

Existing buildings within Strata Schemes and Early Childhood Centres must fit an appropriate device to windows by March 2018 to prevent them opening more than 125mm (representing the size of a young child's head) or a robust screen to resist an outward force of 250 N (~25kg).

The client should engage a building maintenance professional to fit restrictors or permanent screens to the window in bedrooms 2. This must be done as a matter of urgency.

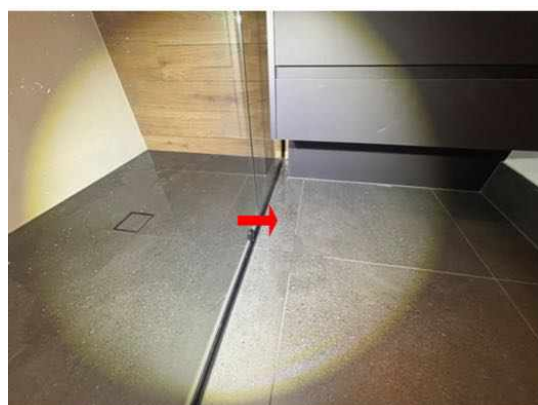
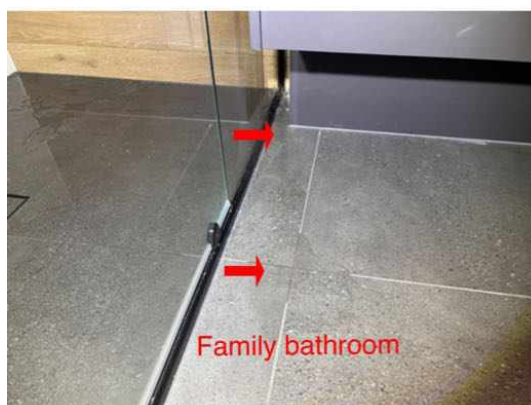
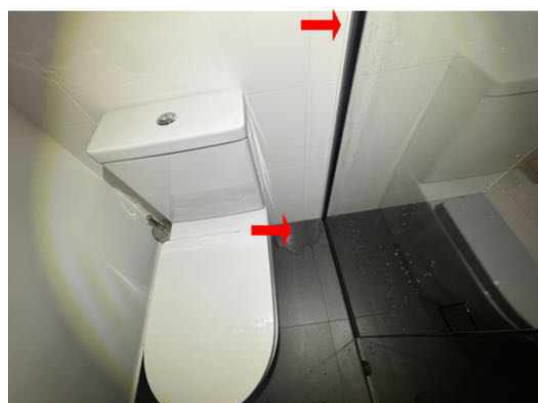
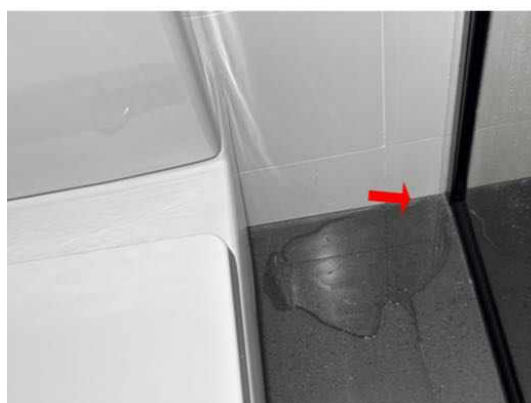
### Finding 3.01

Building:	Main Building
Location:	Bathrooms
Finding:	Bathrooms - shower screen leaking
Information:	At the time of the inspection, it was noted that the shower screen in the family bathroom and in the ensuite were leaking. The sealant on the inside of both of the shower screens needs to be redone.

A building maintenance professional should be engaged to apply sealant to the shower screens. This should be done as a short term priority.

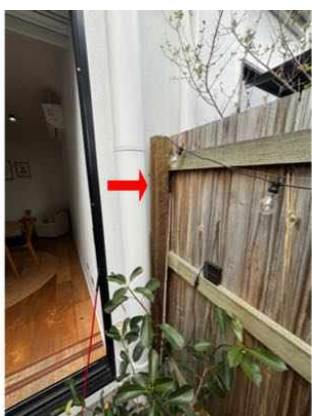
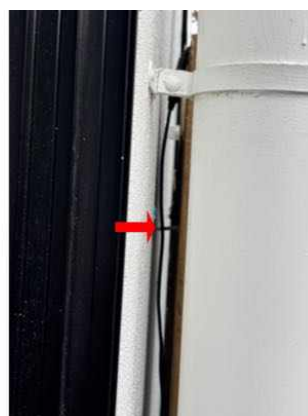
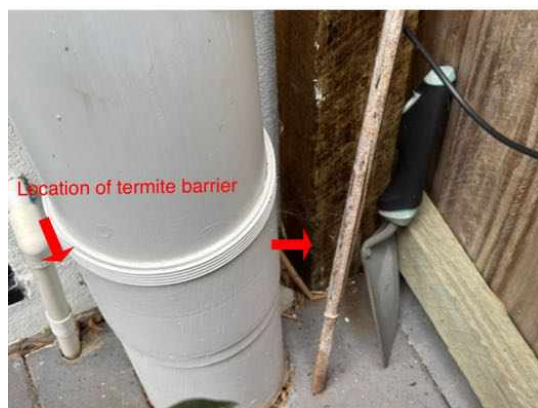
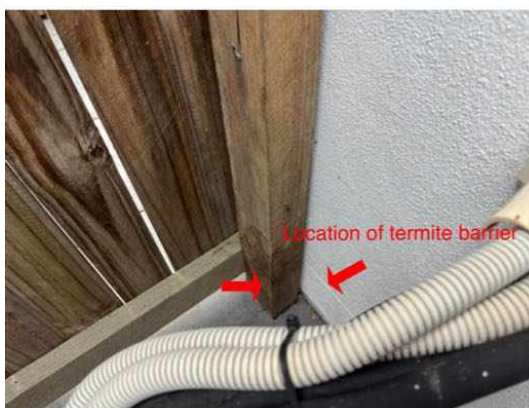
### Finding 3.02

Building:	Main Building
Location:	Rear yard
Finding:	Timber fence - loose
Information:	At the time of the inspection, it was noted that the timber fence next to the sliding door was not securely attached to the building. There is movement to the fence when pressure is applied to it.

It was also found that the timber posts that are attached to the building extend past the line of the physical termite barrier. The timber fence posts covers the visual inspection zone and provides a potential concealed point for termites to bridge the physical termite barrier.

The timber fences may be the responsibility of the body corporate and the client may wish to inform the body corporate of these potential bridging points.

A building maintenance professional or licensed carpenter should be engaged re-attach the timber post to the building and to trim the timber posts above the line of the physical termite barrier. This should be done as a short term priority.

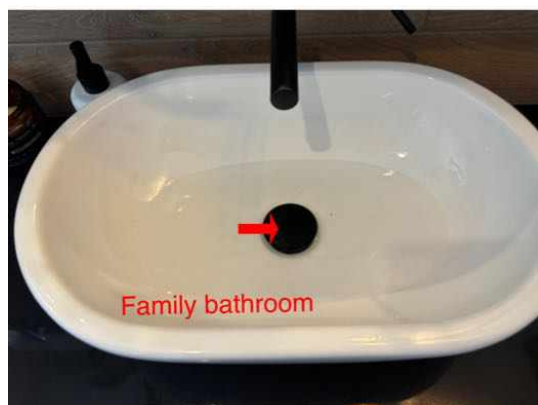
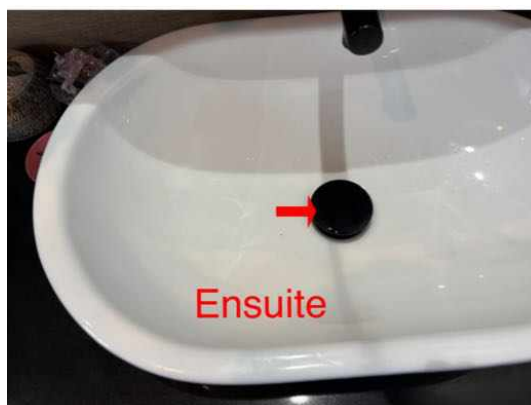
### Finding 3.03

Building:	Main Building
Location:	Bathrooms
Finding:	Pop up wastes - stuck in the open position
Information:	At the time of the inspection, it was noted that the pop up plug wastes to the vanity in both bathrooms were stuck in the open position. The basins cannot be filled.
	A licensed plumber should be engaged to replace the pop up plug wastes. This can be done at the clients discretion.

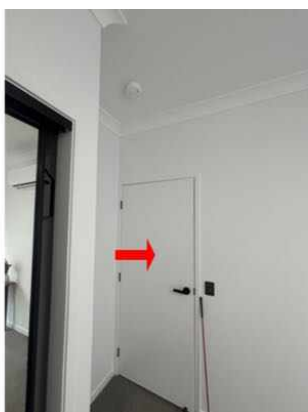
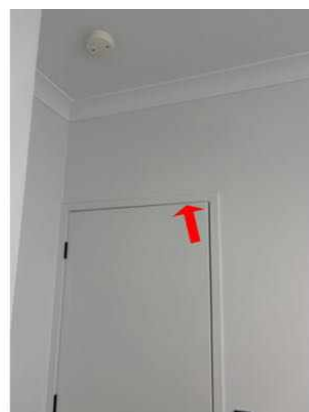
### Finding 3.04

Building: Main Building

Location: Bedroom 2

Finding: Bedroom 2 - door binding on the door jamb

Information: At the time of the inspection, it was noted that the hinged door to bedroom 2 was binding against the top of the door jamb during normal operation. This appears to be general wear and tear. A small amount needs to be trimmed off of the top of the door to restore functionality.

A building maintenance professional or licensed carpenter could be engaged to perform minor rectification works. This can be done at the clients discretion.

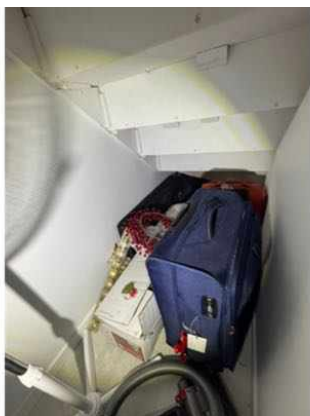
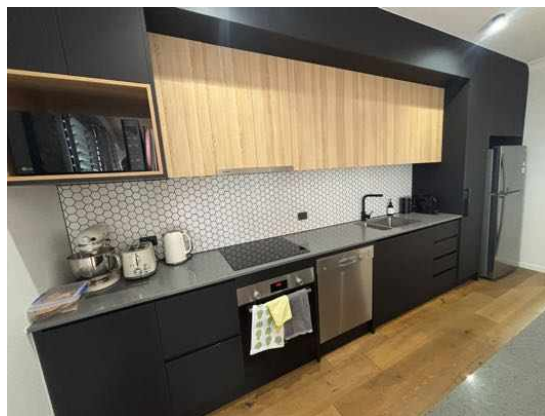
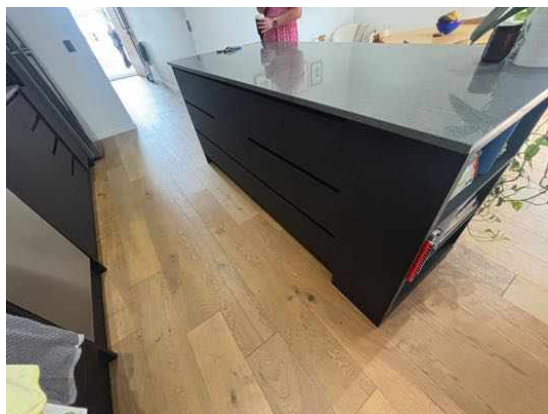
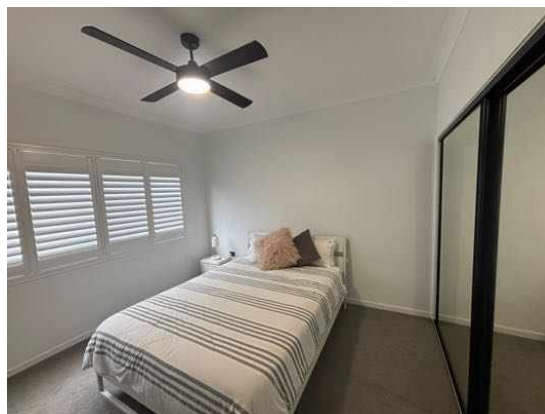
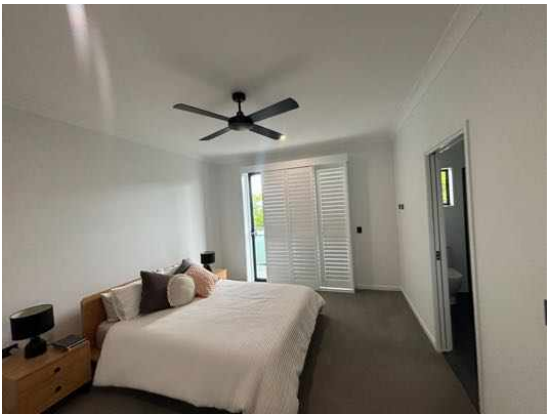
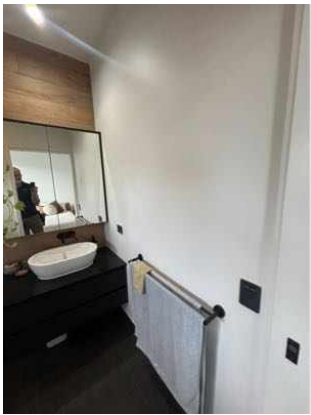
Building: Main Building  
Location: All Internal Areas  
Finding: Obstructions and Limitations - Internal areas  
Information: These photographs are an indication of the obstructions and limitations which impeded full inspection of the property of the internal areas at the time of inspection. These obstructions can hide an array of defects and should be removed to allow full inspection to be carried out. A re-inspection is recommended once the areas are made accessible.

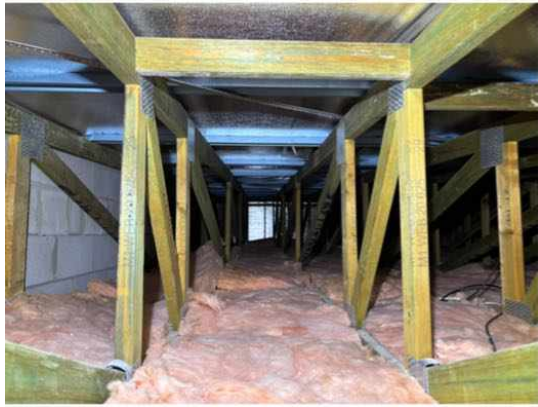
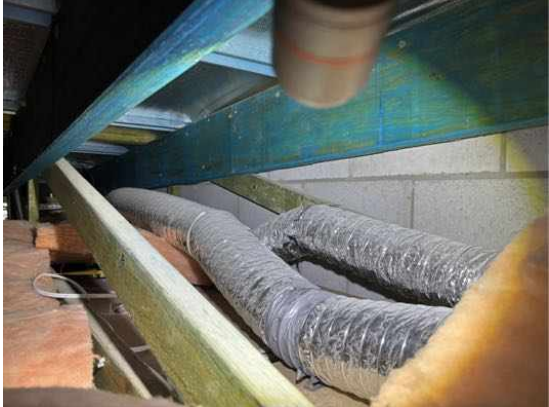
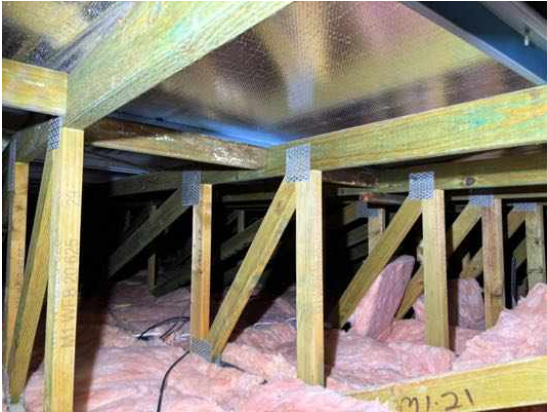
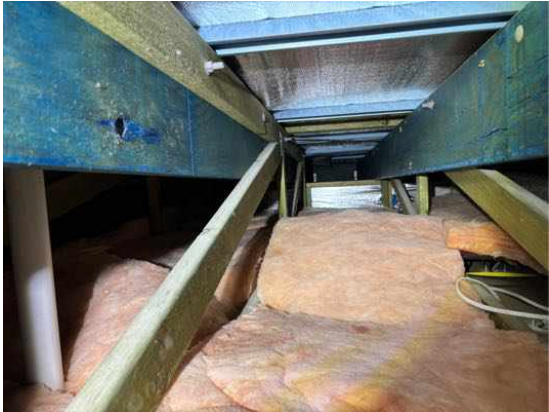
Building: Main Building  
Location: Roof Void  
Finding: Obstructions and Limitations - Roof cavity  
Information: These photographs are an indication of the obstructions and limitations which impeded full inspection of the property of the roof cavity

at the time of inspection. These obstructions can hide an array of defects and should be removed to allow full inspection to be carried out. A re-inspection is recommended once the areas are made accessible.

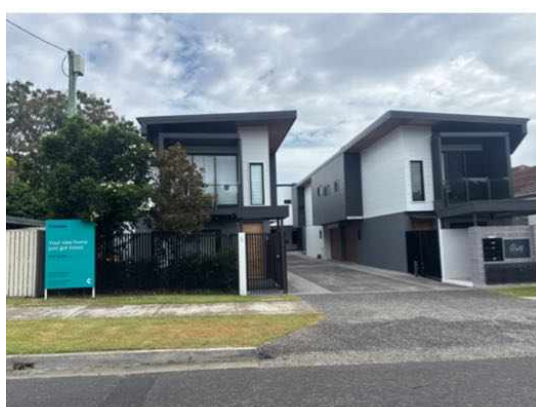
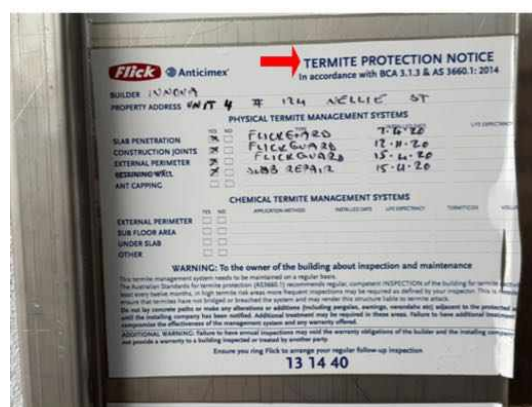
Building: Main Building  
 Location: All External Areas  
 Finding: Evidence of a physical termite management system was identified.  
 Information: At the time of the inspection, evidence of a physical termite management system was found by way of a durable notice in the electricity meter box.

A physical termite barrier was installed to the slab penetrations, perimeter, construction joints and a slab repair during construction. The durable notice is dated from 07/04/2020 to the 12/11/2020.

The client may wish to enquire of the body corporate as to the nature of the termite management plan for the complex and each individual townhouse. Also, are annual termite inspections carried out and up to date.

A termite and timber pest technician should be engaged to carry out annual termite inspections as per AS 3660 in order to further protect the dwelling. Annual termite inspections must be carried out in partnership with any termite treatment system, physical or chemical, as no termite treatment system can be expected to 100% effective. A physical termite barrier does not stop or eliminate termites, a physical termite barrier is designed to expose concealed termite activity.
