## Building Inspection Report

Inspection Date: Wed, 21 Jan 2026

Property Address: 183/33 Lakefront Cres, Varsity Lakes QLD  
4227, Australia

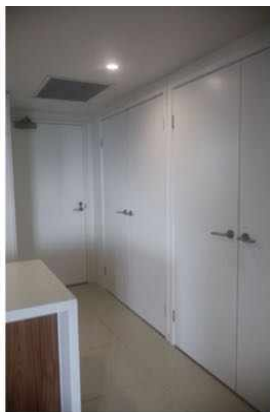
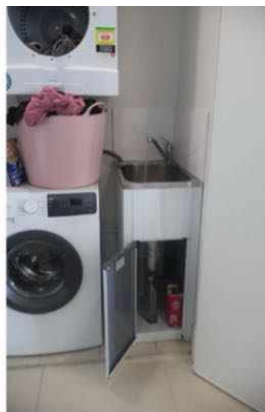
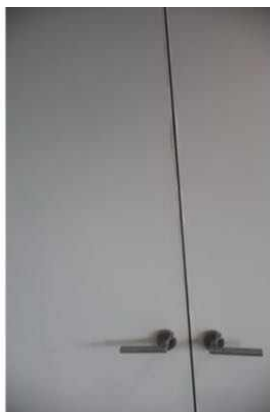
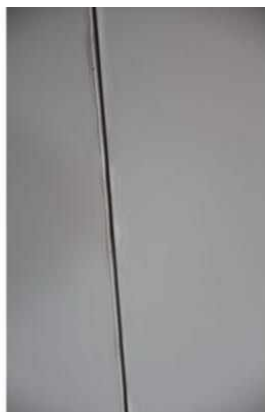
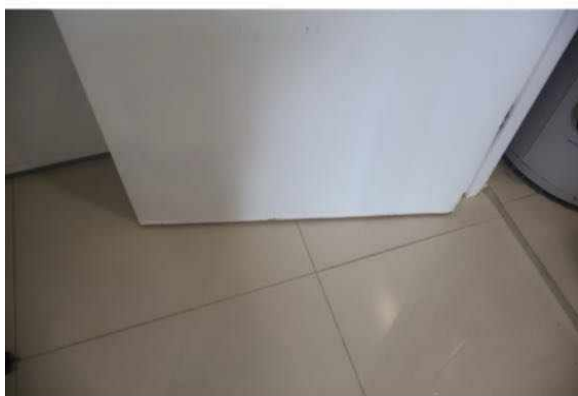
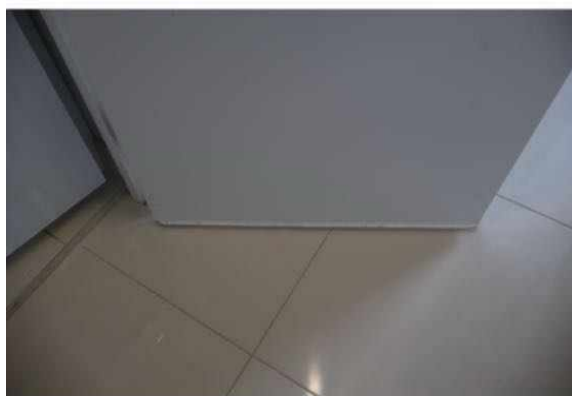
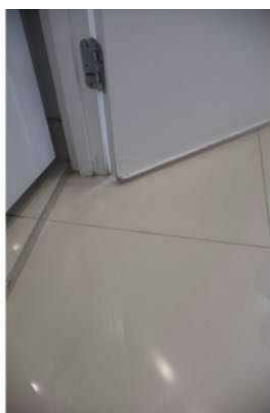
#### Defects 3.01

Building: Main Building  
Location: Laundry > Front  
Finding: Doors - moisture damaged  
Information: At the time of the inspection it was noted that the doors have moisture damage to bottom edges.

Prolong exposure to moisture has damaged the bottom edges of the doors are starting to deteriorate

Where doors are damaged they are no longer protected against weather conditions and may deteriorate at a rapid rate

And require extensive repairs or replacement.

It is recommended the door manufacturer be engaged to inspect the condition of the doors.

It is recommended to seek clarification on doors have adequate protection against weather conditions.

This may be by clarified by door manufacturer or building certifier.

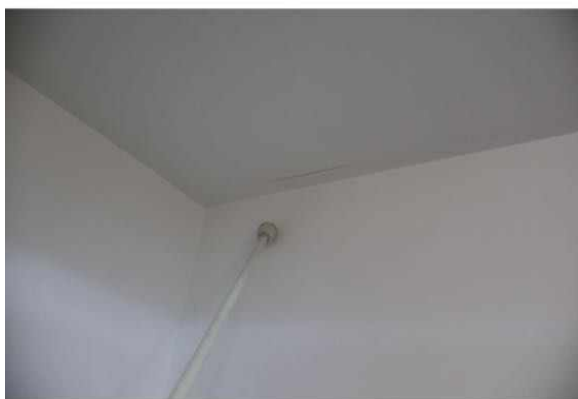
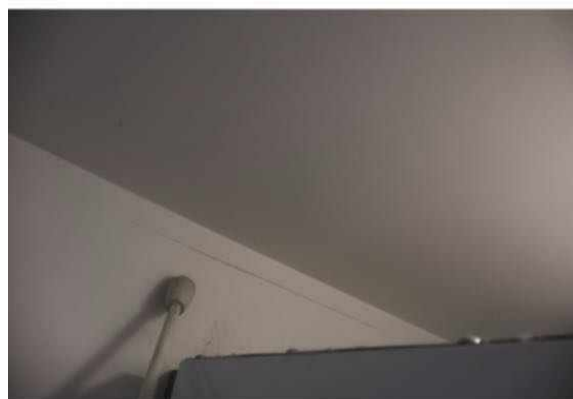
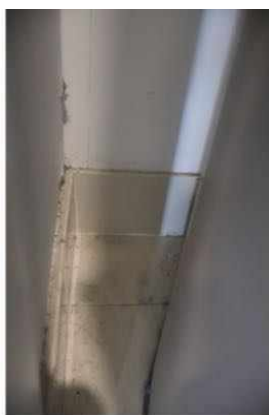
Defects 3.02

Building: Main Building  
 Location: Laundry > Rear  
 Finding: Cracks to internal plaster- Category 1  
 Information: It has been observed that cracking to internal plaster surfaces has occurred. The degree of damage falls within Category 1, described as fine cracks that do not need repair and which are less than 1.0mm in width limit.

Damage of this category is not considered a defect for rectification. Always contact your building inspector should cracks widen, lengthen, or become more numerous.

Laundry wall shows evidence of plaster cracking and may require replacing.

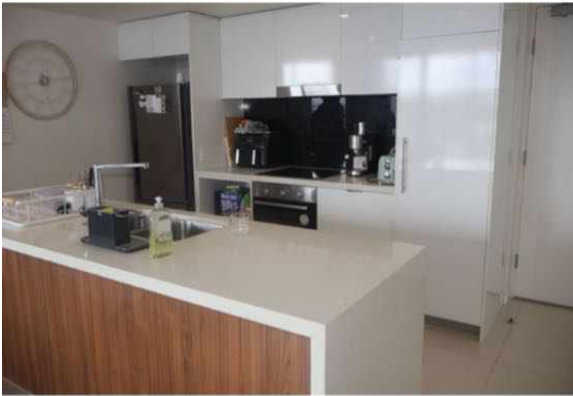
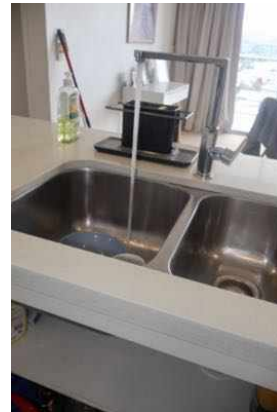
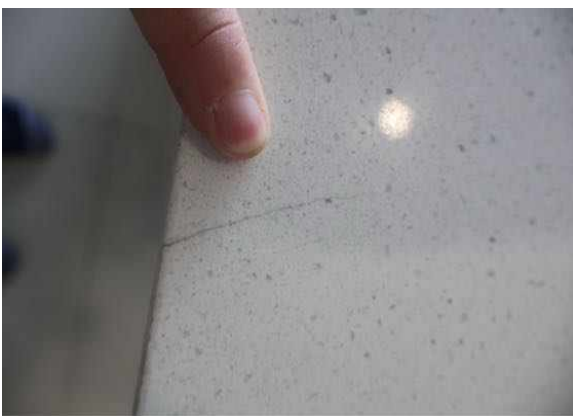
### Defects 3.03

Building: Main Building  
 Location: Kitchen > Front Left  
 Finding: Bench top - Cracked  
 Information: Cracking was evident to the kitchen bench top at the time of inspection, which is suspected to have been by minor impact damage. While the cracking appears to be minor, any further impact damage sustained by the bench top may lead to additional cracking.

As the cracking provides potential ingress for water, secondary water damage may occur to associated cabinetry, walls or flooring, if the cracking is left unmanaged.

Hair line crack to kitchen bench top and may require re-sealing.

Consultation with a bench top repair technician regarding repairs or replacement is required. Remedial works may be required to protect against any further damage.

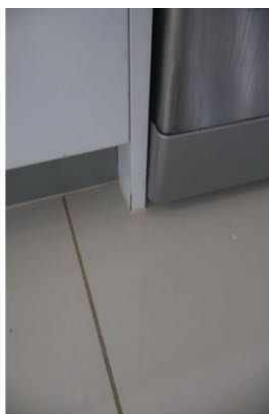
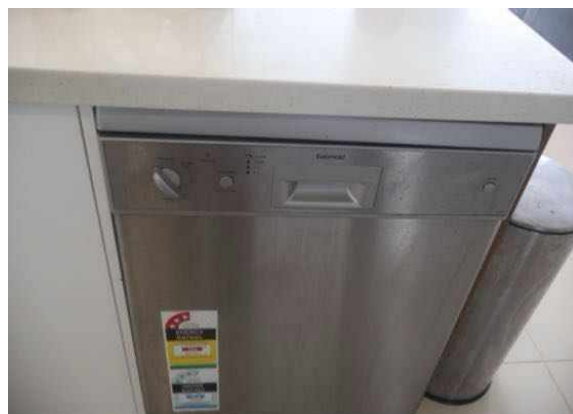
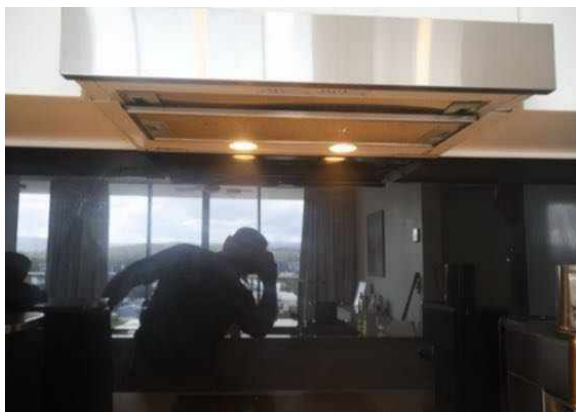
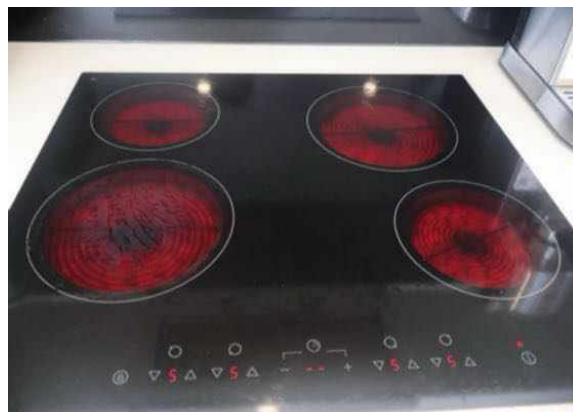
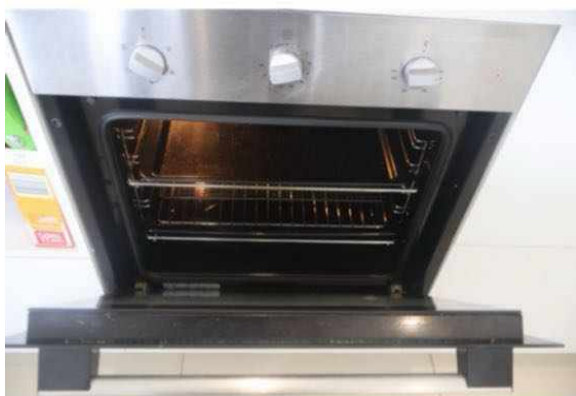
### Defects 3.04

Building: Main Building  
Location: Kitchen > Front Left  
Finding: Cabinetry - moisture damage  
Information: Moisture damage to cabinetry was present at the time of the inspection.

Moisture damage to cabinetry requires monitoring.

Kitchen cabinetry doors show evidence of moisture damage and may require replacing.

Side panel cabinetry left side of dishwasher shows evidence of moisture damage, but is considered minor.

Rectification works may be required.

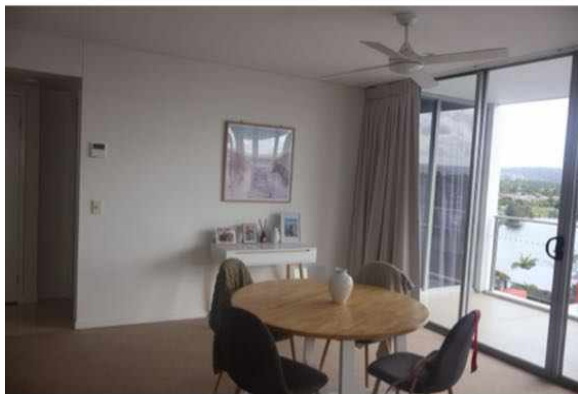
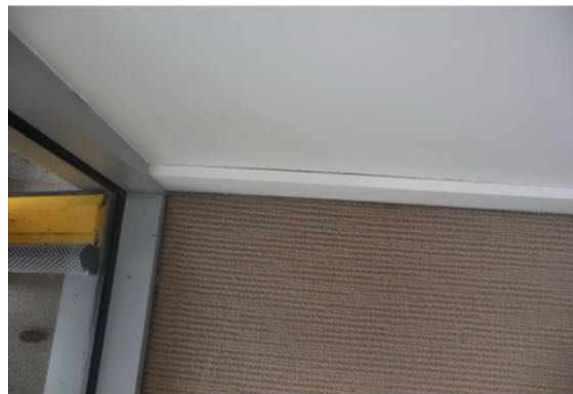
### Defects 3.05

Building:	Main Building
Location:	Dining Room > Rear
Finding:	Beading - gap
Information:	Beading acts (like cornice or skirtings) to cover the intersection or joins of building materials. It was noted at the time of inspection that beading in this area has minor gaps. This deterioration is suspected to have been caused by general ageing, which is expected in a building of this age and condition.

Beading is important in weatherproofing the surrounding building elements and preventing termite or pest ingress. Furthermore, beading works to protect the joins of building materials, which are more susceptible to deterioration and decay.

Beading gaps throughout the property were noted, which is due to minor movement.

Repair or replacement of the beading is advised to ensure the protection and longevity of any associated building elements. Such works may be performed by a general handyperson or qualified carpenter.

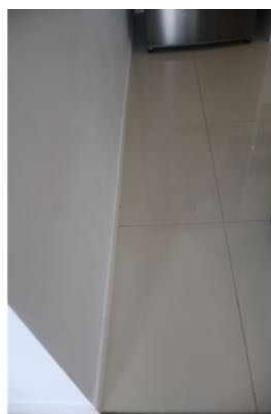
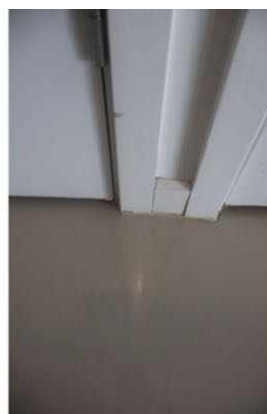
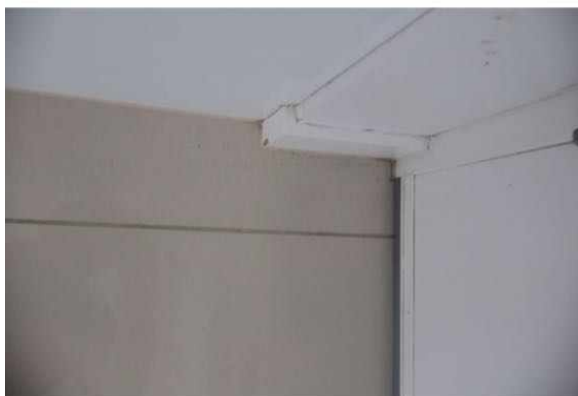
### Defects 3.06

Building:	Main Building
Location:	Lounge Room > Rear
Finding:	Beading - gap
Information:	Beading acts (like cornice or skirtings) to cover the intersection or joins of building materials. It was noted at the time of inspection that beading in this area has minor gaps. This deterioration is suspected to have been caused by general ageing, which is expected in a building of this age and condition.

Beading is important in weatherproofing the surrounding building elements and preventing termite or pest ingress. Furthermore, beading works to protect the joins of building materials, which are more susceptible to deterioration and decay.

Repair or replacement of the beading is advised to ensure the protection and longevity of any associated building elements. Such works may be performed by a general handyperson or qualified carpenter.

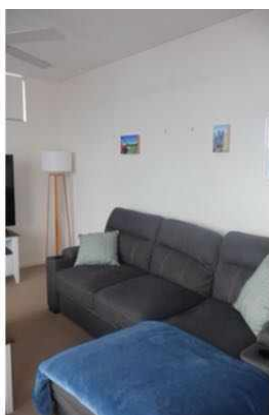
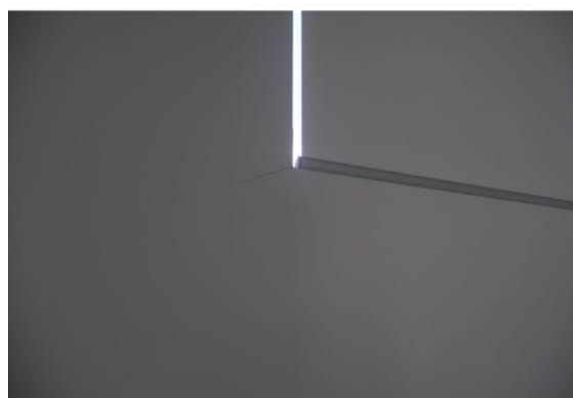
### Defects 3.07

Building:	Main Building
Location:	Lounge Room > Rear
Finding:	Cracks to internal plaster- Category 1
Information:	It has been observed that cracking to internal plaster surfaces has occurred. The degree of damage falls within Category 1, described as fine cracks that do not need repair and which are less than 1.0mm in width limit.

Damage of this category is not considered a defect for rectification. Always contact your building inspector should cracks widen, lengthen, or become more numerous.

Window edge shows evidence of plaster cracking which may require minor rectification works.

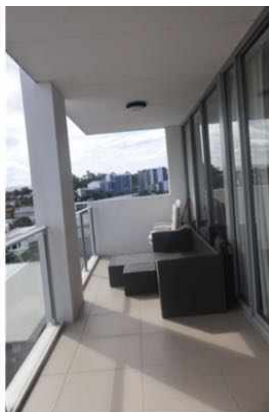
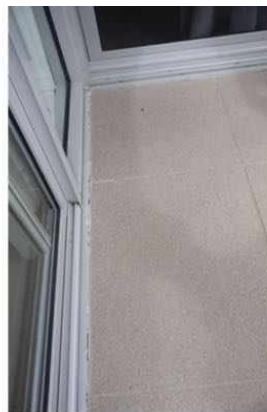
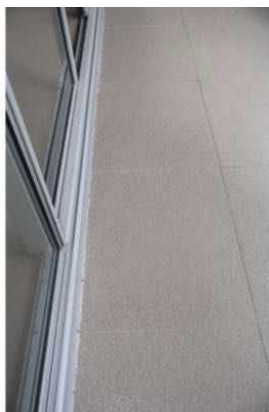
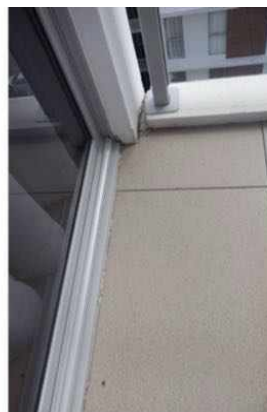
### Defects 3.08

Building:	Main Building
Location:	Balcony > Rear
Finding:	Tile sealant to junctions - defective
Information:	Areas of defective application of waterproof sealant to junctions with tiling were identified. Where these sealants are not installed to standards required by the BCA / NCC and the AS 3958.1 or in accordance with manufacturer's instructions they are considered defective.

Sealant to rear balcony junctions have deteriorated and may require cleaning and re-sealing. Please note, sika flex exterior sealant should be used for this type of application.

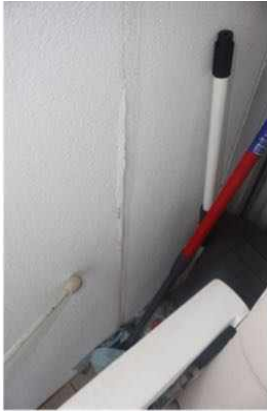
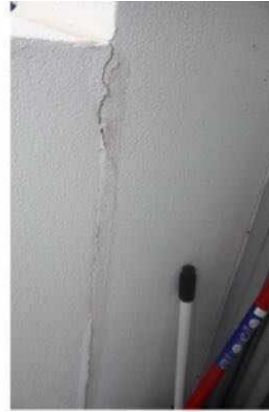
### Defects 3.09

Building:	Main Building
Location:	Balcony > Centre Right
Finding:	Cracks to external render - Category 2
Information:	It has been observed that cracking to external rendered surfaces has occurred. The degree of damage falls within Category 2, described as noticeable cracks which are easily filled. Cracking of this size are generally less than 5mm in width.

Category 2 damage is required to be monitored for a period of 12 months. After the monitoring period, a crack rated at Category 2 or above is considered a defect requiring rectification.

Always contact your building inspector should cracks widen, lengthen, or become more numerous.

Render cracking to external brickwork was noted, rectification works are required.

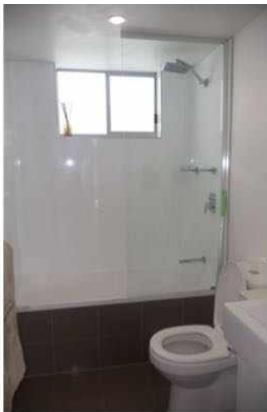
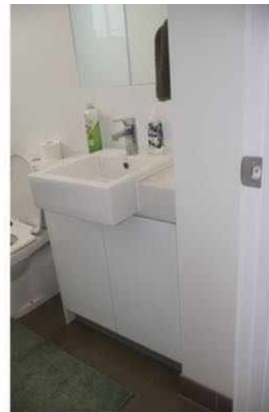
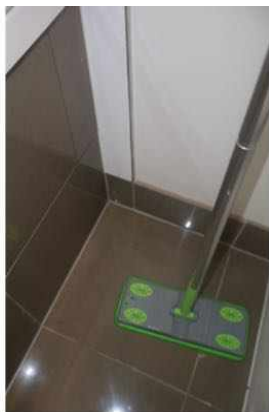
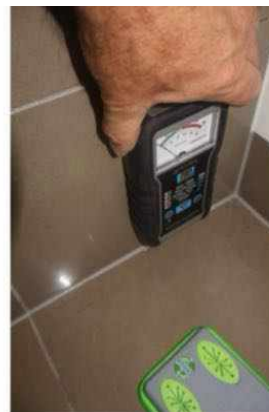
### Defects 3.10

Building: Main Building  
 Location: Bathroom > Rear Right  
 Finding: Shower screen- leaks  
 Information: At the time of inspection it was noted that the shower screen has minor leak.

Although minor leaks to shower screens may seem insignificant, they may cause damage to other fixtures such as grout ,vanities

And create mould damage which may become costly.

Shower screen shows evidence of leaking and requires re-sealing.

Re-Sealing of screen is recommended to be rectified as soon as possible to stop further deterioration.

A handyman may be required to rectify this condition.

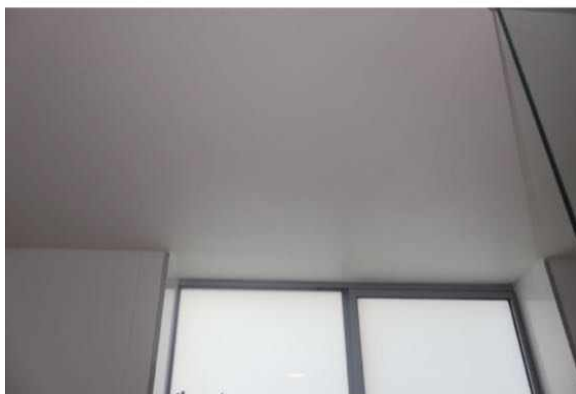
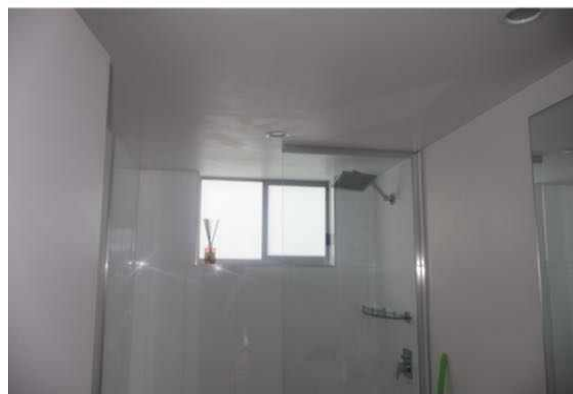
### Defects 3.11

Building:	Main Building
Location:	Bathroom > Rear
Finding:	Ceilings - Scuffed
Information:	Scuffed surfaces, while detracting from the overall appearance of the affected building element, do not indicate any operational or structural damage. This degree of surface damage is consistent with general wear and tear and minor impact damage, normally accumulated over a number of years.

Marked surfaces may be left as is at the discretion of the client; no repairs or replacement are necessarily required, as this is an appearance defect. However, the client may wish to seek quotations for the cost to refurbish or replace the identified building element.

Bathroom ceiling shows evidence of scuff marks, this may be due to lack of maintenance.

A general handyman or plasterer may be appointed to rectify marked surfaces if considered necessary by the client.

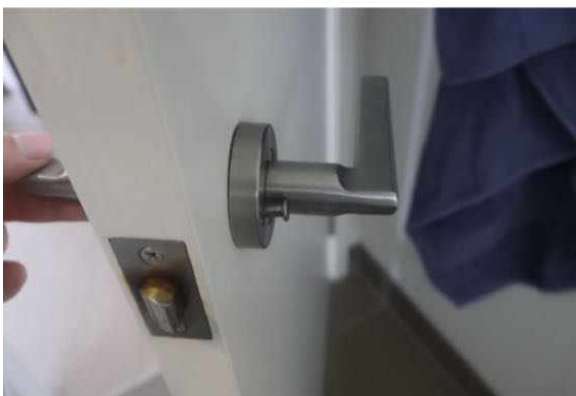
### Defects 3.12

Building:	Main Building
Location:	Bathroom > Front
Finding:	Door - loose handle

Information: The door handle in this area was found to be loose at the time of inspection. This occurs generally when the building materials have aged and decayed, but may be indicative of impact damage (accidental or deliberate).

Repair and/or replacement of the loose door handle is advised to improve the operational state of the associated door.

A qualified carpenter or general handyman should be appointed to repair/replace the door handle at the client's discretion.

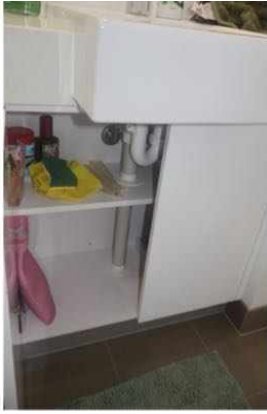
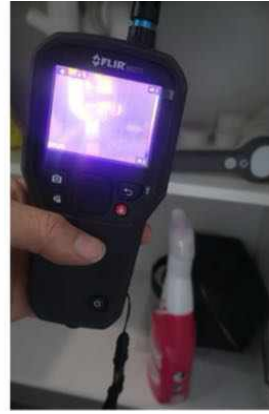
### Defects 3.13

Building: Main Building  
 Location: Bathroom > Centre  
 Finding: Basin waste.partial blockage  
 Information: At the time of inspection it was noted that the basin waste was partially blocked.

This may have detrimental affects to surrounding building element's such as Plaster board,timbers,tiles ,floor coverings, etc. if basin overflows.

Vanity basin shows evidence of a partial blockage and the door handle is loose.

It is recommended that a plumber be engaged as soon as possible to carry out Works to rectify this condition.

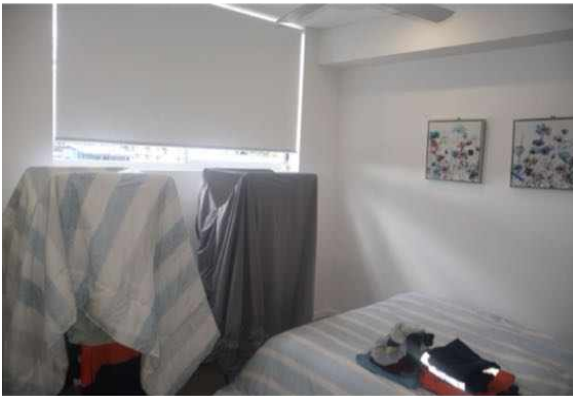
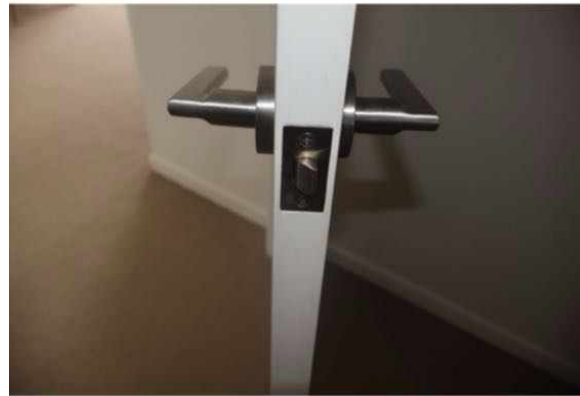
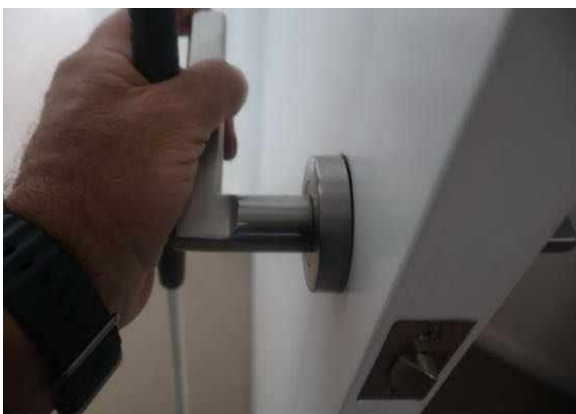
### Defects 3.14

Building: Main Building  
 Location: Bedroom 2 > Front  
 Finding: Door - loose handle  
 Information: The door handle in this area was found to be loose at the time of inspection. This occurs generally when the building materials have aged and decayed, but may be indicative of impact damage (accidental or deliberate).

Repair and/or replacement of the loose door handle is advised to improve the operational state of the associated door.

A qualified carpenter or general handyman should be appointed to repair/replace the door handle at the client's discretion.

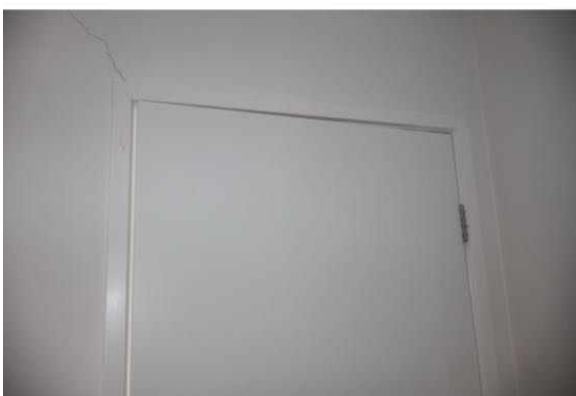
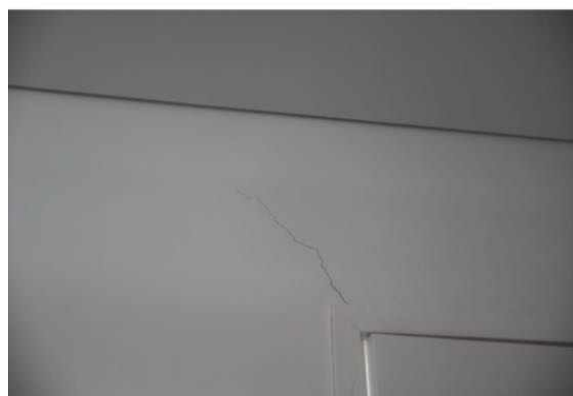
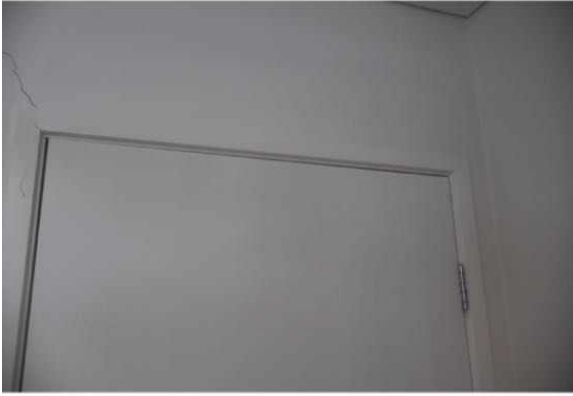
### Defects 3.15

Building:	Main Building
Location:	Bedroom 2 > Front
Finding:	Door - Binding/jamming
Information:	Binding and/or jamming of this door is evident during standard operation. This defect inhibits the functionality of the affected door as well as creating potential for secondary defects to associated building elements, such as damage to the floor covering.

A door that binds to flooring or to the associated door frame may have several causes, ranging from minor defects, such as poor installation of the door or deteriorated hinges, through to major structural issues, such as damage to subfloor structures.

Bedroom 2 door entry shows evidence of binding, jamming and plaster cracking.

Where door binding/jamming appears to indicate major structural issues, a registered builder specialising in re-stumping should be appointed to provide an estimate on the cost of rectification.

For minor causes, a qualified carpenter or general handyperson should be appointed to perform minor rectification works at client discretion.

Rectification works are required.

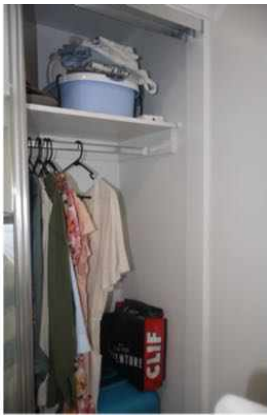
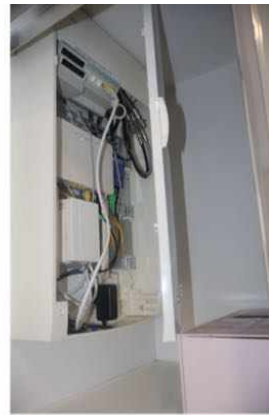
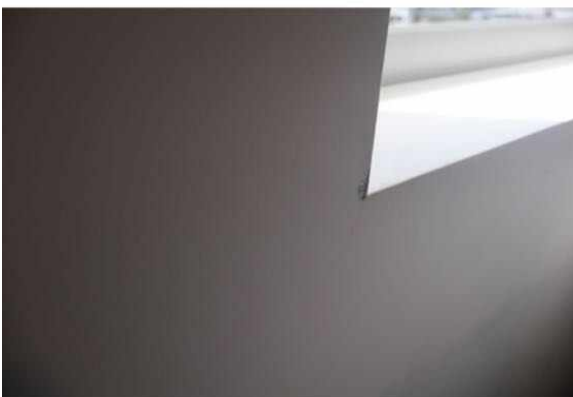
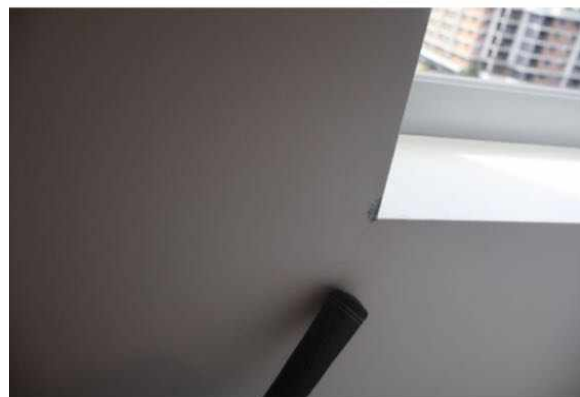
### Defects 3.16

Building: Main Building  
 Location: Bedroom 2 > Rear  
 Finding: Cracks to internal plaster- Category 1  
 Information: It has been observed that cracking to internal plaster surfaces has occurred. The degree of damage falls within Category 1, described as fine cracks that do not need repair and which are less than 1.0mm in width limit.

Damage of this category is not considered a defect for rectification. Always contact your building inspector should cracks widen, lengthen, or become more numerous.

Rear bedroom window edge shows evidence of plaster cracking and may require rectification works.

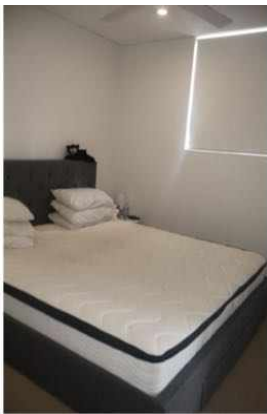
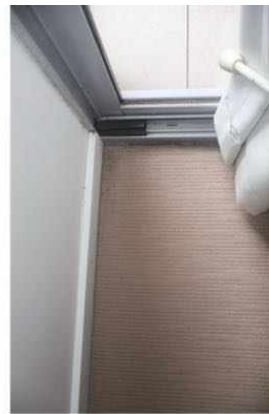
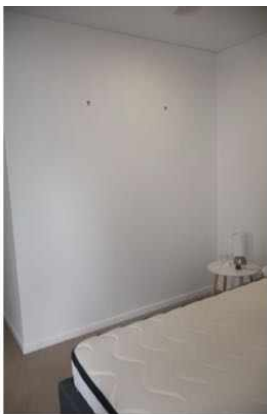
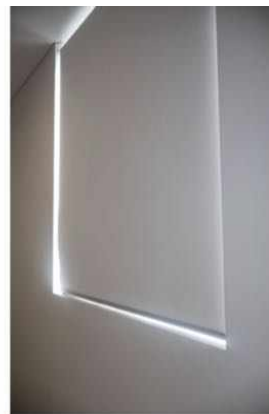
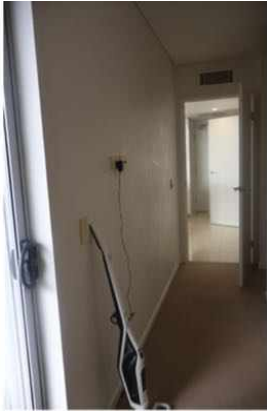
## Defects 3.17

Building: Main Building

Location: Bedroom - Master > Existing

Finding: Walls - Scuffed

Information: Superficial scuff marks were noted to the internal walls in this area at the time of inspection. Marked and scuffed surfaces, while detracting from the overall appearance of the affected building element, do not indicate any operational or structural damage. This degree of surface damage is consistent with general wear and tear.

Master bedroom wall shows evidence of scuff marks.

Marked surfaces may be left at client discretion, as no repair/replacement is necessarily required. Marked surfaces are unlikely to result in the development of secondary damage; however, the client may wish to seek quotations for the cost to refurbish or replace the affected wall linings.

A general handyperson or cleaning contractor may be appointed to rectify marked or scuffed surfaces at the client's discretion.

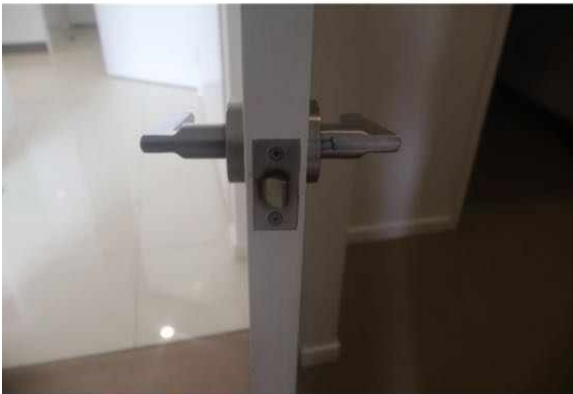
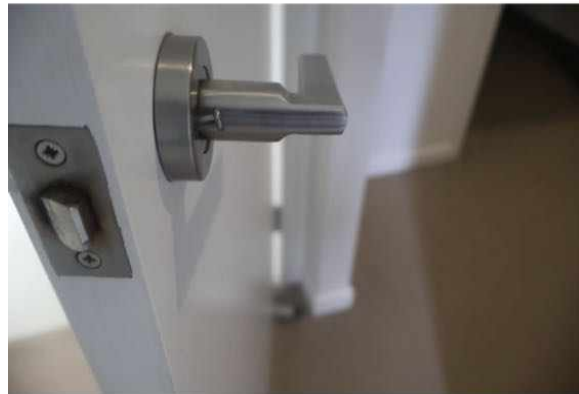
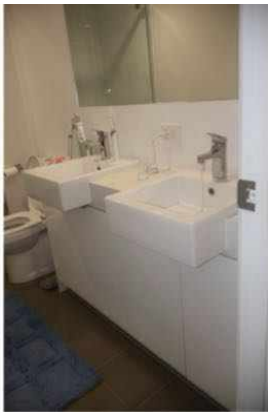
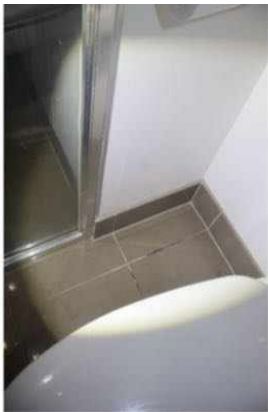
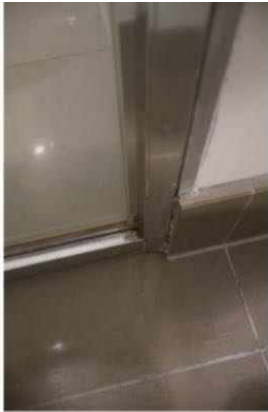
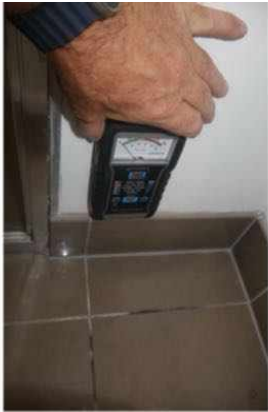
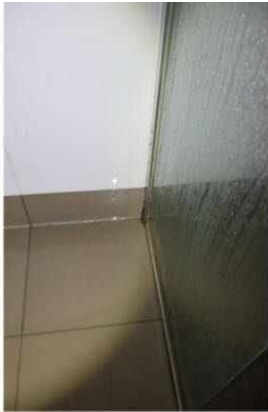
### Defects 3.18

Building: Main Building

Location: Ensuite - Master > Front

Finding: Door - loose handle

Information: The door handle in this area was found to be loose at the time of inspection. This occurs generally when the building materials have aged and decayed, but may be indicative of impact damage (accidental or deliberate).

Door handle is also loose and lock appears not to be working.

Repair and/or replacement of the loose door handle is advised to improve the operational state of the associated door.

A qualified carpenter or general handyman should be appointed to repair/replace the door handle at the client's discretion.
