# Building and Timber Pest Inspection Report

Inspection Date: Thu, 2 Apr 2026

Property Address: 16 The Dress Cir, Athelstone SA 5076,  
Australia

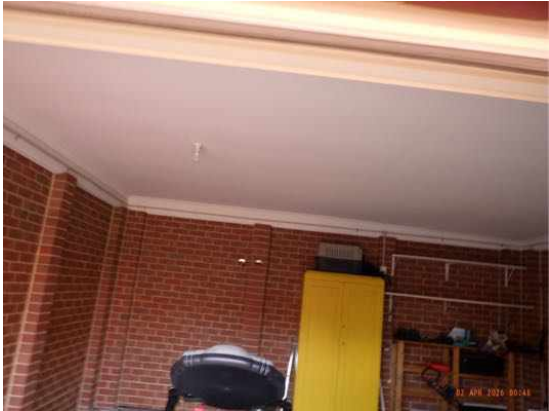
Building:	Building 1
Location:	Garage
Finding:	Ceiling sagging - garage
Information:	Sections of the ceiling were found to have sagging evident to the garage ceiling at time of inspection.

Sagging to the fixed ceiling structure generally indicates that the building materials have swollen, due to contact with water, or that fixings (e.g. nails or glue) have become loose and require reattachment.

This is a very common defect in carports due to their lack of insulation and or their

susceptibility to moisture. Condensation builds up in the roof and rests on the plasterboard softening it somewhat which makes it more likely to sag and release from its fixing points.

Repairs to the ceiling will be required and should be carried out by licensed builders, plasterers and painters in the short term. Fixing battens to the ceiling can be a good short term repair especially adjacent to roller doors.

Insulating the area is also highly recommended.

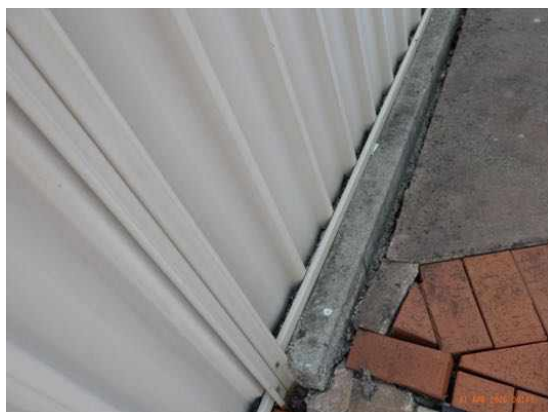
Building:	Building 1
Location:	Yard - Side
Finding:	Retaining wall - Defective
Information:	The retaining wall in this area was found to be defective at the time of inspection. Generally, defective retaining walls are caused by poor original design or material use. However, deteriorated retaining walls may also be a result of substandard construction, poor site drainage or unmanaged stormwater flows.

If left unmanaged, the retaining wall may become a safety hazard if it continues to destabilise. Where retaining walls further rot and decay, an environment is created that is conducive to termite and pest infestation.

Significant repair and replacement should be expected. Where retaining walls are considered structural walls, a structural engineer / surveyor should be consulted regarding required remedial works. Otherwise, a landscaper or retaining wall installer may be appointed to repair or replace the wall, at the discretion of the client.

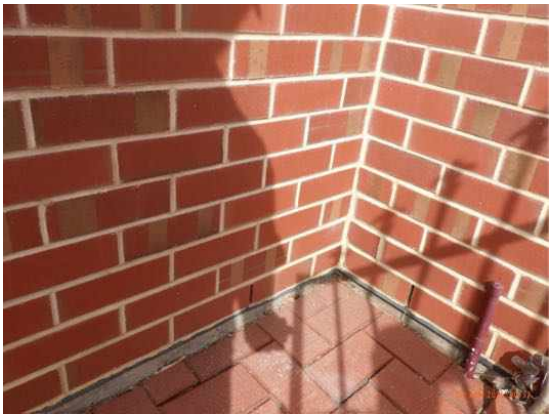
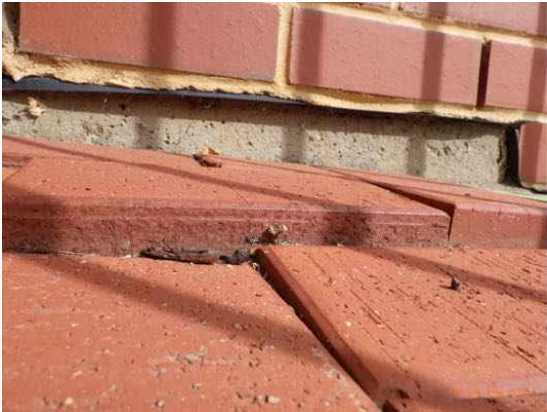
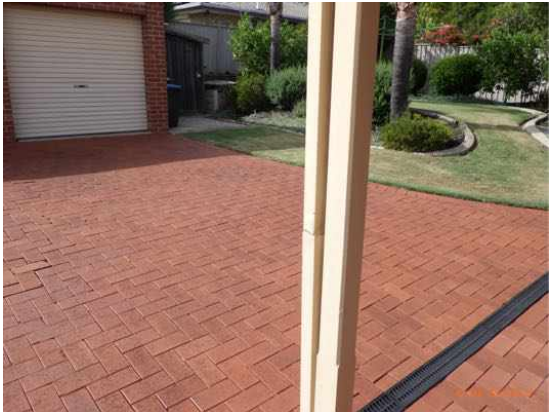
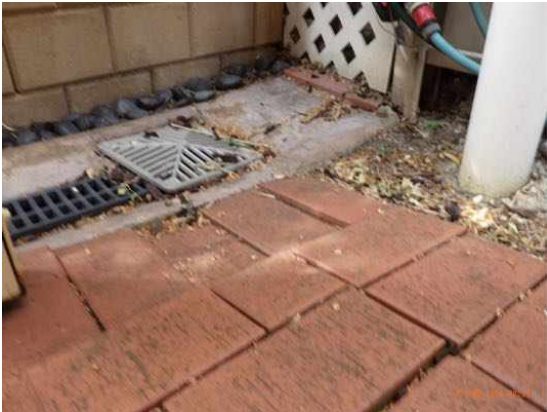
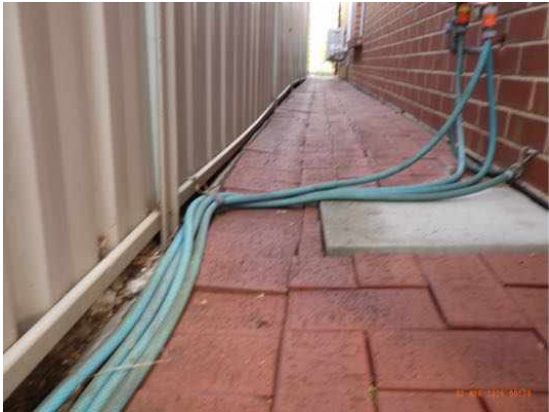
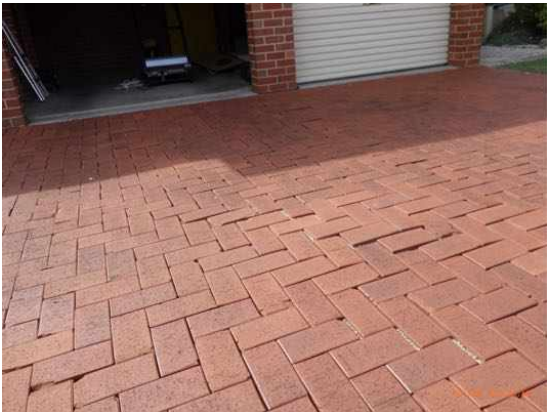
Building:	Building 1
Location:	All External Areas
Finding:	Paving - Uneven
Information:	Sections of the external paved area surrounding the building are uneven, creating a potential trip hazard.

Where paving creates a trip hazard, personal injury may ensue if due caution is not taken by persons within this area.

Movement paving is likely due to heavy traffic from vehicles and potentially poor installation. The slope of the paved driveway is another likely contributing factor.

Re-paving of the area is required as soon as possible to remedy this situation. Further consultation with a specialist paving contractor is advised and works will likely be extensive.

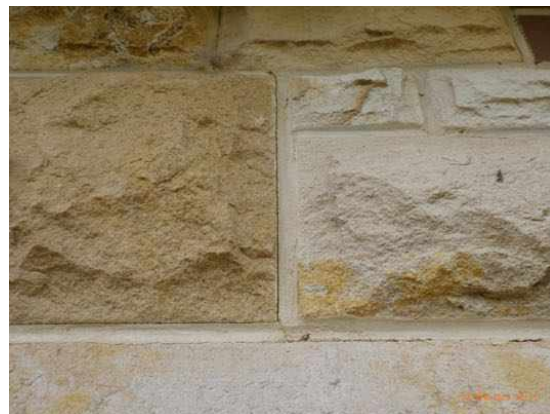
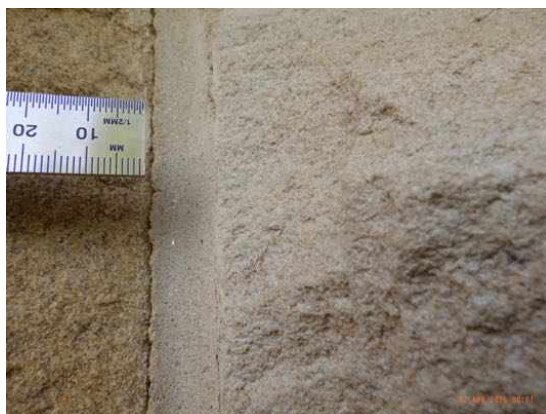
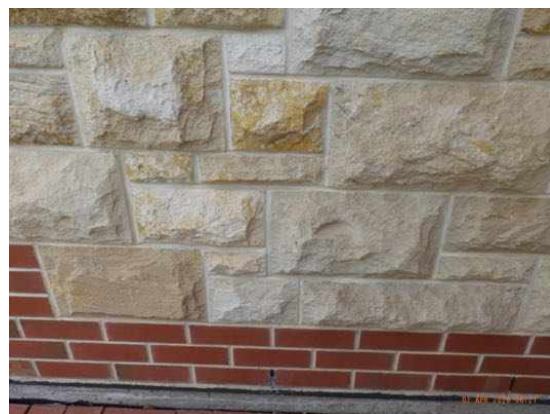
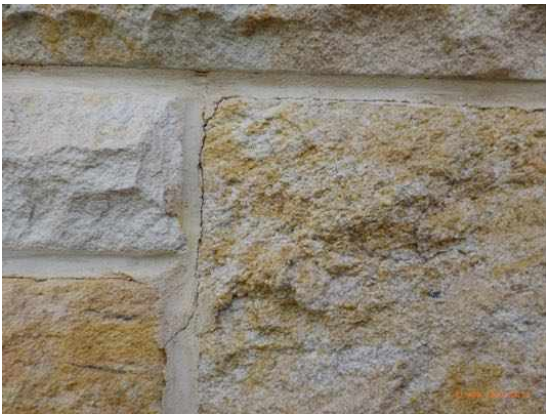
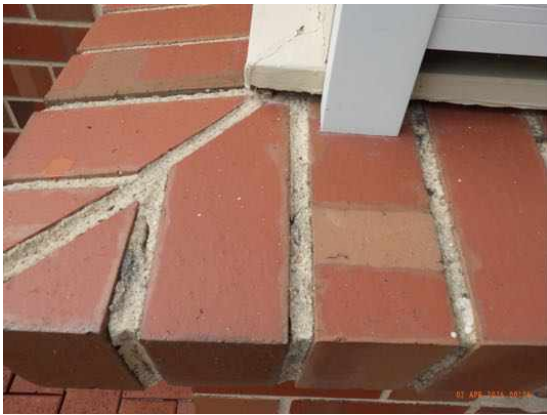
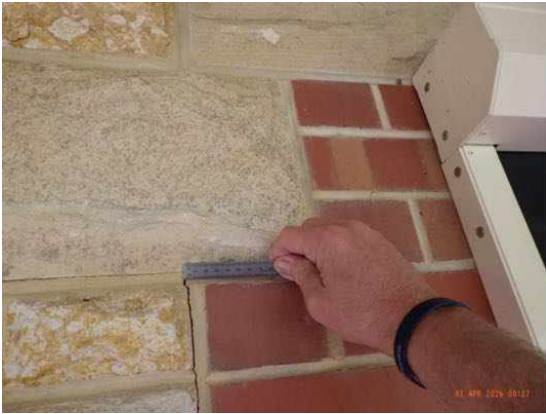
Finding 3.04

Building: Building 1  
Location: Exterior walls  
Finding: Brickwork - Cracking [Fine]  
Information: There were fine cracks evident to the external brickwork at the time of inspection. several cracks were identified between the stone facing and brickwork, and most of these measure less than 1 mm however there were several slightly larger cracks up to 3 mm wide.

Although fine cracks are quite noticeable, they are often only considered to be an appearance defect and usually do not indicate any structural damage. Generally, the cause of a fine crack is indicative of a separation between brickwork and mortar throughout the structure, but single bricks may also show cracks of this nature.

Cracking of this nature can generally be repaired with minor filling and should be conducted by a qualified bricklayer.

Always contact a building inspector should cracks widen lengthen or become more numerous.

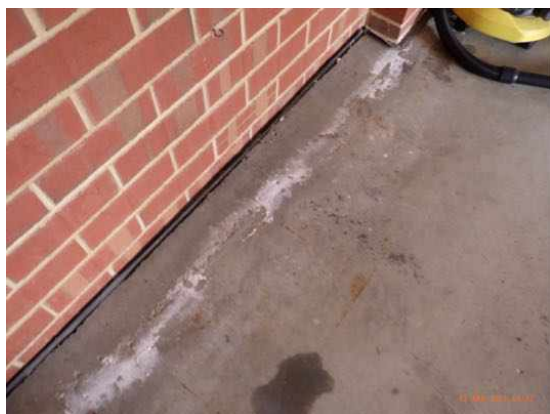
### Finding 3.05

It is typically seen as white salt deposits on the surfaces of concrete pavement and spalling on the face of the concrete.

Always contact a building inspector should efflorescence get significantly worse.

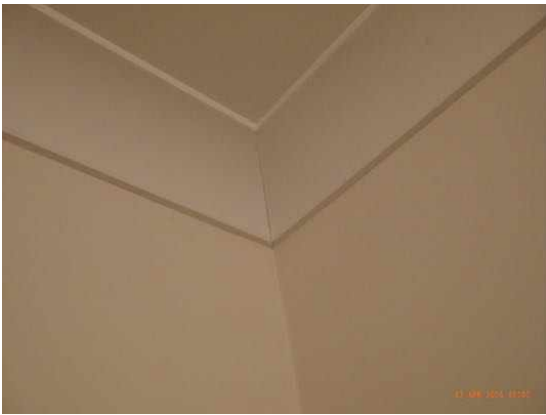
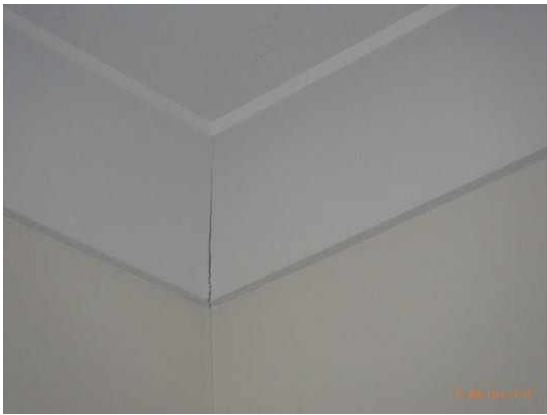
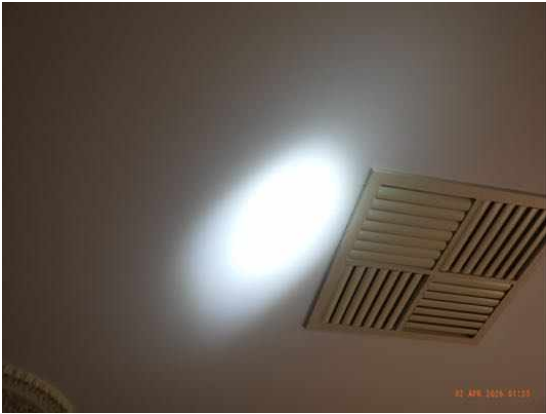
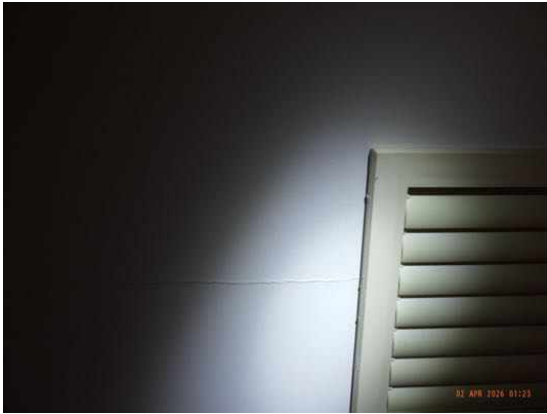
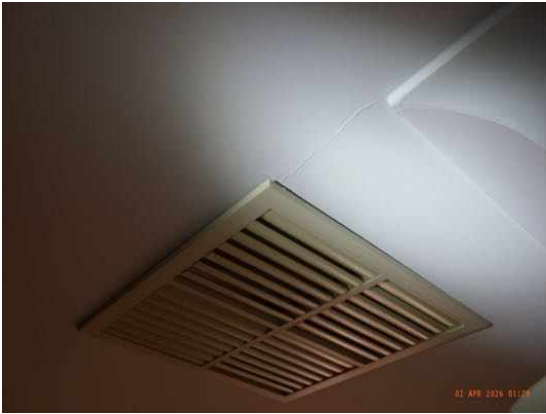
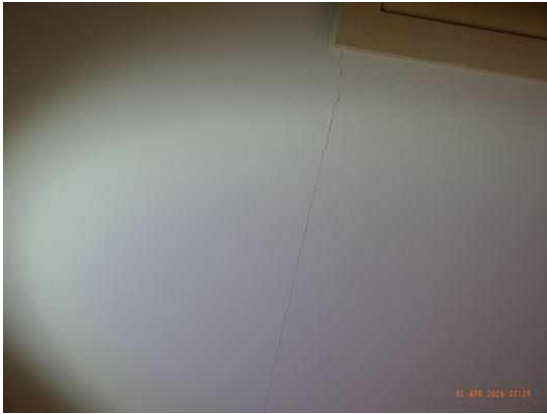
### Finding 3.06

Building:	Building 1
Location:	All Internal Areas
Finding:	Cracking - Damage Category 1 - Fine (up to 1mm)
Information:	There were fine cracks evident to the walls and ceilings throughout the dwelling at the time of inspection.

Although fine cracks are quite noticeable, they are often only considered to be an appearance defect, and usually do not indicate any structural damage. Generally, the cause of a fine crack is indicative of a separation between building materials and finishes (e.g. paint, plaster, etc.) along joins.

Cracking of this nature can generally be repaired with minor sanding, filling and/or repainting. Such works should be performed by a qualified painter or a general handyman.

Monitoring of all cracking should be conducted frequently. Always contact a building inspector should cracks widen, lengthen, or become more numerous.

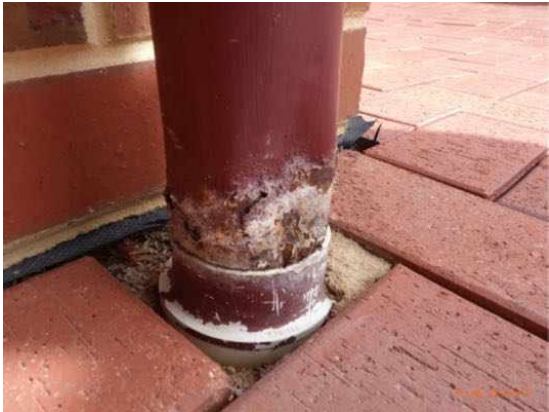
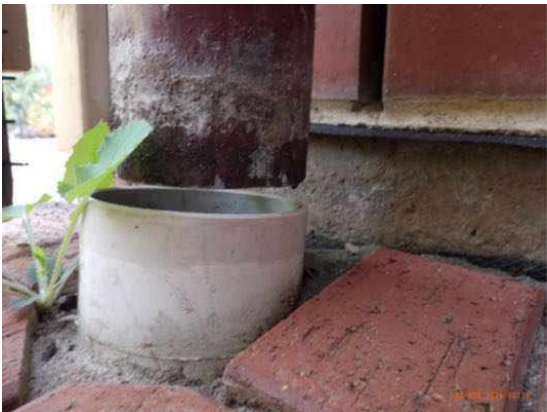
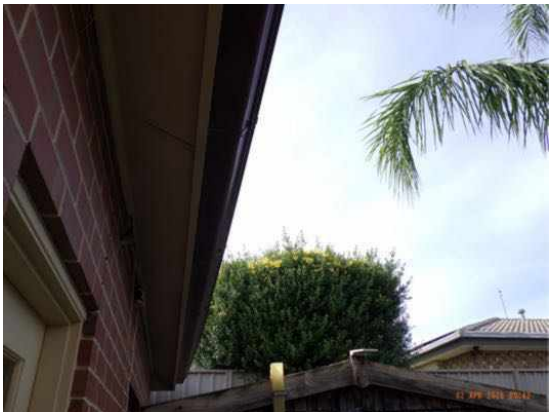
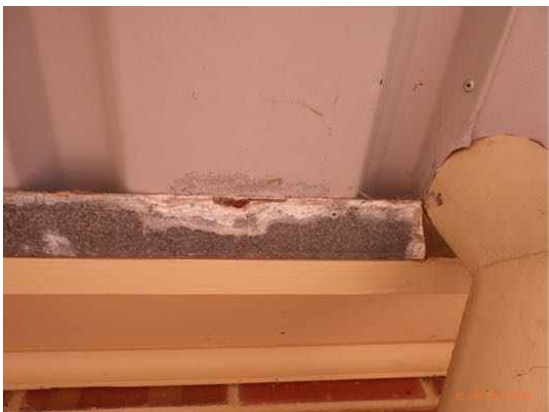
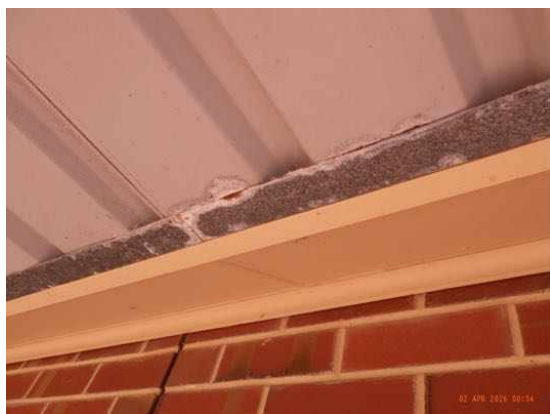
### Finding 3.07

Building:	Building 1
Location:	All External Areas
Finding:	Roof plumbing - Rusted or corroded
Information:	The guttering to the garage has rust evident along with some rusting evident to the rear veranda and downpipes of the house.

Likely contributing factors for premature rusting of gutters include but not limited to buildup of leaf debris or lack of maintenance.

Poorly drained roof areas will also lead to damp conditions surrounding the base perimeter of the building which, if left unmanaged, can lead to a range of secondary

building defects.

Repair and/or replacement of rusted roof plumbing is highly required in order to reinstate the roof drainage system to a fully operational level. To further maintain these areas, gutters should be cleaned frequently, allowing the avoidance of any partial blockages.

A licensed roof plumber or specialist roof restoration company should be appointed to undertake repair works prior to leaks becoming evident.

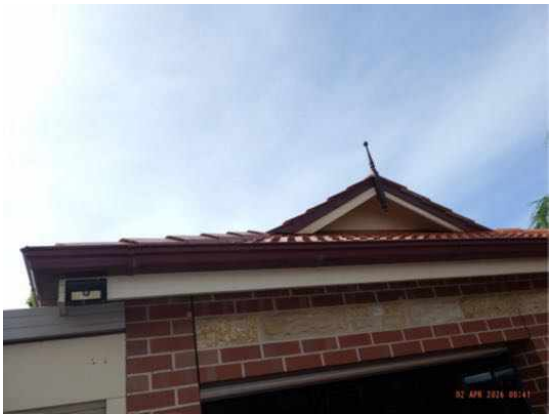
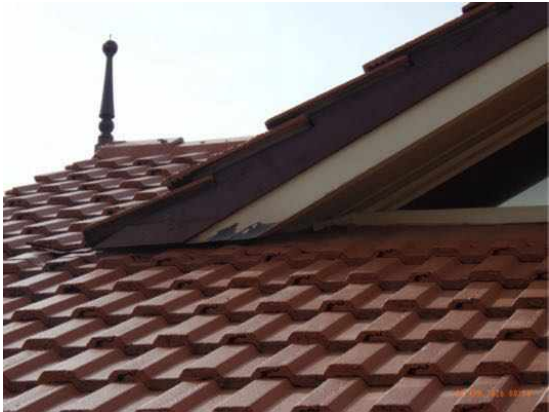
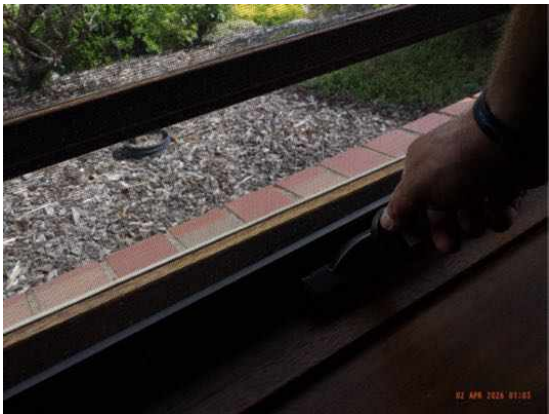
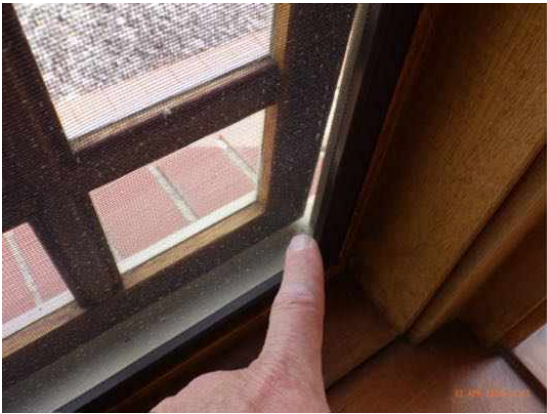
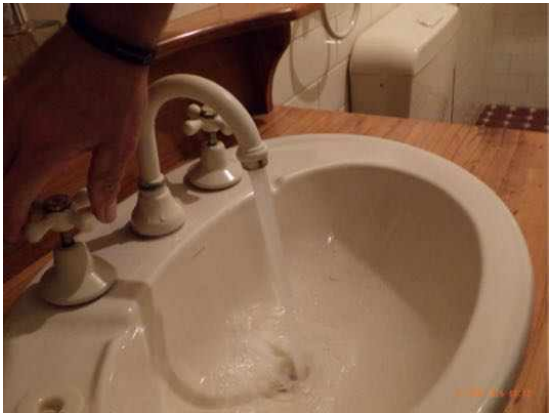
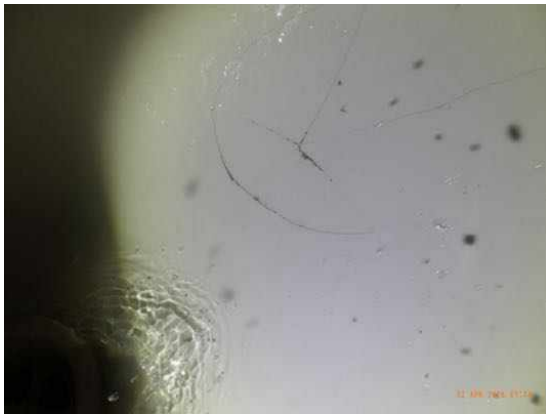
### Finding 3.08

Building:	Building 1
Location:	All Areas
Finding:	Minor defects present
Information:	Minor defects were evident throughout the dwelling at the time of inspection, which are consistent with normal wear and tear and considered appropriate for a property of this age.

These defects are typical of ongoing material ageing, settlement, and general use over time, and include, but are not limited to:

- Minor deteriorated exterior paint
- Wood rot to left side veranda post
- Some windows jamming on frame
- Crack to vanity basin
- Rangehood deteriorated

While these defects are not considered structurally significant at present, they should be addressed as part of routine and ongoing property maintenance to prevent further deterioration. Repairs and maintenance works should be carried out by appropriately licensed and qualified tradespeople to ensure the continued serviceability and longevity of the dwelling.

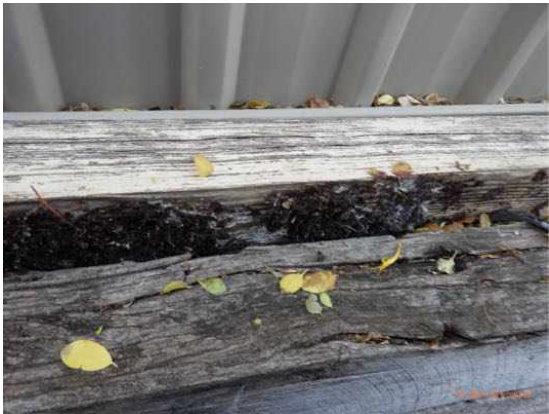
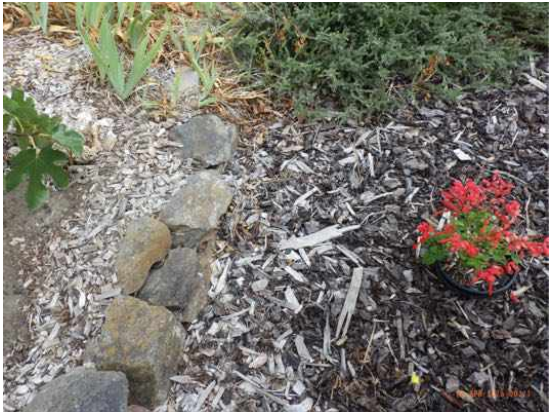
## Finding 6.02

Building:	Building 1
Location:	All External Areas
Finding:	Untreated or non-durable timbers in a hazardous environment
Information:	To reduce the risk of timber pest attack it is essential that timber used in a hazardous environment (e.g. in direct contact with the ground or frequently exposed to damp conditions) is of sufficient durability and/or is adequately preservative treated. Additionally any timber lying around or timber stumps should be removed.

Untreated timbers in direct contact with the ground are likely to develop severe wood rot and/or fungal decay if left unattended creating attraction for subterranean termites to infest the timbers from surrounding areas.

If untreated or non-durable timbers are found to be in a hazardous environment it is highly advised that replacement of these building elements be performed as soon as possible to aid the protection of the property against termite / timber pest attack. Failing this close monitoring is recommended in an attempt to identify termite infestation at an early stage.

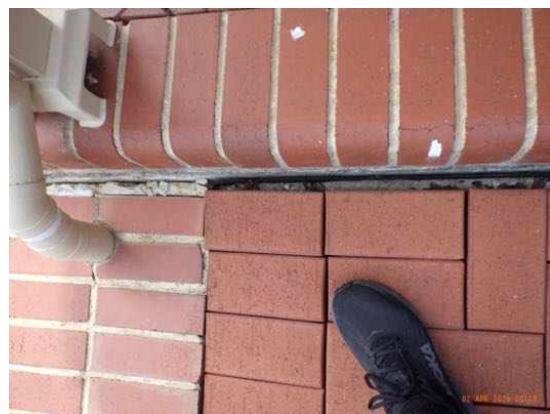
With reactive clay soils, it is extremely important to ensure that all stormwater flows including roof and ground flows are contained and continually maintained.

A licensed paving contractor may be required to Fill the gap between the pavement and the buildings which is recommended in the short term to prevent unwanted moisture accessing the foundation.

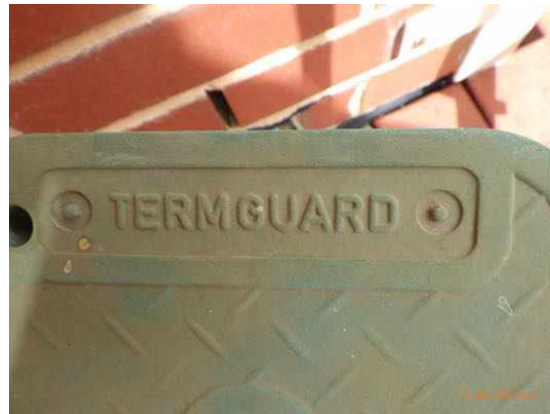
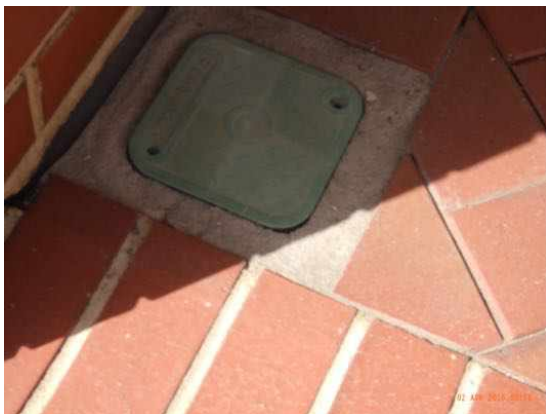
Where a Termite Management System has been identified you should refer to the type of barrier date of installation warranty conditions and any documentation provided by a builder or past owner.

Consult the company who installed the barrier to confirm whether the system is still under warranty.

Most chemical termite management systems expire and require replenishment and all physical systems are primarily designed to prevent concealed entry.
