Building and Timber Pest Inspection Report

Inspection Date: Mon, 2 Feb 2026

Property Address: 29 Chapel St, Maldon VIC 3463, Australia

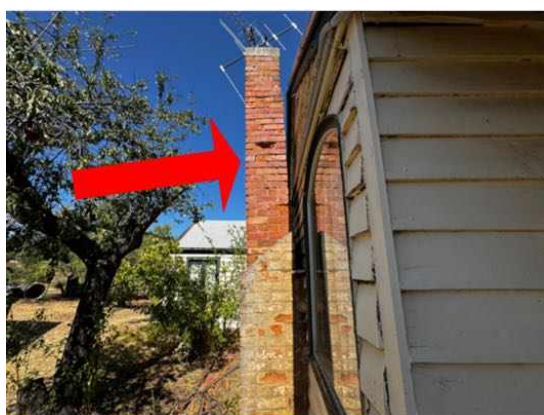
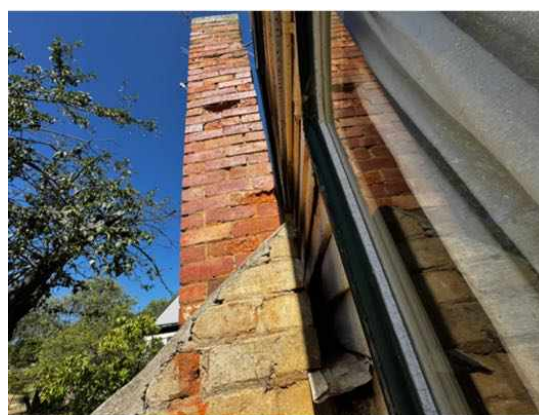
Building: Main Building
 Location: Chimney > Front Left
 Finding: Brick chimney leaning out of plumb – suspected foundation instability
 Information: The brick chimney located on the southern elevation of the building was observed to be leaning out of plumb, indicating suspected movement. Given the apparent age and weathered condition of the chimney, it is suspected that deterioration of the chimney footing or foundation has occurred over time, contributing to the observed lean. Progressive movement of masonry chimneys can result in instability, falling debris, or partial collapse if left unmanaged. While no immediate collapse was observed at the time of inspection, the condition represents a suspected structural defect and may pose a future safety risk if movement continues. This condition is consistent with a Major Defect as defined under AS 4349.1, as it may compromise structural stability and safety.

The chimney should be monitored for further movement. It is recommended that a suitably qualified structural engineer or licensed builder be engaged to assess the stability of the chimney, including the condition of its footing and supporting structure. Remedial works may include stabilisation, reconstruction, or removal of the chimney depending on engineering advice. Any works should be carried out by appropriately qualified trades.

Short term – monitoring should commence immediately, with further investigation and rectification undertaken if movement increases or cracking worsens.

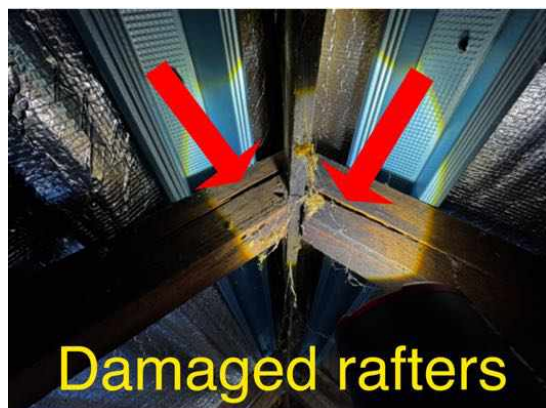
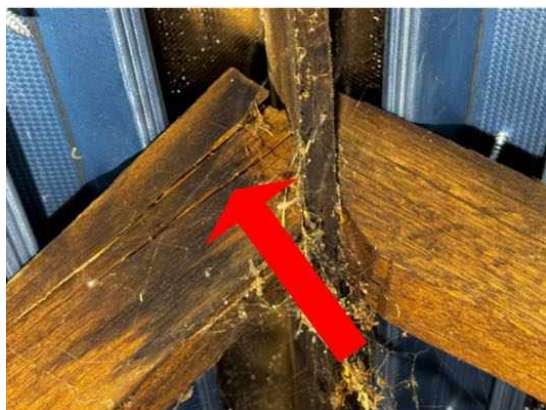
Finding 2.02

Building: Main Building
 Location: Timber rafters > Front

Finding: Damaged roof rafters at ridge beam junction

Information: Several timber rafters within the roof space above the front bedroom and living area were observed to be severely split at the junction where they connect to the ridge beam. The splitting appears significant and is suspected to have occurred during a previous roof replacement, possibly due to incorrect fixing methods, over-driving of fasteners, or inadequate detailing at the ridge connection. The extent of splitting observed is considered to compromise the structural integrity of the affected roof framing members, reducing their capacity to safely transfer roof loads. In accordance with AS 4349.1, damage to primary structural roof members that affects load-bearing performance is classified as a Major Defect and represents a risk of further structural deterioration if left unrectified.

It is recommended that a suitably qualified structural carpenter or structural engineer be engaged to assess the affected rafters. Damaged rafters should be replaced or structurally repaired in accordance with current accepted building practice and engineering requirements. Any rectification works should ensure proper connection detailing to the ridge beam to restore full structural performance.

Short term – rectification should be undertaken as a priority to reduce the risk of further roof movement or structural failure.

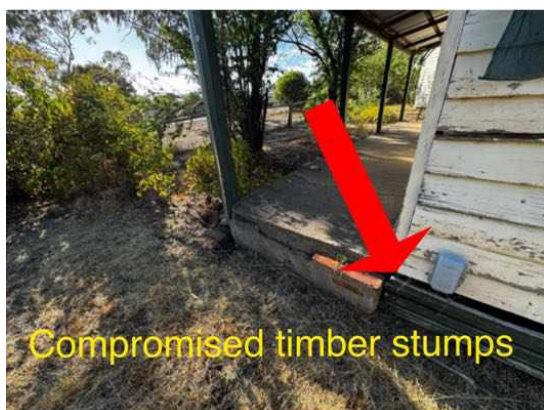
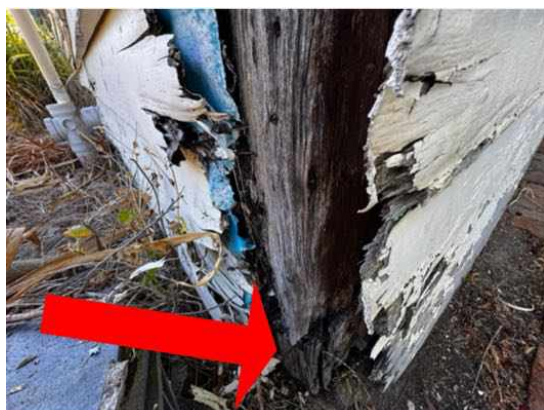
Finding 2.03

Building:	Main Building
Location:	Timber stumps > Rear Right, Front Right, Centre Right
Finding:	Suspected deterioration of timber stumps to northern elevation
Information:	Timber stumps supporting the perimeter of the building along the northern elevation were observed to show considerable signs of deterioration and suspected structural compromise. The affected stumps exhibited visible degradation consistent with age-related decay and prolonged exposure to ground moisture. Due to restricted access conditions, the majority of the subfloor area and remaining timber stumps were inaccessible, and while the accessible stumps away from this elevation appeared to be in comparatively better condition, their overall condition could not be fully verified. In accordance with AS 4349.1, deterioration or damage to load-bearing subfloor supports is classified as a Major Defect, as it may adversely affect the structural stability and serviceability of the building.

It is recommended that a licensed builder or structural engineer be engaged to undertake a full subfloor assessment, including provision of improved access where required. All timber stumps to the northern elevation that are deteriorated or suspected to be compromised should be replaced with compliant supports to restore adequate structural support and maintain the long-term integrity of the building.

Short term – rectification should be undertaken promptly to minimise the risk of further structural movement or settlement.

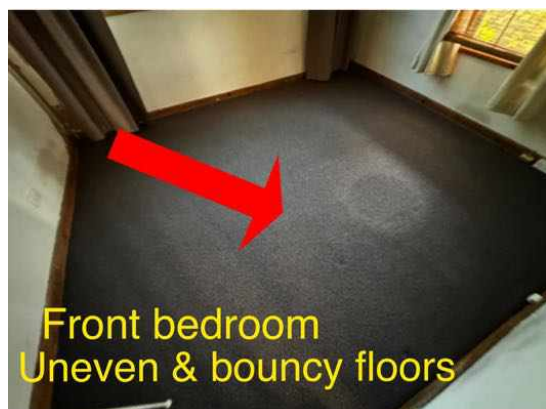
Finding 2.04

Building:	Main Building
Location:	Living room, bedroom 1 > Front Right, Front Left
Finding:	Suspected uneven and bouncy timber flooring to front living and bedroom areas
Information:	<p>Uneven and bouncy floor conditions were detected to the front living area and adjacent bedroom during inspection, with the movement clearly noticeable under foot. The observed floor behaviour is suspected to be the result of settlement or deterioration of timber stumps and/or bearers beneath the floor, particularly toward the southern subfloor area. It is also suspected that the span of the supporting floor structure may be inadequate or no longer performing as intended, contributing to excessive deflection and floor bounce. In accordance with AS 4349.1 – Inspection of Buildings, noticeable floor movement, deflection, or instability is indicative of a Major Defect, as it may adversely affect the structural performance and serviceability of the building.</p>

It is recommended that a licensed builder or structural engineer be engaged to undertake a detailed subfloor assessment, including inspection of timber stumps, bearers, joists, and span configurations. Any timber stumps that have settled, deteriorated, or are inadequately supporting the structure should be re-levelled or replaced, and additional supports installed if required to reduce floor deflection and restore structural performance.

Short term – further investigation and rectification should be undertaken promptly to reduce the risk of ongoing movement and progressive structural damage.

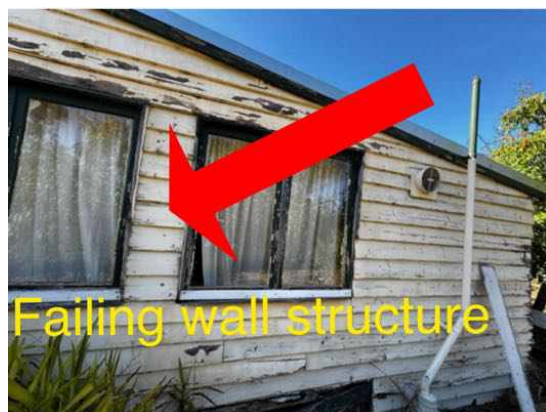
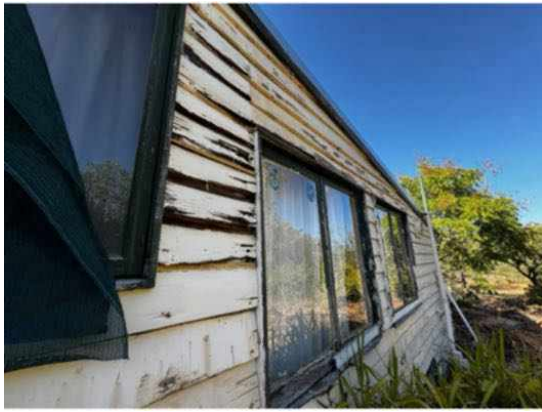
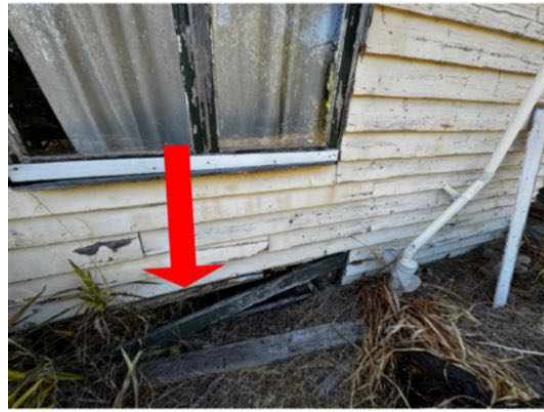
Building: Main Building
Location: Bedroom 2 > Centre Right
Finding: Major structural failure due to termite damage and timber decay – bedroom two external wall
Information: A suspected major structural defect was observed to the external wall of bedroom two, located on the right-hand side (north aspect) of the building. The external wall cladding and the underlying structural timber wall framing were severely affected by suspected termite damage and advanced timber rot. The timber framing was observed to be significantly deteriorated and disintegrating when lightly probed, indicating a substantial loss of structural capacity. The affected wall section could be moved by applying manual force, demonstrating that the wall is no longer providing adequate structural support and is at risk of partial or full collapse. In accordance with AS 4349.1 – Inspection of Buildings, damage that compromises the load-bearing capacity or stability of structural elements is classified as a Major Defect. Due to the extent of deterioration and instability, this condition also constitutes a serious safety hazard, and the affected area is not considered suitable for habitation in its current condition.

It is strongly recommended that the affected area be immediately isolated and access restricted for safety reasons. A structural engineer and licensed builder should be urgently engaged to assess the extent of structural damage, including concealed framing, and to design appropriate remedial works. A licensed termite management professional should also be engaged to confirm active or historical termite activity and implement an appropriate termite treatment and management system prior to or in conjunction with structural repairs.

Immediate – this issue requires urgent attention due to the high risk of structural failure and potential harm to occupants.

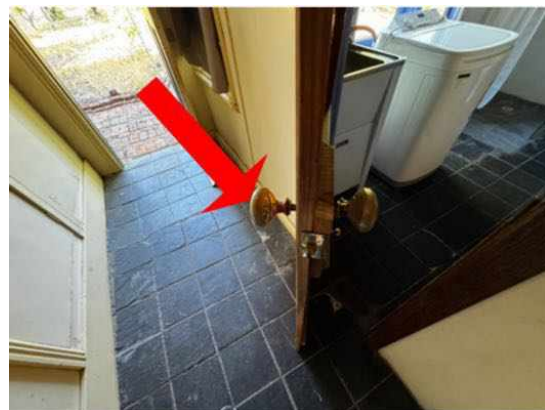
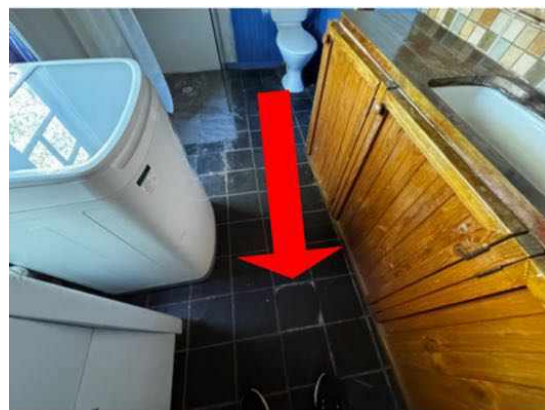
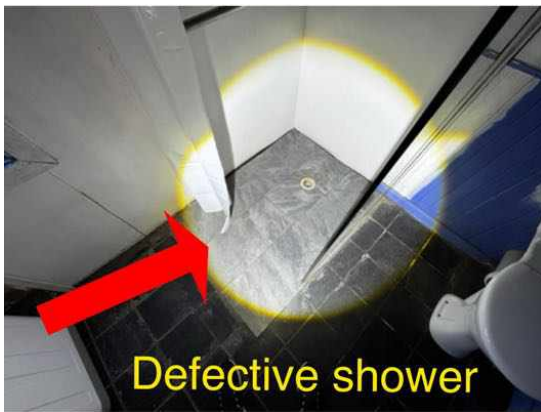
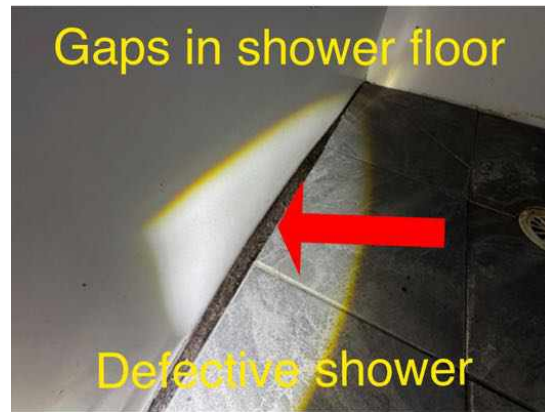
Finding 2.07

Building:	Main Building
Location:	Bathroom > Rear Right
Finding:	Bathroom defects & suspected non-compliant and failed bathroom shower enclosure
Information:	Multiple defects were observed within the bathroom, including a broken door handle, broken floor tiles, and damage to the wall and floor junction behind the washing machine. The shower enclosure was found to be defective, with the shower walls observed to be out of alignment and battening, consistent with building movement. Gaps have formed at the wall and floor junctions inside the shower enclosure, exposing underlying timber elements. During shower operation, water is able to freely discharge into the subfloor, indicating a failure of waterproofing and enclosure

integrity. This condition is considered suspected non-compliant and is assessed as a Major Defect in accordance with AS 4349.1 – Inspection of Buildings, as it has resulted in ongoing water ingress and is likely a contributing factor to the severe timber rot and external building damage observed elsewhere. In its current condition, the shower is not fit for use.

Immediate action is required. Engage a licensed builder and waterproofing contractor to assess the extent of damage, including concealed subfloor and wall framing. The shower enclosure should not be used and will likely require full removal and reconstruction, including compliant waterproofing, rectification of structural movement impacts, and replacement of any damaged timber elements. Associated bathroom defects, including damaged tiles and fixtures, should be rectified concurrently.

Immediate. The shower should be taken out of service until rectification works are completed to prevent further structural deterioration and moisture damage.

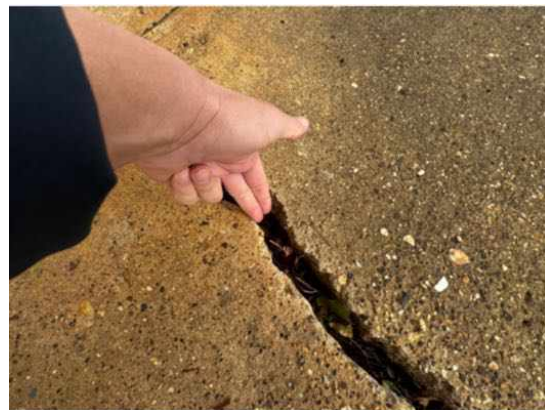
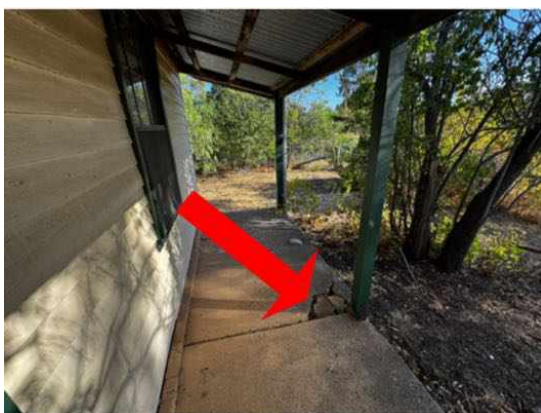
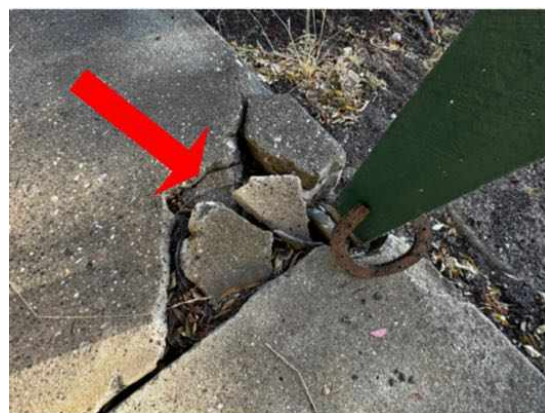
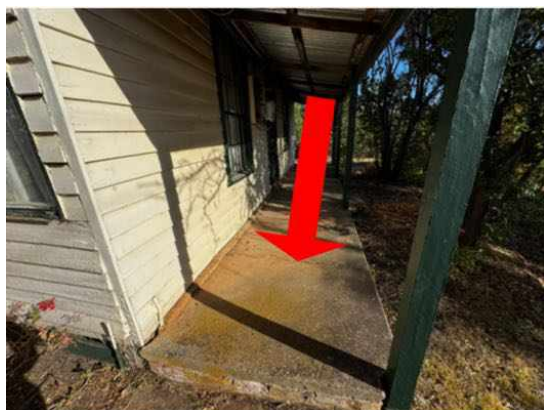
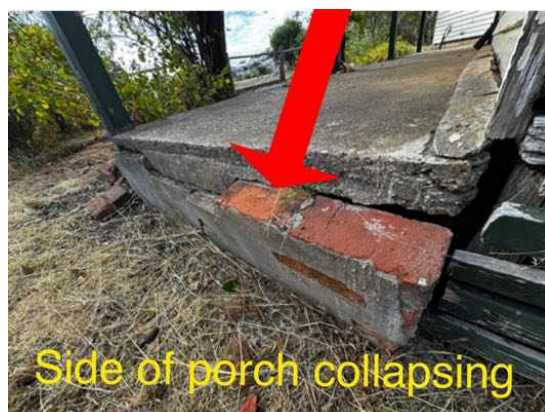
Finding 2.08

Building:	Main Building
Location:	Porch > Front
Finding:	Major cracking to concrete front porch
Information:	Significant cracking was observed to the concrete paving at the front porch in multiple locations, with several cracks measured to be greater than 10 mm in width, exceeding acceptable tolerances and indicating structural movement rather than minor shrinkage. In addition, the side section of the elevated concrete porch was observed to be collapsing, indicating a loss of support to the slab edge. The pattern and severity of cracking, combined with the partial collapse, is consistent with foundation and footing movement. The likely contributing cause is excessive moisture in the ground,

suspected to be the result of uncontrolled water discharge from an adjacent downpipe, which may be saturating the soil supporting the porch. Given the age of the building and deteriorating site conditions, ongoing moisture exposure is likely accelerating ground instability. In accordance with AS 4349.1 – Inspection of Buildings, this condition is classified as a Major Defect due to the risk of continued movement, progressive structural deterioration, and potential safety concerns.

A structural engineer should be engaged to assess the extent of the movement, footing stability, and soil conditions. A licensed plumber should also be engaged to rectify the downpipe discharge, ensuring stormwater is properly connected and directed away from the building. Rectification works may include stabilisation of the foundations, repair or replacement of the affected concrete porch sections, and implementation of appropriate drainage controls to prevent recurrence.

Immediate. Investigation and rectification should be undertaken as soon as practicable to reduce the risk of further collapse, ongoing movement, and associated safety hazards.

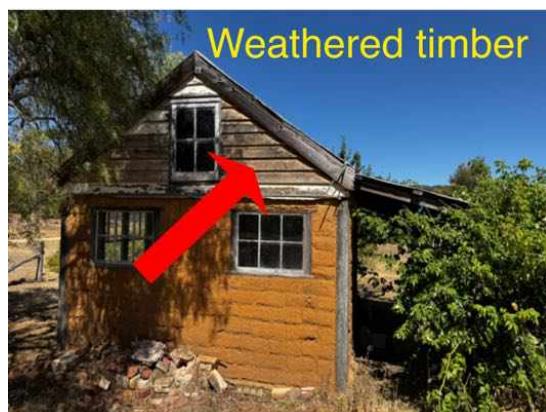
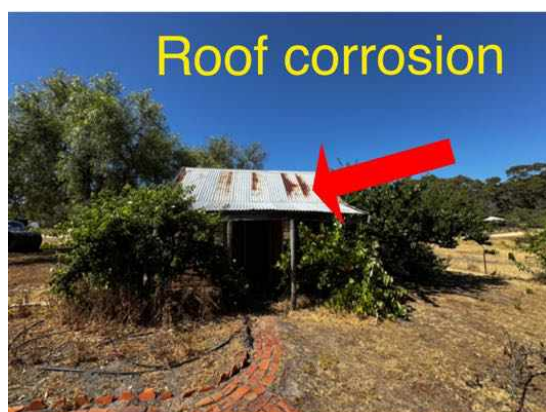
Finding 3.01

Building:	Bungalow
Location:	Walls, roof > Rear Left
Finding:	Weathered bungalow cladding and corroded metal roof – rear structure
Information:	The bungalow located at the rear of the property was observed to have weathered timber cladding, with signs of surface deterioration consistent with prolonged exposure to the elements. The timber cladding is suspected to have insufficient protective coating remaining, which may accelerate deterioration if left untreated. In addition, the metal roof sheeting to the bungalow showed visible signs of surface corrosion, indicating breakdown of protective finishes and potential for progressive rusting. While no active water leaks were observed at the time of inspection, ongoing deterioration of both the timber cladding and metal roofing may lead to moisture ingress and further degradation of building elements over time. This condition is considered a Minor Defect in accordance with AS 4349.1, as it represents maintenance-related deterioration rather than immediate structural failure.

It is recommended that the timber cladding be sanded, primed, and resealed or repainted using an appropriate exterior coating system to prolong its service life. The

metal roof should be assessed by a suitably qualified tradesperson to determine whether maintenance treatment (such as rust treatment and recoating) is sufficient or if partial or full replacement is required. Ongoing maintenance should be implemented to prevent further deterioration.

Medium term – maintenance works should be carried out to prevent progression of deterioration and future moisture-related issues.

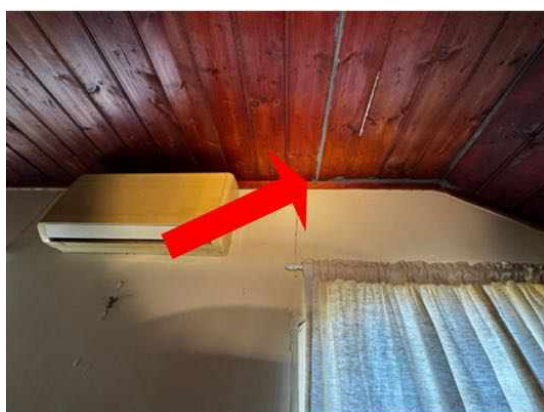
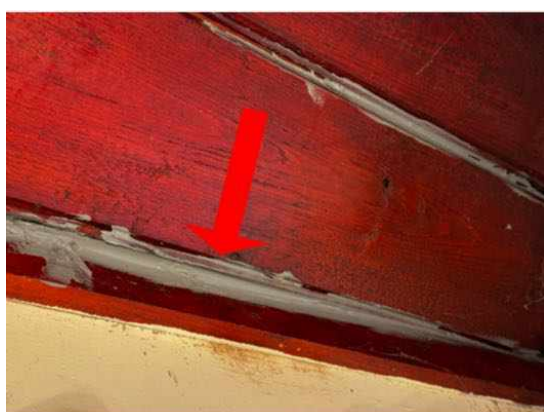
Finding 3.02

Building:	Main Building
Location:	Living Room > Front Left
Finding:	Suspected ceiling panel separation due to building movement – living area
Information:	Several timber ceiling panels within the living area were observed to have visible gaps and cracking between panel joints. These defects have been filled with silicone sealant, resulting in a substandard and visually poor finish. The sealant application appears to be a makeshift remedial measure rather than a permanent repair. Based on the widespread evidence of building movement observed elsewhere within the property, including uneven floors, binding doors, and wall cracking, it is suspected that the ceiling gaps and cracking are primarily the result of building movement rather than poor installation. The sealant is suspected to have been applied in an attempt to

limit drafts, dust migration, and potential pest ingress from the ceiling cavity into habitable areas, without addressing the underlying movement-related cause. In accordance with AS 4349.1 – Inspection of Buildings, this condition is classified as a Minor Defect, as it affects presentation and amenity but does not currently compromise structural integrity.

It is recommended that a qualified builder or structural practitioner review the extent of suspected building movement and its effect on internal finishes. Once movement is assessed and addressed where required, the ceiling panels should be properly repaired or replaced, with joints reinstated using appropriate fixing and finishing methods to achieve an acceptable and durable finish.

Within the short to medium term, or sooner if cracking widens, ceiling panels continue to separate, or additional signs of movement become evident.

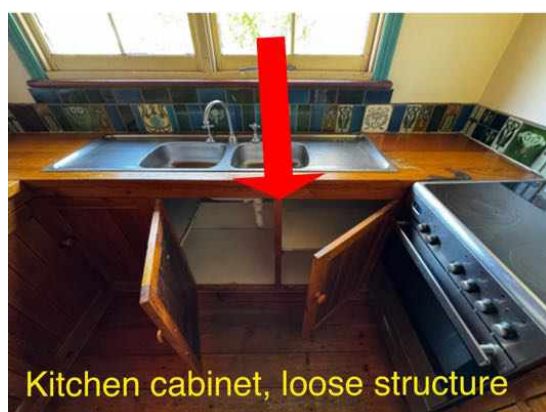
Finding 3.03

Building: Main Building
 Location: Kitchen > Rear Left
 Finding: Loose and inadequately fixed kitchen base cabinet – under sink

Information: The base cabinet located beneath the kitchen sink was observed to be loose and unstable, with the cabinet carcass moving when manual pressure was applied. This condition indicates that the cabinet is not adequately secured to the wall or adjoining cabinetry, which is inconsistent with acceptable installation practice. While the cabinet remains functional at the time of inspection, the lack of proper fixing increases the risk of progressive damage to cabinet doors, hinges, plumbing connections, and the cabinet carcass itself. In accordance with AS 4349.1 – Inspection of Buildings, this condition is classified as a Minor Defect, as it affects serviceability and durability but does not currently pose a safety or structural risk.

Within the short term, as part of routine maintenance, to prevent further deterioration or damage to the cabinetry and associated fittings.

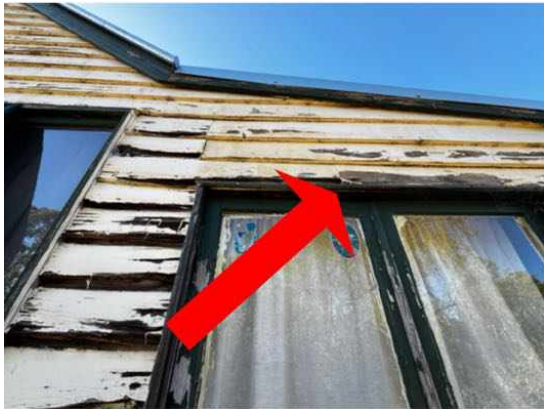
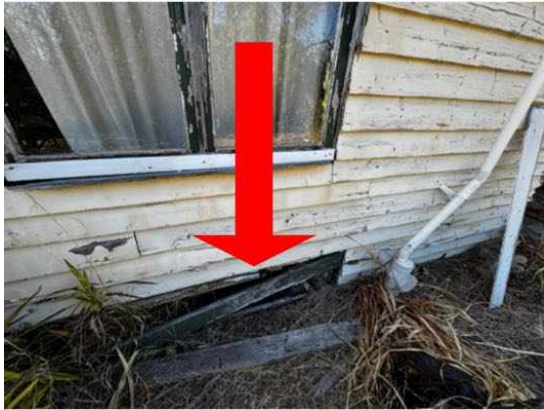
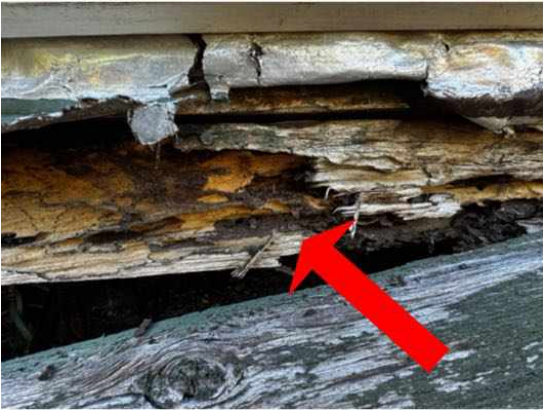
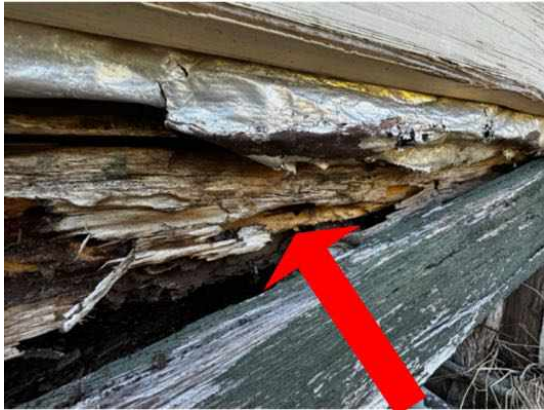
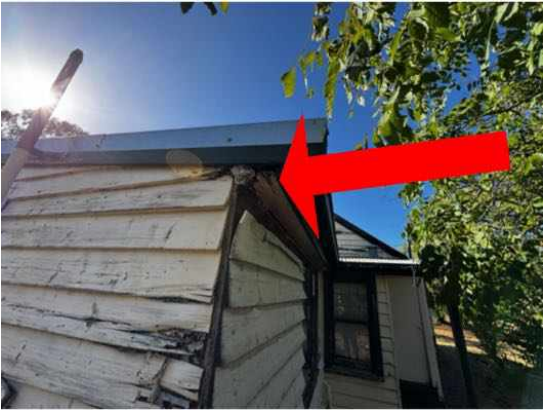
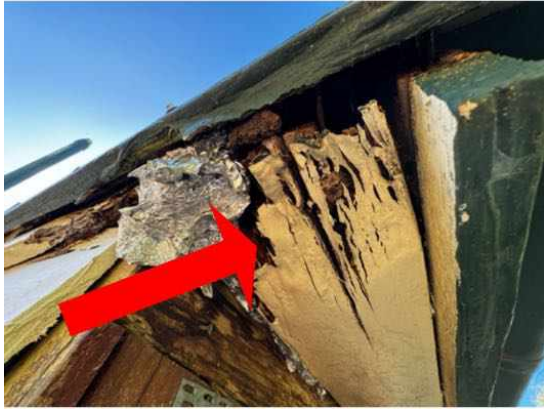
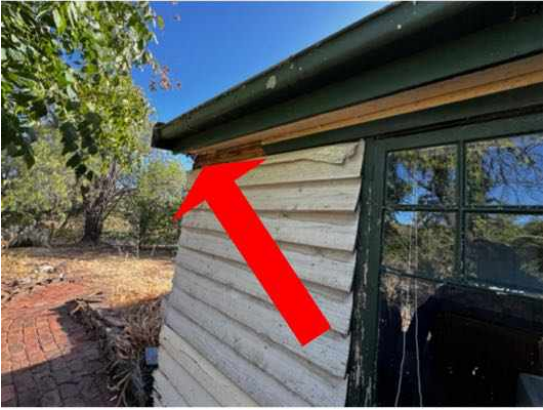
Building: Main Building
Location: All Areas > All Areas
Finding: Severe termite damage and timber rot to external wall – unsafe condition
Information: Severe and extensive suspected termite damage in conjunction with advanced timber

rot was observed to the external wall on the northern side of the building, most notably to the wall servicing the middle bedroom. The external weatherboard cladding in this area and other areas of the building was found to be severely deteriorated, with the damage extending into the internal wall cavity on the northern side of the building. The timber framing elements within the wall cavity were observed to be extensively damaged and structurally compromised to the point where the wall exhibited noticeable movement when moderate manual force was applied. This condition indicates a complete loss of structural capacity to this wall section and presents a serious risk of partial or full wall collapse. The affected area is therefore considered unsafe for habitation. Additional suspected termite damage was observed to other external wall areas, however these were not as advanced as the primary location described above. This condition is consistent with a Major Defect as defined under AS 4349.

Urgent action is required. The affected area should be immediately isolated and access restricted. A licensed builder and suitably qualified structural engineer should be engaged to assess the extent of structural damage and determine appropriate demolition, structural repair or rebuilding requirements. A licensed termite management professional should also be engaged to undertake a full termite inspection, identify active or dormant termite activity, and implement an appropriate termite treatment and management system in accordance with AS 3660. Any structural repairs should not proceed until termite risks have been adequately addressed.

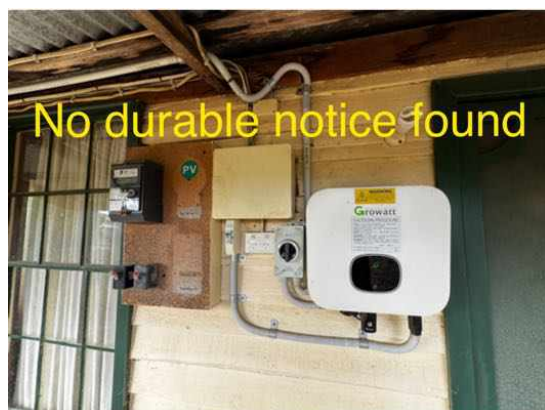
Building:	Main Building
Location:	Meter Box > Front
Finding:	Termite management system - no evidence of chemical installation (TP)
Information:	At the time of inspection, there was no visible evidence to suggest that a chemical termite management system has been installed or remains effective. In addition, no durable notice was observed within the electrical switchboard to identify the presence, type, or date of any termite protection measures.

For this reason, the installation of a chemical termite management system is highly recommended to reduce the risk of termite activity. A durable notice should also be installed within the electrical switchboard to clearly identify the treatment provided and support ongoing inspection and maintenance.

Engagement of a licensed termite management or pest control contractor is recommended as a matter of priority to assess the site conditions, consider local termite risk, and determine the most appropriate treatment method and procedures for this property.

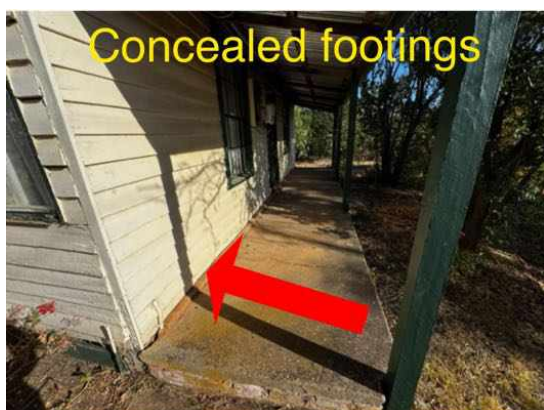
Building:	Main Building
Location:	Porch > Front
Finding:	Concrete paved porch are hard up against building (TP)
Information:	At the time of inspection, the concrete paved area to the front porch was observed to be constructed hard up against the building, concealing the edge of the building and footing. This condition restricts visual access to the building perimeter and limits the ability to inspect critical areas intended for early detection of termite activity.

early warning, increasing the likelihood of undetected termite activity.

As a result, the paved area to the front porch is considered to increase the risk of concealed termite entry. It is recommended that a licensed termite management or pest control contractor be engaged to assess this area and provide advice on suitable rectification options, which may include modifying the paving to reinstate inspection access or implementing supplementary termite management measures appropriate to the existing conditions.

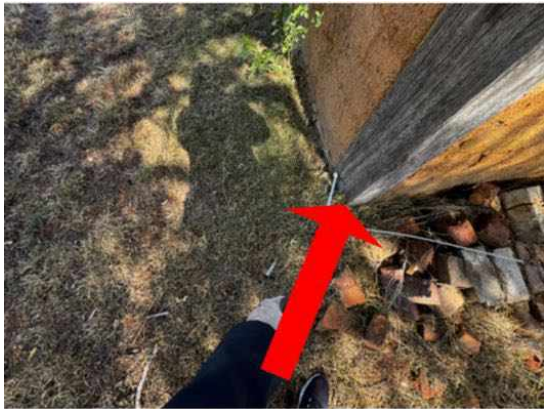
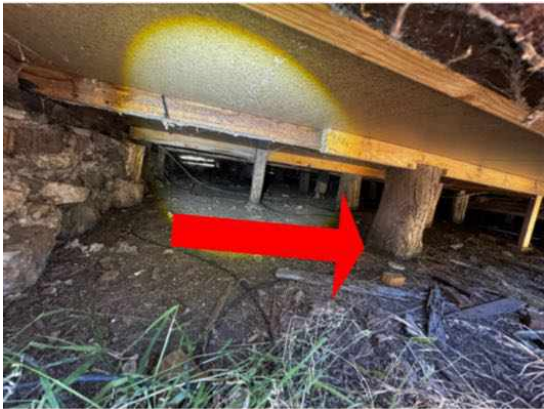
Finding 6.04

Building:	Main Building
Location:	All Areas > All Areas
Finding:	Timber in or on direct ground (TP)
Information:	At the time of inspection, multiple conducive termite conditions were observed around the external areas of the building, including timber vegetable garden structures, timber planter boxes, timber retaining walls to garden beds, firewood storage located to the rear and side yards, stored timber planks to the rear and side of the property, and a dead, decaying tree trunk positioned near the front boundary. Evidence of decaying timber was also noted within the firewood stacks and in other timber materials stored around the site.

Conditions that provide timber food sources, retain moisture, or allow concealed termite activity are recognised as significantly increasing termite risk to existing buildings. Decaying and stored timber materials in contact with or close to the ground can attract subterranean termites, support ongoing foraging activity, and allow colonies to establish concealed pathways toward nearby structures without early detection.

As a result, the number and distribution of these conducive conditions are considered to substantially increase the risk of termite activity affecting the property. It is recommended that a licensed termite management or pest control contractor be engaged to assess and manage these risks, which may include removal of decaying timber, relocation or replacement of timber elements with non-susceptible materials,

improved storage practices for firewood and timber, and implementation or review of appropriate termite management measures suited to the existing building and site conditions.

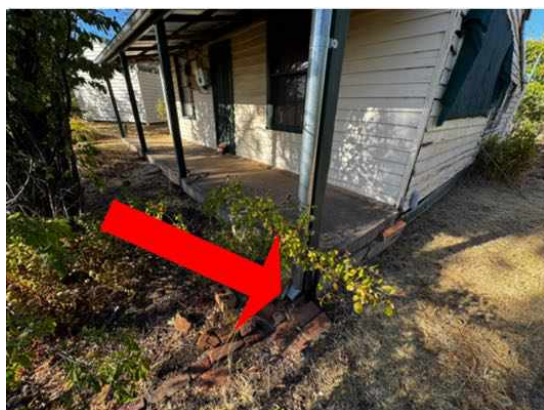
Finding 6.05

Building: Main Building
 Location: Porch > Front Right
 Finding: Disconnected downpipe to front elevation (TP)
 Information: At the time of inspection, a downpipe servicing the front porch was observed to be not connected to a drainage system and discharging directly onto the ground. This condition promotes poor site drainage and allows ongoing water accumulation around the base of the building.

Conditions that result in persistent dampness or poor drainage around a building are recognised as conducive to termite activity, as elevated moisture levels can attract subterranean termites and support concealed foraging activity toward the structure.

Uncontrolled discharge of roof water can therefore increase both moisture-related deterioration and termite risk.

As a result, the disconnected downpipe is considered to contribute to conditions conducive to termite activity. It is recommended that an appropriately qualified roof plumber be engaged to inspect all roof plumbing and ensure that downpipes are correctly connected to the stormwater drainage system, with no roof water discharged directly onto the ground.

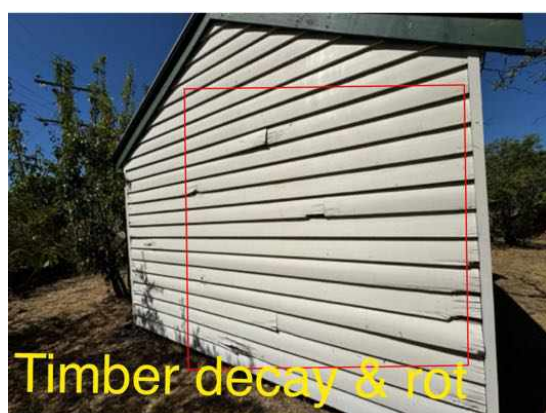
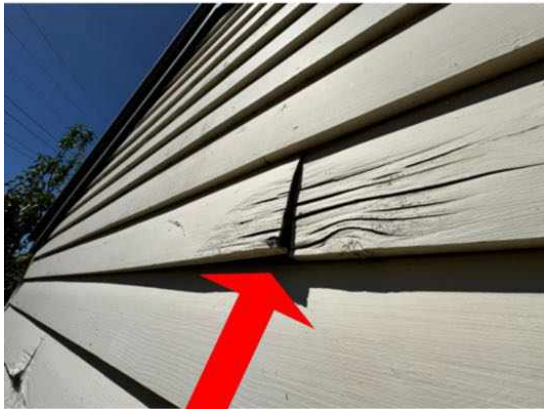
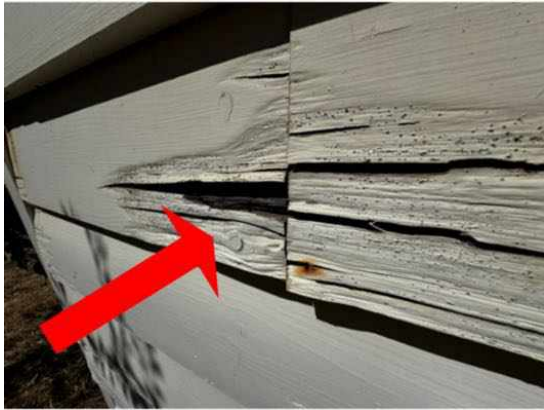
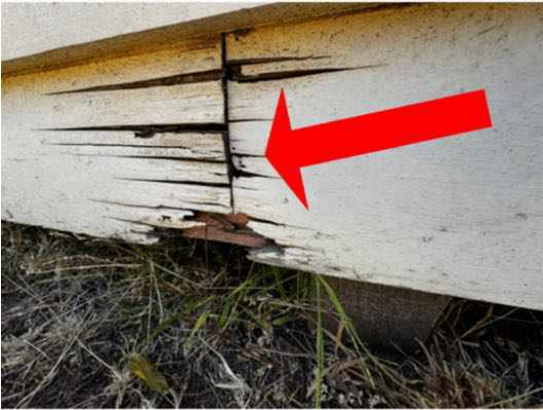
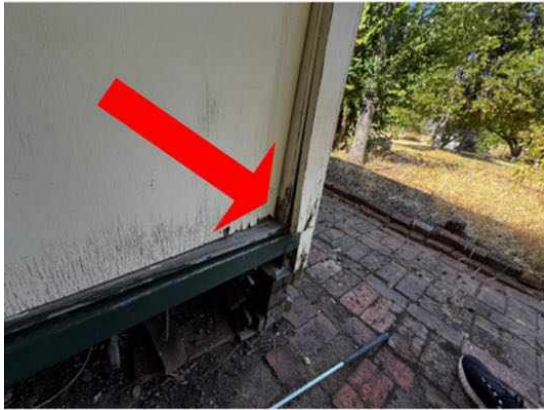
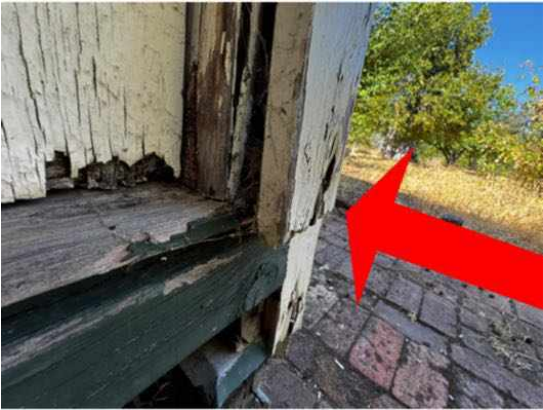
This condition is suspected to have developed over time due to prolonged moisture exposure and a lack of appropriate timber maintenance, allowing moisture ingress and decay to progress within the timber elements. In accordance with AS 3660.2, deteriorated and moisture-affected timber is recognised as increasing the risk of termite activity, as decayed timber can attract termites and may provide concealed access or harbourage.

As a result, these conditions are considered to present an elevated risk of ongoing deterioration and termite susceptibility. It is recommended that an appropriately qualified builder or carpenter be engaged to further assess the extent of timber decay, remove any concealed deteriorated material, and undertake suitable repairs or replacement, with consideration also given to advice from a licensed termite management or pest control contractor where termite risk is identified.

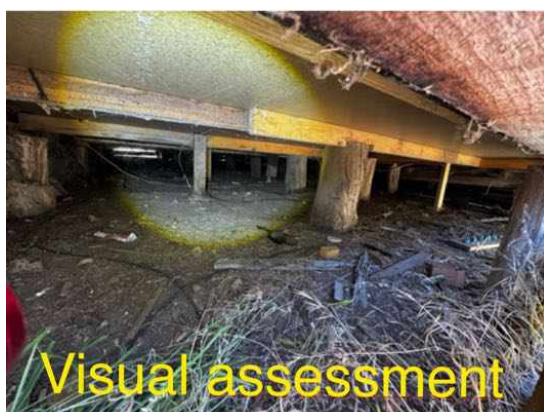
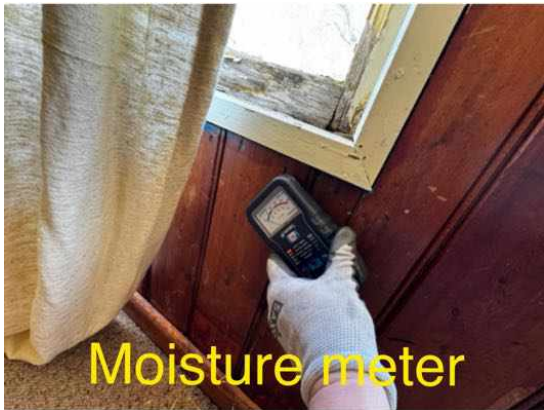
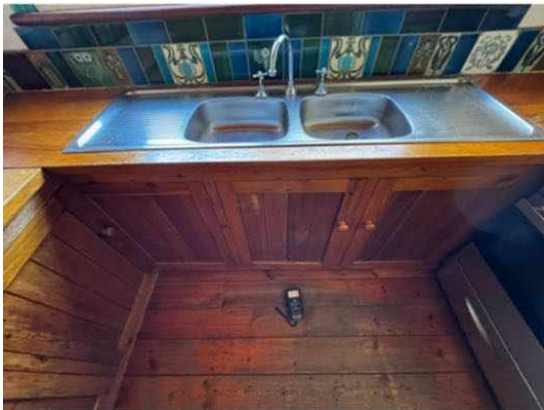
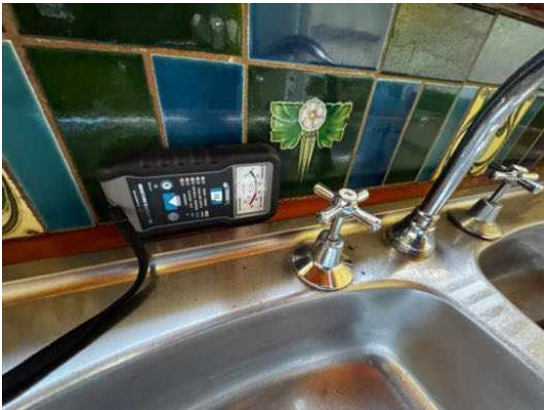
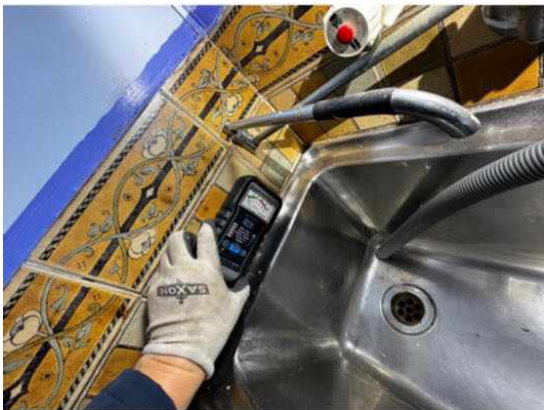
Building: Main Building
Location: All Areas > All Areas
Finding: Termite investigation techniques (TP)
Information: All accessible areas of the dwelling were inspected, with particular attention paid to wet areas, which were closely assessed for elevated moisture levels and temperature anomalies that may indicate conditions conducive to termite activity. No evidence of termite activity was identified within the interior of the dwelling at the time of inspection. However, evidence of termite damage was found to the exterior and wall cavities of the building.

In an attempt to identify concealed or hidden timber pest activity, a range of inspection techniques were adopted. These included the use of a moisture meter to assess susceptible areas, sounding of timber elements using a handheld probing device, and visual assessment of materials for signs commonly associated with termite activity. These signs include moisture-related deterioration, deformation of timber, termite mud leads or bridging, and irregular or regular shaped holes within timber elements that may indicate pest-related damage.

It is noted that termite activity can generate increased moisture and localized temperature variations, and where such irregularities are detected, further investigation may be warranted. However, it is also acknowledged that certain obstructions, including floor coverings, wall linings, wall tiles, and fixed cabinetry such as bathroom fit-offs, can conceal termite activity and limit the effectiveness of visual inspection. As a result, the absence of visible evidence at the time of inspection does not eliminate the possibility of concealed termite activity within inaccessible or obstructed areas of the building.
