Building and Timber Pest Inspection Report

Inspection Date: Wed, 21 Jan 2026

Property Address: 1 Harcourt Ave, Frankston South VIC 3199,
Australia

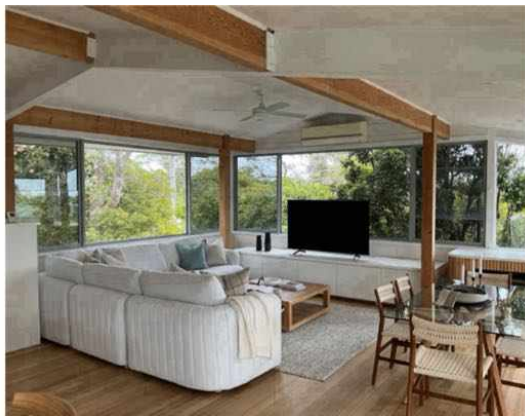
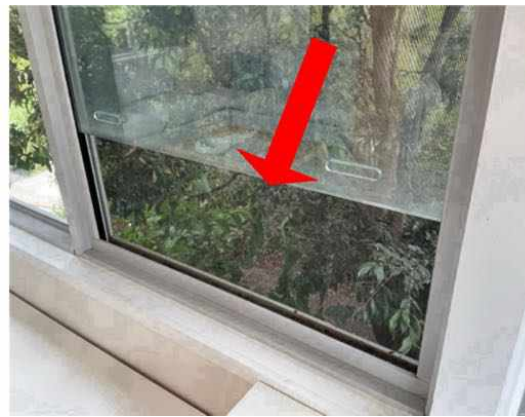
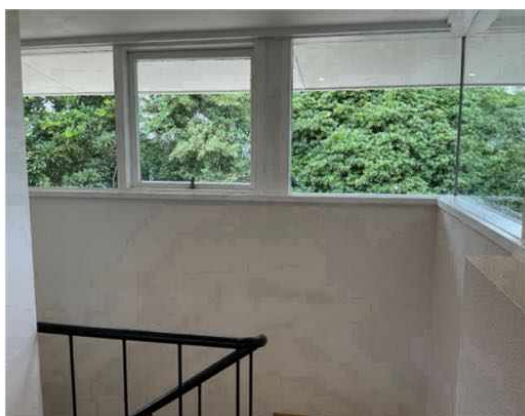
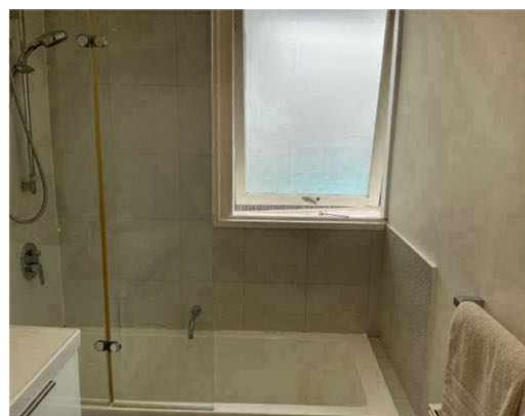
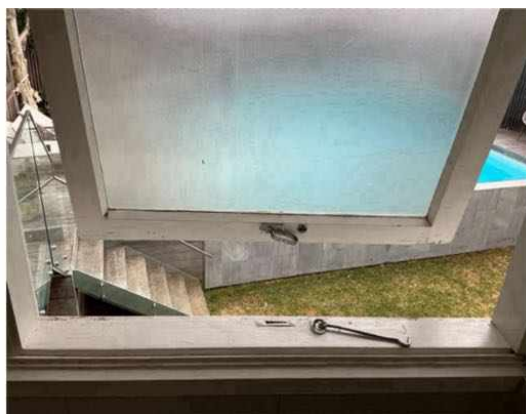
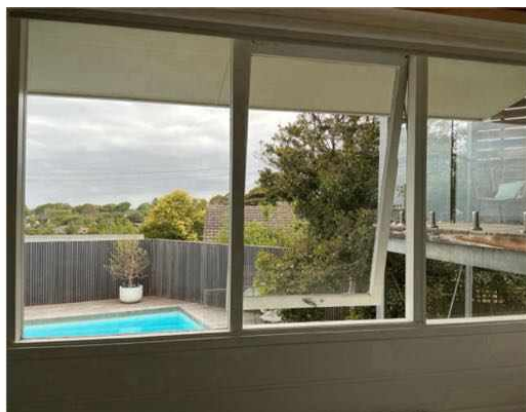
| Finding: | Upper floor windows open too far |
| Information: | The inspection identified that the upper-floor windows in this double-story property do not meet the safety guidelines for openable windows in elevated spaces. Specifically, these windows open wider than the maximum allowable width of 125mm, creating a potential fall hazard. Openable windows in elevated spaces must be restricted in their opening width or fitted with barriers to prevent accidental falls. Installing restrictors or compliant barriers will enhance safety and ensure the property adheres to Australian safety standards, providing a safer environment for all occupants, particularly young children. |

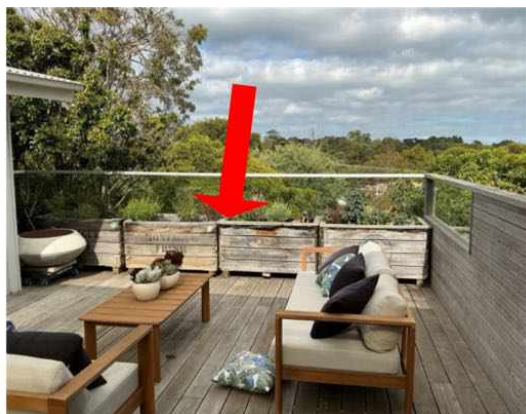
Finding 1.02

Building: Main Building
 Location: Balcony
 Finding: Balustrade - Suspected Non-Compliance
 Information: Part of the balustrade to the patio facilitates climbing with a horizontal ledge and garden beds, creating a potential fall hazard particularly for children.

This defect creates a potential safety hazard and should be rectified as soon as possible to ensure the safety of the area and to meet present building standards and regulations.

A registered builder should be contacted to discuss possible rectification solutions.

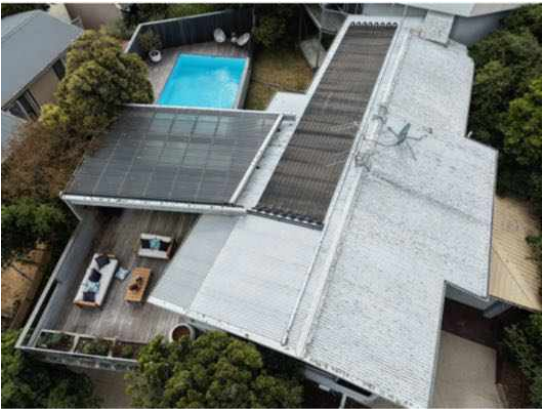
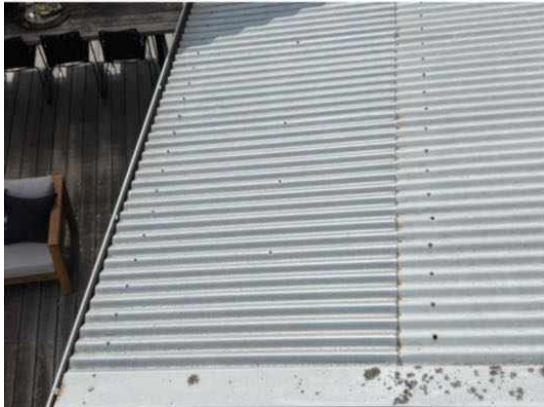
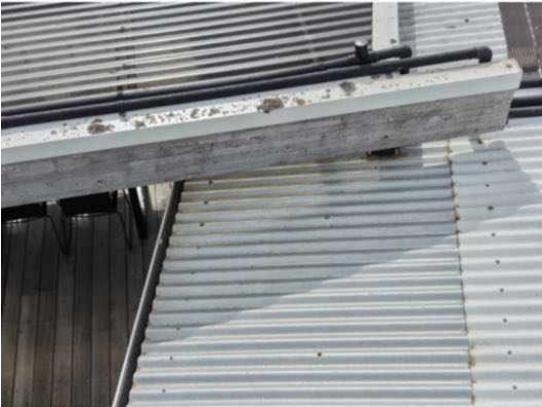
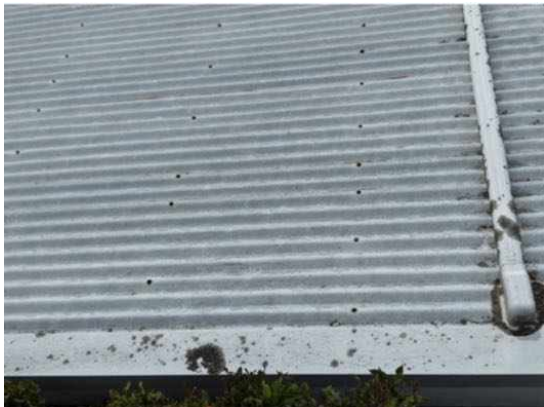
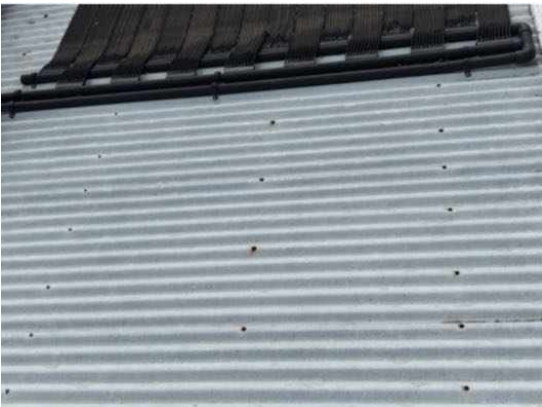
Finding 3.06

Building: Main Building
Location: Roof Exterior
Finding: Fixings rusted/deteriorated
Information: Rusting and deteriorating fixings to the exterior roof was noticed on inspection. Rusting/deteriorating fixings can happen over a period of time or if incorrect fixings are used. Recommend engaging a plumber to replace fixings to reduce the risk of water penetration and further deterioration as soon as possible.

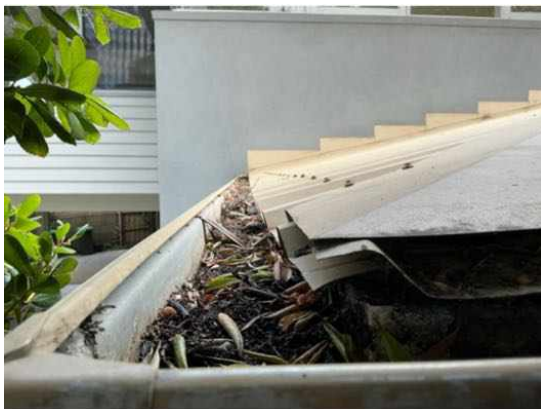
Finding 3.07

Building: Main Building
Location: Roof Exterior
Finding: Gutters -Partially Blocked with debris
Information: It was noticed on inspection that some of the gutters were partially blocked with debris. Roof plumbing structures, such as guttering and downpipes, should be free of all debris to prevent blockages. Blockages of the guttering and downpipes will lead to pooling and accumulated water overflows, which is likely to subsequently flood eaves and exterior walls.

Blocked gutters are likely to lead to high levels of moisture in the affected areas. Such moisture will not only cause rust and decay of the associated building materials, but can also provide conditions that are conducive to termite and timber pest activity. Blockages in gutters should therefore be removed immediately to ensure dry conditions are maintained.

Consult a Licensed Plumber for further specific advice on remedial works that may be required. In the interim, it is highly advised that blocked gutters be removed by the homeowner or a general handyperson as a matter of urgency.

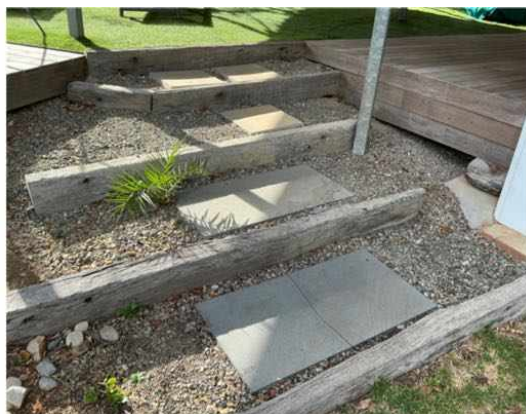
Finding 3.08

| Finding: | Loose paving |
| Information: | Some of the pavers to the rear steps are coming loose/cracked. This is likely a result of expected building movement, general expansion, and/or contraction of building materials in different weather conditions. Recommend engaging a landscaper to repair/replace the pavers at the owners discretion to reduce the risk of further deterioration. |

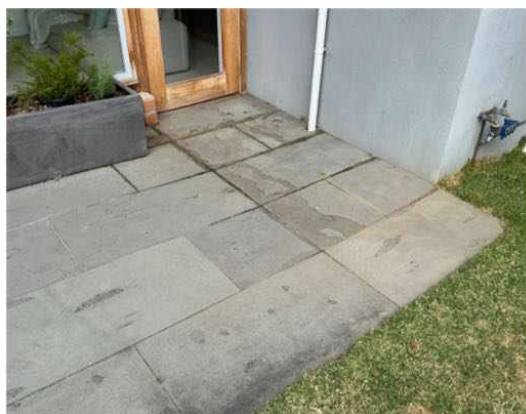
Finding 3.09

| Finding: | Grouting deterioration |
| Information: | The exterior grout in this area is deteriorating and calcifying. |

Deterioration of grout joints reduces the effectiveness of the tiled surface in preventing water ingress.

Damaged or missing grout allows moisture to penetrate below the tiled surface.

Prolonged moisture ingress can compromise the waterproofing membrane, lead to leaks into adjoining parts of the building and cause damage to the building structure.

The condition observed indicates that the waterproofing system may be at risk of failure if not rectified.

Recommend engaging a licensed tiler or waterproofing contractor to remove and replace defective grout and sealants as soon as possible.

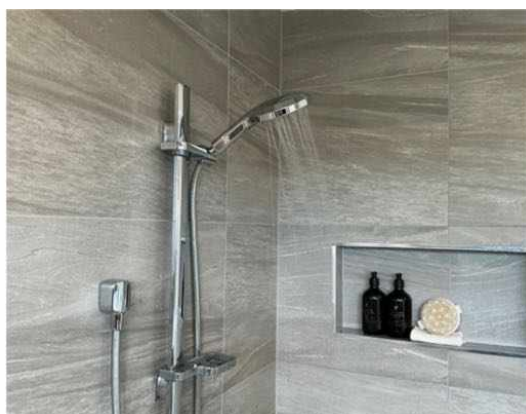
Finding 3.10

| Finding: | Ensuite Shower head is dripping/leaking |
| Information: | The shower head to the ensuite bathroom is loose and dripping/leaking. This can often happen over time with deterioration or if the shower head is loose and needs tightening. Recommend engaging a plumber to repair/replace the shower head to reduce the risk of further deterioration and water leaks as soon as possible. |

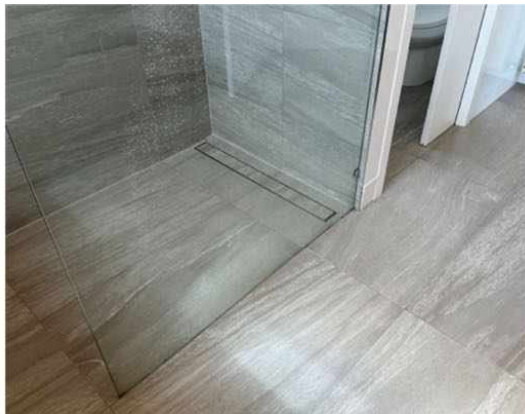
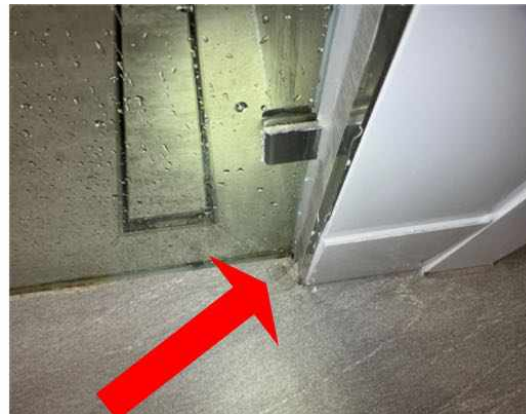
Finding 3.11

| Finding: | Ensuite-Shower screen leaking |
| Information: | Leaking was evident to the ensuite shower screen at the time of inspection. It is suspected that the leaking has occurred as a result of minor impact damage to the shower screen or general ageing of the building elements. Leaking from the shower screen, where left unattended, is likely to lead to water damage to adjoining flooring and walls. Such damage can lead to water damage and necessitate extensive remedial works being required. Active water leaks may also create an environment that is susceptible to the formation and development of mould. |

Appointment of a caulking contractor is required to repair or replace the shower screen. Such works should be performed as soon as possible to ensure that no further damage occurs.

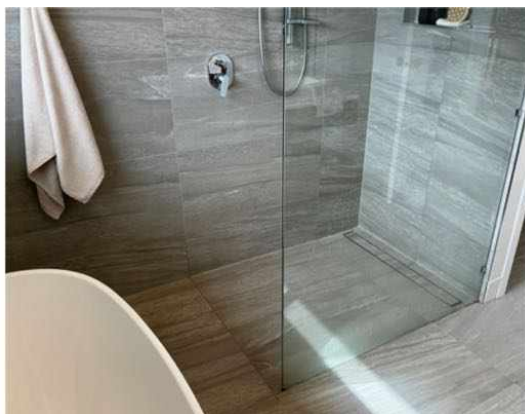
Finding 3.12

Building: Main Building
 Location: Ensuite - Master
 Finding: No Shower screen
 Information: No shower screen fitted to the bathroom.

Water from the shower when left unattended, is likely to lead to water damage to adjoining flooring and walls. Such damage can lead to water damage and necessitate extensive remedial works being required. Active water leaks may also create an environment that is susceptible to the formation and development of mould.

Appointment of a shower screen installer is required to install a shower screen to the shower area. Such works should be performed as soon as possible to ensure that no damage occurs.

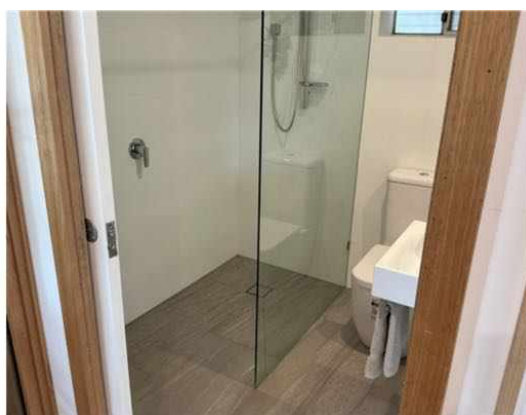
Finding 3.13

Water from the shower when left unattended, is likely to lead to water damage to adjoining flooring and walls. Such damage can lead to water damage and necessitate extensive remedial works being required. Active water leaks may also create an environment that is susceptible to the formation and development of mould.

Appointment of a shower screen installer is required to install a shower screen to the shower area. Such works should be performed as soon as possible to ensure that no damage occurs.

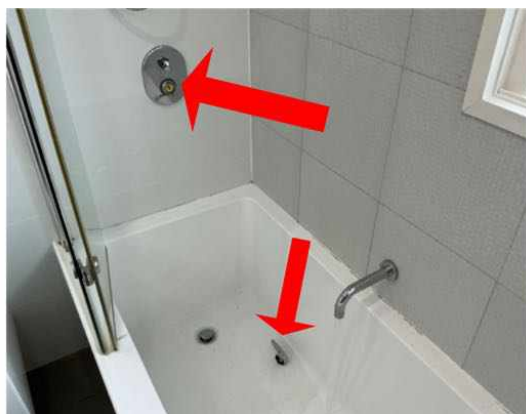
Finding 3.14

Building: Main Building
Location: Bathroom
Finding: Tap - Loose
Information: The tap in the bathroom has not been installed correctly, or has deteriorated with age, and is consequently loose. This tap being loose creates potential for water leaks and subsequent water damage to the surrounding area.

Where taps or spouts are loose, a qualified plumber should be appointed to re-fix the plumbing fitting.

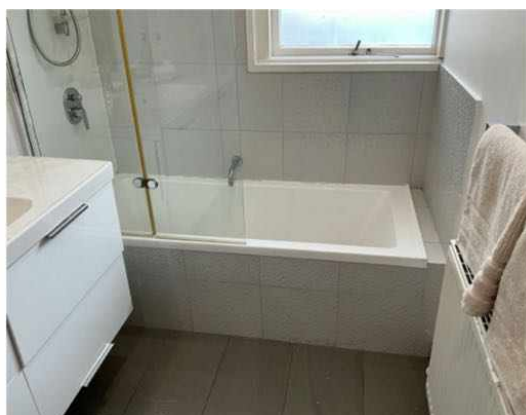
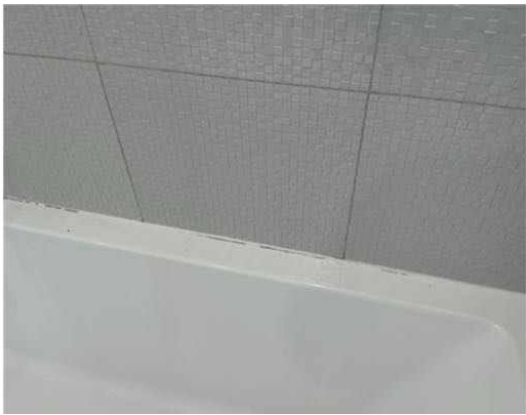
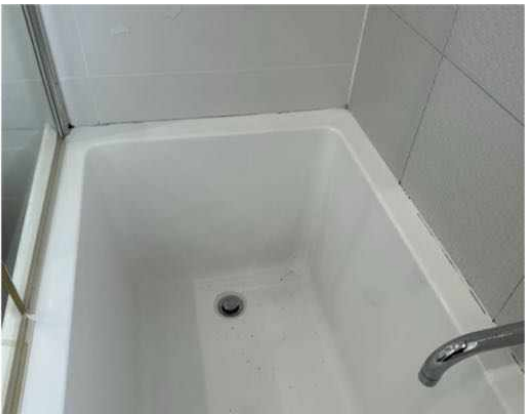
Finding 3.15

| Finding: | Bathroom Sealant grouting - Missing or damaged degraded |
| Information: | It was noted on inspection that sealant or grout is degraded/missing or damaged to the tiled shower alcoves and or other areas of the bathrooms. |

Different materials and floor areas move at different rates, generally causing cracking to grout or sealant at this point. A flexible sealant is required to allow for expected expansion and contraction, while keeping the joint water tight and protective of all associated building materials.

Flexible and mould resistant materials should be applied to affected areas to prevent any subsequent water damage that is likely to occur. Regular maintenance and replacement of damage or missing or damaged sealant and grout is highly recommended to the wet areas, as this is a regular wear and tear defect. Sealant and grouting in areas that come into regular contact with water should be maintained for the long term care of your property.

A sealant specialist or tiling contractor should be appointed to complete these works as soon as possible

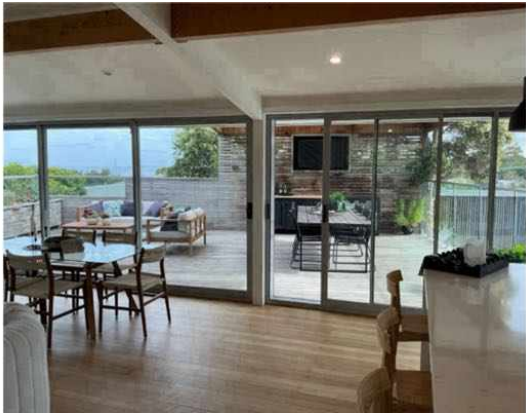
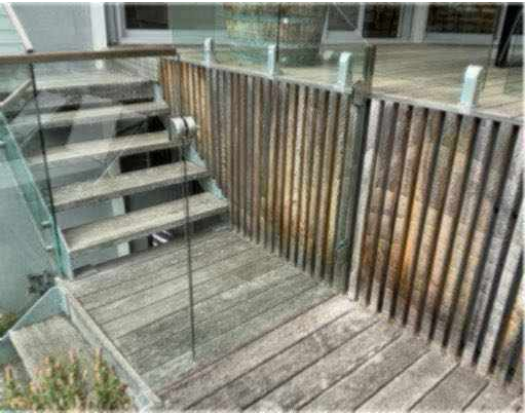
Finding 3.16

Building: Main Building
 Location: Various parts of the building
 Finding: Doors/windows, gate and cabinets required maintenance
 Information: Some of the doors, windows cabinets and gate to the building require some maintenance to make them operate more smoothly. This can happen overtime with deterioration or lack of maintenance. Recommend engaging a carpenter to repair/maintain at the owners discretion.

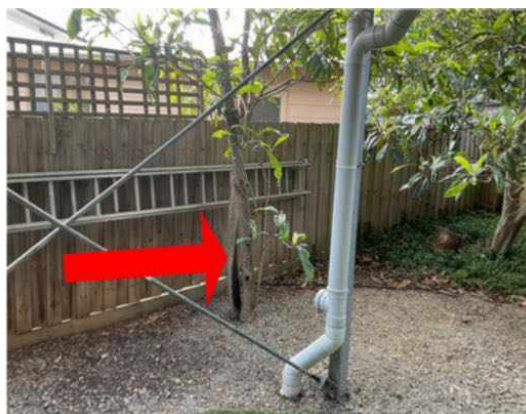
Building: Main Building
Location: Yard - Back
Finding: Trees termite damage
Information: Despite no live termite or timber pest activity being indicated, previous termite damage was found to have affected these trees in the rear yard. This damage is considered to be inactive and is minor in nature. Recommend engaging a pest controller for an invasive investigation on the trees and to install a termite barrier immediately.

It is advised that the area be visually inspected frequently to ensure that the condition of affected building materials does not worsen. At the time of inspection, damage is only considered to be superficial.

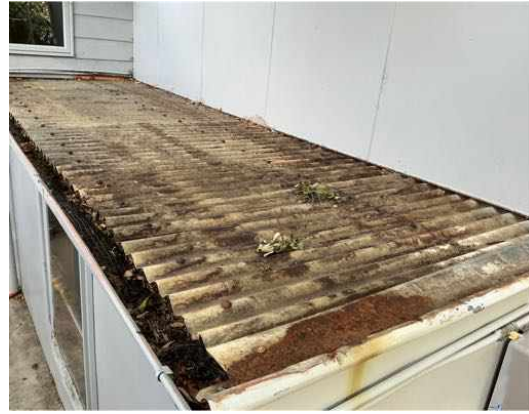
| Information: | It was identified that the shed roofing structure has an insufficient fall or angle, which prevents effective water drainage and parts are starting to rust. This defect increases the risk of water pooling on the roof surface and may lead to various secondary building defects including. |

Engage a registered building contractor to assess the roofing structure (potentially including structural changes to the roof)and provide a quotation for rectification works. Modify the roof angle to meet the required minimum fall for proper drainage insuring compliance with relevant building standards and codes. Inspect roof plumbing systems to confirm they are correctly installed and functioning efficiently in conjunction with the roof modifications.

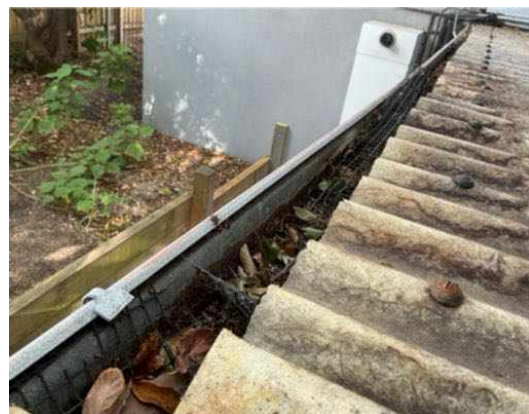
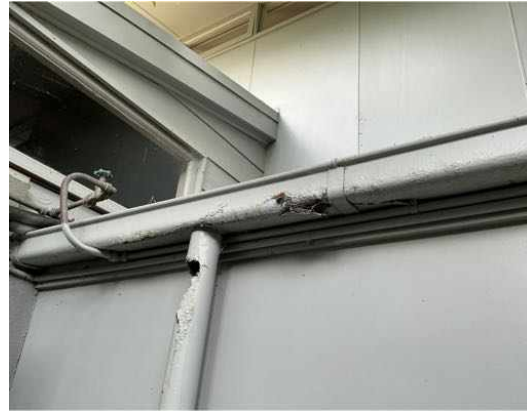
Finding 6.03

Finding: Gutters - Rusted or corroded

Where possible, the use of galvanized (treated) metals or aluminium coated metals aid in rust prevention, as does regular general maintenance. Rust formation can be controlled with coatings, such as paint, that isolate the iron from the environment.

Rusting and corrosion should be managed by ideally removing or limiting the affected surface from exposure to moisture. A registered builder may be appointed to replace any building elements that have been severely affected by rust or water damage.

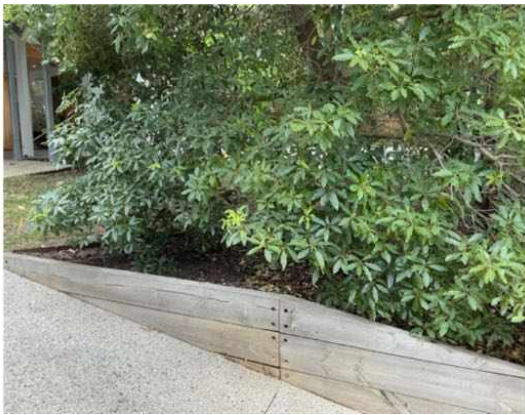
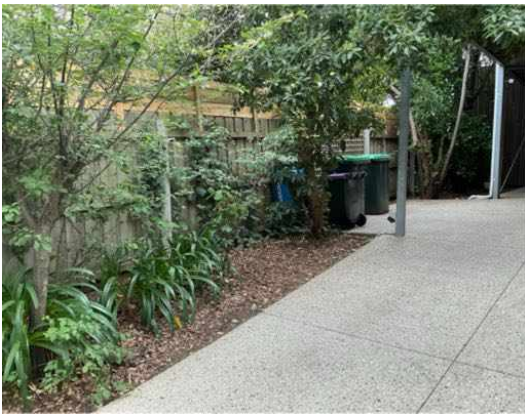
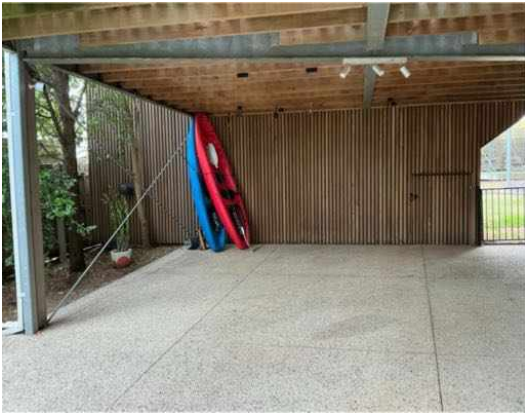
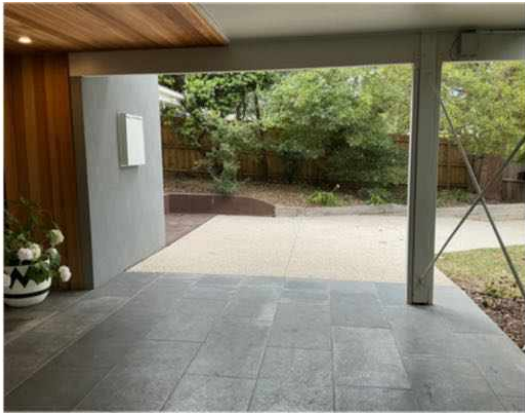
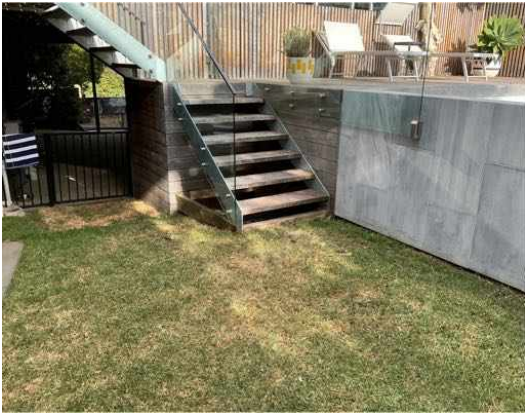
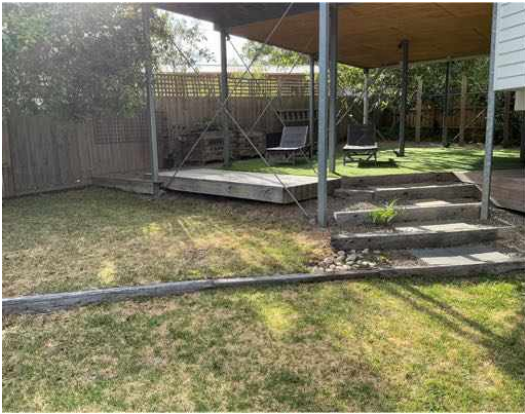
Finding 6.06

Building: Main Building
Location: All External Areas
Finding: Bridging attachments to buildings
Information: Bridging occurs when items against a building provide a concealed entry point for termites into the building or by passing around a termite management system.

Remove untreated timber that is in direct contact with external grounds. Consider replacement with more durable materials i.e. treated timber or non timber elements. Frequent pest inspections are advised to readily identify any termite activity in these areas.

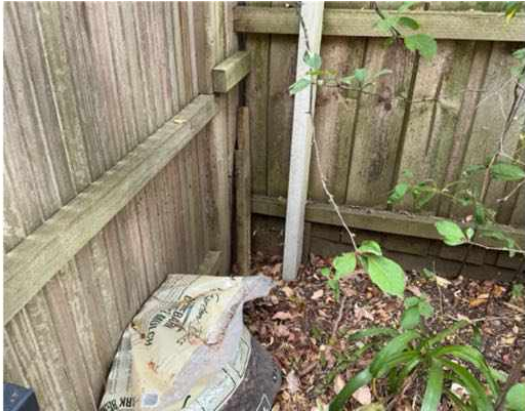
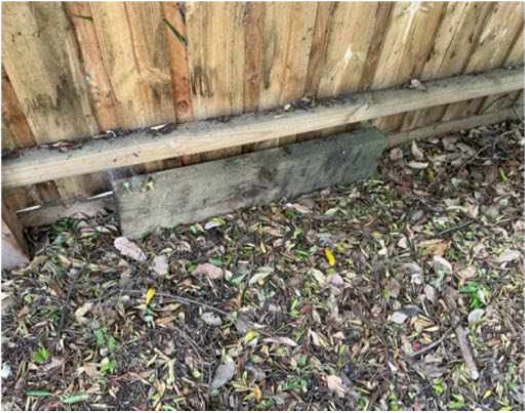
Finding 6.08

Building: Main Building
Location: Yards
Finding: Tree roots/stumps and timbers - external area
Information: Tree roots/stumps and timbers to the external property increases the risk of termite activity being present. As they are likely to come into contact with weather conditions or excessive moisture wood rot is likely to develop on timbers that are not treated.

It is highly recommended that any stored timbers or stumps be immediately removed from areas in which they may attract any termite / timber pest attack. Minimisation of risk / prevention of termite attack is far more adequate than dealing with the presence of termite activity.

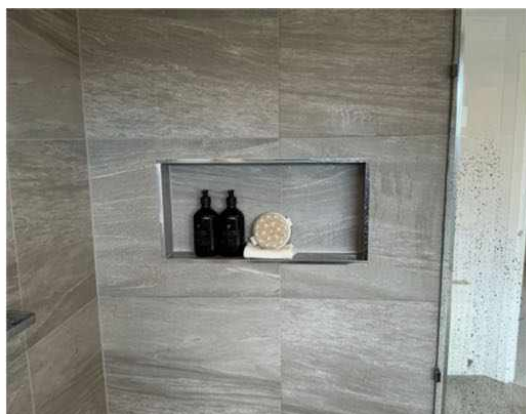
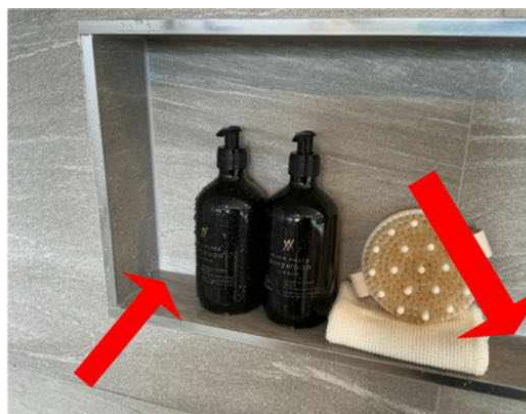
Finding 6.09

This pooling is minor overall but is still considered unsatisfactory, as standard practices would not permit this situation to occur. Pooling water can create conditions that are conducive to termites and mould growth over time. Where left unmanaged, the degradation of sealant and grouting is also likely to occur, possibly necessitating further repair works. Recommend engaging a tiler to rectify to reduce the risk of further deterioration as soon as possible.

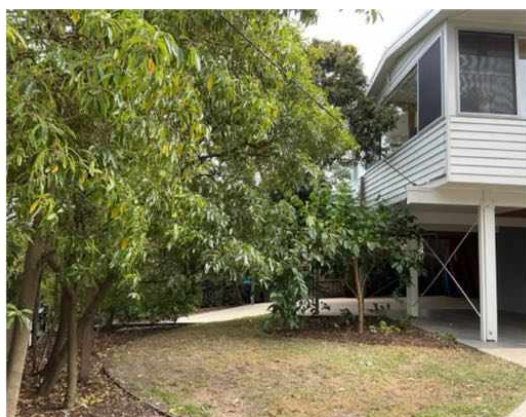
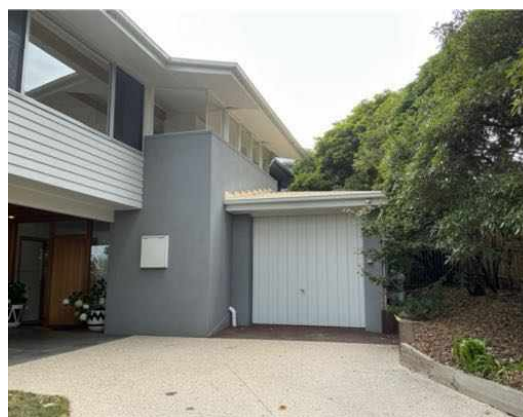
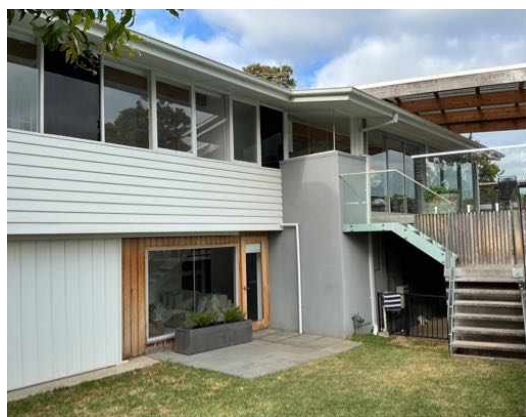
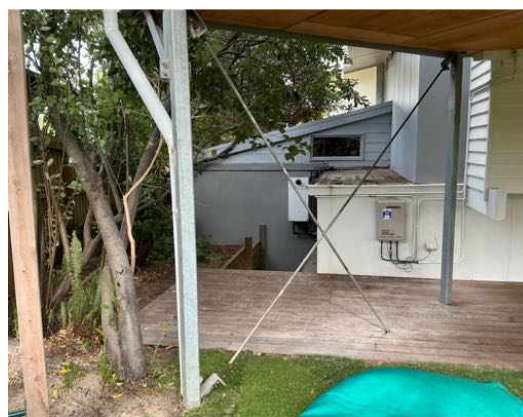
Building: Main Building
 Location: All External Areas
 Finding: Additional Photos - Obstructions and Limitations
 Information: These photographs are an indication of the obstructions and limitations which impeded full inspection of the property at the time of inspection. These obstructions can hide an array of defects and should be removed to allow full inspection to be carried out. A re-inspection is recommended once the areas are made accessible.

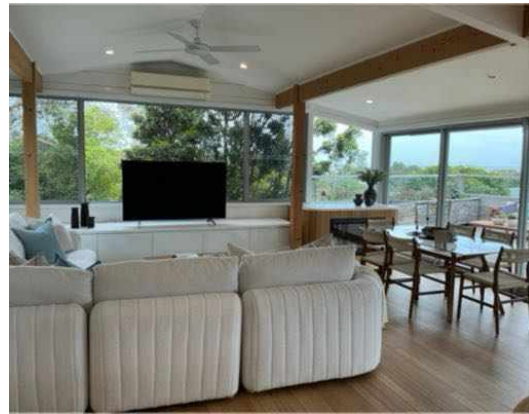
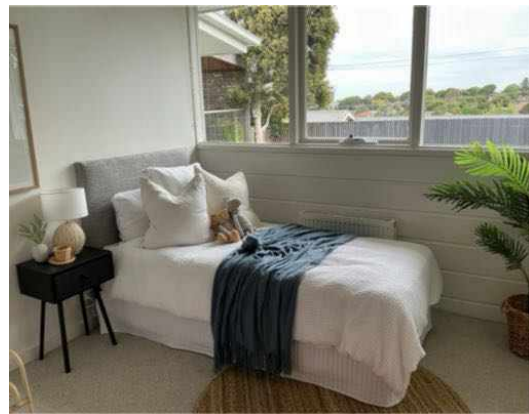
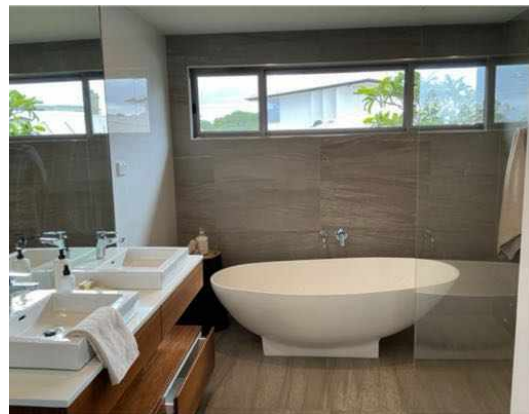
Building: Main Building
 Location: All Internal Areas
 Finding: Additional Photos - Obstructions and Limitations
 Information: These photographs are an indication of the obstructions and limitations which impeded full inspection of the property at the time of inspection. These obstructions can hide an array of defects and should be removed to allow full inspection to be

carried out. A re-inspection is recommended once the areas are made accessible.

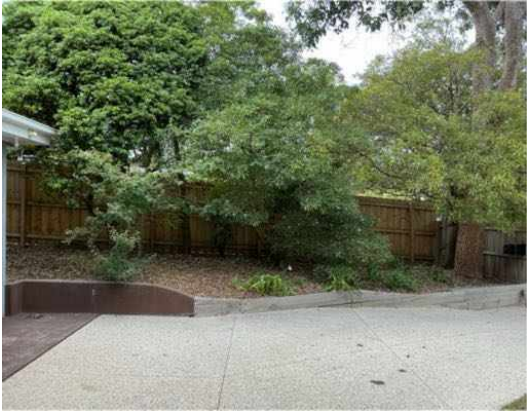
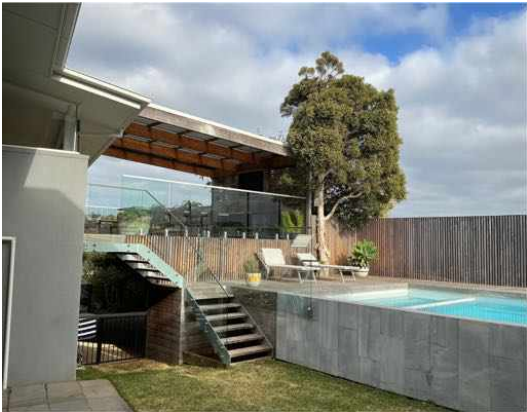
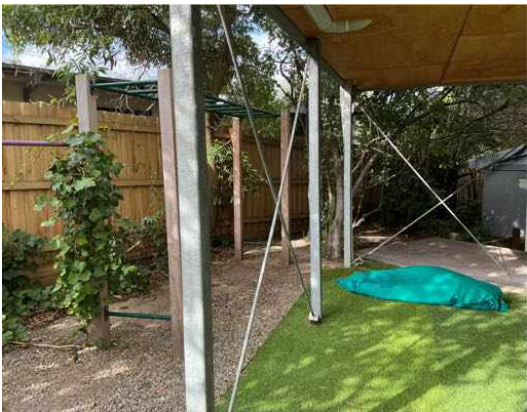
Building: Main Building
Location: Yards
Finding: large trees near property
Information: Some large trees are growing near the structure. Tree roots can cause major foundation and plumbing related issues. Recomend engaging an arborist to further investigate and advise on the severity of the root systems and any rectification works that may be required to reduce the risk of property damage and deterioration.
