Building and Timber Pest Inspection Report

Inspection Date: Mon, 16 Feb 2026

Property Address: 1/75 Hudson St, Hurstville NSW 2220,
Australia

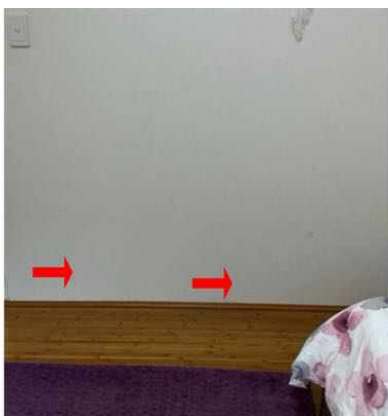
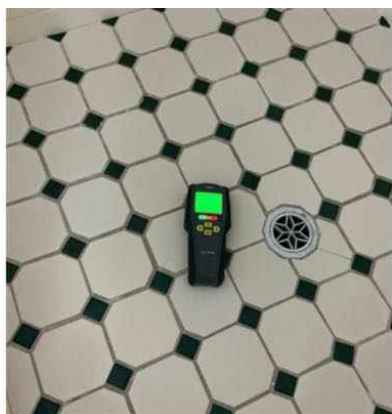
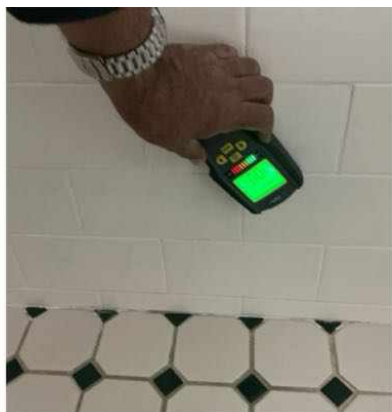
Finding 2.01

Building: Main Building
Location: Bathroom
Finding: Elevated Moisture Bathroom & Back of shower
Information: Elevated moisture levels were detected to tiled surfaces in bathroom/shower areas. The back of shower area also showed elevated moisture with visible minor deterioration evident at the time of inspection. This may be due to porous or missing grout, cracked tiles or recent use, however the possibility of waterproofing membrane failure or plumbing leaks cannot be excluded. Persistent moisture ingress can lead to concealed damage, including timber rot and mould growth. Further investigation by a licensed plumber and/or waterproofing contractor is recommended as soon as possible.

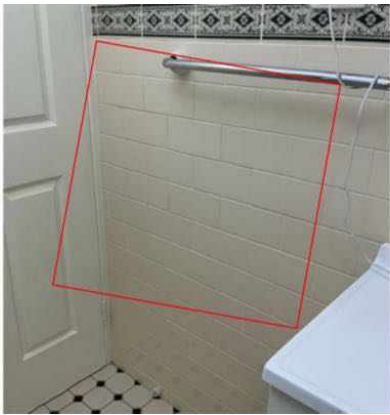
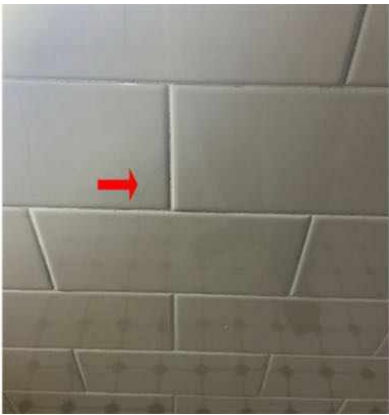
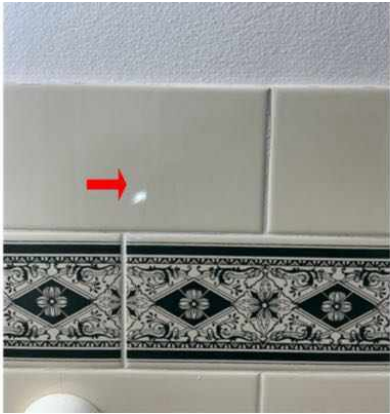
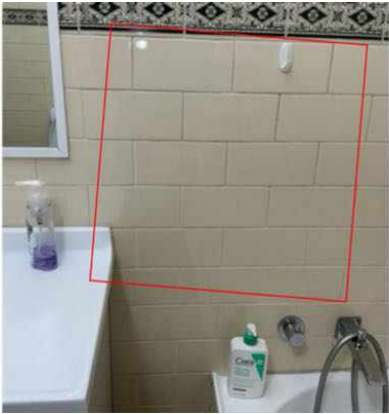
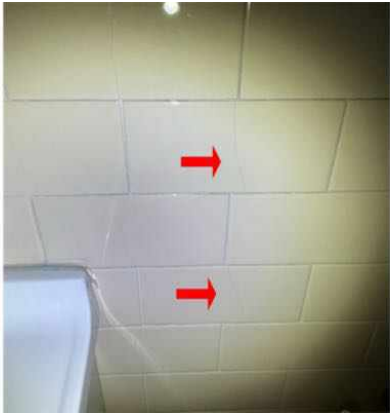
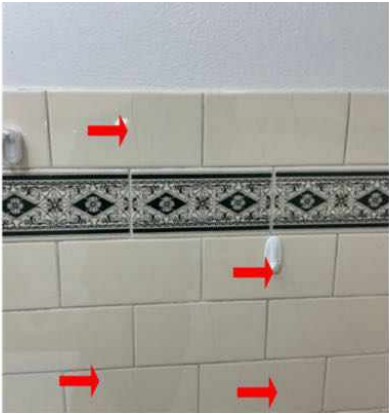
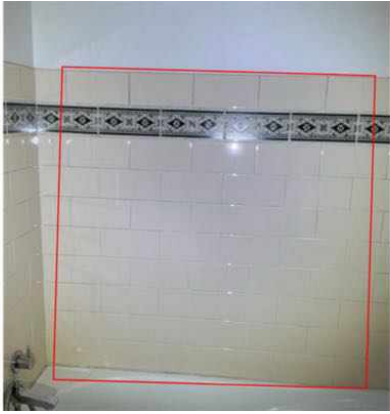
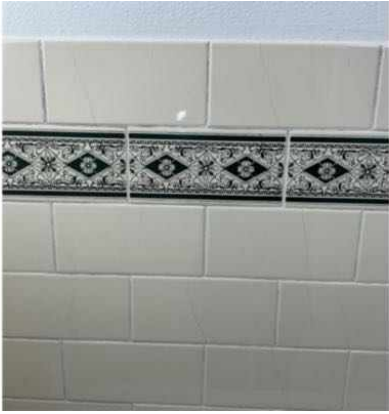
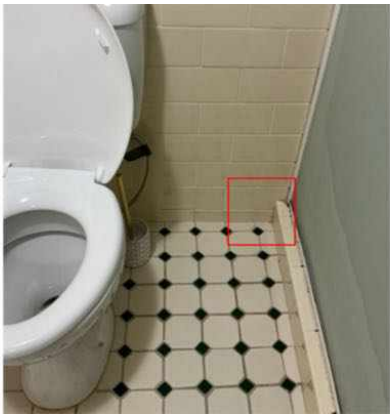
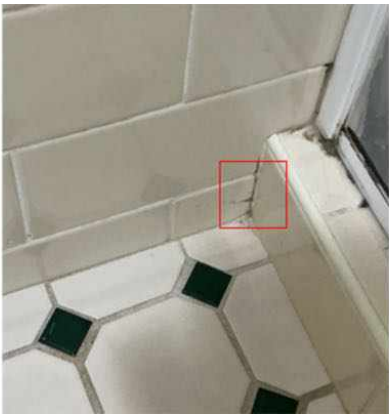
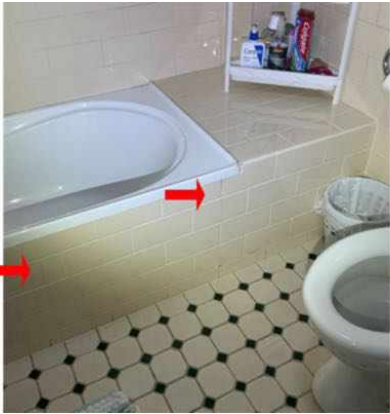
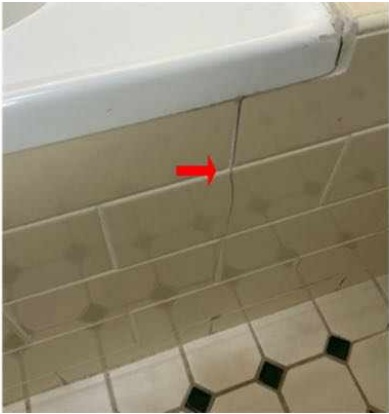
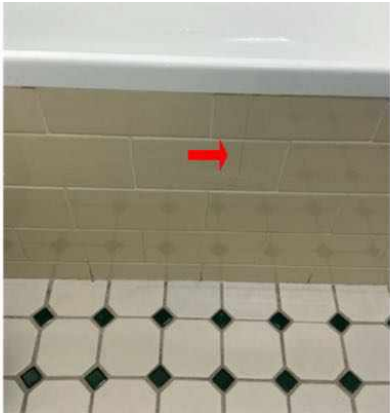
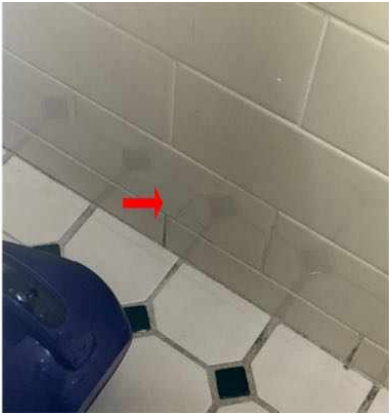
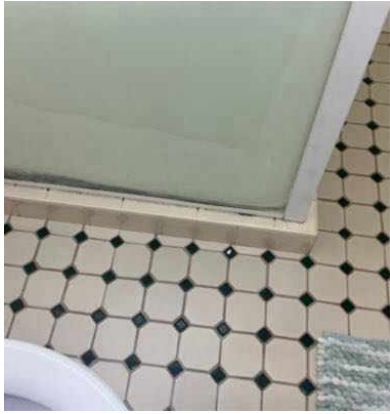
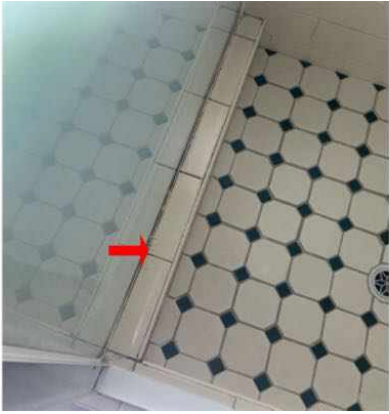
Finding 3.01

Building:	Main Building
Location:	All Internal Areas
Finding:	Tiles - Cracked or damaged
Information:	Cracking was evident to the tiling in this area at the time of inspection. While the cracking appears to be minor, this area is frequently exposed to water, allowing potential for water penetration into adjoining sections of walls or flooring.

If left unmanaged, water penetration to these areas may lead to subsequent water damage, which is likely necessitate repair work to affected building elements.

A tiling contractor should be appointed to ensure that no further water damage occurs. The re-application of silicone and grouting throughout remaining tile work is also advised, to further protect the area against water penetration.

Where water penetration has led to water damage, appointment of a relevant tradesperson may be required to repair damaged building elements.

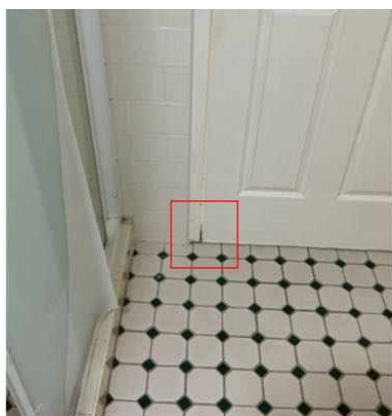
Finding 3.02

Building: Main Building
 Location: All Internal Areas
 Finding: Wet-Area Door Jambs – Moisture Staining / Decay
 Information: moisture staining and deterioration were observed at the base of the wet-area door jamb and architraves. This is commonly due to water splashing or moisture tracking from the bathroom floor into adjacent joinery or inadequate waterproof transition at the bathroom threshold.

Further inspection by a licensed waterproofing contractor is recommended to verify exact cause and remedial measures

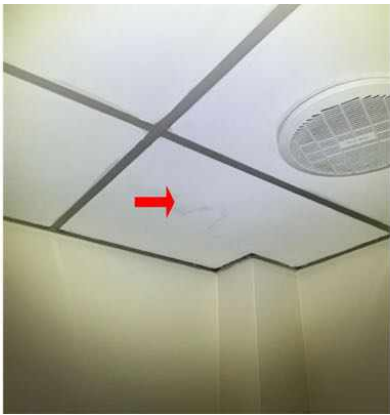
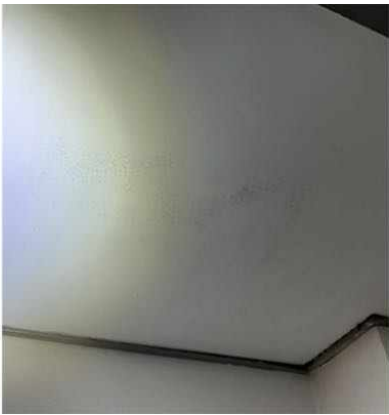
Finding 3.03

Building: Main Building
 Location: Bathroom
 Finding: Water Staining - Humidity or Ventilation
 Information: The ceiling surface in the images shows faint darkened spotting or shadowing, commonly consistent with surface mould or humidity-related staining, often found in bathroom or wet area ceilings with insufficient ventilation. While there is no visible sagging or major water damage, the pattern suggests prolonged moisture exposure, possibly due to steam accumulation or minor condensation issues. According to AS 4349.1–2007 (Appendix C), this would be classified as a minor defect unless further deterioration or active leaks are found. Recommend improving mechanical or natural ventilation, cleaning the surface with mould treatment, and monitoring for recurrence.

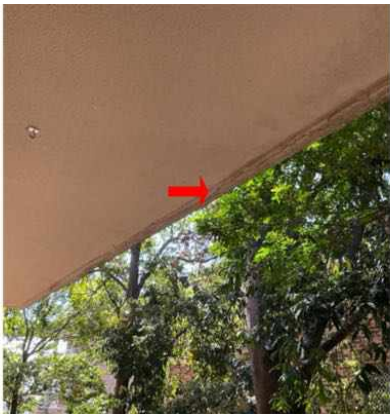
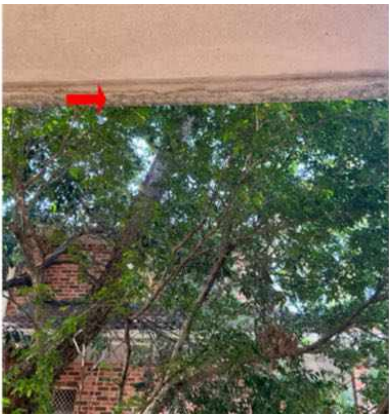
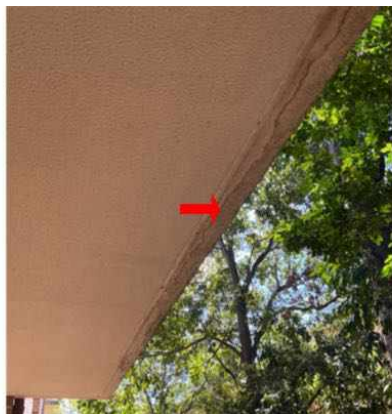
Finding 3.04

Finding: Water staining

Information: Water staining was evident in this area at the time of inspection. Water staining indicates that surfaces have been exposed to excessive moisture over time. The minerals and other elements in the water lead to staining, which may graduate to corrosion and deterioration if left unmanaged.

While mostly an appearance defect, water staining can be indicative of more serious defects, which may be currently concealed by other building elements.

Where water staining is active, a licensed plumber must be consulted to identify the cause of the staining and to provide advice on any reparation works that may be required. Replacement of any broken or damaged structures is advised.

Conversely, where water staining is old and inactive, affected building materials may be repaired or replaced at client discretion. A qualified carpenter or registered builder may be appointed to perform these works.

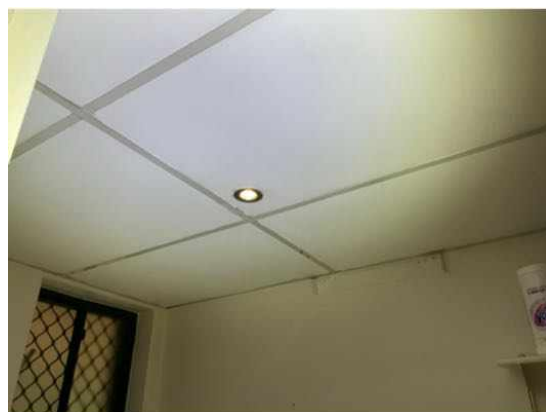
Finding 3.05

Building:	Main Building
Location:	Laundry
Finding:	Building element - Missing - No ventilation
Information:	Although some building elements may seem irrelevant or unnecessary, all building elements play a key role in the operation and function of the overall structure and its performance.

Replacement of any missing building element should be conducted as soon as possible to ensure that no damage or functional issues occur to associated building materials.

The appropriate tradesperson should be appointed as soon as possible to replace the missing building element.

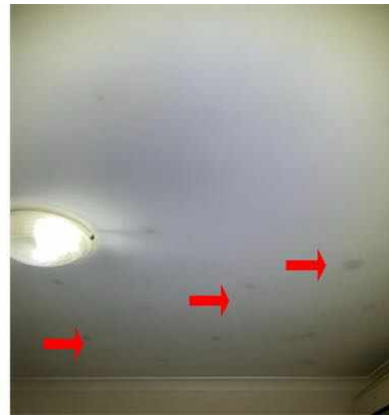
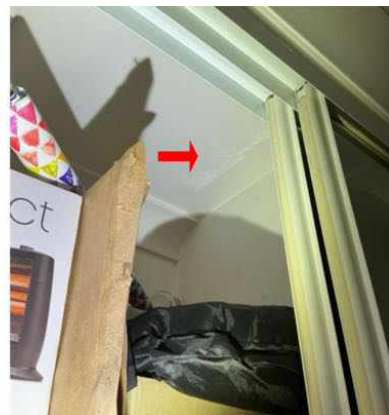
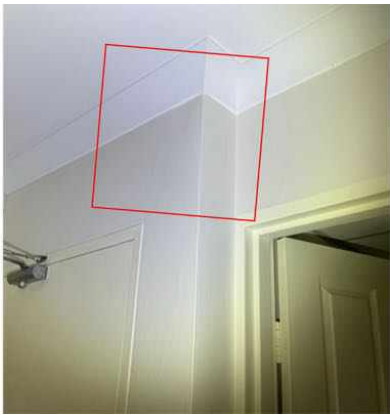
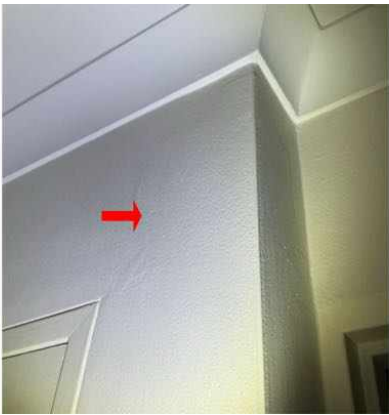
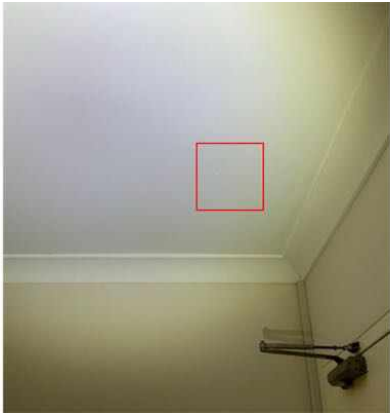
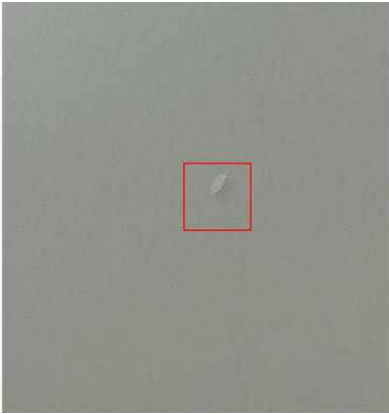
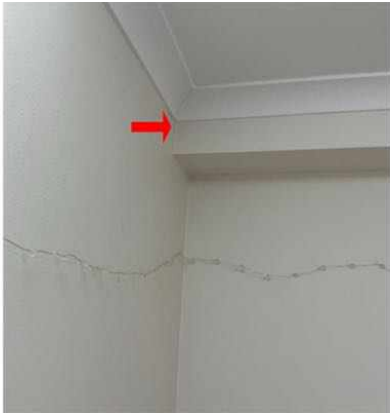
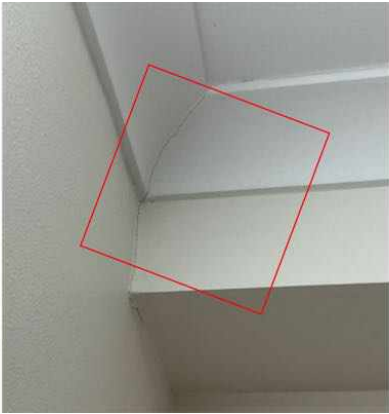
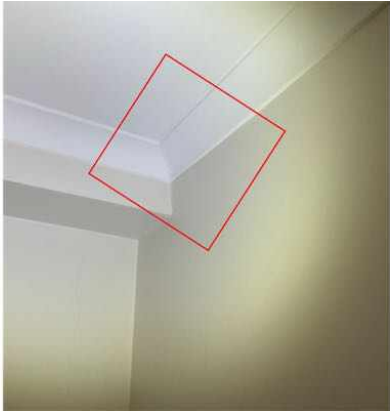
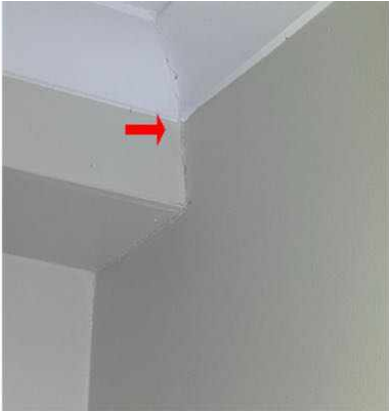
Finding 3.06

Building:	Main Building
Location:	All Internal Areas
Finding:	Paint finish and hairline cracking
Information:	The paint finish in this area was identified as being incomplete at the time of inspection including some hairline minor cracking.

Whilst incomplete or missing paint finish is generally an appearance defect, it can also lead to the development of secondary building defects over time. Incomplete areas of paint finish expose the area to moisture, potentially accelerating the deterioration of underlying building materials.

Incomplete paint finishes should be sanded back, filled, leveled and painted, as applicable. Where inadequate or missing paint protection has led to the deterioration of the associated building element, repair and/or replacement of this building element may be required.

A painting contractor should be appointed as soon as possible to perform necessary works to aid the appearance of the affected area and to ensure the area is protected against further deterioration. Alternatively, the homeowner following manufacturer instructions may perform these works.

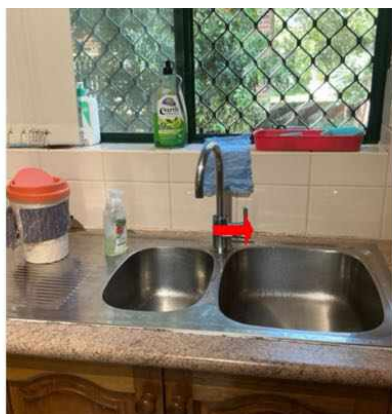
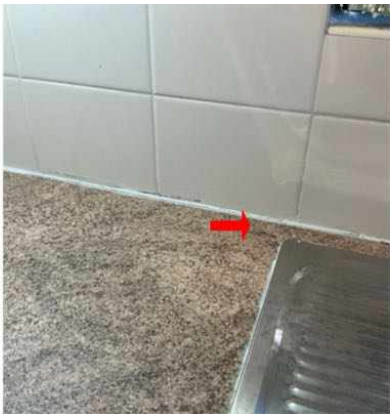
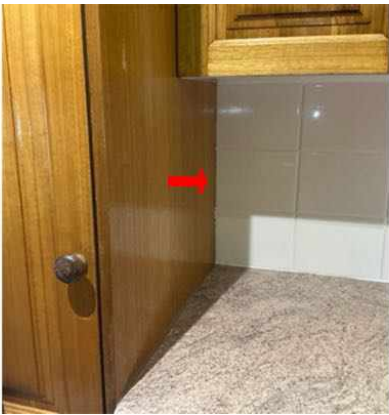
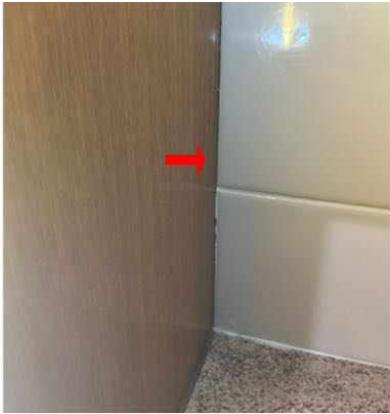
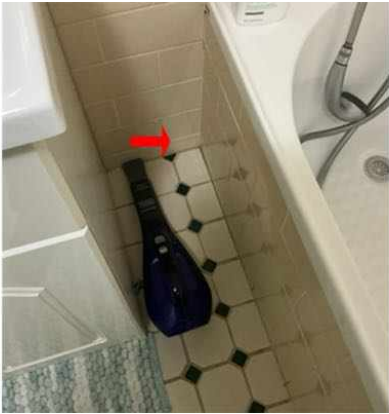
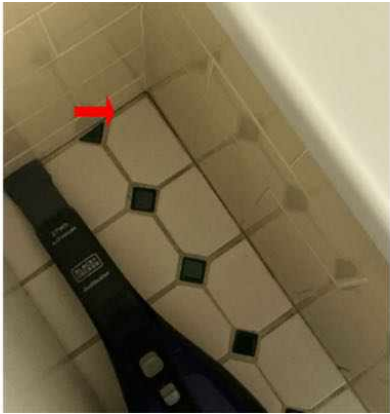
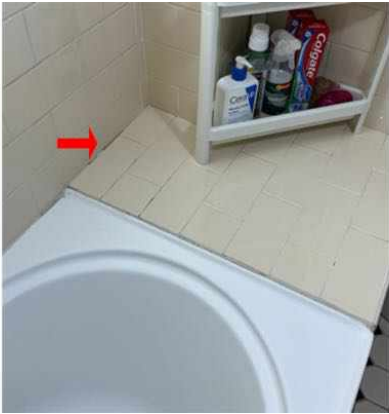
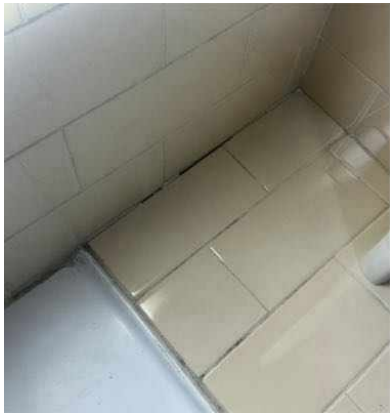
Finding 3.07

Building:	Main Building
Location:	All Internal Areas
Finding:	Sealant and grouting - Missing or degraded
Information:	It was noted on inspection that sealant or grout is degraded. There is also evidence of poor workmanship and excessive use of sealant. Silicone should never be used as a first line of defence against waterproofing. Further inspection by a licensed waterproofing contractor is highly recommended.

Different materials and floor areas move at different rates, generally causing cracking to grout or sealant at this point. A flexible sealant is required to allow for expected expansion and contraction, while keeping the joint water tight and protective of all associated building materials.

There appears to be excessive mould to the sealant and grout which will likely require scraping out and replacement.

Flexible and mould resistant materials should be applied to affected areas to prevent any subsequent water damage that is likely to occur. Regular maintenance and replacement of damage or missing or damaged sealant and grout is highly recommended to the wet areas, as this is a regular wear and tear defect. Sealant and grouting in areas that come into regular contact with water should be maintained for the long term care of your property.

A sealant specialist or tiling contractor should be appointed to complete these works as soon as possible.

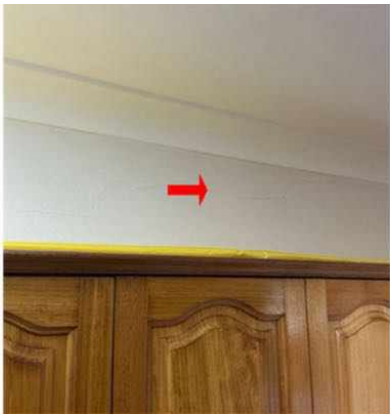
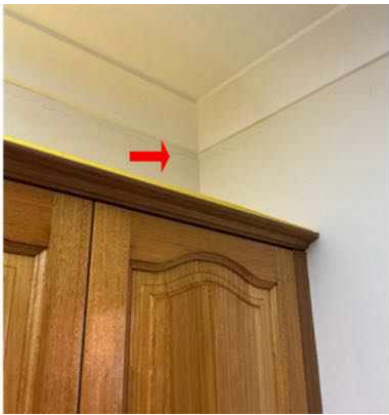
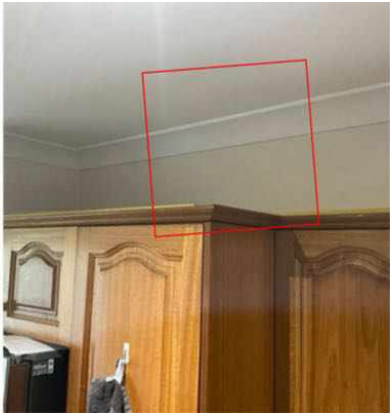
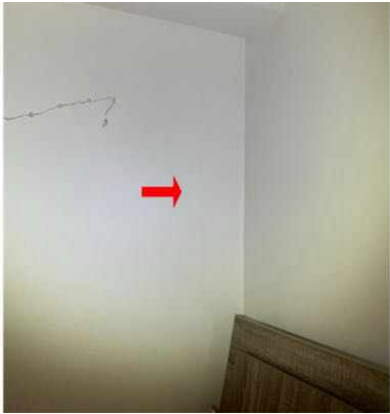
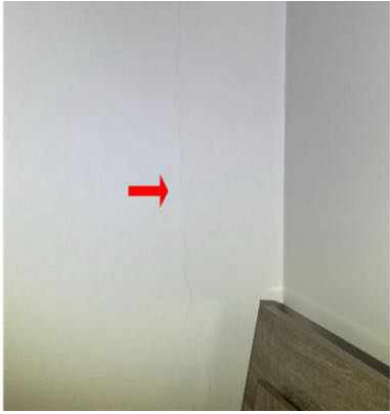
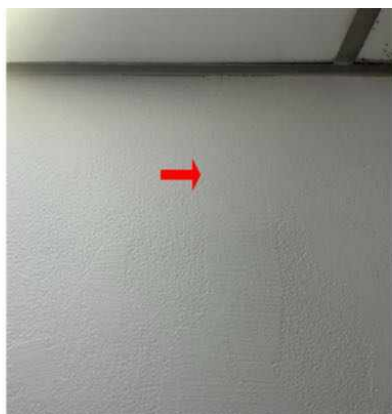
Finding 3.08

Building: Main Building
Location: All Internal Areas - Kitchen , Lounge, bedroom, bathroom
Finding: Cracks to internal render - Category 1
Information: It has been observed that cracking to internal rendered surfaces has occurred. The degree of damage falls within Category 1, described as fine cracks that do not need repair and which are less than 1.0mm in width limit.

Damage of this category is not considered a defect for rectification. Always contact your building inspector should cracks widen, lengthen, or become more numerous.

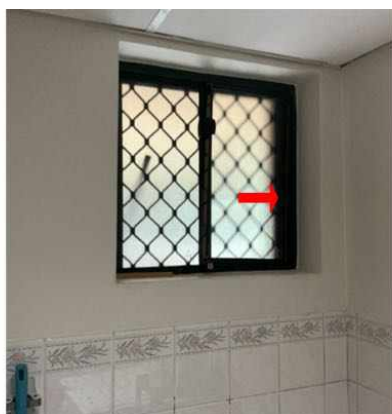
Finding 3.09

Building:	Main Building
Location:	Laundry
Finding:	Building element - Damaged - Window not sliding and out of track
Information:	Breakage occurs generally when the building materials have either aged and decayed, or as a result of damage (accidental or deliberate).

Repair and/or replacement of broken elements is advised to ensure that additional secondary defects do not arise as a consequence. Such works are necessary, as all building elements play a key role in the operation and function of the overall structure and its performance.

A relevant tradesperson should be appointed to repair or replace the affected building element prior to any subsequent damage being caused.

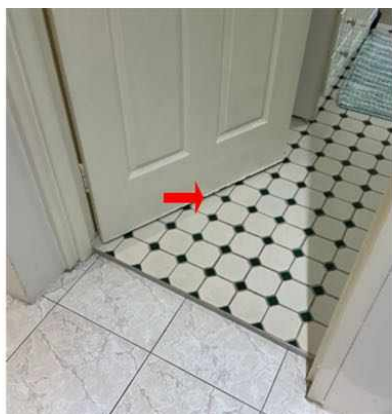
Finding 3.10

Building:	Main Building
Location:	Bathroom, Laundry
Finding:	Delamination of timbers
Information:	Delamination is one means by which composite materials (e.g. layered timber composites) may fail over time. In laminated materials, repeated cyclic stresses may

lead to the formation of mini-structures of separate layers, with significant loss of mechanical toughness. Water penetration or the presence of excessive moisture also generally contributes to delamination.

Where building materials have become delaminated, they lose their structural strength, and are likely to have a variety of appearance and serviceability defects as a result.

Delamination of timbers may be repaired where the area affected is minor and/or easily accessible, by gluing and screwing layers back together. However, this is an interim repair, and where delamination has occurred, the client should plan for the replacement of affected timbers sooner than would otherwise be expected.

All timber structures affected by delamination should be replaced as soon as possible to avoid any further damage. Repair and replacement estimates should be sought from a registered builder or qualified carpenter.

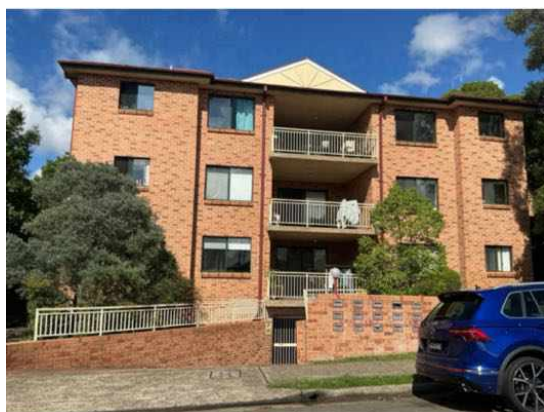
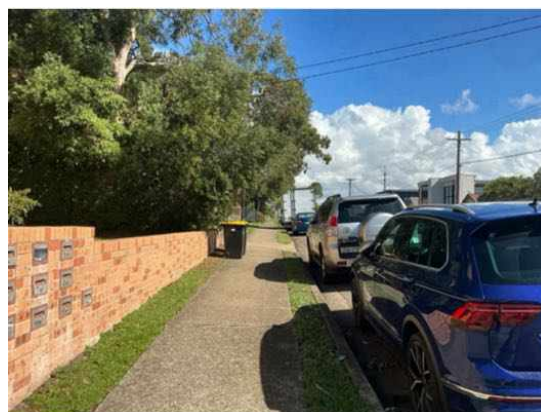
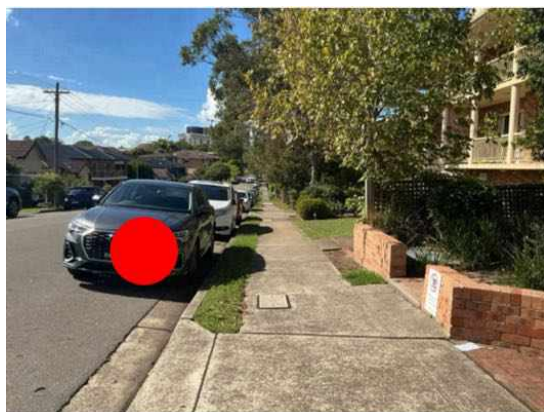
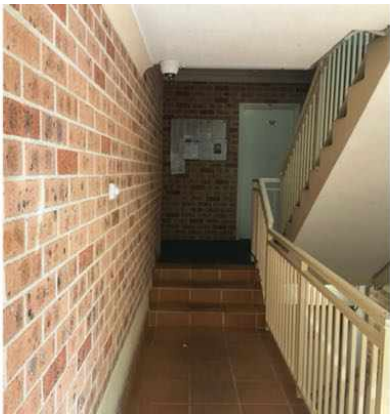
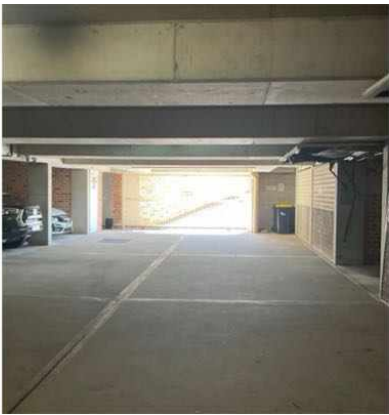
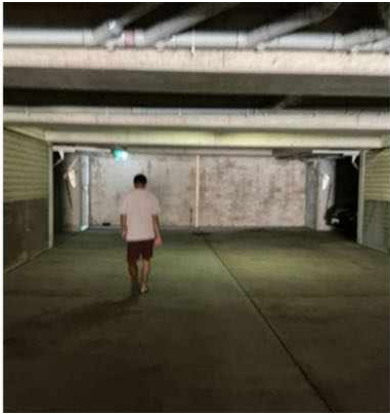
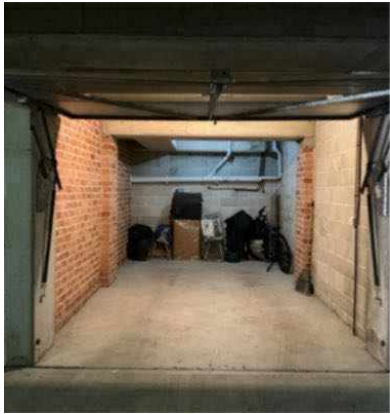
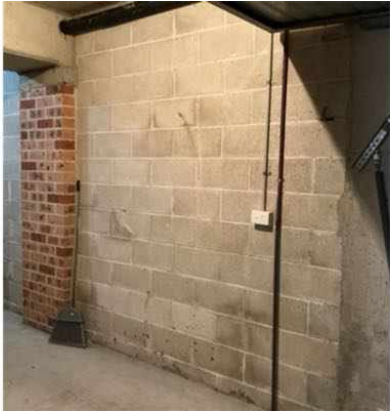
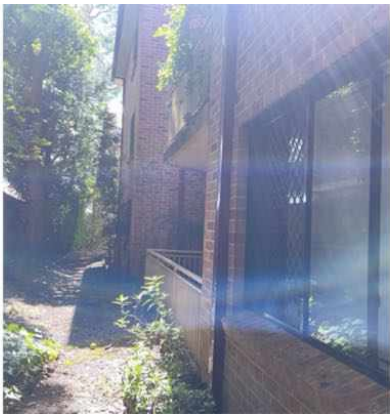
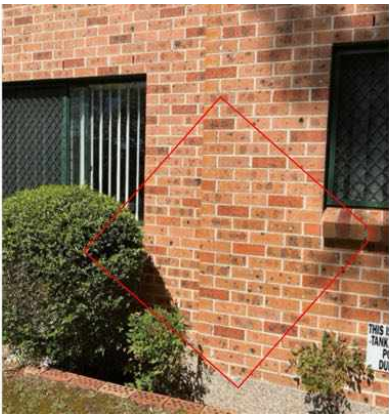
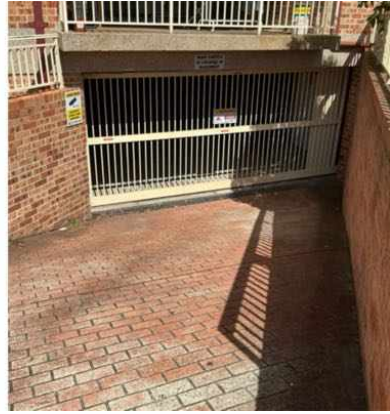
Building: Main Building
Location: All External Areas
Finding: Additional Photos - Obstructions and Limitations
Information: These photographs are an indication of the obstructions and limitations which impeded full inspection of the property at the time of inspection. These obstructions can hide an array of defects and should be removed to allow full inspection to be carried out. A re-inspection is recommended once the areas are made accessible.

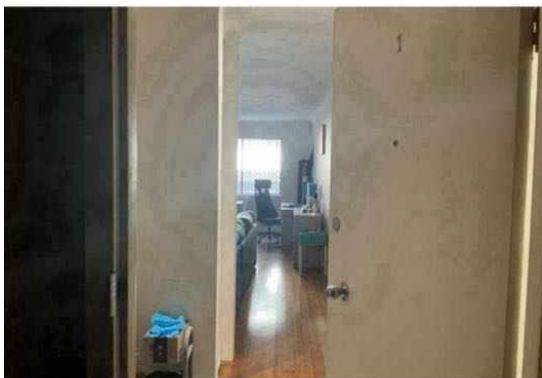
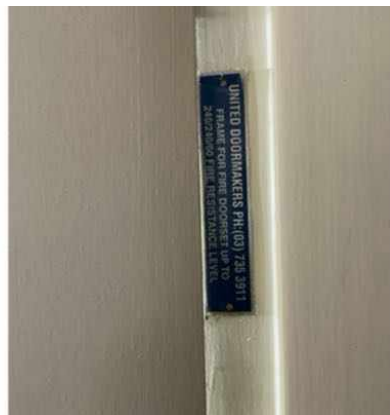
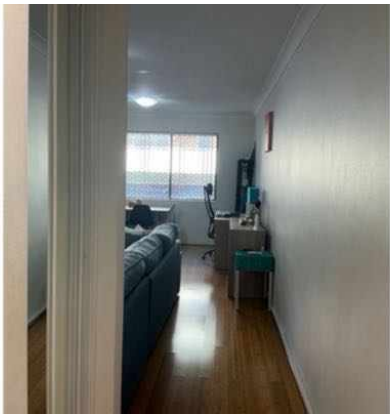
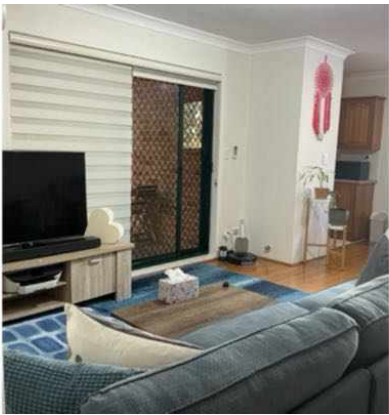
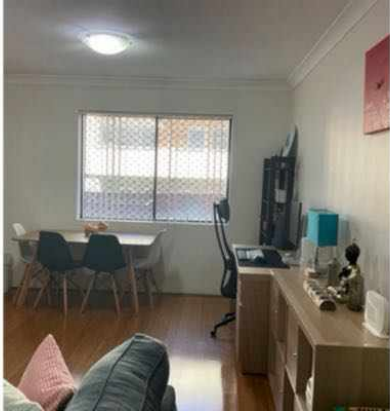
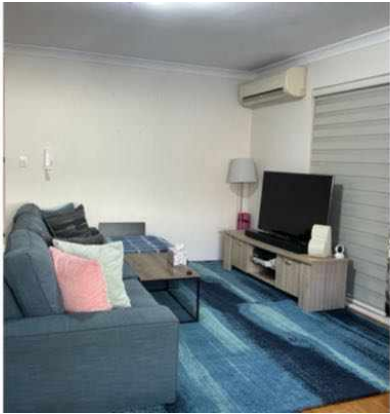
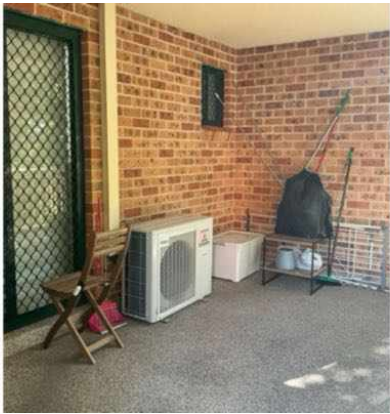
Building: Main Building
Location: All Internal Areas
Finding: Additional Photos - Obstructions and Limitations
Information: These photographs are an indication of the obstructions and limitations which impeded full inspection of the property at the time of inspection. These obstructions can hide an array of defects and should be removed to allow full inspection to be carried out. A re-inspection is recommended once the areas are made accessible.
