Building and Timber Pest Inspection Report

Inspection Date: Fri, 30 Jan 2026

Property Address: 657 Ryan Rd, Glenroy NSW 2640, Australia

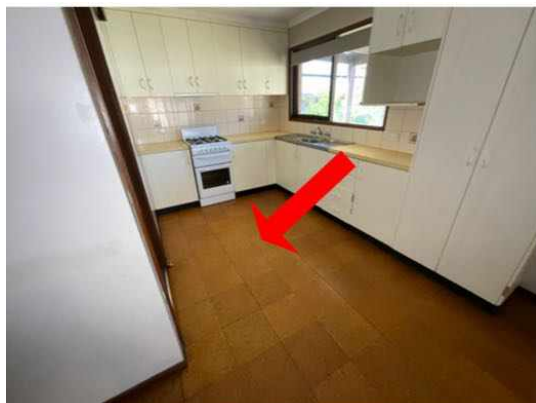
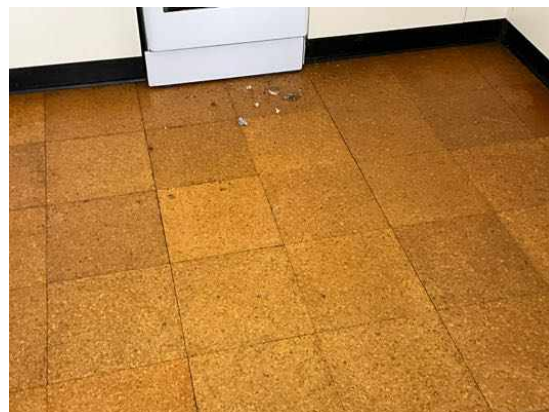
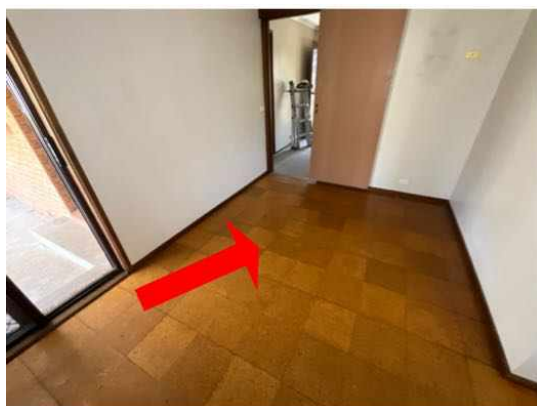
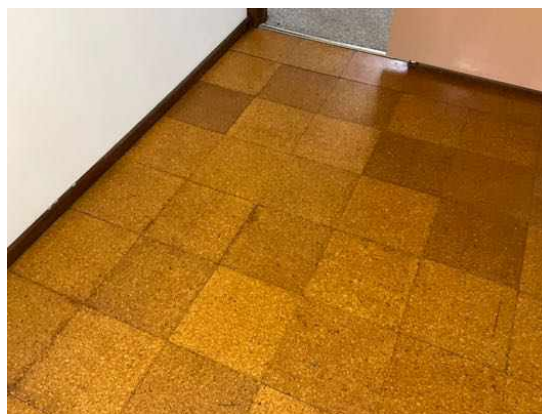
Finding 3.01

Building: Building 1

Location: Kitchen, dining

Finding: Floors - bouncy

Information: The internal flooring in this area was identified as being bouncy at the time of inspection. A bouncy floor surface generally presents as a discernible change in level as they are walked across, in noisy or creaking flooring, or in consequent movement of surrounding furniture and fixtures.

Bouncy floors generally indicate that the floorboards or the subfloor structures are coming loose from the joists that they are installed on. Bouncy flooring may also be the result of gaps between flooring and stumps or joist structures, which require packing.

The client is advised to seek quotations for required repairs from a Registered Builder specialising in re-stumping. The potential resolution may range from packing gaps in subfloor structures through to replacement of subfloors stumps and refixing of flooring.

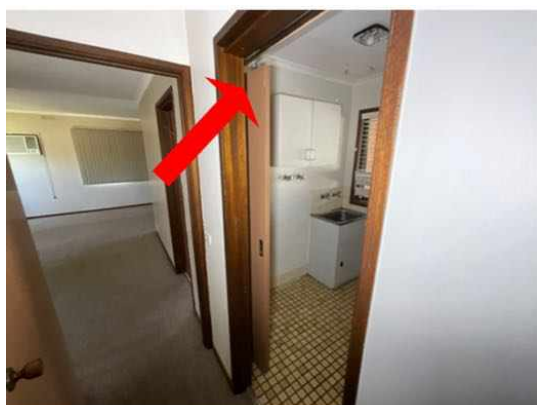
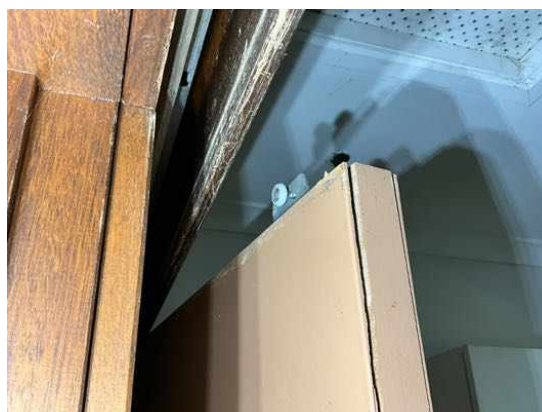
Finding 3.02

Building: Building 1
 Location: Laundry
 Finding: Door- Stiff to slide
 Information: The door in this area was jammed and difficult to slide along the associated tracks at the time of the inspection. Restricted function of the affected door may pose as a potential safety hazard if required for emergency egress from the building.

Generally, factors such as general age of the building element and a lack of maintenance are the usual causes for this type of defect.

Replacement of door hardware or tracks may be required, as well as minor repairs and cleaning. A registered builder or general handy person will be required to repair the affected doors.

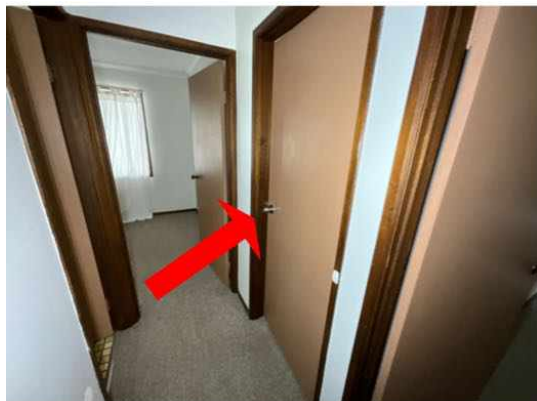
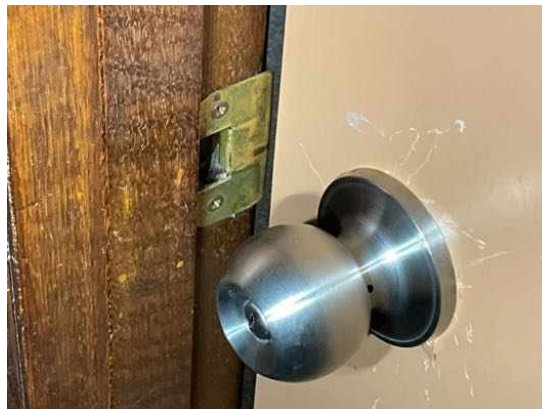
Finding 3.03

Building: Building 1
 Location: Bedroom 2
 Finding: Door - Striker plate misaligned
 Information: The striker plate to this door appears to have become misaligned and has consequently resulted in the door's operation being compromised.

This is a common defect and is expected in a property of this age, whether being due to substandard installation or general deterioration of the door hardware.

Readjustment of the striker plate is recommended at client discretion. Works such as these can be completed by a general handyman or qualified carpenter.

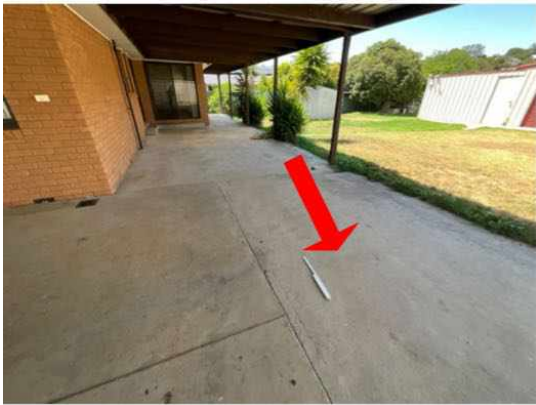
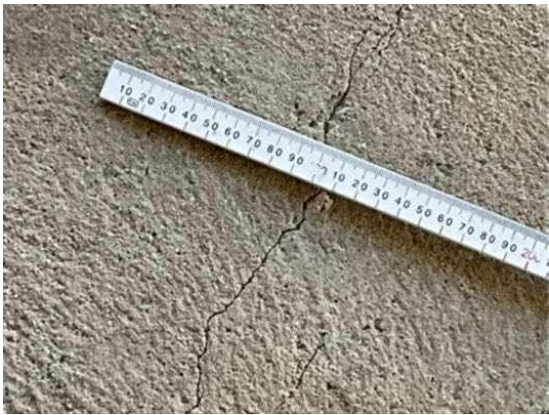
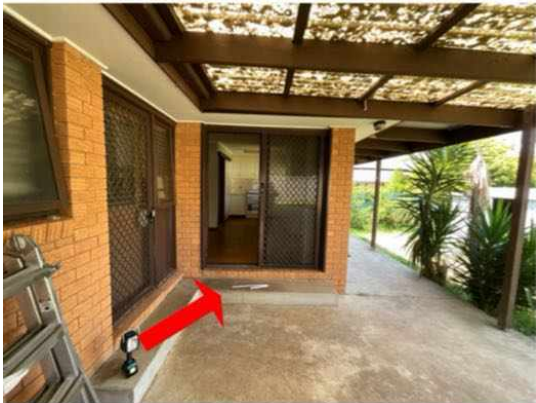
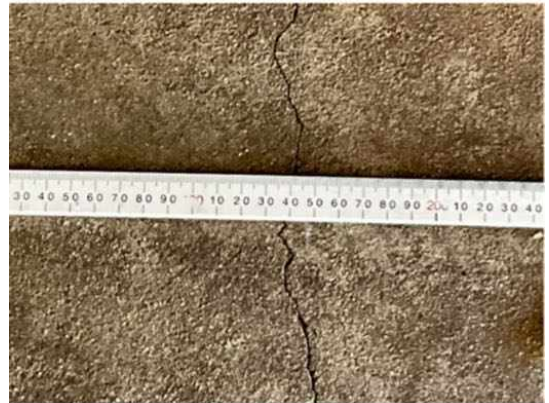
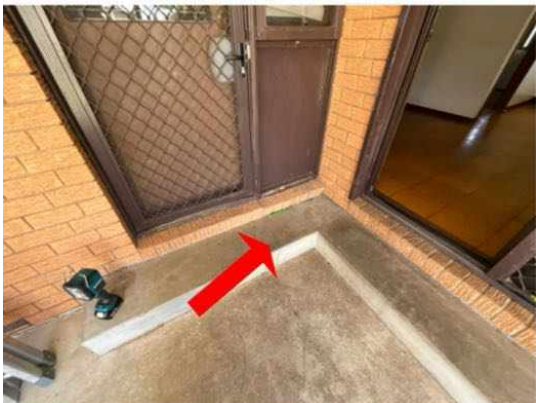
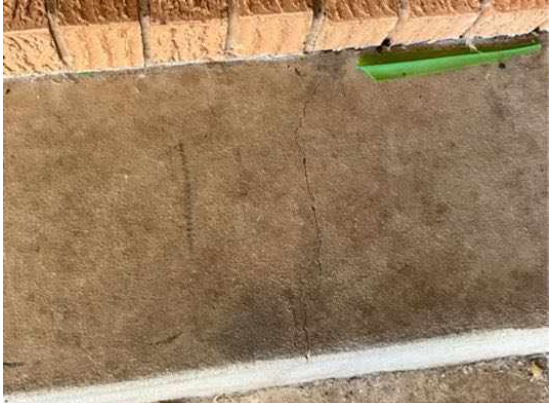
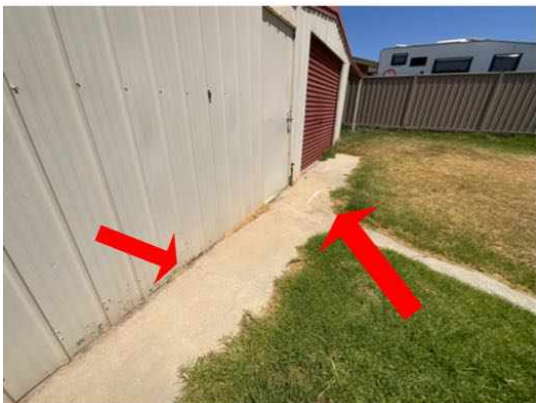
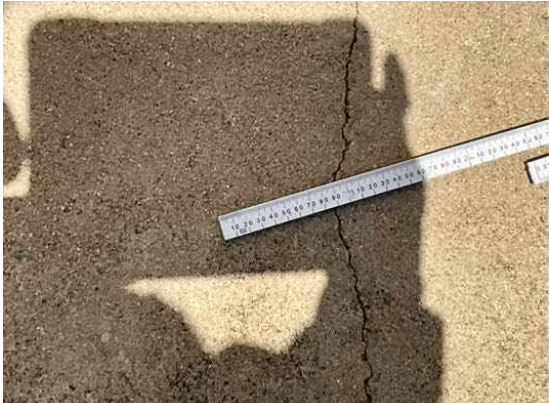
Finding 3.04

Building:	Building 1
Location:	Carport, back door, back yard
Finding:	Cracking - External Concrete Paving Damage Category 1 - Fine (less than 2mm)
Information:	Fine cracks were identified in external concrete paving. Although fine cracks are quite noticeable, they are often only considered to be an appearance defect, and usually do not indicate any structural damage. To be considered a Category 1 or fine crack, the crack is found to be less than 2mm in width.

Generally the cause of a hairline crack in existing concrete paving such as driveways and pathways is indicative of the expansion and contraction of the concrete. Such causes are generally due to environmental factors, such as moisture levels, weather conditions, root systems of nearby trees or the soil types on which they are laid.

Fine cracks may also be due to poor original installation of the concrete. Factors such as poor compaction of the sub surface and/or inadequate reinforcing of the slab may create cracking and other secondary defects.

Monitoring of all cracking should be conducted frequently. Always contact a building inspector should cracks widen, lengthen, or become more numerous.

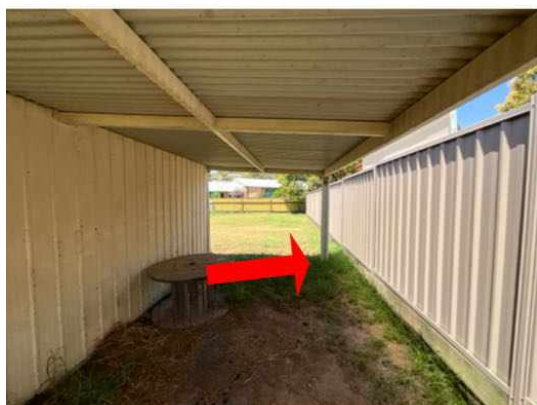
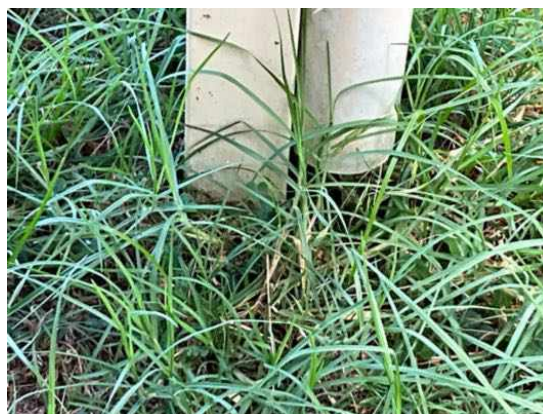
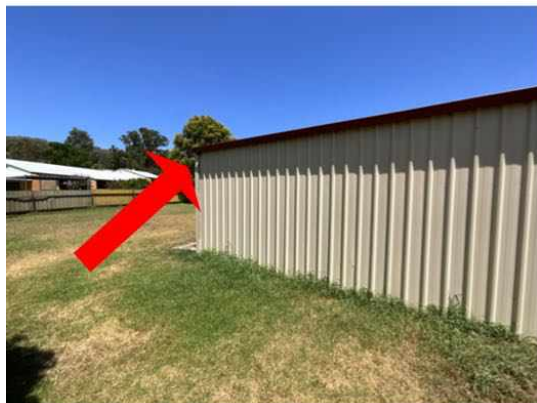
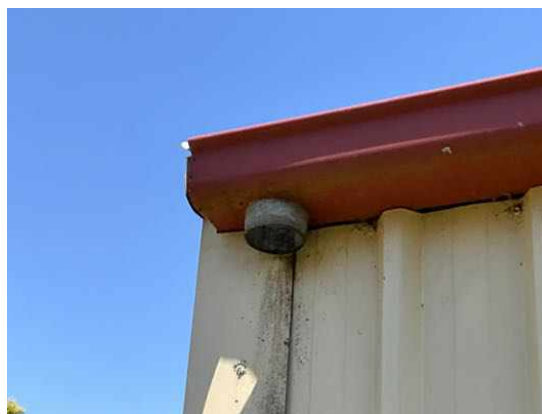
Finding 6.01

Building: Building 1
Location: Garage
Finding: Stormwater drain - Not connected
Information: The roof plumbing is not adequately connected to stormwater drainage on the site. This disconnection negatively impacts the functional capacity of the roof plumbing.

Where roof plumbing doesn't drain adequately, the area at the base perimeter can become excessively damp, potentially creating an environment that is susceptible to rust and corrosion of surrounding building elements, as well as attracting termites and other pests.

It is highly recommended that a plumber be appointed to further inspect the area and to install adequate drainage equipment where necessary.

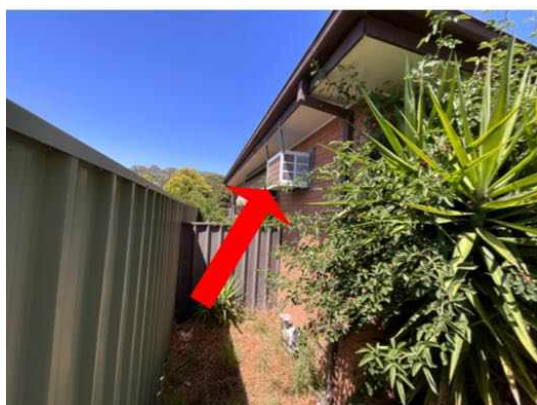
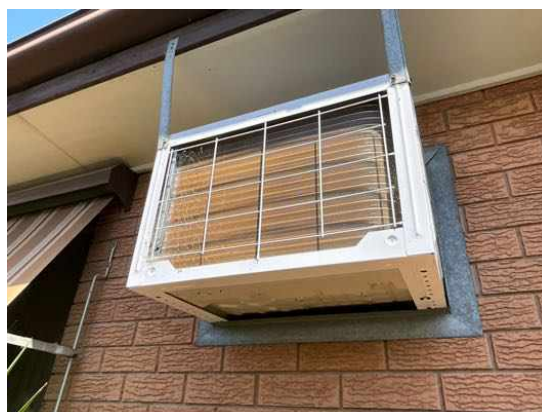
Finding 6.02

Building:	Building 1
Location:	Yard - Side
Finding:	Air conditioner - Disconnected overflow
Information:	The Air Conditioner (A/C) overflow was found to be disconnected from storm water drainage and is creating excessive moisture in the surrounding area.

Such leaking creates an environment which is conducive to an array of defects, including water damage to associated building elements and the attraction of termite or timber pest infestation.

It is highly recommended that a licensed plumber be appointed to connect the A/C overflow in order to prevent such an environment from being created. These minor works should be carried out as soon as possible.

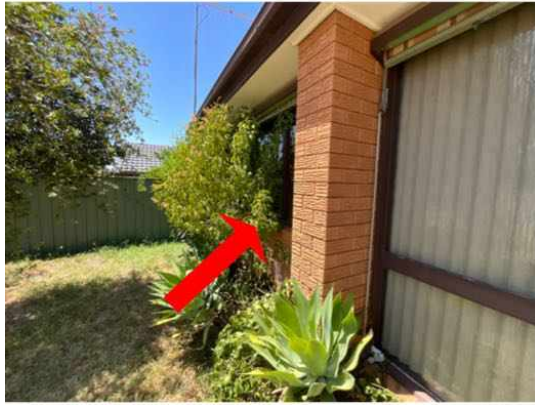
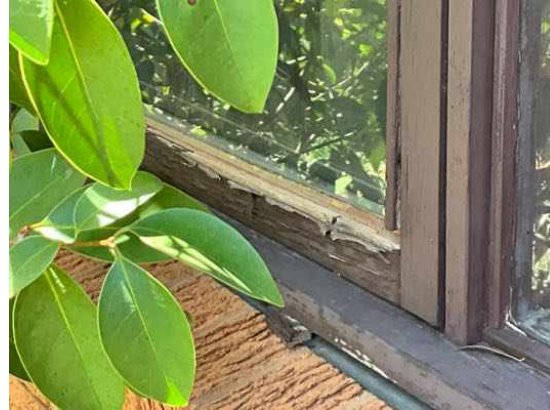
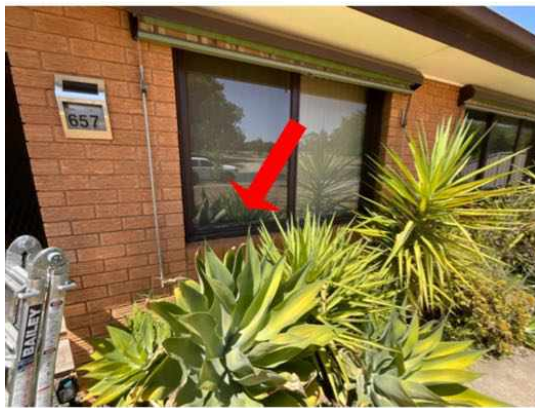
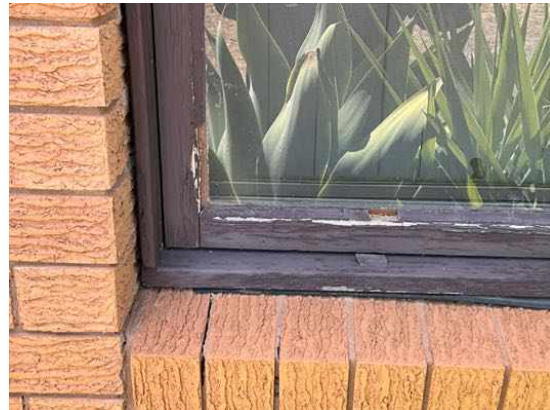
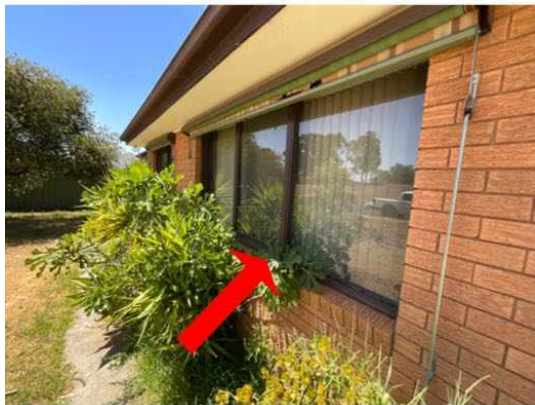
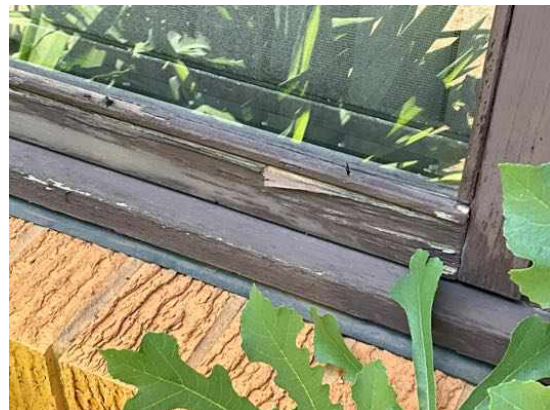
Finding 6.03

Building:	Building 1
Location:	Timber windows
Finding:	Timber - exposed to weather
Information:	External timbers that are frequently exposed to harsh weather conditions require adequate protection in order to maintain their condition. Where timbers have not been

painted or treated adequately, general deterioration is likely to occur at an accelerated rate.

If left unattended, replacement of these timbers is likely to be necessary in the short-term future. Adequate treatment of these timbers is required as soon as possible by a painting contractor or general handyman.

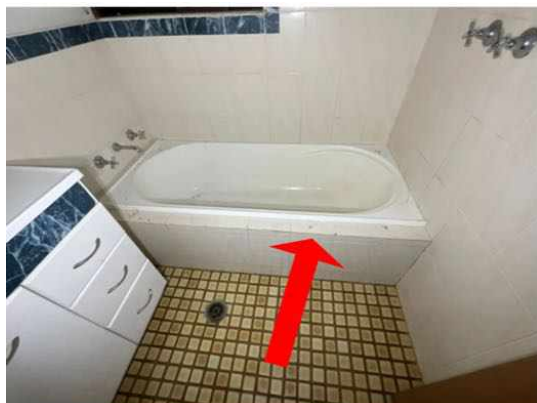
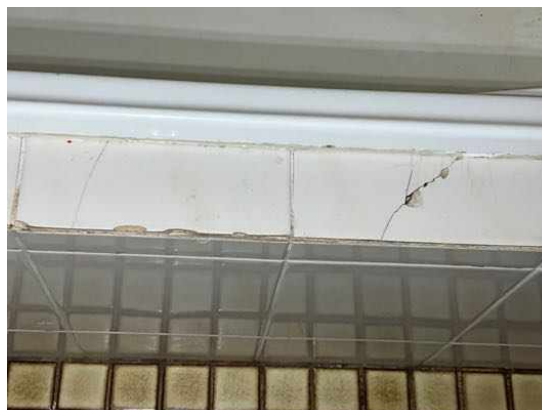
Finding 6.04

Building:	Building 1
Location:	Bathroom
Finding:	Wall Tiles- Cracked

Information: Cracked tiles within the household detract from the overall appearance of the affected areas, as well as creating potential for water penetration to adjoining building elements. If left unmanaged, water damage may occur as a result of constant water penetration over a prolonged period of time.

While not considered a matter of urgency, replacement of tiles is advised as a solution. A Tiling Contractor may be appointed to perform these works at client discretion.

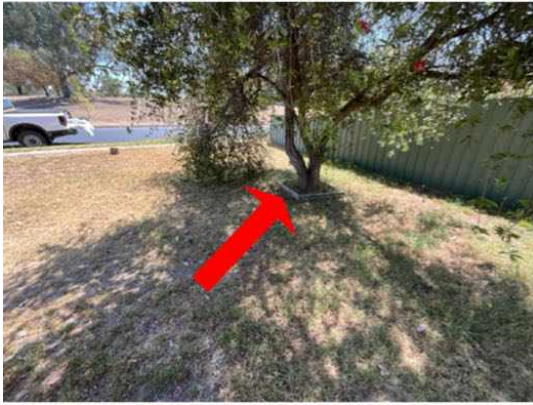
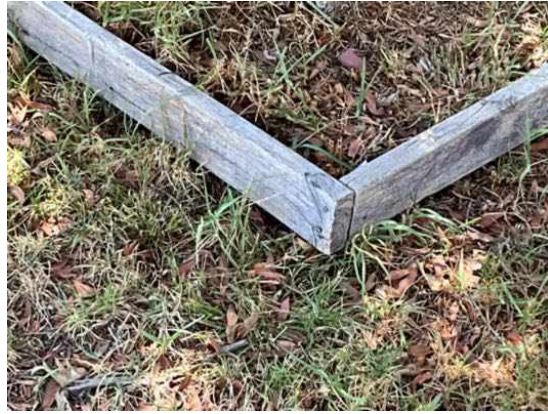
Finding 6.05

Building: Building 1
 Location: Yard - Front
 Finding: Untreated or non-durable timbers in a hazardous environment
 Information: To reduce the risk of timber pest attack it is essential that timber used in a hazardous environment (e.g. in direct contact with the ground or frequently exposed to damp conditions) is of sufficient durability and/or is adequately preservative treated.

Untreated timbers in direct contact with the ground are likely to develop severe wood rot and/or fungal decay if left unattended creating attraction for subterranean termites to infest the timbers from surrounding areas.

If untreated or non-durable timbers are found to be in a hazardous environment it is highly advised that replacement of these building elements be performed as soon as possible to aid the protection of the property against termite / timber pest attack.

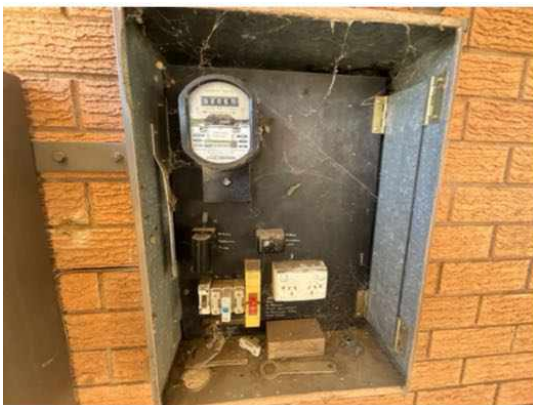
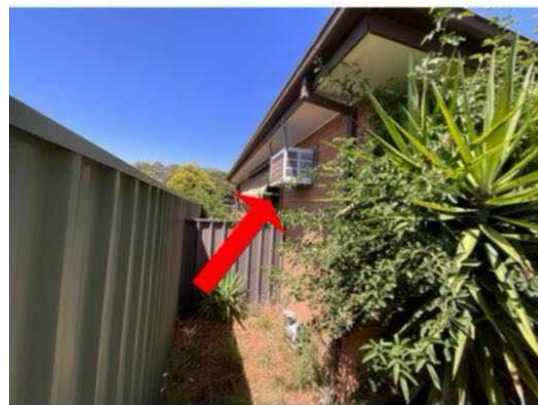
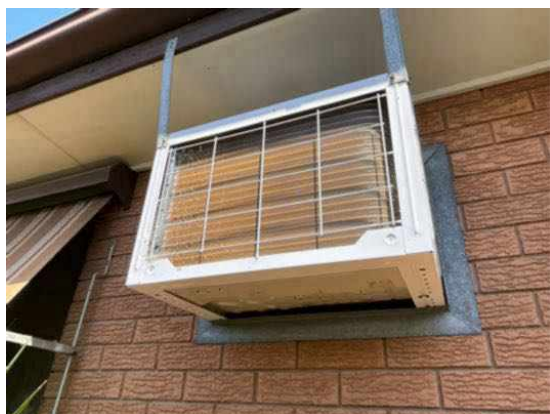
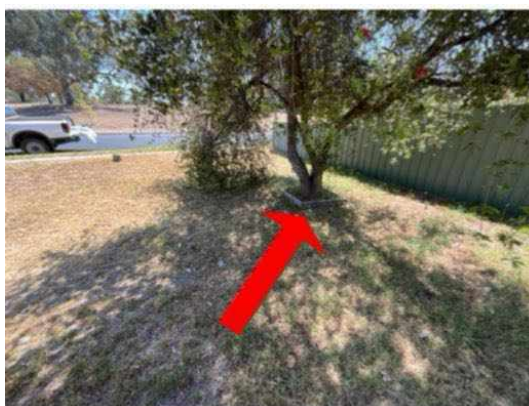
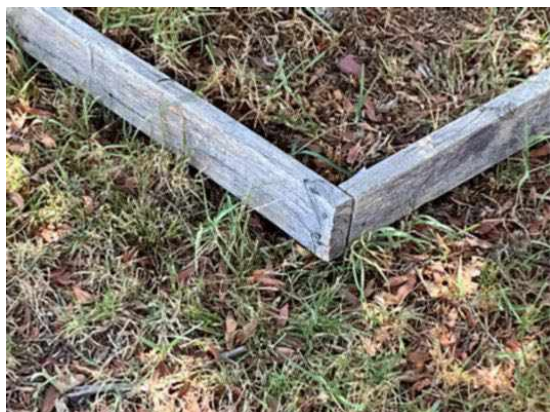
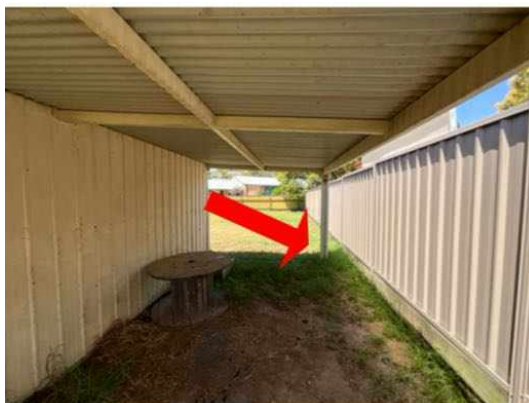
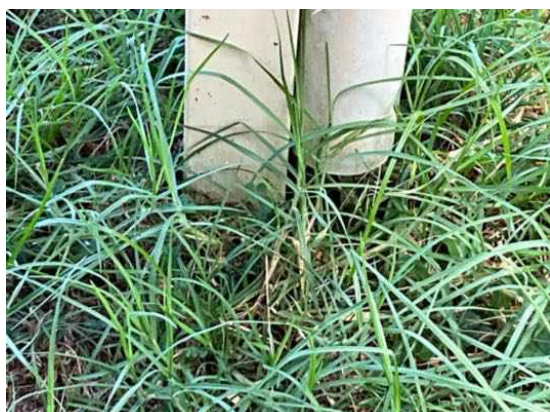
Finding 6.06

Building:	Building 1
Location:	All External Areas
Finding:	Termite Management System - no evidence of a chemical installation
Information:	The application of a post-construction chemical termite barrier is highly recommended for all properties, particularly if live termite activity has been found on the site previously. Such barriers are highly effective in preventing termite attack on any timber building elements throughout the property.

A durable notice should be placed in the switchboard unit to indicate current termite barriers. At the time of inspection, it appeared as though no termite management system has been installed, with no evidence to suggest preventative works taking place.

The client may consider gaining further advice from a pest controller as to the costs and procedures involved with this application. It is recommended that obtaining such advice be a short-term priority.

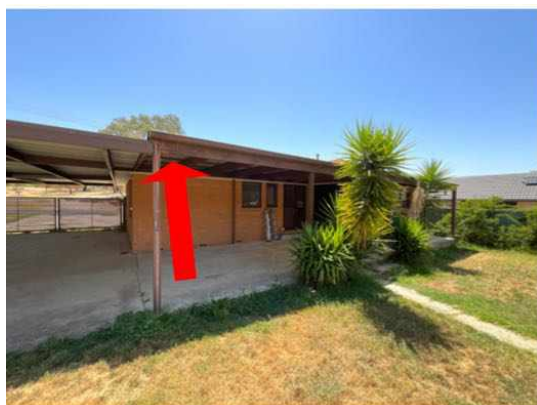
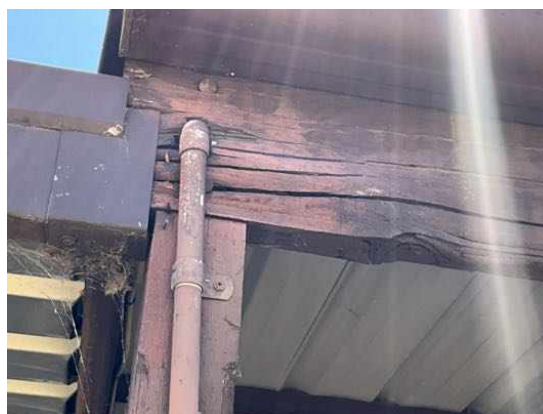
Finding 7.01

Building:	Building 1
Location:	Verandah
Finding:	Fungal decay - present (localised)
Information:	Fungal decay also known as wood decay or wood rot generally refers to the deterioration of timber elements when in contact with excessive levels of moisture for a prolonged period of time.

The development of fungal decay is accelerated by temperatures in the range of 5degreeC to 40degreeC as well as the presence of oxygen. Generally fungal decay develops on timber elements that are in use in an external environment which are exposed to rain penetration.

In this case although the affected timber element is in a decaying state the extent of any visible damage appears to be localised to a specific area and is yet to spread to other parts of the building element or affect adjoining structures. The fungal decay is therefore likely to be of a relatively superficial nature with minimal impact on the structural integrity or tensile strength of the timber element.

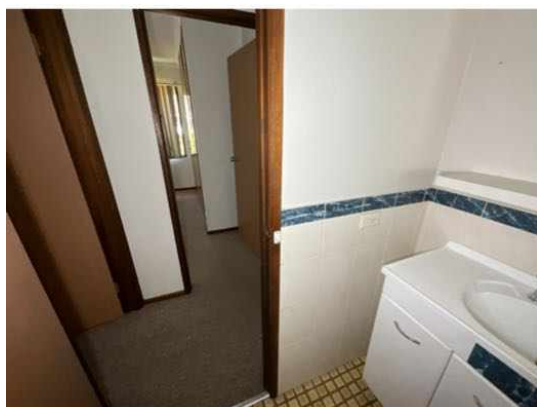
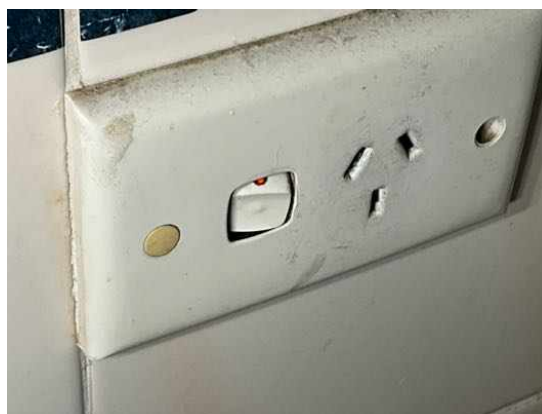
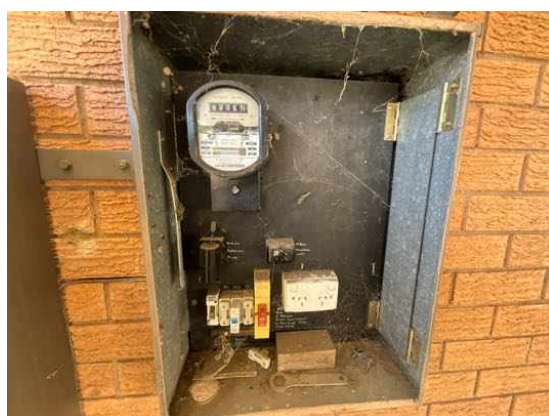
Building: Building 1
 Location: All Areas
 Finding: Electrical elements- deteriorated
 Information: Deteriorated and damaged electrical elements were identified during the course of the visual inspection. Deteriorated electrical wiring and elements represent a potential safety hazard including for fire and personal contact.

Contact a licensed electrician urgently for further inspection, investigation and rectification.

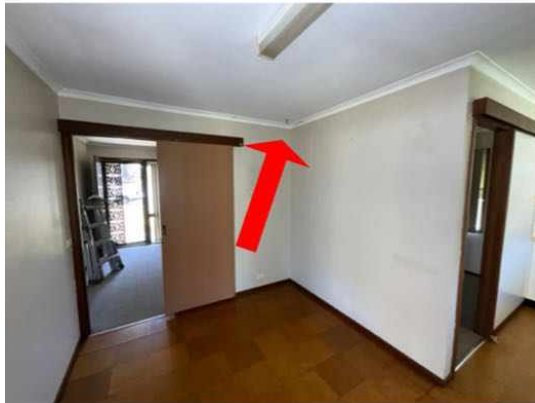
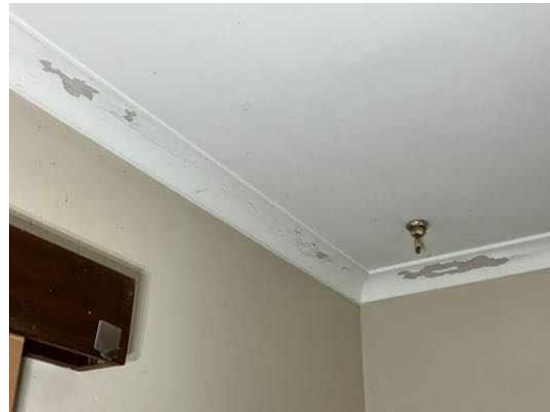
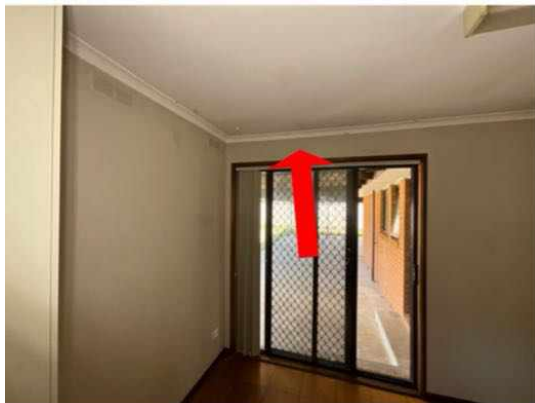
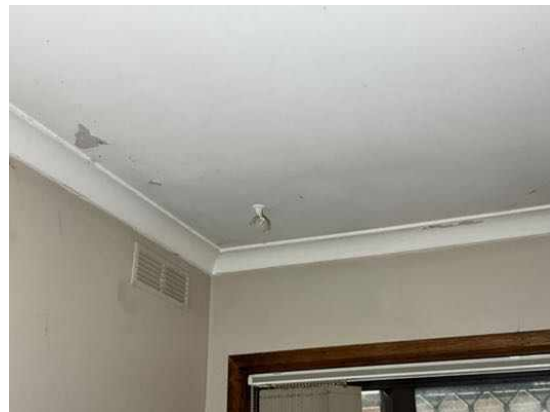
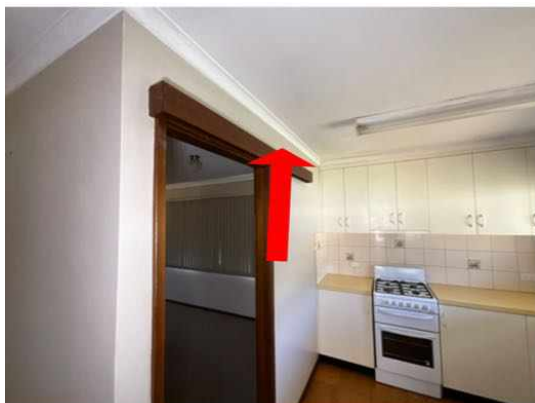
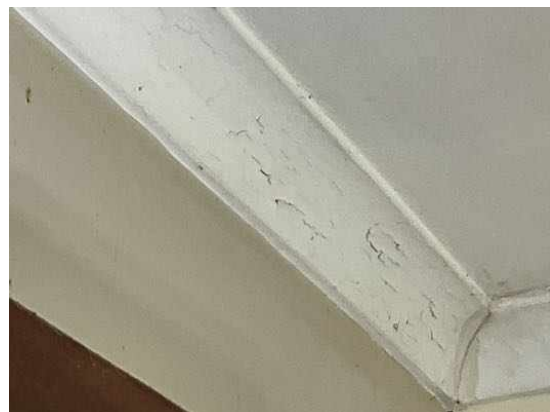
Building: Building 1
 Location: Kitchen, dining
 Finding: Paint- Flaking
 Information: Sections of paint in this area was found to have deteriorated. Paint flaking is generally an indication of excessive moisture in the area, that is currently hidden by the painted

surface.

The presence of excessive moisture can have major implications on associated building elements if left unattended. While only seemingly minor at this stage, the damage cannot be determined due to the paint obstructing any further inspection of the damage.

A qualified Painter should be contacted at the Owner's discretion to re-paint the area.

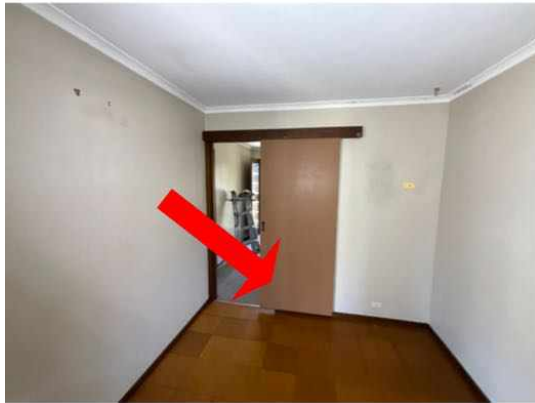
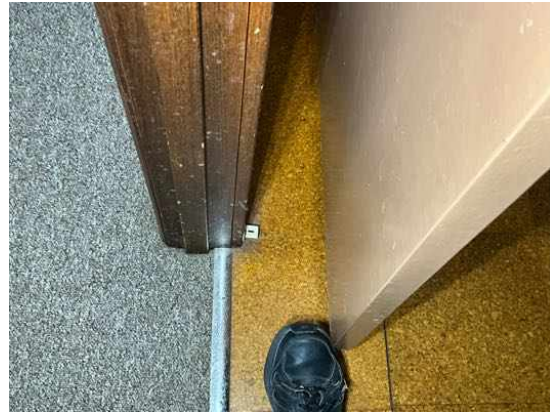
Location: Dining Room
 Finding: Door Guide Missing
 Information: The operation of this Door is impaired by the lack of a Guide at the bottom. This guide stops the door impacting the surrounding Architrave and causing impact damage. This guide also prevents the Door from coming off the track and falling.

Replacement of the guide can be done by a Handy Person at the discretion of the Owner to prevent further damage to the structure and avoid potential safety hazards.

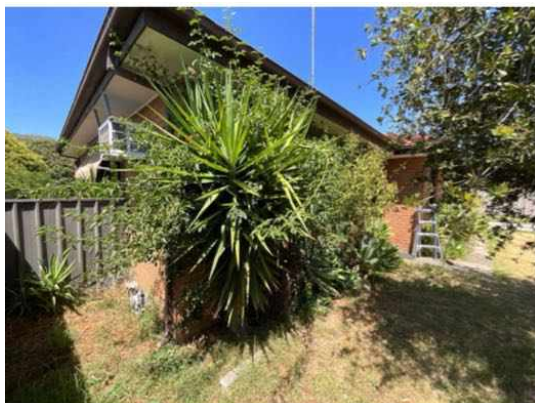
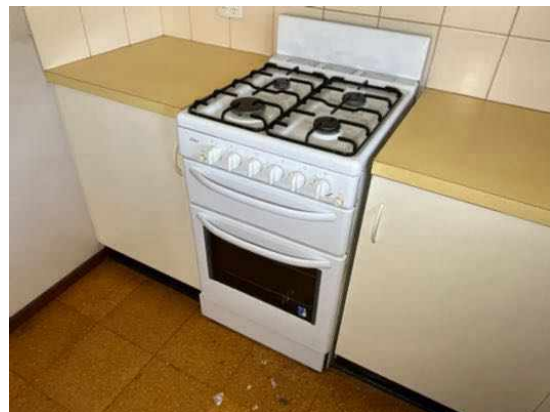
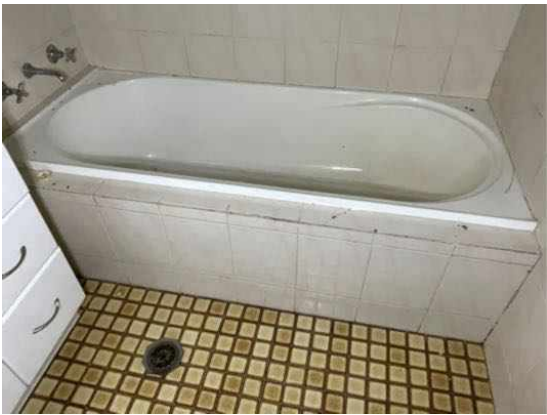
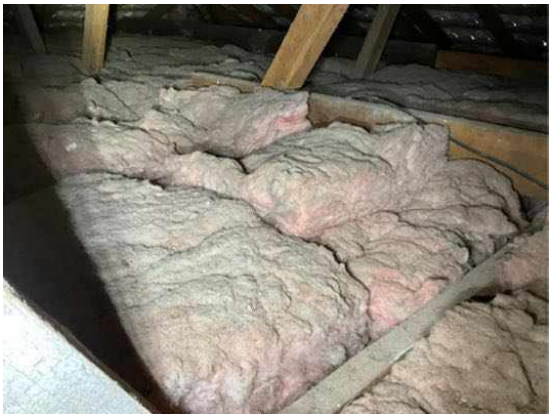
Building: Building 1
 Location: All Areas
 Finding: Additional Photos - Obstructions and Limitations
 Information: These photographs are an indication of the obstructions and limitations which impeded full inspection of the property at the time of inspection. These obstructions can hide an array of defects and should be removed to allow full inspection to be carried out. A re-inspection is recommended once the areas are made accessible.
