# Building and Timber Pest Inspection Report

Inspection Date: Wed, 18 Feb 2026

Property Address: 204 Mildura Dr, Helensvale QLD 4212,  
Australia

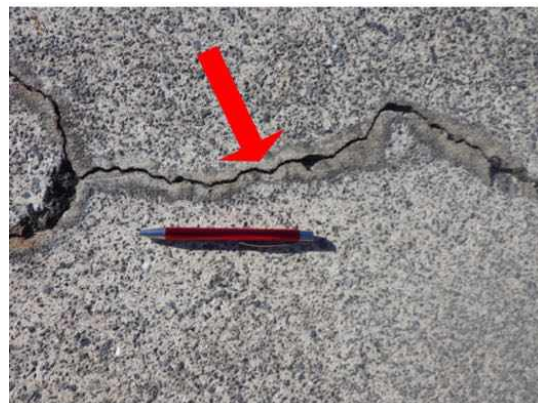
Building: Main Building  
 Location: Driveway > Ground Level  
 Finding: Cracking in concrete slab - Category 1-2  
 Information: Cracking coded as Category 1 - 2 was identified in the driveway and footpaths concrete slabs (as per example photos). A Category 1 crack is described as a fine but noticeable crack, with the slab at an otherwise reasonable level.

To be considered Category 1, the approximate width of the crack is less than 1.0mm, or a less than 10mm change in offset when a 3m straight edge is placed over the defect.

Category 1 cracks should be monitored for a period of 12 months. At the end of the monitoring period, identified cracks that are rated greater than Category 2 are considered defects, and require rectification.

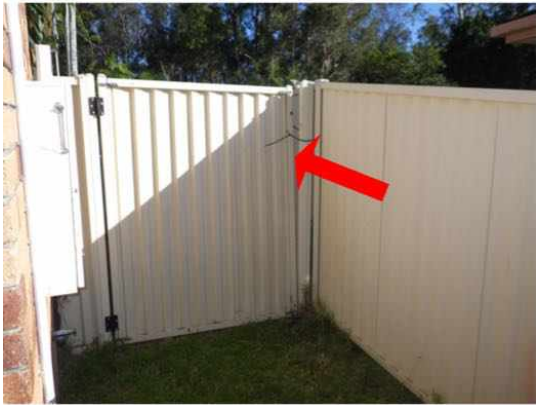
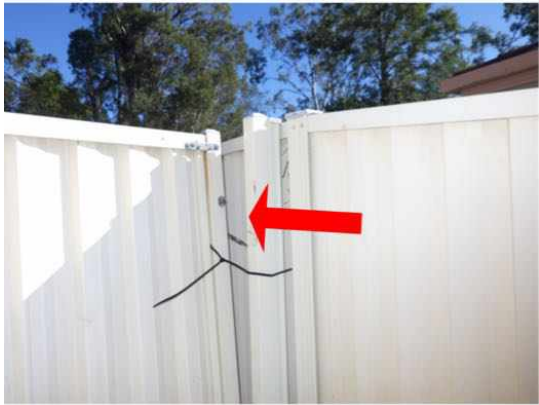
**Finding 3.02**

Building: Main Building  
Location: Exterior walls - right & left sides > Front Left,Front Right  
Finding: Damaged Gates  
Information: The fabricated metal gates to the right and left sides of the property show signs of damage or deterioration either by accident or by force.

A fencing contractor or general handyman could be appointed to repair or replace the broken gates..

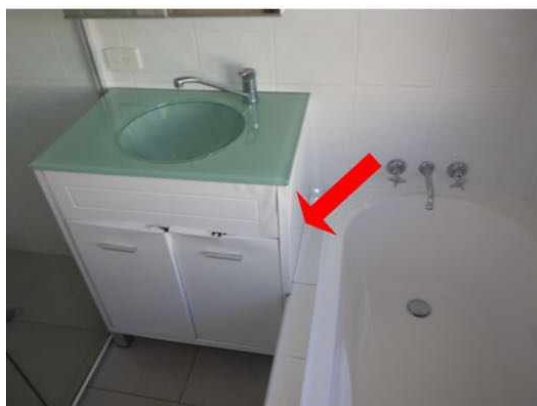
### Finding 3.23

Building:	Main Building
Location:	Bathroom > Centre Left
Finding:	Tiles - Missing
Information:	It was noted on inspection that floor tiles are missing from under the bathroom vanity unit. It is important this area is tiled and sealed to prevent moisture or liquids penetrating under the surrounding tiles and/or the wall linings. Tiles and sealant also prevents vermin from accessing and or nesting in these areas.

A tiling contractor should be appointed to complete these works as soon as possible.

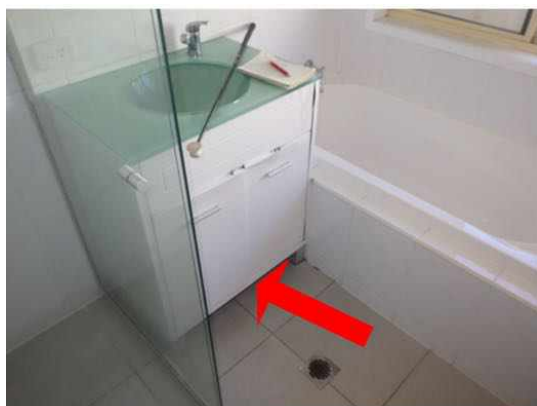
### Finding 3.24

Building:	Main Building
Location:	Bathroom > Centre Left
Finding:	Cabinetry - Deterioration
Information:	At the time of inspection the bathroom cabinetry showed signs of deterioration. The level of damage appears consistent with exposure to moisture or general wear and tear.

A qualified cabinet maker or general handyman could be engaged to undertake repair works at the clients discretion.

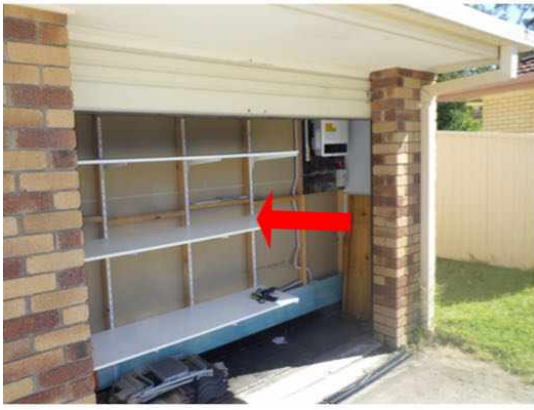
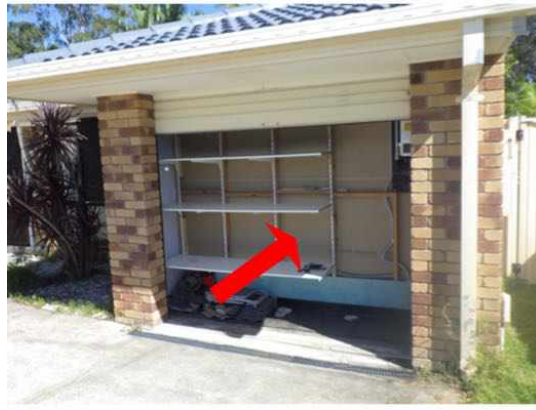
### Finding 3.36

Building: Main Building  
 Location: Garage > Ground Level  
 Finding: Concrete floors - damaged  
 Information: Areas where the concrete floor in the garage area have been damaged were identified at the time of inspection. The damage consists of deep gouges chips and scrape and associated marks. The damage appears consistent with incomplete alteration and/or renovation work.

A licensed carpenter could be engaged to undertake repair work at the clients discretion.

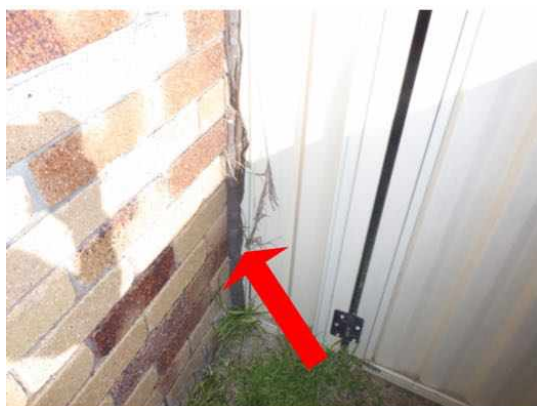
## Finding 6.03

Building:	Main Building
Location:	Exterior walls - left side > Front Right
Finding:	Stormwater pipe - Damaged
Information:	The down pipe to the left side exterior wall of the building has suffered damage to the top of the down pipe adaptor.

It is recommended that a plumber or handyman be appointed to repair the down pipe as necessary.

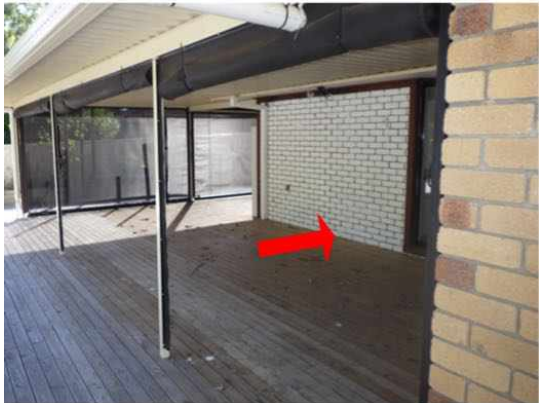
**Finding 6.06**

Building: Main Building  
 Location: Deck > Existing  
 Finding: No Access  
 Information: At the time of inspection there was no access to the sub floor area of the timber deck to the rear of the property.

The client should engage a licensed carpenter or general handyman regarding provision of a hatch or access door to the timber deck sub floor area.
