Building Inspection Report

Inspection Date: Mon, 23 Feb 2026

Property Address: 25 Dennis St, Highett VIC 3190, Australia

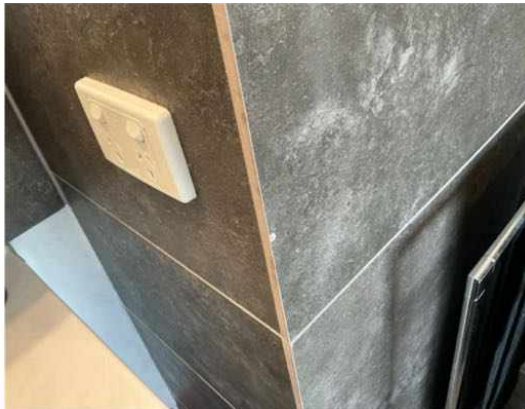
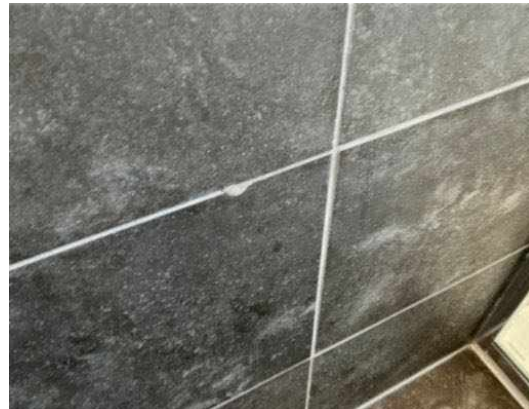
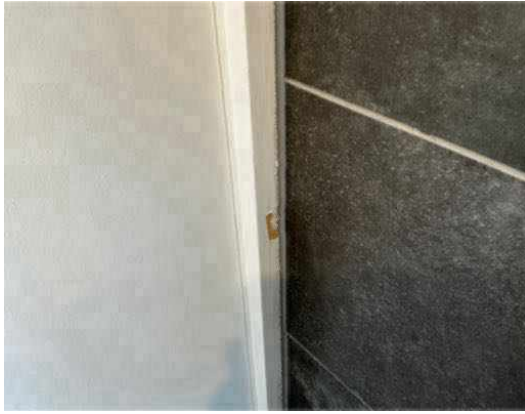
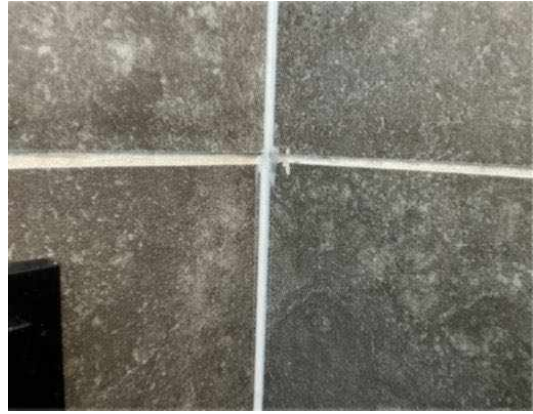
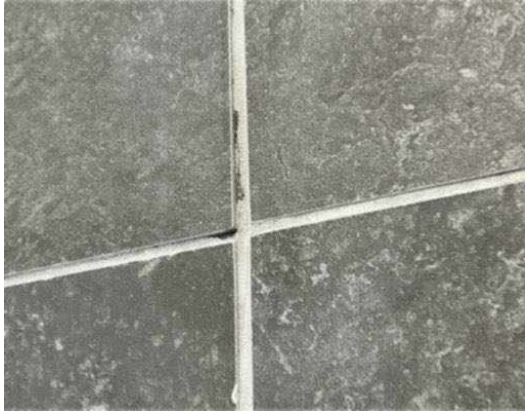
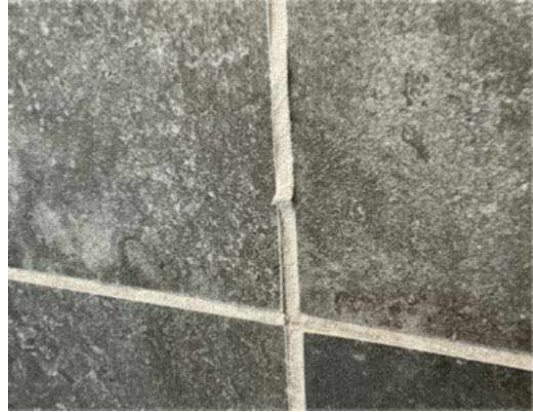
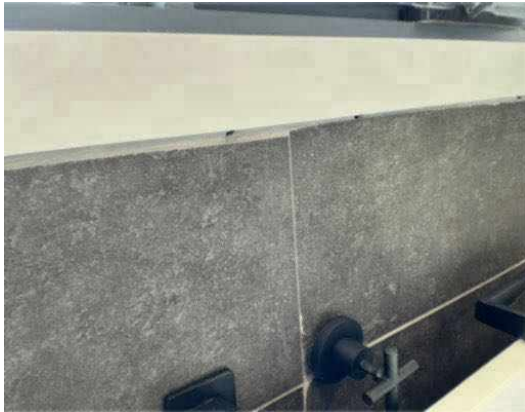
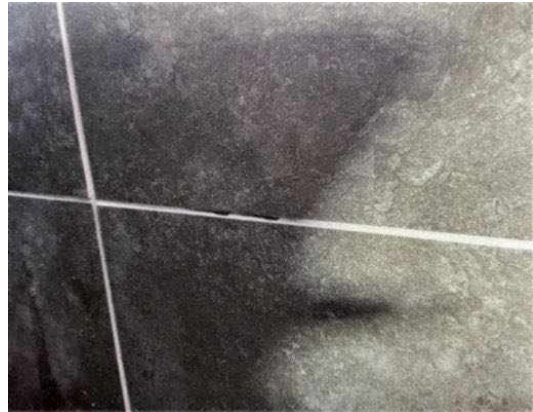
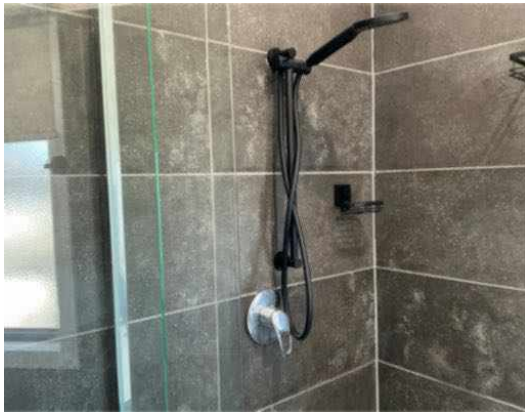
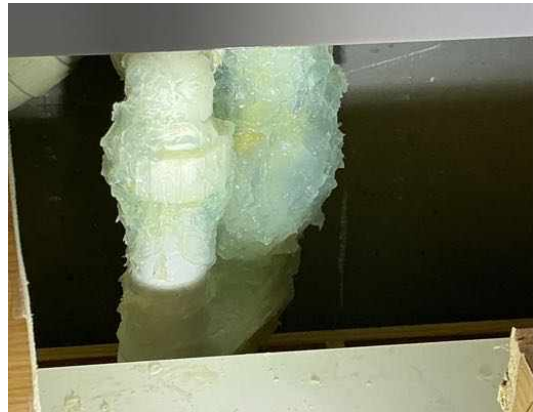
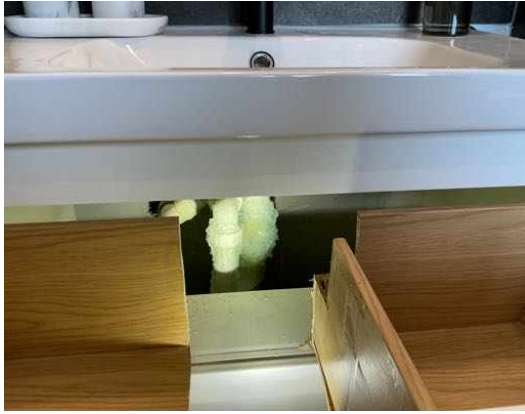
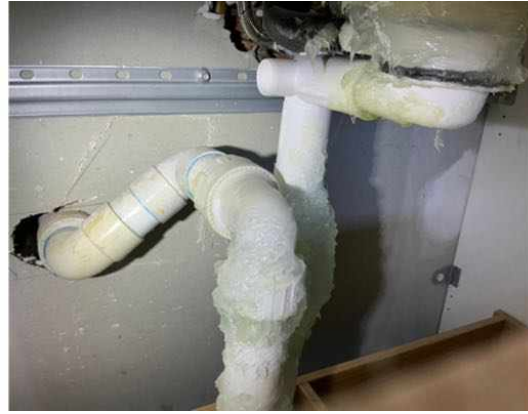
Defects 2.01

Building: Main Building
Location: Bathroom tiling
Finding: Unconventional handyman work
Information: This handyman work appears to have been completed to a substandard level and does not comply with regular building practices. Where handyman work is not completed satisfactorily, accelerated deterioration of the associated building elements is likely to occur and secondary defects to surrounding structures may develop.

It is highly recommended that the substandard work be rectified by professional services. Works to improve this area are likely to increase the safety and the operation of the associated building elements.

The client should exercise care when coming into the immediate vicinity of the substandard works. Rectification works are advised as soon as possible by the appropriate trades.

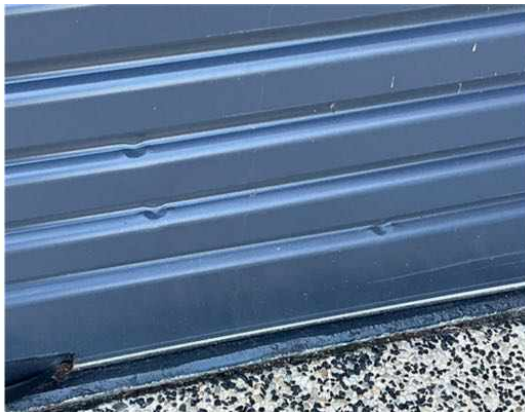
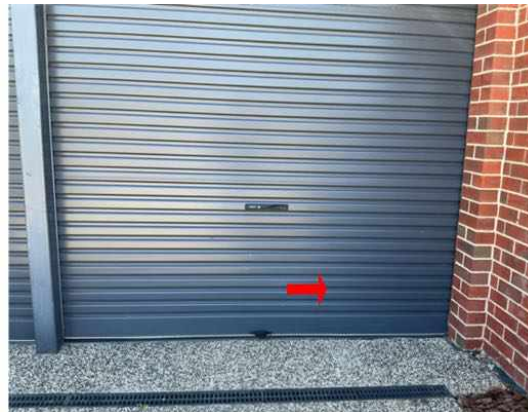
Defects 3.01

Building:	Main Building
Location:	Garage
Finding:	Garage door - Superficial markings
Information:	The garage roller door has a number of marks and dents likely to have resulted from impact damage be it accidental or deliberate impact at sometime.

Garage roller doors can fail when the building materials have aged but may be indicative of impact damage (accidental or deliberate). While superficial markings detract from the aesthetics of the building element, the functionality has not been hindered in any way.

Repair and/or replacement of the two garage doors would improve the condition of the garage but certainly not an urgent item

A qualified roller door installer or supplier should be engaged to check out the operation and overall condition of the doors to determine if repair is an option otherwise replacement may need to be considered.

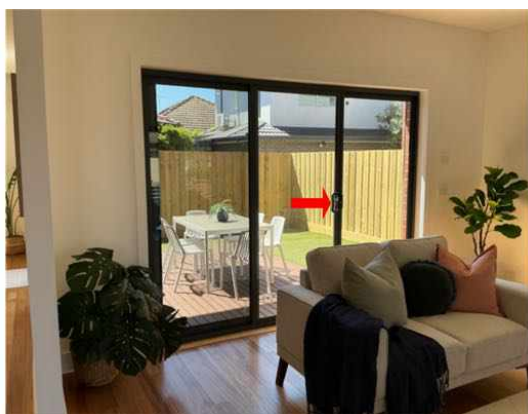
Defects 3.02

Building:	Main Building
Location:	Lounge Room
Finding:	Door - stiff to slide
Information:	The door to this area was difficult to operate at the time of inspection. This is likely due to damaged wheels which help the door to operate in a smooth fashion.

Doors provide ventilation and exits to the adjoining area and should be at a fully operational level to ensure user comfort and safety. Restricted function of the door may also pose as a potential safety hazard if required for emergency egress from the building.

Generally, factors such as general age of the building element and a lack of maintenance are the usual causes for this type of defect.

Replacement of door running hardware may be required, as well as minor repairs and cleaning. A registered builder or general handy person will be required to repair the sliding door.

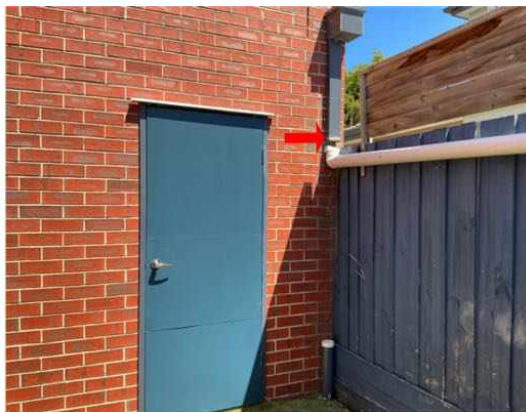
Defects 3.03

Building:	Main Building
Location:	Rear Elevation
Finding:	Stormwater drain - Not connected
Information:	The roof plumbing is not adequately connected to stormwater drainage on the site. This disconnection negatively impacts the functional capacity of the roof plumbing.

Where roof plumbing doesn't drain adequately, the area at the base perimeter can become excessively damp, potentially creating an environment that is susceptible to rust and corrosion of surrounding building elements, as well as attracting termites and other pests.

It is highly recommended that a plumber be appointed to further inspect the area and to install adequate drainage equipment where necessary.

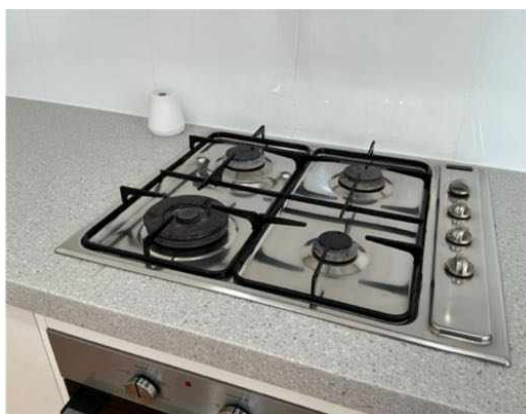
Defects 3.04

Building:	Main Building
Location:	Kitchen
Finding:	Rear right ignition- Not operating
Information:	Non-operational items should be addressed to ensure that the full function of the building structure is available. Where some building elements are not operating as intended, it is possible that secondary building defects could arise due to their non-operation.

Repair and/or replacement of the faulty building element is recommended. It is highly recommended that the relevant tradesperson be engaged to perform any necessary works.

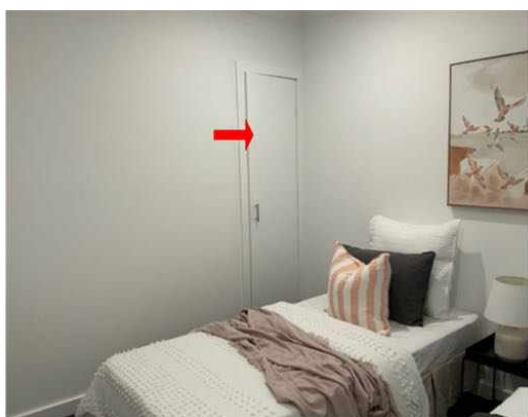
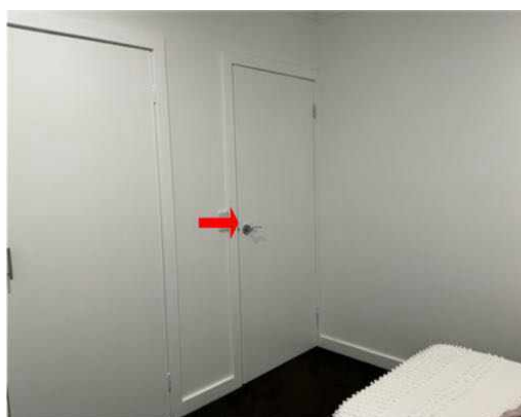
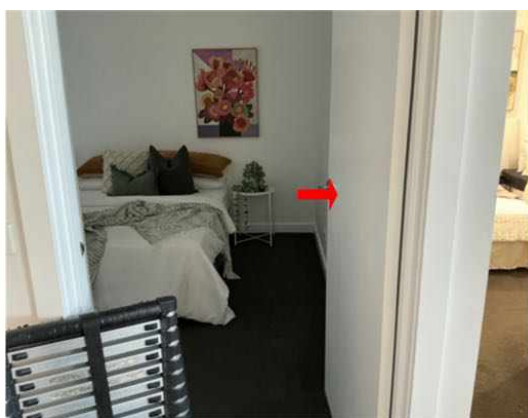
Defects 3.05

Building:	Main Building
Location:	All Areas
Finding:	Sticking or jamming
Information:	Building elements which are sticking or jamming are difficult to operate and don't function as intended. There are a variety of causes for sticking and jamming.

The most usual causes are swelling of timbers due to moisture, bulging or bowing of

metal frames, or general material deterioration. Generally, sticking and jamming building elements indicate that their frames are uneven or out of level, generally as result of movement to surrounding walls and floors.

Easement will be required, which usually depends on the building materials used. This may involve some sanding and/or application of a lubricant. It will almost always include ensuring the areas are cleaned and free of any debris that may be detrimental to their operational state.

Appointment of a carpenter or general handyman is recommended to rectify any sticking/jamming building elements.

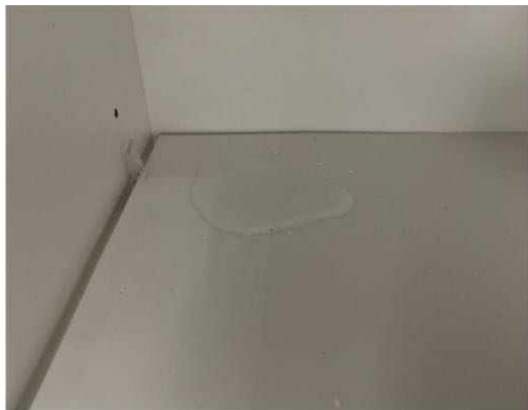
Defects 3.06

Building:	Main Building
Location:	Ensuite - Master
Finding:	Tap - Leaking
Information:	The tap in this area was found to be leaking at the time of inspection. This is a common defect that is consistent with general ageing of the building element. However, it may be indicative of substandard plumbing workmanship if the tap is relatively new.

While this defect only seems minor, if left unmanaged, it is likely to result in the development of rust, water damage and/or extensive water usage.

It is advised that a handyman or licensed plumber be appointed to perform remedial works on the affected tap. Such works should be performed prior to the development of secondary defects to ensure adequate functionality of all associated building elements.

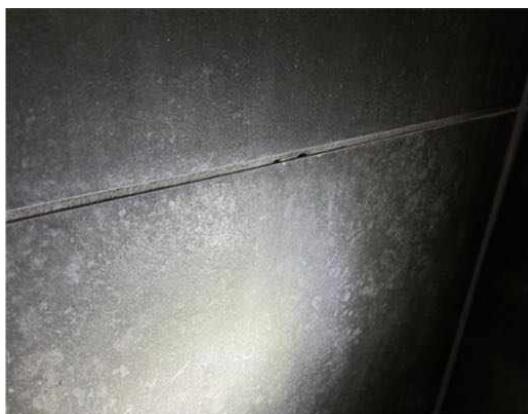
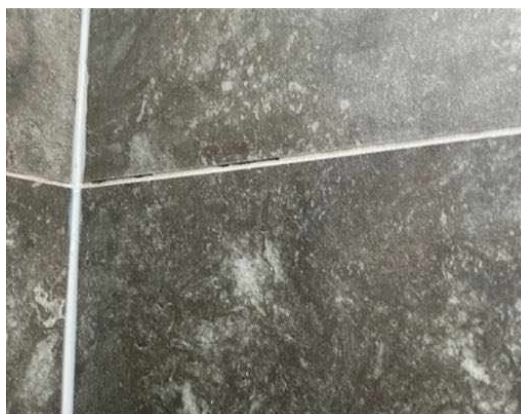
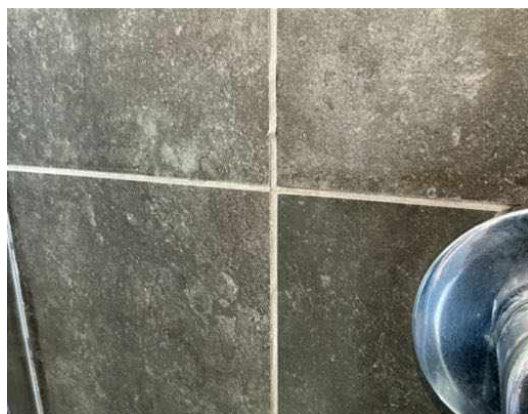
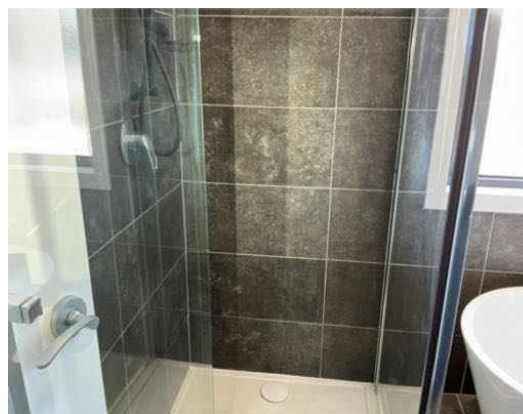
Defects 3.07

Building:	Main Building
Location:	Bathroom
Finding:	Grout - Missing
Information:	Grout is missing in this area. Grout is used to protect gaps and crevices in building materials to ensure that they are water-tight and prevent water penetration to the associated structures.

Where grout is missing, a tiling contractor should be appointed immediately to apply grout and re-apply any silicone where necessary. Failure to do so is likely to lead to water damage to the surrounding area.

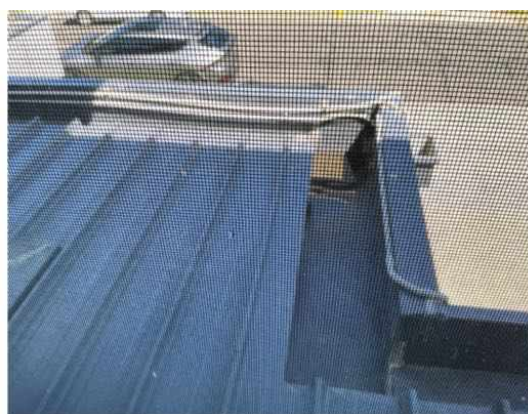
Defects 3.08

Building:	Main Building
Location:	Roof Exterior
Finding:	Gutters - Water pooling
Information:	Water was found to be pooling in sections of the roof guttering. This is generally a secondary defect caused by blocked or partially blocked gutters. Such blockages and subsequent water pooling are likely to lead to rust and water damage to associated structures if left unattended.

Any areas of guttering that shows evidence of water pooling should be checked for partial or full blockages and any secondary damage that may have occurred as a result. Depending on the extent of the damage, building elements may require repair and/or replacement to ensure adequate roof drainage and function of exterior plumbing system.

A roofing plumber should be appointed as soon as possible to rectify this issue. It is highly advised that all gutters be maintained on a frequent basis to ensure the condition of roof plumbing.

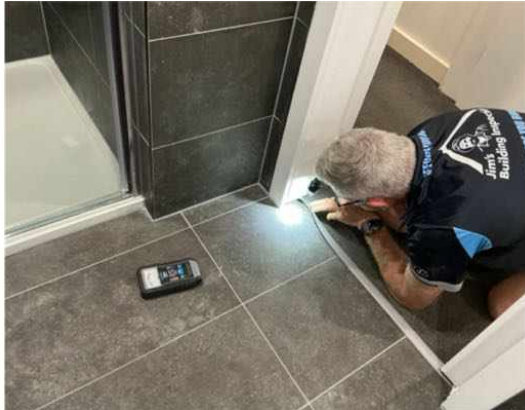
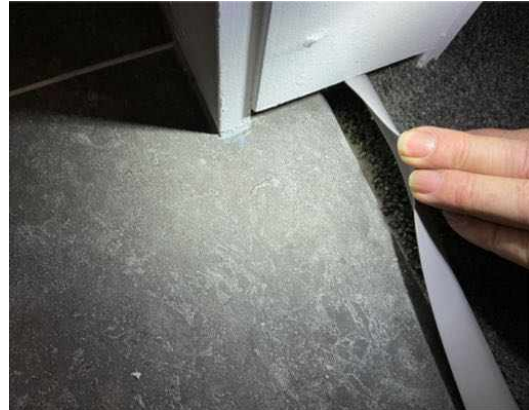
Defects 3.09

Building:	Main Building
Location:	Ensuite - Master

Finding: Waterstop - missing
 Information: It was identified that there is a performance issue with a shower base tiling as it does not have any water stop installed in this area

This is a defect with reference to Standards and Tolerances. AS 3740.

This shower base tiling will need to be reworked in order to comply.

These works are to be completed prior to final Handover.

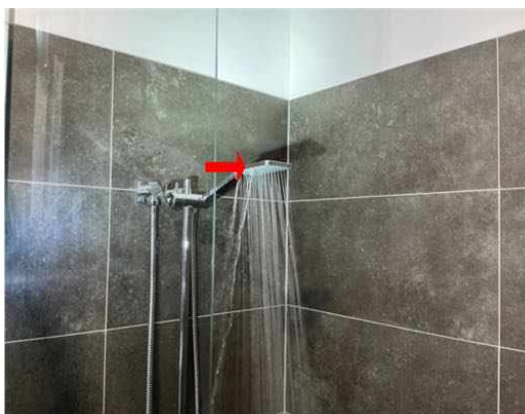
Defects 3.10

Building: Main Building
 Location: Ensuite - Master
 Finding: Showerhead faulty
 Information: The showerhead to the ensuite bathroom was found to be faulty. At the time of inspection, this showerhead may be replaced at the clients convenience.

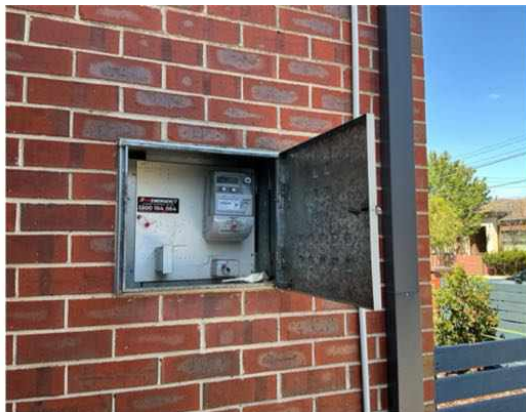
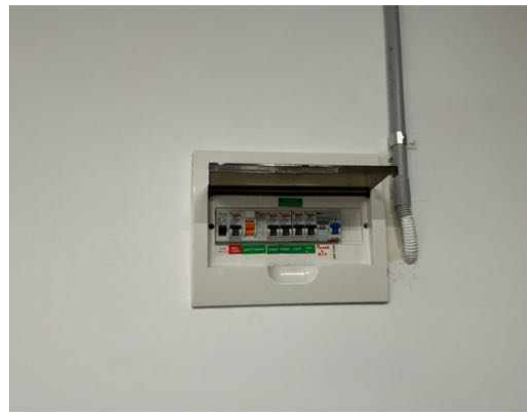
Building:	Main Building
Location:	Electrical Switchboard
Finding:	Termite Management System - no evidence of a chemical installation
Information:	The application of a post-construction chemical termite barrier is highly recommended for all properties, particularly if live termite activity has been found on the site previously. Such barriers are highly effective in preventing termite attack on any timber building elements throughout the property.

A durable notice should be placed in the switchboard unit to indicate current termite barriers. At the time of inspection, it appeared as though no termite management system has been installed, with no evidence to suggest preventative works taking place.

The client may consider gaining further advice from a pest controller as to the costs and procedures involved with this application. It is recommended that obtaining such advice be a short-term priority.

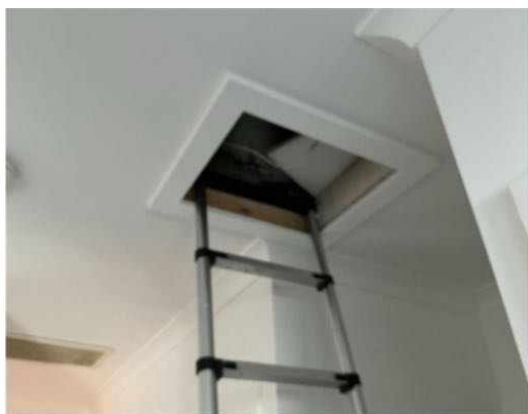
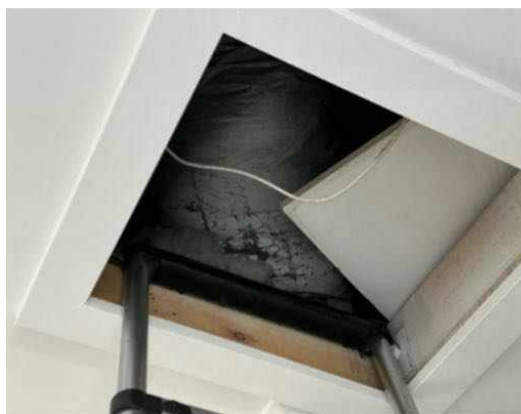
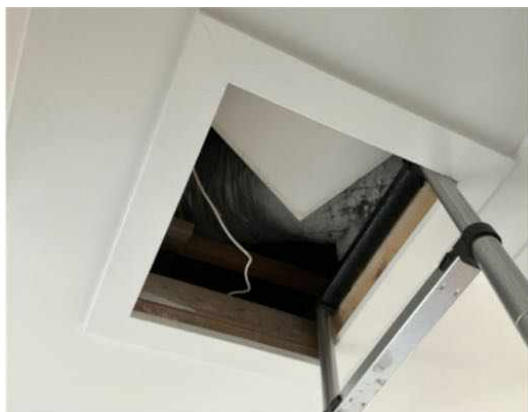
Building:	Main Building
Location:	Roof Void
Finding:	Roof void access limitations
Information:	Limited access to the roof void was present due to facts including but not limited to access hatch size or placement, for this reason access to the roof void was minimal.

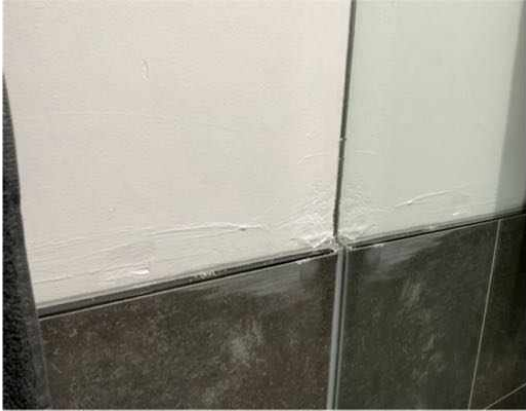
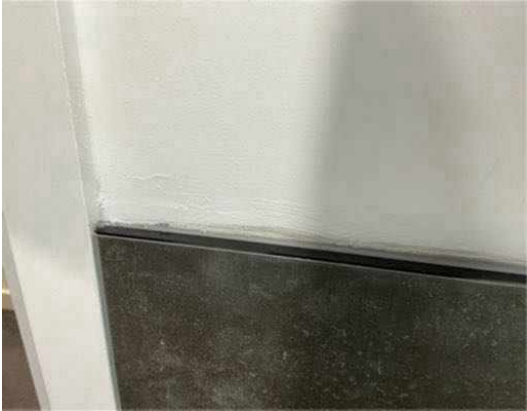
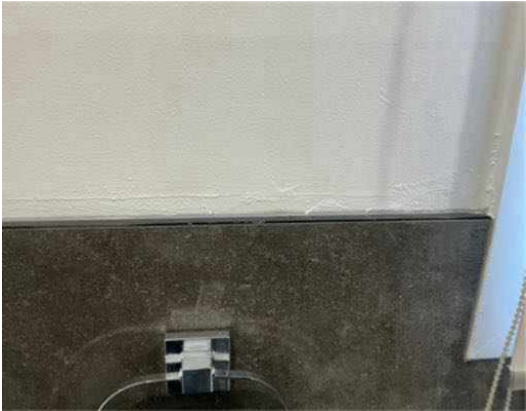
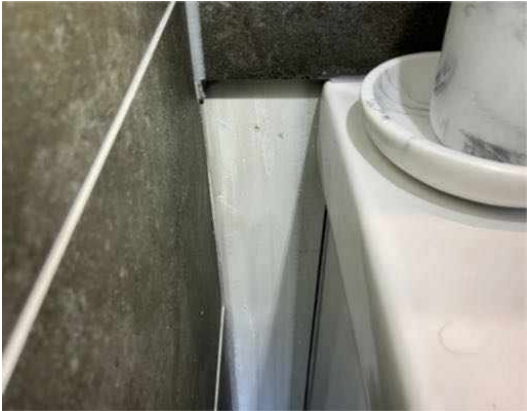
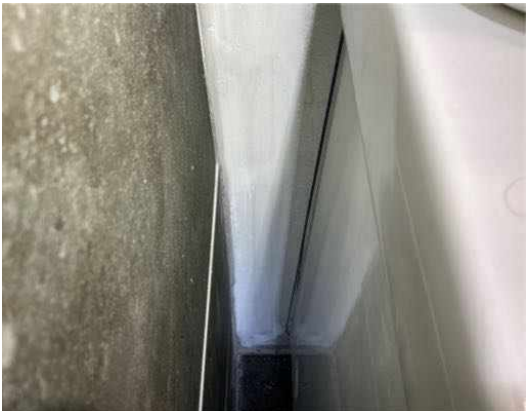
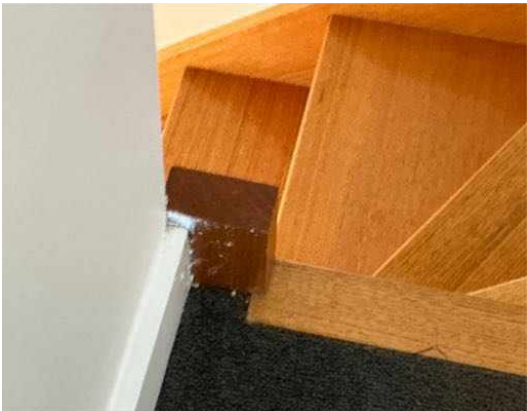
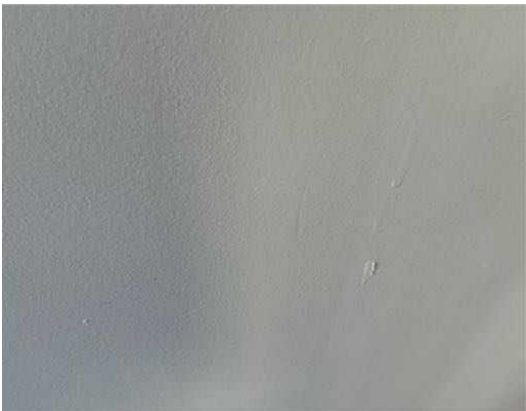
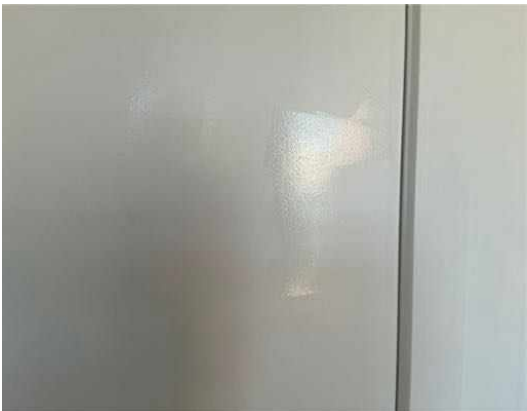
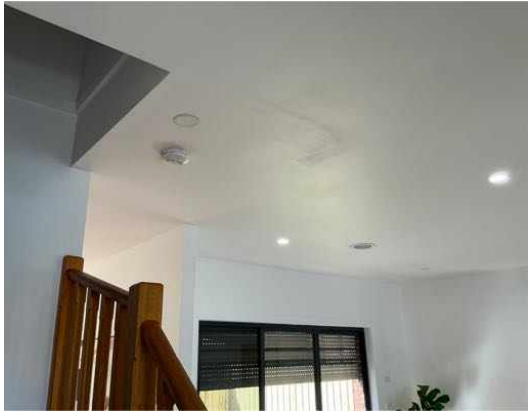
Building:	Main Building
Location:	All Areas
Finding:	Paint finish - Substandard
Information:	The paint finish in this area was found to have been completed to a substandard level. Substandard painting is generally classified as an appearance defect. However, the substandard appearance may also be indicative of poor surface preparation and substandard workmanship.

If this applies, further areas of poor and incomplete finishes could develop over time. Furthermore, substandard paint finishes in areas exposed to moisture, e.g. external areas or wet areas, could lead to deterioration of underlying building materials.

Substandard paint finishes should be sanded back, filled, leveled and repainted, as applicable. Where inadequate paint protection has led to the deterioration of the associated building element, repair and/or replacement of this building element may be required.

A painting contractor should be appointed as soon as possible to perform necessary works to aid the appearance of the affected area and to ensure that the area is protected against further deterioration. Alternatively, the homeowner following manufacturer instructions may be able to provide this service.
