# Building and Timber Pest Inspection Report

Inspection Date: Tue, 24 Mar 2026

Property Address: 7 Bridge Rd, WESTMEAD, NSW, 2145,  
Australia

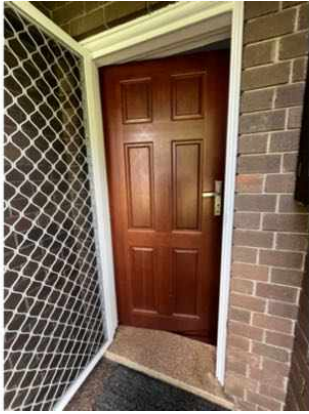
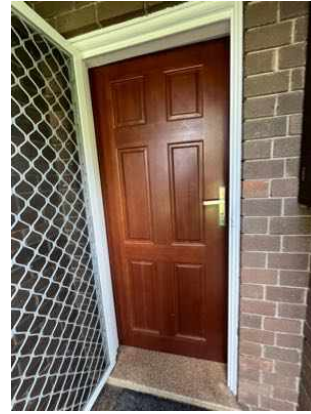
Information: It appears that there is a problem with this door as it is binding or jamming during normal operation. This defect not only affects the functionality of the door but also poses a risk for other building elements such as damage to the floor covering.

There could be various reasons behind the binding of the door, ranging from minor issues like poor installation or damaged hinges to major structural problems such as damage to the subfloor.

If the problem appears to be a major structural issue, it is advisable to seek the services of a registered builder who specializes in re-stumping. They can provide an estimate for the cost of repairing the problem.

For minor issues, it is recommended to hire a qualified carpenter or handyman to carry out the necessary repairs as per the client's discretion.

In some cases, the binding of the door may be caused by termite activities. In such instances, it is recommended to monitor the situation closely or conduct an invasive inspection to identify the root cause of the problem.

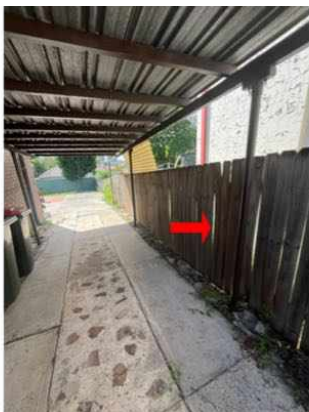
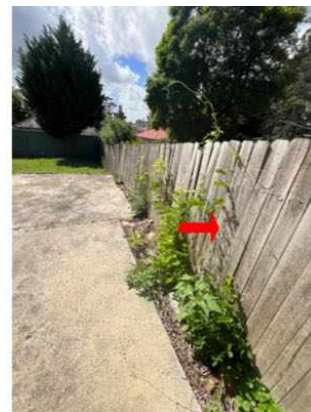
### Finding 3.02

Finding: Fencing - Deteriorated

Information: It was noted at the time of inspection that sections of the fencing throughout the property have deteriorated. Typically fencing deteriorates due to age and or wear, rot and or rust which is generally expected for a structure of this age, due to prolonged exposure to weather conditions. Sometimes inadequate installation or maintenance can be to blame.

If left unattended, it is likely that further damage will occur. It is suspected that repair of several elements of the fencing may be required however replacement may be a consideration of the client also.

A licensed fencing contractor should be appointed to provide further advice and perform rectification works as necessary.

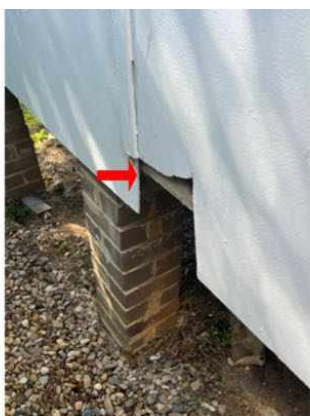
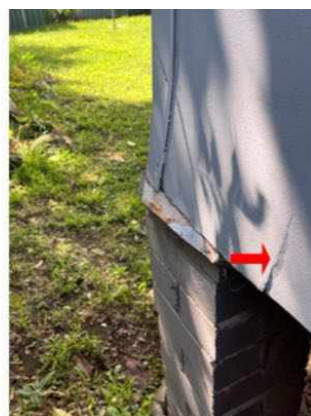
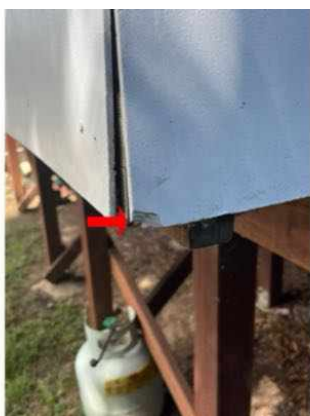
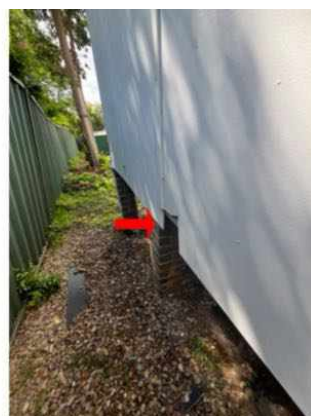
### Finding 3.03

Finding: Wall with ACMs cracked and broken

Information: The external wall cladding to the subfloor perimeter is observed to be damaged and deteriorated in several locations, particularly at sheet junctions and lower edges. Sections of the sheeting are cracked, broken and missing, exposing the underlying framing and creating openings into the subfloor space. The damage appears consistent with age-related deterioration and possible impact or moisture-related weakening, with further evidence of delamination and friability noted along the edges. The condition of the material raises concern that the cladding may contain asbestos cement (ACMs), which was commonly used in this type of installation, and the observed deterioration increases the risk of fibre release if disturbed. Additionally, gaps at joints and penetrations reduce the effectiveness of the enclosure, allowing potential pest entry and moisture ingress.

It is recommended that the material be treated as presumed asbestos-containing until confirmed otherwise by laboratory testing. A licensed asbestos assessor should be engaged to sample and assess the material, and any repair or removal works should be carried out by appropriately licensed contractors in accordance with relevant safety regulations. In the interim, the material should not be disturbed.

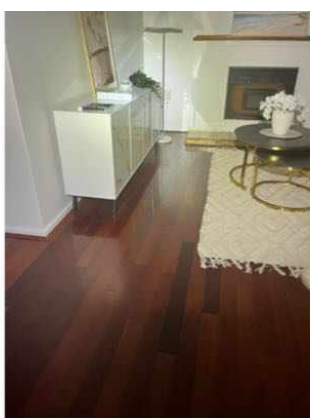
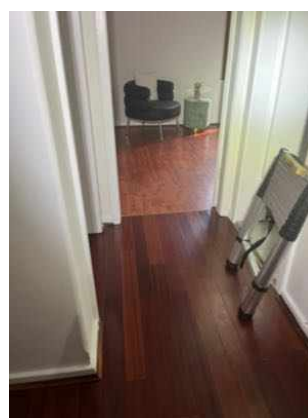
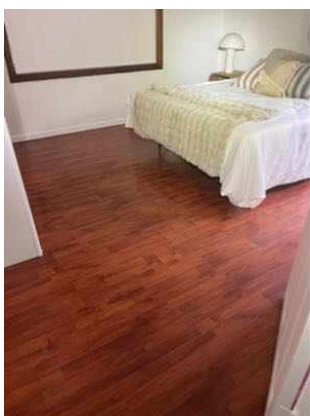
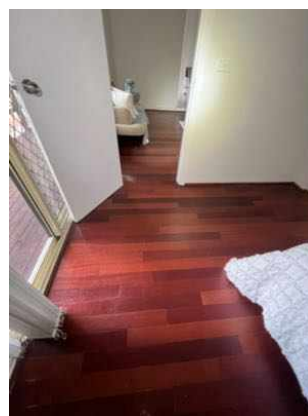
### Finding 3.04

Building: Main Building  
Location: All Areas  
Finding: Flooring - Uneven

**Information:** The internal flooring in this area is out of level and uneven. Uneven flooring is likely to indicate minor defects such as expected movement of the foundations of the property, but may also indicate subsidence of the associated subfloor stumps.

It is advised that the flooring be closely monitored to identify any further movement. Where flooring remains relatively unchanged for an extended period of time (i.e. several months), it is likely that this defect has been caused by expected movement of the foundations of the property.

However, where flooring is uneven further, potentially invasive inspection of the subfloor structures and stumps in this area is required. In this case, works to repair are likely to be required, and would be carried out by a registered builder specialising in re-stumping.

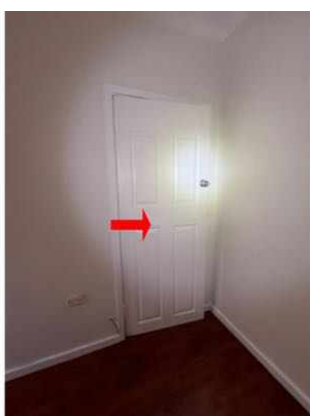
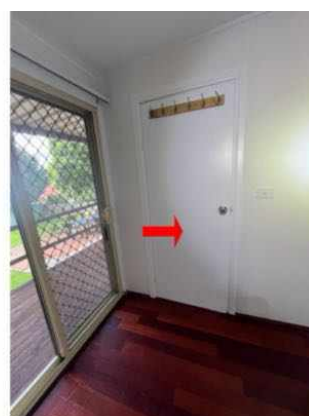
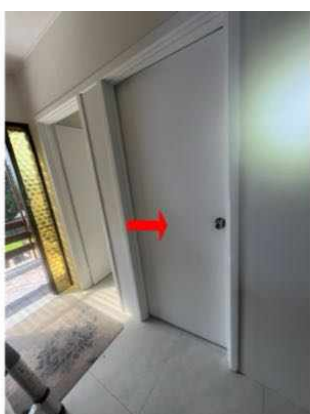
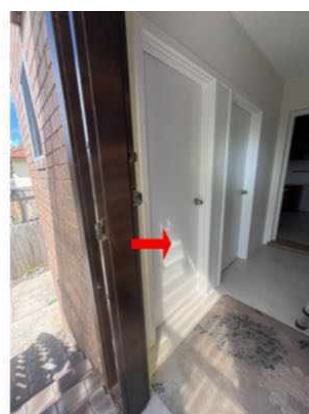
### Finding 3.05

**Building:** Main Building  
**Location:** All Areas  
**Finding:** Doors Binding or Jamming  
**Information:** It appears that there is a problem with this door as it is binding or jamming during normal operation. This defect not only affects the functionality of the door but also poses a risk for other building elements such as damage to the floor covering.

There could be various reasons behind the binding of the door, ranging from minor issues like poor installation or damaged hinges to major structural problems such as damage to the subfloor.

If the problem appears to be a major structural issue, it is advisable to seek the services of a registered builder who specializes in re-stumping. They can provide an estimate for the cost of repairing the problem.

For minor issues, it is recommended to hire a qualified carpenter or handyman to carry out the necessary repairs as per the client's discretion.

In some cases, the binding of the door may be caused by termite activities. In such instances, it is recommended to monitor the situation closely or conduct an invasive inspection to identify the root cause of the problem.

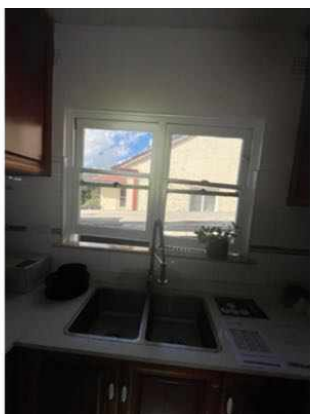
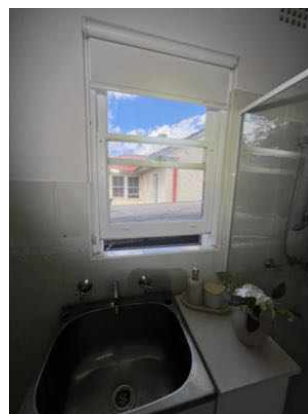
### Finding 3.06

Building:	Main Building
Location:	All Areas
Finding:	Windows - Stiff to slide
Information:	Several windows throughout the property were jammed and difficult to operate at the time of the inspection. Windows provide ventilation to the adjoining area and should be at a fully operational level to ensure user comfort. Restricted function of the window

may also pose as a potential safety hazard if required for emergency egress from the building.

Generally, factors such as general age of the building element and a lack of maintenance are the usual causes for this type of defect.

Replacement of window hardware or frame may be required, as well as minor repairs and cleaning. A registered builder or general handy person will be required to repair the affected windows.

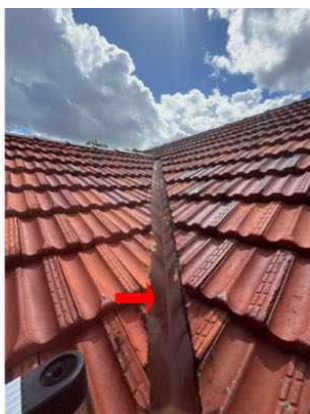
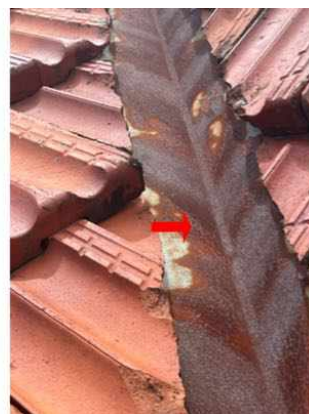
### Finding 3.07

Building:	Main Building
Location:	Roof Exterior
Finding:	Valley Gutter - Rusted
Information:	The valley gutter area shows advanced signs of rust and surface corrosion, particularly where roof tiles meet at the junction.

This deterioration is likely due to the accumulation of leaf litter or debris in the valley, which can obstruct water flow and lead to pooling.

Standing water accelerates corrosion in metal roof plumbing components, eventually causing leaks and water ingress into internal roof or wall cavities. If left unresolved, this condition may lead to water damage to internal finishes, ceiling linings, or even structural timber elements.

It is strongly recommended that the rusted valley gutter be repaired or replaced by a licensed plumber or roof restoration specialist.

Regular clearing of debris from valley gutters is also advised to maintain effective roof drainage and extend the service life of roofing elements.

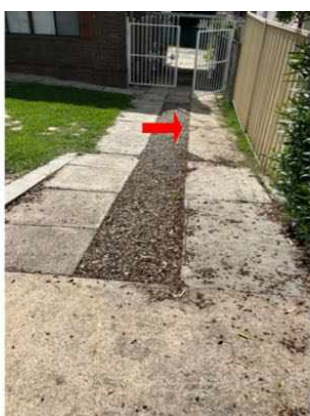
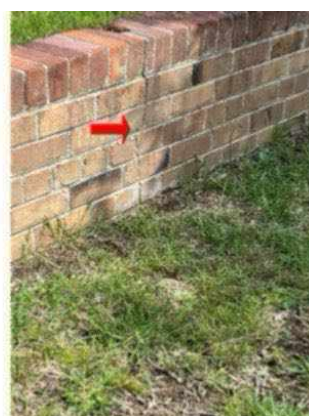
### Finding 3.08

Building:	Main Building
Location:	All Areas
Finding:	Deterioration due to fair wear and tears
Information:	Certain forms of deterioration commonly associated with fair wear and tear may not be specifically identified or itemised within this report. Minor cracking to brickwork, mortar joints, render, concrete paving, tiles, plaster linings, and timber beading, along with isolated areas of mortar loss, stiff or tight-operating windows, and similar age-related conditions, are typical of buildings over time and do not necessarily indicate defective workmanship or structural failure.

Some of minor defects due to fair and wear and tears are ; minor cracks on concrete pavements, minor cracks on brick fence, deteriorated brick mortar, uneven pavement, cracked tile, cracked glass, not latching door and minor rattling door due to misaligned strike plate.

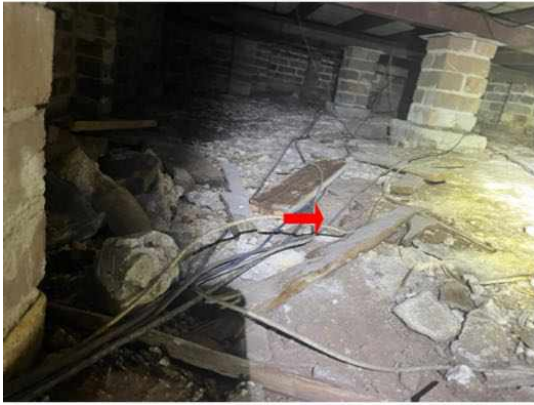
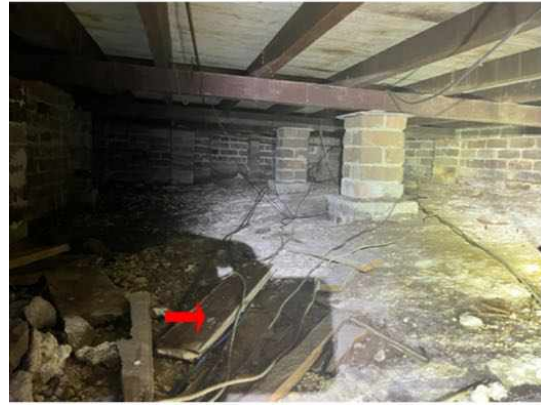
Building: Main Building  
 Location: All Areas  
 Finding: Conditions Conducive to Termite Activity  
 Information: The following areas and environmental conditions were identified as conducive to termite activity. These conditions increase the risk of concealed termite entry and should be addressed through appropriate maintenance, repairs, improved drainage, additional monitoring, or the installation of a compliant termite management system.

The HWS overflow discharges directly to ground, resulting in constant moisture at the building perimeter. Excess moisture provides conditions favourable to termite activity.

Air conditioner condensation lines discharging near walls can cause damp soil conditions, attracting termites.

Blocked gutters were noted to cause overflow, directing water onto walls and foundations. Excess moisture increases termite attractivity.

Stumps and garden beds near the dwelling provide both moisture and cellulose, creating ideal termite feeding sites.

Timber offcuts, cardboard, or loose debris in subfloor or external areas provide an ongoing food source.

Recommendation: Where no system exists, install a compliant termite management system and retain all documentation for future reference.

Recommendation: Connect the overflow to suitable stormwater drainage to divert water away from all structural elements.

Recommendation: Ensure AC overflow pipes are connected to appropriate stormwater drainage.

Recommendation: Clean and maintain gutters and downpipes regularly.

Recommendation: Remove decaying stumps and avoid positioning garden beds directly against walls.

Recommendation: Remove all loose timber and maintain the subfloor clear of debris.

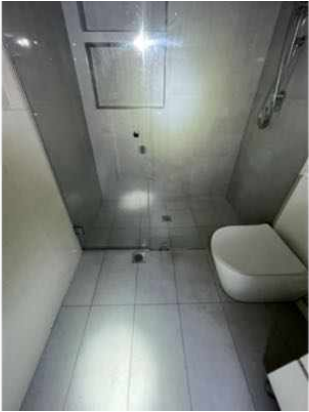
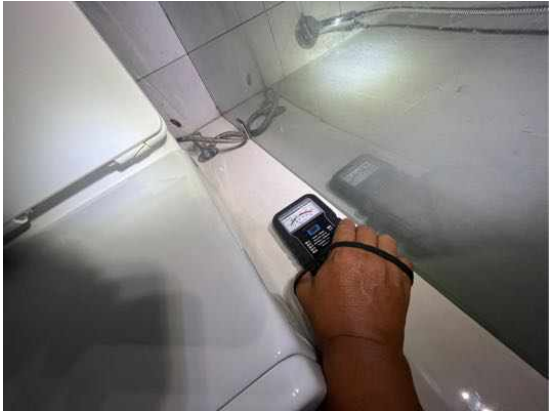
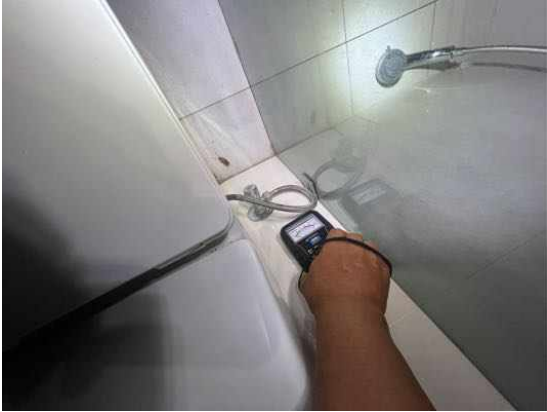
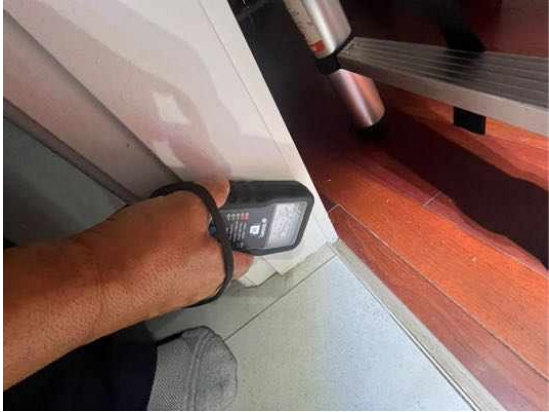
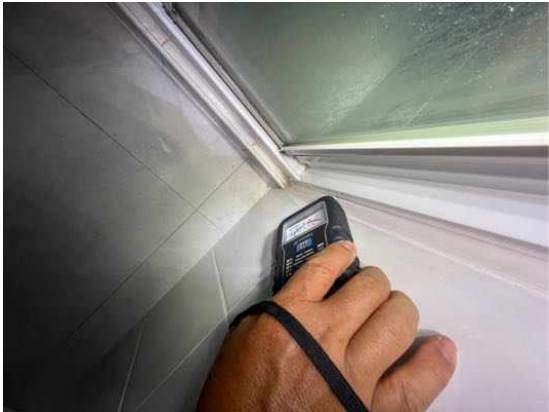
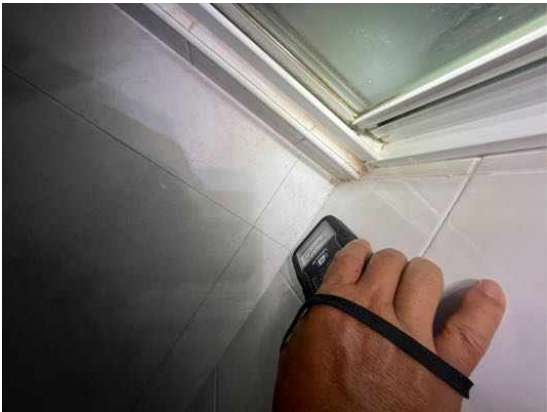
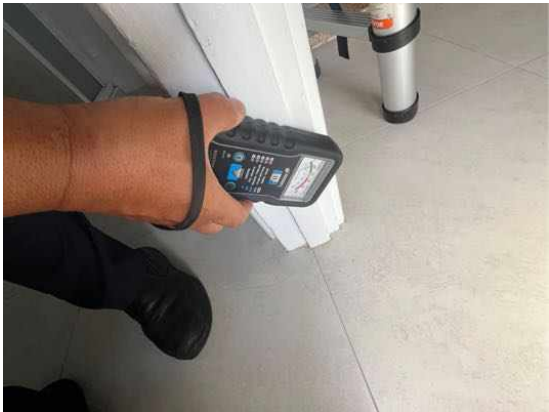
Building: Main Building  
Location: Bathrooms  
Finding: Minimum Moisture Readings Detected  
Information: After assessing the shower recess, the moisture content of the walls within and surrounding the wet area was examined. The readings showed no significant variation between the walls behind the shower and other internal walls, and there were no visible signs of recent moisture-related damage on the surrounding accessible wall surfaces. Based on these findings, the waterproofing system appears to be performing adequately at the time of inspection, with no current evidence of active leakage.

However, it must be acknowledged that if the shower has not been used recently, moisture meter readings may not provide an accurate indication of the waterproofing condition. A lack of elevated readings under these circumstances does not conclusively confirm that the shower is free from leaks.

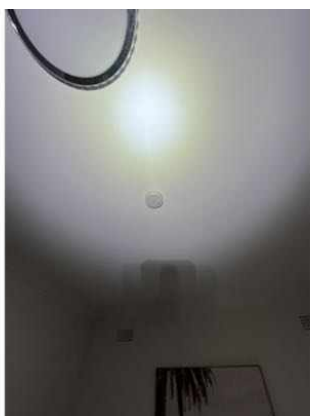
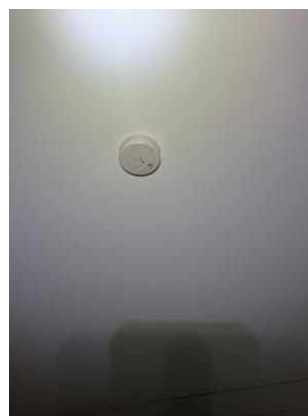
Building:	Main Building
Location:	Lounge Room
Finding:	Smoke Detector - Not hardwired
Information:	Smoke detectors were installed. It is recommended that mains operated, battery backup smoke detectors be installed in accordance with the Building Code of Australia (Part 3.7.2) and the relevant Australian Standards. The operation of these detectors should be checked and ensure that operational batteries are fitted prior to occupation.

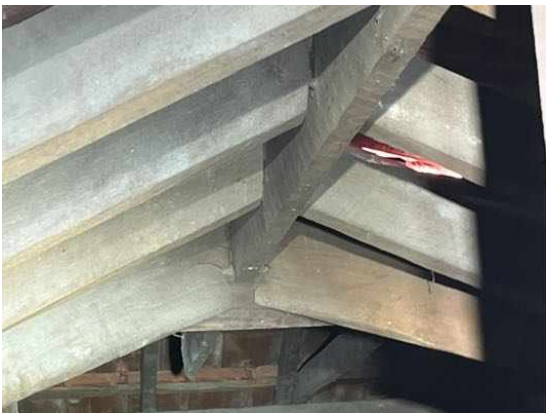
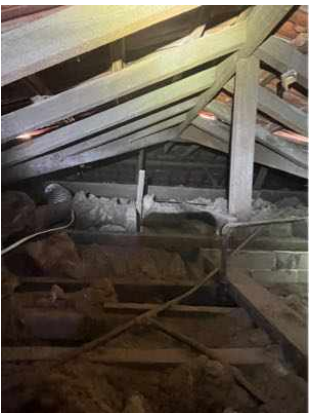
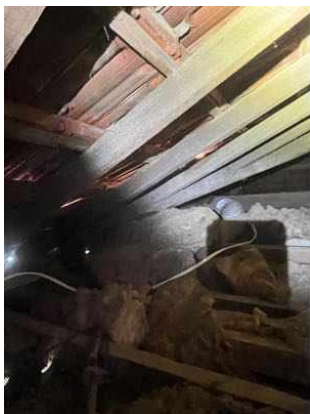
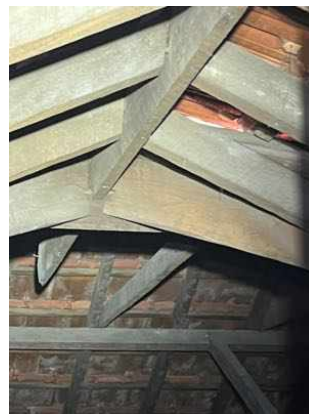
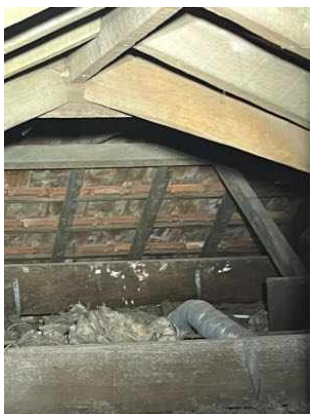
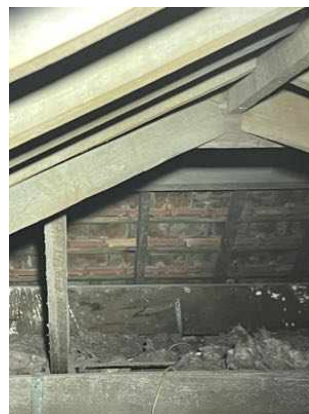
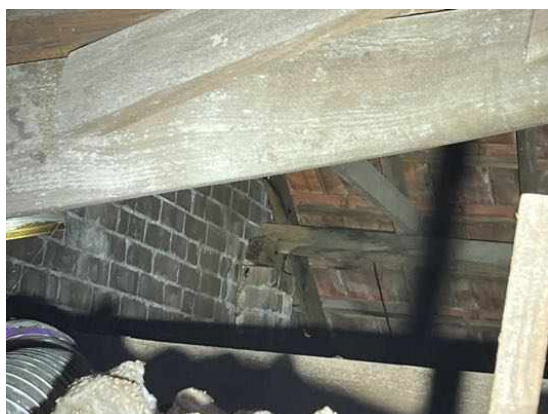
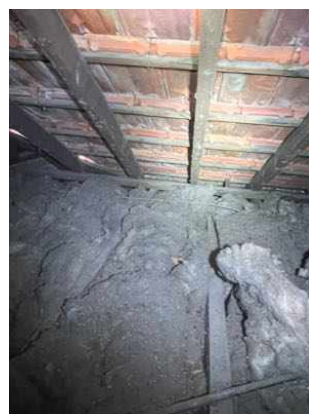
Building:	Main Building
Location:	Roof Void
Finding:	Condition of Building Elements in the Roof Void
Information:	The roof void was inspected and the visible structural framing, including timber rafters, purlins and underpurlins, appeared generally serviceable with no evidence of significant distortion, sagging or structural failure noted at the time of inspection. The roof tiling to the underside was observed to be typical of its age, with no widespread signs of active water ingress; however, isolated daylight penetration was noted at tile junctions, which may indicate minor gaps, displacement or aged bedding and pointing. While no active moisture staining was clearly evident at the time of inspection, these areas may allow wind-driven rain entry under certain conditions and should be monitored and maintained as required.

A flexible duct associated with the AC system was observed within the roof space; however, its installation appears informal, with no clear evidence of proper support or secure connection at all points. This may affect system efficiency and long-term

durability. Electrical cabling was noted running across the ceiling joists in a loose manner, which is typical of older installations, although care should be taken to ensure it remains protected and not subject to damage.

Overall, the roof void condition is consistent with an older structure, showing general age-related wear rather than any immediate structural concern. Ongoing maintenance of roof coverings, improvement of insulation distribution, and minor rectification of service installations would be beneficial to maintain performance and reduce the risk of future issues.

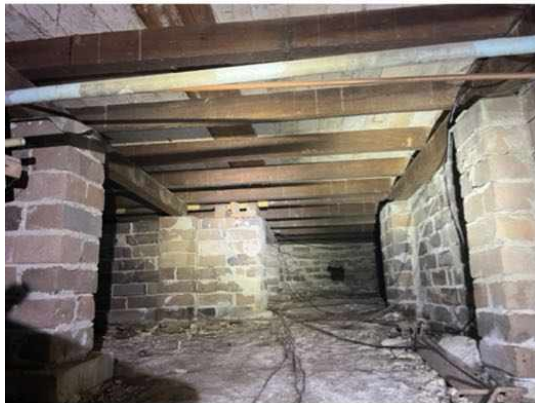
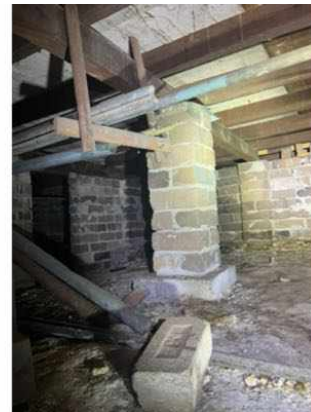
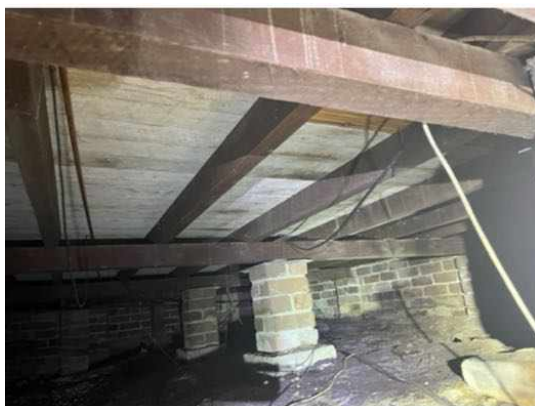
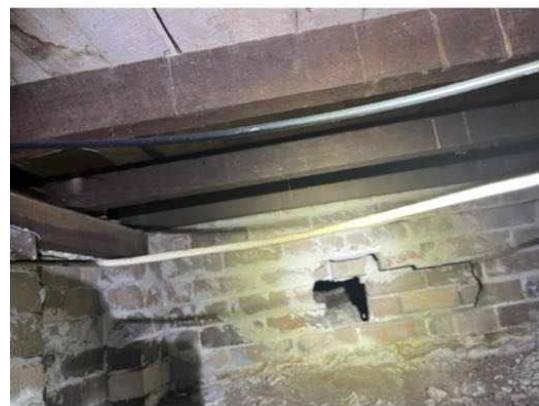
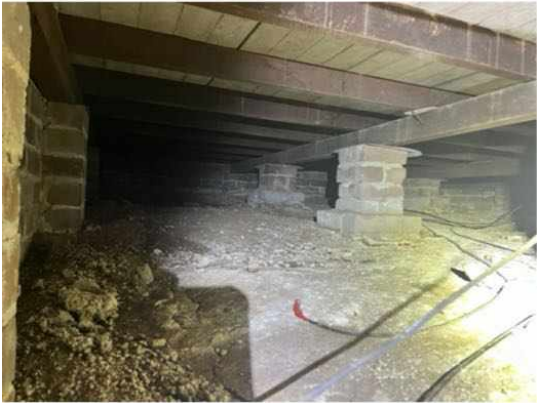
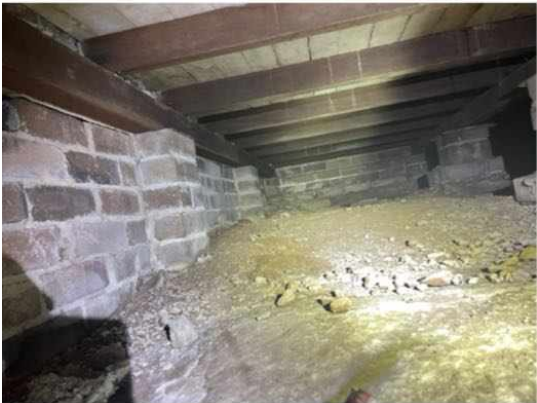
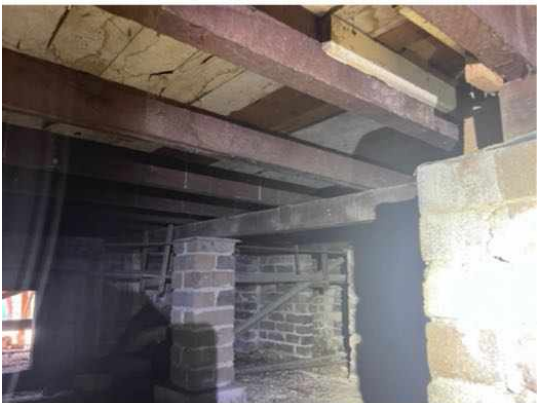
Building:	Main Building
Location:	Subfloor
Finding:	Condition of Building Elements in the Roof Void
Information:	The subfloor area was inspected and is of conventional construction comprising timber bearers and joists supported on masonry piers. The timber framing generally appeared serviceable with no obvious signs of significant structural failure; however, there is evidence of moisture-related deterioration to the subfloor lining/underfloor sheeting, which is sagging, delaminated and locally deteriorated in several areas. This condition is consistent with prolonged exposure to damp conditions and may affect durability over time.

The masonry piers and perimeter walls exhibit notable defects, including cracking, mortar deterioration and areas of displacement. Sections of the perimeter wall show horizontal cracking and localised loss of bricks, indicating possible past movement, inadequate lateral support or previous alteration without proper reinstatement. While the majority of piers appear to be supporting the structure, some show signs of wear and minor misalignment, which should be monitored and may require rectification to ensure ongoing stability.

The subfloor environment is poorly maintained, with debris, loose materials and uneven ground surfaces present throughout. There are signs of moisture influence, including damp soil and staining to masonry, which may be exacerbated by limited subfloor ventilation. Services within the subfloor, including plumbing and electrical cabling, appear to have been installed in an ad hoc manner, with loose and unsupported wiring noted and plumbing that appears retrofitted.

Overall, the subfloor condition reflects an ageing structure with a combination of moisture-related deterioration, maintenance issues and some structural concerns associated with the masonry supports. Further assessment by a suitably qualified contractor or structural specialist is recommended to address the cracking and displacement in the masonry, improve ventilation and drainage to the subfloor, and tidy and secure services to reduce the risk of damage or future defects.
