# Building and Timber Pest Inspection Report

Inspection Date: Thu, 12 Feb 2026

Property Address: 90 Landscape Rd, Tallarook VIC 3659,  
Australia

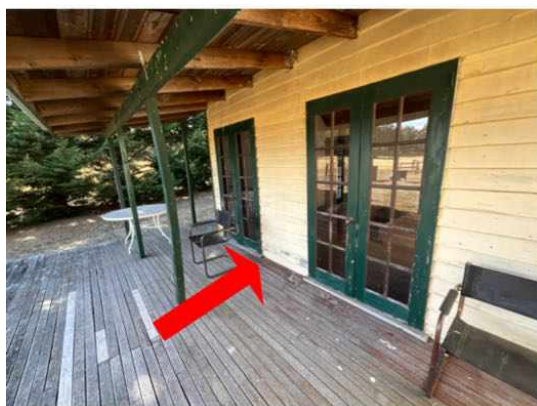
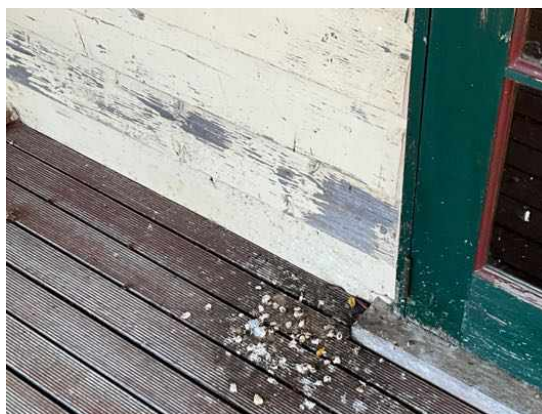
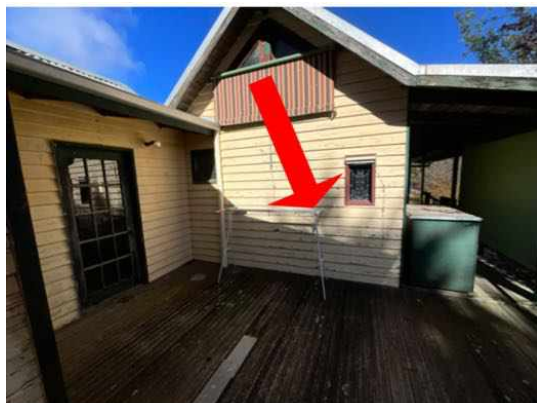
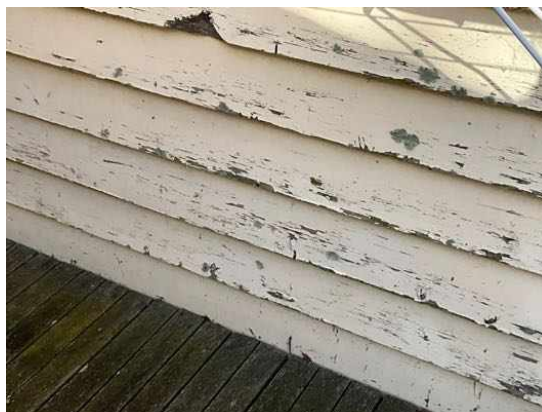
#### Finding 3.01

Building:	Building 1
Location:	All External Areas
Finding:	External painting deteriorated
Information:	Much of the external paintwork including but not limited to windows, fascias, guttering, veranda and other external fitments have been neglected and require attention to prepare and re-paint.

Whilst incomplete or missing paint finish is generally an appearance defect, it can also lead to the development of secondary building defects over time. Incomplete areas of paint finish expose the area to moisture, potentially accelerating the deterioration of underlying building materials.

Degraded paint finishes should be sanded back, filled, leveled and painted, as applicable. Where inadequate or missing paint protection has led to the deterioration of the associated building element, repair and/or replacement of this building element may be required.

A painting contractor should be appointed as soon as possible to perform necessary works to aid the appearance of the affected area and to ensure the area is protected against further deterioration. Alternatively, the homeowner following manufacturer instructions may perform these works.

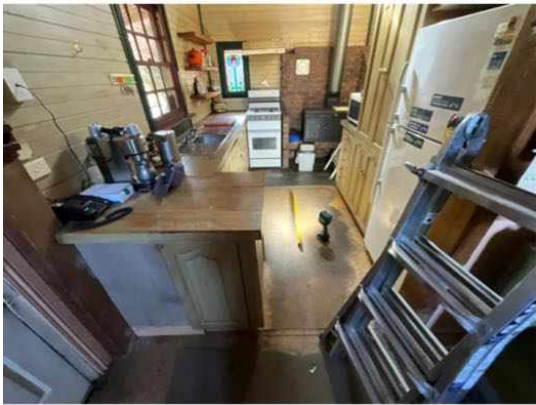
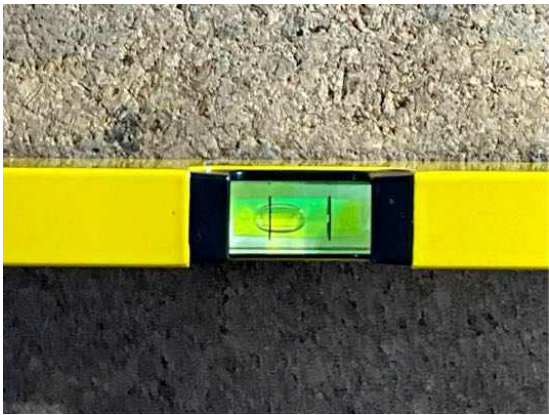
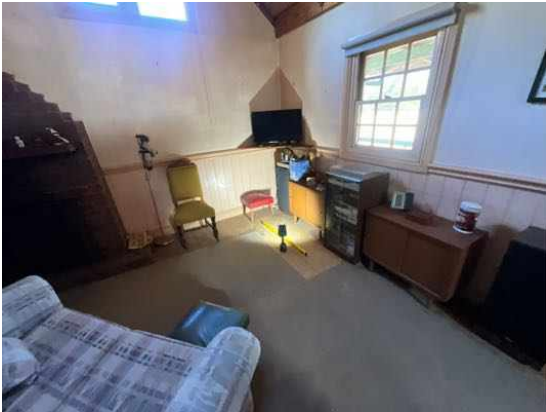
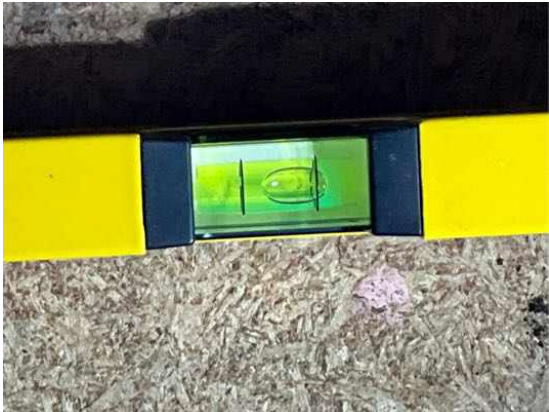
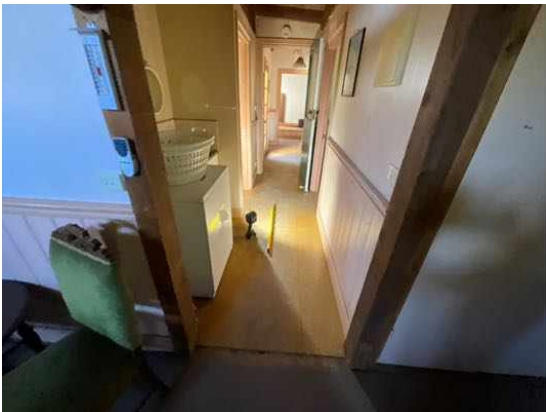
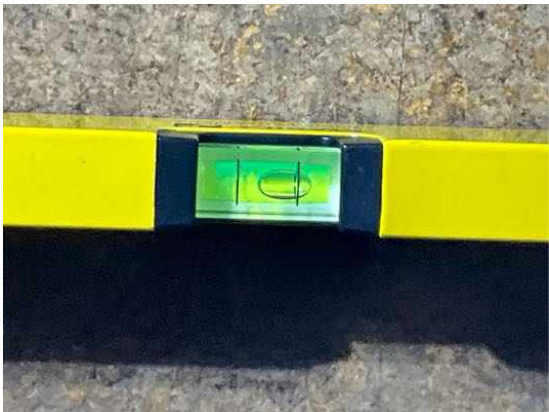
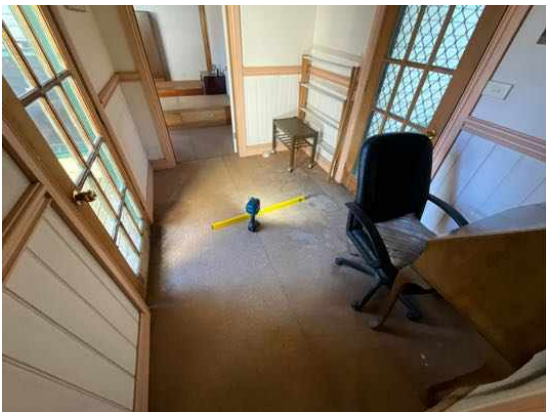
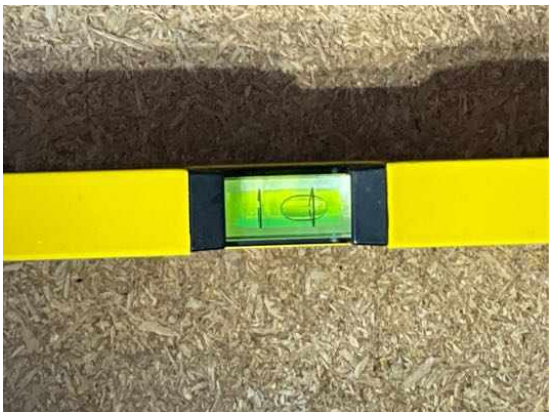
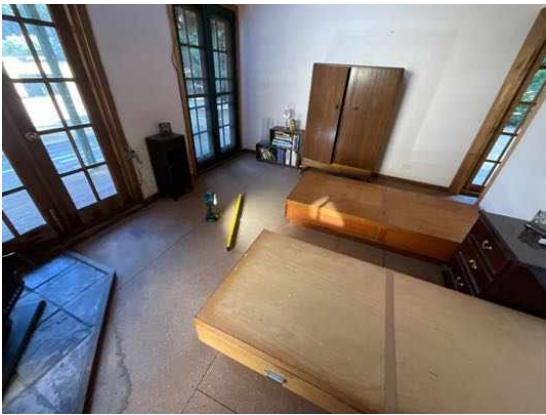
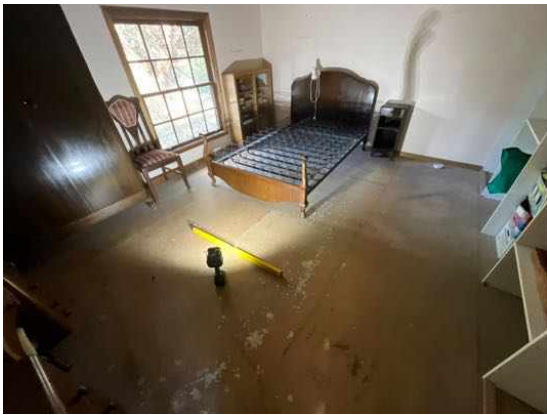
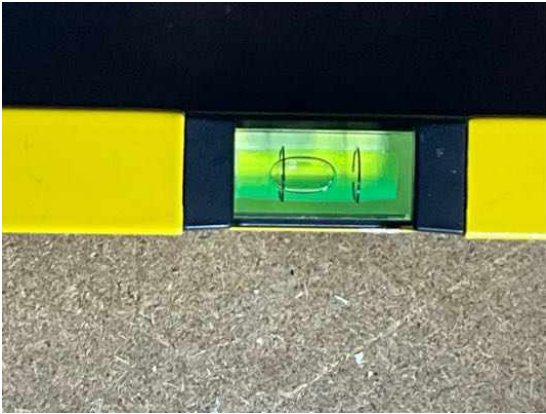
### Finding 3.02

Building:	Building 1
Location:	All Internal Areas
Finding:	Flooring - Uneven
Information:	The internal flooring in this area is out of level and uneven. Uneven flooring is likely to indicate minor defects such as expected movement of the foundations of the property, but may also indicate subsidence of the associated subfloor stumps.

It is advised that the flooring be closely monitored to identify any further movement. Where flooring remains relatively unchanged for an extended period of time (i.e. several months), it is likely that this defect has been caused by expected movement of the foundations of the property.

However, where flooring is uneven further, potentially invasive inspection of the subfloor structures and stumps in this area is required. In this case, works to repair are likely to be required, and would be carried out by a registered builder specialising in re-stumping.

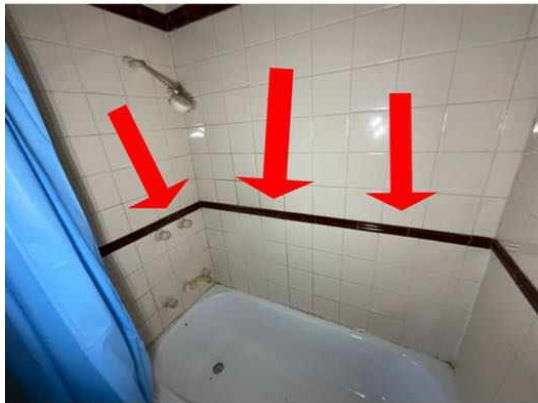
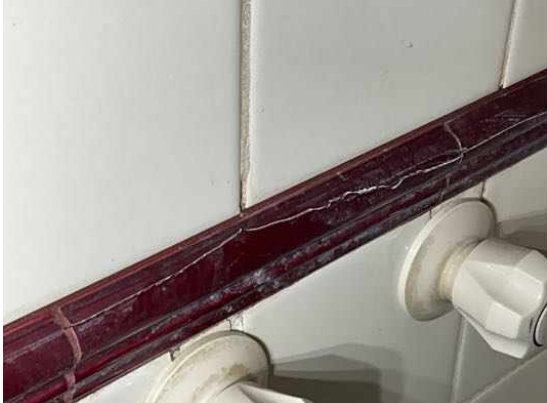
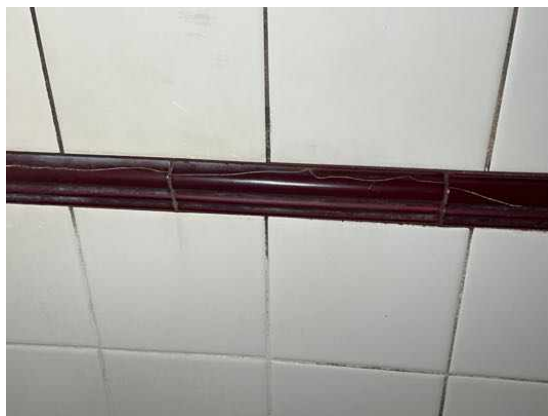
**Finding 3.03**

Building: Building 1  
Location: Bathroom  
Finding: Wall Tiles- Cracked  
Information: Cracked tiles within the household detract from the overall appearance of the affected areas, as well as creating potential for water penetration to adjoining building elements. If left unmanaged, water damage may occur as a result of constant water penetration over a prolonged period of time.

While not considered a matter of urgency, replacement of tiles is advised as a solution. A Tiling Contractor may be appointed to perform these works at client discretion.

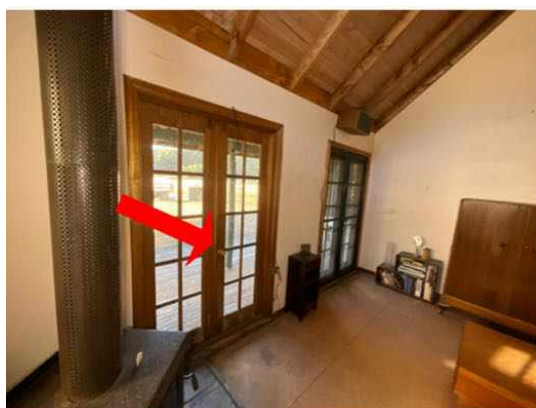
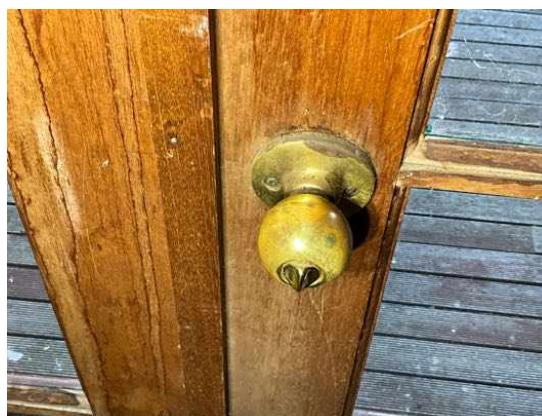
### Finding 3.04

Building:	Building 1
Location:	Bedroom - Master
Finding:	Door handles - Not latching
Information:	It was noted that the Internal doors were not latching during operation at the time of inspection. Whilst detracting from the functionality of this building element, this minor defect may also indicate problems with the Door Frame or Structure.

It is suspected that this defect has occurred due to minor issues with the associated hinges. Such damage is identified as general wear and tear, which is expected for building elements of this age.

A qualified carpenter or general handyperson may be appointed to perform rectification works as necessary, at client discretion. If left unattended, further functional impairment is likely to occur.

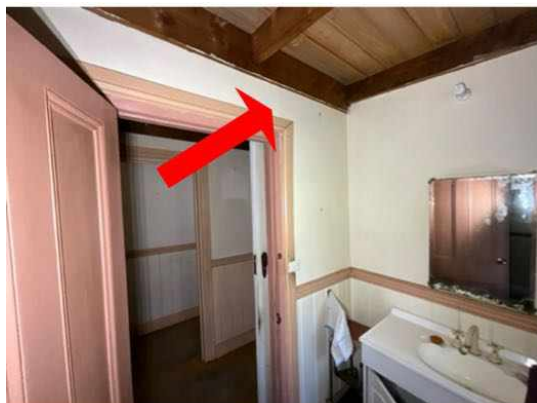
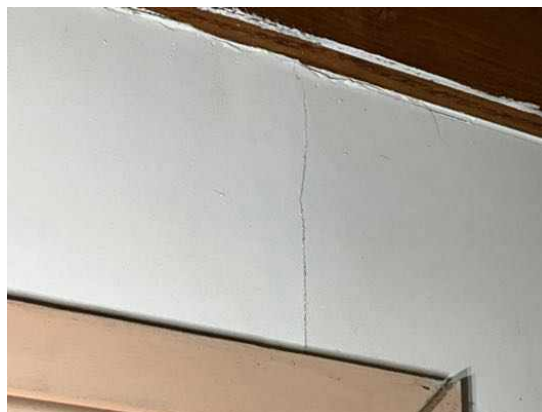
### Finding 3.05

Building:	Building 1
Location:	Bathroom
Finding:	Cracking - Damage Category 1 - Fine (up to 1mm)
Information:	Although fine cracks are quite noticeable, they are often only considered to be an

appearance defect, and usually do not indicate any structural damage. Generally, the cause of a fine crack is indicative of a separation between building materials and finishes (e.g. paint, plaster, etc.) along joints.

Cracking of this nature can generally be repaired with minor sanding, filling and/or repainting. Such works should be performed by a qualified painter or a general handyman.

Monitoring of all cracking should be conducted frequently. Always contact a building inspector should cracks widen, lengthen, or become more numerous.

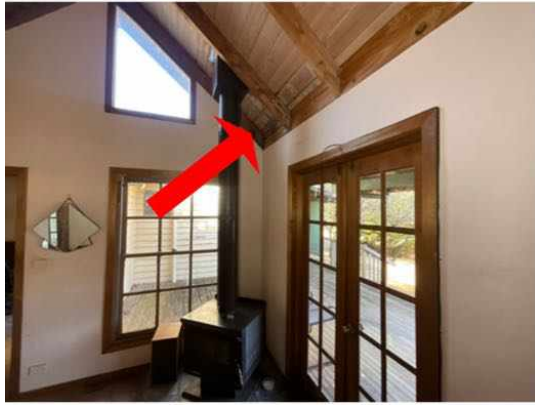
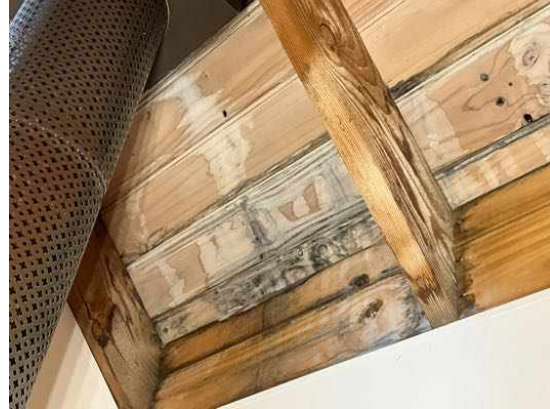
### Finding 6.01

Building: Building 1  
 Location: Bedroom - Master  
 Finding: Ceiling - Water stained  
 Information: Water staining to ceiling linings in this area was evident at the time of inspection. Water staining indicates that surfaces have been exposed to excessive moisture over time. The minerals and other elements in the water lead to staining, which may graduate to corrosion and deterioration if left unmanaged.

While mostly an appearance defect, water staining can be indicative of more serious defects, which may be currently concealed by interior ceilings.

Where water staining is active, a licensed plumber must be consulted to identify the cause of the staining and to provide advice on any reparation works that may be required. Replacement of any damaged structures is advised.

Conversely, where water staining is old and inactive, affected building materials may be repaired or replaced at client discretion.

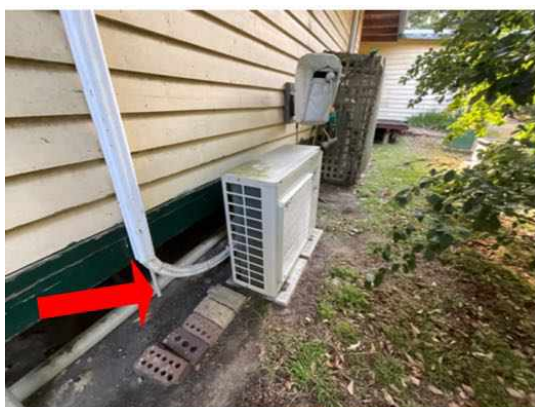
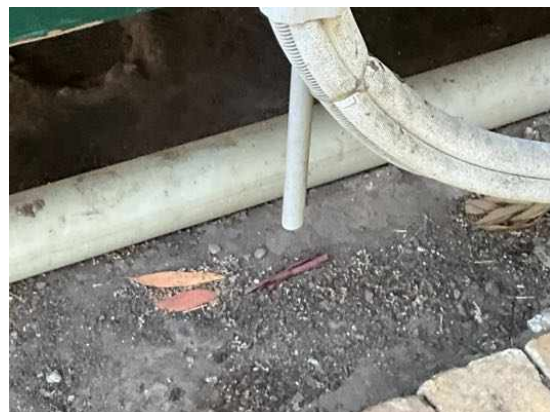
## Finding 6.02

Building: Building 1  
 Location: Yard - Back  
 Finding: Air conditioner - Disconnected overflow  
 Information: The Air Conditioner (A/C) overflow was found to be disconnected from storm water drainage and is creating excessive moisture in the surrounding area.

Such leaking creates an environment which is conducive to an array of defects, including water damage to associated building elements and the attraction of termite or timber pest infestation.

It is highly recommended that a licensed plumber be appointed to connect the A/C overflow in order to prevent such an environment from being created. These minor works should be carried out as soon as possible.

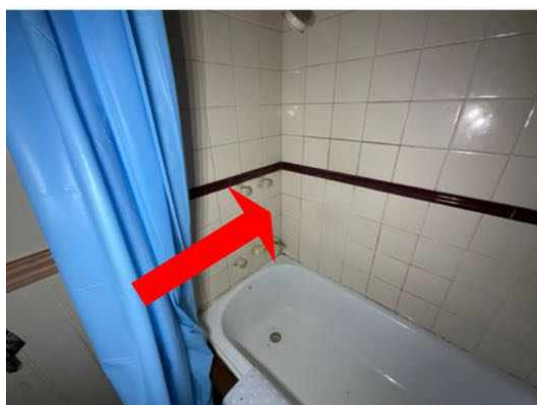
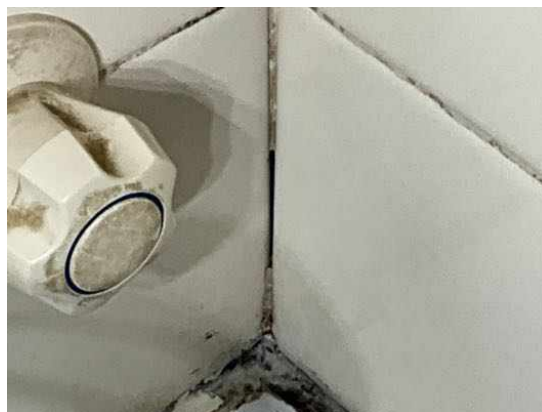
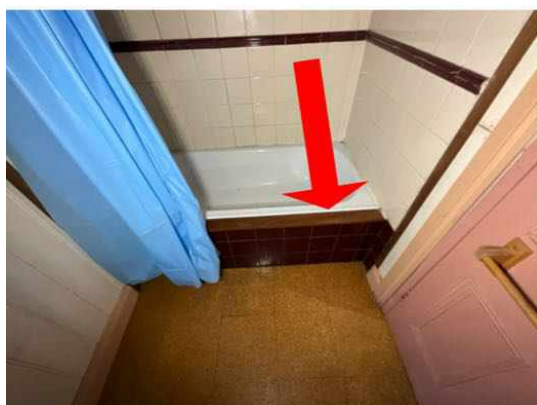
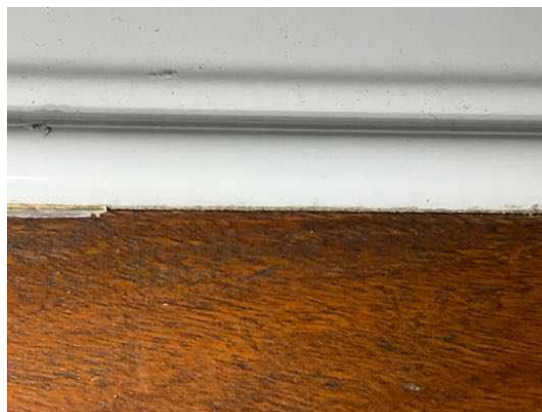
### Finding 6.03

Building:	Building 1
Location:	Bathroom
Finding:	Inadequate sealant or Grout
Information:	This area has a lack of effective Sealant or Grout. This is allowing the ingress of water to the structure inside the wall.

The presence of water encourages Termite attack, Mould and Fungal Decay.

A Tiler or General Handy person must be contacted as soon as possible to effect repairs and prevent further deterioration.

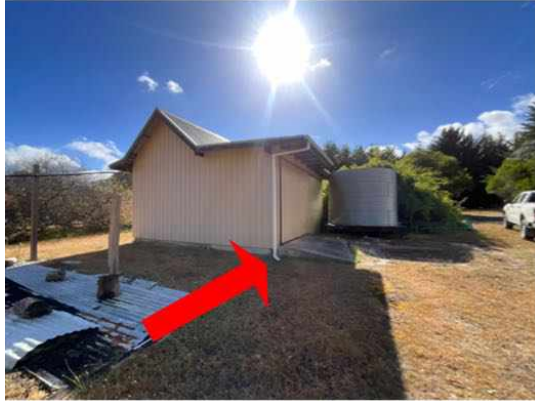
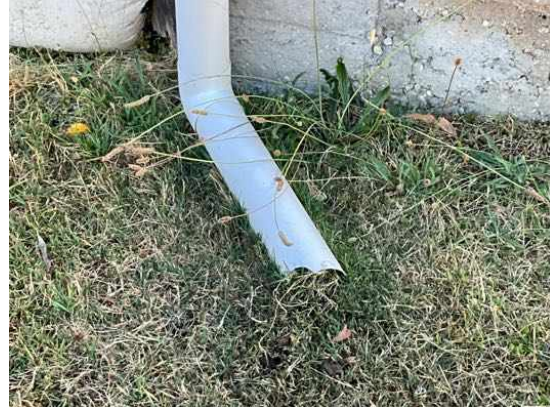
### Finding 6.04

Building:	Building 1
Location:	Shed
Finding:	Stormwater drain - Not connected
Information:	The roof plumbing is not adequately connected to stormwater drainage on the site. This disconnection negatively impacts the functional capacity of the roof plumbing.

Where roof plumbing doesn't drain adequately, the area at the base perimeter can become excessively damp, potentially creating an environment that is susceptible to

rust and corrosion of surrounding building elements, as well as attracting termites and other pests.

It is highly recommended that a plumber be appointed to further inspect the area and to install adequate drainage equipment where necessary.

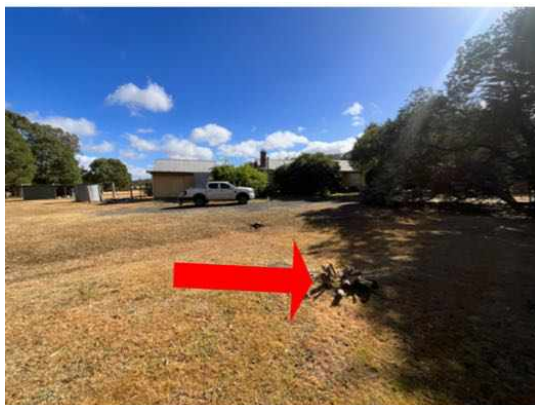
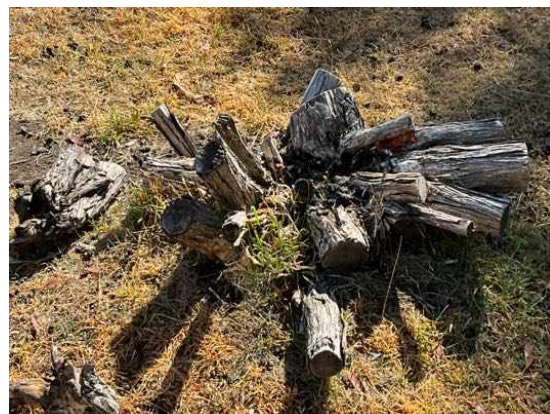
### Finding 6.05

Building:	Building 1
Location:	Yard - Back
Finding:	Tree Stump in Ground
Information:	Any tree stumps in the yard not removed during the tree removal process provides the opportunity for Termite infestation and is likely to be subject to decay from damp conditions against the stump.

All tree stumps should be removed by professional tree removal services where possible. Meanwhile regular inspections are advised to identify any termite activity in the areas identified.

Services for tree stump removal should be contacted as soon as possible to reduce the risk of timber pest attack.

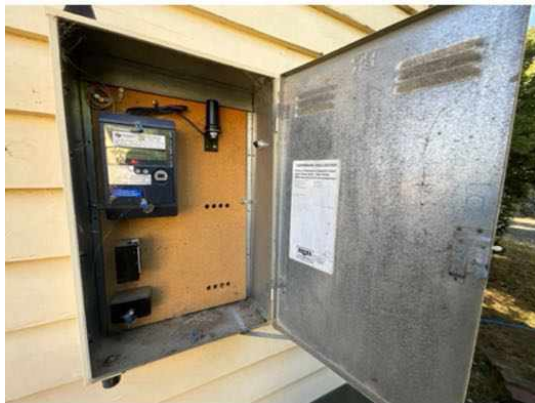
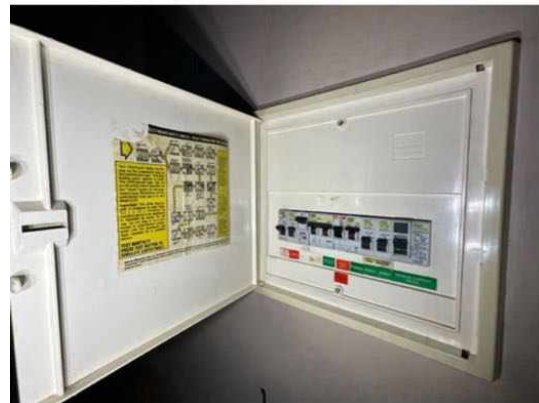
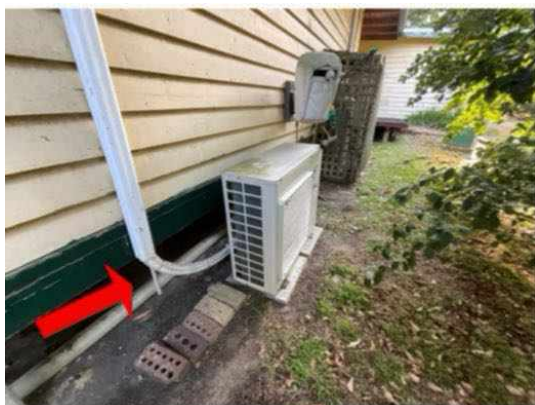
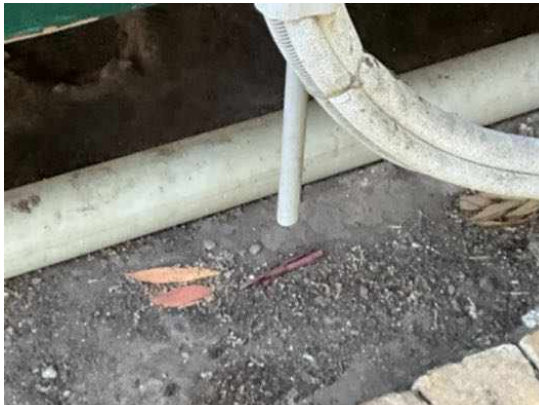
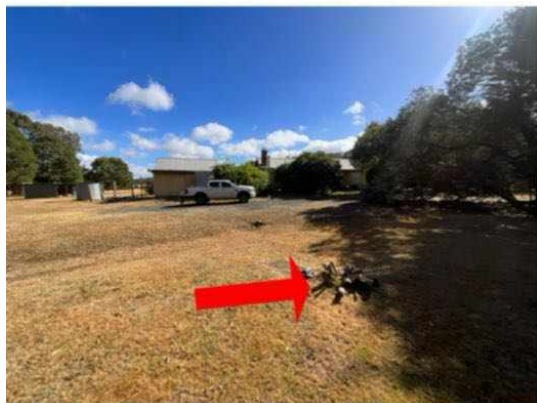
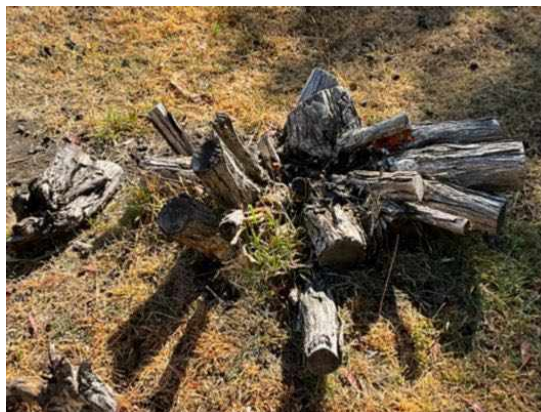
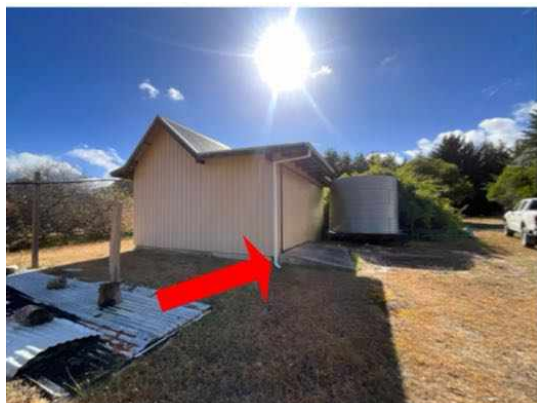
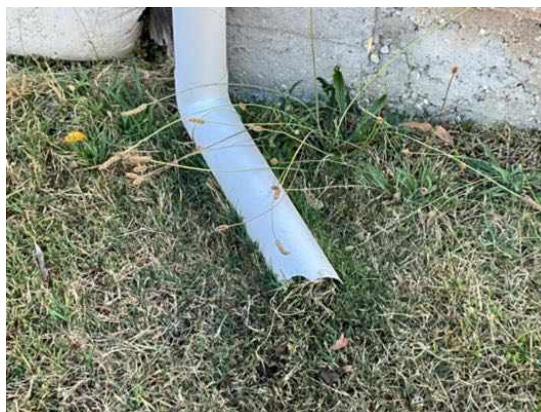
### Finding 6.06

Building: Building 1  
Location: All External Areas  
Finding: Termite Management System - no evidence of a chemical installation  
Information: The application of a post-construction chemical termite barrier is highly recommended for all properties, particularly if live termite activity has been found on the site previously. Such barriers are highly effective in preventing termite attack on any timber building elements throughout the property.

A durable notice should be placed in the switchboard unit to indicate current termite barriers. At the time of inspection, it appeared as though no termite management system has been installed, with no evidence to suggest preventative works taking place.

The client may consider gaining further advice from a pest controller as to the costs and procedures involved with this application. It is recommended that obtaining such advice be a short-term priority.

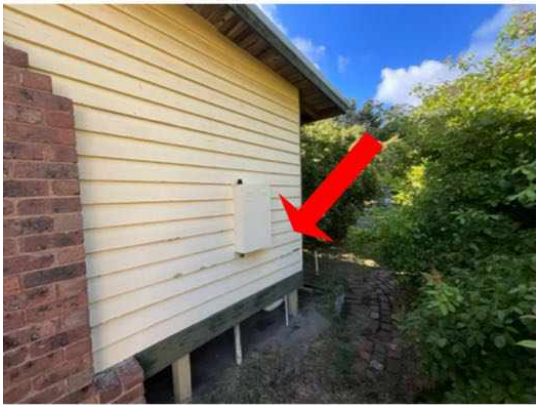
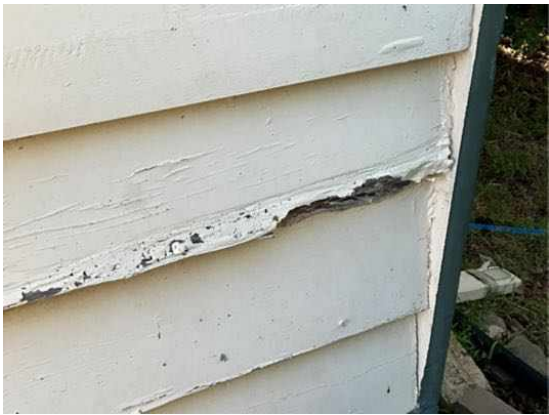
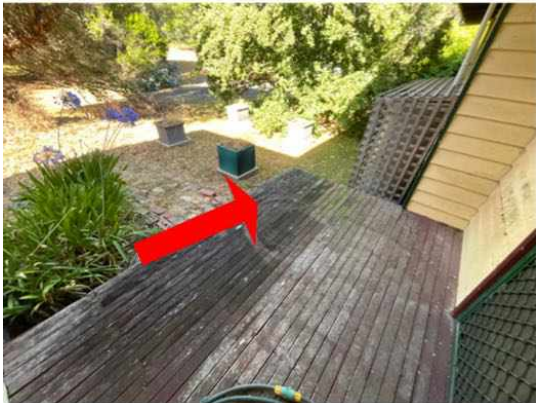
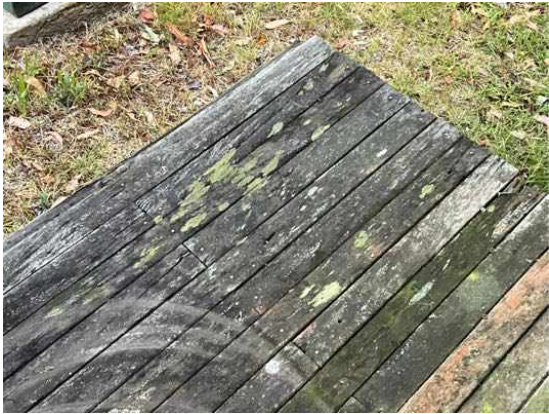
### Finding 7.01

Building:	Building 1
Location:	Side wall, deck
Finding:	Fungal decay - present (localised)
Information:	Fungal decay also known as wood decay or wood rot generally refers to the deterioration of timber elements when in contact with excessive levels of moisture for a prolonged period of time.

The development of fungal decay is accelerated by temperatures in the range of 5degreeC to 40degreeC as well as the presence of oxygen. Generally fungal decay develops on timber elements that are in use in an external environment which are exposed to rain penetration.

In this case although the affected timber element is in a decaying state the extent of any visible damage appears to be localised to a specific area and is yet to spread to other parts of the building element or affect adjoining structures. The fungal decay is therefore likely to be of a relatively superficial nature with minimal impact on the structural integrity or tensile strength of the timber element.

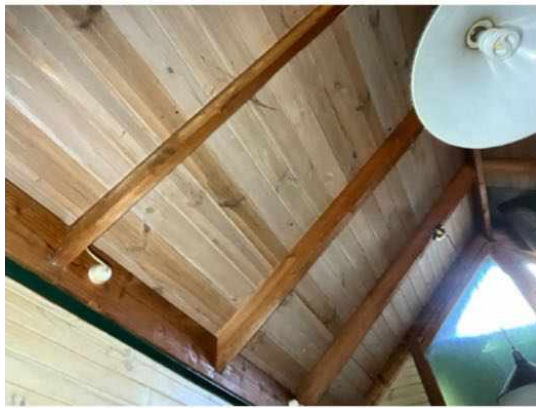
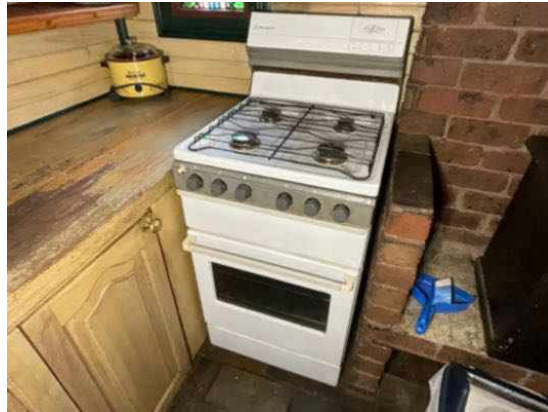
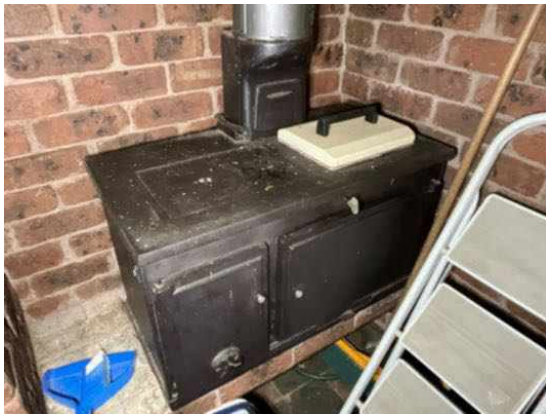
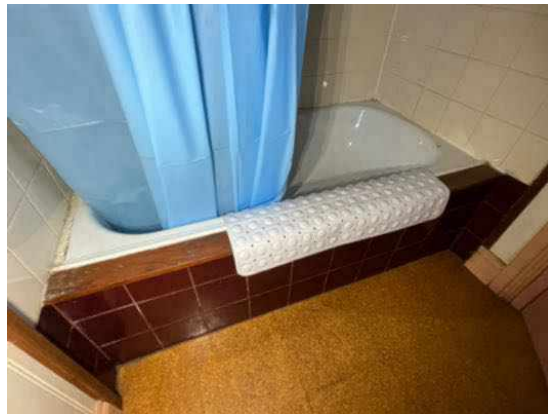
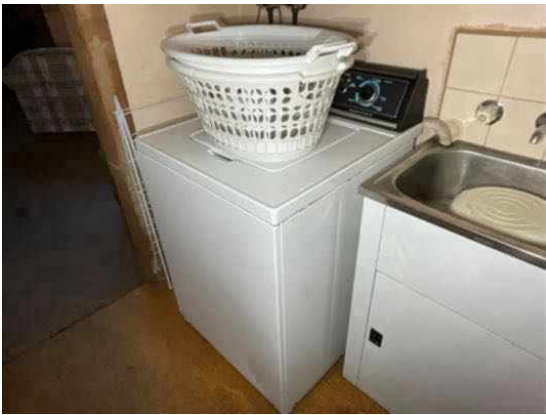
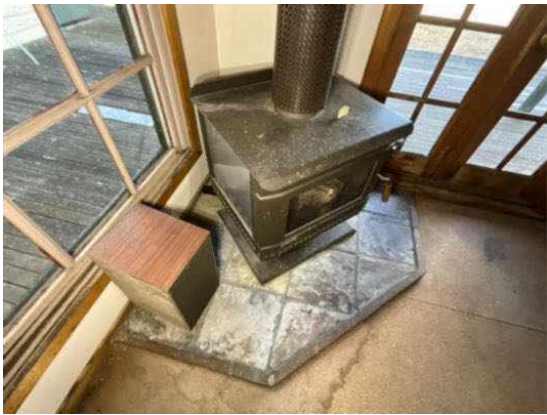
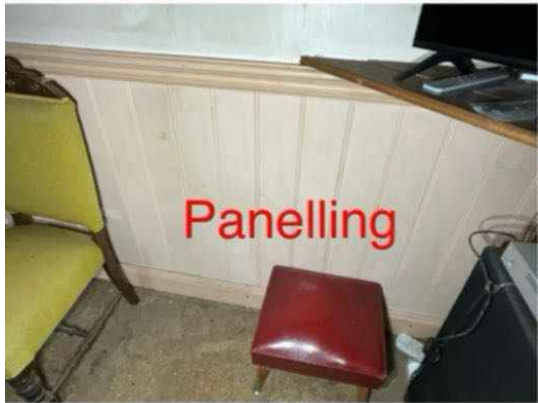
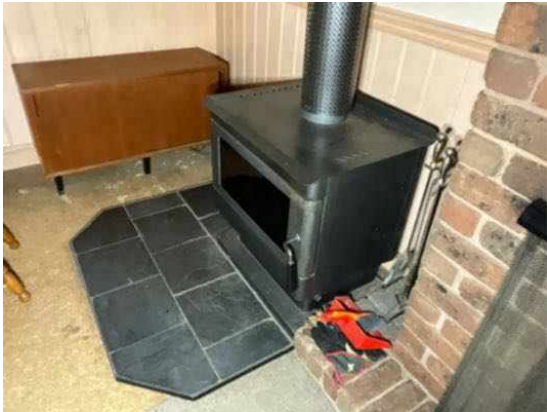
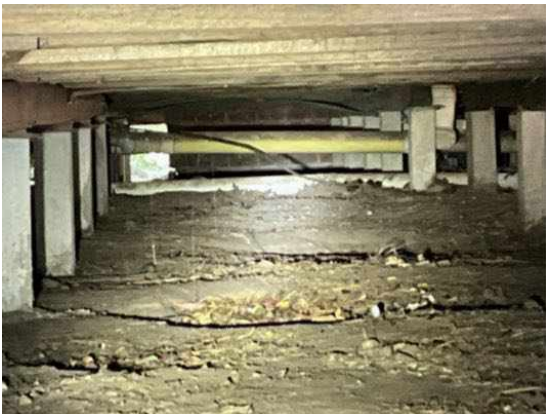
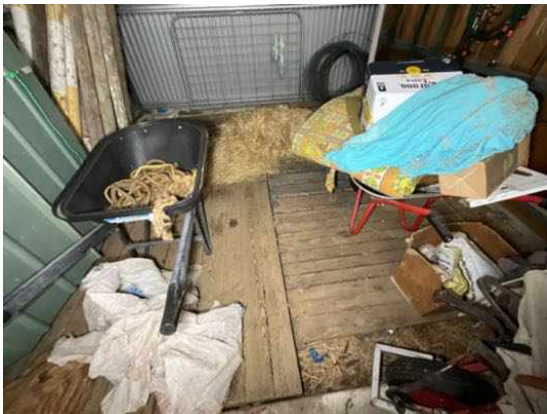
#### Noted Item

Building: Building 1  
Location: All Areas  
Finding: Additional Photos - Obstructions and Limitations  
Information: These photographs are an indication of the obstructions and limitations which impeded full inspection of the property at the time of inspection. These obstructions can hide an array of defects and should be removed to allow full inspection to be carried out. A re-inspection is recommended once the areas are made accessible.
