Building Inspection Report

Inspection Date: Tue, 3 Mar 2026

Property Address: 13 Henshaw Ct, Narre Warren South VIC
3805, Australia

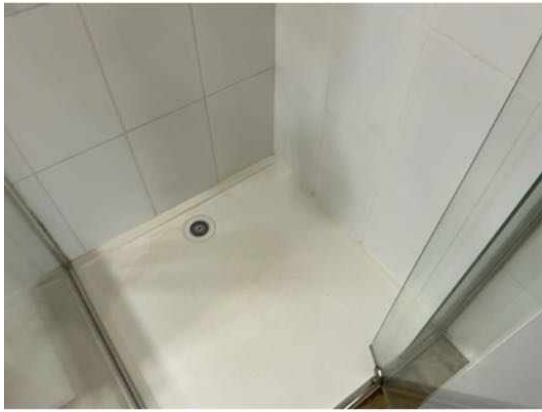
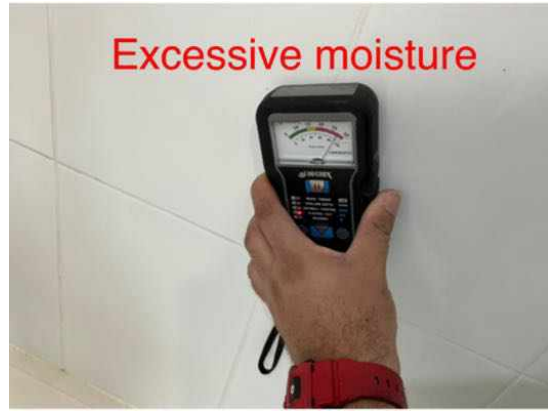
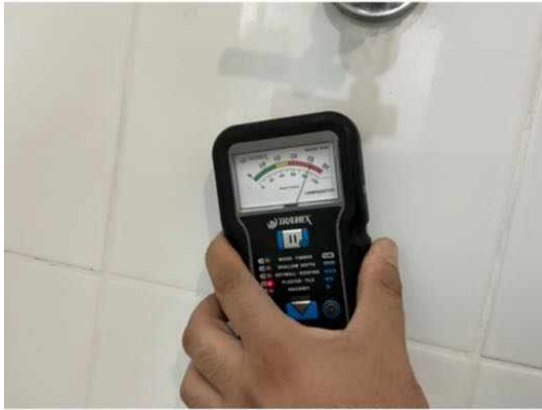
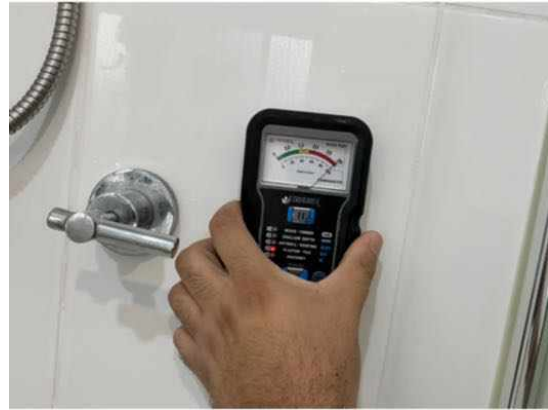
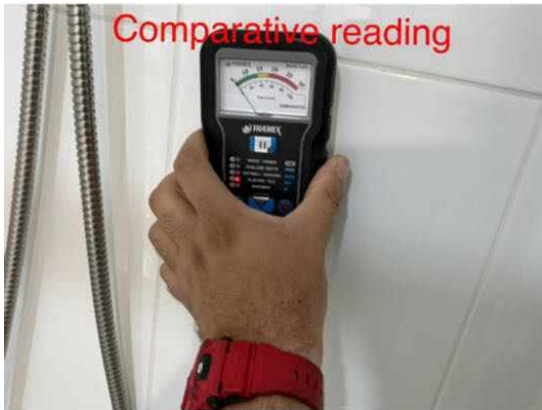
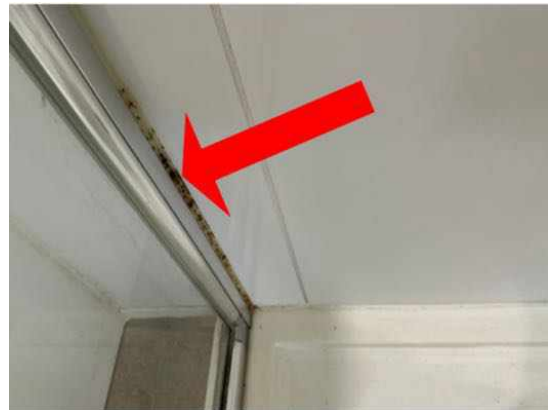
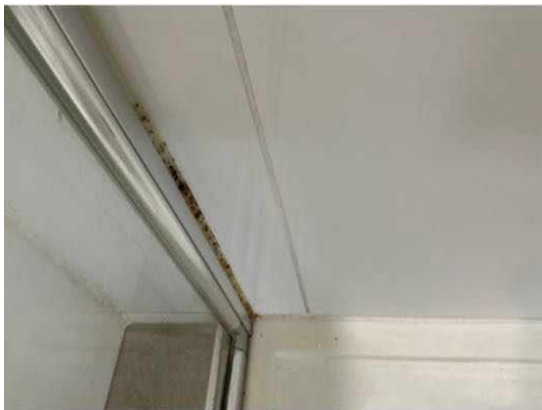
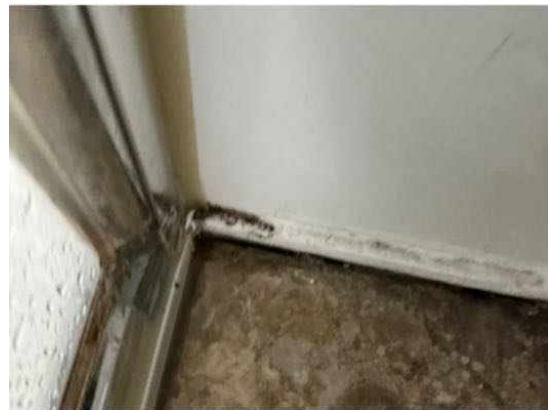
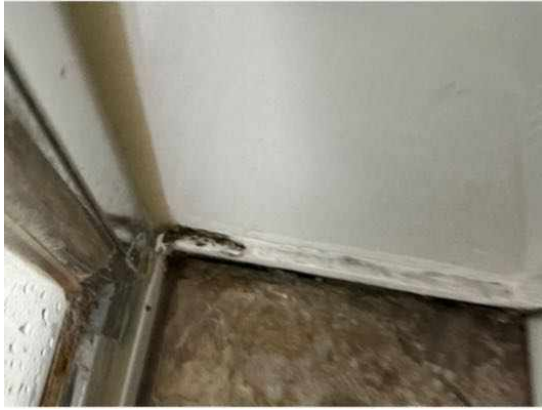
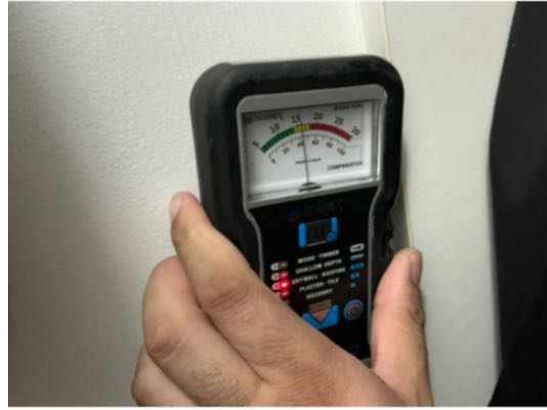
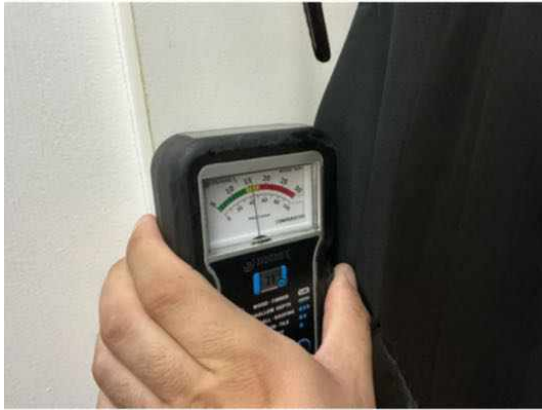
Defects 3.01

| Finding: | Suspected Moisture Intrusion – Ensuite Shower Area - Urgent attention needed |
| Information: | Excessive moisture readings were detected to the lower section (approximately the bottom 600 mm) of the ensuite shower wall at the time of inspection when tested using a non-invasive moisture meter. Further moisture testing was conducted to the adjacent wall located behind the shower within the walk-in robe, where elevated moisture readings were also recorded to the plasterboard surface. These findings may indicate the presence of moisture within the wall cavity. |

As this inspection is non-invasive in nature, the exact cause of the elevated moisture readings could not be determined. Possible contributing factors may include plumbing leakage, deterioration or failure of the shower waterproofing system, or water ingress through deteriorated or failed shower sealant.

It is recommended that a licensed plumber be engaged without delay to undertake further invasive investigation to accurately determine the source of the moisture and carry out the necessary rectification works. Additionally, mould growth was observed to the silicone sealant at the base of the shower screen/shower base junction. The affected sealant should be thoroughly cleaned or removed and replaced (re-siliconed) to eliminate mould and restore proper sealing.

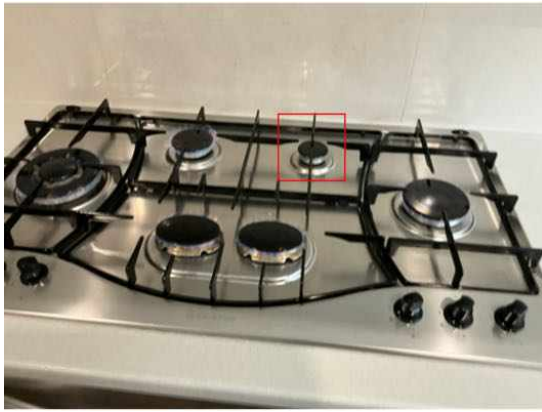
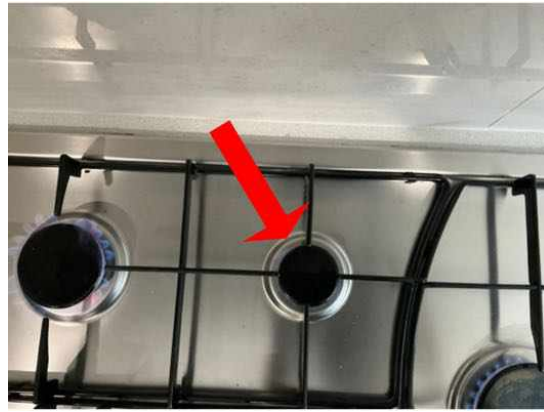
Defects 3.02

Building: Main Building
 Location: Kitchen
 Finding: Non-Operational Kitchen Cooktop Burner
 Information:

At the time of the inspection, one of the burners on the kitchen cooktop was found to be non-operational during functional testing.

The non-functioning burner may indicate a fault with the burner assembly, ignition system, gas supply to the burner, or another component of the appliance. As such, the cooktop may not be operating as intended and may require servicing.

It is recommended that a qualified appliance technician or gas fitter be engaged to inspect the cooktop, diagnose the fault, and carry out the necessary repairs to restore proper operation.

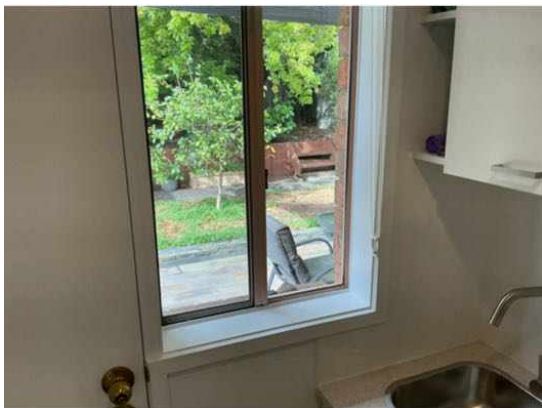
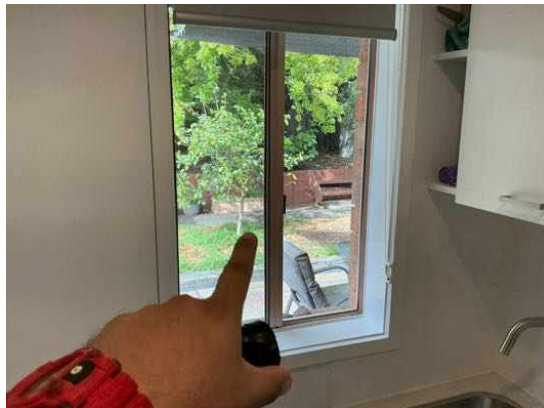
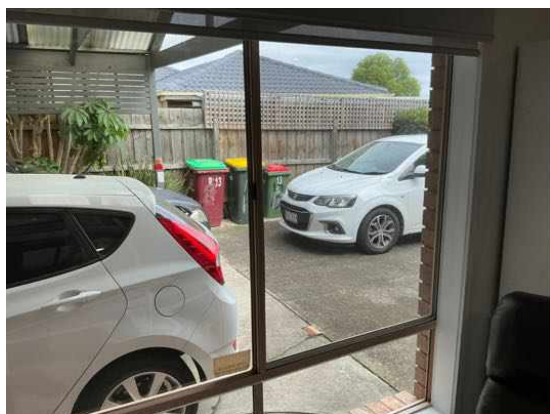
Defects 3.03

Information: Several windows throughout the property were jammed and difficult to operate at the time of the inspection. Windows provide ventilation to the adjoining area and should be at a fully operational level to ensure user comfort. Restricted function of the window may also pose as a potential safety hazard if required for emergency egress from the building.

Generally, factors such as general age of the building element and a lack of maintenance are the usual causes for this type of defect.

Replacement of window hardware or frame may be required, as well as minor repairs and cleaning. A registered builder or general handy person will be required to repair the affected windows.

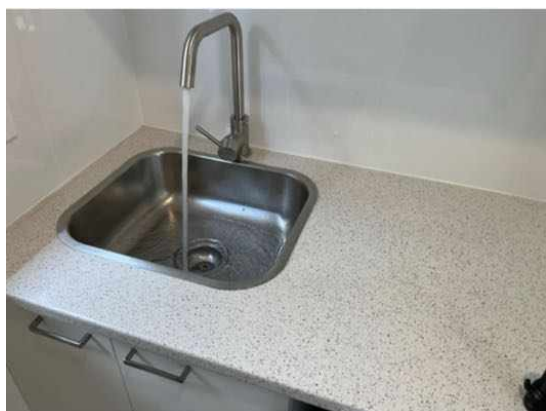
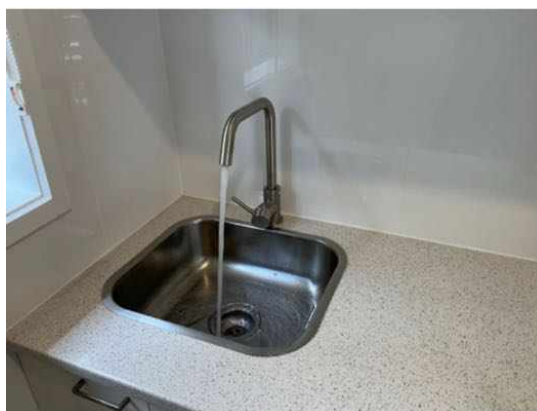
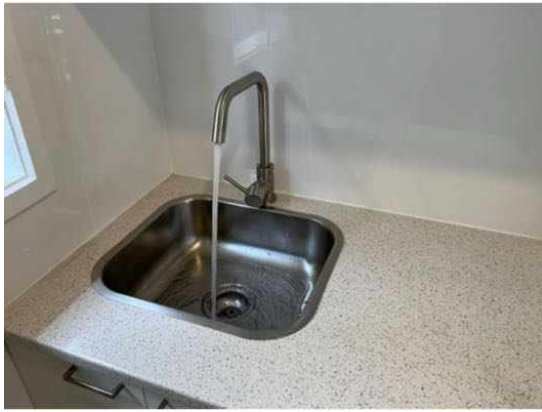
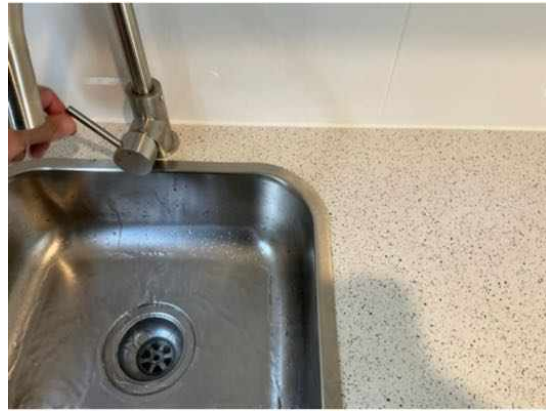
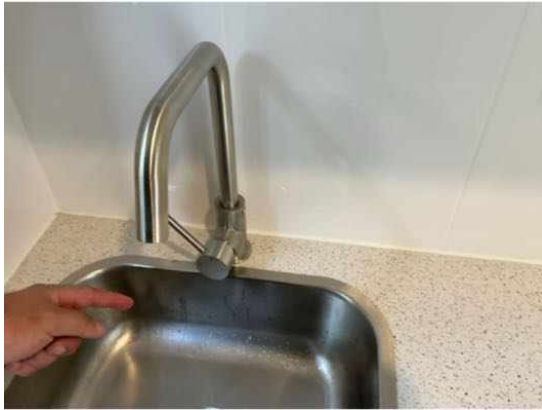
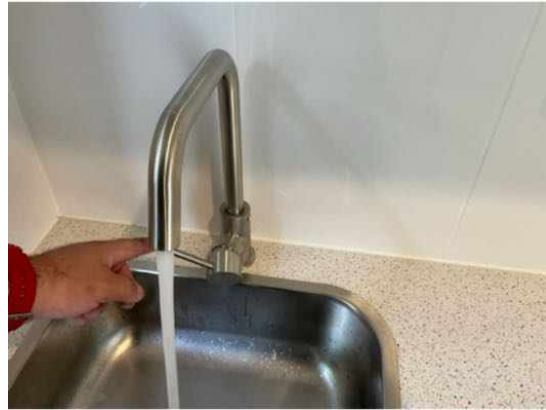
Defects 3.04

Building: Main Building
Location: Laundry
Finding: Laundry Tap – No Hot Water Supply
Information:

At the time of the inspection, the laundry tap was tested and found to be operational; however, only cold water was discharging, and no hot water was available from the fixture.

This condition may indicate an issue with the hot water supply to the tap, a faulty mixer or tap component, or a possible disconnection or blockage within the hot water line serving the laundry area. The exact cause could not be determined during this visual and non-invasive inspection.

It is recommended that a licensed plumber be engaged to inspect the laundry tap and associated plumbing connections, assess the hot water supply to the fixture, and carry out any necessary repairs or component replacement to restore proper operation.

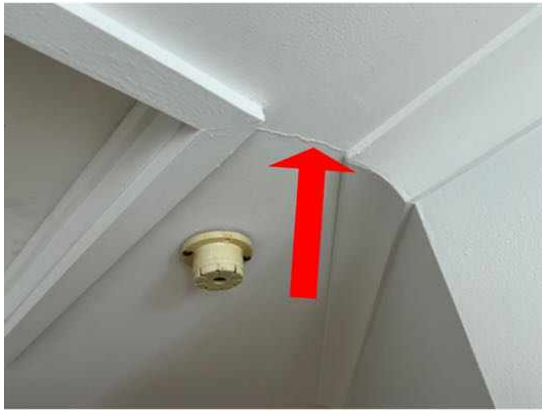
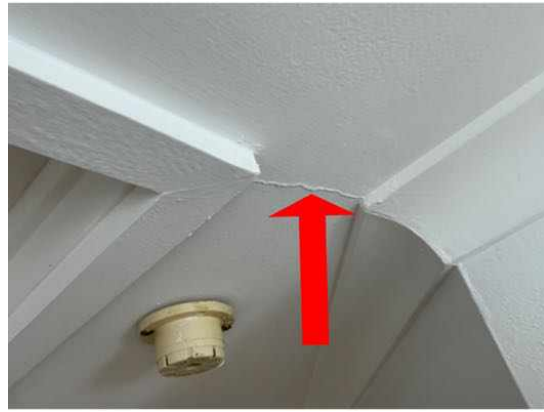
Defects 3.05

Building: Main Building
 Location: Hallway next to manhole
 Finding: Minor Ceiling Crack Adjacent to Manhole
 Information:

A minor crack was observed in the plaster ceiling adjacent to the manhole opening at the time of the inspection.

This type of cracking is commonly associated with minor building movement, settlement, or stress concentrations around ceiling openings such as manholes. The crack appears to be cosmetic in nature and is not considered structurally significant.

For cosmetic improvement, the crack can be filled, sealed, and repainted by a qualified painter or plaster repairer if required.

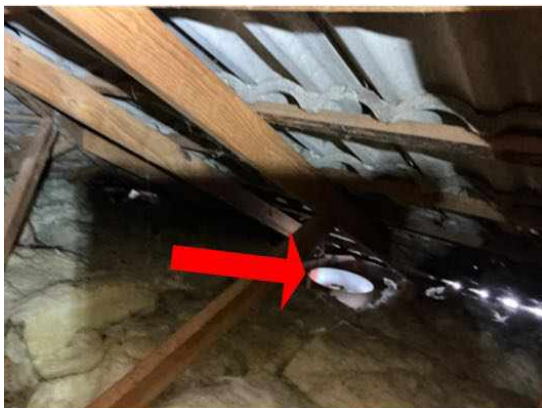
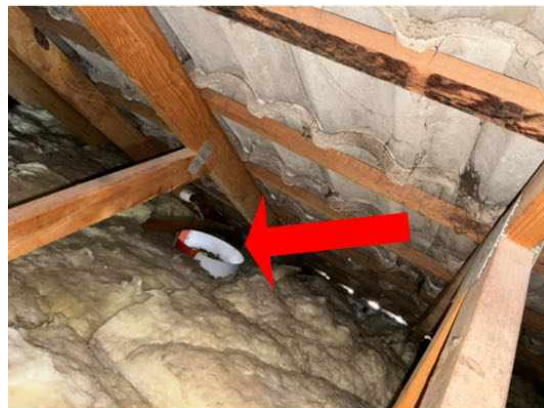
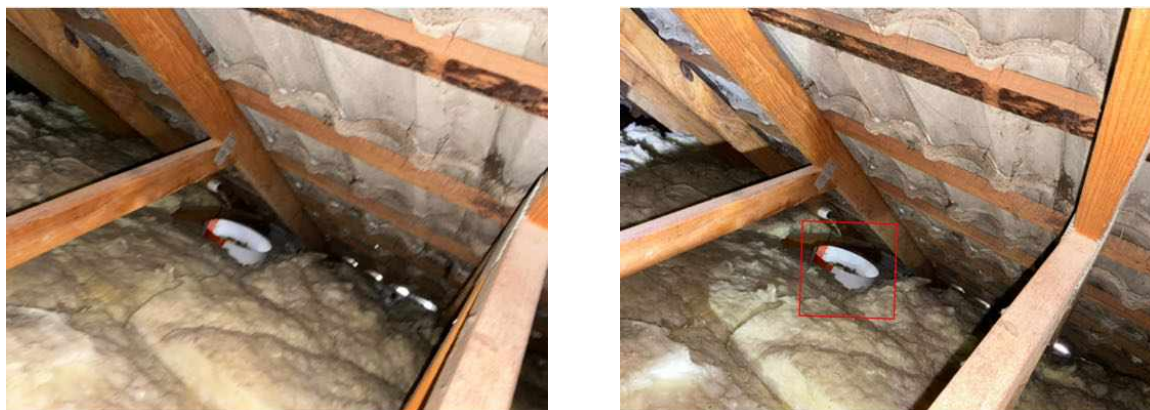
Defects 3.06

Building: Main Building
 Location: Roof Void
 Finding: Bathroom Exhaust Fans Not Ducted to External Atmosphere
 Information: The exhaust fans installed in the bathrooms were observed to be discharging directly into the roof cavity rather than being ducted to the external atmosphere. This configuration does not comply with best practice ventilation standards, as it allows moist air to accumulate within the roof space.

Prolonged moisture build-up in the roof cavity can lead to elevated humidity levels, which may contribute to mould growth, timber decay, and potential damage to insulation or other roof components over time.

It is recommended that a licensed ventilation specialist or electrician be engaged to install compliant ducting that vents the exhaust air to the outside of the building, in accordance with current building regulations and ventilation standards.

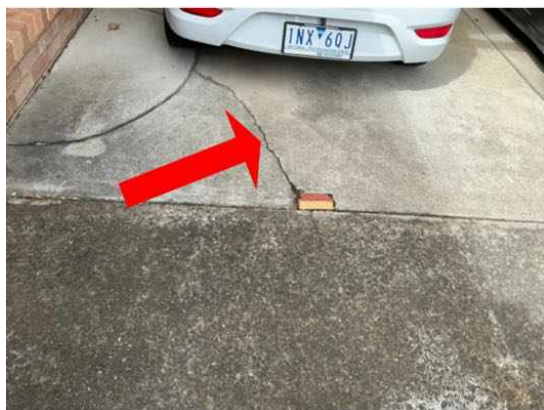
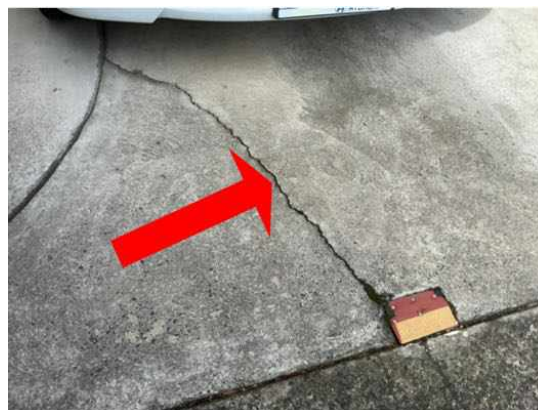
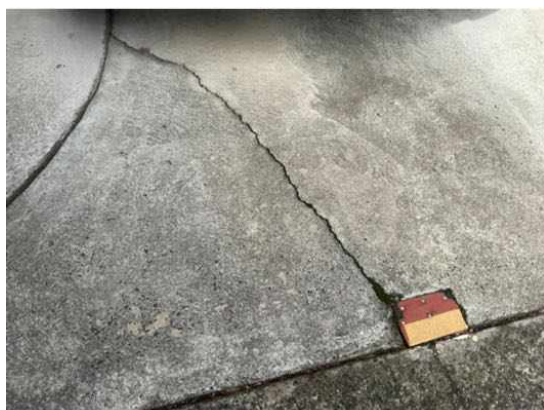
Defects 3.07

| Finding: | Cracking - External Concrete Paving Damage Category 2 - Distinct (less than 3mm) |
| Information: | Distinct cracks were identified in external concrete paving. Distinct cracks are generally found in older concrete paving, and may also present as a trip hazard as consequence of an uneven or curved surface. |

General age and expected deterioration of the paved areas is a common cause of this type of cracking. However, expansion and contraction of the slab may also have occurred due to environmental factors. Such factors include variable moisture and weather conditions, the presence of trees and their roots having a settling or lifting affect on the soil, or the effect of load bearing, e.g. heavy vehicles over a sustained period of time.

Cracking to this degree may also be due to poor original installation of the concrete. Factors such as poor compaction of the sub surface and/or inadequate reinforcing of the slab may create cracking and other secondary defects.

Repairs are likely to be required to prevent further cracking and to reduce hazards associated with cracking, such as tripping. Monitoring of all cracking should be conducted frequently. Always contact a building inspector should cracks widen, lengthen, or become more numerous.

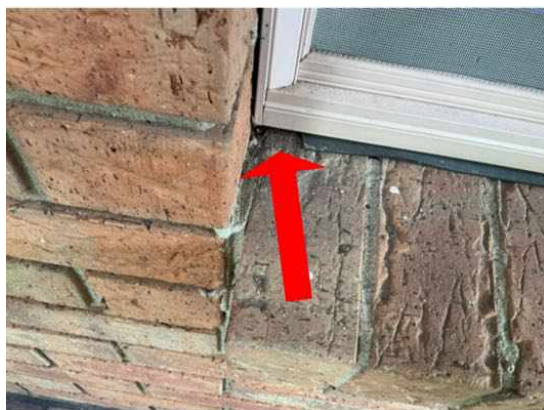
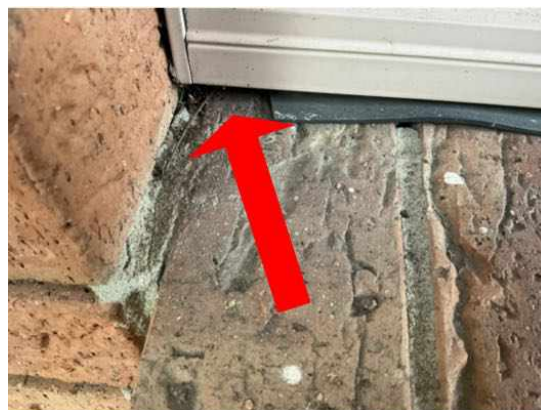
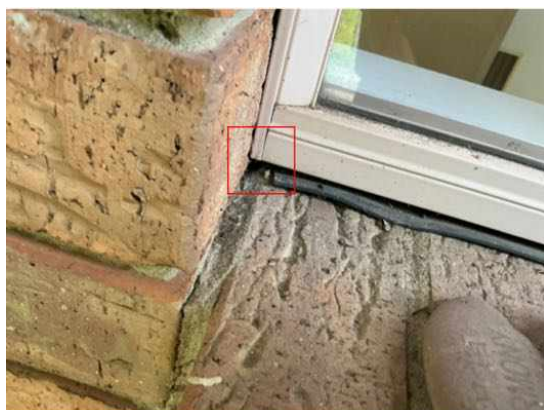
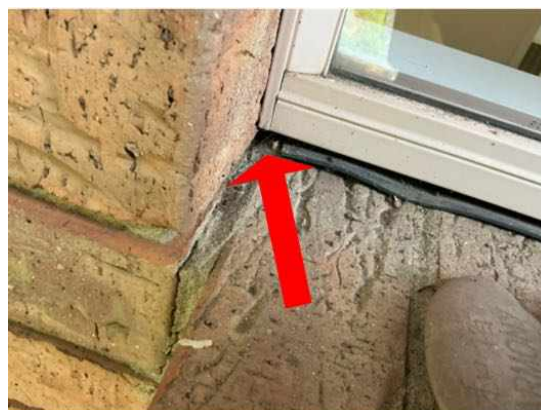
Defects 3.08

| Information: | Multiple gaps were identified between the external window frames and the adjoining brickwork across several elevations. These gaps appear to be the result of either poor or inconsistent sealant application during installation, or deterioration of the original sealant over time. |

Unsealed or poorly sealed gaps can allow moisture ingress, wind-driven rain, draughts, and provide potential entry points for pests. Ongoing exposure to moisture may also contribute to internal dampness and premature deterioration of surrounding building elements.

A qualified handyman or registered builder should apply a consistent, waterproof, flexible exterior-grade sealant around all affected windows to ensure adequate weatherproofing and protection against moisture and pest entry.

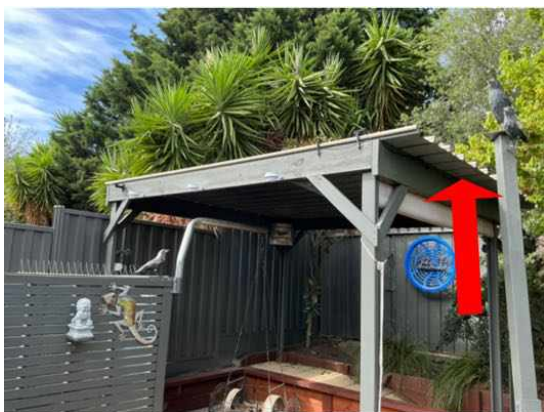
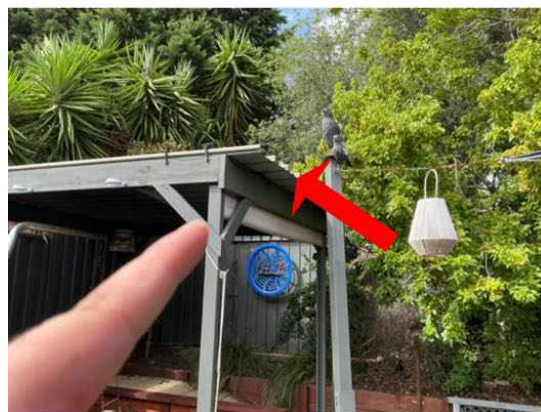
Defects 3.09

Building: Main Building
 Location: Rear cover patio
 Finding: Absence of Gutter and Drainage to Rear Covered Patio
 Information:

The covered patio structure located at the rear of the property was observed to be constructed without any guttering or stormwater drainage provisions at the time of the inspection.

The absence of gutters may allow rainwater to discharge directly off the patio roof, which can lead to uncontrolled water runoff around the surrounding areas. Over time, this may contribute to excessive moisture accumulation near the structure, potential deterioration of adjacent building elements, or soil erosion.

It is recommended that a qualified roofing contractor be engaged to install appropriate guttering and connect it to a suitable stormwater drainage system to ensure controlled collection and discharge of rainwater away from the structure.

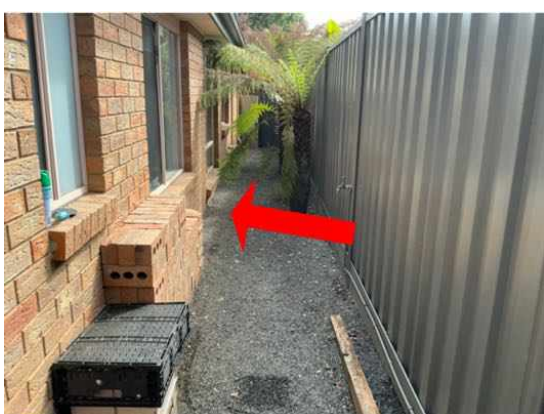
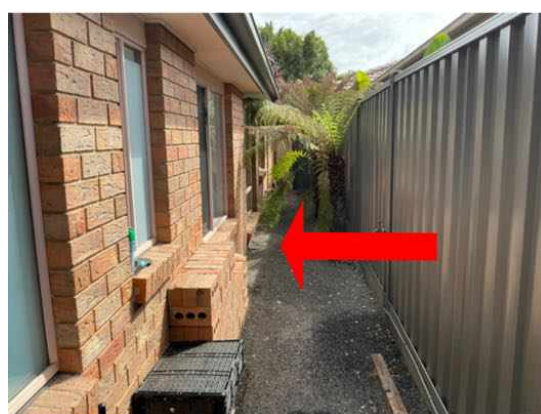
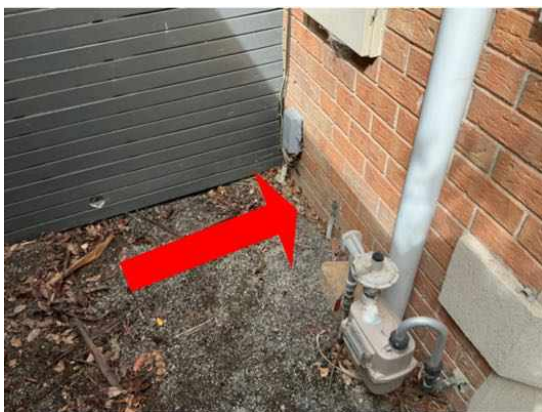
Defects 3.10

Building: Main Building
 Location: All External Areas
 Finding: Site drainage - Inadequate
 Information: The site drainage in the yards was found to be inadequate at the time of inspection, creating potential for subsequent water damage to associated building elements.

It is important that water does not lie against the base of walls; surrounding paths and ground levels should be sloped to drain water away from walls. Downpipes should not discharge stormwater onto lower walls or plinths. Stormwater should be carried away by large, regularly cleaned drains. Ground levels may need to be lowered to expose a buried DPC.

Where site drainage is inadequate, installation of an Agricultural (Aggie) Drain may be required. A qualified plumber should be appointed to further inspect the property and perform any remedial works as necessary. Water damage and secondary defects are likely to occur if left unmanaged.

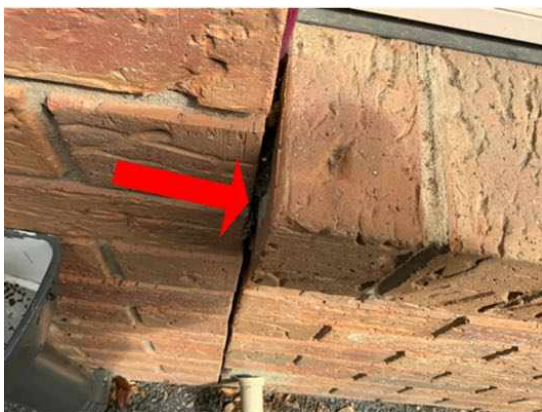
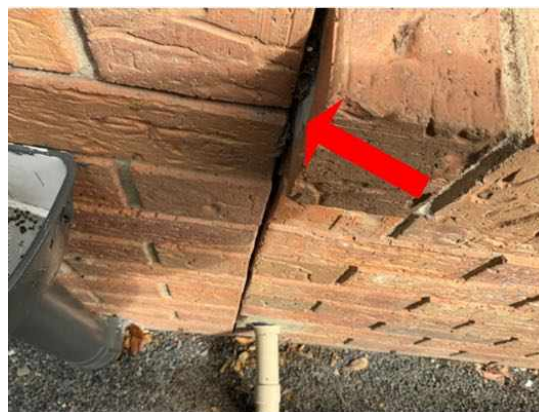
Defects 3.11

| Finding: | Brickwork expansion joint - Seal missing. |
| Information: | During the inspection, it was noted that the seal for the brickwork expansion joint is missing on sections of the exterior walls. Expansion joints in brickwork are critical as they accommodate the natural movement of building materials caused by thermal expansion, contraction, and other environmental factors. The absence of a proper seal in these joints can lead to several issues: |

- Water Penetration: Without a seal, water can penetrate the expansion joint, potentially leading to water damage within the wall cavity and interior spaces. This can result in dampness, mold growth, and deterioration of building materials.

- Energy Efficiency: Gaps in the expansion joints can affect the building's insulation properties, leading to increased energy consumption for heating and cooling.

To address this issue, it is recommended that a qualified handyman, caulking specialist, or bricklayer be engaged to inspect and reseal the expansion joint. This will help maintain the integrity, durability, and appearance of the brickwork, as well as prevent potential water ingress and structural problems.

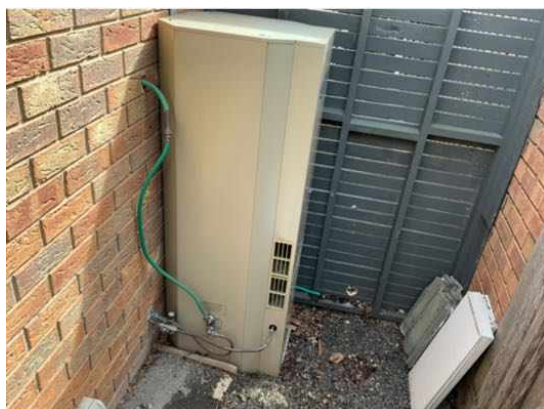
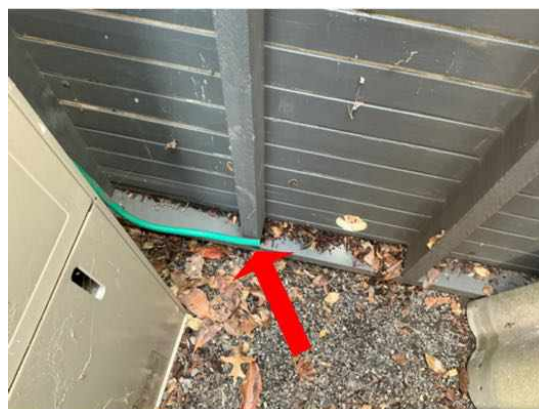
Defects 3.12

| Information: | The Hot Water System (HWS) overflow was found to be disconnected from storm water drainage and is creating excessive moisture in the surrounding area. |

These damp conditions can lead to secondary defects such as rot, rust or corrosion of associated building elements, the formation of fungal decay, or even the creation of potential slip hazards. When coupled with poor site drainage, pooling of water may also attract termite activity to this area.

It is highly recommended that a licensed plumber be appointed to connect the HWS overflow in order to prevent such an environment from being created. These minor works should be carried out as soon as possible.

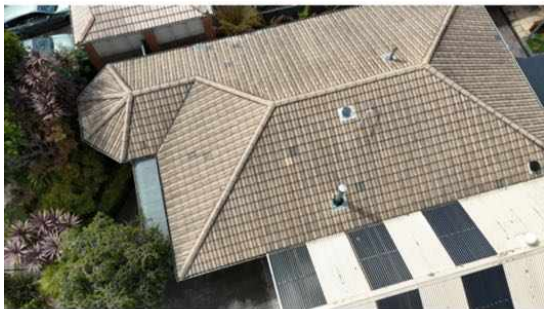
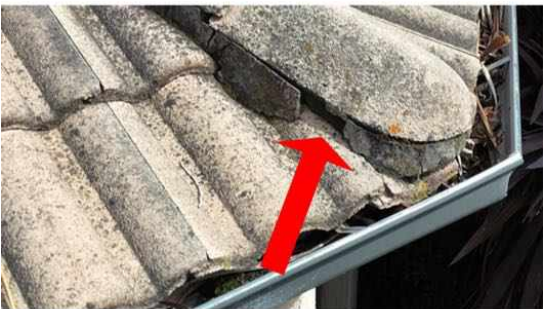
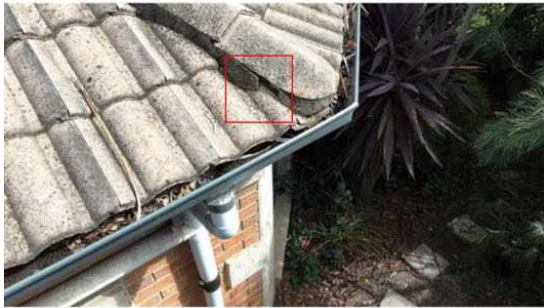
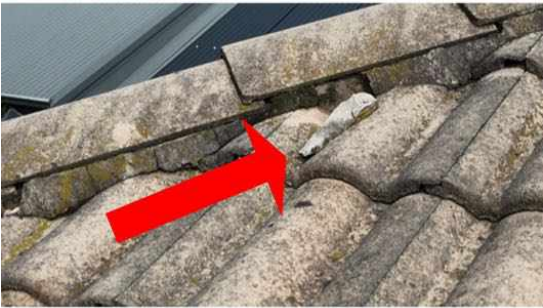
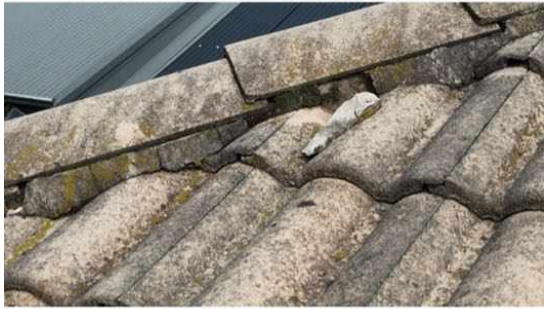
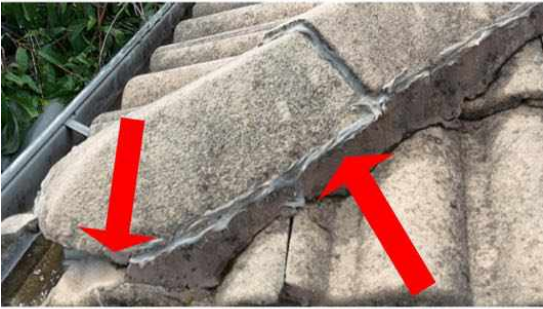
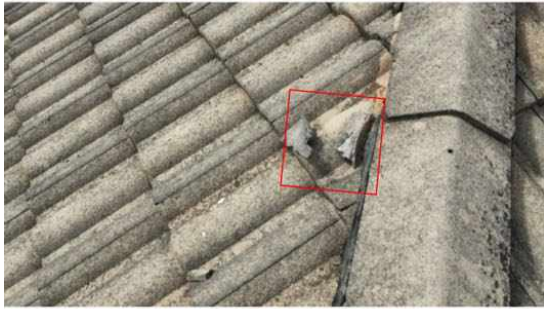
Defects 3.13

| Information: | Upon inspection of the exterior roofing, the majority of roof tiles were considered to be in a fair condition. While weathering of the tiles is consistent with the age of the property, maintenance works are required. |

Isolated areas of mortar have come loose in the valleys and minor cracking is also present. Re-pointing and re-sealing may be considered as an interim solution by the client to help preserve and extend the life span of the tiles.

Where left unmanaged, deteriorating roof tiles are likely to lead to a number of secondary defects, including minor water leaks and weather exposure to internal roofing structures.

Consultation with a roofing contractor is highly advised to gain advice on cost of remedial works that may be required in the short to medium term. Remedial works are

likely to increase the longevity of the exterior roofing structure.

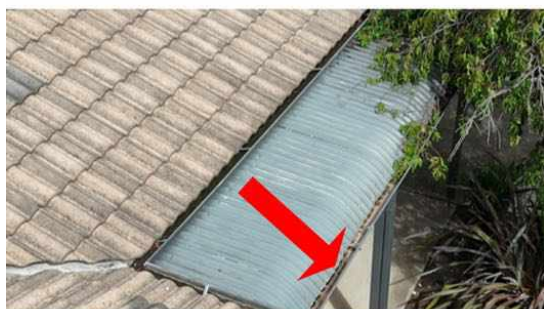
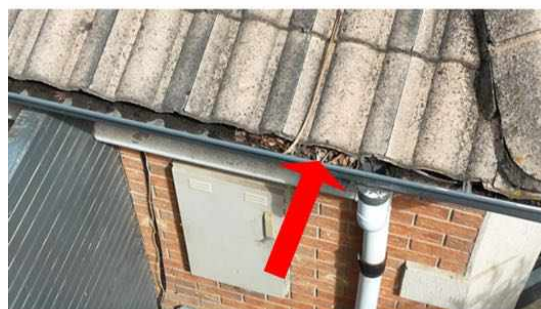
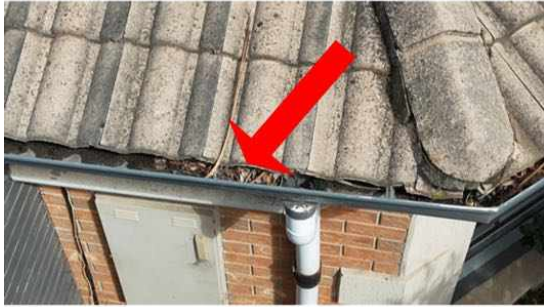
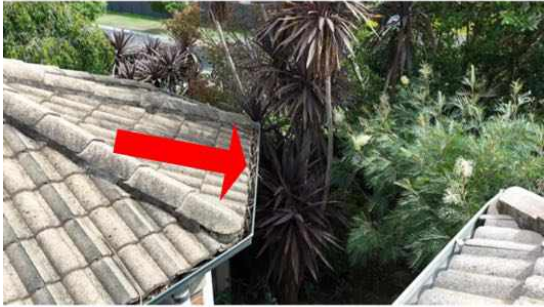
Defects 3.14

Blocked gutters are likely to lead to high levels of moisture in the affected areas. Such moisture will not only cause rust and decay of the associated building materials, but can also provide conditions that are conducive to termite and timber pest activity. Blockages in gutters should therefore be removed immediately to ensure dry conditions are maintained.

Consult a Licensed Plumber for further specific advice on remedial works that may be required. In the interim, it is highly advised that blocked gutters be removed by the homeowner or a general handyperson as a matter of urgency.

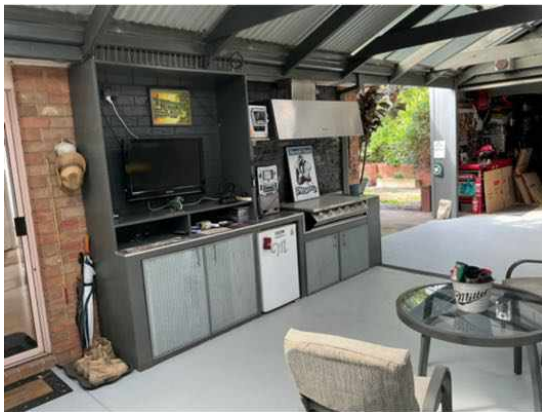
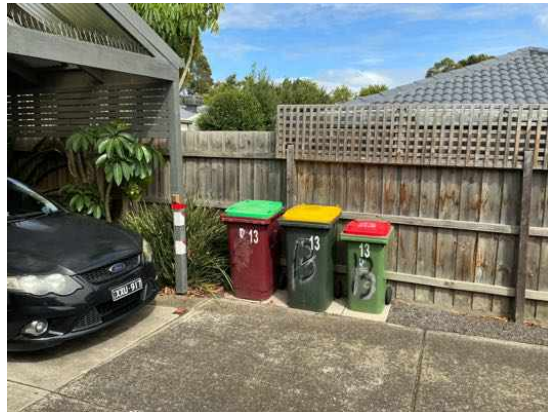
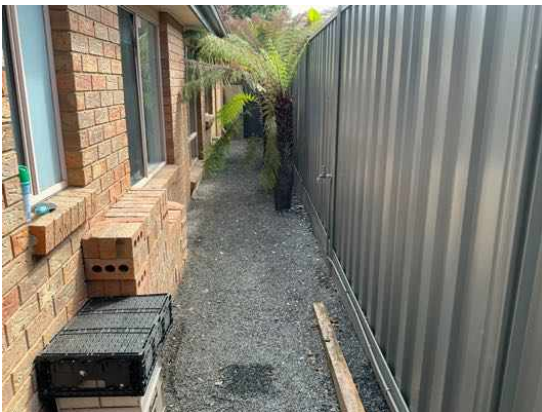
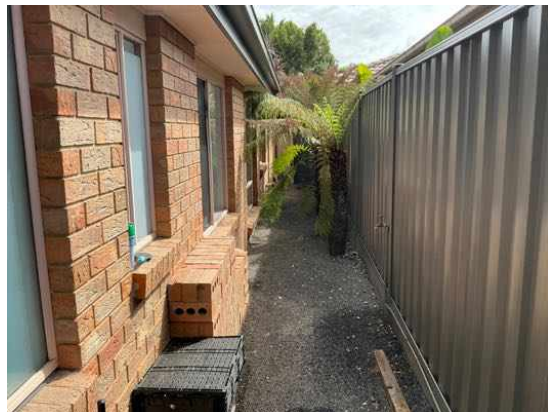
Building: Main Building
 Location: All External Areas
 Finding: Obstructions and Limitations - Exterior
 Information: These photographs are an indication of the obstructions and limitations which impeded the inspection of the external areas of the property at the time of inspection. These obstructions can hide an array of defects and should be removed to allow full inspection to be carried out. A re-inspection is recommended once the areas are made accessible.

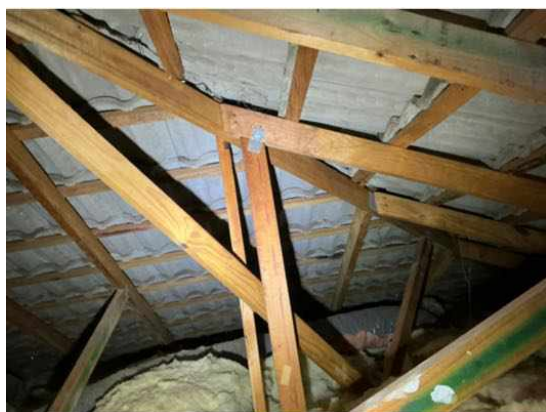
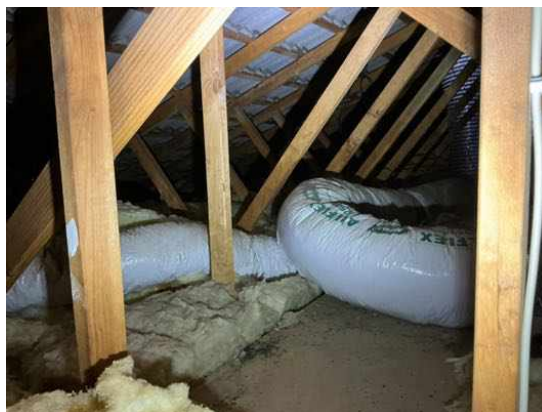
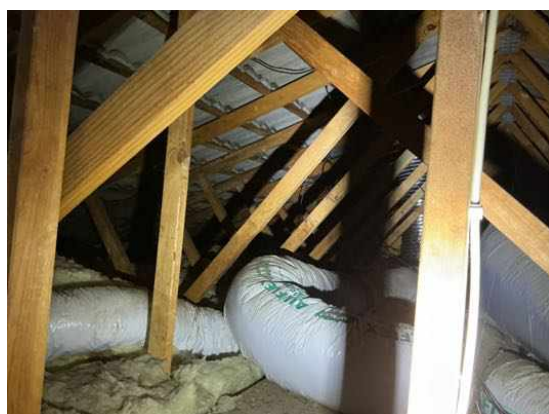
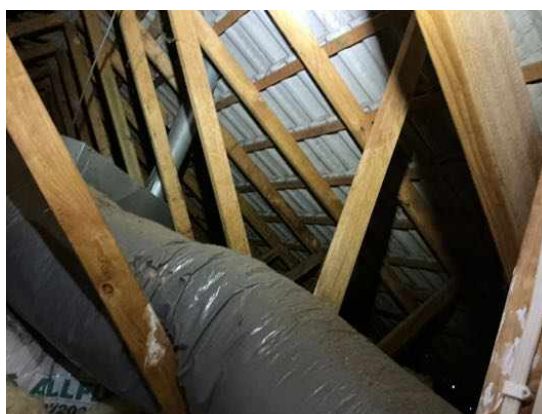
Building: Main Building
 Location: Roof Void
 Finding: Obstructions and Limitations - roof cavity
 Information: These photographs are an indication of the obstructions and limitations which impeded the inspection of the roof cavity area of the property at the time of inspection.

The roof manhole opening was particularly narrow and provided restricted entry dimensions. In addition, fixed laundry cabinetry and a benchtop were installed directly beneath the manhole, significantly limiting safe and practical access into the roof space.

These obstructions can conceal an array of defects including structural deficiencies, moisture ingress, insulation concerns, timber pest activity and non-compliant building alterations. Although reasonable attempts were made to access and inspect the roof cavity to the extent safely possible, inspection coverage was limited due to the restricted entry conditions.

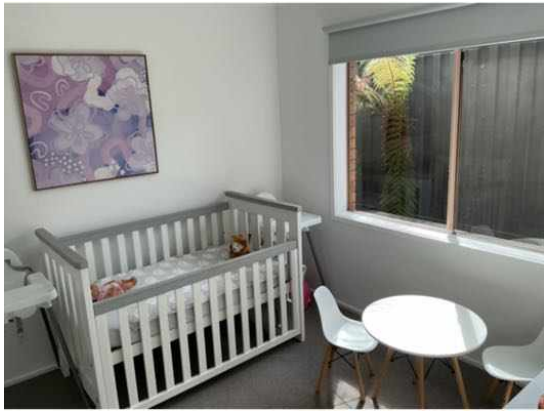
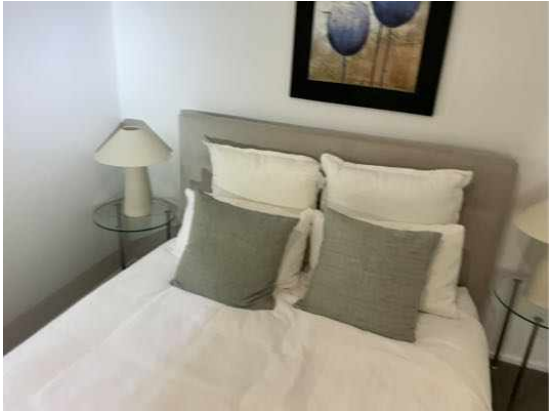
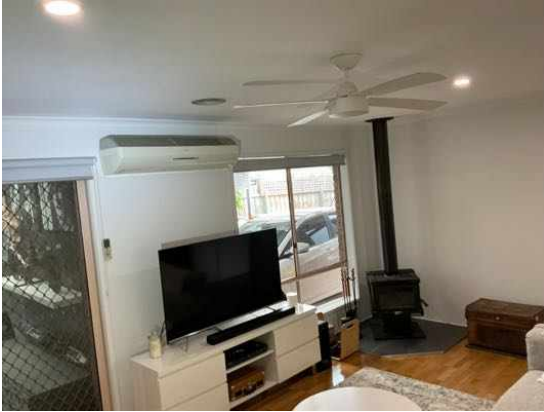
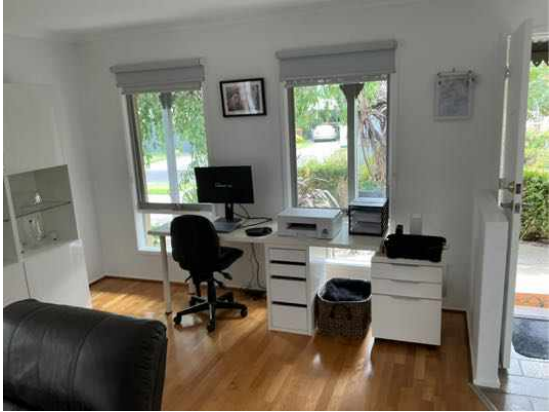
| Finding: | Obstructions and Limitations - Interior |
| Information: | These photographs are an indication of the obstructions and limitations which impeded the inspection of the internal areas of the property at the time of inspection. These obstructions can hide an array of defects and should be removed to allow full inspection to be carried out. A re-inspection is recommended once the areas are made accessible. |
