## Building Inspection Report

Inspection Date: Wed, 1 Apr 2026

Property Address: 104/17-19 Rookwood Rd, Yagoona NSW  
2190, Australia

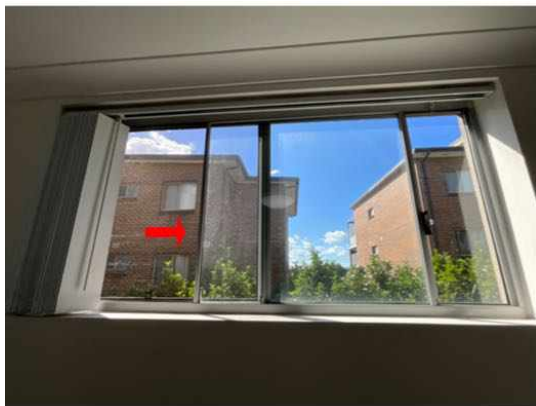
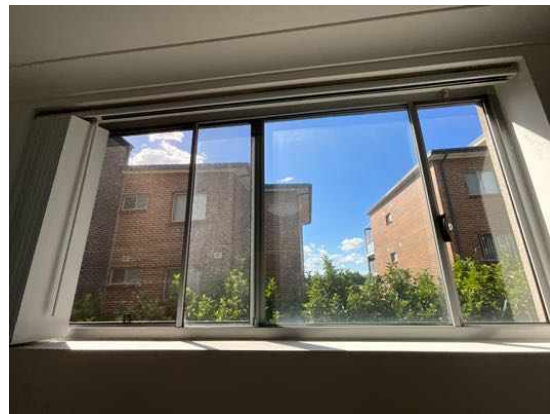
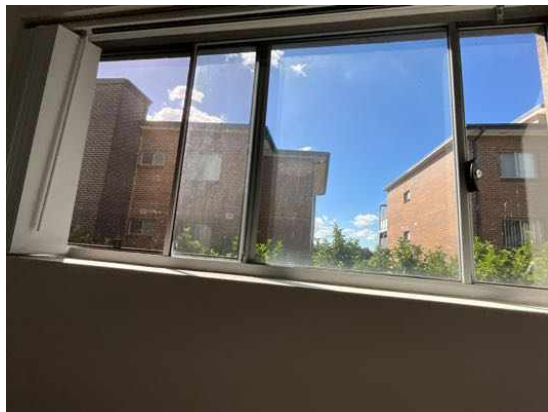
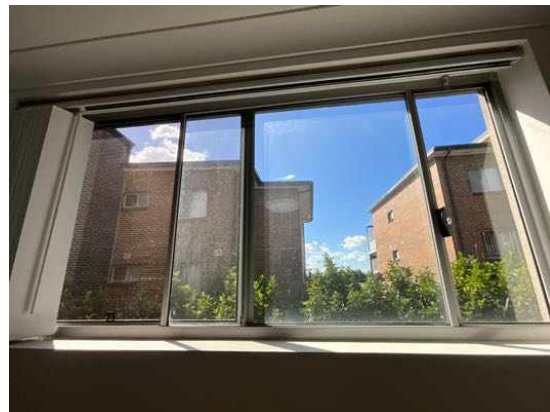
#### Defects 1.01

Building:	Main Building
Location:	All Areas
Finding:	Window child lock missing
Information:	The window in question lacks a child lock mechanism, which poses a potential safety risk to young occupants in the premises. As per Australian Standards windows accessible to children should be equipped with appropriate child safety locks to prevent accidental opening, reducing the risk of falls and ensuring compliance with safety regulations.

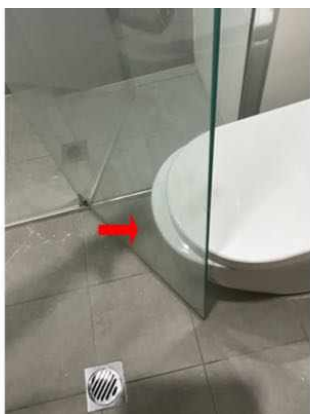
#### Defects 1.02

Building:	Main Building
Location:	Ensuite
Finding:	Shower screen - Hitting toilet
Information:	A safety hazard was identified in the bathroom of the property. The issue pertains to the shower screen, which, when fully opened, makes contact with the adjacent toilet.

This situation poses an immediate risk to the safety and well-being of occupants due to the potential for accidents and injuries.

Collision between the shower screen and the toilet can cause injury to individuals using the bathroom, particularly if the shower screen shatters upon impact. The repeated contact between the shower screen and the toilet can also result in damage to both fixtures, leading to costly repairs or replacements.

This is to be addressed prior to handover.

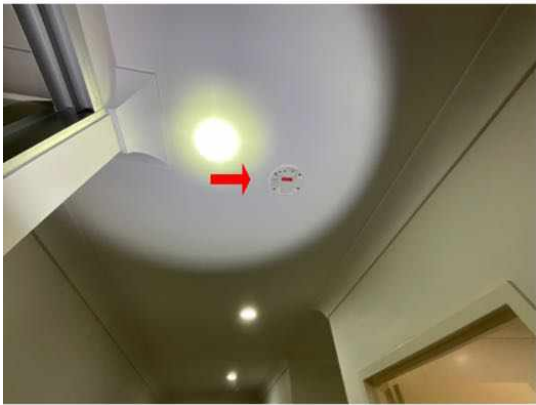
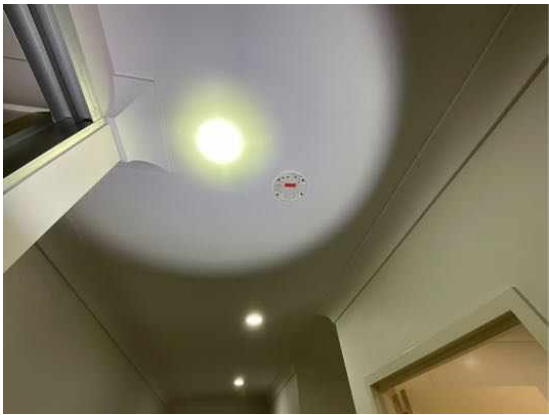
### Defects 1.03

Building:	Main Building
Location:	All Areas
Finding:	Smoke Detectors and Alarms
Information:	Reporting on Smoke Detectors or Alarms, including hard wired smoke detection systems and their legislative requirements, is outside the Scope of this Report.

Please note that this defect is highlighted as a caution only. We suspect, based on our experience in the building industry, that the absence of smoke detectors, or their poor condition, should be addressed as a matter of urgency to improve occupant safety.

Further Inspection and/or advisory services is necessary to provide advice on the sufficiency, type and location of smoke detectors, and to test the functionality of all devices. Greater requirements for fire safety and detection exist for commercial buildings.

Always ensure sufficient working and suitable smoke detectors are installed prior to occupying any building. Additionally, it is advised that all smoke detectors be tested by the homeowner on a monthly basis.

Please refer to AS3786 and state based legislation, which may also apply.

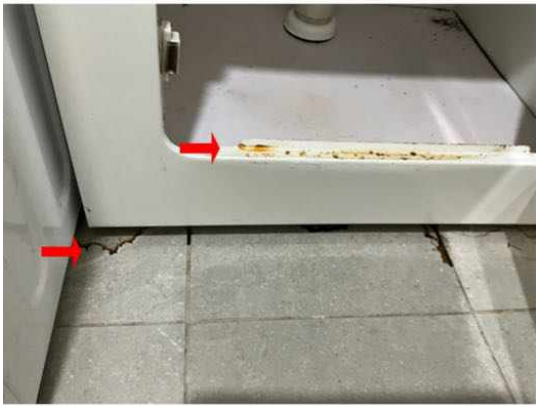
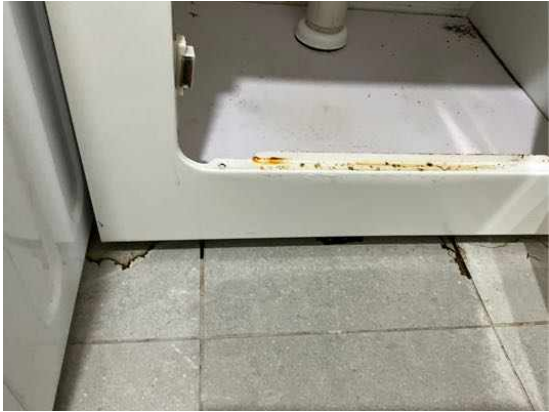
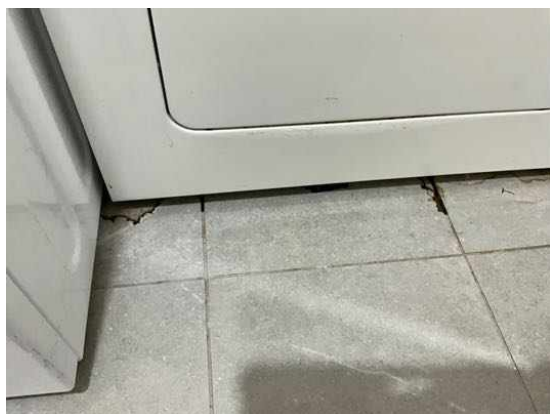
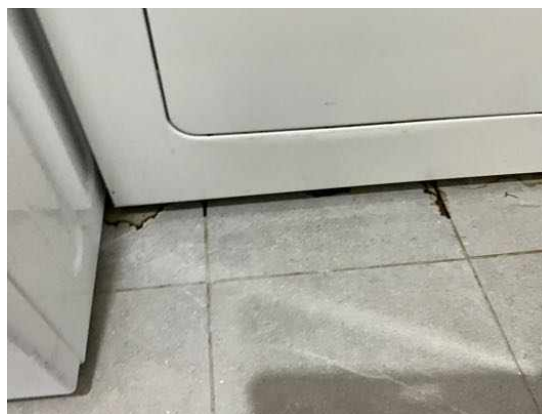
**Defects 3.01**

Building: Main Building  
Location: Laundry  
Finding: Water Stains in Vanity  
Information: "Water stains observed in the vanity area, compromising its appearance and potentially causing damage."

Continued water exposure may lead to material damage, mold growth, and diminished aesthetic appeal.

A licensed plumber or maintenance professional should assess and fix any leaks contributing to the water stains, while a cleaning or restoration service may be needed to address the visible stains and prevent further damage.

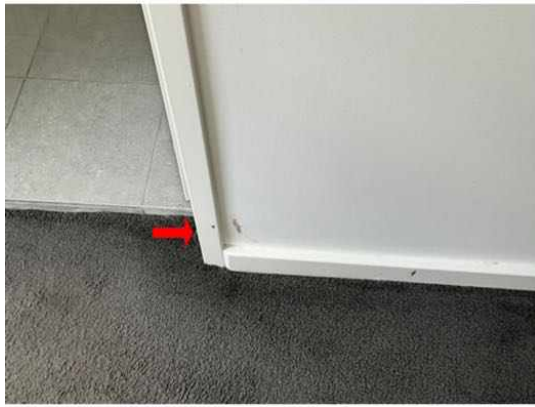
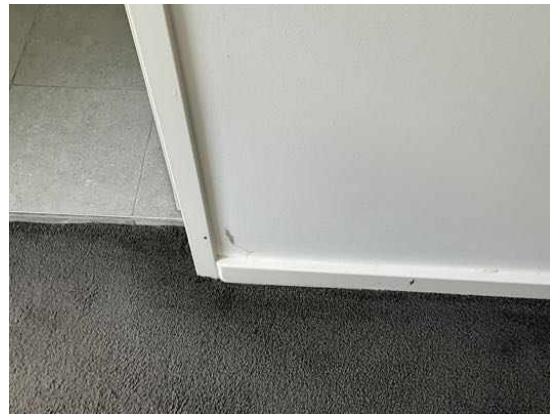
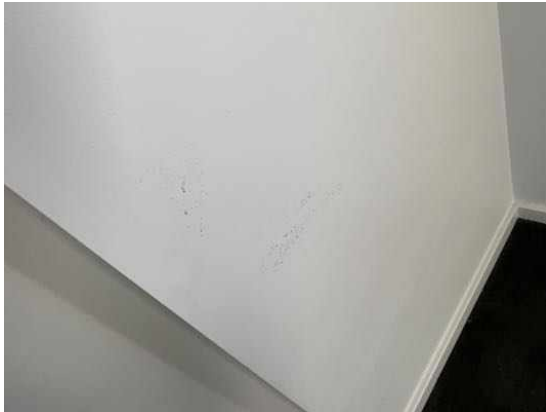
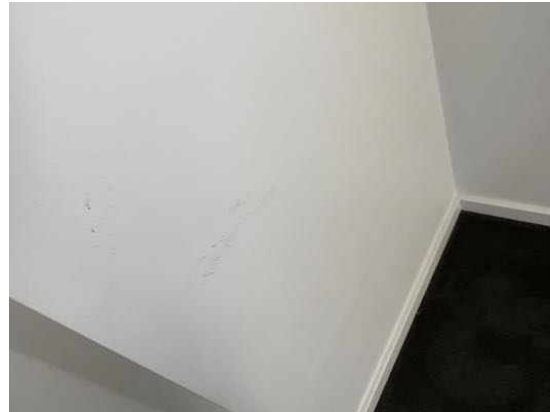
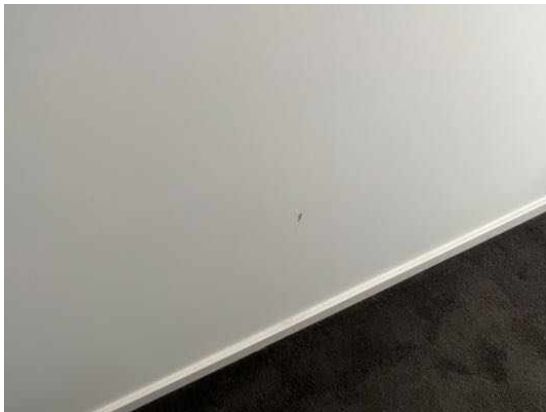
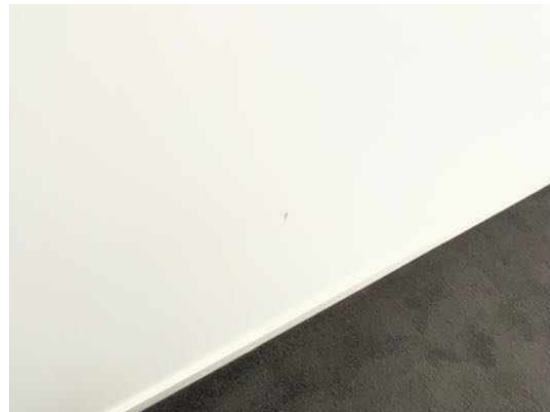
## Defects 3.02

Building:	Main Building
Location:	All Areas
Finding:	Paint surface - Scratches
Information:	Scratches have been identified on the paint surface, detracting from the overall appearance and quality of the painted surface.

The presence of scratchy paint poses several risks, including:

1. Aesthetic Degradation: Scratches mar the appearance of the painted surface, diminishing its visual appeal and potentially lowering property value.
2. Corrosion Vulnerability: Exposed areas of bare metal due to scratched paint are susceptible to corrosion, leading to structural damage and compromised durability.
3. Environmental Hazards: Scratched paint can release hazardous chemicals into the environment, posing risks to both human health and the ecosystem.

A qualified painter should address the issue promptly to repair the scratched paint. Depending on the severity of the scratches, repair options may include sanding, priming, and repainting the affected area to restore the integrity and appearance of the paint surface.

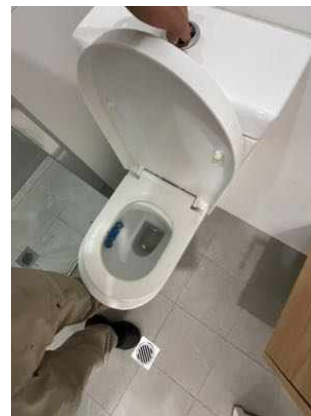
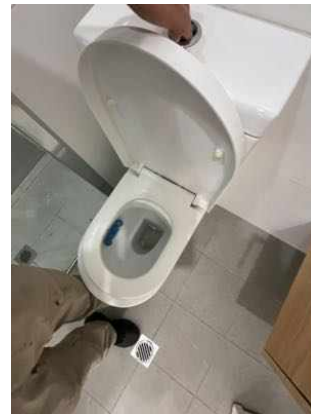
### Defects 3.03

Building: Main Building  
 Location: Ensuite  
 Finding: Flush Tank Not Operational  
 Information: The flush tank is currently not operational, rendering the toilet unusable. This could be due to various issues such as a malfunctioning flush mechanism, water supply issues, or internal component failure.

- **\*\*Sanitation Concerns:\*\*** An inoperative flush tank can lead to unsanitary conditions, unpleasant odors, and potential health hazards due to the inability to properly dispose

of waste.

- **\*\*Inconvenience:\*\*** The lack of a functioning toilet can cause significant inconvenience to occupants, especially in households with limited bathroom facilities.

- **\*\*Water Damage:\*\*** Continuous attempts to flush an inoperative tank could lead to leaks or overflows, potentially causing water damage to the surrounding areas.

- **\*\*Plumber:\*\*** A qualified plumber should be contacted to diagnose and repair the issue. The plumber will inspect the flush tank, identify the root cause of the problem, and replace or repair any faulty components to restore proper functionality.

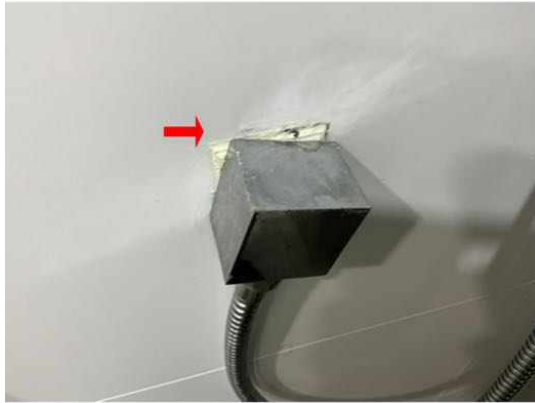
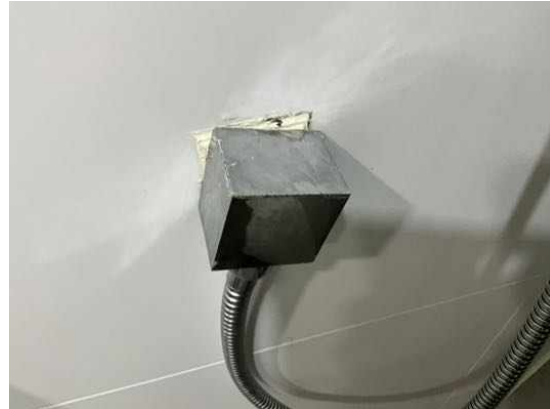
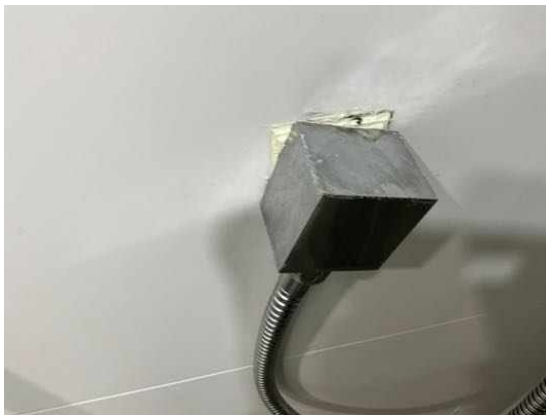
### Defects 3.04

Building:	Main Building
Location:	Ensuite
Finding:	Poor workmanship
Information:	The structure exhibits signs of poor workmanship, evident in various aspects of construction and finishing.

Risk: Poor workmanship poses a range of risks, including compromised structural integrity, potential safety hazards, and a decreased lifespan of the structure. It may

also lead to aesthetic and functional issues.

Resolution: A qualified contractor or construction professional should be consulted to assess and address the poor workmanship. They can implement corrective measures to ensure structural soundness, safety, and overall quality of the construction.

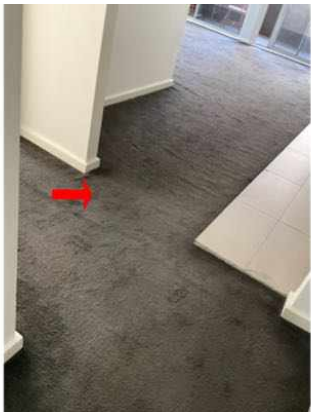
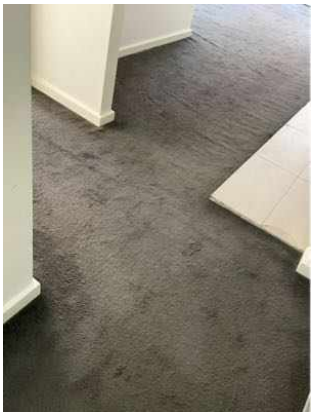
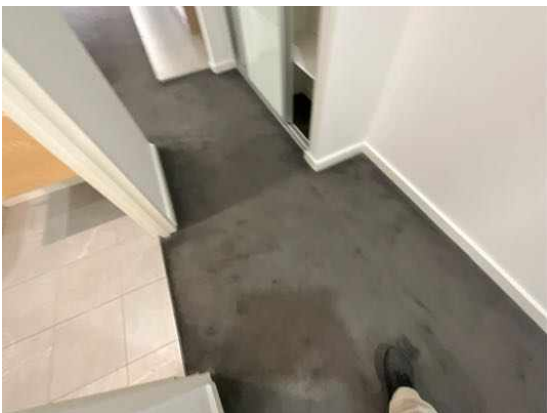
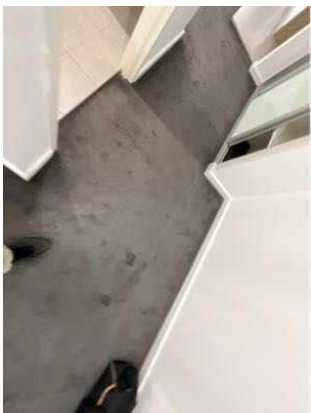
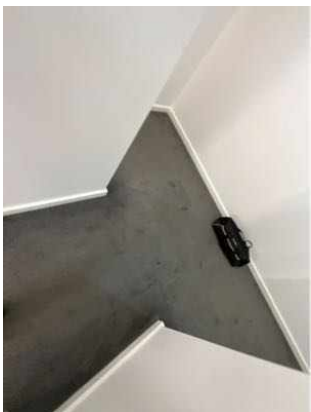
### Defects 3.05

Building:	Main Building
Location:	All Areas
Finding:	carpet exhibits visible signs of aging
Information:	Carpets are exhibiting visible signs of aging, including fraying edges, faded colors, and flattened fibers, diminishing their aesthetic appeal and functional quality.

The risk associated with aging carpets includes diminished appearance, decreased comfort, potential tripping hazards due to frayed edges, and a negative impact on indoor air quality if fibers begin to degrade and release particles into the air.

Professional carpet cleaning and restoration services can address issues such as deep cleaning to rejuvenate colors, repairing frayed edges, and restoring fibers.

Additionally, replacing the carpets entirely may be necessary in severe cases of aging or damage beyond repair.

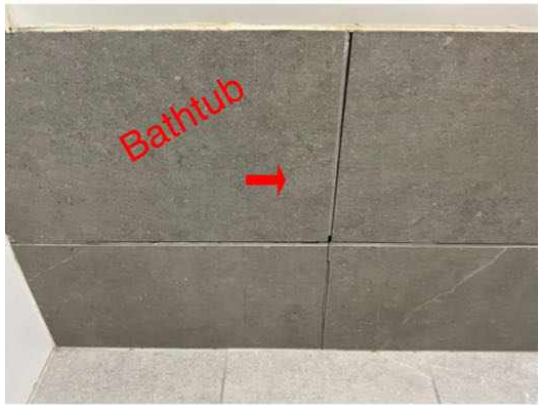
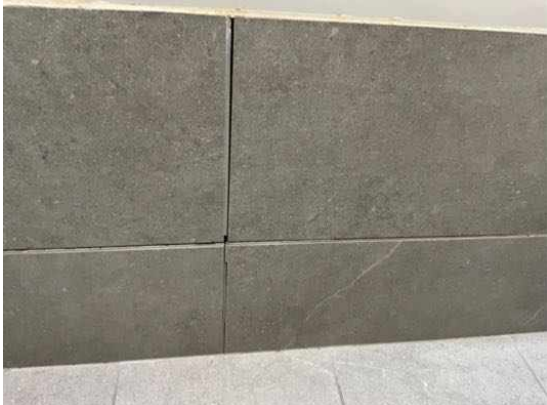
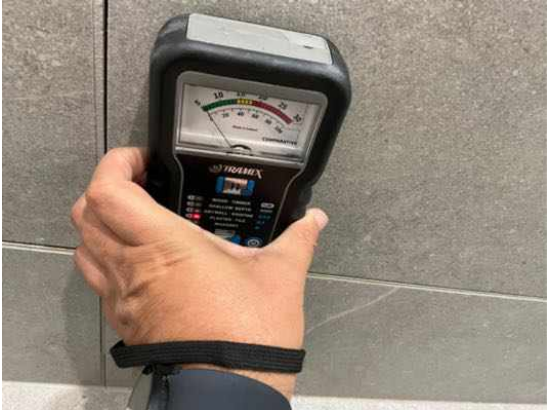
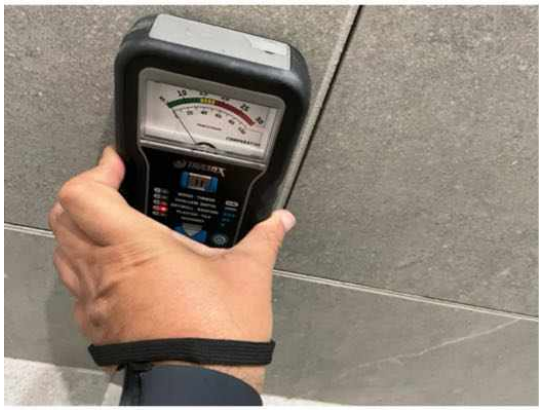
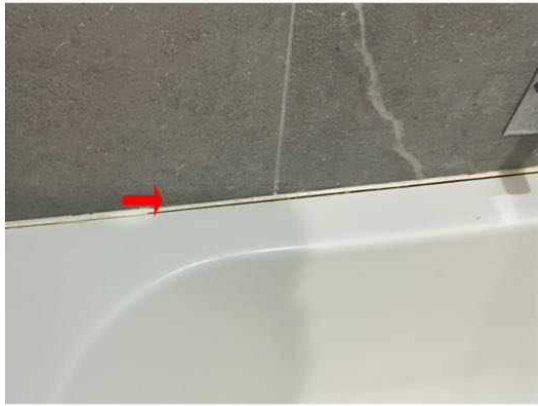
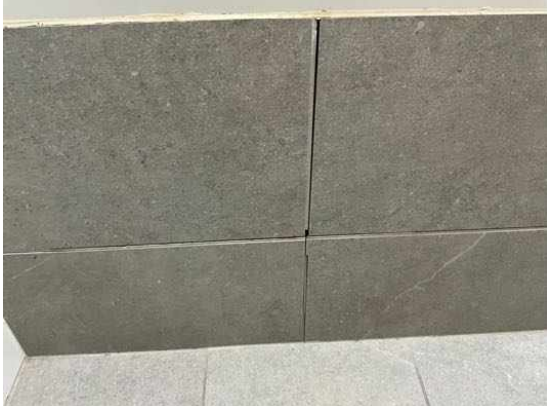
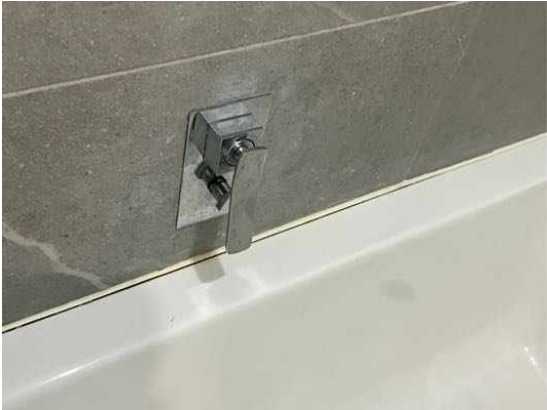
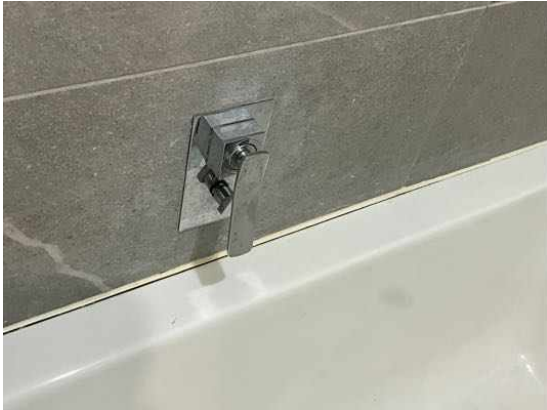
### Defects 3.06

Building:	Main Building
Location:	Bathroom
Finding:	Sealant and grouting - Missing or damaged
Information:	It was noted on inspection that sealant or grout is degraded to the tiled shower alcove and or other areas of the bathroom.

Different materials and floor areas move at different rates, generally causing cracking to grout or sealant at this point. A flexible sealant is required to allow for expected expansion and contraction, while keeping the joint water tight and protective of all associated building materials.

There appears to be excessive mould to the sealant and grout which will likely require scraping out and replacement.

Flexible and mould resistant materials should be applied to affected areas to prevent any subsequent water damage that is likely to occur. Regular maintenance and replacement of damage or missing or damaged sealant and grout is highly recommended to the wet areas, as this is a regular wear and tear defect. Sealant and grouting in areas that come into regular contact with water should be maintained for the long term care of your property.

A sealant specialist or tiling contractor should be appointed to complete these works as soon as possible

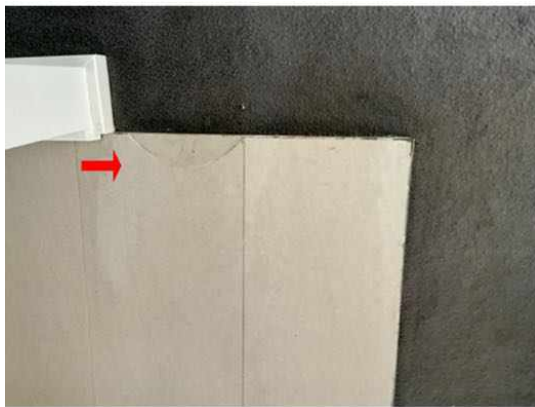
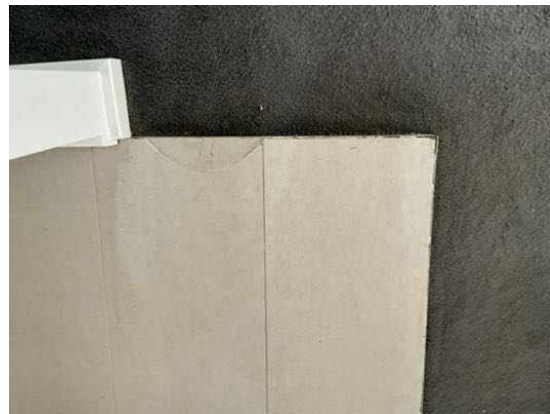
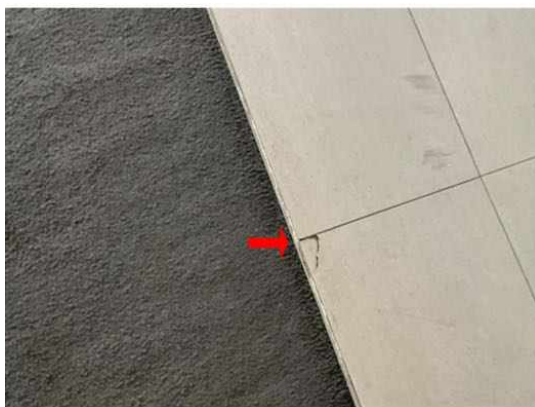
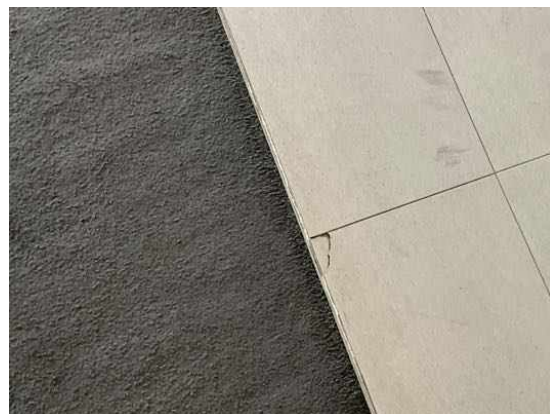
Defects 3.07

Building: Main Building  
Location: Kitchen  
Finding: Floor Tile crack  
Information: A floor tile has a visible crack on the surface.

The damaged tile presents a trip hazard, may lead to cuts if stepped on barefoot, and can allow moisture ingress into the substrate, which may cause further deterioration or loosening of adjacent tiles. It also affects the overall appearance of the floor.

A licensed tiler should be engaged to remove the damaged tile and install a matching replacement. If spare tiles are unavailable, additional remedial work may be required to blend the repair with surrounding finishes.
