## Building Inspection Report

Inspection Date: Fri, 6 Feb 2026

Property Address: 12 Absalom Street Riverstone NSW 2765

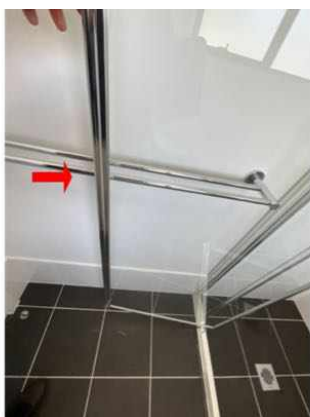
#### Defects 1.01

Building:	Main Building
Location:	Bathroom
Finding:	Door Interference - Obstructive Towel Rail Installation
Information:	The towel rail has been installed in a position that restricts the door from fully opening. The door comes into direct contact with the rail, which may cause damage to both components over time and impairs normal use of the door.

- Guide to Standards and Tolerances 2017 –(Fittings and fixtures): All fittings and fixtures must be installed to operate as intended and not impede the use of surrounding elements, including doors and openings.
- The placement must ensure free and safe operation of all access ways.

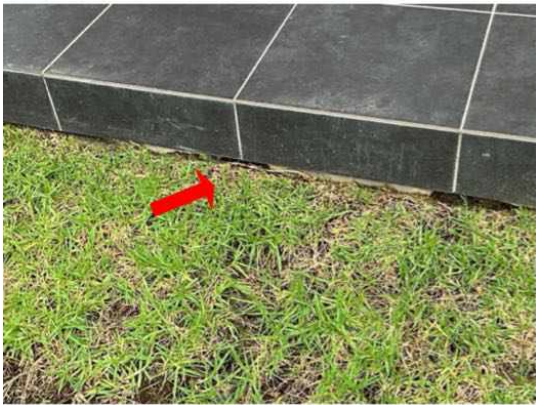
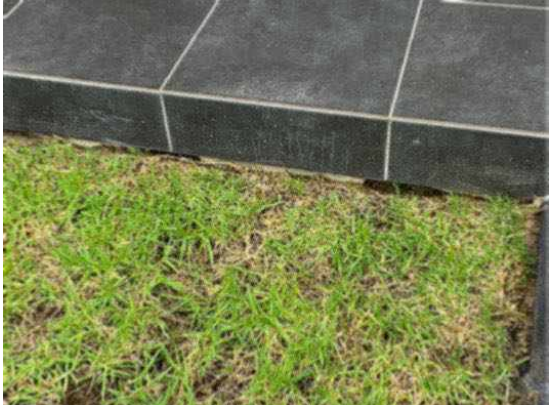
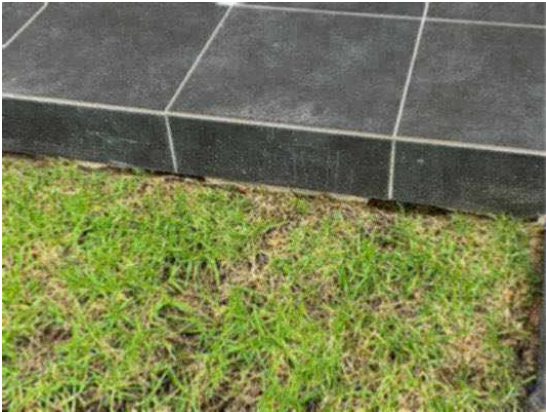
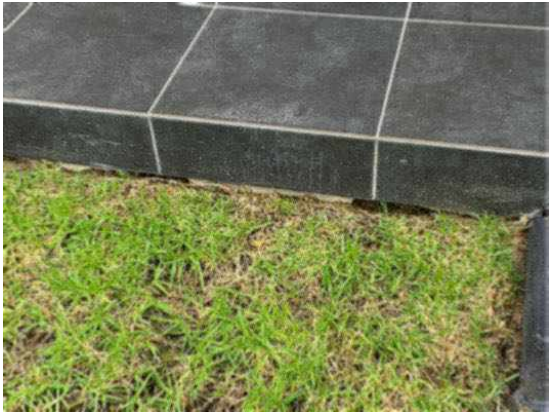
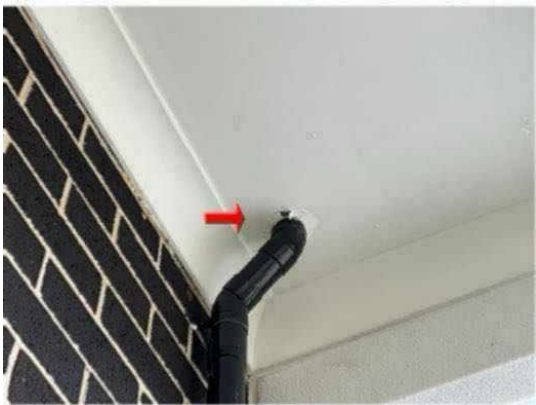
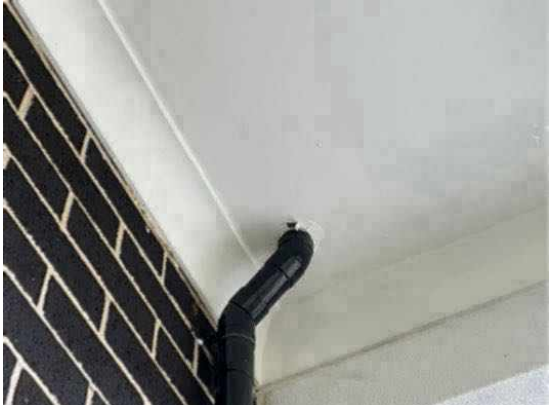
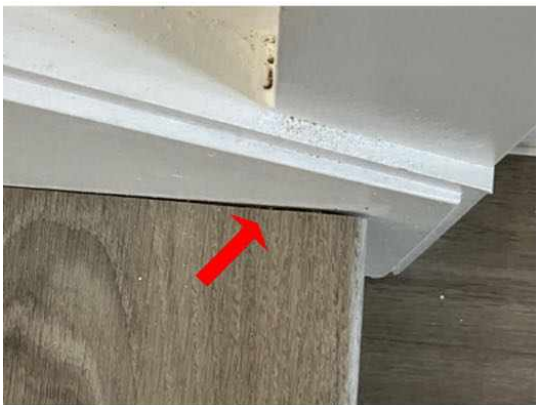
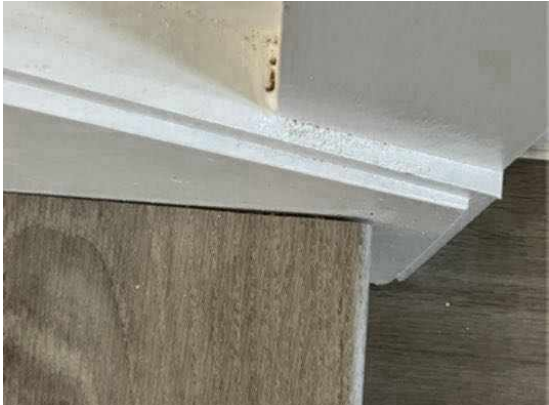
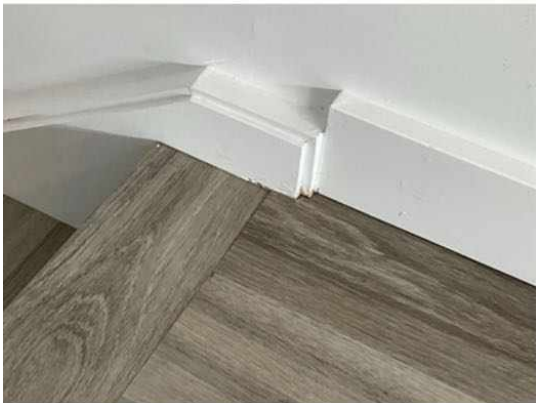
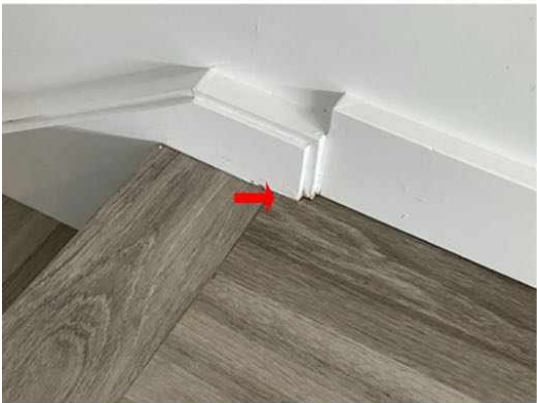
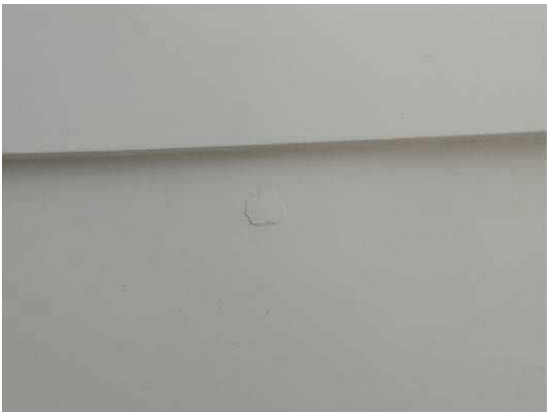
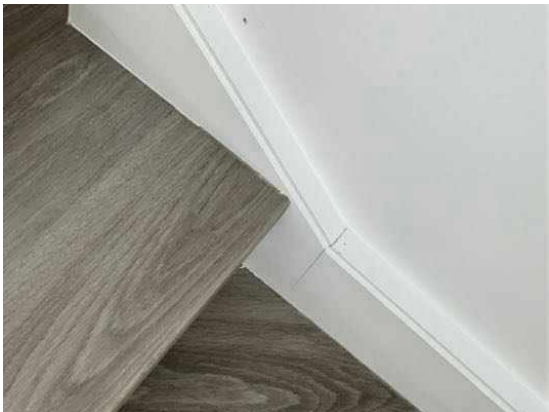
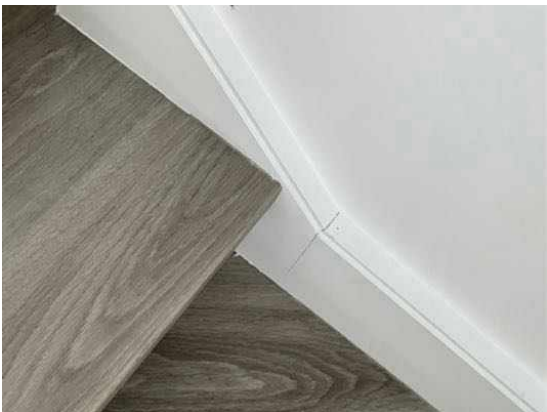
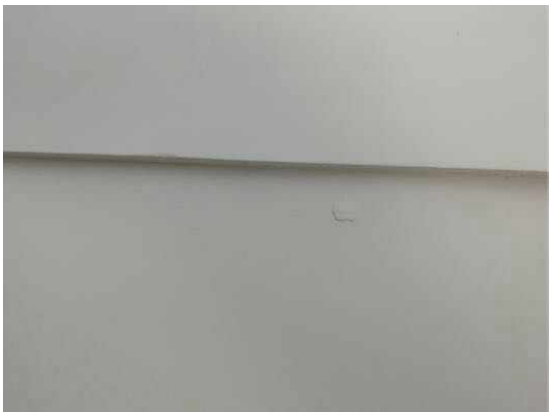
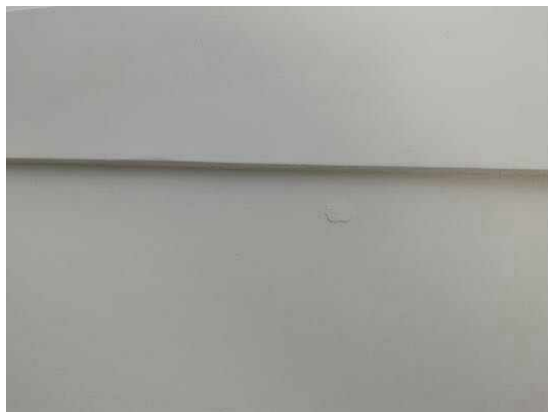
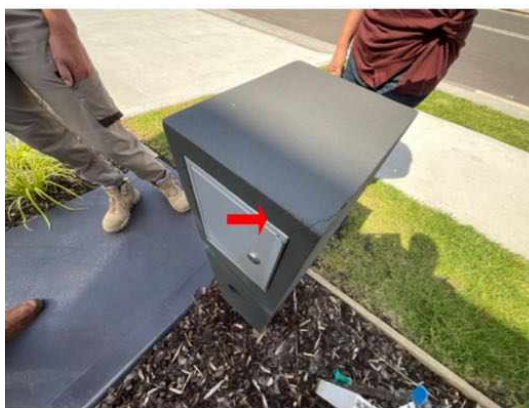
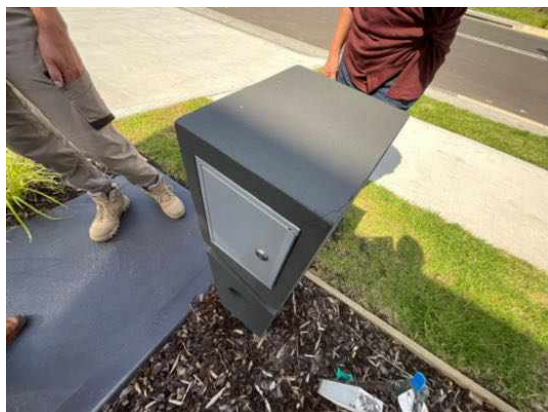
#### Defects 3.01

Building:	Main Building
Location:	All Areas
Finding:	Substandard Work- Various Areas of the Building
Information:	Substandard work has been identified in multiple areas throughout the building, failing

to meet the requirements specified by Australian Guides and Tolerances.

- **\*\*Paint Application:\*\*** Inconsistent and incomplete paint coverage on walls, ceilings, and downpipes, with visible brush marks, drips, and streaks.
- **\*\*Fixtures and Fittings:\*\*** Misaligned or improperly installed fixtures and fittings, not meeting the standard requirements for level and alignment.
- **\*\*Tiling:\*\*** Unevenly laid tiles with inconsistent grout lines and lippage exceeding allowable tolerances.

- Accelerated deterioration and reduced durability of the affected elements.
- Compromised aesthetic quality and overall value of the property.
- Potential safety hazards and increased maintenance costs.
- Negative impact on the building's functionality and usability.

All identified areas of substandard work must be rectified to meet the standards outlined in the Guide to Standards and Tolerances. This includes:

- Repainting surfaces with proper surface preparation and uniform application.
- Realigning and properly installing fixtures and fittings.
- Re-laying uneven tiles to achieve consistent grout lines and allowable lippage.

A comprehensive inspection should be conducted post-repairs to ensure all rectifications comply with the required standards.

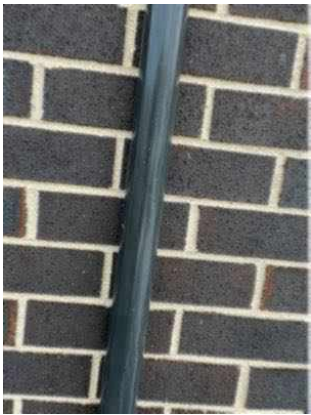
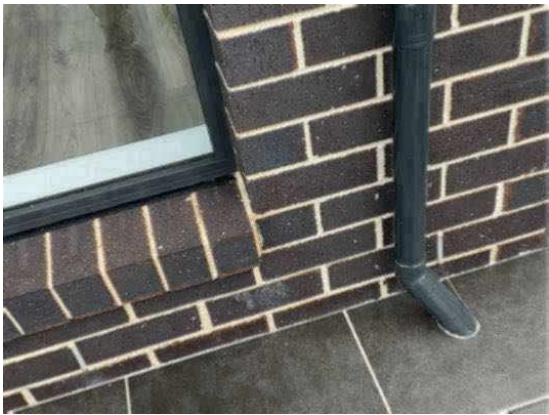
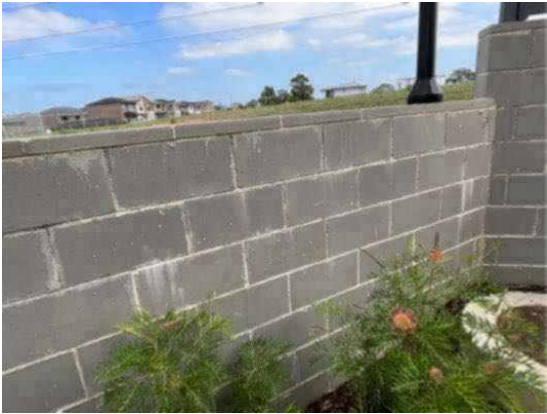
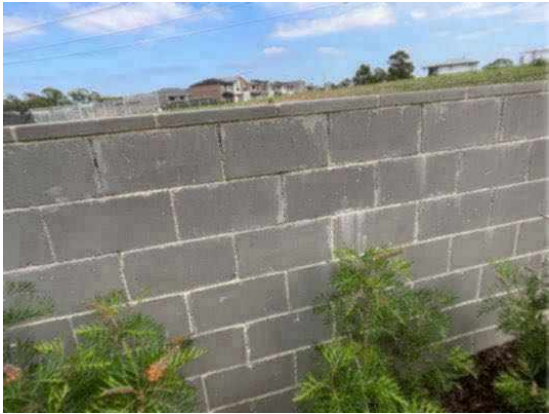
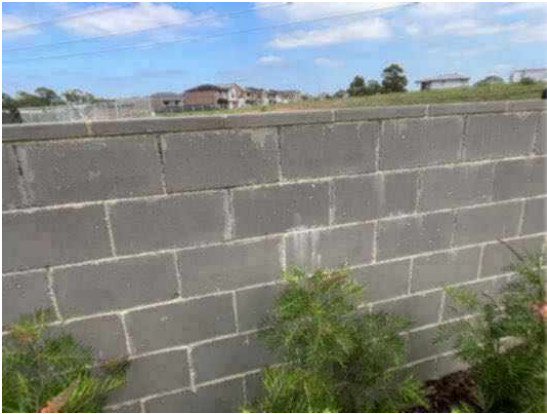
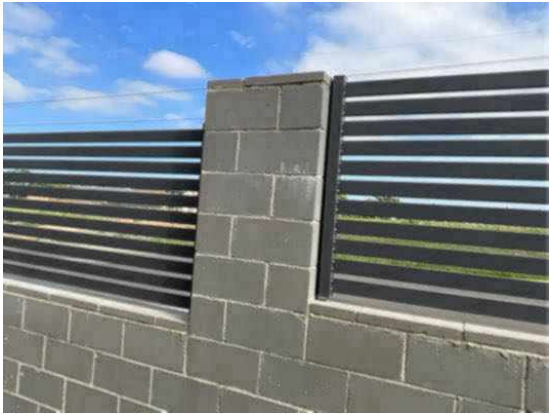
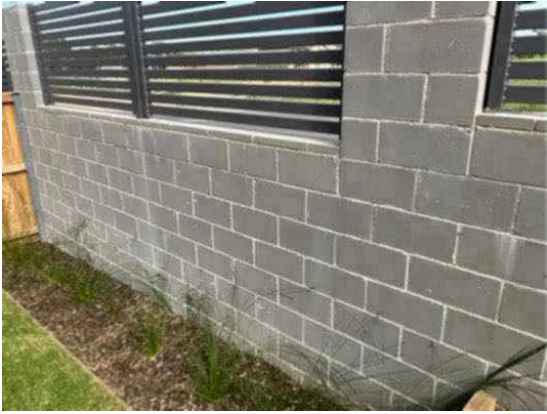
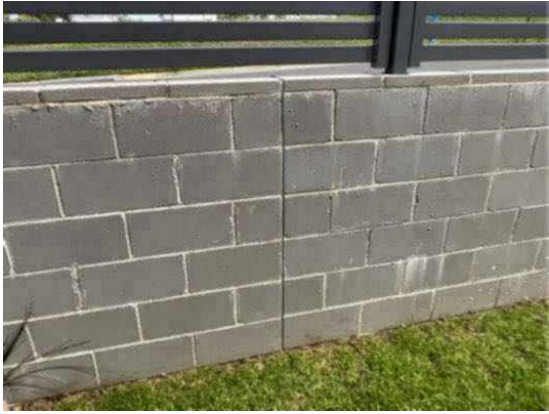
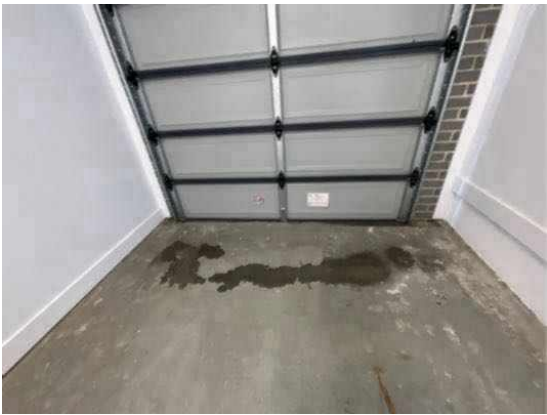
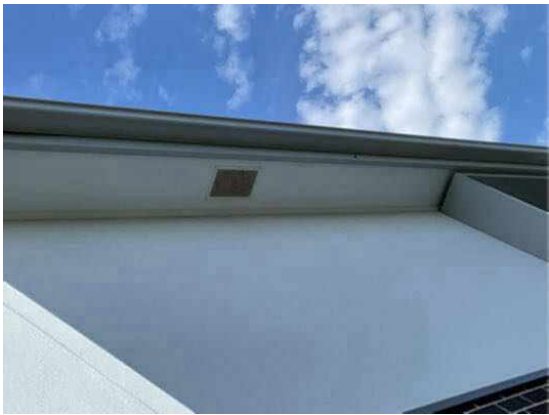
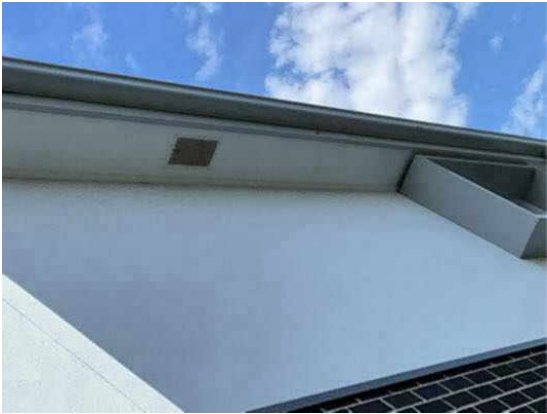
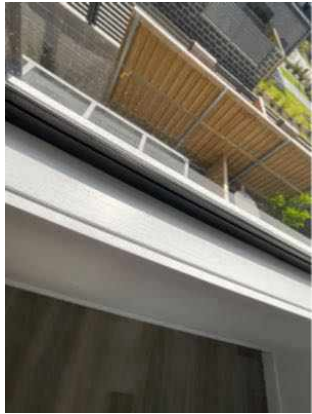
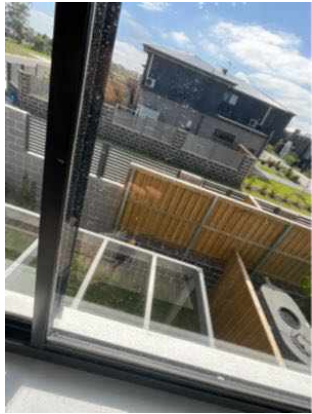
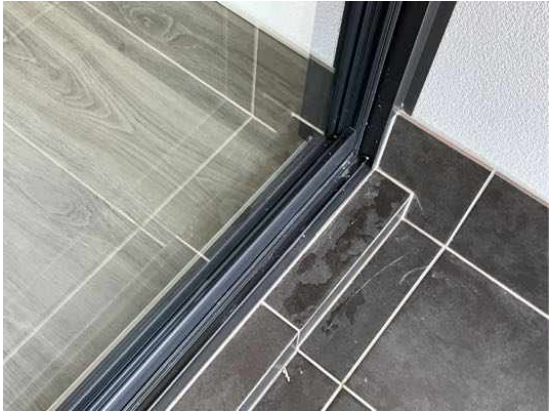
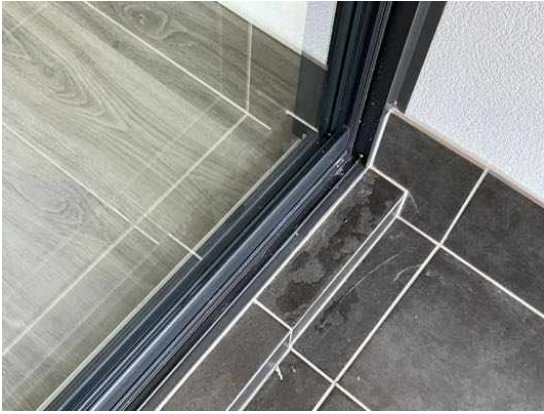
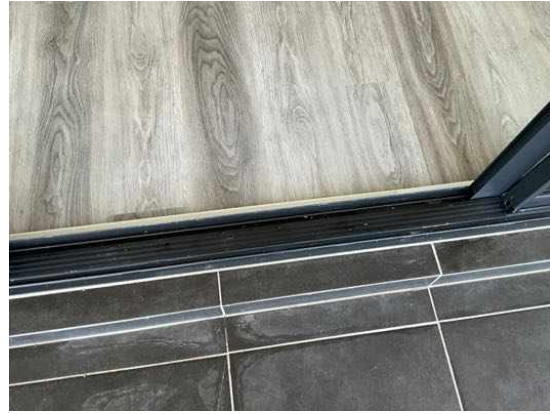
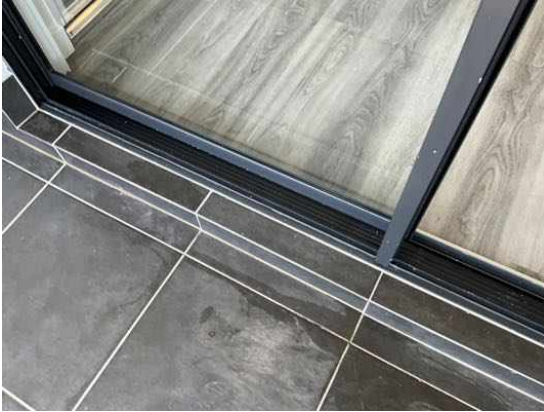
### Defects 3.02

Building:	Main Building
Location:	All Areas
Finding:	Cleaning required
Information:	It was observed that the house requires cleaning.

Works are defective where windows are not clean, floors are not swept, mopped or vacuumed as appropriate, tiles, sinks, basins, baths, windows or any other area throughout the property are not cleaned, and shelving, drawers and cupboards are not ready for use not cleaned and ready for use at handover.

This is to be referenced against the Australian Standards & Tolerances clause 19.8 Cleaning.

This is to be addressed prior to handover.

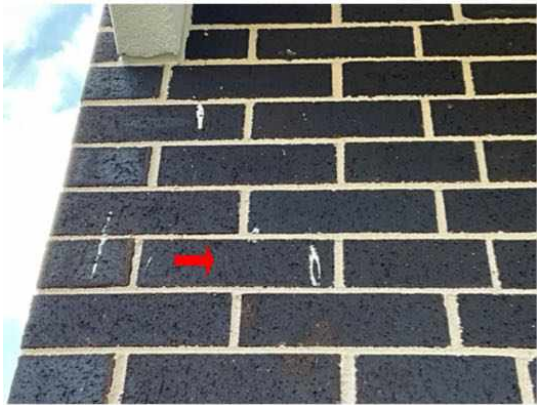
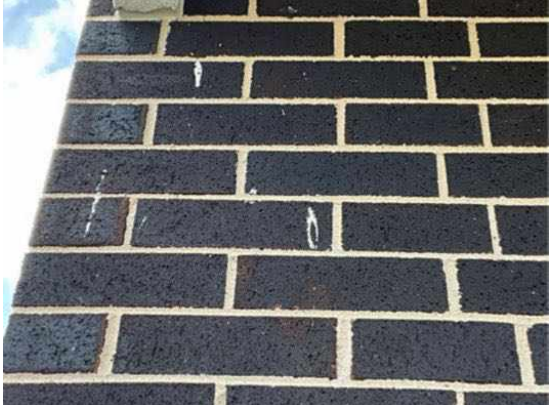
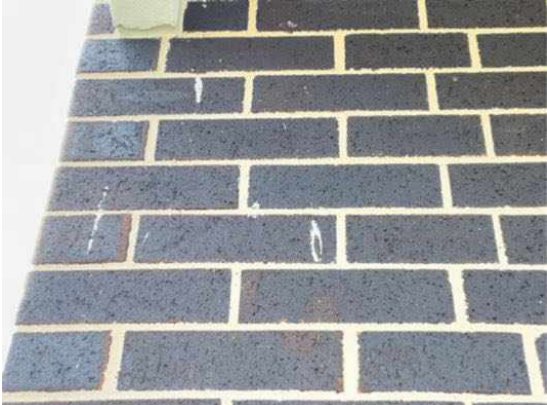
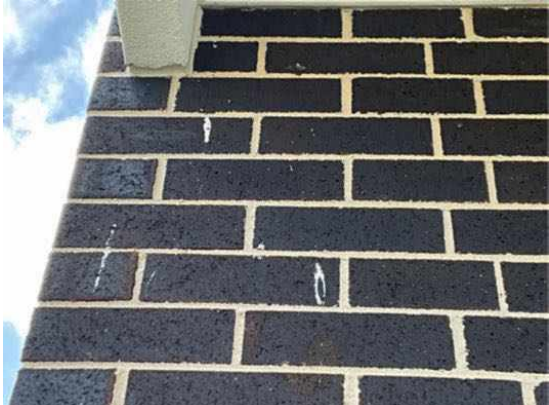
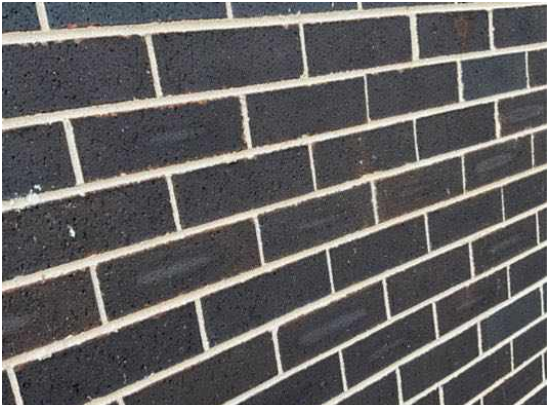
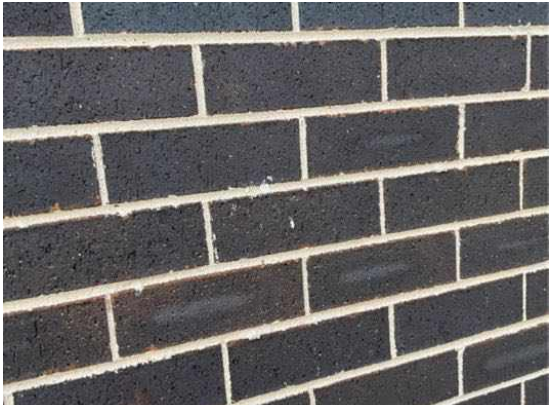
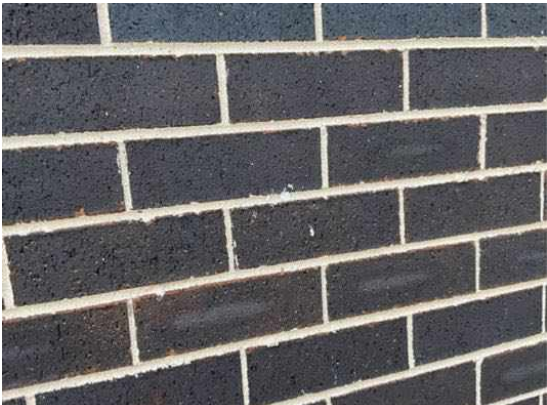
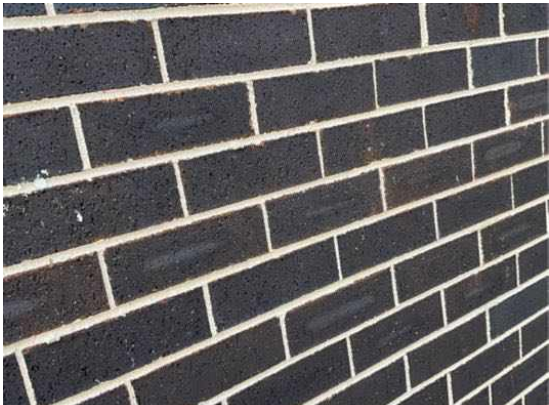
### Defects 3.03

Building:	Main Building
Location:	All Areas
Finding:	Paint - Substandard
Information:	Areas were identified where the surface finish of the painting is substandard and this is considered a defect.

Any irregularity in the surface which is visible from a normal viewing position is considered a defect. Marks may also be a result of fault by other tradespeople throughout the construction process.

Defective surface finish of paintwork is marked with an arrow to the below photos in the following locations.

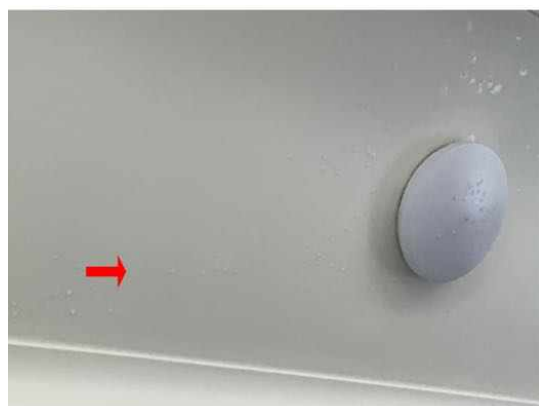
### Defects 3.04

Location: Front Elevation

Finding: Water staining

Information: Water staining was evident in this area at the time of inspection. Water staining indicates that surfaces have been exposed to excessive moisture over time. The minerals and other elements in the water lead to staining, which may graduate to corrosion and deterioration if left unmanaged.

While mostly an appearance defect, water staining can be indicative of more serious defects, which may be currently concealed by other building elements.

Where water staining is active, a licensed plumber must be consulted to identify the cause of the staining and to provide advice on any reparation works that may be required. Replacement of any broken or damaged structures is advised.

Conversely, where water staining is old and inactive, affected building materials may be repaired or replaced at client discretion. A qualified carpenter or registered builder may be appointed to perform these works.

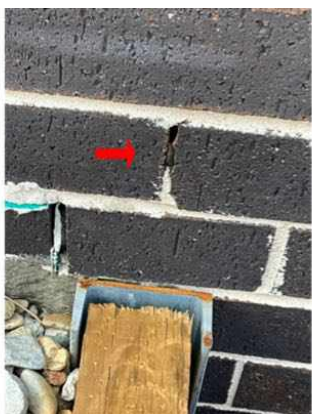
### Defects 3.05

Building:	Main Building
Location:	Exterior walls - left side
Finding:	Mortar joints - Filling required
Information:	Instances of voids and holes affecting the masonry mortar have been identified. Excepting weep holes and vents voids and holes are defects if they are visible from a normal viewing position.

Where a building element is installed in such a way that it fails to achieve the required minimum standard or level of finish at the time of the inspection, the builder needs to rectify the defect as soon as possible and complete works to the required standard prior to handover.

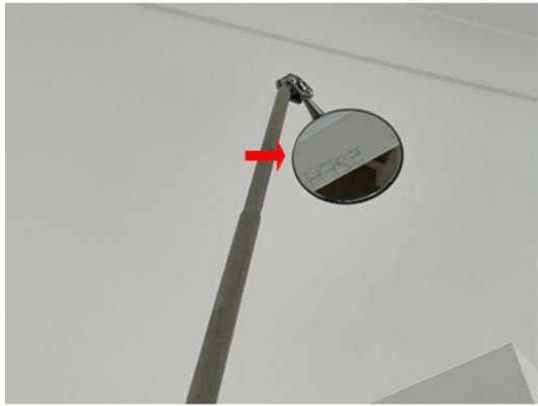
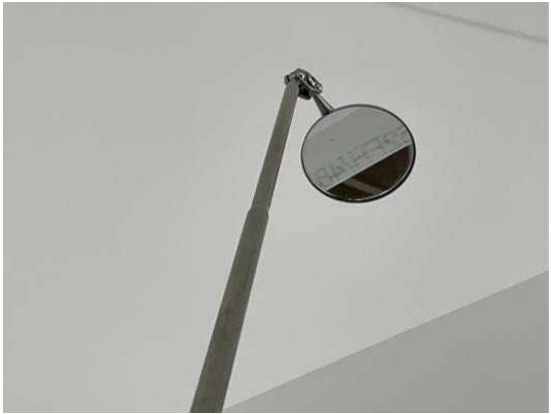
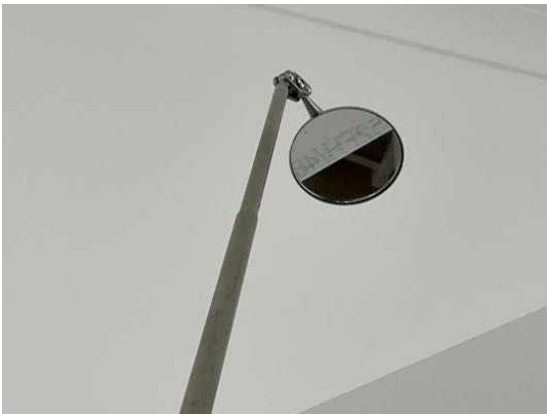
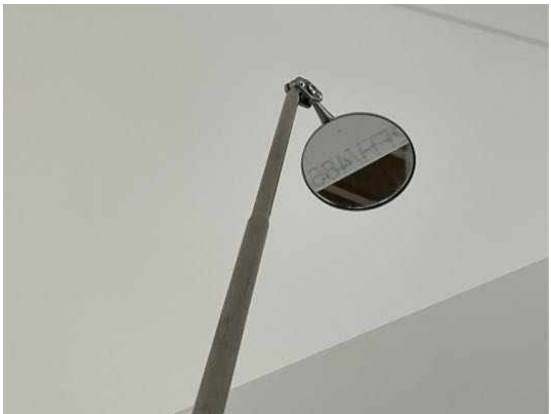
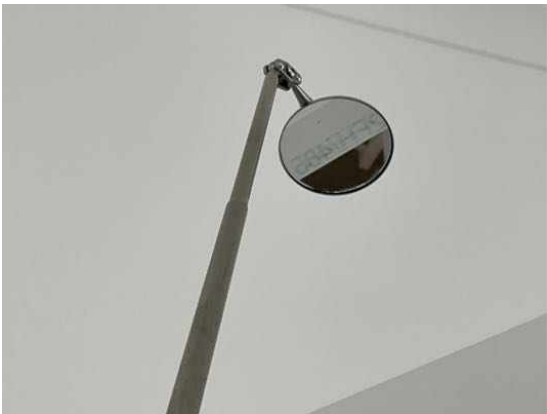
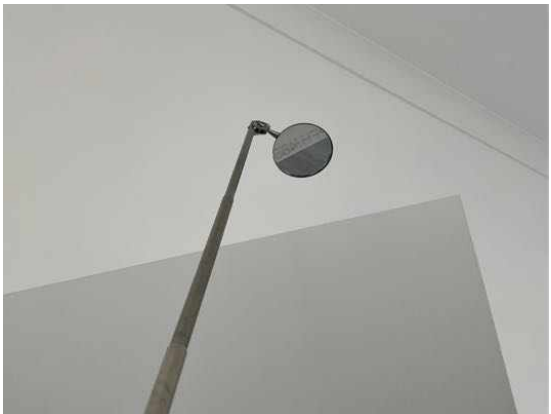
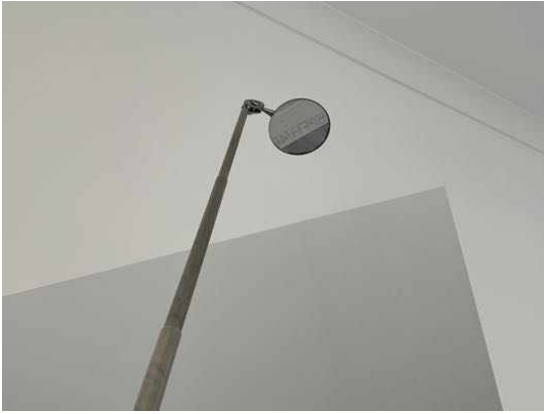
## Defects 3.06

Building:	Main Building
Location:	All Areas
Finding:	Incomplete Painting of Doors
Information:	The paintwork on the doors throughout the building is incomplete, failing to meet the requirements specified by Australian Guides and Tolerances.

- **\*\*Coverage:\*\*** Incomplete paint coverage on the doors, with visible areas left unpainted or thinly coated.
- **\*\*Edges and Corners:\*\*** Edges and corners of the doors are inadequately painted, showing bare or poorly covered areas.

- Reduced durability and protection of the door surfaces against wear and environmental factors.
- Compromised aesthetic quality and overall visual appeal of the building.
- Increased maintenance costs due to the need for early repainting or repairs.

The doors must be repainted to meet the standards outlined in the Guide to Standards and Tolerances. This includes:

- Ensuring complete and consistent paint coverage on all surfaces of the doors.
- Achieving a smooth and even finish without visible defects such as brush marks, drips, or streaks.

- Proper surface preparation to ensure good paint adhesion and prevent peeling or flaking.
- Thoroughly painting edges and corners to achieve a uniform appearance.

A detailed inspection should be conducted post-repainting to confirm compliance with the required standards.

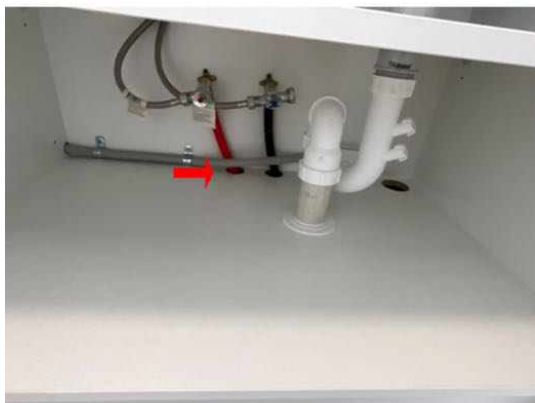
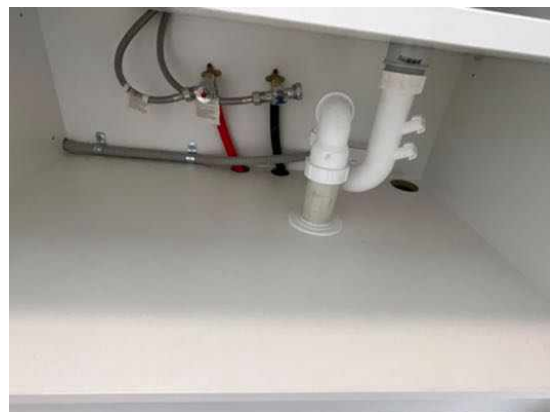
### Defects 3.07

Building: Main Building  
 Location: All Areas  
 Finding: Pipe Penetrations - caps required  
 Information: It was noted that at the time of the inspection the pipe penetrations were defective as stated in the Australian Standards and Tolerances 7.3.

- a. properly grouted as appropriate
- b. fitted through neat minimal size penetrations (in the case of cabinetwork)
- c. fitted with tight fitting cover plates or collars with penetrations kept to the smallest size practicable.

This is to be rectified prior to handover.

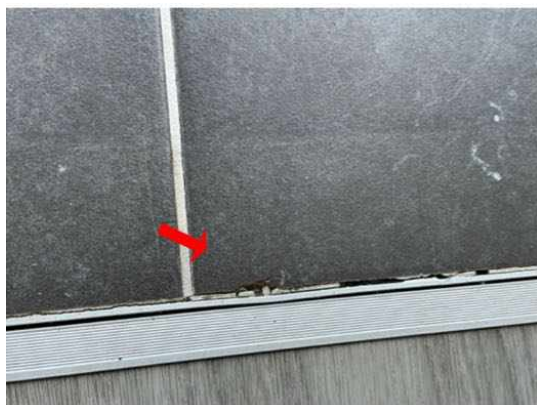
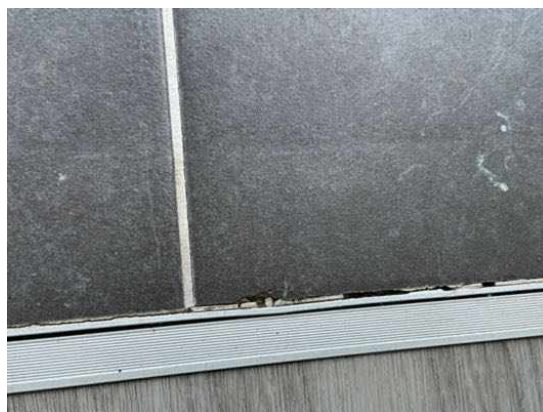
### Defects 3.08

Location: Front door  
 Finding: Tiles - Chipped  
 Information: Cracked, pitted, chipped, scratched or loose tiles

Tiles are defective if they are cracked, pitted, chipped, scratched or loose at handover.

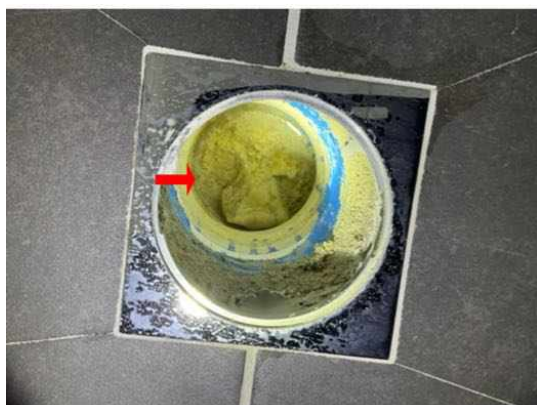
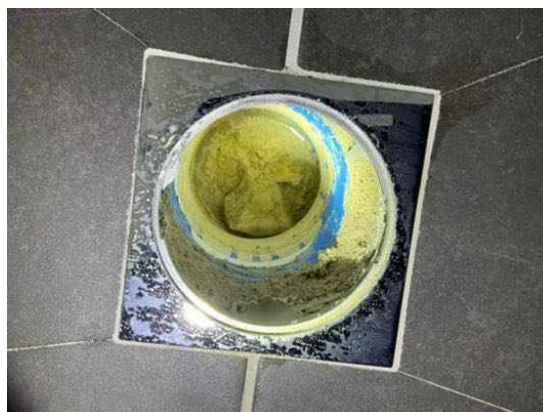
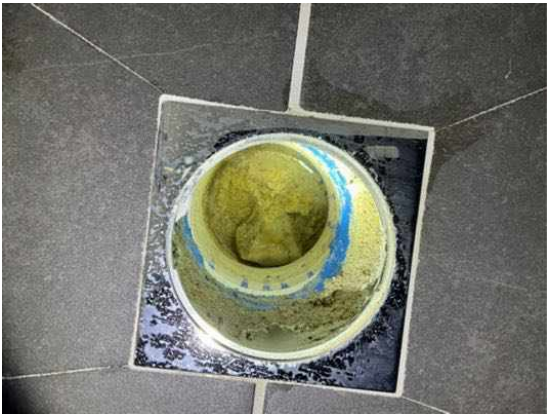
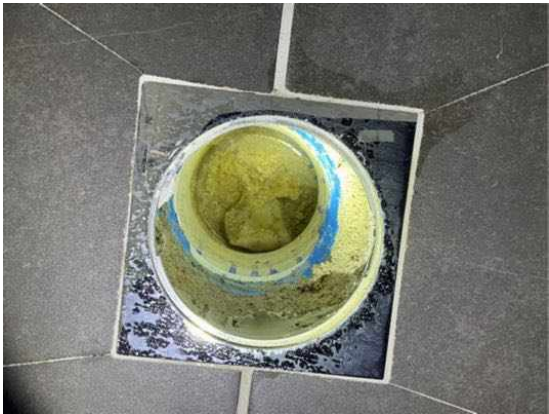
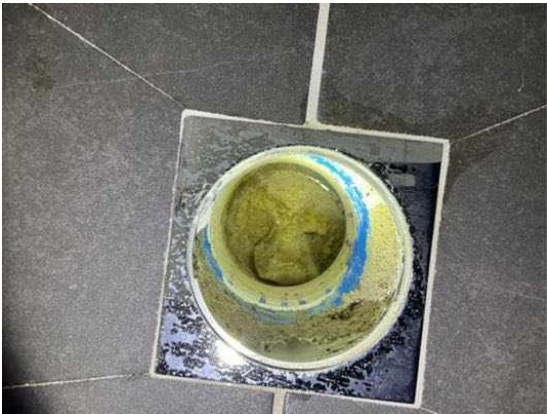
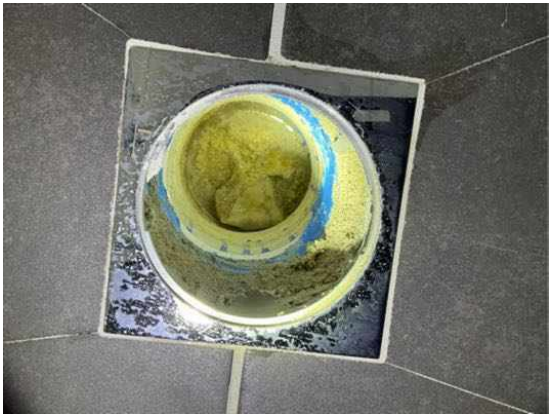
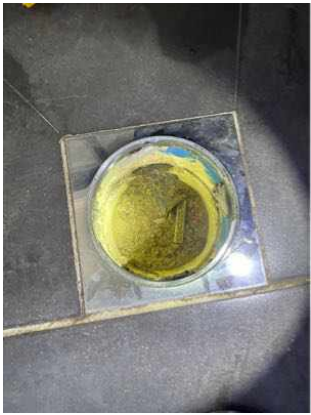
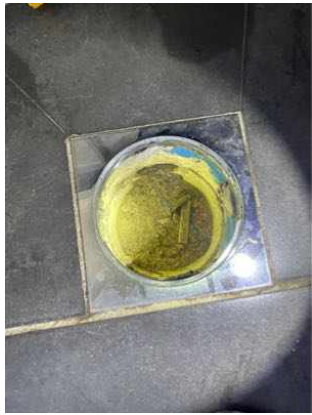
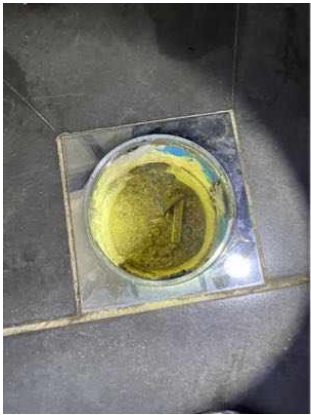
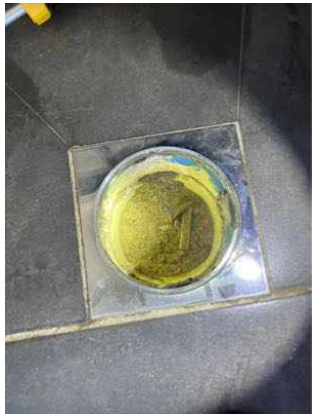
### Defects 3.09

Building: Main Building  
 Location: All Areas  
 Finding: Floor waste Debris  
 Information: It was noted that there is builder debris in the floor waste drainage. Debris in the plumbing system may lead to blockages in the future.

This is referenced against the Australian Standards and Tolerances clause 19.8 Cleaning - Owners are entitled to expect that the building site and works are clean and tidy on completion.

Building sites are defective if they are not clear of building debris. All floor wastes need to be checked and cleared prior to handover.
