# Building and Timber Pest Inspection Report

Inspection Date: Wed, 28 Jan 2026

Property Address: 1/45 Arthur St, Coffs Harbour NSW 2450,  
Australia

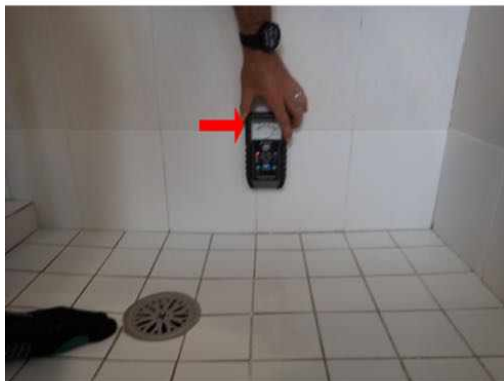
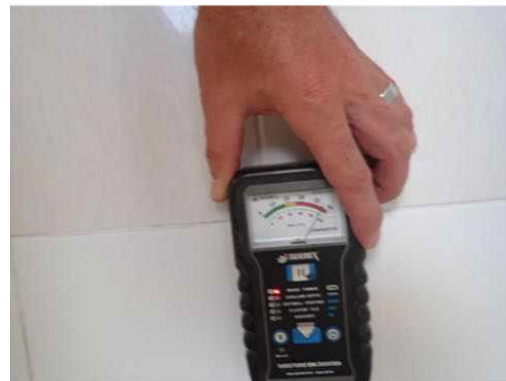
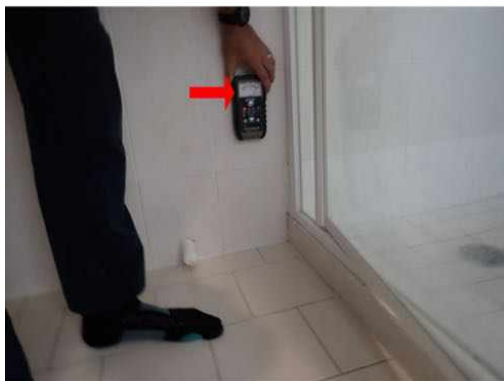
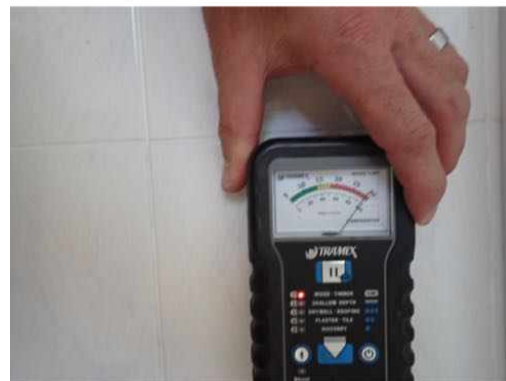
#### Finding 2.01

Building: Main Building  
Location: Bathroom  
Finding: High Moisture Readings in Bathroom Shower Area  
Information: High moisture meter readings were recorded in the bathroom shower area at the time of inspection. This indicates elevated moisture levels that may be associated with leaking plumbing, failed waterproofing, or deteriorated grout and sealants. Ongoing moisture exposure can lead to damage to wall linings, framing, and finishes if left unaddressed. Further investigation is recommended to determine the source of moisture. Assessment and rectification should be carried out by a licensed plumber and/or waterproofing contractor.

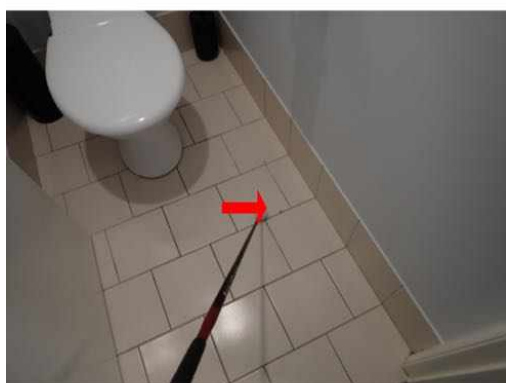
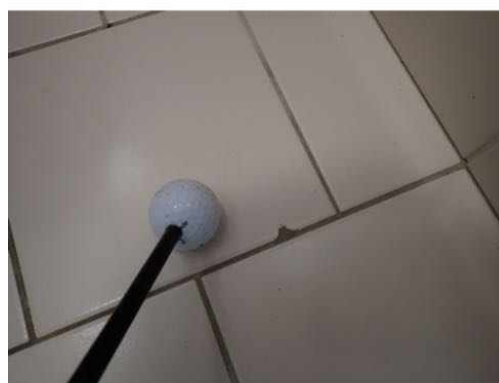
### Finding 3.01

Building:	Main Building
Location:	Toilet (WC)
Finding:	Chipped Floor Tile
Information:	A chipped floor tile was identified within the WC (toilet). This is a minor, cosmetic defect; however, damaged tiles can worsen over time and may allow moisture to penetrate the tile surface or grout joints. Repair or replacement of the affected tile is recommended as required. Works should be carried out by a tiler or suitably qualified tradesperson.

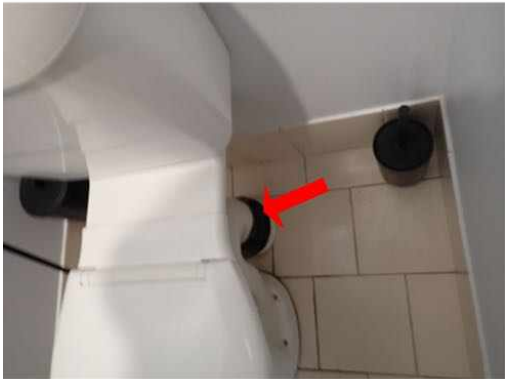
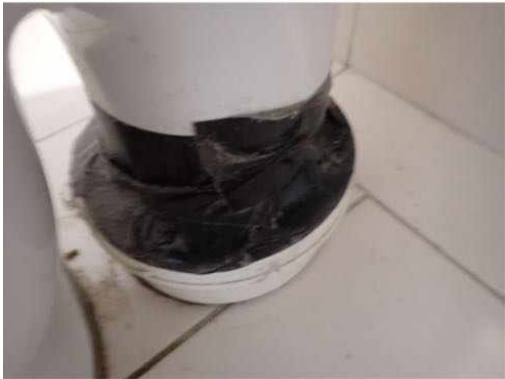
### Finding 3.02

Building:	Main Building
Location:	Toilet (WC)
Finding:	Duct Tape to Toilet Fitting
Information:	Duct tape was observed around a toilet fitting, indicating a poor or deteriorated connection. While no active leaking was identified at the time of inspection, this type of repair is temporary and may conceal or precede future leaks. Further investigation and proper repair or replacement of the affected fitting is recommended to prevent water damage. Works should be carried out by a licensed plumber.

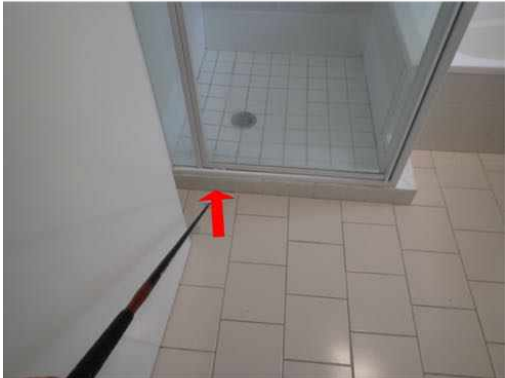
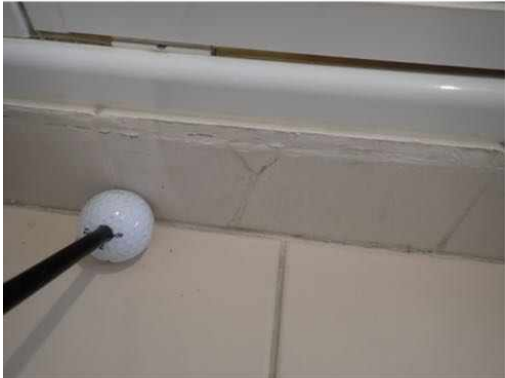
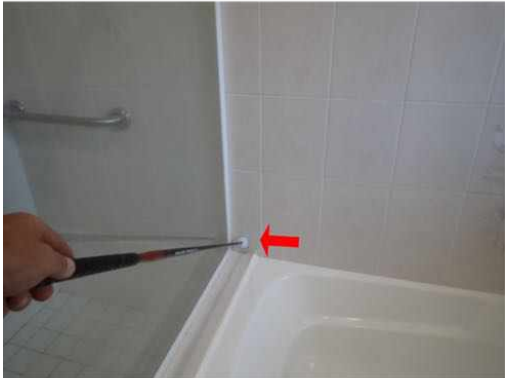
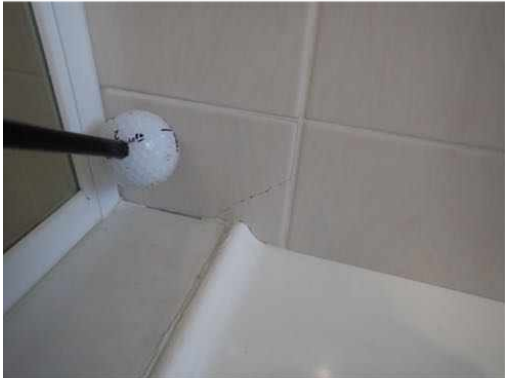
**Finding 3.03**

Building: Main Building  
Location: Bathroom  
Finding: Minor Cracks in Tiles to Shower Hob and Bath Edge  
Information: Minor cracks in tiles were identified to the bathroom shower hob and to a wall tile at the top edge of the bath. This condition may allow moisture penetration behind the tiled surfaces and can be indicative of movement or impact. If left unaddressed, ongoing moisture ingress may lead to deterioration of underlying substrates and waterproofing. Further assessment and repair or replacement of the affected tiles is recommended. Works should be carried out by a licensed tiler, with waterproofing assessment as required.

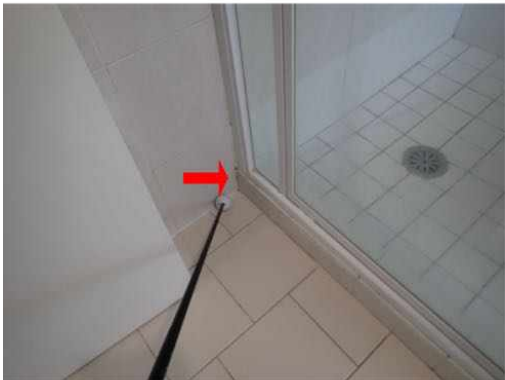
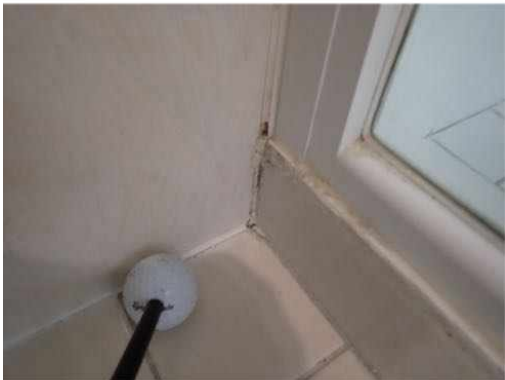
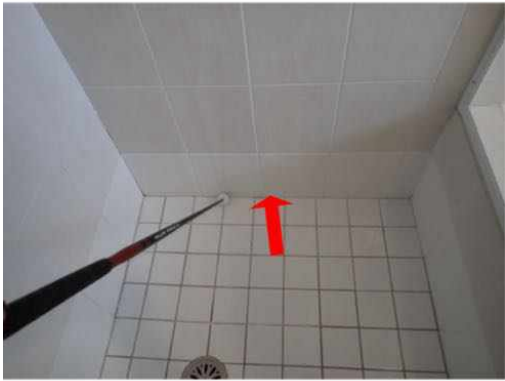
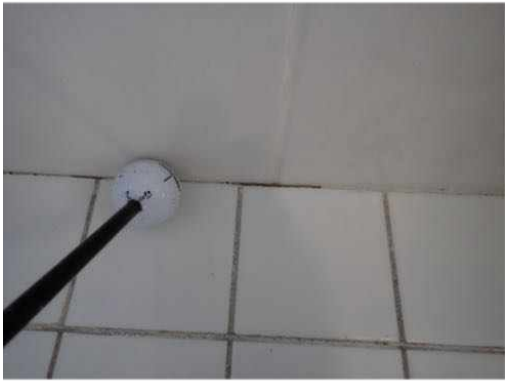
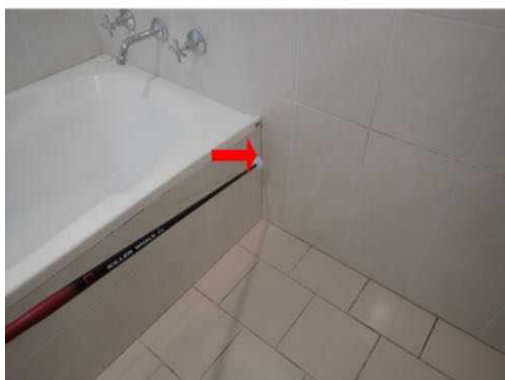
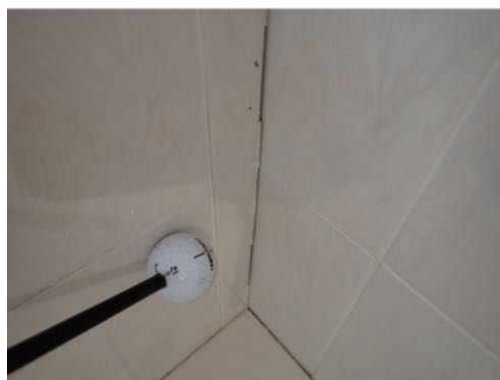
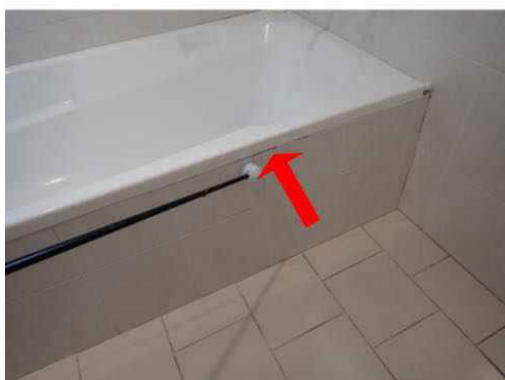
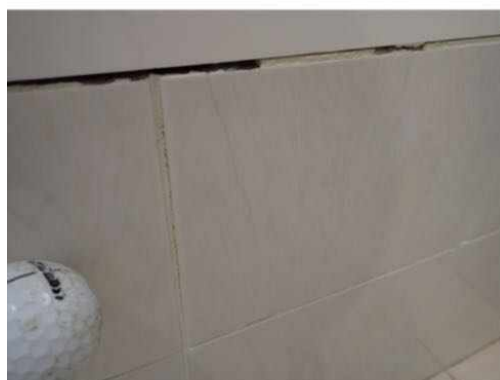
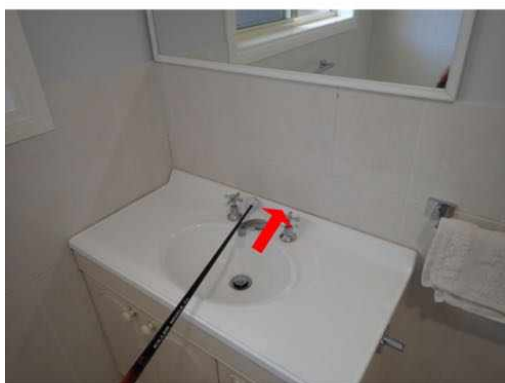
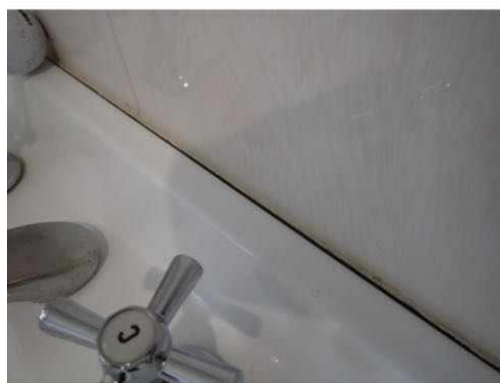
**Finding 3.04**

Building: Main Building  
Location: Bathroom  
Finding: Deteriorated Silicone and Grout to Bathroom  
Information: Deteriorated silicone sealant and grout were identified within the bathroom. This condition may allow moisture penetration behind tiled surfaces, potentially leading to damage to the underlying substrates and waterproofing over time. Timely maintenance, including removal and replacement of failed sealants and grout, is recommended to reduce the risk of moisture-related damage. Works should be carried out by a licensed tiler or suitably qualified tradesperson.

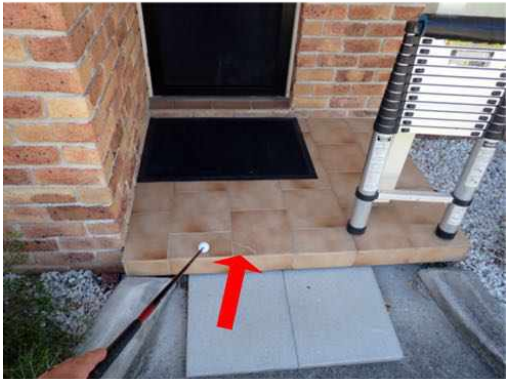
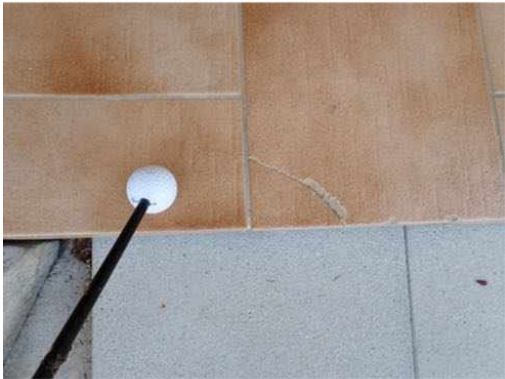
### Finding 3.05

Finding: Cracked Floor Tile to Front Entry Porch

Information: A cracked floor tile was identified at the front entry porch. This is a minor defect that may be related to impact, movement, or age-related wear. While currently not considered structural, cracked tiles can worsen over time and may present a trip hazard or allow moisture ingress. Repair or replacement of the affected tile is recommended as required. Works should be carried out by a tiler or suitably qualified tradesperson.

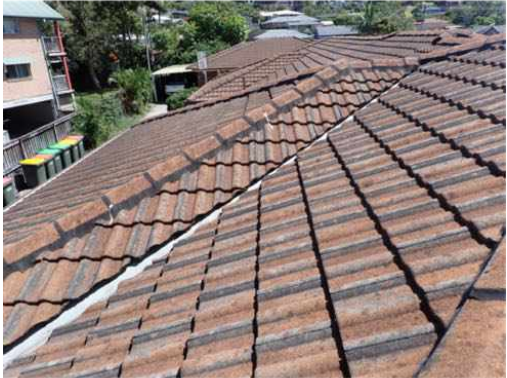
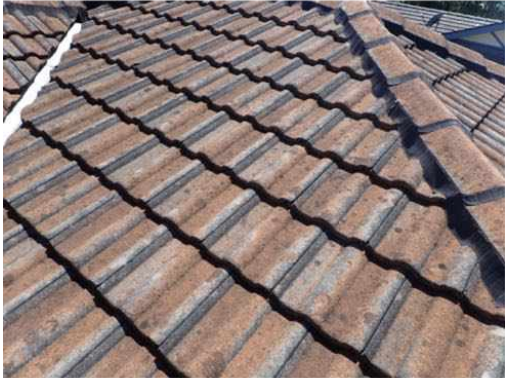
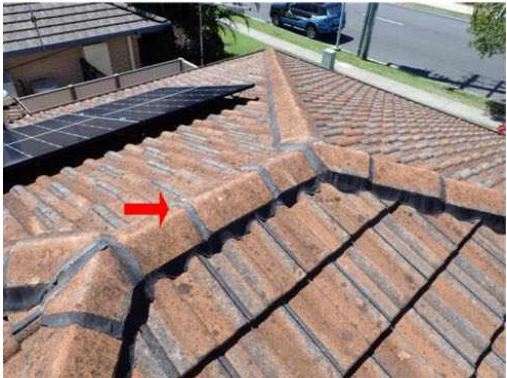
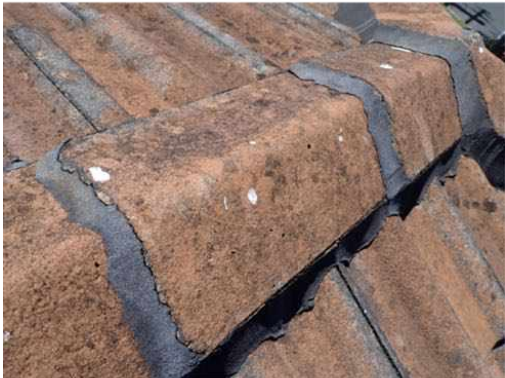
**Finding 3.06**

Building: Main Building  
Location: Roof Exterior  
Finding: Roof Tiles – Age-Related Wear  
Information: The roof tiles were observed to be in fair condition overall, with age-related fading and minor cracking to the mortar. These conditions are consistent with normal wear over time and were not considered critical at the time of inspection. Ongoing monitoring and maintenance, including repointing or repairs as required, is recommended to help maintain the roof’s weatherproof performance. Works should be carried out by a licensed roofing contractor or suitably qualified roof tiler.

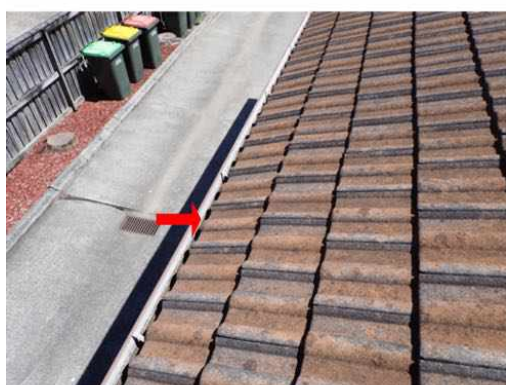
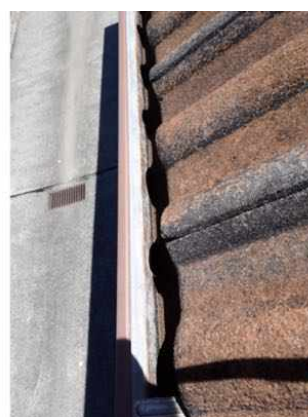
### Finding 3.07

Building:	Main Building
Location:	Roof Exterior
Finding:	Gutters – Age-Related Surface Rust
Information:	Age-related surface rust was identified to sections of the gutters. This condition is consistent with normal wear and weather exposure and, while not critical at the time of inspection, may worsen over time and lead to reduced service life or leaks. Ongoing monitoring and maintenance, including treatment or replacement where required, is recommended. Works should be carried out by a licensed roof plumber or suitably qualified contractor.

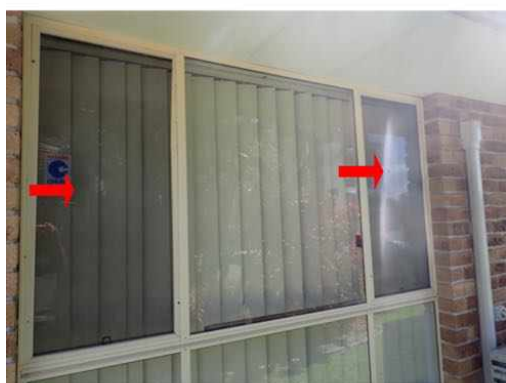
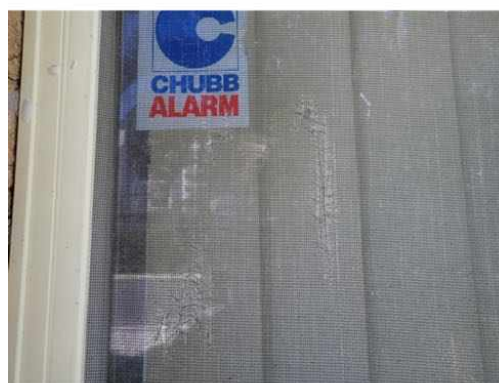
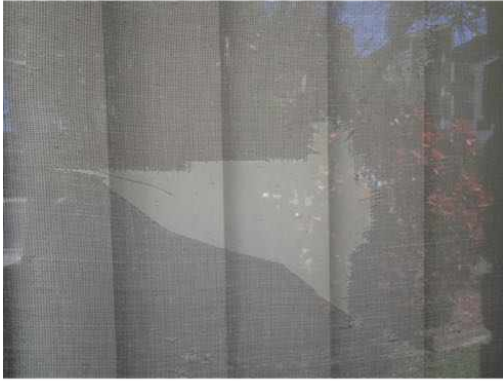
### Finding 3.08

Building:	Main Building
Location:	Living room
Finding:	Damaged Fly Screens — Living Room
Information:	Damaged fly screens were identified to the living room windows. This is a minor defect that affects insect protection and general amenity. Repair or replacement of the affected fly screens is recommended as required. Works can be carried out by a glazier or suitably qualified handyman.

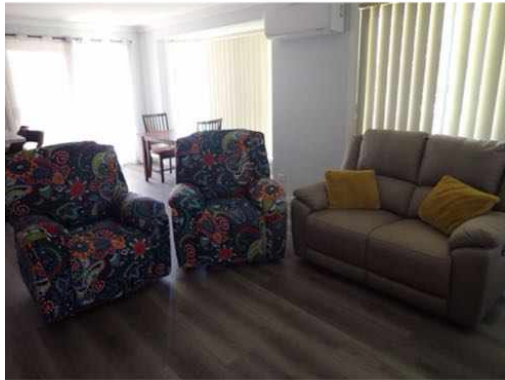
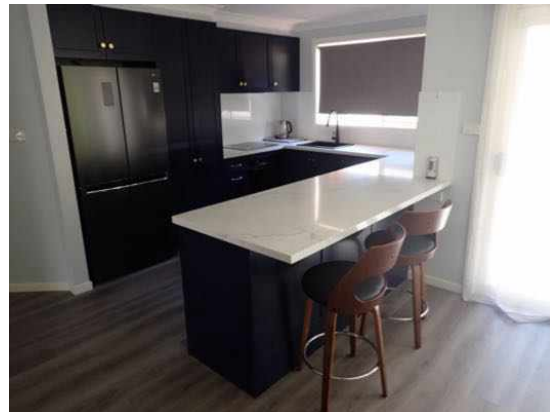
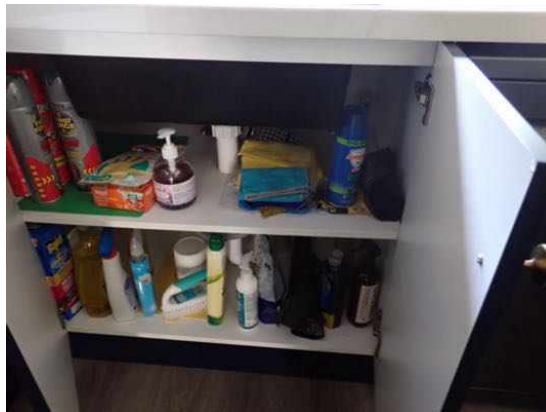
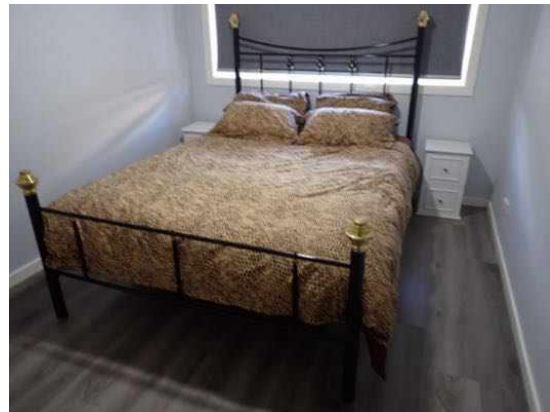
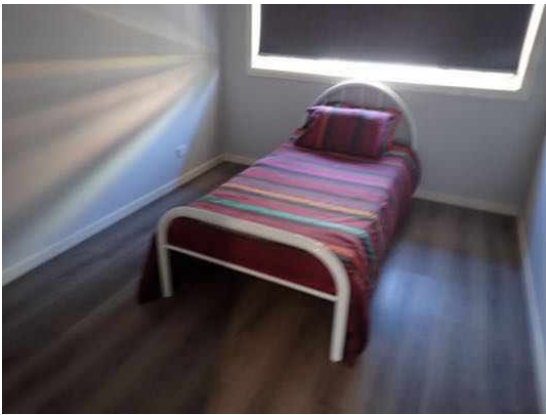
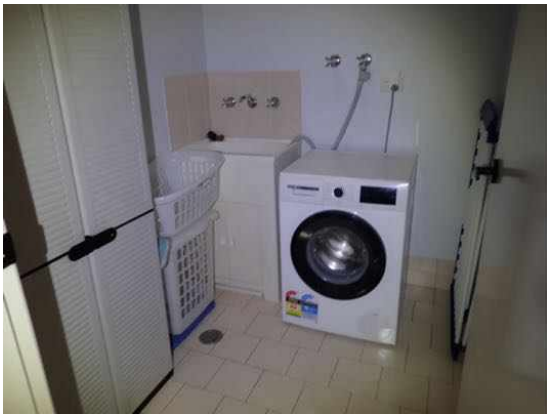
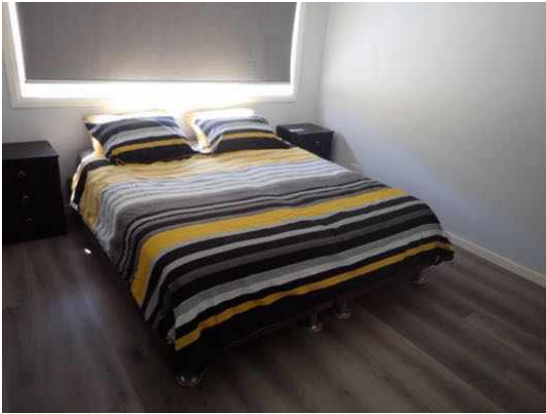
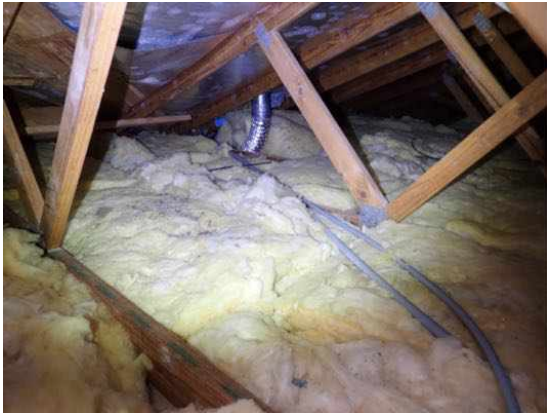
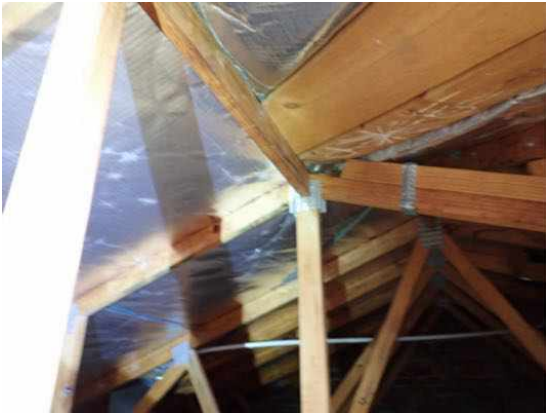
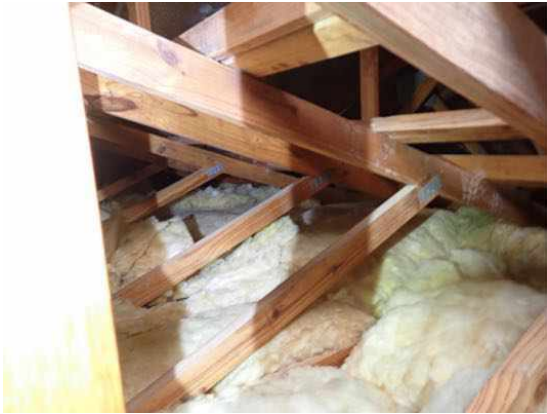
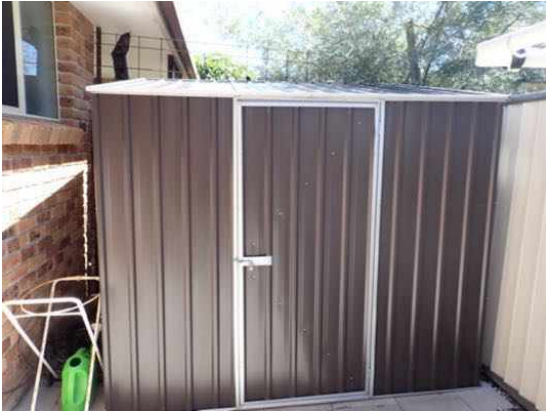
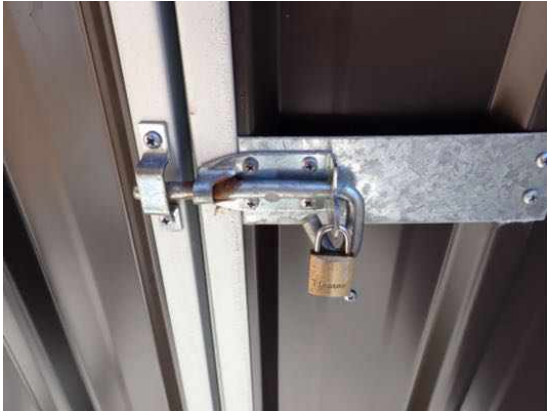
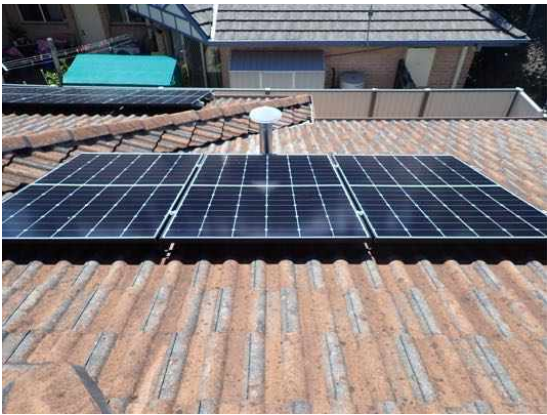
#### Noted Item

Building: Main Building  
Location: All Areas  
Finding: Additional Photos - Obstructions and Limitations  
Information: These photographs are an indication of the obstructions and limitations which impeded full inspection of the area at the time of inspection. These obstructions can hide an array of defects and should be removed to allow full inspection to be carried out. A re-inspection is recommended once the areas are made accessible.
