Building and Timber Pest Inspection Report

Inspection Date: Tue, 20 Jan 2026

Property Address: 1 Karol Ct, Hampton Park VIC 3976,
Australia

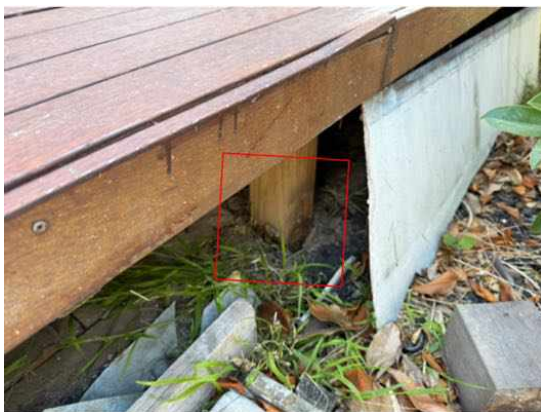
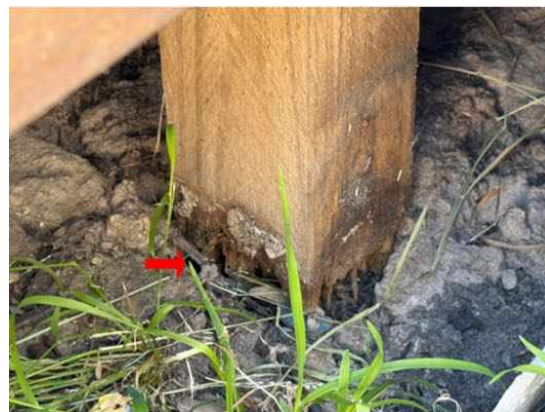
Finding: Deck Support Post Deterioration

Information: The timber deck support post/footing is in direct contact with the ground and has deteriorated due to prolonged moisture exposure. Visible timber rot and decay were noted at the base of the post, indicating a loss of structural integrity. Timber elements in ground contact are highly susceptible to rot and pest attack and do not provide adequate long-term support when left unprotected.

This condition compromises the load-bearing capacity of the deck structure and poses a safety risk, as continued deterioration may result in structural movement or failure.

A suitably qualified and registered builder should be engaged immediately to replace the affected post. Rectification should include installing a compliant concrete footing and an approved post support or stirrup to ensure the replacement timber post is isolated from ground contact and adequately protected against future moisture damage.

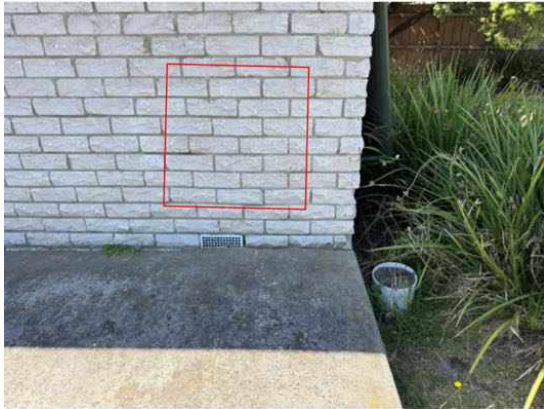
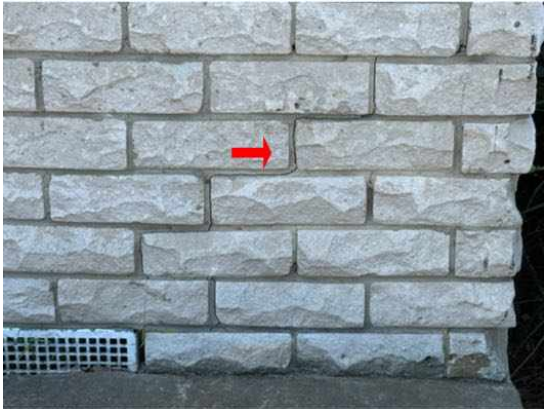
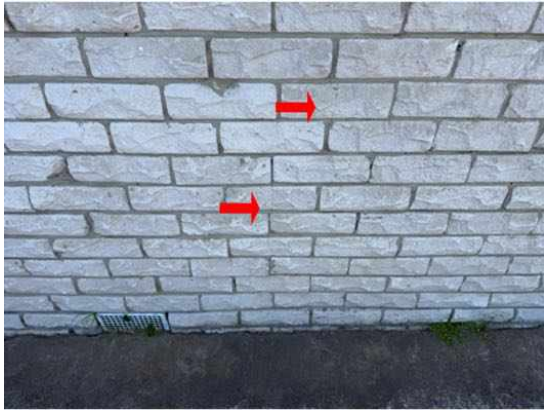
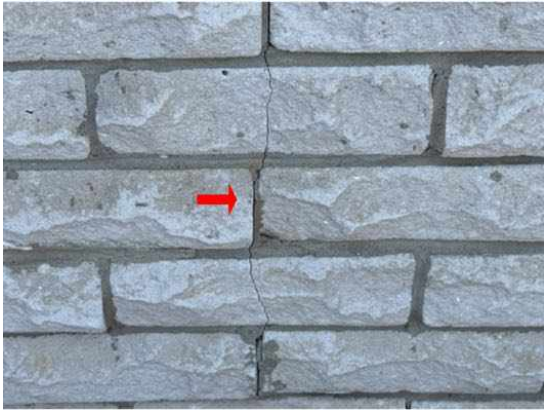
Building: Main Building
Location: All External Areas
Finding: Brickwork - Step cracking
Information: Step cracking was identified to the brickwork in most external brickwork areas at the time of inspection. Step cracking, which is similar to other forms of cracking, has a variety of possible causes. However, the most common is the subsidence of adjacent footings.

Step cracking is a relatively common defect, and is most likely to occur adjacent to windows, doors and other openings. Mortar failure in the gaps between affected bricks indicates the stresses and tensions affecting the wall.

Where step cracking is extensive or severe, the client is advised to consult a structural engineer. Minor step cracking can be used as a warning sign to address factors causing stress to the wall, which can include the effect of surrounding trees, water leaks, soil erosion, or even the presence of reactive soils in the surrounding area.

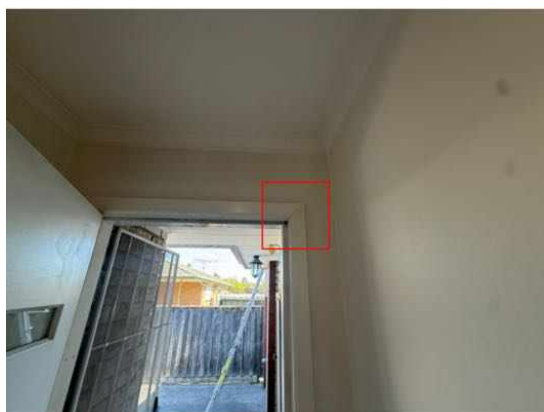
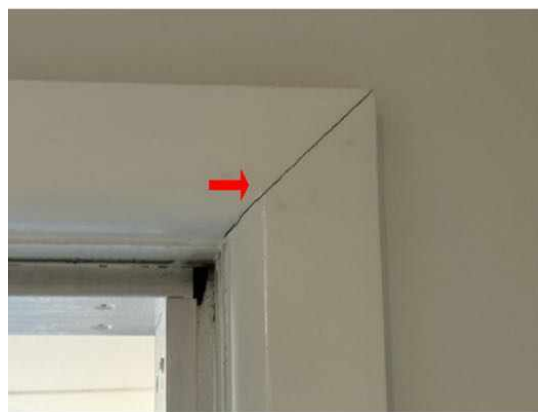
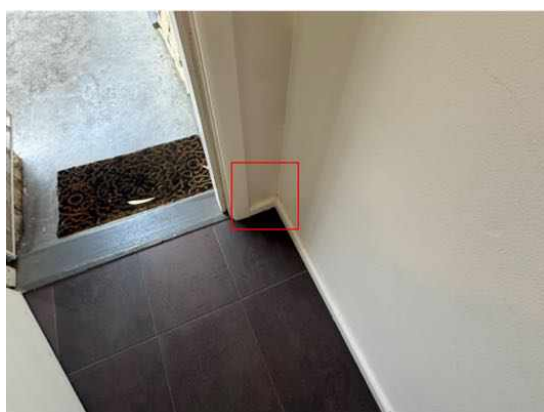
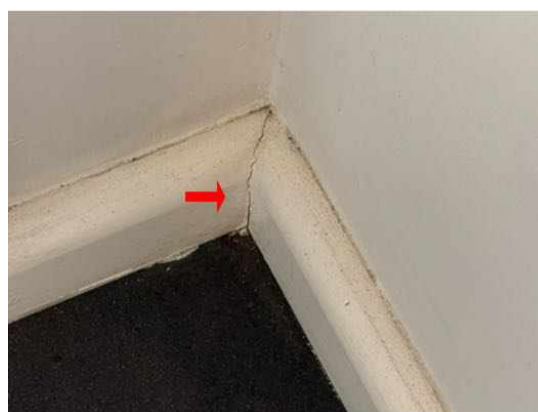
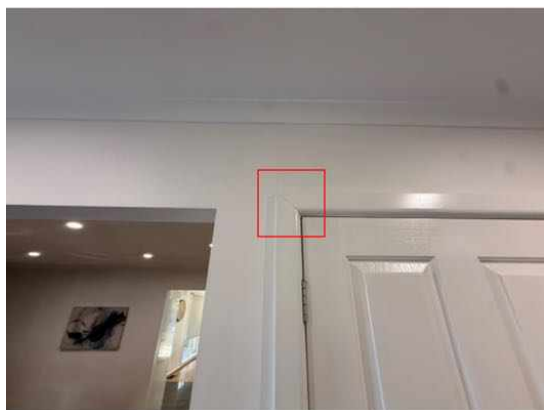
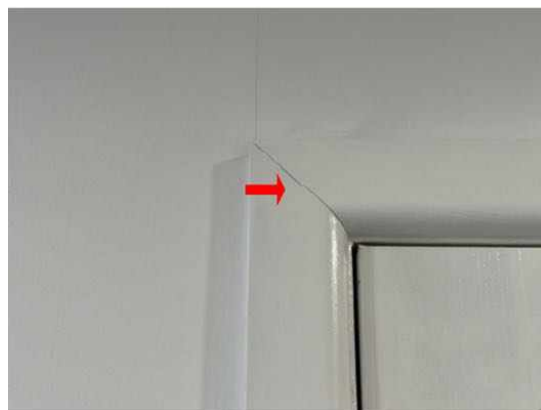
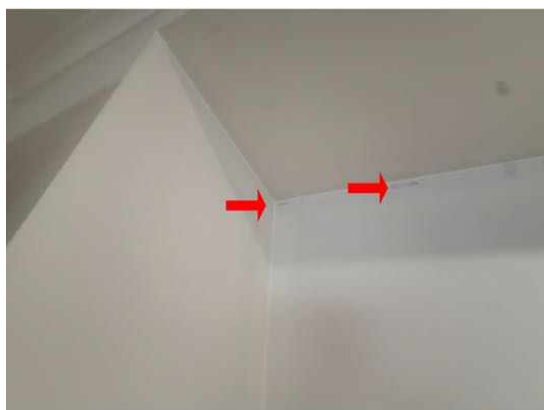
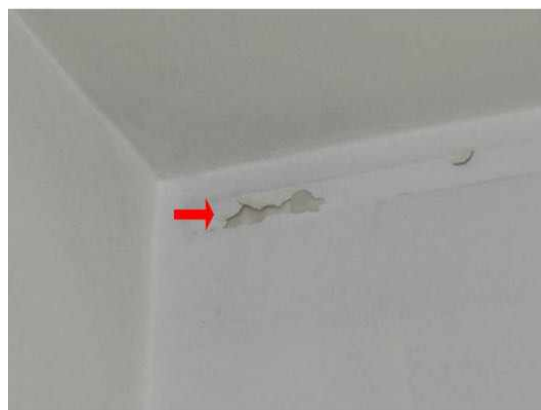
Finding 3.02

Finding: Paint finish - deteriorated

Information: The paint finish in most internal areas was identified as being deteriorated at the time of inspection.

Whilst incomplete or missing paint finish is generally an appearance defect, it can also lead to the development of secondary building defects over time. Incomplete areas of paint finish expose the area to moisture, potentially accelerating the deterioration of underlying building materials.

Incomplete paint finishes should be sanded back, filled, leveled and painted, as applicable. Where inadequate or missing paint protection has led to the deterioration of the associated building element, repair and/or replacement of this building element may be required.

A painting contractor or general handyman should be appointed as soon as possible to perform necessary works to aid the appearance of the affected area and to ensure the area is protected against further deterioration. Alternatively, the homeowner following manufacturer instructions may perform these works.

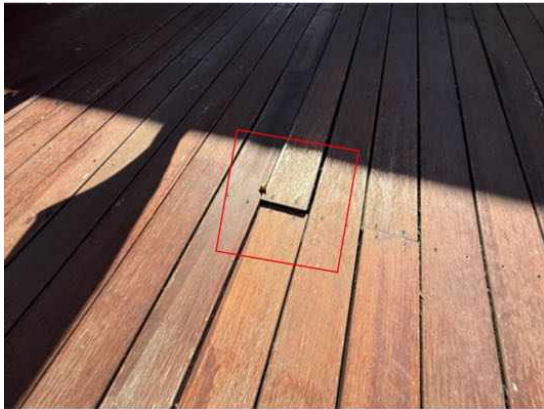
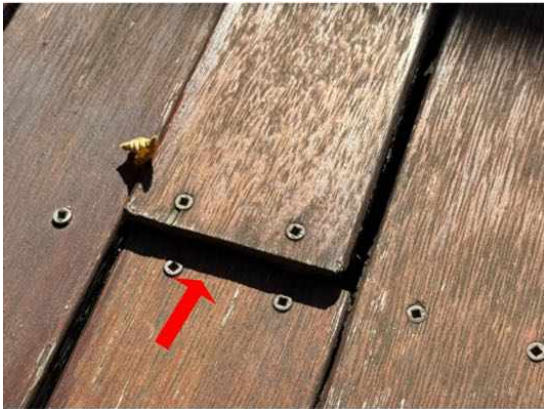
Finding 3.03

Building:	Main Building
Location:	Deck
Finding:	Deck- deteriorated
Information:	It was noted at the time of inspection that sections of the decking was deteriorated/loose.

Typically decking deteriorates due to age and or wear which is generally expected for a structure of this age, due to prolonged exposure to weather conditions.

Sometimes inadequate installation or maintenance can be to blame. If left unattended, it is likely that further damage will occur. It is suspected that repair of several elements of the balustrades may be required however replacement may be a consideration of the client also.

A licensed carpenter contractor should be appointed to provide further advice and perform rectification works as necessary.

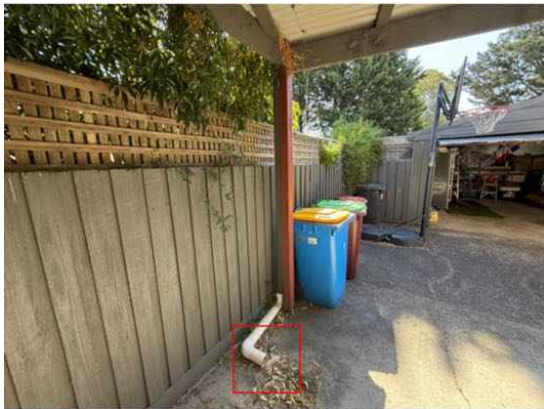
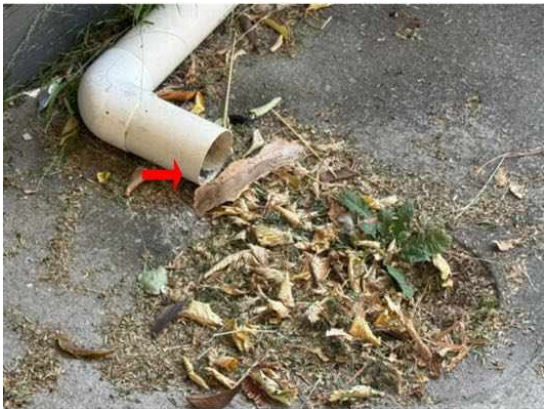
Finding 3.04

Building: Main Building
 Location: Carport
 Finding: Stormwater drain - Not connected
 Information: The roof plumbing is not adequately connected to stormwater drainage on the site, in the carport area. This disconnection negatively impacts the functional capacity of the roof plumbing.

Where roof plumbing doesn't drain adequately, the area at the base perimeter can become excessively damp, potentially creating an environment that is susceptible to rust and corrosion of surrounding building elements, as well as attracting termites and other pests.

It is highly recommended that a plumber be appointed to further inspect the area and to install adequate drainage equipment where necessary. It was also noted at the time of inspection that this carport drain seemed blocked, so further investigation is required.

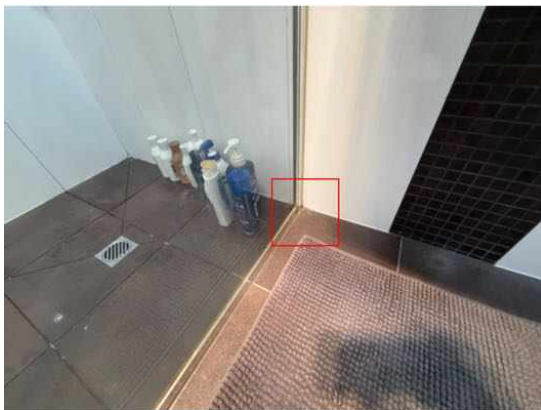
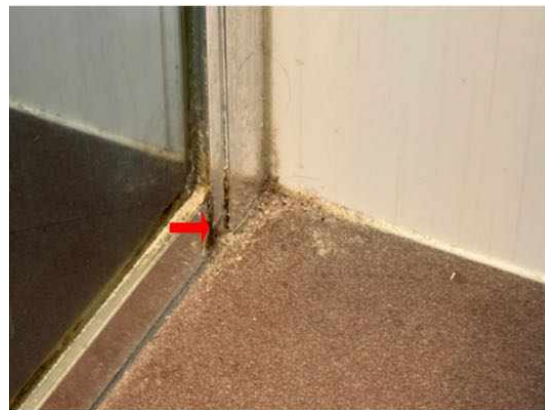
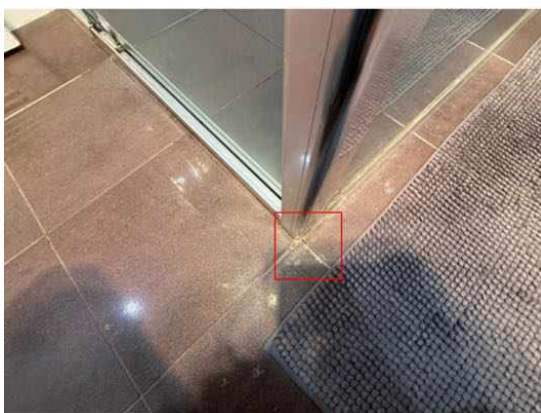
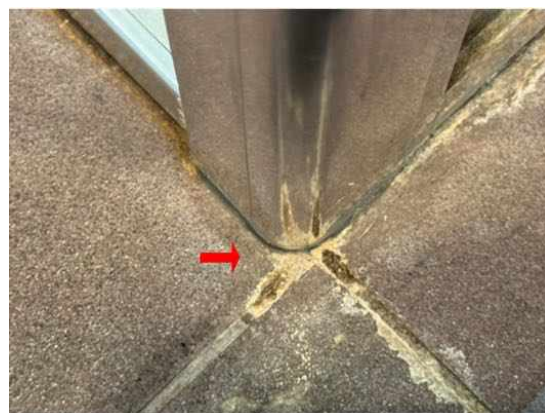
Finding 3.05

Finding: Sealant and grouting - Missing or damaged
Information: It was noted on inspection that sealant or grout is degraded to the tiled shower alcove and or other areas of the bathroom.

Different materials and floor areas move at different rates, generally causing cracking to grout or sealant at this point. A flexible sealant is required to allow for expected expansion and contraction, while keeping the joint water tight and protective of all associated building materials.

There appears to be excessive mould to the sealant and grout which will likely require scraping out and replacement.

Flexible and mould resistant materials should be applied to affected areas to prevent any subsequent water damage that is likely to occur. Regular maintenance and replacement of damage or missing or damaged sealant and grout is highly recommended to the wet areas, as this is a regular wear and tear defect. Sealant and grouting in areas that come into regular contact with water should be maintained for the long term care of your property.

A sealant specialist or tiling contractor should be appointed to complete these works as soon as possible

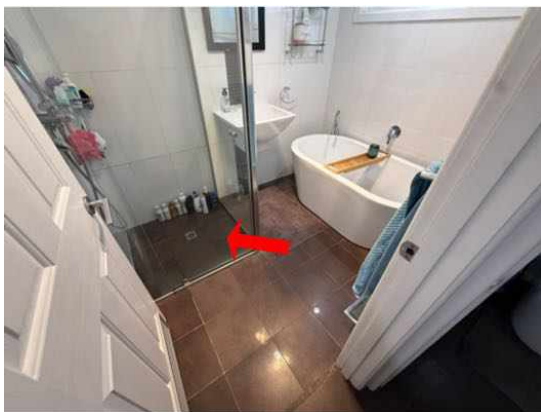
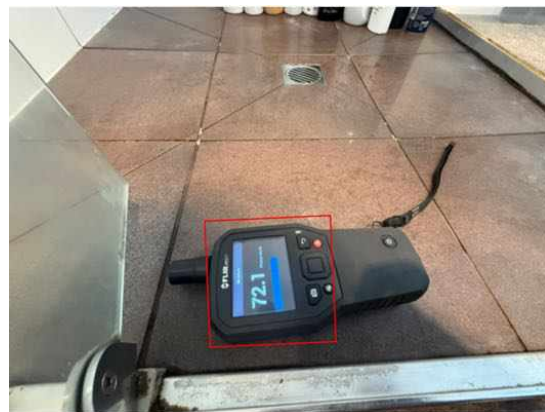
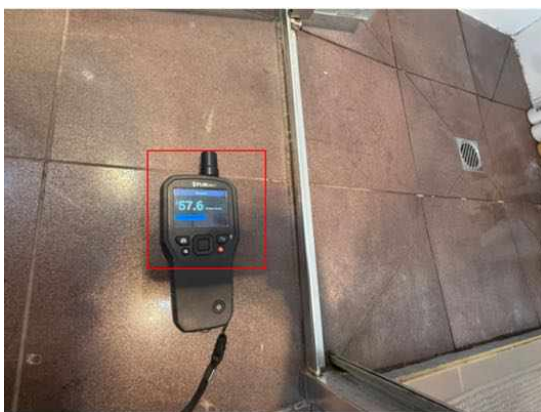
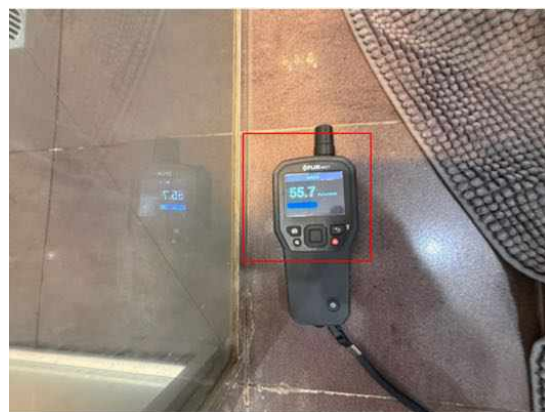
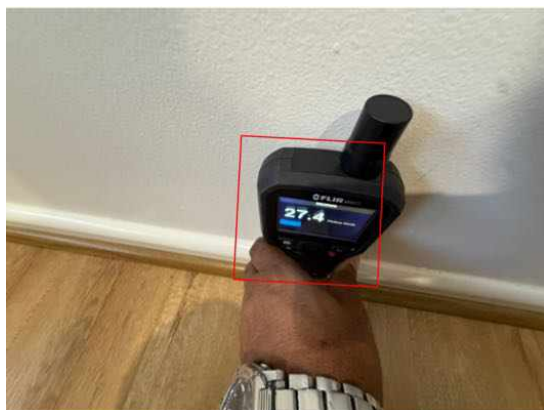
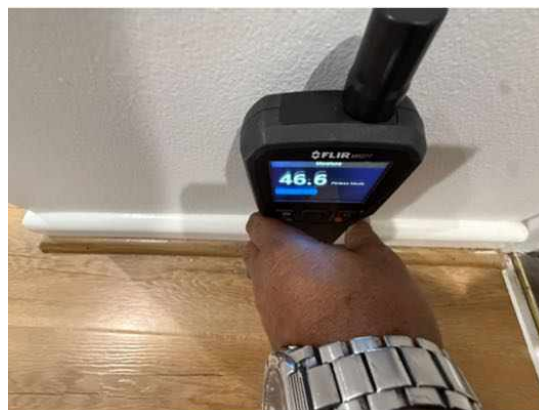
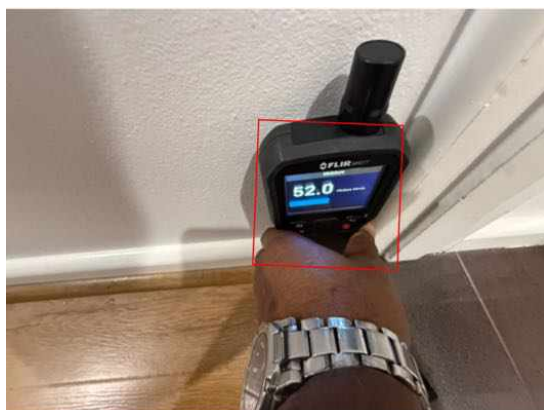
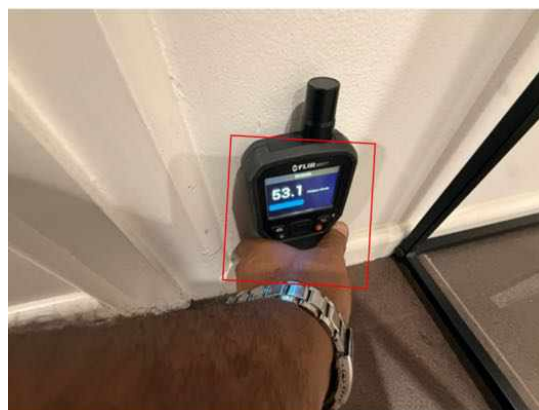
Finding 3.06

Damp is evident to the lower 300mm of wall to the shower alcove. This defect is quite common, and is suspected to have been caused by moisture permeating through the grouting in this area, which shows evidence of deterioration. Leaking pipes within the adjoining wall is also a possible cause.

Unmanaged damp in the shower recess is likely to facilitate the formation and development of mould and fungi growth, decaying associated building materials and compromising their structural integrity. It is important to address damp conditions, as the World Health Organisation notes that excess moisture leads - on almost all indoor materials - to growth of microbes such as moulds, fungi and bacteria, which subsequently emit spores and other matter into the indoor air. Exposure to these contaminants is associated with a wide range of respiratory and other health-related problems.

Consultation with a qualified plumber or bathroom specialist is advised immediately to identify the cause of damp and to perform remedial works as required. Where excessive mould growth is present, further inspection by a specialist environmental health inspector should also be considered.

Always ensure that sealant and grout is in good condition to prevent any moisture issues occurring in the future.

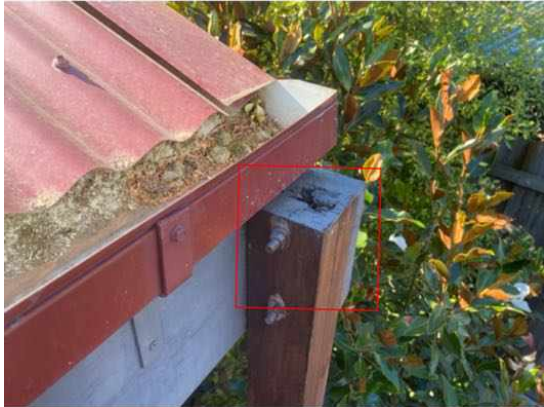
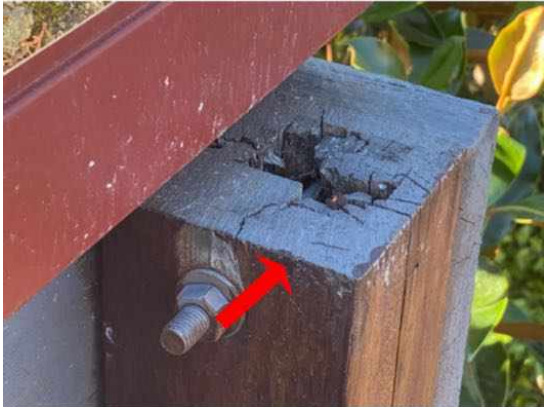
Finding 3.07

Finding: Wood rot Post

Information: The verandah post shows some evidence of wood rot. Wood rot, also known as Fungal Decay, occurs when timbers and other cellulose building materials are exposed to damp conditions on an ongoing basis. This could be the result of exposure to weathering over a prolonged period of time, or the attraction of excessive moisture from other abutting building materials. Contributing factors also include poor air ventilation in the area.

Wood rot is often associated with general damp problems and is evidenced by a 'musty' smell or mould and mildew occurring on surfaces. If left unmanaged, damp conditions can lead to structural issues if the decay of timbers are left to continue.

Early intervention and regular maintenance, particularly of exterior timbers, will prolong the useful life of these building elements. Prior to any works being performed, the cause of the moisture that has created the visible wood rot should be identified and addressed in a suitable manner. Replacement of affected timbers may then be a necessary step in protecting surrounding building elements from such deterioration.

A qualified plumber may be appointed to assess the cause of excessive moisture and to provide advice on any remedial works as required. A qualified carpenter or

registered builder may also be required to replace affected building materials, as soon as possible.

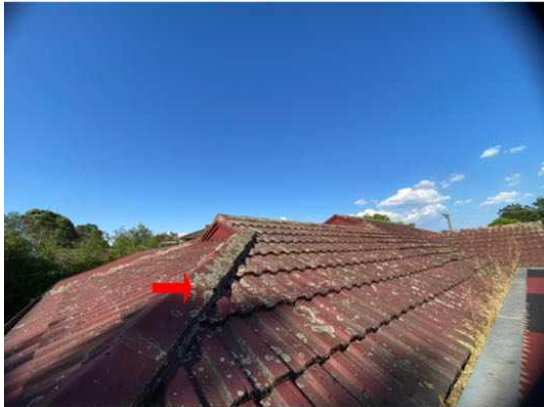
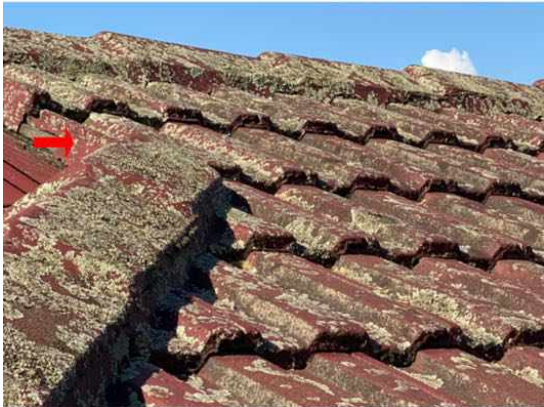
Finding 3.08

Building: Main Building
 Location: Roof Exterior
 Finding: Moss external roof tiles
 Information: Moss and lichen growth are present across the exterior roof tiles, along with an accumulation of organic debris in the gutters.

This can retain moisture and prevent proper drainage, creating a damp environment conducive to timber pest activity.

Prolonged dampness increases the risk of concealed leaks, deterioration of roof timbers, and conditions favourable for termite or fungal attack.

The gutters and roof surfaces should be cleared of all organic matter, and the moss/lichen treated or removed.

Regular maintenance by owner or general handyman, is recommended to ensure effective roof drainage and to reduce conducive conditions for timber pests at the owners discretion.

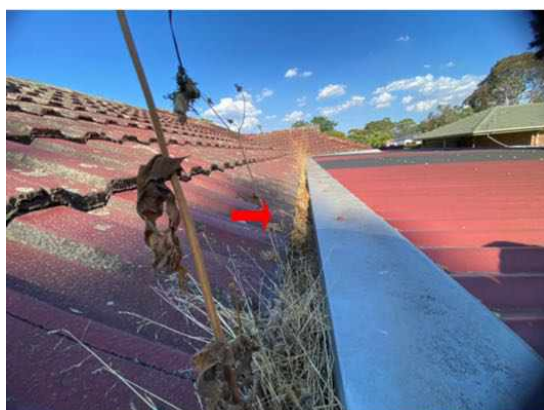
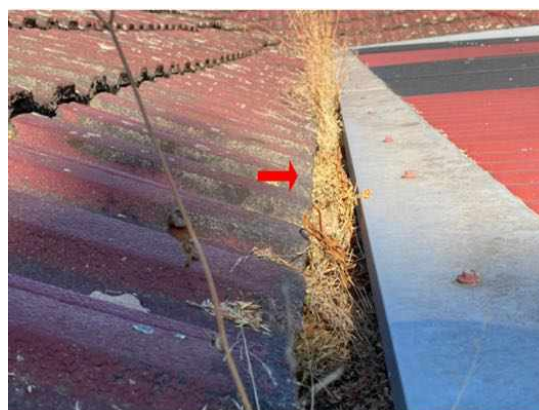
Finding 3.09

Building:	Main Building
Location:	Roof Exterior
Finding:	Debris in Gutters
Information:	Roof plumbing structures, such as guttering and downpipes, should be free of all debris to prevent blockages. Blockages of the guttering and downpipes will lead to pooling and accumulated water overflows, which is likely to subsequently flood eaves and exterior walls.

Blocked gutters are likely to lead to high levels of moisture in the affected areas. This moisture cause rust and decay of the associated building materials such as eave linings, timber trusses and internal plaster. Blockages in gutters should therefore be removed immediately to ensure dry conditions are maintained.

Consult a Licensed Plumber for further specific advice on remedial works that may be required. In the interim, it is highly advised that blocked gutters be removed by the homeowner or a general handyperson as a matter of urgency.

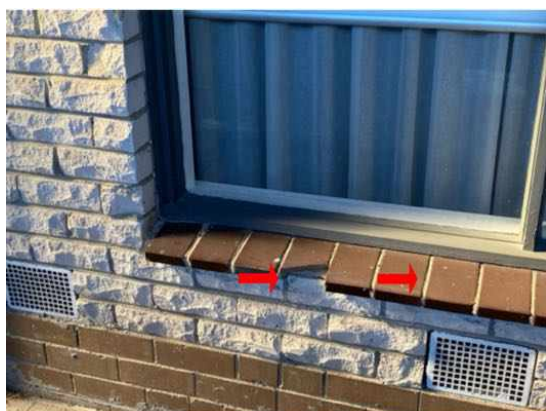
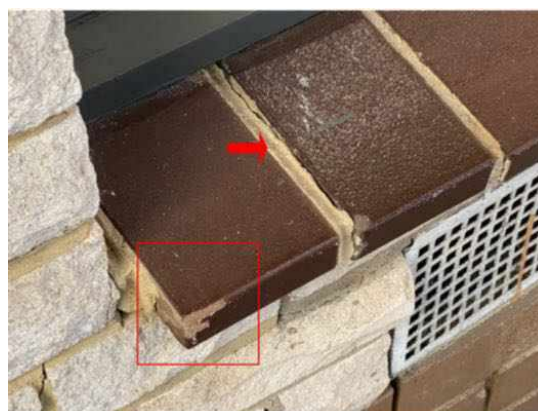
Finding 3.10

Building:	Main Building
Location:	Carport
Finding:	Cracked and Damaged Window Sill Tiles
Information:	Cracked and broken tiles were observed to the external window sill. The damage is likely the result of age, weather exposure, or minor movement of the supporting masonry or damage. While this issue is not considered a structural or immediate safety concern at the time of inspection, the damaged tiles may allow moisture penetration into the underlying brickwork and wall structure if left unaddressed, which could lead to further deterioration over time.

It is recommended that the damaged window sill tiles be repaired or replaced, and that all joints be appropriately re-bedded and sealed to restore weather resistance and prevent future moisture ingress, at the owners discretion.

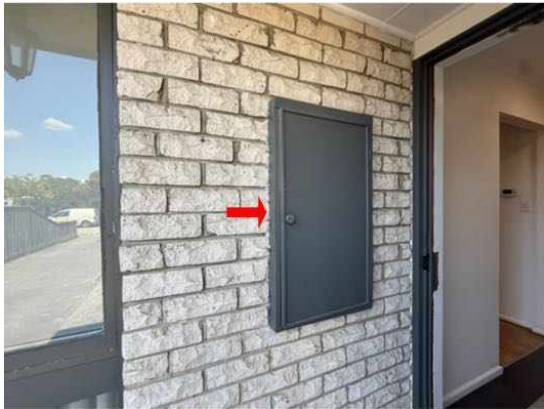
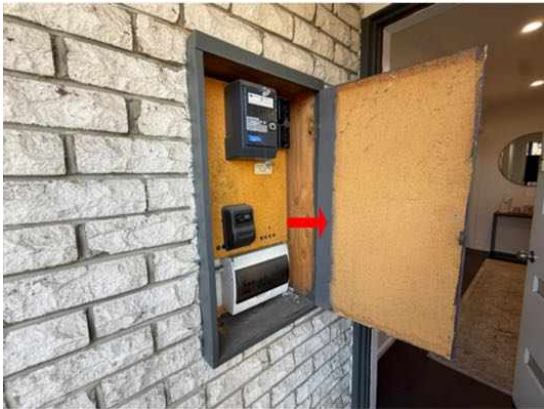
Building:	Main Building
Location:	Yard - Front
Finding:	Termite Management System - no evidence of a chemical installation
Information:	The application of a post-construction chemical termite barrier is highly recommended for all properties, particularly if live termite activity has been found on the site previously. Such barriers are highly effective in preventing termite attack on any timber building elements throughout the property.

A durable notice should be placed in the switchboard unit to indicate current termite barriers. At the time of inspection, it appeared as though no termite management system has been installed, with no evidence to suggest preventative works taking place.

The client may consider gaining further advice from a pest controller as to the costs and procedures involved with this application. It is recommended that obtaining such advice be a short-term priority.

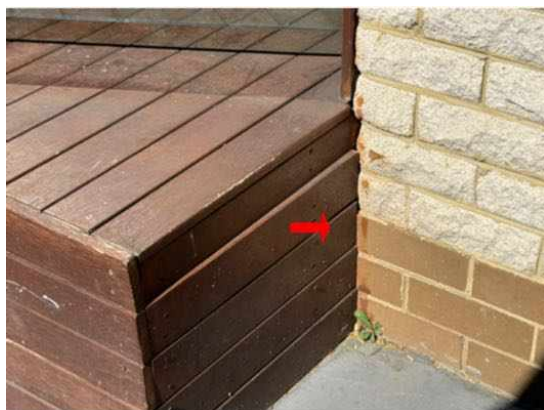
Finding 6.02

Building: Main Building
Location: Deck
Finding: Bridging of termite barrier - Decking
Information: Bridging of termite barriers occurs when termites bridge (usually by building a mud tunnel) a termite barrier or inspection zone or where termites have a passage allowing them to bridge the barrier.

Where bridging has occurred full inspection is prevented and termites may enter a property in a concealed or undetectable manner.

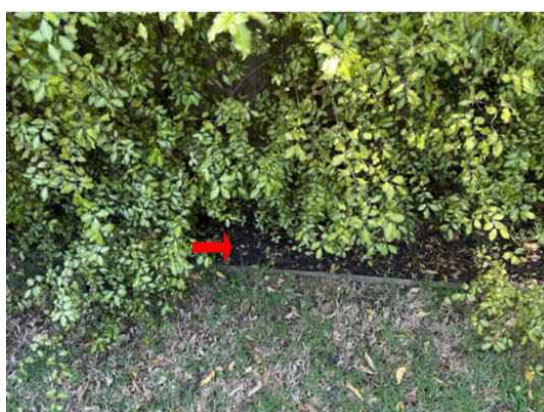
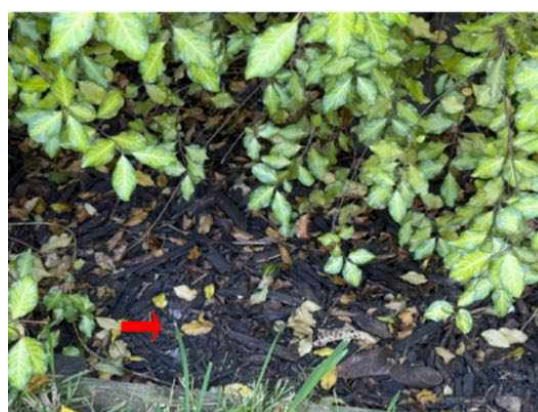
Finding 6.03

Building:	Main Building
Location:	All External Areas
Finding:	Mulch - Garden Beds
Information:	Tan bark mulch has been used in garden beds surrounding the perimeter of the property. While commonly used for landscaping, this organic material retains moisture and provides a food source, thus creating conducive conditions for sub terranean termite activity.

A Reduction in mulch levels to no more than 50mm in depth, ensuring it is kept at least 75mm clear of slab edges, weep holes, and structural timbers is recommended. Consider replacing with non-organic ground cover in high-risk areas.

The property owner should consult a qualified landscaper urgently to rectify this condition.

A pest technician should reinspect periodically.

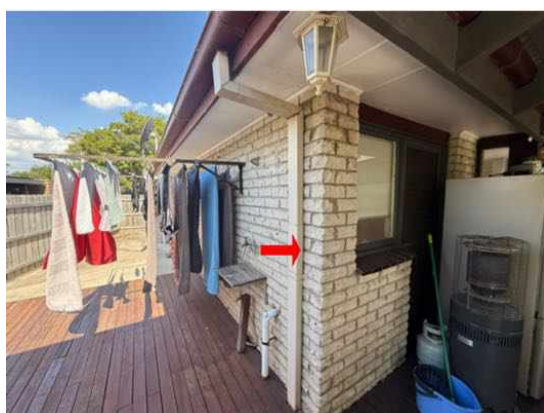
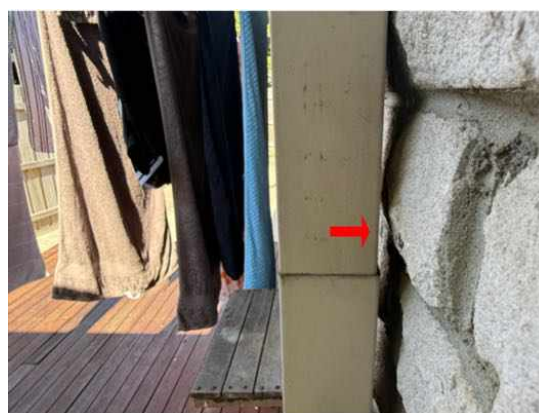
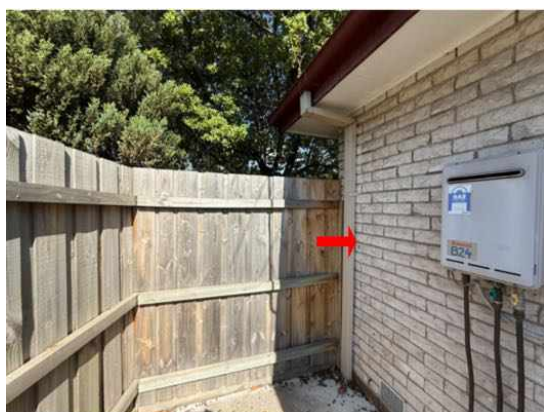
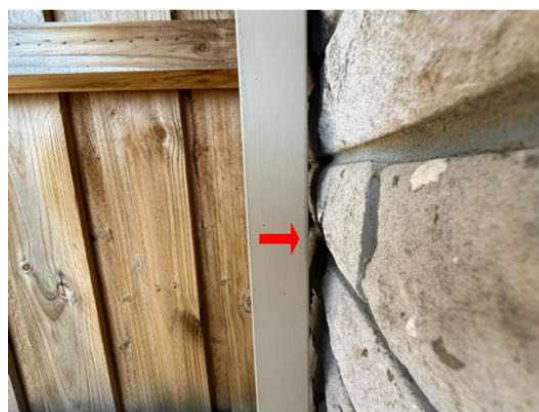
Finding 6.04

Building:	Main Building
Location:	All External Areas
Finding:	Potential bridging of termite barrier - downpipes

Where any part of an attachment to a building is not isolated and is not provided with a clear gap of not less than 25mm from the building, bridging occurs. Attachments to buildings such as hot water services, downpipes, verandahs, decks, steps, fences, service conduits and the like provide the opportunity for concealed entry.

Building attachments of this nature need to be frequently inspected for termite activity by a qualified inspector.

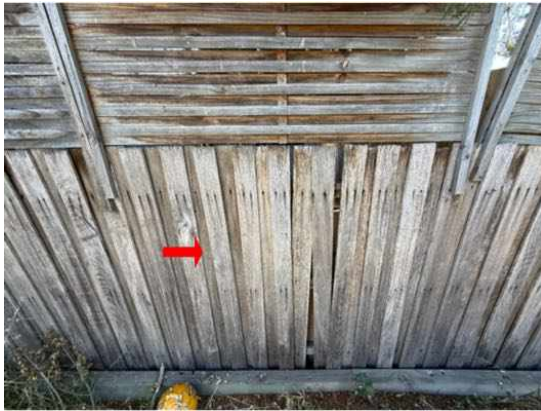
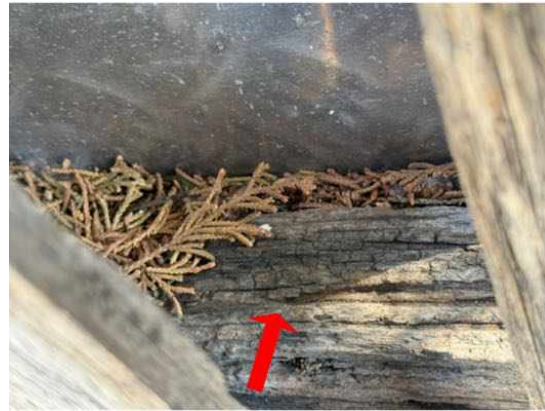
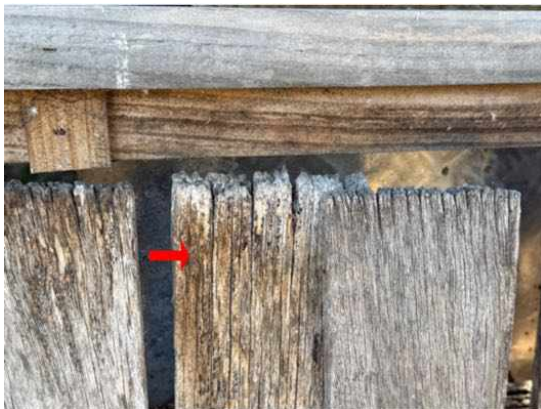
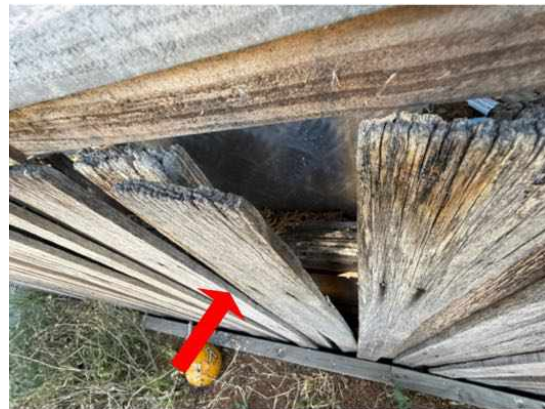
Finding 7.01

Building: Main Building
 Location: Fencing
 Finding: Wood rot & deteriorated - Rear left Fence
 Information: The rear left fence shows evidence of wood rot and deterioration.

Wood rot, also known as Fungal Decay, occurs when timbers and other cellulose building materials are exposed to damp conditions on an ongoing basis. This condition is common for fences of this age.

Wood rot is often associated with general damp problems and is evidenced by a 'musty' smell or mould and mildew occurring on surfaces. When left unmanaged, damp conditions lead to further problems such as the attraction of Subterranean termites as moist timbers are a food source, as well as the further decay of timber elements in this area.

Early intervention and regular maintenance, particularly of exterior timbers, will prolong the useful life of these building elements.

A qualified Fencing contractor should be appointed urgently, to provide quotes to replace the rear fencing and assess the street side fencing for remedial repair or replacement.

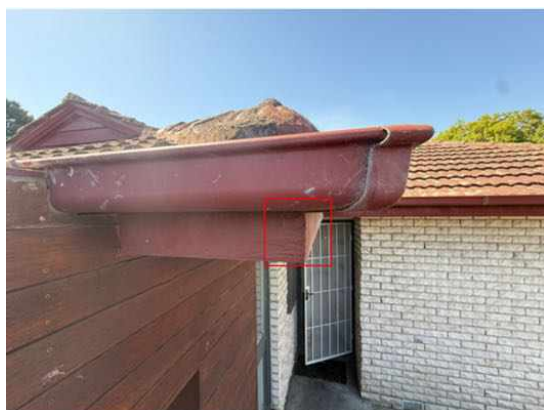
Finding 7.02

Building:	Main Building
Location:	Roof Exterior
Finding:	Fascias - Wood rot
Information:	Wood rot was found to be affecting fascias and barges mostly at the front of the

property, but there was also some seen in other areas also, evidenced by the presence of mould on the surface in some areas. Wood rot, also known as Fungal Decay, occurs when timbers and other cellulose building materials are exposed to damp conditions on an ongoing basis.

It is likely that this wood rot has developed as a result of faults in the roof plumbing, creating excessive moisture in these areas. Frequent exposure to rain and other weather conditions also make fascias and bargeboards susceptible to accelerated deterioration.

Early intervention and regular maintenance will prolong the useful life of these building elements. Prior to any works being performed, the cause of the moisture that has created the visible wood rot should be identified and addressed in a suitable manner.

It is advised that a roof plumber be appointed to inspect all roof plumbing and subsequently identify the cause of the wood rot. Replacement of affected fascias and bargeboards may then be a necessary step in protecting surrounding building elements from such deterioration.

A qualified plumber may be appointed to assess the cause of excessive moisture and to provide advice on any remedial works as required. A qualified carpenter or registered builder may also be required to replace affected building materials, as soon as possible.

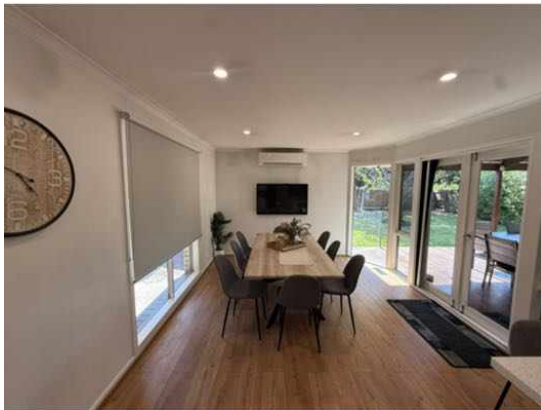
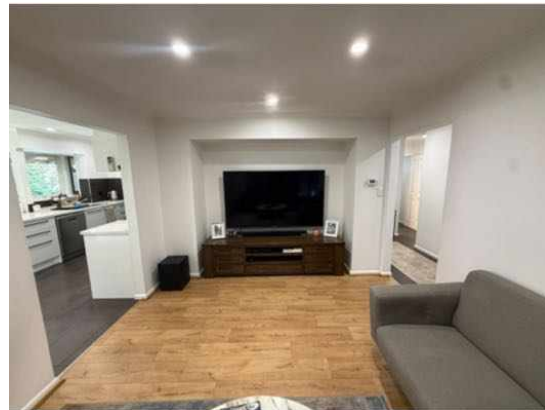
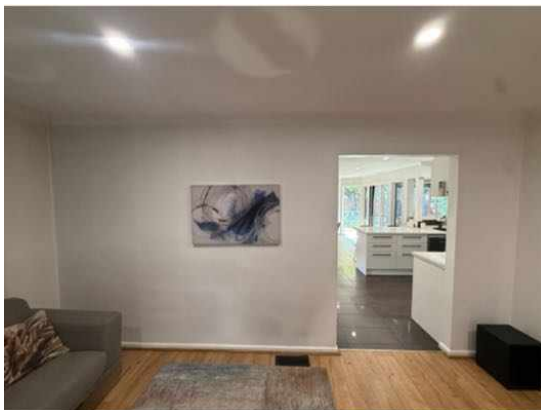
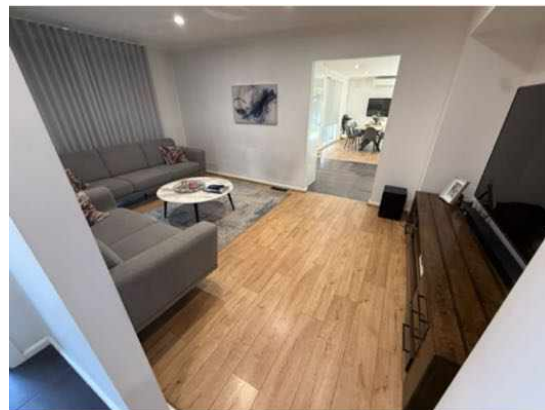
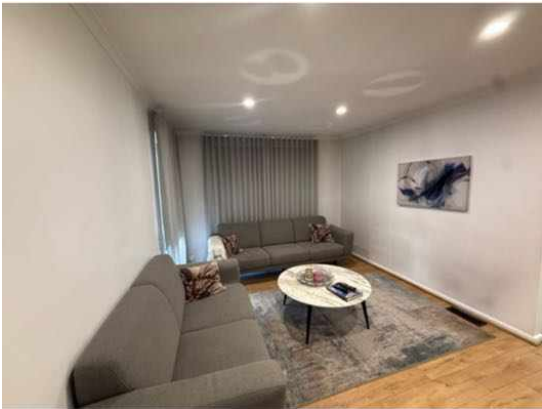
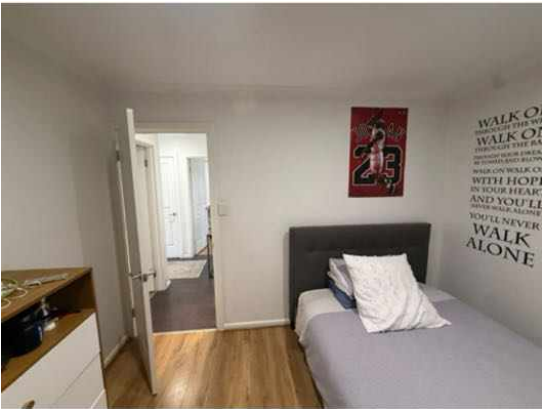
Building: Main Building
Location: All Areas
Finding: Additional Photos - Obstructions and Limitations
Information: These photographs are an indication of the obstructions and limitations which impeded full inspection of the property at the time of inspection. These obstructions can hide an array of defects and should be removed to allow full inspection to be carried out. A re-inspection is recommended once the areas are made accessible.
