Building and Timber Pest Inspection Report

Inspection Date: Fri, 6 Feb 2026

Property Address: 6/33 Burke Rd, Malvern East VIC 3145,
Australia

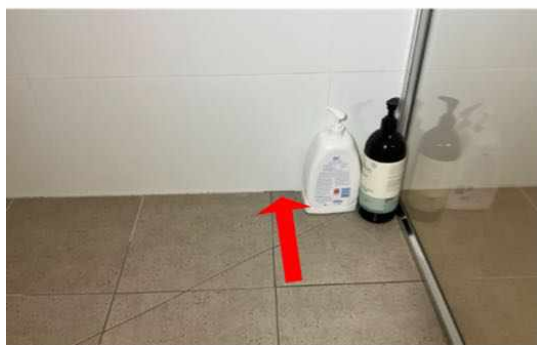
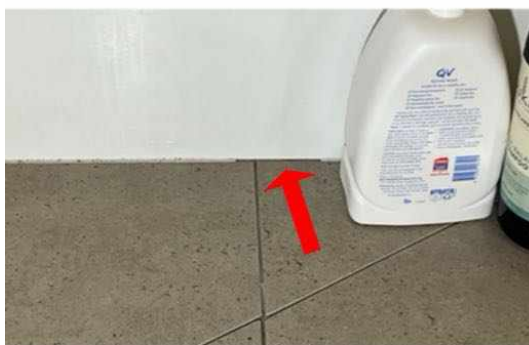
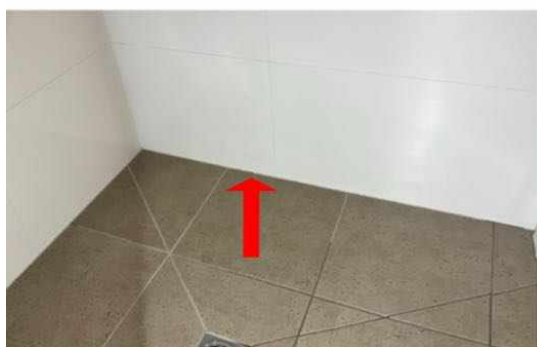
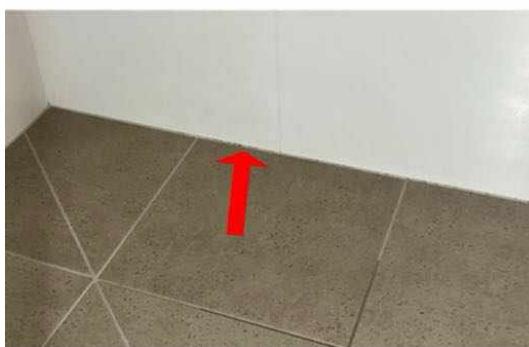
Finding: Grout or sealant - Missing or degraded within the bathroom area

Information: It was noted on inspection that grout or sealant is degraded to areas within the bathroom.

Different materials move at different rates, generally causing cracking to grout at this point. Build up of moisture in the bathroom can also cause grout and sealants to degrade and become mouldy.

Any damaged or degraded materials should be scraped out and flexible and mould resistant materials should be applied to affected areas to prevent any subsequent water damage that may occur. Regular maintenance and replacement of damaged or missing grout/ sealant is highly recommended to the wet areas, as this is a regular wear and tear defect. Both grout and sealant in areas that come into regular contact with water should be maintained for the long term care of your property.

A bathroom specialist or tiling contractor should be appointed to complete these works as soon as possible.

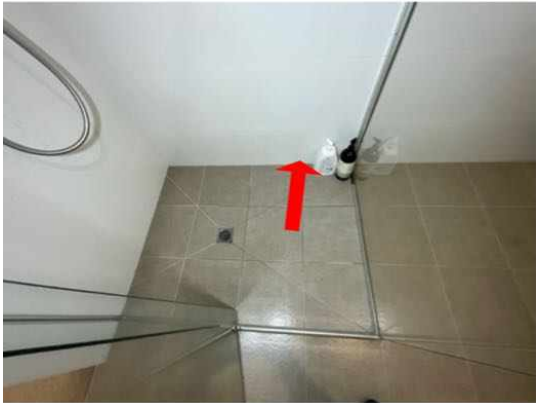
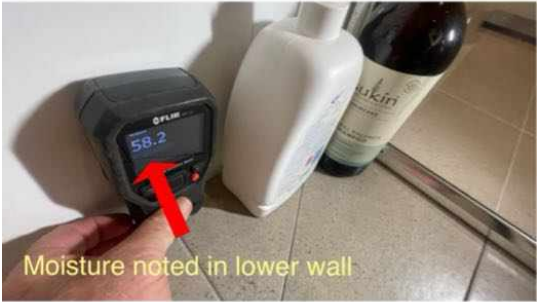
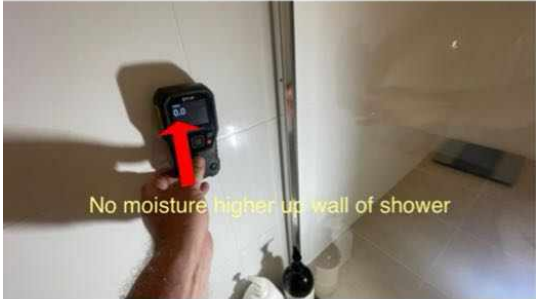
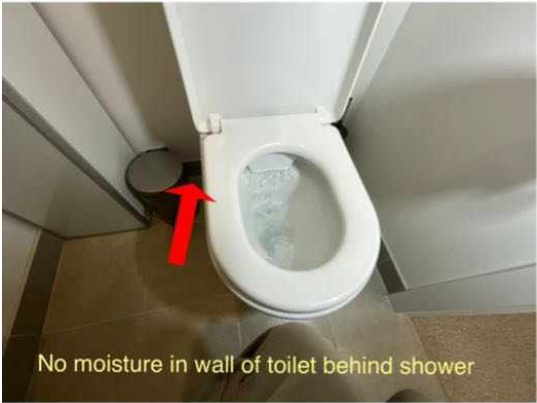
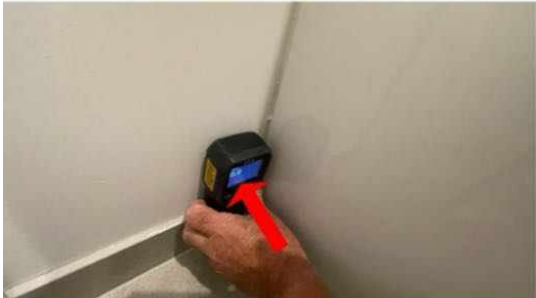
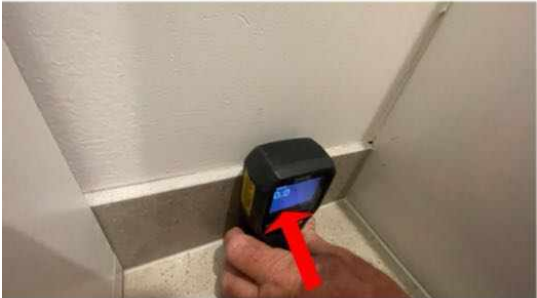
Finding 3.02

Building:	
Location:	Bathroom
Finding:	Shower damp - Monitor
Information:	Damp is evident to the lower 400mm of wall to the shower alcove. There was no moisture noted higher up the wall nor in the wall of the wardrobe in the bedroom directly behind the shower area.

This defect is quite common, and is suspected to have been caused by moisture permeating or leaching through the grouting and perhaps gaps in the sealant.

Monitoring the area is advised and if any visual signs of excessive moisture appear (peeling paint, mould) then consultation with a qualified plumber or bathroom specialist would be advised to identify the cause of damp and to perform remedial works as required.

Always ensure that sealant and grout is in good condition to prevent any moisture issues occurring in the future.

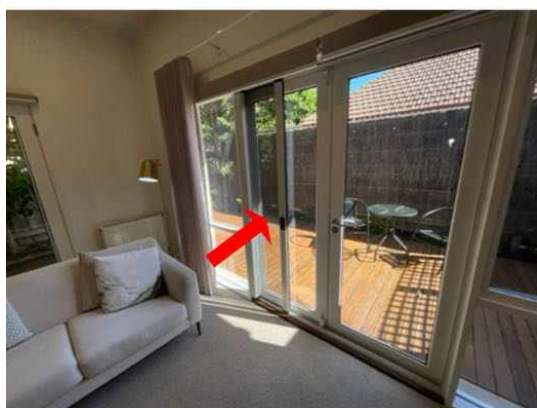
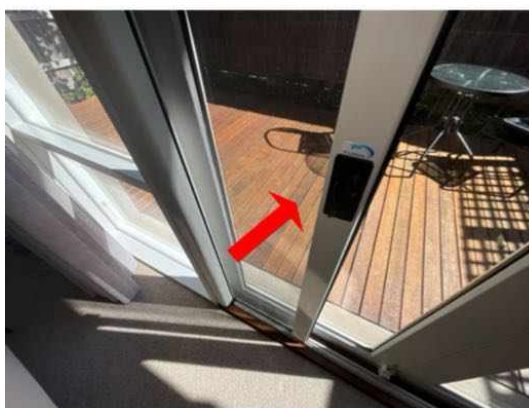
Finding 3.03

Location: Living Room
 Finding: Door - Stiff to slide
 Information: The door in this area was stiff and difficult to slide along the associated tracks at the time of the inspection. The door also appeared to be slightly loose within the frame.

Restricted function of the affected door may pose as a potential safety hazard if required for emergency egress from the building.

Generally, factors such as age of the building element and a lack of maintenance are the usual causes for this type of defect.

Cleaning of the tracks may improve the operation of the door. Replacement of door hardware or tracks may be required should the cleaning not be effective.

A door specialist or competent handyman may be engaged to perform this task.

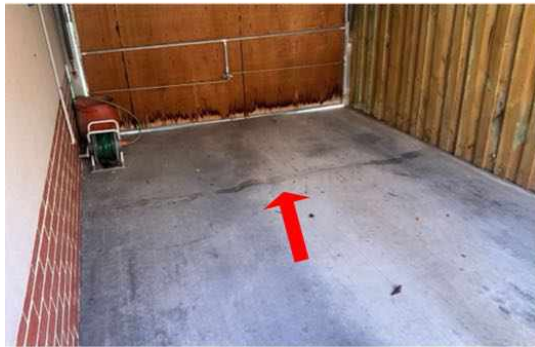
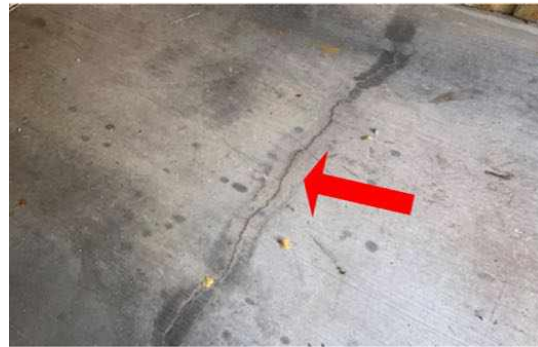
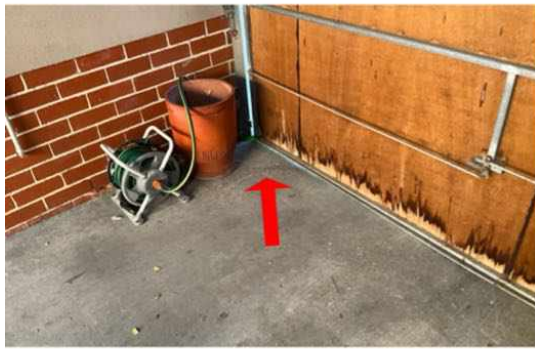
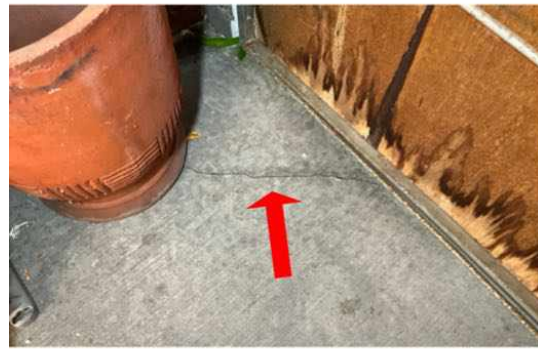
Finding 3.04

Building:
 Location: Garage
 Finding: Cracking - Concrete flooring within garage - fine
 Information: Fine cracks were identified in the concrete flooring of the garage . Although fine cracks may be quite noticeable, they are only considered to be an appearance defect, and usually do not indicate any structural damage.

Generally the cause of a fine cracks in existing concrete paving such as driveways, garages and pathways is indicative of the expansion and contraction of the concrete. Such causes are generally due to environmental factors, such as moisture levels, weather conditions, root systems of nearby trees or the soil types on which they are laid.

Fine cracks may also be due to poor original installation of the concrete. Factors such as poor compaction of the sub surface and/or inadequate reinforcing of the slab may create cracking and other secondary defects.

Monitoring of all cracking should be conducted frequently. Always contact a building inspector should cracks widen, lengthen, or become more numerous.

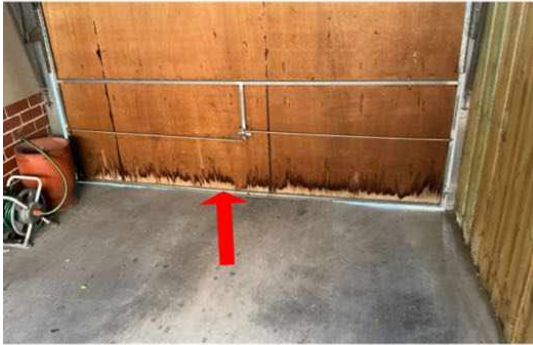
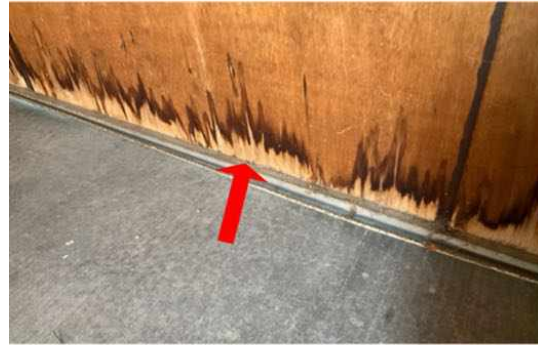
Finding 3.05

Inside of garage door showing signs of moisture staining to the base

At the time of inspection the inside of the garage door showed evidence of moisture staining at the base.

Doors should be sealed on all faces including top and bottom to prevent moisture seeping into the door structure and potentially causing secondary damage.

A suitably qualified handyman or painter may be engaged to inspect the door and re seal the door.

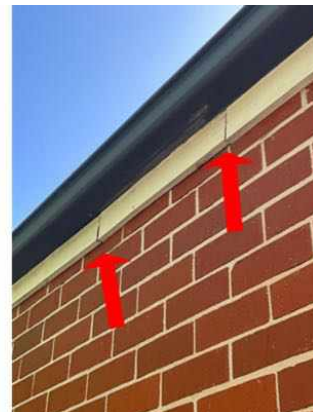
Finding 3.06

Information: The fascia boards around the outside of the property underneath the guttering had some gaps within it where the boards join. This can allow moisture to get into the ends of the boards and cause rotting to the timbers.

It is advised that a qualified carpenter or competent handyman be engaged to inspect the fascia boards and seal the gaps where relevant. Failure to act on this defect may result in further deterioration of the property.

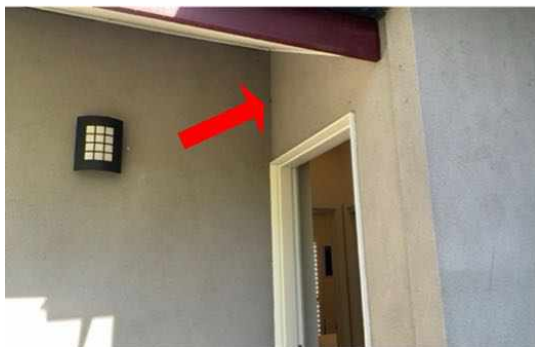
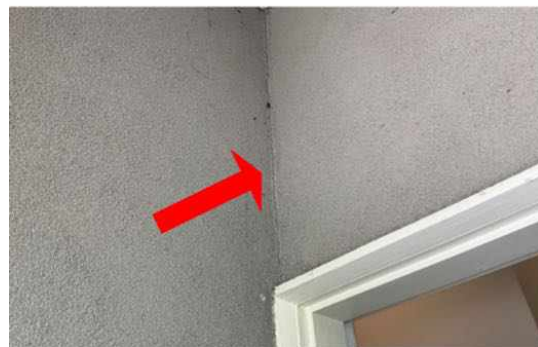
Finding 3.07

Finding: Rendered wall - minor cracking

Information: Minor cracking to the rendered wall was identified at the time of inspection.

This type of cracking is often consistent with general movement of the foundations of the property and is not considered a major structural defect.

Consultation with a suitably qualified renderer should be sought to determine costs involved with any repairs necessary.

Should cracks increase in size or number, speak with your building inspector for further advice.

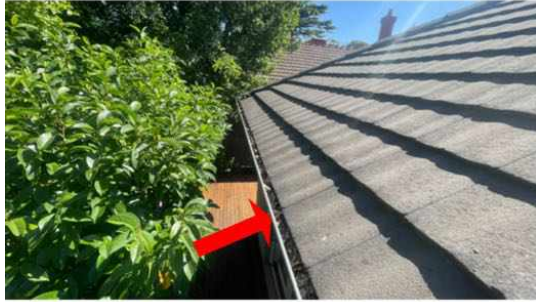
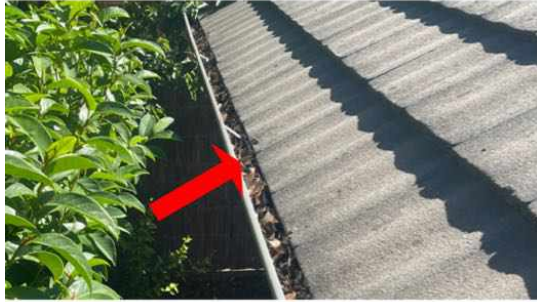
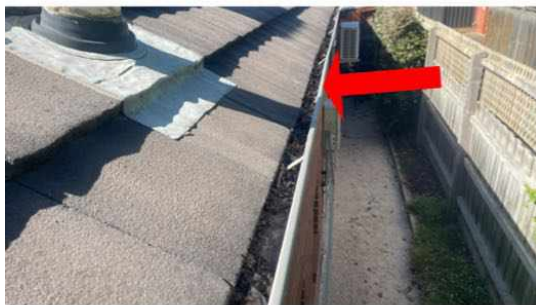
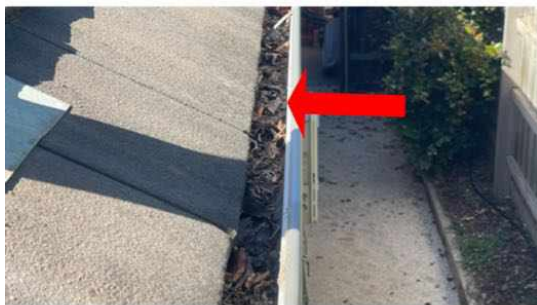
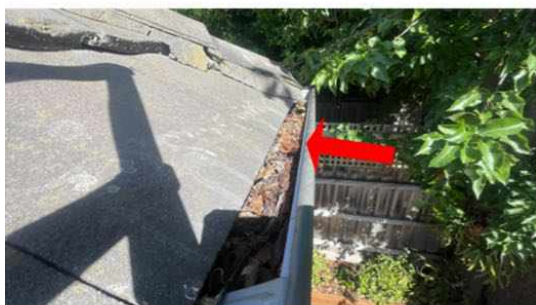
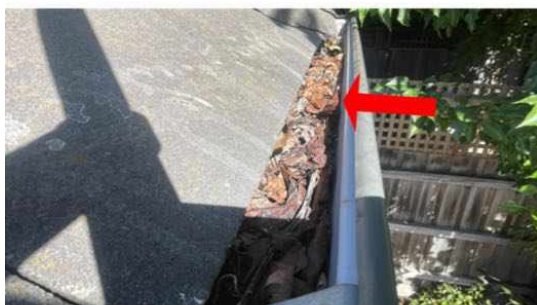
moisture will not only cause rust and decay of the associated building materials, but can also provide conditions that are conducive to termite and timber pest activity. Blockages in gutters should therefore be removed immediately to ensure dry conditions are maintained.

It is highly advised that blocked gutters be cleared by the homeowner or a general handyperson as a matter of urgency. Failure to do so may result in moisture entering the property causing more significant damage.

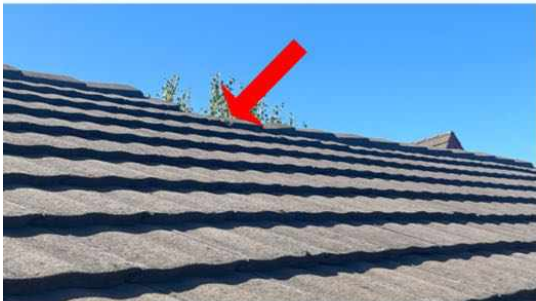
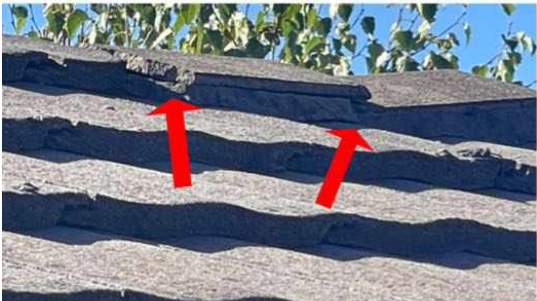
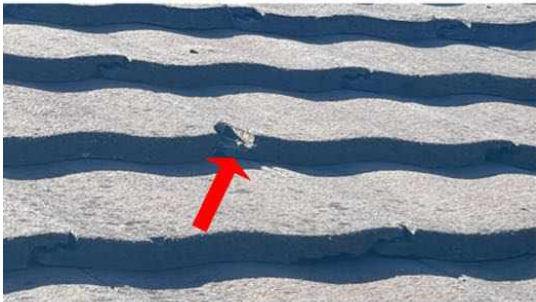
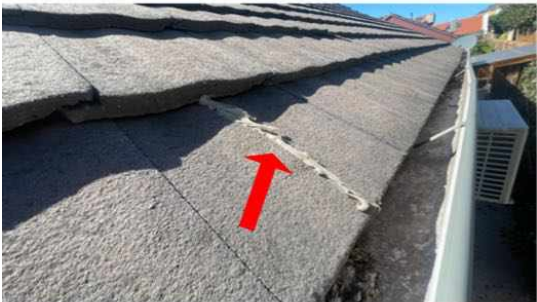
Finding 3.09

Location: Roof Exterior
Finding: Weathered Roof tiles - fair condition but with some minor maintenance required
Information: Upon inspection of the exterior roofing, the majority of roof tiles were considered to be in a fair condition. While weathering of the tiles is consistent with the age of the property, some minor maintenance works are required.

Cracking of the mortar around the ridge and hip capping was noted. Tiles had shifted from their original positions allowing gaps underneath the tiles.

Repairs to the roof is required.

Consultation with a roofing contractor is advised to gain advice on remedial works that will be required . Where left unmanaged, damage can lead to a number of secondary defects, including water leaks and weather exposure to internal roofing structures.

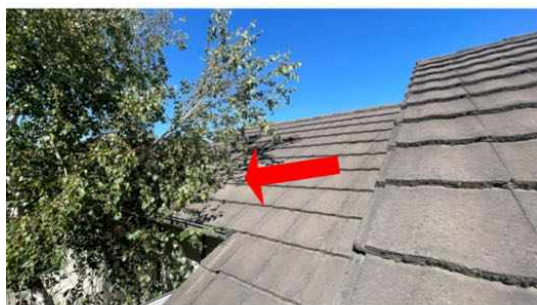
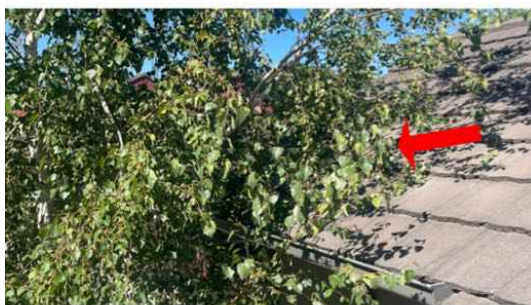
Finding 3.10

Information: At the time of inspection, it was noted the trees were overhanging the roof exterior . Overhanging trees often result in excessive amounts of leaf debris accumulating in gutters.

It is highly advised that all overhanging tree branches be removed as soon as possible to prevent any further damage. An arborist may be engaged to perform this task.

Gutters should then be cleaned out by a gutter cleaning specialist. Repair and/or replacement of sections of damaged guttering may also be required where the extent of the damage necessitates.. Consultation with a licensed roof plumber will be required where guttering has been damaged.

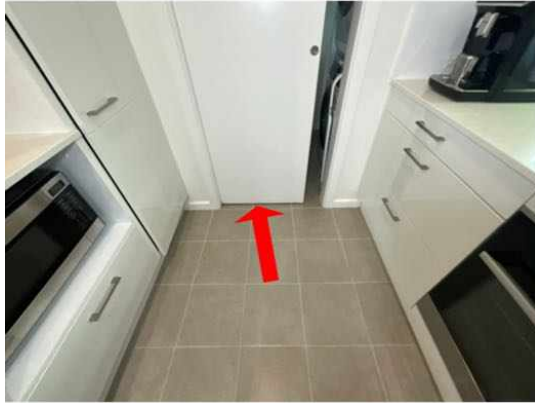
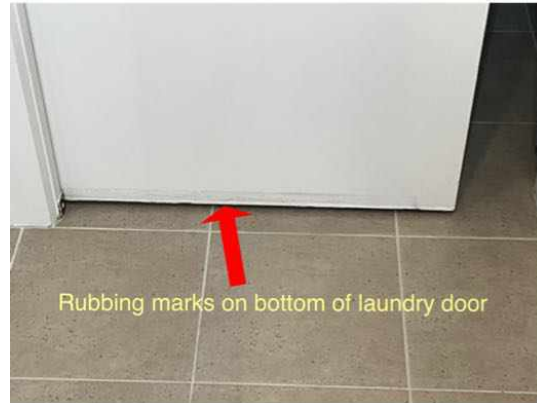
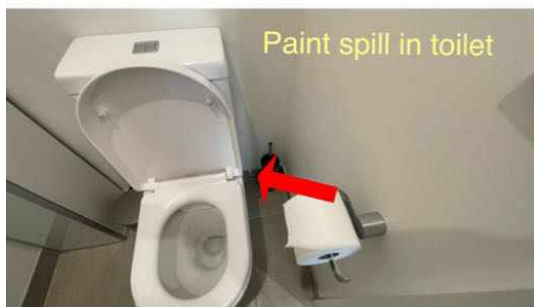
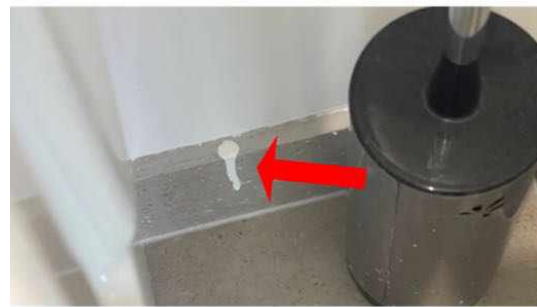
Finding 3.11

Building:
Location: All Areas
Finding: Additional Photos - minor defects
Information: Additional photos are provided for your general reference. Arrows have been included where necessary to highlight areas of importance.

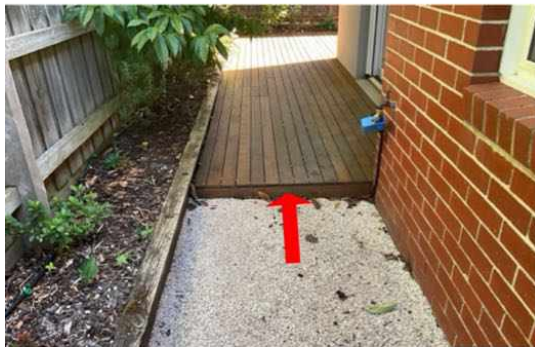
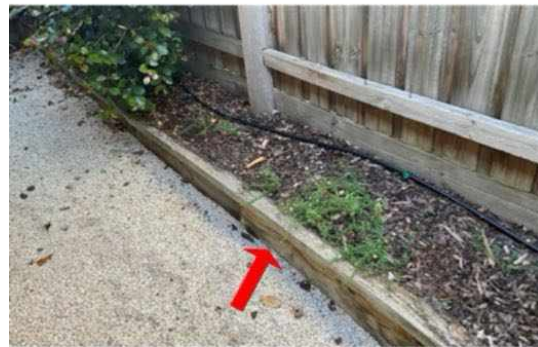
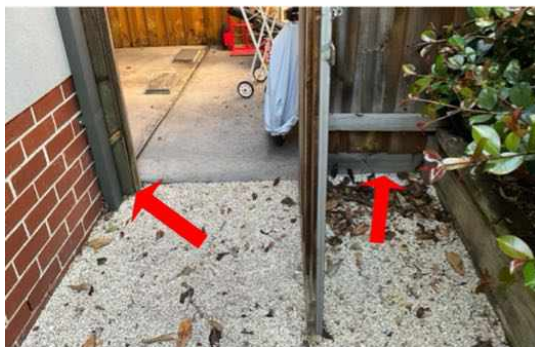
Information: Where timber elements are in direct contact with the ground and consequently moisture or dampness, they become conducive to termite activity. Whether timber is used as a building element, part of a fencing structure or stored as an unused item, they can provide an environment that is attractive to termite infestation.

When met with excessive moisture, timber begins to decay and develop wood rot. Any timbers that are in direct contact with external grounds especially if left untreated or non-durable also provide ingress for subterranean termites into that particular element.

Where possible, the removal of any such materials that may be conducive to termite activity should be carried out as soon as possible to minimise the risk of termite attack. Where not possible or practical, regular monitoring of timber elements is recommended. Replacement of any damaged materials should be carried out where necessary.

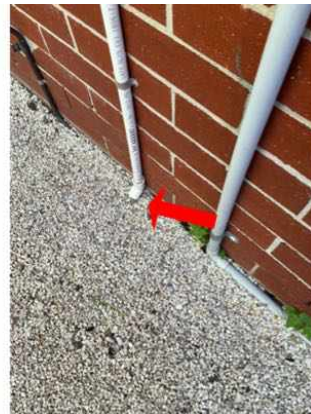
These damp conditions can lead to secondary defects such as rot, rust or corrosion of associated building elements, the formation of fungal decay, or even the creation of potential slip hazards. When coupled with poor site drainage, pooling of water may also attract termite activity to this area.

It is highly recommended that a qualified plumber be appointed to install adequate drainage to the overflow or at least redirect it away from the edge of the house. These works will ensure that the area remains dry and free of any secondary defects.

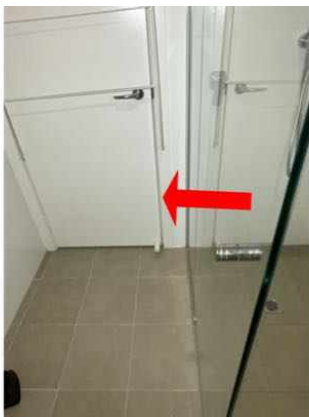
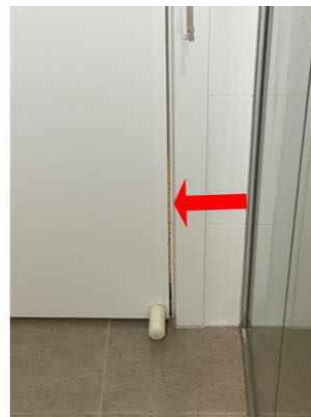
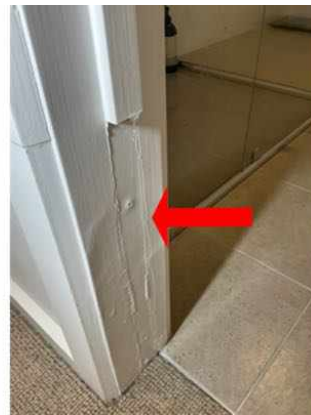
Information: At the time of inspection, it was noted that the bathroom door frame had a gap on the side at the base when the door was closed. It is unclear as to why this is present.

Whilst the door opened and closed as intended , the homeowner may wish to attend to the frame to ensure it seals correctly.
