Building and Timber Pest Inspection Report

Inspection Date: Thu, 12 Mar 2026

Property Address: 29 Warringa St, Salisbury Plain SA 5109, Australia

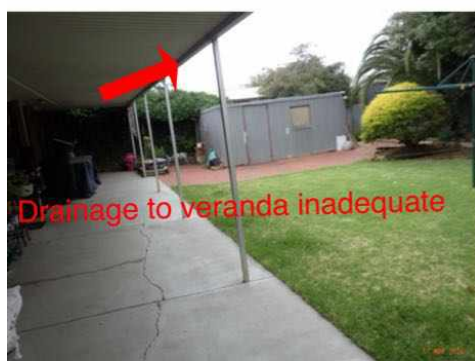
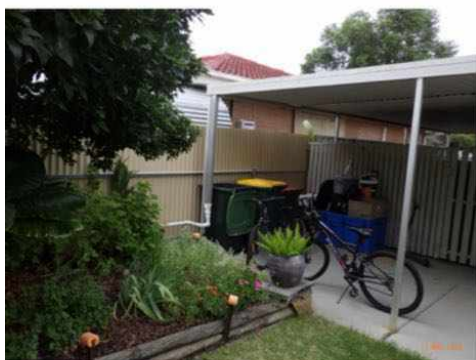
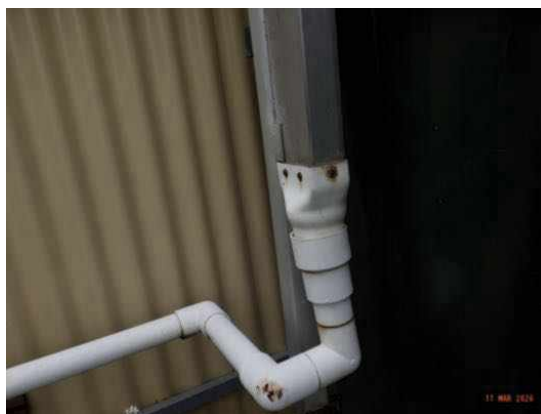
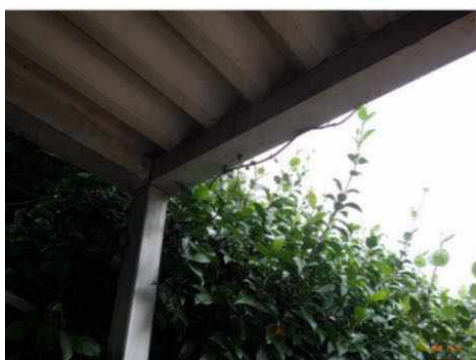
Building: Building 1
 Location: Yard - Back and side
 Finding: Stormwater run off- Inadequate
 Information: The stormwater run-off to the veranda, right side and rear was found to be inadequate at the time of inspection, creating potential for subsequent water damage to associated building elements.

It is important that water does not lie against the base of walls; surrounding paths and ground levels should be sloped to drain water away from walls. Downpipes should not discharge stormwater onto lower walls or plinths. Stormwater should be carried away by large, regularly cleaned drains. Ground levels may need to be lowered to expose a buried DPC.

Where drainage is inadequate, installation of additional drainage may be required. A qualified builder should be appointed to further inspect the property and perform any remedial works as necessary. Water damage and secondary defects are likely to occur if left unmanaged.

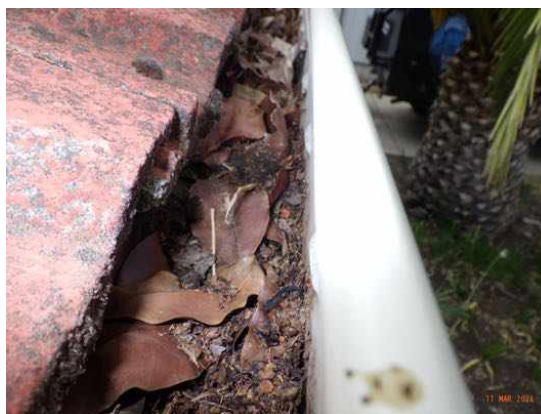
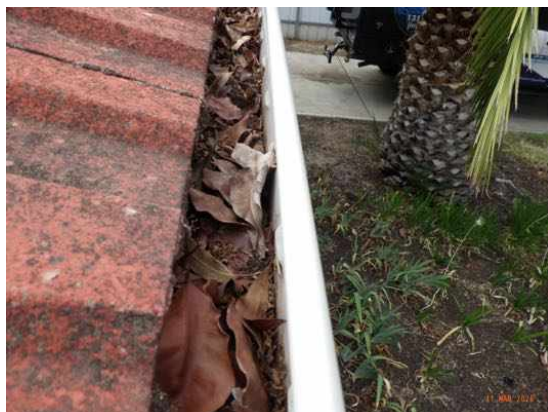
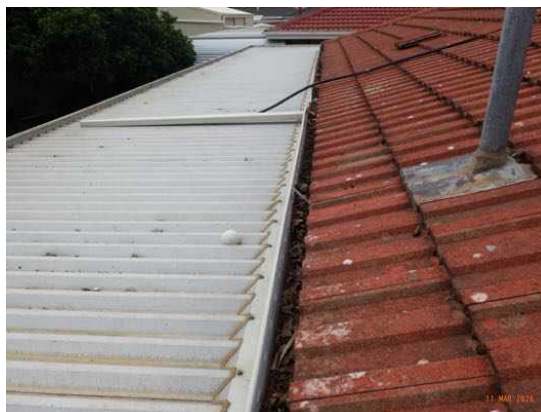
Finding 2.02

Building:	Building 1
Location:	Roof Exterior
Finding:	Gutters - Blocked
Information:	Roof plumbing structures, such as guttering and downpipes, should be free of all debris to prevent blockages. Blockages of the guttering and downpipes will lead to pooling and accumulated water overflows, which is likely to subsequently flood eaves and exterior walls.

Blocked gutters are likely to lead to high levels of moisture in the affected areas. Such moisture will not only cause rust and decay of the associated building materials, but can also provide conditions that are conducive to termite and timber pest activity. Blockages in gutters should therefore be removed immediately to ensure dry conditions are maintained.

Consult a Licensed Plumber for further specific advice on remedial works that may be required. In the interim, it is highly advised that blocked gutters be removed by the homeowner or a general handyperson as a matter of urgency.

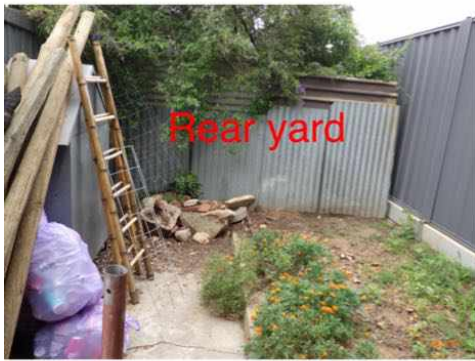
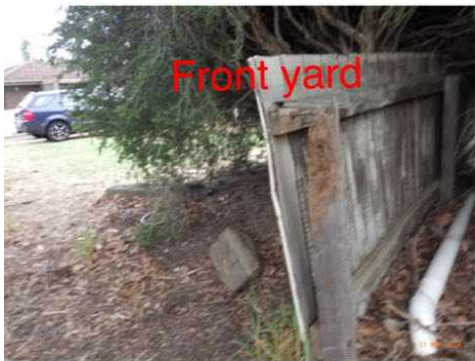
Finding 3.01

Building:	Building 1
Location:	Yard - Side
Finding:	Fencing - Deteriorated
Information:	It was noted at the time of inspection that sections of the fencing throughout the property have deteriorated. Typically fencing deteriorates due to age and or wear, rot and or rust which is generally expected for a structure of this age, due to prolonged exposure to weather conditions. Sometimes inadequate installation or maintenance can be to blame.

If left unattended, it is likely that further damage will occur. It is suspected that repair of several elements of the fencing may be required however replacement may be a consideration of the client also.

A licensed fencing contractor should be appointed to provide further advice and perform rectification works as necessary.

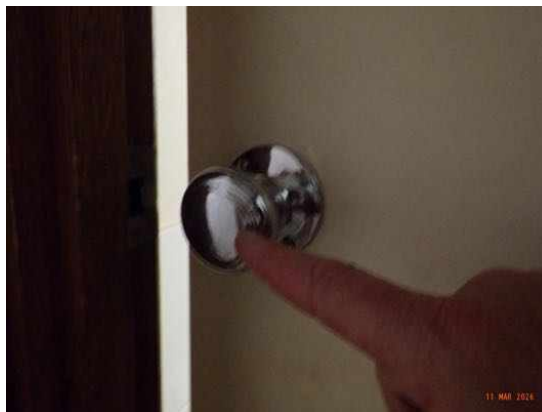
Finding 3.02

Building:	Building 1
Location:	All Internal Areas
Finding:	Several Doors - Striker plate misaligned
Information:	The striker plate to several doors appears to have become misaligned and has consequently resulted in the door's operation being compromised.

This is a common defect and is expected in a property of this age, whether being due to substandard installation or general deterioration of the door hardware and or seasonal changes. As movement has been noted to the property this is a likely contributing factor to the doors not striking and rubbing on floor coverings.

Readjustment of the striker plates is recommended at client discretion. Works such as these can be completed by a general handyman or qualified carpenter.

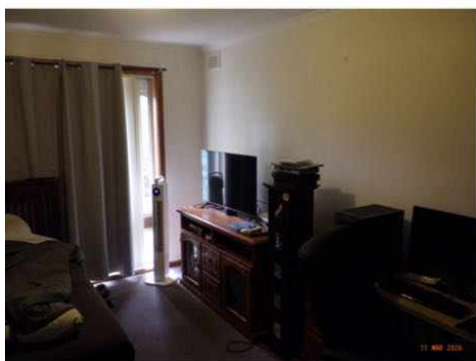
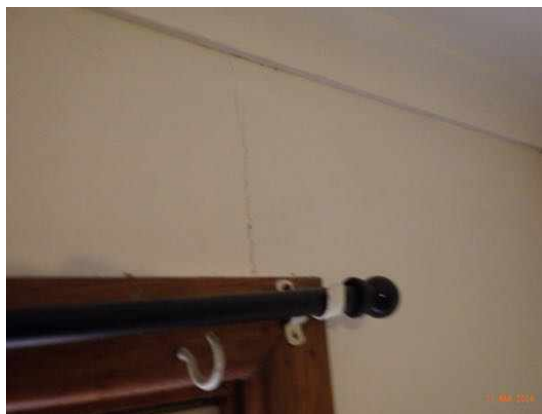
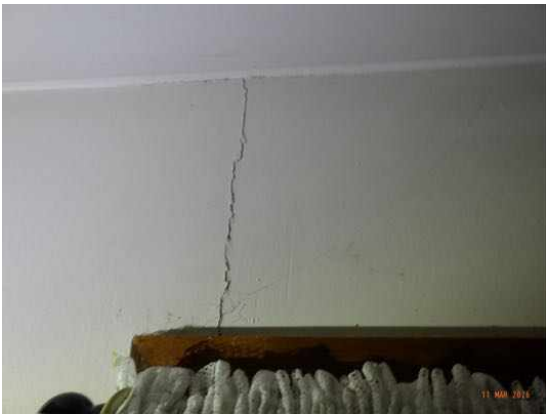
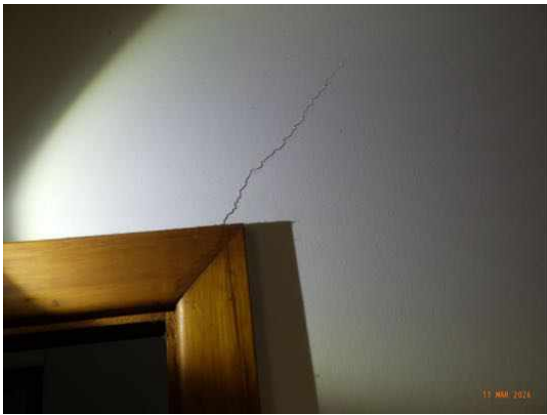
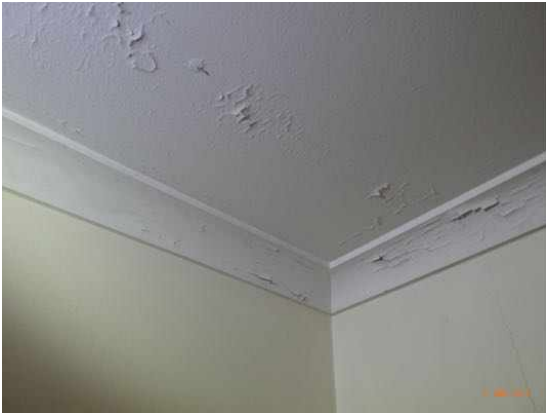
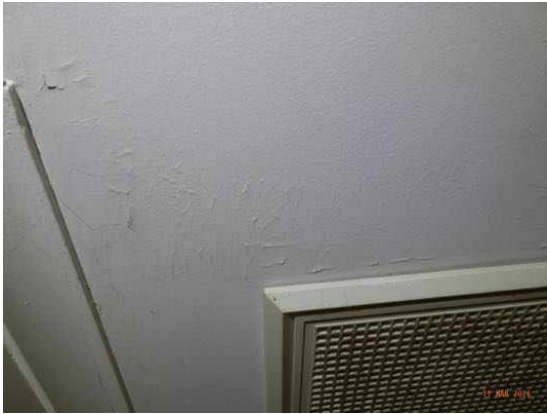
Finding 3.03

Building:	Building 1
Location:	All Internal Areas
Finding:	Cracking - Damage Category 1 - Fine (up to 1mm)
Information:	There were fine cracks and minor paint deterioration evident to the walls and ceilings throughout the dwelling at the time of inspection.

Although fine cracks are quite noticeable, they are often only considered to be an appearance defect, and usually do not indicate any structural damage. Generally, the cause of a fine crack is indicative of a separation between building materials and finishes (e.g. paint, plaster, etc.) along joints.

Cracking of this nature can generally be repaired with minor sanding, filling and/or repainting. Such works should be performed by a qualified painter or a general handyman.

Monitoring of all cracking should be conducted frequently. Always contact a building inspector should cracks widen, lengthen, or become more numerous.

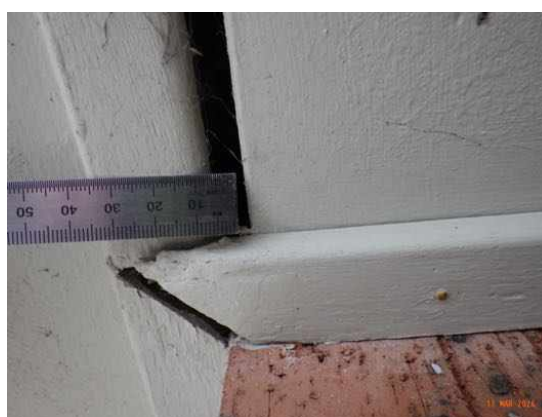
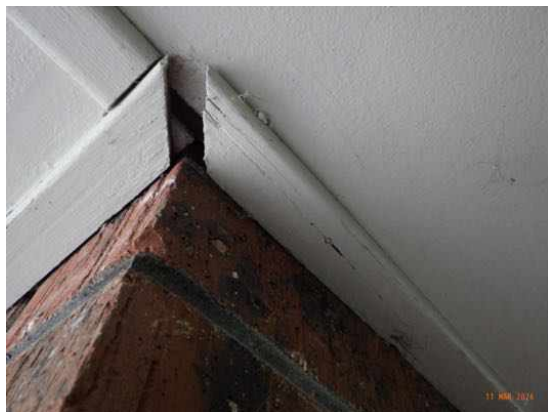
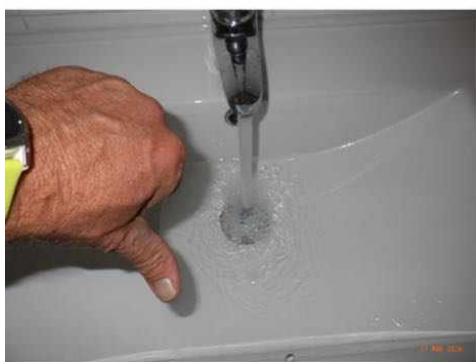
Finding 3.04

Building:	Building 1
Location:	All Areas
Finding:	Minor defects present
Information:	Minor defects were evident throughout the dwelling at the time of inspection, which are consistent with normal wear and tear and considered appropriate for a property of this age.

These defects are typical of ongoing material ageing, settlement, and general use over time, and include, but are not limited to:

- Minor gapping to eaves linings
- Drain plugs jammed to vanity unit

While these defects are not considered structurally significant at present, they should be addressed as part of routine and ongoing property maintenance to prevent further deterioration. Repairs and maintenance works should be carried out by appropriately licensed and qualified tradespeople to ensure the continued serviceability and longevity of the dwelling.

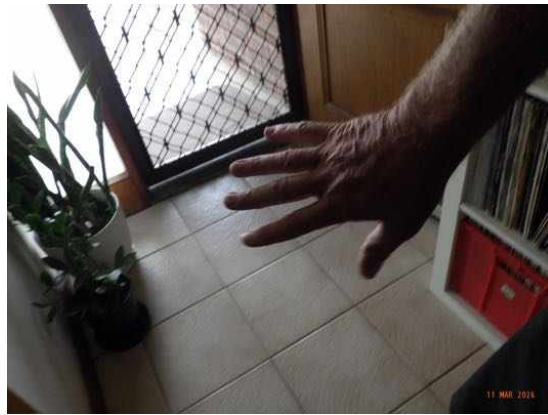
Finding 3.05

Building:	Building 1
Location:	Entry
Finding:	Tiles - Drummy
Information:	Drummy tiles were identified to the entry tiles at the time of inspection.

The term 'drummy' refers to tiles that have become detached from their fixing, despite otherwise being in relatively good condition, or sometimes they get laid onto dust during the building process and never really form a good bond. Such defects are generally caused by physical or moisture damage to the area or poor workmanship during the building process.

As no damage to tiles or grout was evident at the time of inspection further monitoring is recommended and should deterioration to the tiles become evident a licensed tiling contractor should be appointed to required repairs at the discretion of the client.

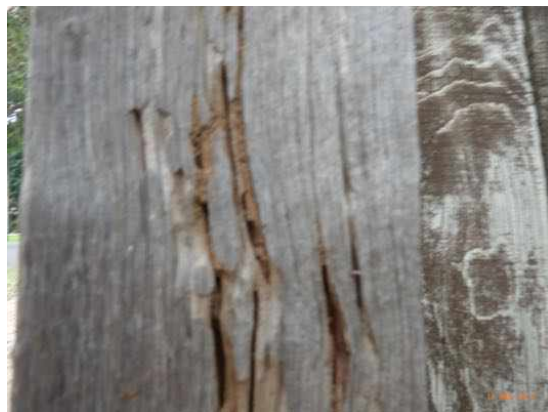
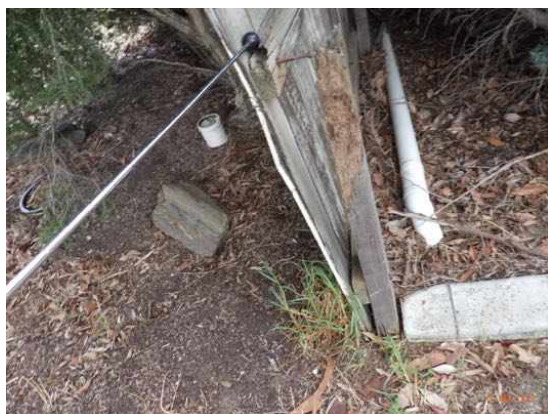
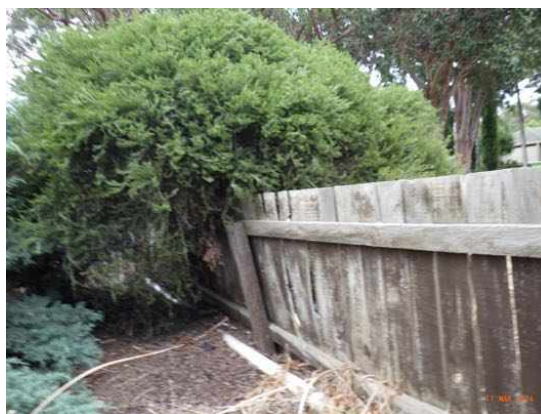
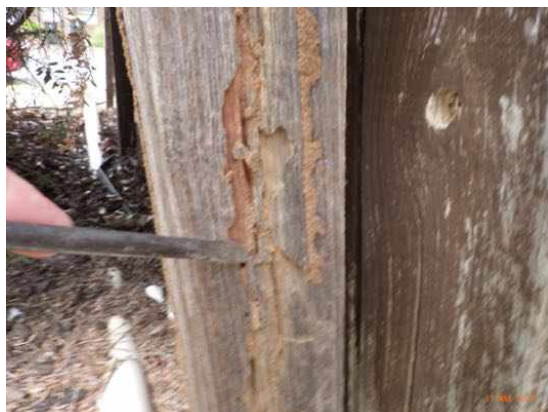
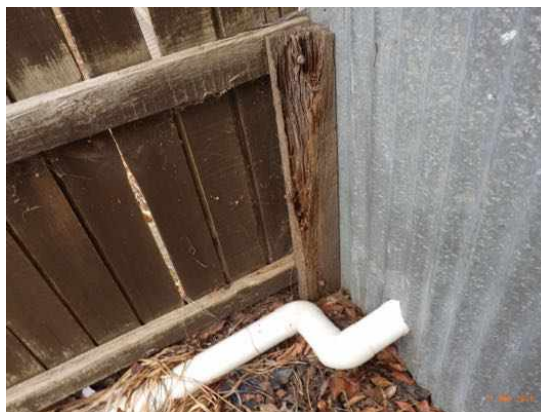
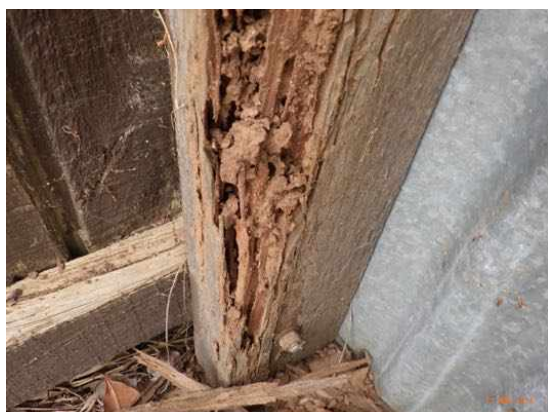
Building:	Building 1
Location:	Yard
Finding:	Evidence of termite damage - minor
Information:	Despite no live termite or timber pest activity being indicated, previous termite damage was found to have affected this area. This damage is considered to be inactive and is minor in nature.

It is advised that the area be visually inspected frequently to ensure that the condition of affected building materials does not worsen. At the time of inspection, damage is not structural and is only considered to be superficial.

A building contractor may be appointed to provide a further invasive inspection if further damage is evident.

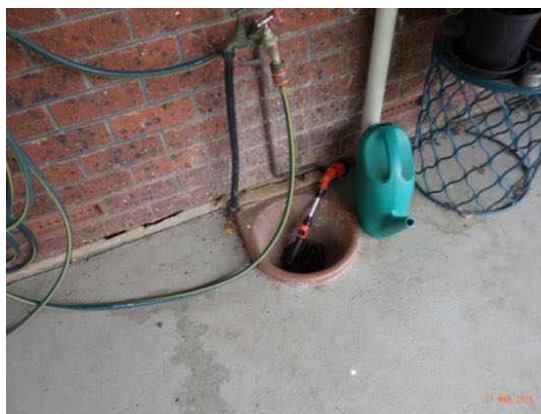
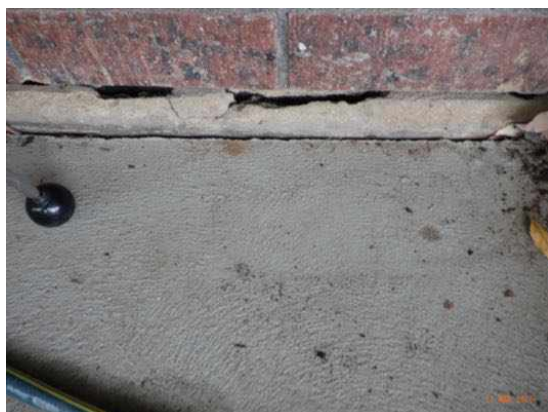
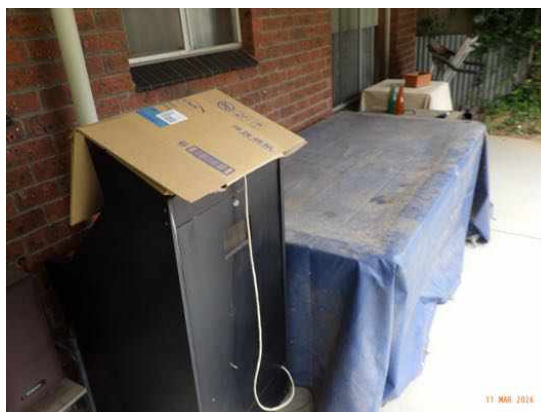
Finding 6.01

If the slab edge is not properly exposed there is a high risk of termite attack. The risk is lessened with steel frame construction however still present.

Where the slab edge cannot be properly inspected, it is highly recommended that termite or timber pest inspections be carried out every 12 months to aid protection of the property against infestation.

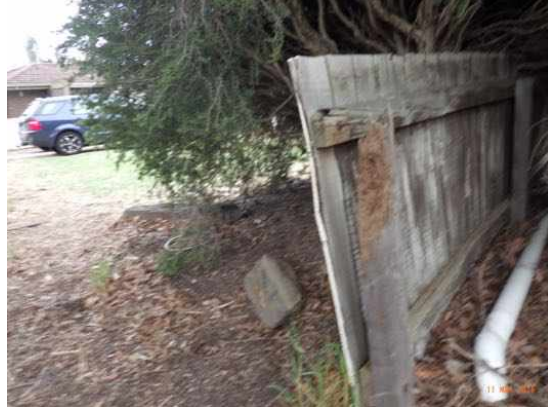
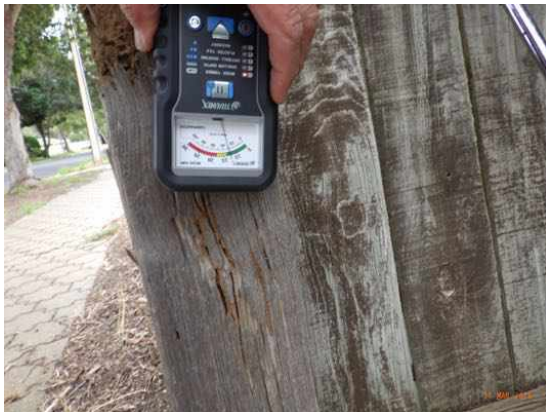
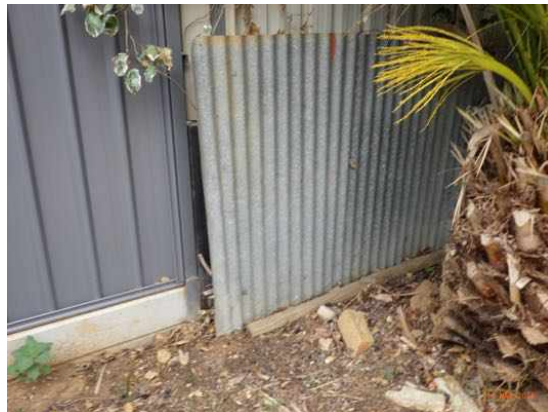
Finding 6.02

Building:	Building 1
Location:	All External Areas
Finding:	Untreated or non-durable timbers in a hazardous environment
Information:	To reduce the risk of timber pest attack it is essential that timber used in a hazardous environment (e.g. in direct contact with the ground or frequently exposed to damp conditions) is of sufficient durability and/or is adequately preservative treated. Additionally any timber lying around or timber stumps should be removed.

Untreated timbers in direct contact with the ground are likely to develop severe wood rot and/or fungal decay if left unattended creating attraction for subterranean termites to infest the timbers from surrounding areas.

If untreated or non-durable timbers are found to be in a hazardous environment it is highly advised that replacement of these building elements be performed as soon as possible to aid the protection of the property against termite / timber pest attack. Failing this close monitoring is recommended in an attempt to identify termite infestation at an early stage.

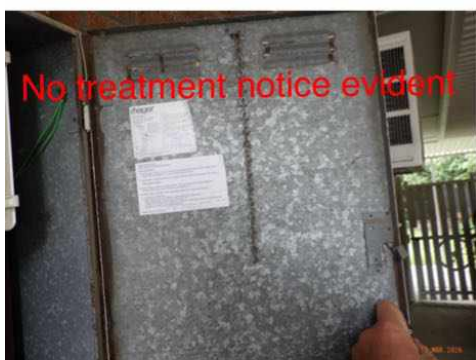
Finding 6.03

Building:	Building 1
Location:	All Areas
Finding:	Termite Management System - no evidence of a chemical installation steel frame
Information:	The application of a post-construction chemical termite barrier is highly recommended

for all properties, particularly if live termite activity has been found on the site previously. Such barriers are highly effective in preventing termite attack on any timber building elements throughout the property.

A durable notice should be placed in the switchboard unit to indicate current termite barriers. At the time of inspection, it appeared as though no termite management system has been installed, with no evidence to suggest preventative works taking place.

As the dwelling is steel frame, the risk of termite infestation is greatly reduced however still present.

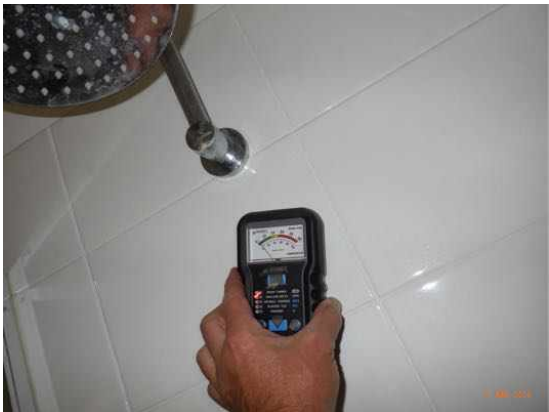
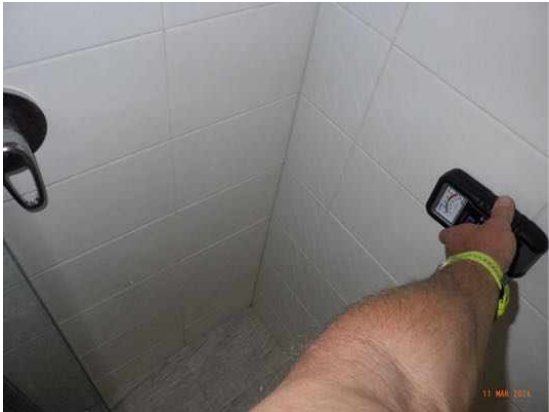
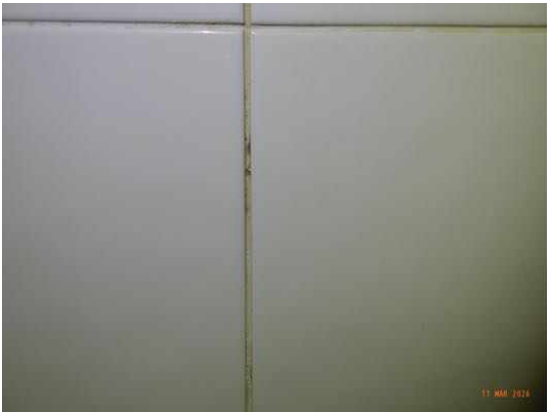
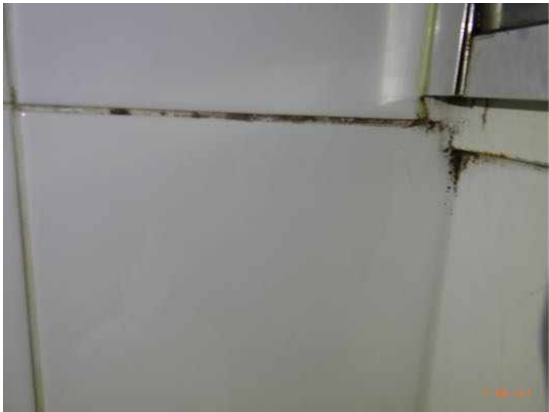
This defect is quite common, and is suspected to have been caused by moisture permeating or leaching through the tiling, grouting and sealant in this area, which shows evidence of deterioration.

There were high moisture readings around the taps and on the adjacent wall however there were no high readings transferring to the other side of the wall.

Unmanaged damp in the shower recess is likely to facilitate the formation and development of mould and fungi growth, decaying associated building materials and compromising their structural integrity of associated elements.

Consultation with a bathroom sealant specialist is advised immediately to make repairs to the shower alcove.

Always ensure that sealant and grout is in good condition to prevent any moisture issues occurring in the future.

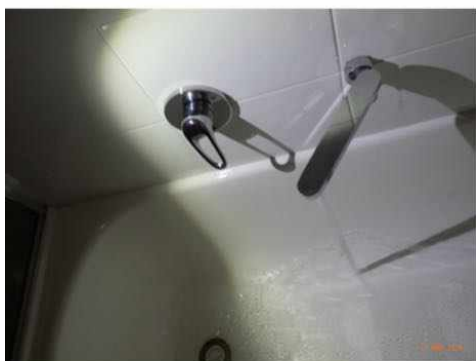
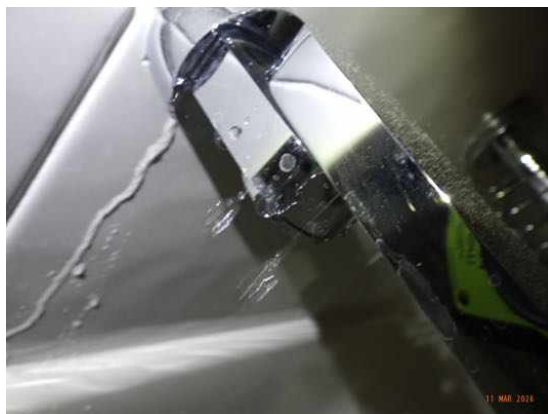
Finding 6.06

Building: Building 1
Location: Bathroom
Finding: Bath - Leaking
Information: At the time of inspection, the bath tap showed evidence of leaking during operation.

Although common, water leaks can be detrimental to surrounding building elements. Rust, corrosion, decay and water damage are all potential outcomes of a water leak that is left unattended, which are then likely to develop into more serious defects and may necessitate major repair works.

Additionally, water leaks may significantly increase the termite risk to the dwelling.

It is highly advised that water leak be addressed by a licensed plumber as soon as possible to prevent any damage.
