Building and Timber Pest Inspection Report

Inspection Date: Mon, 23 Mar 2026

Property Address: 12 Clarence Ave, Bli Bli QLD 4560, Australia

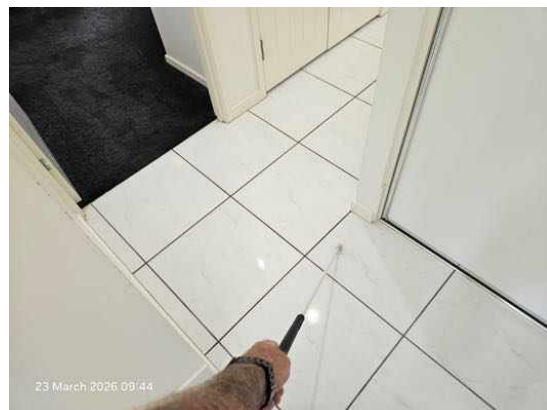
The term 'drummy' refers to tiles that have become detached from their fixing, despite otherwise being in relatively good condition. Such defects are generally caused by physical or moisture damage to the area. Drummy tiled areas may also be a direct result of poor workmanship during the construction process.

Tiled areas may swell and shrink with changes in air humidity if the area has sustained moisture damage. Any exposure to moisture is capable of causing tiled areas to become drummy and/or cracked over a prolonged period of time. Drummy tiled areas generally require removal and replacement of affected tiles.

Specialist trades are available for these types of services. A licensed builder may be required to undertake works if damage is extensive or if secondary building defects have resulted. Otherwise, it is advised that a tiling contractor or a tile adhesive injection service may be appointed to perform works as necessary.

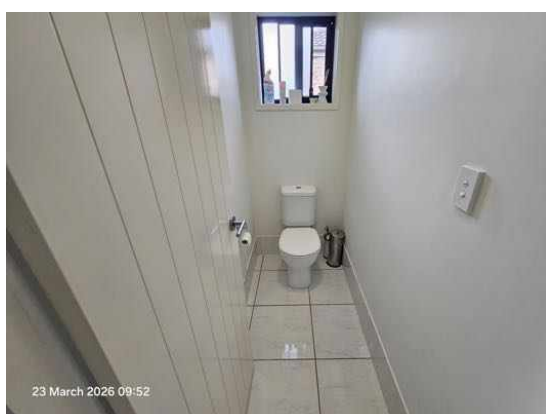
Building: Main Building
Location: Kitchen. Bath, WC
Finding: Water Hammer
Information: Evidence of water hammer has been noted to be present in the kitchen sink, the bath mixer, and in the toilet cistern cock. Water hammer is generally caused by factors that create high water pressure in the affected plumbing system usually evidenced by a banging or vibrating noise during operation of a tap or appliance. The toilet appears to react to pressure when the cistern fill ends.

Although water hammer is generally considered to be a minor defect, increased stress by hydraulic shock within the water pipes can cause weaknesses to develop and in worst cases for a pipe to burst. Water hammer can also accentuate the movement of poorly fixed water pipes which can lead to fatigue cracks or friction holes developing.

Securely fixing loose water pipes and installing shock absorbing devices designed to lessen the effect of water hammer, can be a solution for affected water reticulation systems.

A licensed plumber should be appointed to advise on any remedial works as necessary.

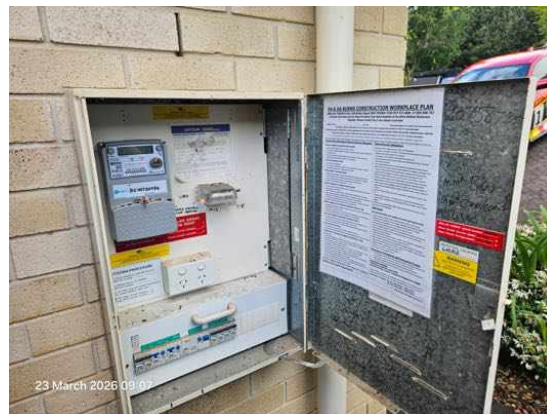
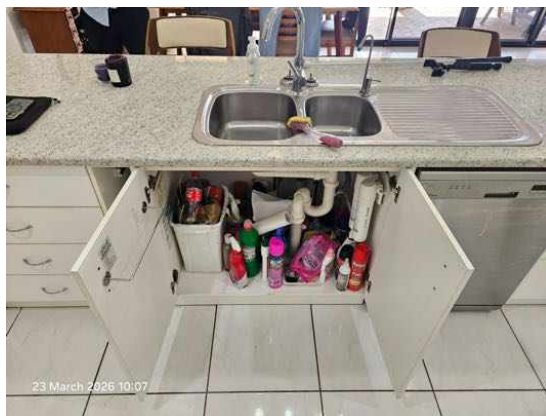
Building: Main Building
 Location: Meter box, kitchen cupboard
 Finding: Durable pest inspection notice - not assessable
 Information: On the day of inspection it was noted that the durable timber pest inspection / treatment notice was missing, not visible or out of date. These notices / stickers are to verify the timber pest inspection dates, the inspector, the currency and type of timber pest system / barrier in place or being used in and around the property.

Annual, or more regular, inspections are crucial in maintaining and managing the properties timber pest risk profile. By not having regular inspections of the property raises the properties risk of undetected defects and damage. Without regular inspection at intervals of not greater than annually the buildings risk profile will be categorised as high. Properties with trees within 50m and with gardens close to the building are at greater risk and will have a high risk profile.

It is recommended that a licensed timber pest controller be contacted to assess the properties needs and provide costings for an annual inspection programme.

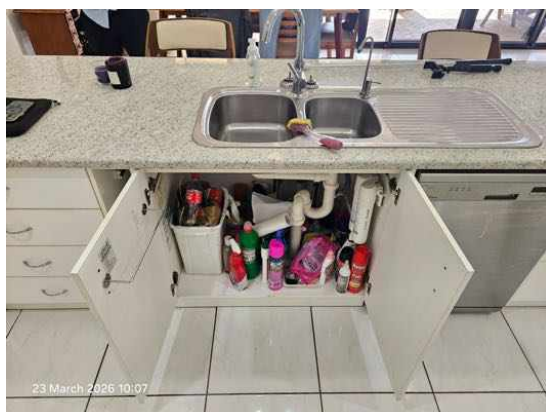
The building employs a “Trithor” physical barrier system to the perimeter and slab penetrations in combination with a Cypress Pine structural frame.

In order for a barrier system to be effective, the property must have regular inspections at intervals of not greater than 12 months. Depending on the risk profile attributed to the property, these inspections may be recommended at lesser time periods.
