# Building and Timber Pest Inspection Report

Inspection Date: Fri, 30 Jan 2026

Property Address: 13 St James Ct, Narre Warren VIC 3805,  
Australia

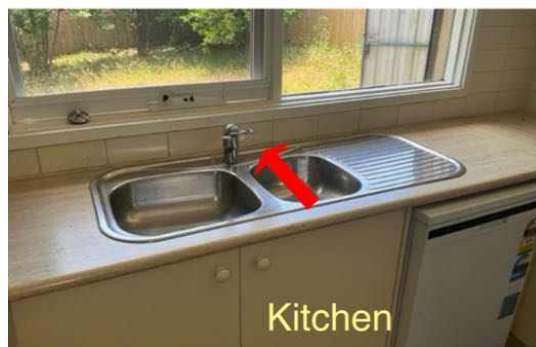
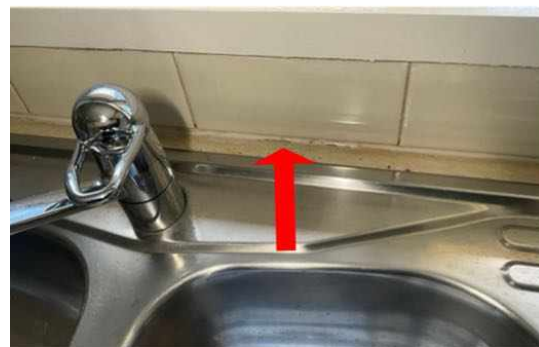
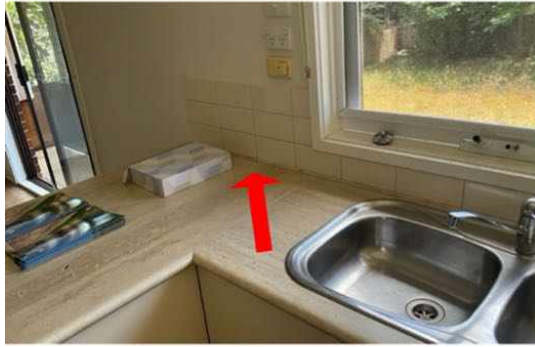
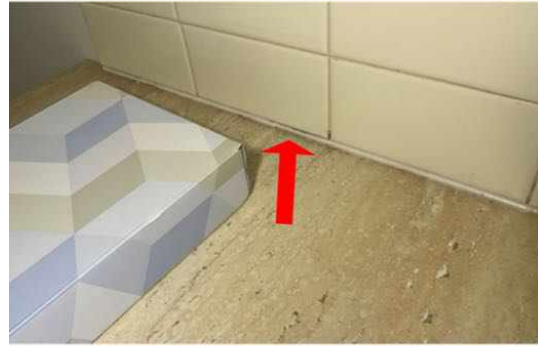
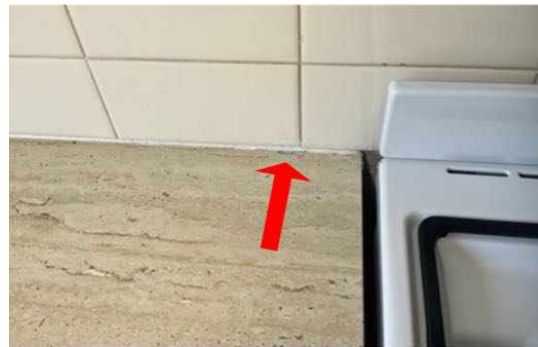
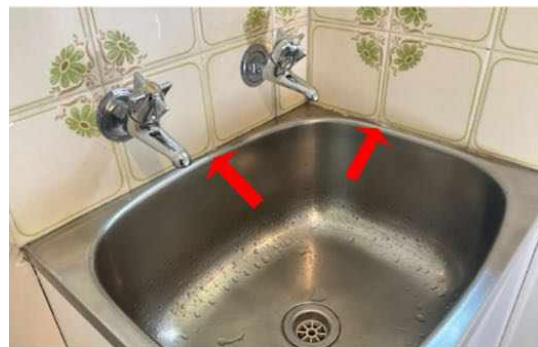
Finding: Sealant/ grout - Damaged or Missing

Information: Sealant or grout is damaged in this area. Sealant and grout is used to protect gaps and crevices in building materials to ensure that they are water-tight and prevent water penetration to the associated structures.

Failure to do so may lead to further deterioration of the sealant which in turn can lead to water damage to the surrounding area.

Where sealant or grout is missing or damaged , a competent handyman may be appointed to scrape out and re-apply any silicone where necessary.

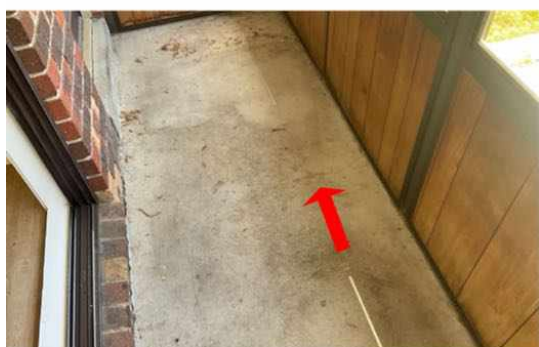
Building:  
Location: Sunroom  
Finding: Cracking - Concrete flooring in the sunroom  
Information: Fine but noticeable cracks were identified in the concrete flooring of the sunroom . Although fine cracks are quite noticeable, they are often only considered to be an appearance defect, and usually do not indicate any structural damage.

Generally the cause of a fine crack in existing concrete flooring is indicative of the expansion and contraction of the concrete. Such causes are generally due to environmental factors, such as moisture levels, weather conditions, or to poor original installation of the concrete. Factors such as inadequate reinforcing of the slab may

create cracking and other secondary defects.

Monitoring of all cracking should be conducted frequently. Always contact a building inspector should cracks widen, lengthen, or become more numerous.

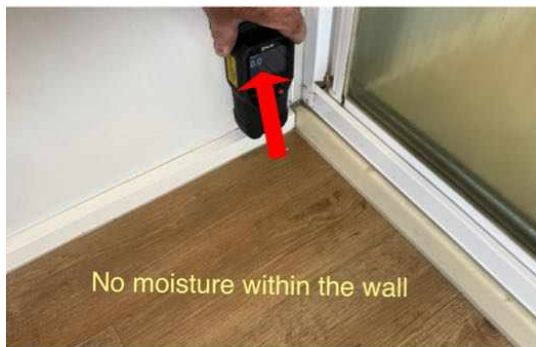
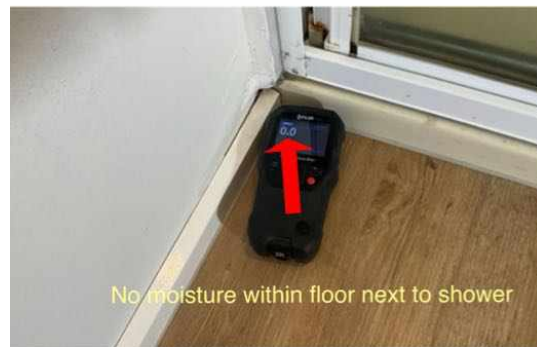
Finding: Suspected Moisture damage to lower wall next to shower

Information: Evidence of suspected moisture damage was identified to the lower wall next to the shower.

It is suspected that this has occurred as a result of excess moisture from spills from the shower. No current moisture was noted to the area when tested with a moisture meter. As such it is suspected no further damage will occur in the area.

A competent handyman may be engaged to inspect the moisture damaged areas and repair or replace any items at the discretion of the homeowner.

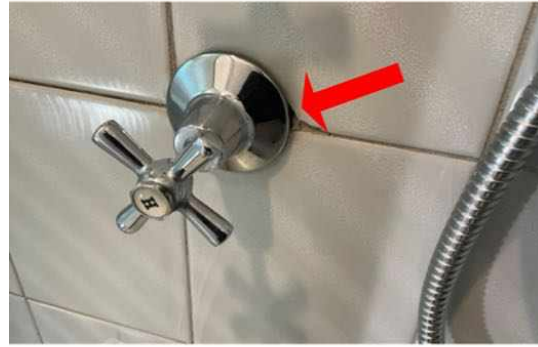
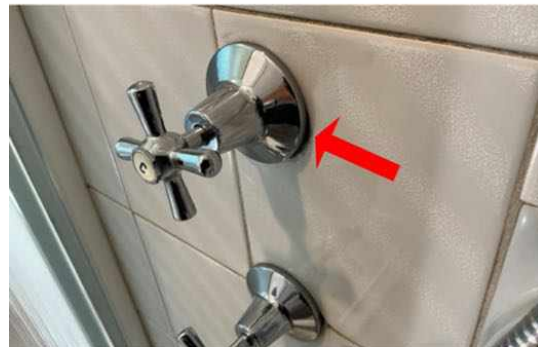
Information: At the time of inspection, gaps were noted around the taps in the shower. These gaps can lead to water ingress behind the tiles which in turn can lead to secondary damage to other building materials.

All tap hardware and connections should be tightly fixed and sealed to prevent moisture ingress.

A competent handyman can be engaged to seal up the gaps.

This should be carried out as a priority. Failure to do so may result in further damage.

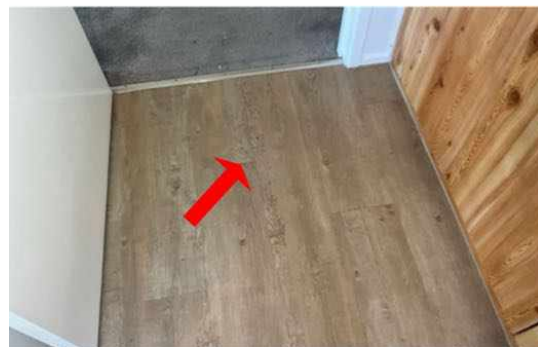
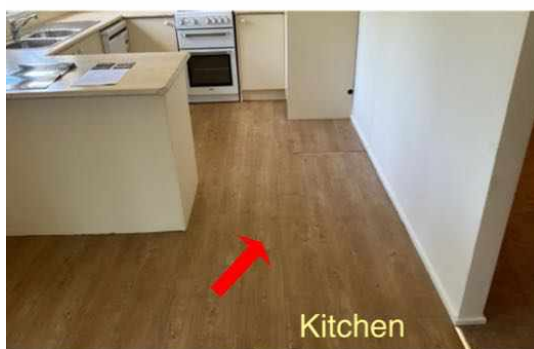
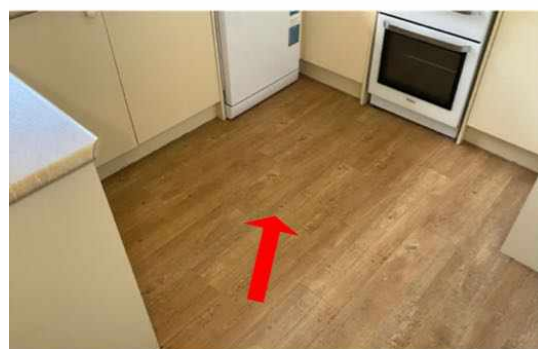
flooring.

The area should be monitored for any changes or movement. Should this occur, consultation with a flooring specialist should be undertaken to determine the cause . The potential resolution may involve lifting and relaying the flooring through to full replacement .

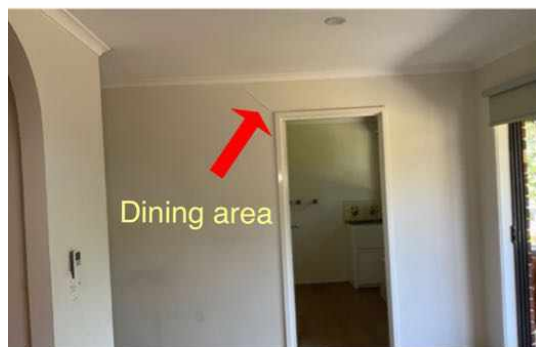
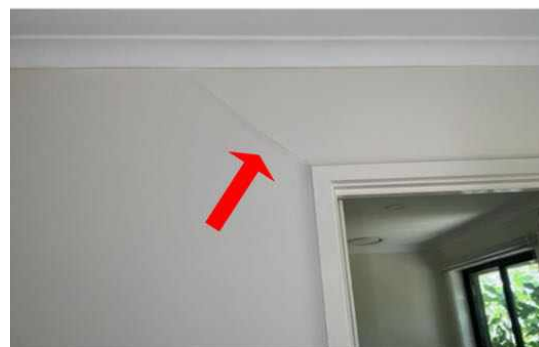
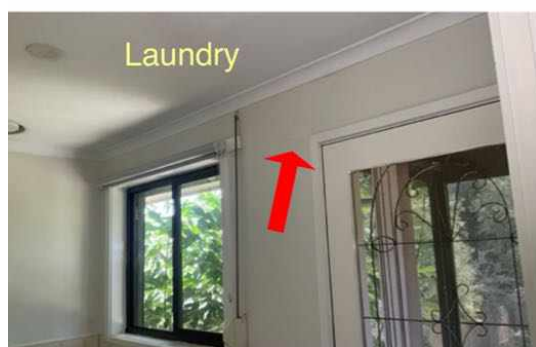
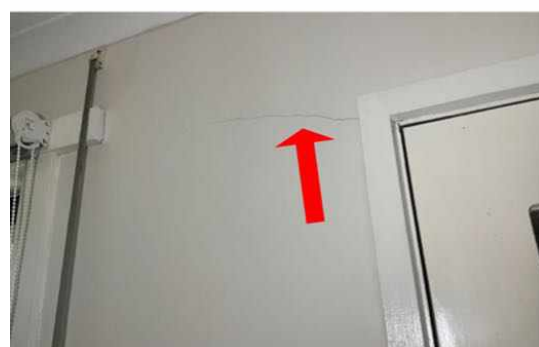
Building:  
 Location: All Areas  
 Finding: Cracking to plasterboard walls - Noticeable

Information: Cracking was noted within the plasterboard wall in the dining area and also laundry.

Noticeable cracks are a common occurrence as a result of many primary defects. Such causes may include age, general wear and tear, expected building movement, general expansion/contraction of building materials in different weather conditions, and/or minor failings in the installation or application of building materials.

Noticeable cracks may result in minor sticking or jamming of associated doors and windows, which require easement. However, noticeable cracks are easily filled and repaired.

Monitoring of all cracking should be conducted frequently. Always contact a building inspector should cracks widen, lengthen, or become more numerous. Additionally, your building inspector should also be contacted if associated building elements such as doors and windows become more difficult to operate over time.

Relevant tradespeople, such as carpenters, painters and plasterers, should be appointed to perform remedial works, as deemed necessary.

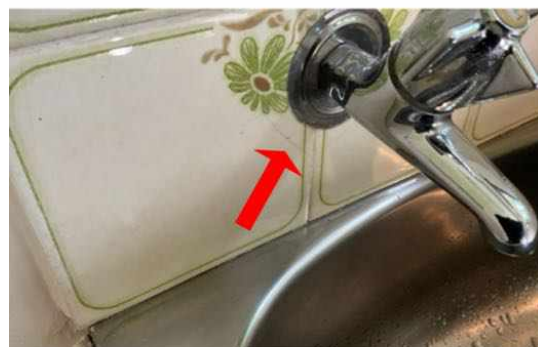
Finding: Wall tiles - Cracked

Information: Cracking in the wall tiles around the tap was evident in the laundry at the time of inspection. It is suspected that this cracking has occurred as a result of the slight movement within the building, impact damage or poor initial installation.

Cracked tiles throughout the household detract from the overall appearance of the affected areas, as well as creating potential for water penetration to adjoining building elements. If left unmanaged, water damage can occur as a result of constant water penetration over a prolonged period of time.

While not considered a matter of urgency, replacement of cracked tiles is advised as a solution. A tiling contractor may be appointed to perform these works at client discretion.

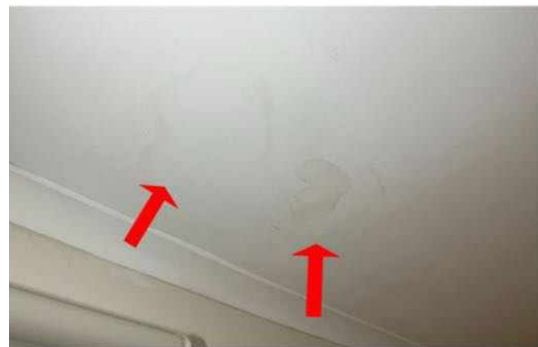
Finding: Ceiling - Water stained

Information: Water staining to ceiling linings in this area was evident at the time of inspection. No current moisture was noted in the ceiling when checked with a moisture meter.

Water staining indicates that surfaces have been exposed to excessive moisture over time. The minerals and other elements in the water lead to staining, which may graduate to corrosion and deterioration if left unmanaged.

While mostly an appearance defect, water staining can be indicative of more serious defects, which may be currently concealed by interior ceilings.

Please note: it is suspected the staining may have been from a leak which has subsequently been fixed. Ongoing monitoring of the ceiling should be carried out to ensure no leaking occurs in the area in the future.

Where water staining is active ( not suspected in this instance), a licensed plumber must be consulted to identify the cause of the staining and to provide advice on any reparation works that may be required. Replacement of any damaged structures is advised.

Conversely, where water staining is old and inactive, the ceiling may be repainted at the client's discretion.

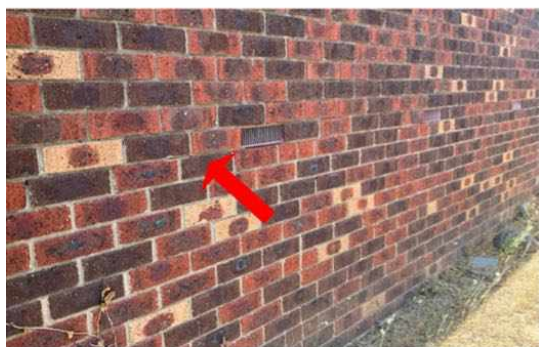
**Finding 3.16**

Building:  
 Location: All External Areas  
 Finding: Brickwork - Cracking [Fine]  
 Information: Find cracking was noted within the mortar between brickwork on this exterior wall .

Although fine cracks are quite noticeable, they are often only considered to be an appearance defect and usually do not indicate any structural damage. Generally, the cause of a fine crack is indicative of a separation between brickwork and mortar throughout the structure, but single bricks may also show cracks of this nature.

Cracking of this nature can generally be repaired with minor filling and should be conducted by a qualified bricklayer.

Always contact a building inspector should cracks widen lengthen or become more numerous.

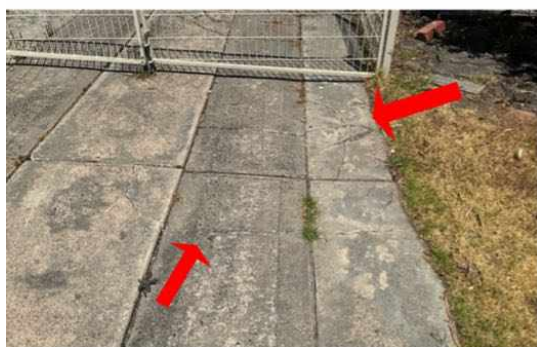
Building:  
Location: Driveway  
Finding: Noticeable Cracking - Concrete driveway  
Information: Noticeable cracks were identified in the concrete driveway.

General age and expected deterioration of the concreted areas is a common cause of this type of cracking. However, expansion and contraction of the driveway may also have occurred due to environmental factors. Such factors include variable moisture and weather conditions, the presence of trees and their roots having a settling or lifting affect on the soil, or the effect of load bearing, e.g. heavy vehicles over a sustained period of time.

Cracking to this degree may also be due to poor original installation of the driveway. Factors such as poor compaction of the sub surface and/or inadequate reinforcing of the slab may create cracking and other secondary defects. Noticeable cracks may also be due to subsidence of soils.

The area should be monitored for any changes that may occur and potentially cause tripping hazards. Should this occur, repair and likely replacement of the concrete section may be necessary.

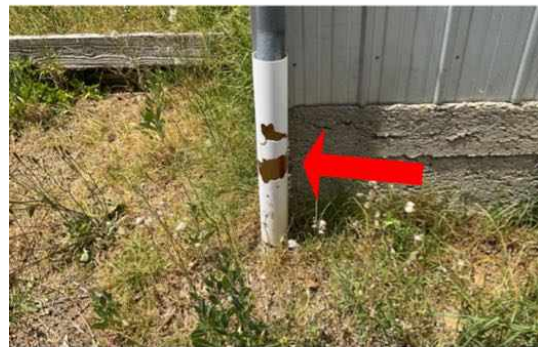
Building: Garage  
 Location: Garage  
 Finding: Downpipe damaged at the base  
 Information: At the time of inspection, the downpipe in this area has been damaged at the base near ground level . This has the potential to allow water to escape the downpipe and pool around the edge of the house.

Pooling water can undermine the foundations of the property over time and can also create conditions conducive to timber pest activity.

It is recommended that a licensed plumber be engaged to correctly seal the downpipe to prevent any leaking.

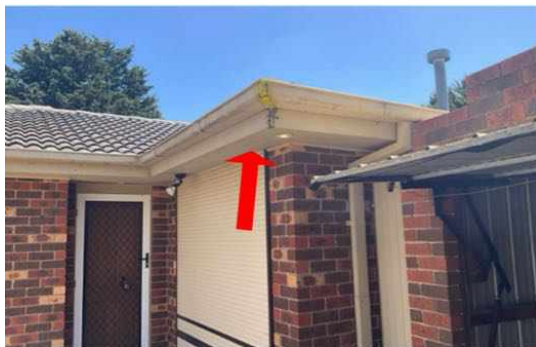
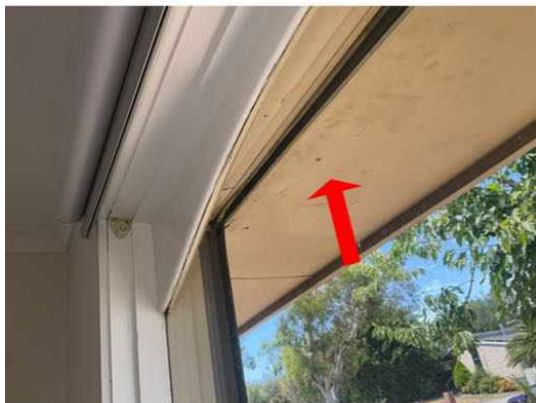
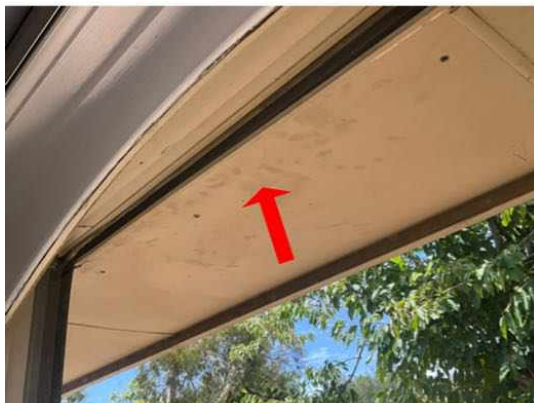
### Finding 3.21

Building: Eaves  
 Location: Eaves  
 Finding: Eave linings - Water stained  
 Information: At the time of inspection, there appeared to be some water staining to various areas of the eaves linings around the property .

Please note: Eave sheeting was traditionally made of asbestos containing material (ACM) . Caution should be taken in the area. It is highly recommended that an asbestos inspection and sampling be carried out to determine the presents of any ACM. Consultation with your Jim's consultant should be carried out to seek further information.

Where water staining is active, a licensed plumber must be consulted to identify the cause of the staining and to provide advice on any reparation works that may be

Conversely, where water staining is old and inactive, affected building materials may be repaired or replaced at client discretion. All gutters should be cleared to allow for correct operation.

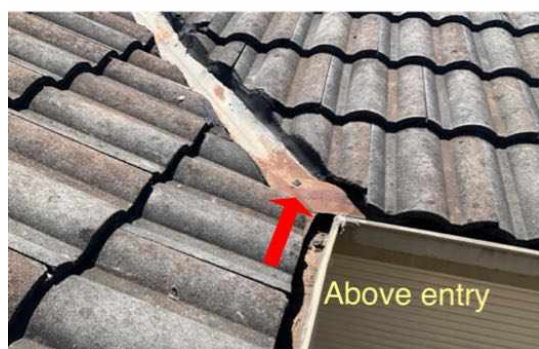
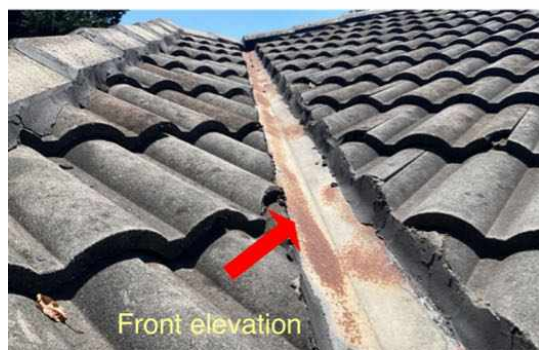
If left unmanaged, this can lead to holes developing and potential water ingress to the internal roofing structures - leading to secondary damage of building elements. Accelerated deterioration of the valley channels and any associated building elements is also likely to occur.

A roofing contractor should be appointed to assess the damage and to perform remedial works as necessary. Works may include replacement of severely affected areas or minor works such as the application of rust-retardant surface protectors.

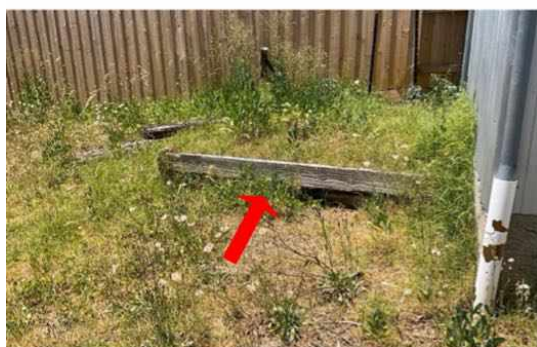
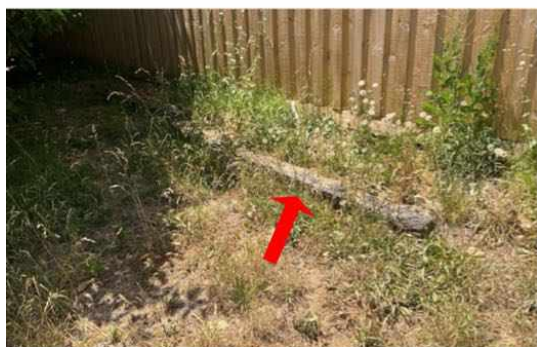
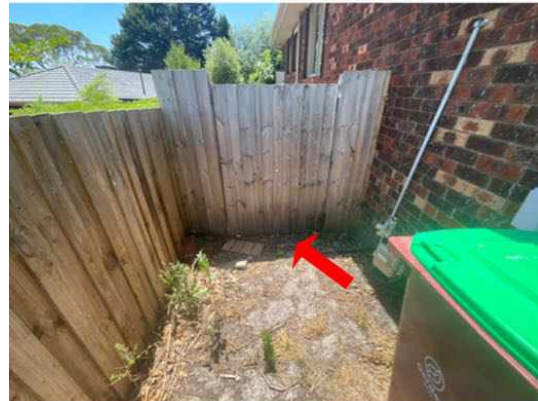
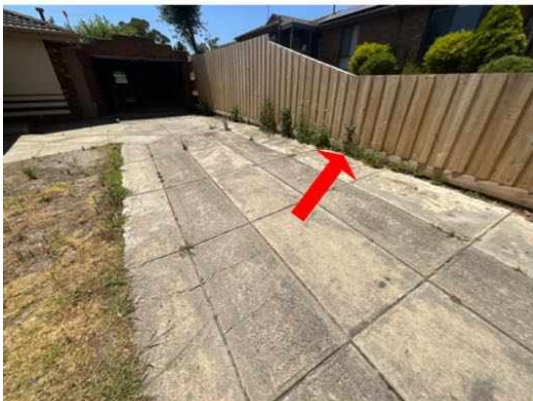
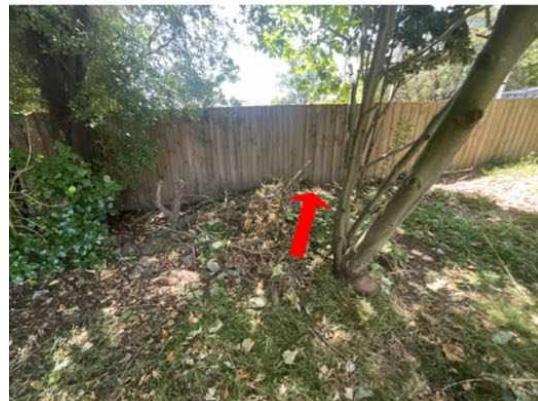
When met with excessive moisture, timber begins to decay and develop wood rot. Any timbers that are in direct contact with external grounds especially if left untreated or non-durable also provide ingress for subterranean termites into that particular element.

Where possible, the removal of any such materials that may be conducive to termite activity should be carried out as soon as possible to minimise the risk of termite attack. Where not possible or practical, regular monitoring of timber elements is recommended. Replacement of any damaged materials should be carried out where necessary.

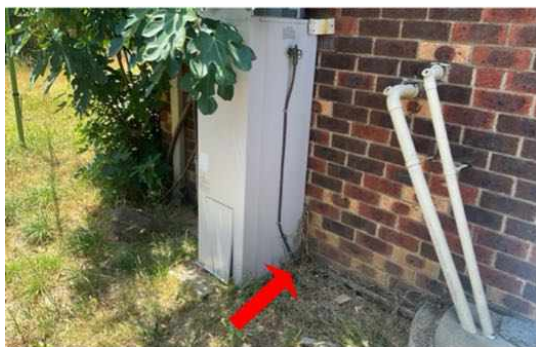
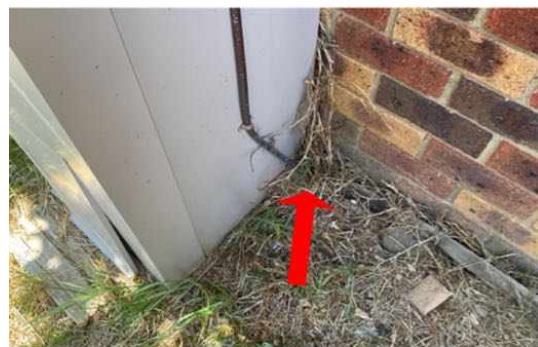
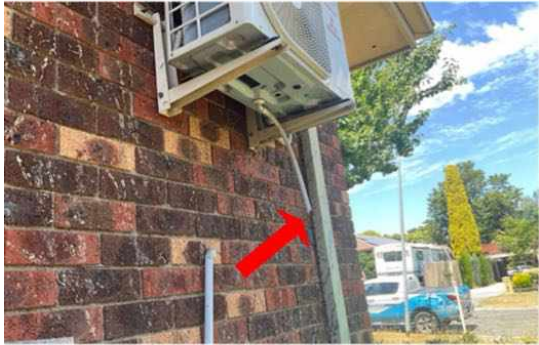
These damp conditions can lead to secondary defects such as rot, rust or corrosion of associated building elements or the formation of fungal decay. When coupled with poor site drainage, pooling of water may also attract termite activity to this area.

It is recommended that a qualified plumber be appointed to install adequate drainage to the overflows or that they be diverted away from the edge of the building. These works will ensure that the area remains dry and free of any secondary defects.

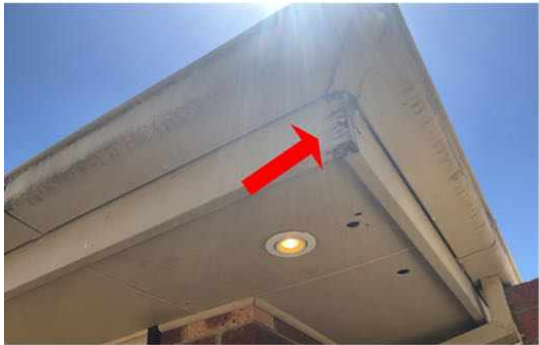
**Finding 7.01**

Generally fungal decay develops on timber elements that are in use in an external environment which are exposed to rain penetration.

Decaying timbers can create an environment conducive to timber pest attack. It is recommended that the decaying timbers be repaired / replaced to lessen the risk of timber pests.
