Building and Timber Pest Inspection Report

Inspection Date: Wed, 28 Jan 2026

Property Address: 4 Ingles Dr, Redbank Plains QLD 4301,
Australia

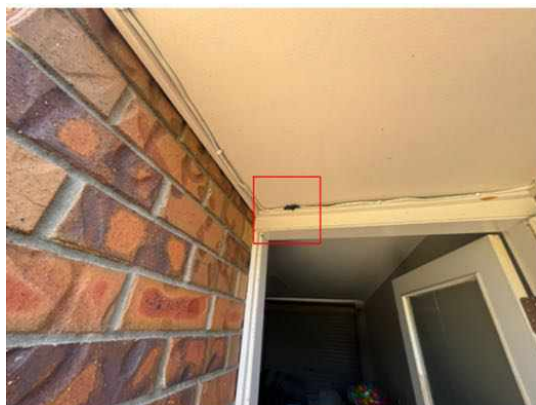
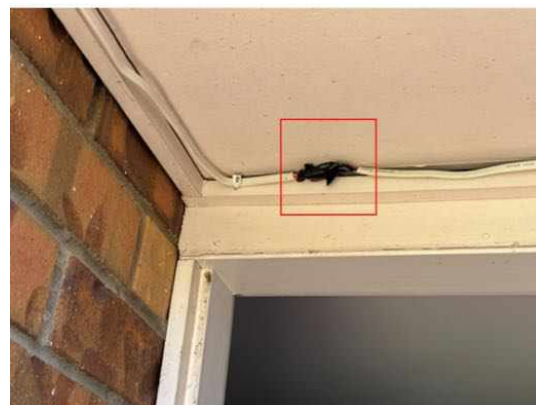
Finding 1.01

Building:	Main Building
Location:	Rear elevation
Finding:	Electrical junction box - Missing
Information:	At the time of the inspection, it was noted that an electrical cable to a light at the rear of the dwelling was not encased in a junction box. It must be presumed that this cable is live once the light switch is turned on.

Junction boxes provide a second insulation barrier to adequately seal off and protect the wires, increasing the safety of the immediate environment and ensuring that the wiring is not damaged.

The absence of junction boxes poses as an electrical safety hazard, providing risk of electrocution. It appears as though wiring in this area has been completed to a substandard level of workmanship, evidenced by the lack of adequate wiring protection.

Appointment of a licensed electrician is highly advised to provide additional information on the risks of unprotected wiring and to install junction boxes and any other elements as required. Such works should be carried out as a matter of urgency; until this time, any persons within this area should exercise a high level of caution.

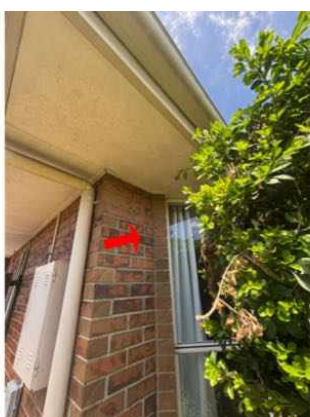
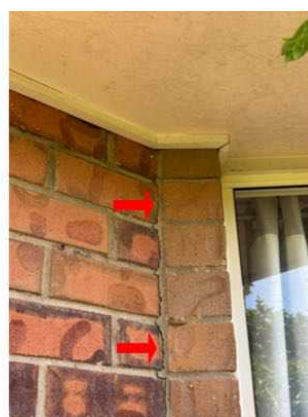
Finding 3.01

Building:	Main Building
Location:	Front elevation
Finding:	Brickwork - minor cracking
Information:	At the time of the inspection, it was noted that there was minor cracking to the mortar joint of the brickwork next to the front left hand side window. This may be due to the brickwork not being toothed in.

A building maintenance professional could be engaged to remove the mortar and use a flexible sealant to create an expansion joint. This can be done at the clients discretion.

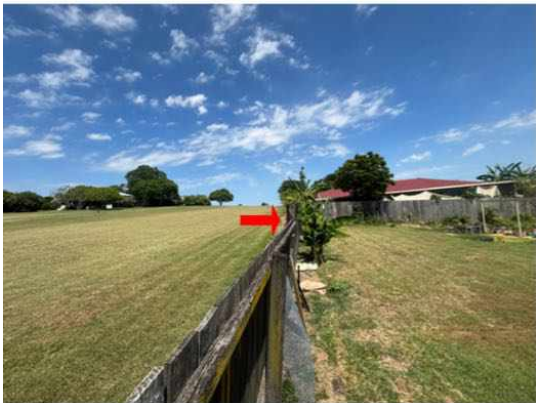
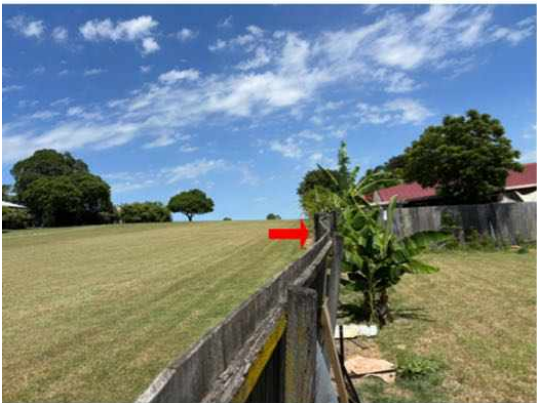
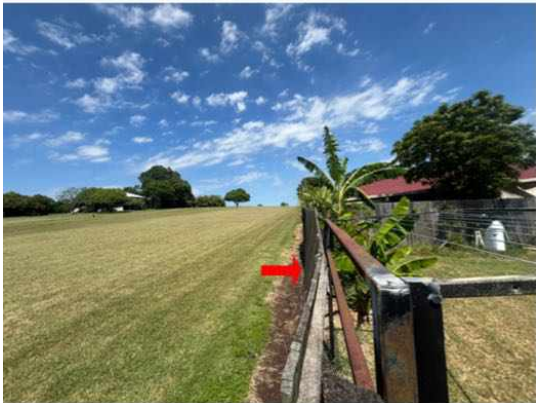
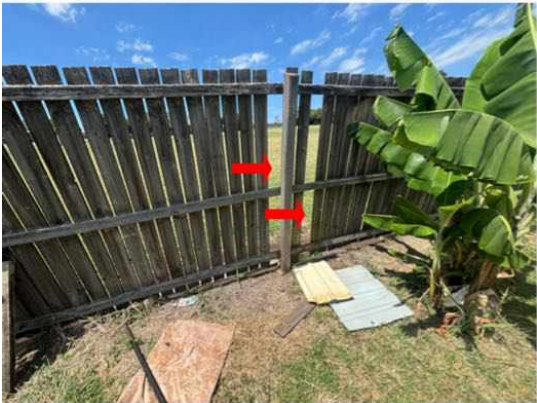
Finding 3.02

Building:	Main Building
Location:	Rear yard
Finding:	Boundary fence - deteriorating
Information:	At the time of the inspection, it was noted that the rear boundary fence was deteriorating. The rear timber fence is leaning into the yard and there is movement to it when pressure is applied. This may be due to the timber posts suffering from wood rot. Several palings are missing on the rear fence.

A fencing contractor could be engaged to assess the boundary fences and provide a solution for these issues. This can be done at the clients discretion.

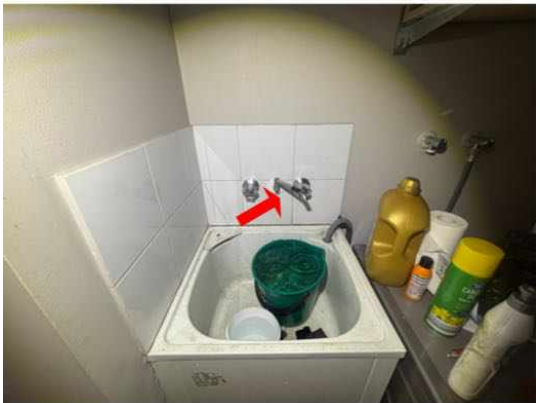
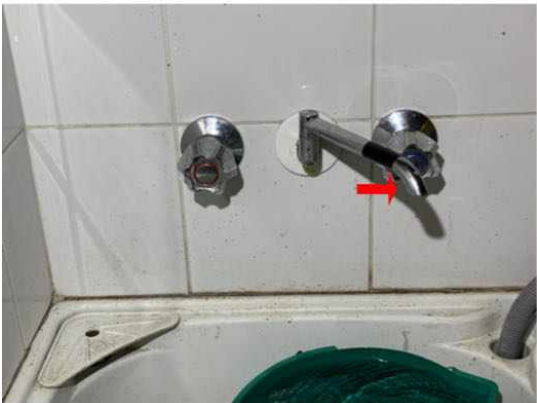
Finding 3.03

Building: Main Building
Location: Laundry
Finding: Laundry - tub taps leaking
Information: At the time of the inspection, it was noted that the taps to the laundry tub were leaking when the taps were in the off position. A bucket is catching the water. This may be due to general wear and tear of the seals in the laundry tub taps.

A licensed plumber should be engaged to replace the seals in the taps. This should be done as a short term priority.

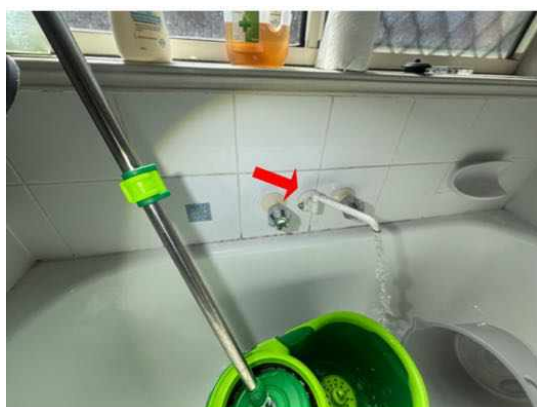
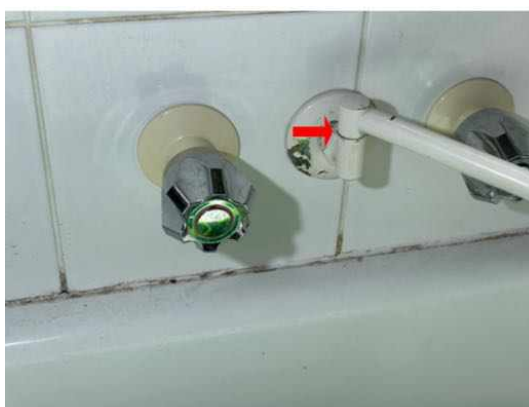
Finding 3.04

Building:	Main Building
Location:	Family bathroom
Finding:	Family bathroom - bath tub taps leaking
Information:	At the time of the inspection, it was noted that the taps to the bath tub were leaking when the taps were in the off position. A bucket is catching the water. This may be due to general wear and tear of the seals in the laundry tub taps. The bath tub spout is leaking from the swivel joint when the taps are turned on.

A licensed plumber should be engaged to replace the seals in the taps. This should be done as a short term priority.

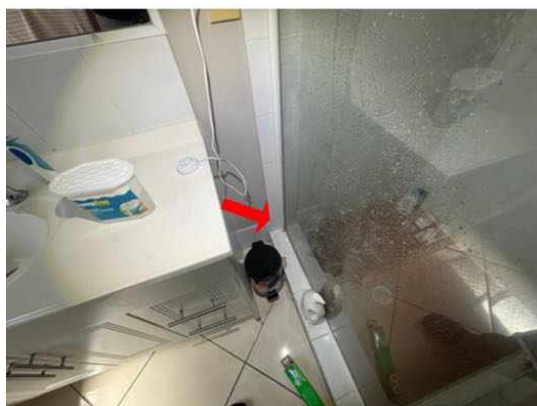
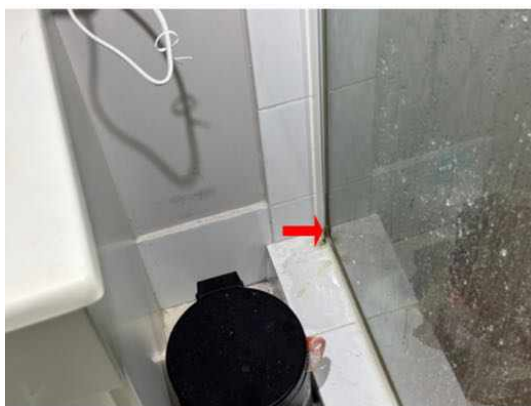
Finding 3.05

Building:	Main Building
Location:	Family bathroom
Finding:	Family bathroom - shower screen leaking
Information:	At the time of the inspection, it was noted that the shower screen in the family bathroom was leaking.

A building maintenance professional should be engaged to apply sealant to the shower screen. This should be done as a short term priority.

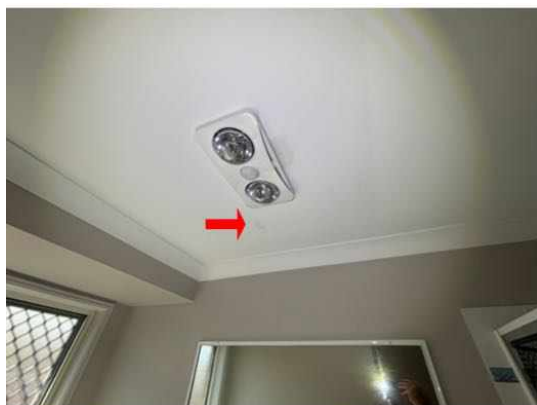
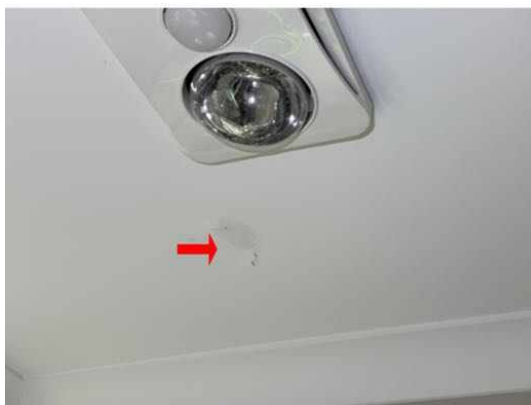
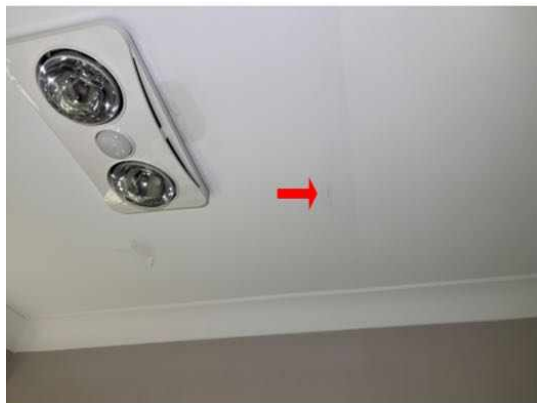
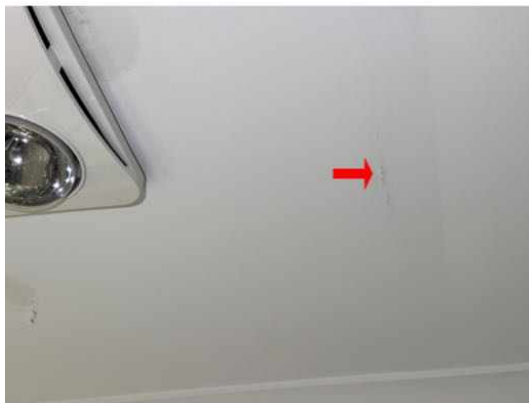
Finding 3.06

Building: Main Building
Location: Family bathroom
Finding: Family bathroom - paint peeling
Information: At the time of the inspection, it was noted that the paint was peeling to sections of the ceiling in the family bathroom.

Peeling paint can be caused by moisture, poor preparation or age. There was no evidence of moisture found.

A painter or building maintenance professional could be engaged to rectify this issue. This can be done at the clients discretion.

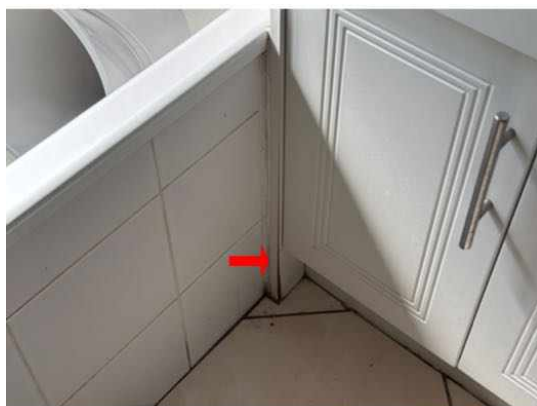
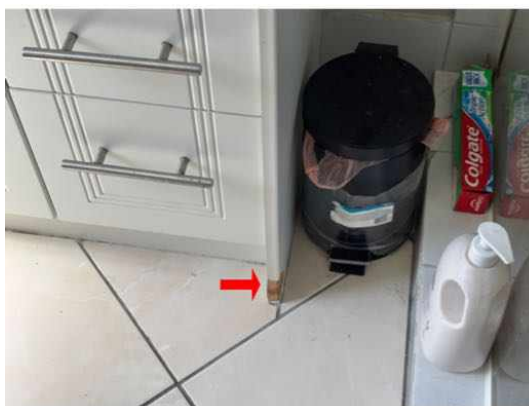
Finding 3.07

Building:	Main Building
Location:	Family bathroom
Finding:	Family bathroom - moisture damage
Information:	At the time of the inspection, it was noted that there was moisture damage to the base of the vanity in the family bathroom. This may be due to the type of materials used in an environment where moisture is expected.

A building maintenance professional could be engaged to repair the family bathroom vanity. This can be done at the clients discretion.

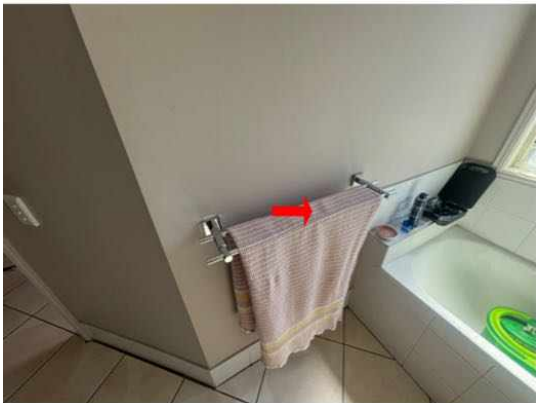
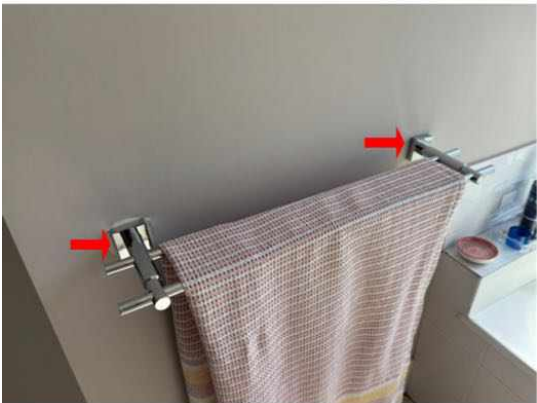
Finding 3.08

Building:	Main Building
Location:	Family bathroom
Finding:	Family bathroom - towel rail loose
Information:	At the time of the inspection, it was noted that the towel rail in the family bathroom was loose. This appears to be from general wear and tear. If not addressed, the towel rail may come away from the wall.

This may require simple adjustment of the fasteners attaching the towel rail. A building maintenance professional could be engaged to carry out this minor repair. This can be

done at the clients discretion.

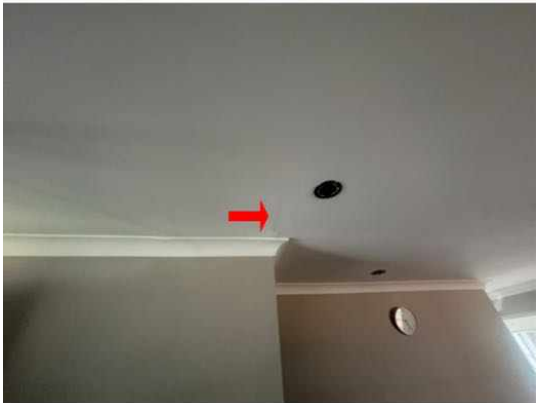
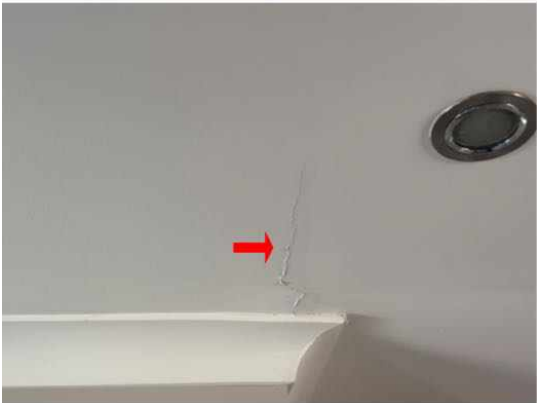
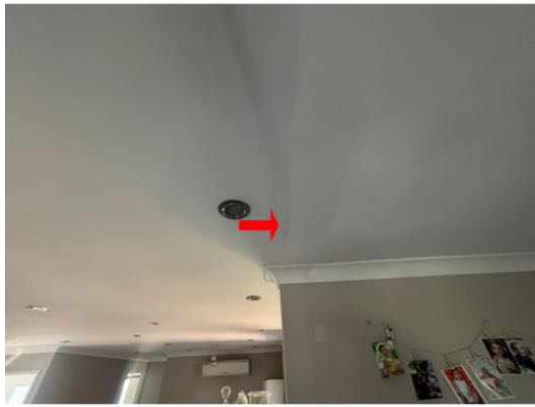
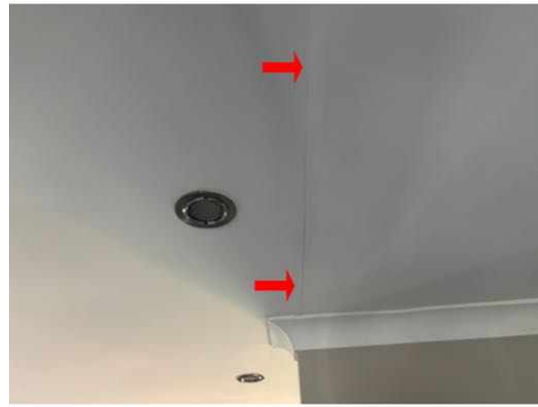
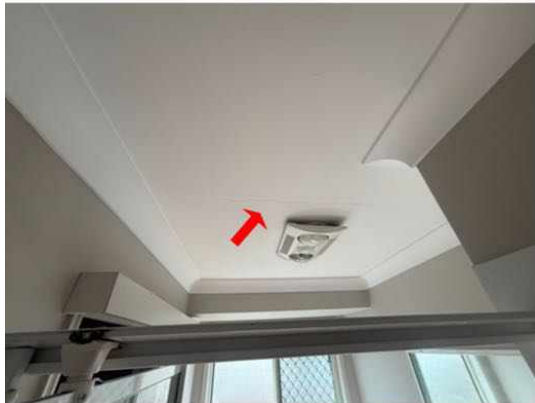
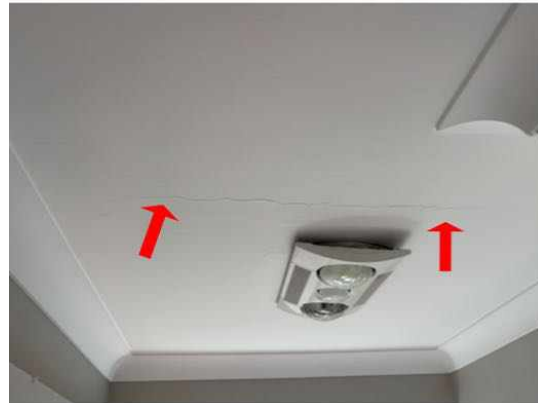
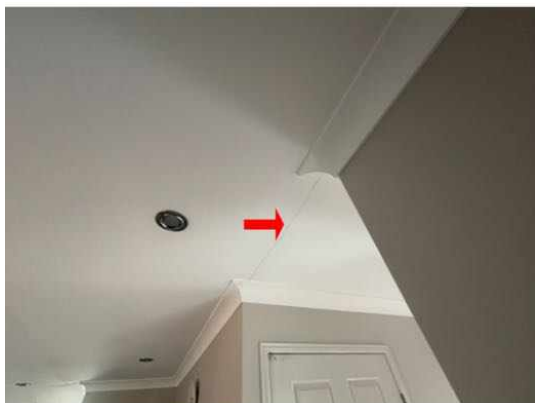
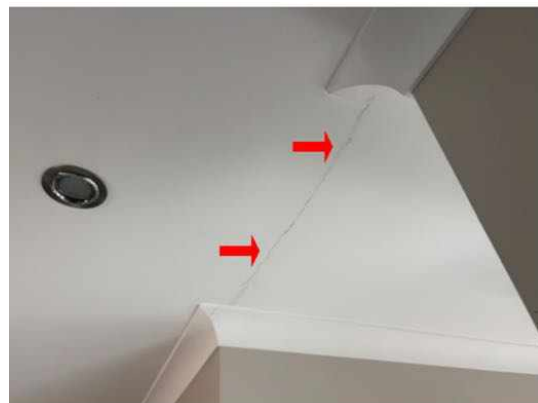
Finding 3.09

Building: Main Building
Location: All Internal Areas
Finding: Ceiling lining - cracking
Information: At the time of the inspection, it was noted that there was cracking to the ceiling lining in the lounge area, ensuite and hallway outside of the family bathroom. This appears to be general wear and tear and movement of the associated building materials.

The functionality of the ceiling lining is not affected at present. A plasterer could be engaged to repair the cracks. This can be done at the clients discretion.

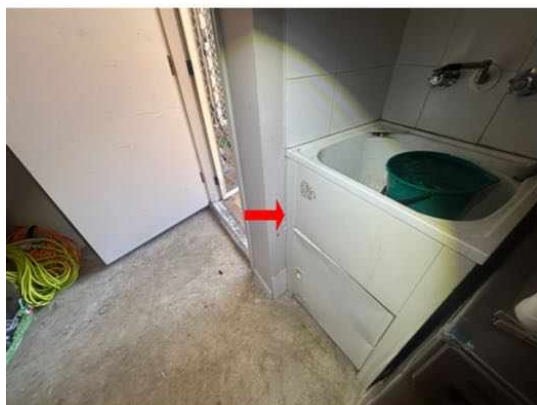
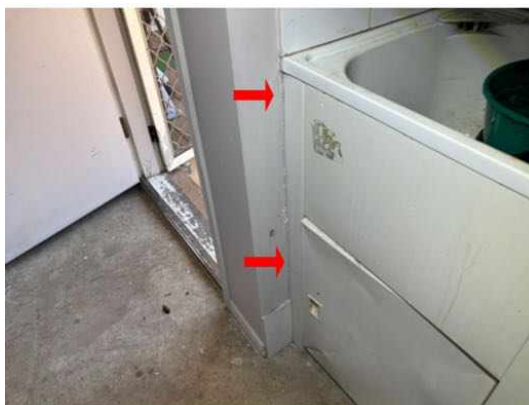
Finding 3.10

Finding: Laundry - evidence of moisture damage

Information: At the time of the inspection, it was noted that there was evidence of moisture damage to the wall lining on the left hand side of the laundry tub. This may be due to water being splashed from the laundry tub. Normal moisture readings were recorded in this area.

A building maintenance professional or painting contractor could be engaged to carry out this repair. This can be done at the clients discretion.

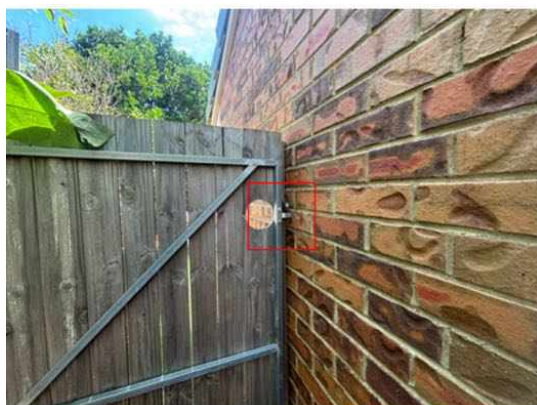
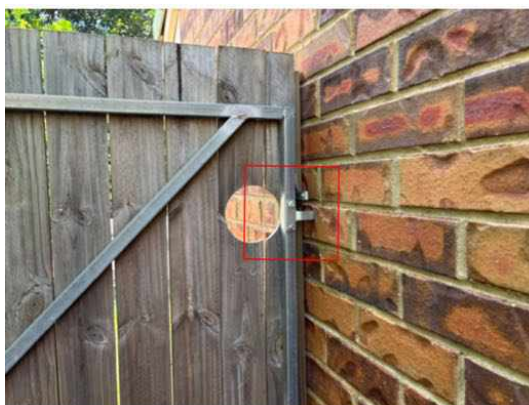
Finding 3.11

Finding: Side gate - inoperable

Information: At the time of the inspection, it was noted that the side gate on the right hand side of the dwelling is inoperable. The gate is jammed against the brickwork most likely due to movement of the fence that the gate is attached too.

A building maintenance professional or fencing contractor could be engaged to carry out the necessary repairs to return functionality to the gate. This can be done at the clients discretion.

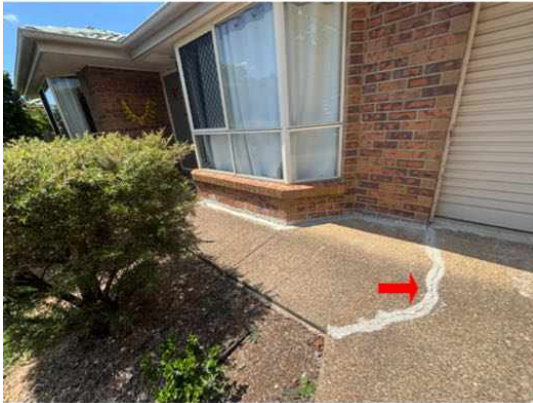
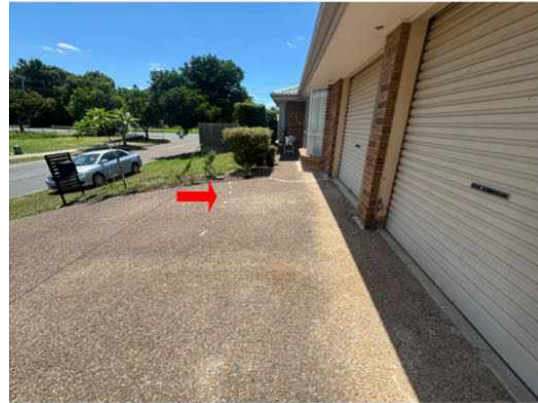
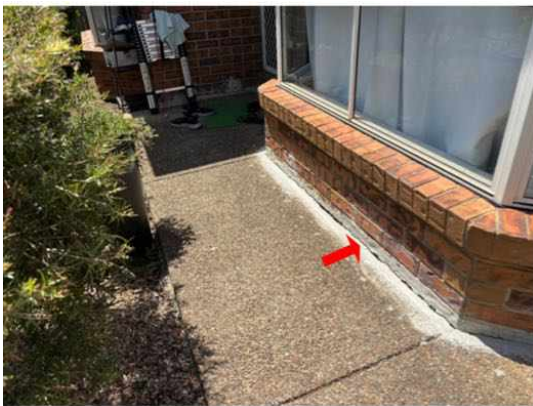
Finding 3.12

Finding: Concrete - cracking

Information: At the time of the inspection, it was noted that there was some cracking to the concrete driveway and footpath at the front of the dwelling. There is evidence of minor subsidence under the window next to the front door. These issues appear to be historic. The client should monitor this area for any change to the cracking.

A concreter could be engaged to replace the affected concrete areas if further cracking occurred. This can be done at the clients discretion.

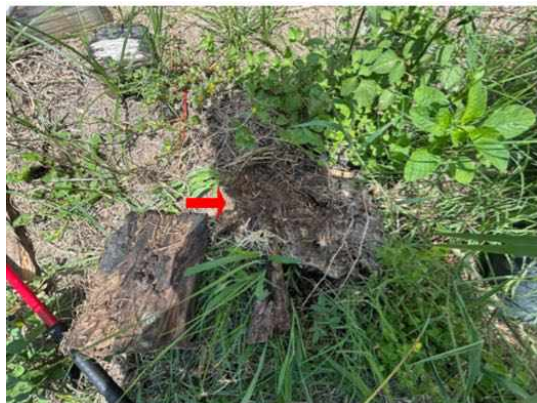
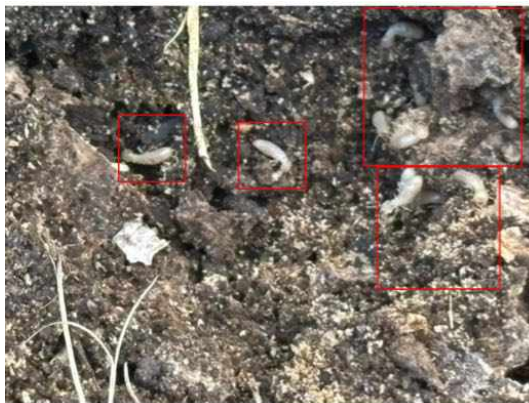
Finding 4.01

Building:	Main Building
Location:	All External Areas
Finding:	Evidence of live termite activity was identified (species unknown)
Information:	At the time of the inspection, it was noted that there was live termite activity in an old tree stump on the right side of the back yard.

The species of the termites could not be identified at the time of inspection which may impact on the mode of eradication.

Works to eradicate live termites should be undertaken immediately to prevent any further damage that will inevitably ensue.

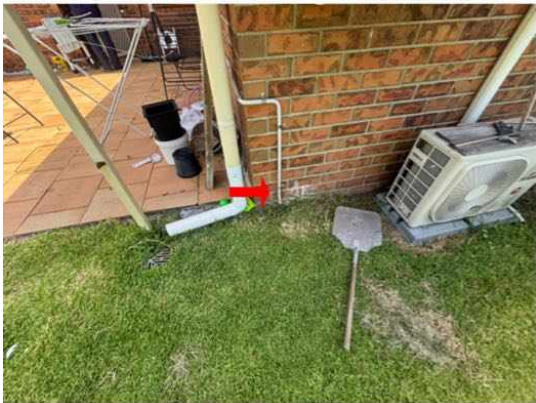
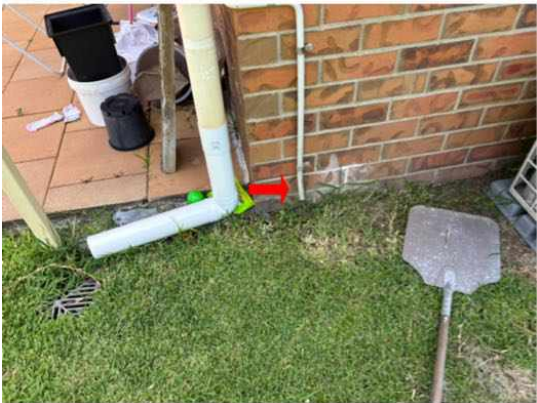
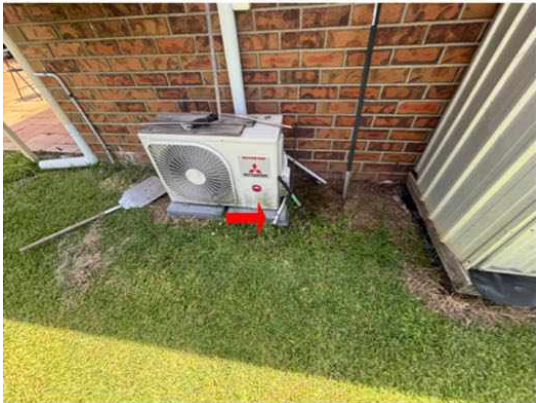
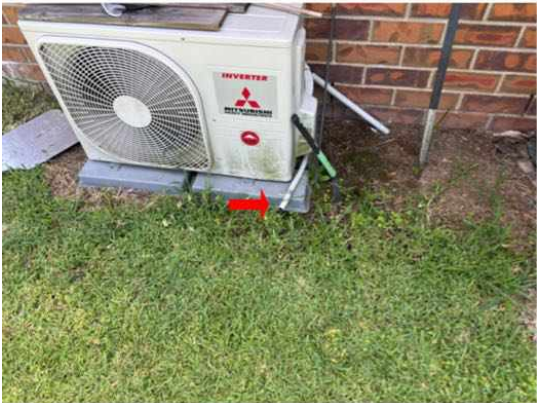
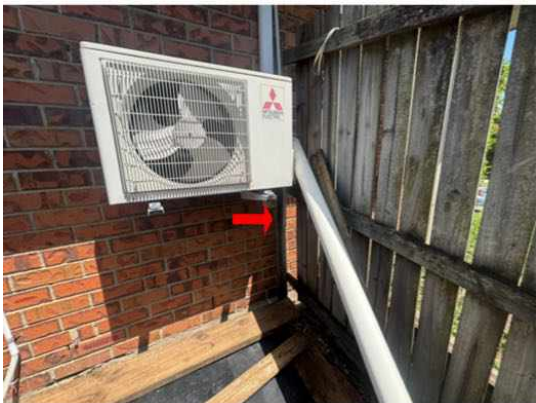
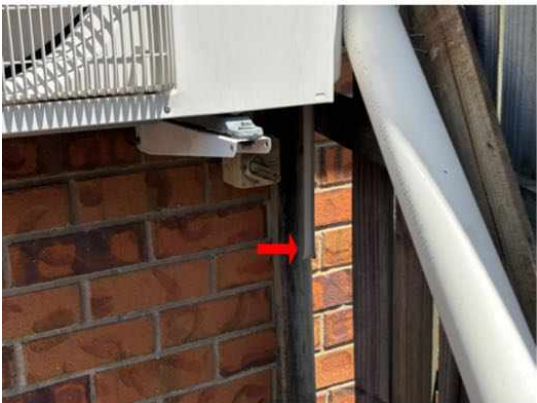
Finding 6.01

Building:	Main Building
Location:	All External Areas
Finding:	Air conditioner - Disconnected overflows
Information:	At the time of the inspection, it was noted that the air conditioner drain overflows to all the units were not connected to the storm water drainage and as a result are draining next to the foundations of the dwelling.

Air conditioning overflows that are not connected to the storm water drainage and are draining near the foundation can create excessive moisture in the surrounding area.

Such leaking creates an environment which is conducive to an array of defects, including water damage to associated building elements and the attraction of termite or timber pest infestation.

It is highly recommended that a licensed plumber be appointed to connect the A/C overflow in order to prevent such an environment from being created. These minor works should be carried out as soon as possible.

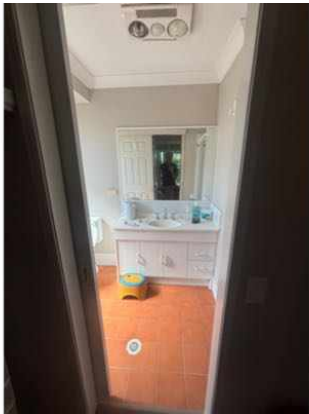
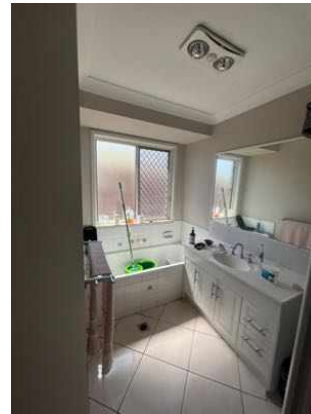
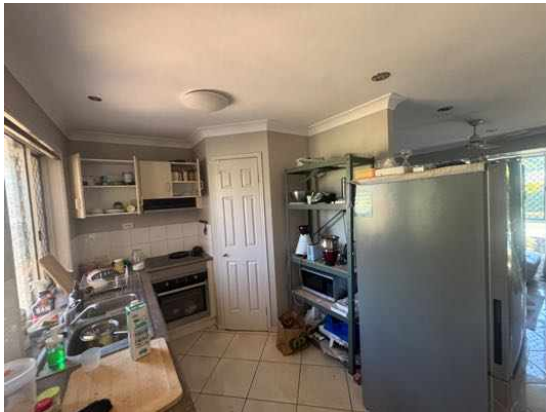
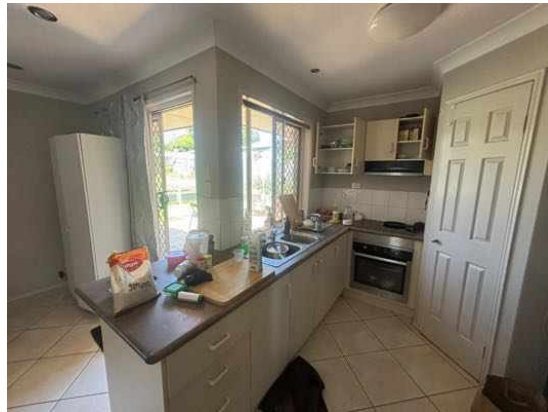
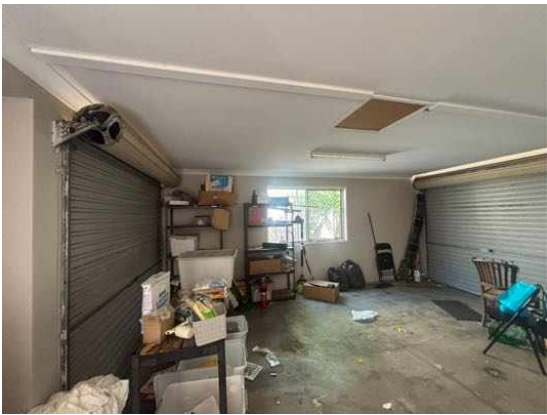
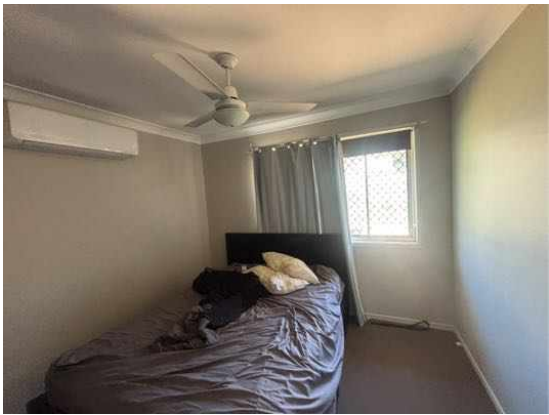
Building: Main Building
Location: All Internal Areas
Finding: Obstructions and Limitations - Internal areas
Information: These photographs are an indication of the obstructions and limitations which impeded full inspection of the property of the internal areas at the time of inspection. These obstructions can hide an array of defects and should be removed to allow full inspection to be carried out. A re-inspection is recommended once the areas are made accessible.

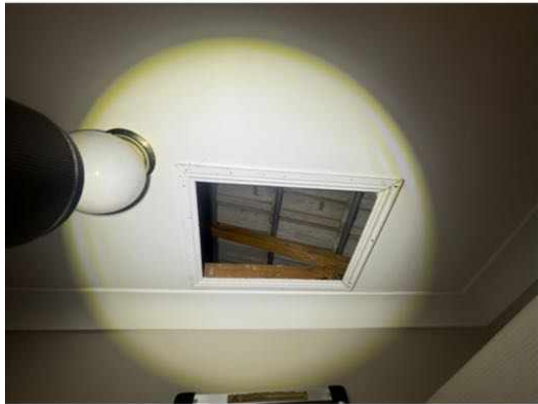
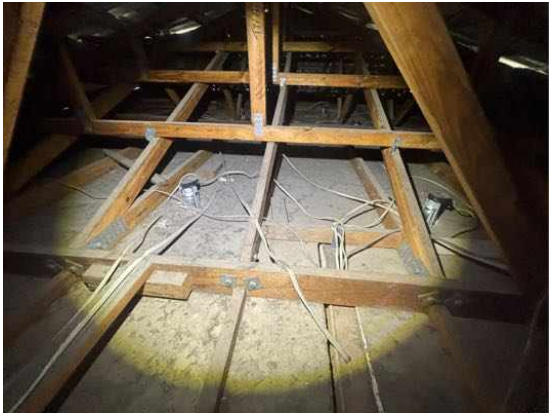
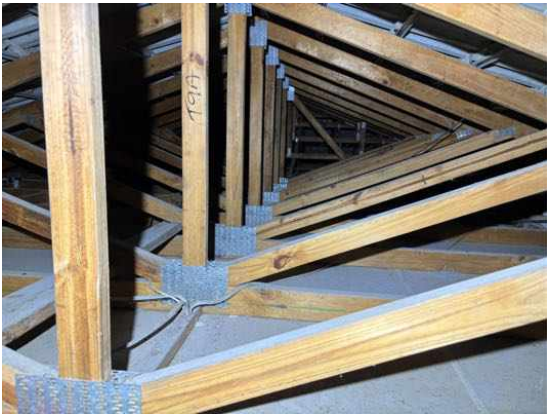
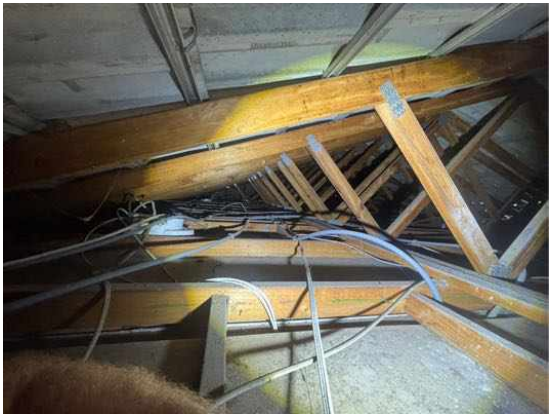
Building: Main Building
Location: Roof Void
Finding: Obstructions and Limitations - Roof cavity
Information: These photographs are an indication of the obstructions and limitations which impeded full inspection of the property of the roof cavity

at the time of inspection. These obstructions can hide an array of defects and should be removed to allow full inspection to be carried out. A re-inspection is recommended once the areas are made accessible.

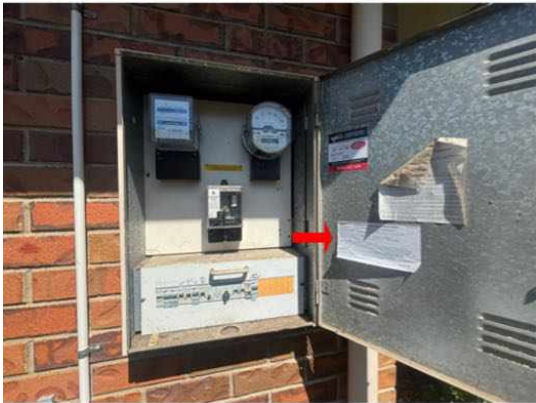
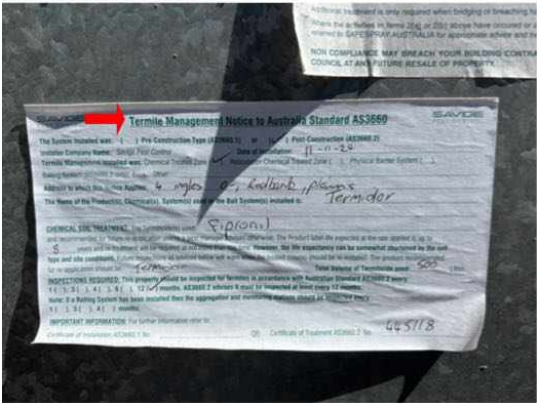
Building: Main Building
 Location: All External Areas
 Finding: Evidence of a current chemical termite management system was identified.
 Information: At the time of the inspection, evidence of a current chemical termite management system was found by way of a durable notice in the electricity meter box.

Annual termite inspections must be carried out in partnership with any termite treatment system, physical or chemical, as no termite treatment system can be expected to be 100% effective.
