## Building Inspection Report

Inspection Date: Wed, 18 Mar 2026

Property Address: 26 Exhibition Dr, Modbury North SA 5092,  
Australia

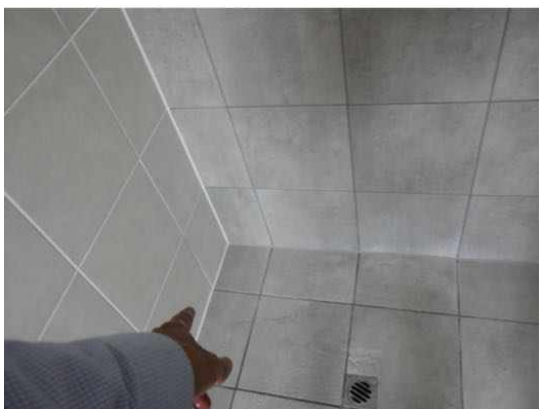
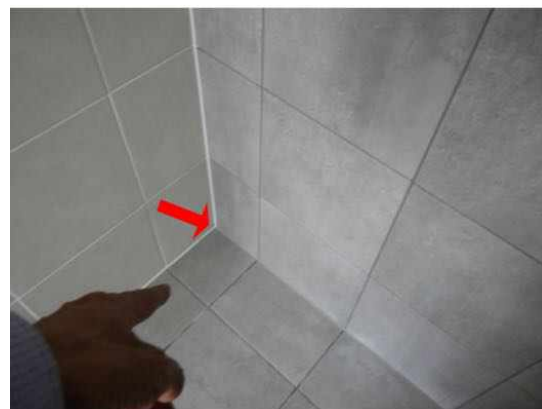
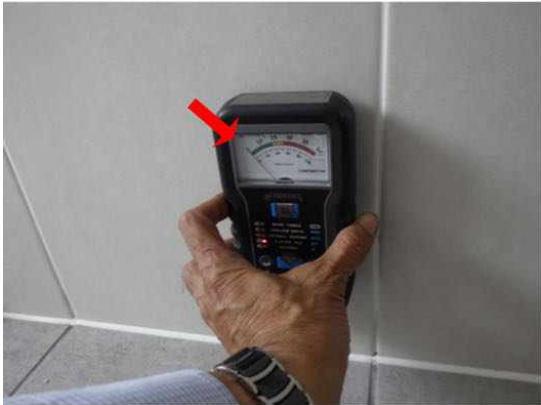
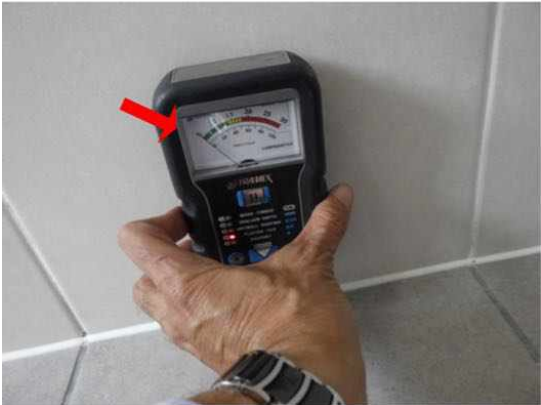
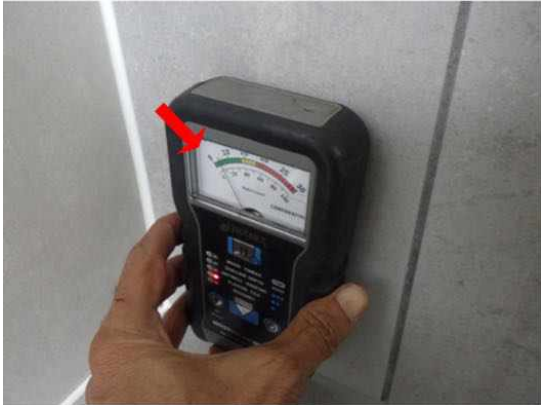
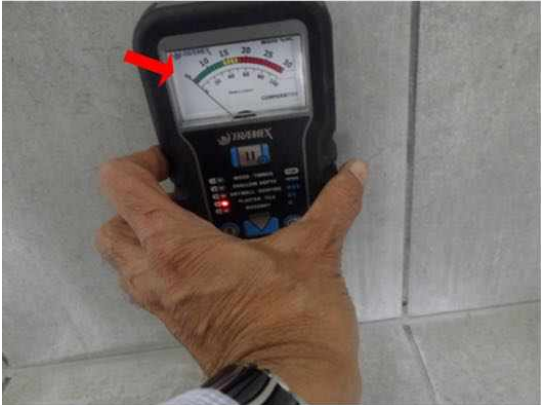
#### Defects 2.01

Building: Building 1  
Location: Bathroom 2  
Finding: Sealant and grouting - Missing or damaged  
Information: It was noted on inspection that sealant or grout is degraded to the tiled shower alcove and or other areas of the bathroom- ensuite.

Apart from that at the time of inspection no high moisture readings were noted in this shower alcove area.

Different materials and floor areas move at different rates, generally causing cracking to grout or sealant at this point. A flexible sealant is required to allow for expected expansion and contraction, while keeping the joint water tight and protective of all associated building materials.

Flexible and mould resistant materials should be applied to affected areas to prevent any subsequent water damage that is likely to occur. Regular maintenance and replacement of damage or missing or damaged sealant and grout is highly recommended to the wet areas, as this is a regular wear and tear defect. Sealant and grouting in areas that come into regular contact with water should be maintained for the long term care of your property.

A sealant specialist or tiling contractor should be appointed to complete these works as soon as possible

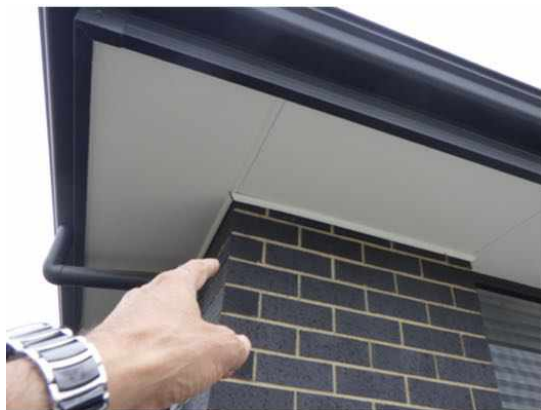
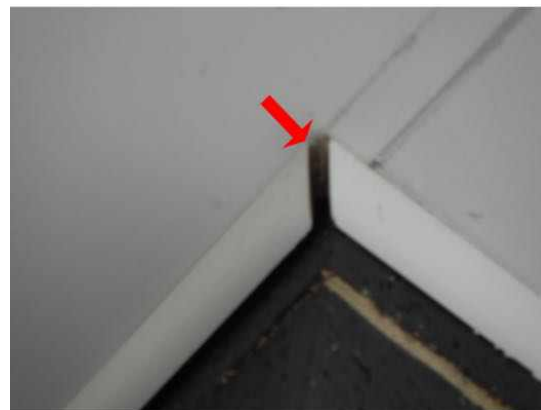
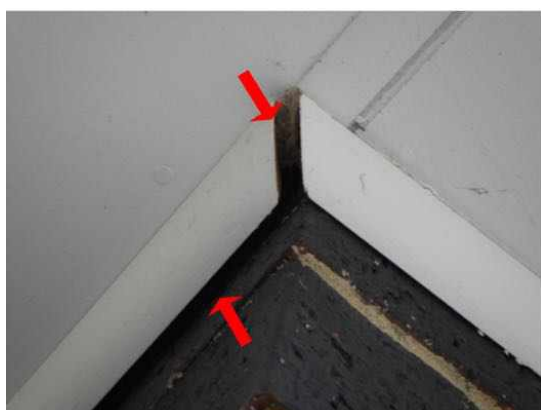
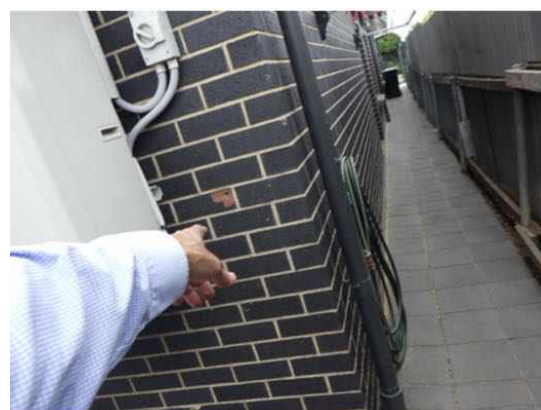
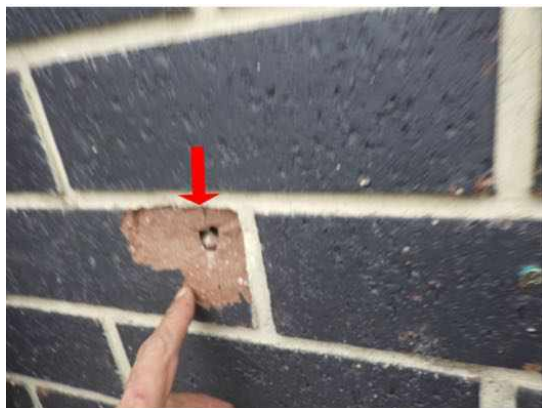
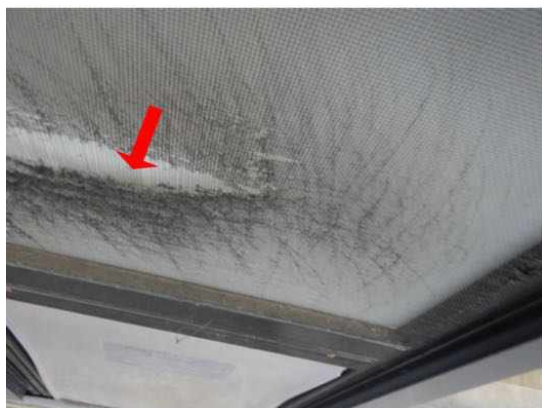
Defects 3.02

Building: Building 1  
 Location: All External Areas >  
 Finding: Building element - Damaged/ Loose from its original fixing  
 Information: At the time of inspection it was noticed that few sections of building elements were damaged / loose from its original fixing around the property - eg- External wall front - Timber member loose from its original fixing , rear brick - chipped & Sliding door frame assembly - flyseen damaged.

Breakage occurs generally when the building materials have either aged and decayed, or as a result of damage (accidental or deliberate).

Repair and/or replacement of broken elements is advised to ensure that additional secondary defects do not arise as a consequence. Such works are necessary, as all building elements play a key role in the operation and function of the overall structure and its performance.

A relevant tradesperson should be appointed to repair or replace the affected building element prior to any subsequent damage being caused.

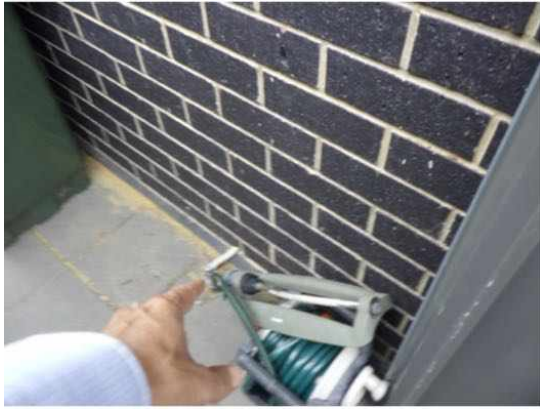
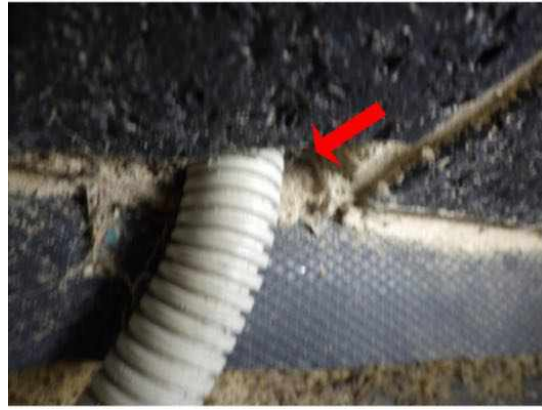
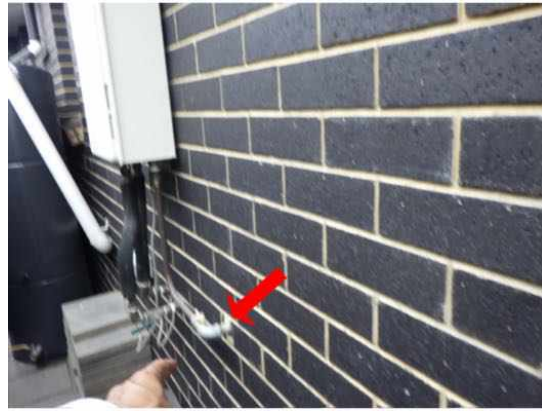
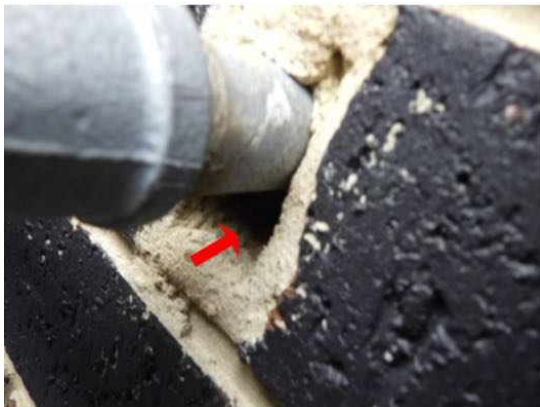
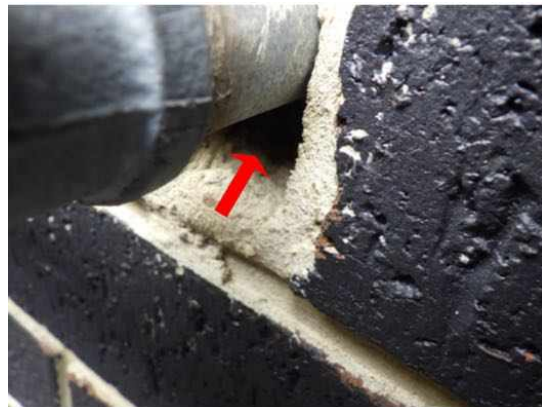
### Defects 3.03

Building:	Building 1
Location:	All External Areas
Finding:	External walls - Holes
Information:	Significant holes were identified around pipe penetrations in this wall section. It is suspected that the installation of this pipework was completed to a substandard level of workmanship or is incomplete.

Gaps and holes around pipework makes the area susceptible to insect and vermin ingress, as well as allowing water penetration to the cavity wall. As such, associated building elements are likely to deteriorate at an accelerated rate, and major implications are expected if holes around the pipework are left unmanaged.

All excessive holes, gaps or cracks should be adequately filled by a suitable sealant or trimmings as soon as possible to prevent any further damage. Such works may be conducted by a general handyperson or licensed plumber.

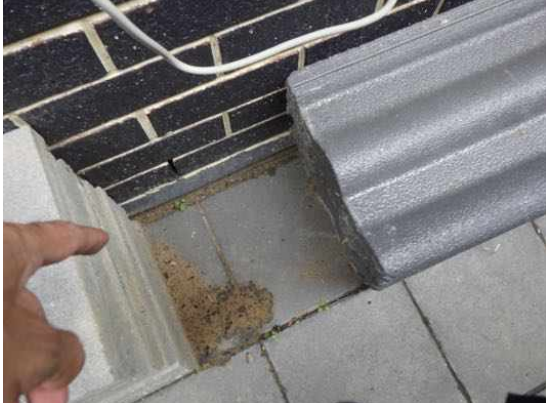
### Defects 3.04

Building:	Building 1
Location:	All External Areas
Finding:	Bridging - Vegetation
Information:	Where vegetation obstructs inspection of building elements, also known as bridging as it provides a bridging point for the access of termites, full inspection can not be achieved. Consequently moisture or dampness may be present and the areas becomes conducive to termite activity. Plants against or very close to buildings provide cover, shade and can provide an environment that is attractive to termite infestation.

The removal and replanting of species that do not provide "cover" or cutting back of

existing vegetation will assist greatly in preventing Bridging from occurring.

The removal of any such materials that may be conducive to termite activity should be carried out as soon as possible and arrange re inspection to minimize the risk of termite attack.

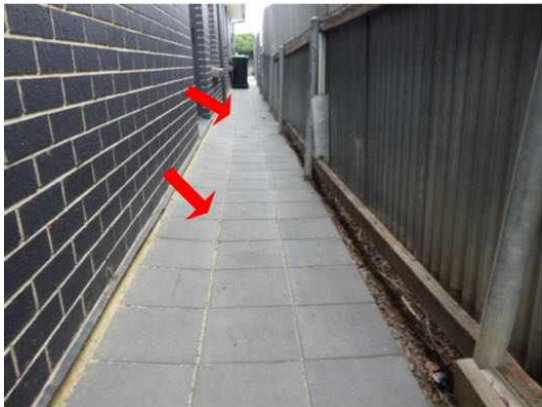
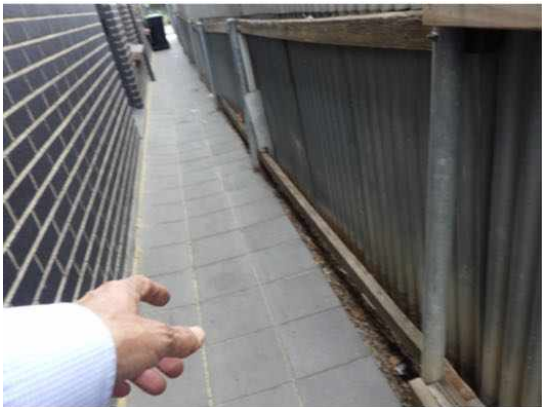
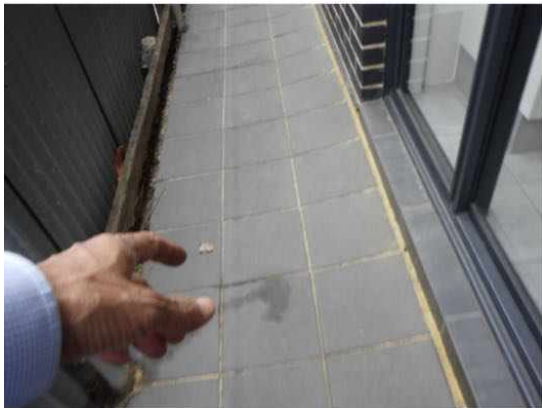
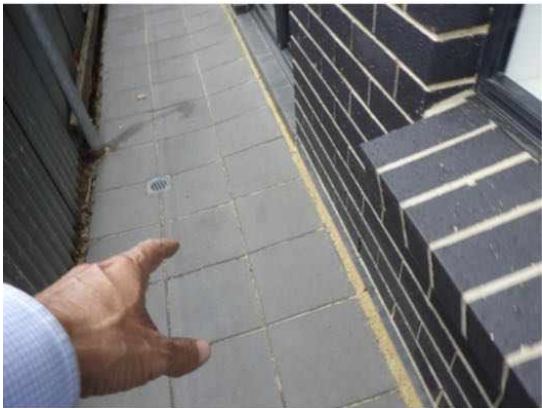
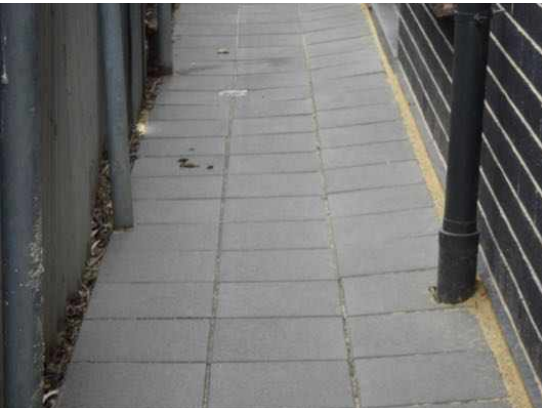
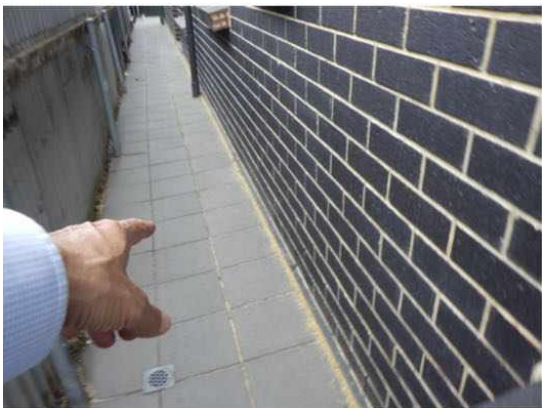
**Defects 3.05**

Building:	Building 1
Location:	All External Areas
Finding:	Paving - Uneven
Information:	Sections of the external paved area are uneven, creating a potential trip hazard. It

appears as though the area has been subject to rough installation, or that paving sections have lifted due to movements in the foundation of the property.

Where paving creates a trip hazard, personal injury may ensue if due caution is not taken by all persons within this area.

Re-paving of the area is required as soon as possible to remedy this situation. Further consultation with a specialist concreter is advised.

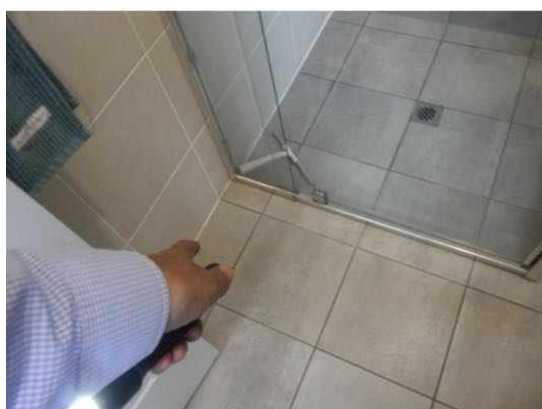
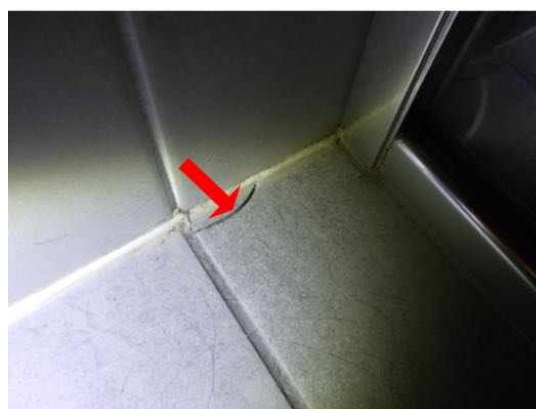
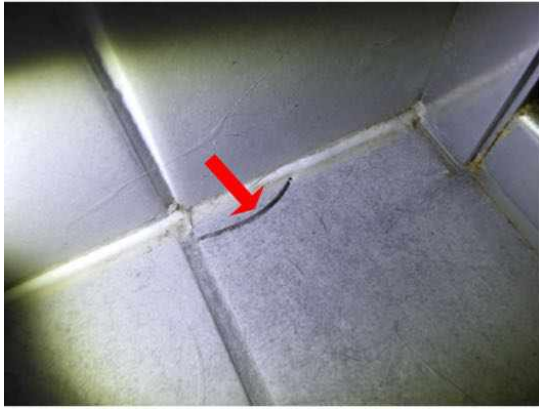
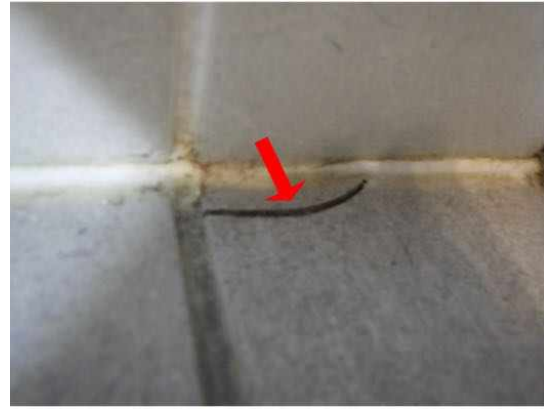
### Defects 3.06

Building:	Building 1
Location:	Bathroom - Ensuite
Finding:	Floor tiles - Cracked
Information:	Cracking in the floor tiles was evident in this bathroom - ensuite area at the time of inspection. It is suspected that this cracking has occurred as a result of the floor being uneven and lacking a solid or suitable foundation for the tiles to be laid on. Settlement in the floor foundations may also have caused movement and resulted in the cracking of tiles in this area.

Cracked tiles throughout the household detract from the overall appearance of the affected areas, as well as creating potential for water penetration to adjoining building elements. If left unmanaged, water damage may occur as a result of constant water penetration over a prolonged period of time.

While not considered a matter of urgency, replacement of cracked floor tiles is advised as a solution. A tiling contractor or general handyperson may be appointed to perform these works at client discretion. Where cracks become more numerous, consultation with a registered builder may be required.

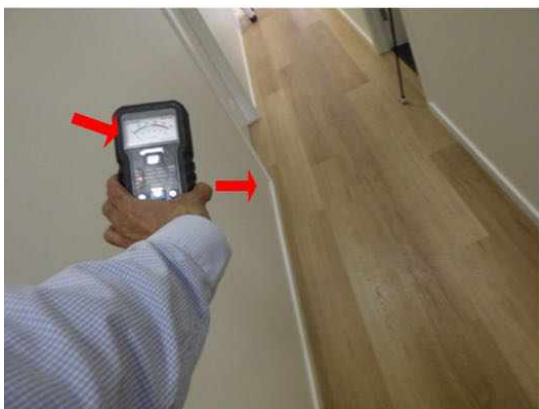
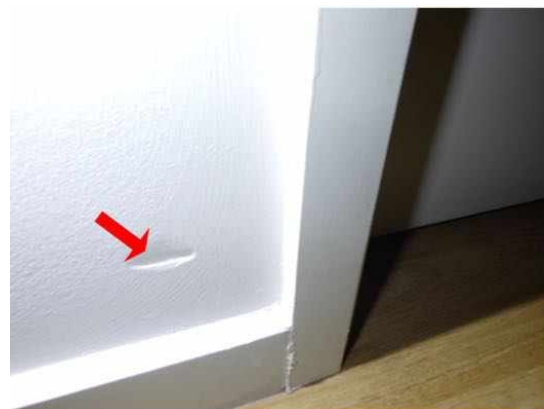
### Defects 3.07

Building:	Building 1
Location:	All Internal Areas
Finding:	Internal wall - Scuffed
Information:	At the time of inspection it was noticed few sections of internal walls are scuffed.

Scuffed surfaces, while detracting from the overall appearance of the affected building element, do not indicate any operational or structural damage. This degree of surface damage is consistent with general wear and tear and minor impact damage, normally accumulated over a number of years.

Marked surfaces may be left as is at the discretion of the client; no repairs or replacement are necessarily required, as this is an appearance defect. However, the client may wish to seek quotations for the cost to refurbish or replace the identified building element.

A general handyman or plasterer may be appointed to rectify marked surfaces if considered necessary by the client.

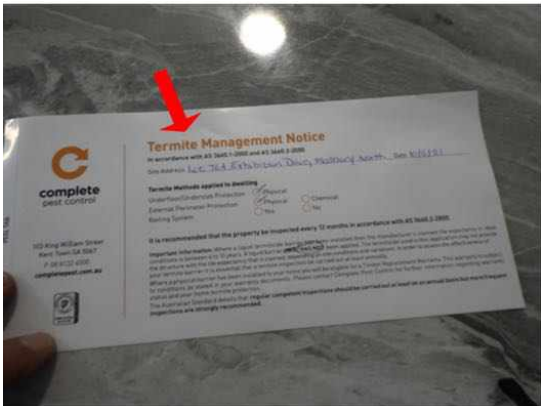
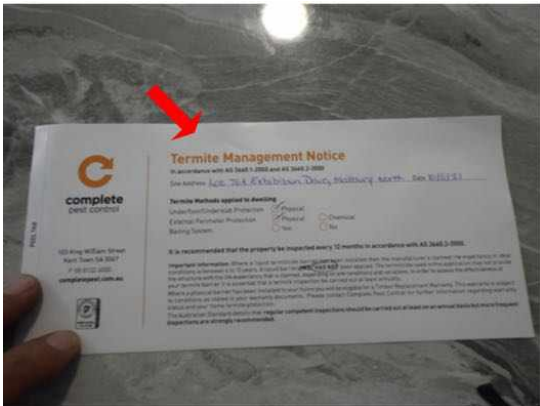
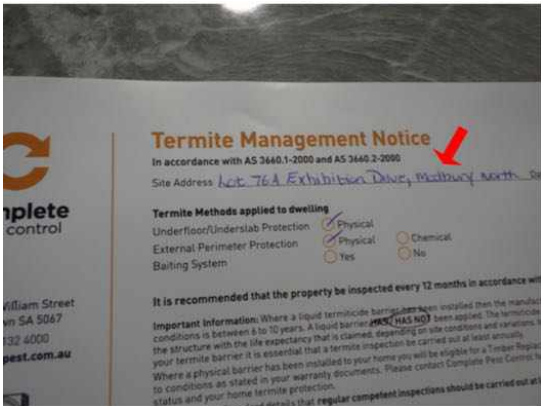
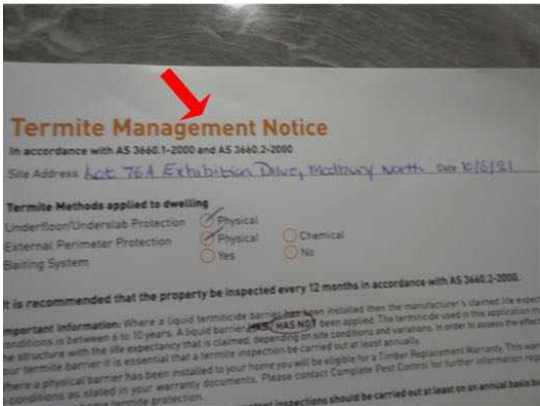
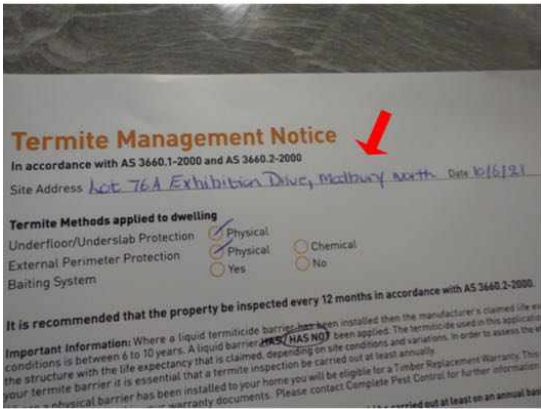
Building: Building 1  
 Location: All External Areas  
 Finding: Evidence of a previous termite management system was identified  
 Information: There are a number of factors which indicate the presence of a previously installed or applied termite barrier. The most common are a durable notice (to the inside of your meter box) observable physical barriers installed to building perimeter and in ground reticulation systems.

Where a Termite Management System has been identified you should refer to the type of barrier date of installation warranty conditions and any documentation provided by a builder or past owner. Consult the company who installed the barrier to confirm whether the system is still under warranty.

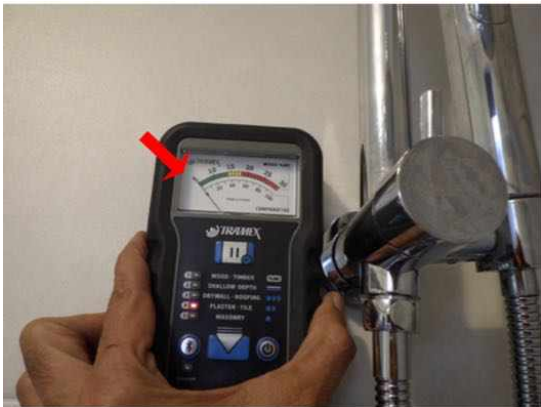
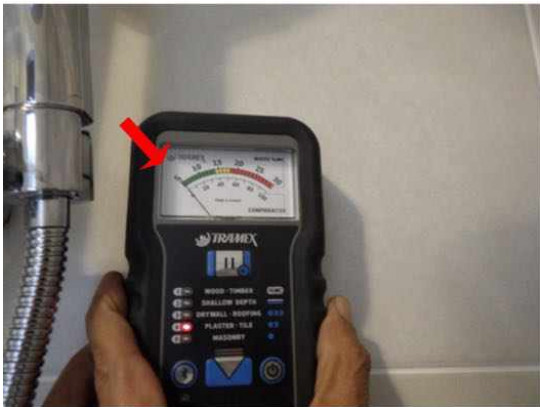
Building: Building 1  
 Location: Bathroom - Ensuite  
 Finding: Shower Alcove - No Damp  
 Information: At the time of inspection it was noticed that damp is not evident to the shower alcove.
