Building and Timber Pest Inspection Report

Inspection Date: Tue, 3 Mar 2026

Property Address: 14A Eastern Arterial Rd, St Ives NSW 2075,
Australia

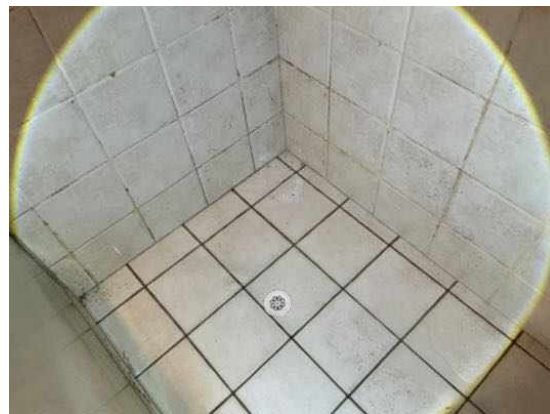
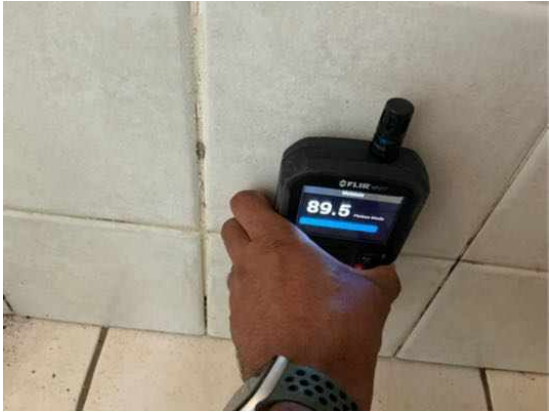
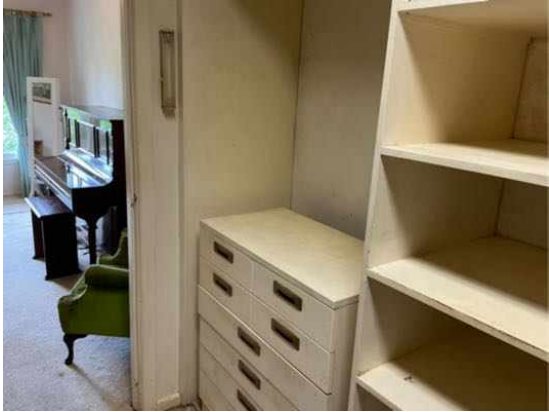
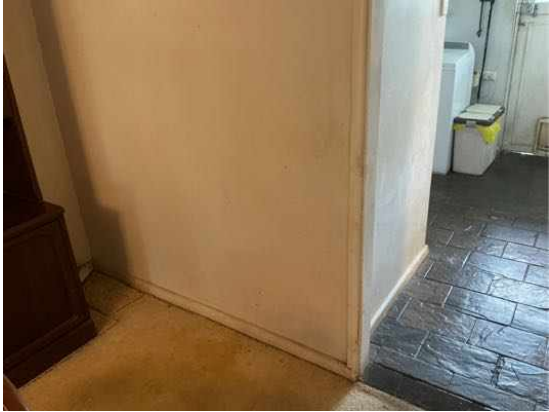
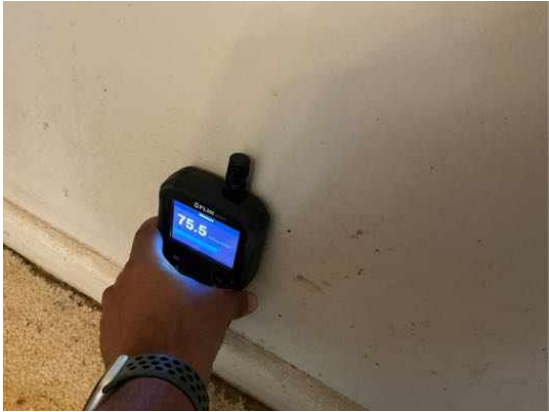
Finding: Excessive Moisture - Waterproofing Failed

Information: At the time of inspection, high moisture meter readings were recorded at the base of the bathroom wall, indicating that the waterproofing system has failed and is no longer performing as intended. The presence of excess moisture suggests ongoing water penetration behind wall finishes, which poses a risk of structural damage, timber decay, tile debonding, and potential mould development if left unresolved.

This issue is categorised as a major defect, as the failure of waterproofing compromises the integrity of the bathroom structure and requires specialist attention. It is strongly recommended that the client engage a licensed plumber to assess and rectify any plumbing-related causes contributing to moisture ingress, followed by a qualified waterproofing specialist to remove affected finishes, repair damaged substrates, and reinstate a compliant waterproofing system to current standards.

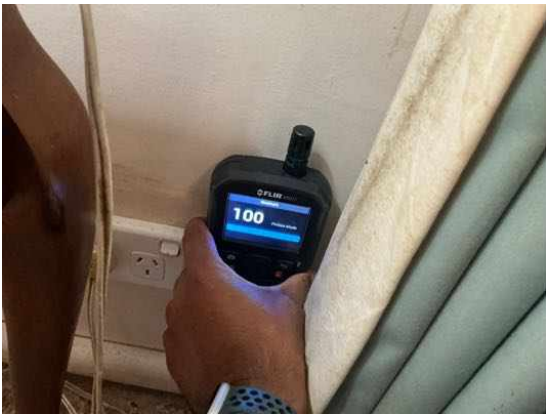
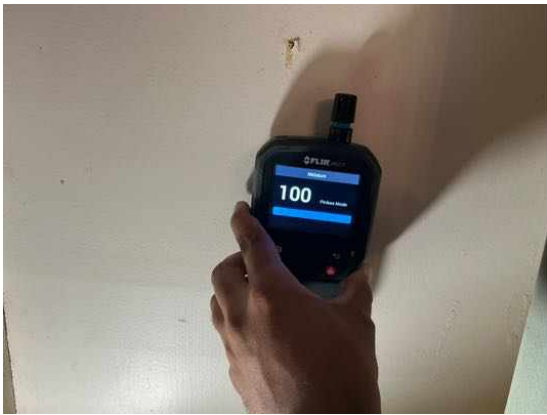
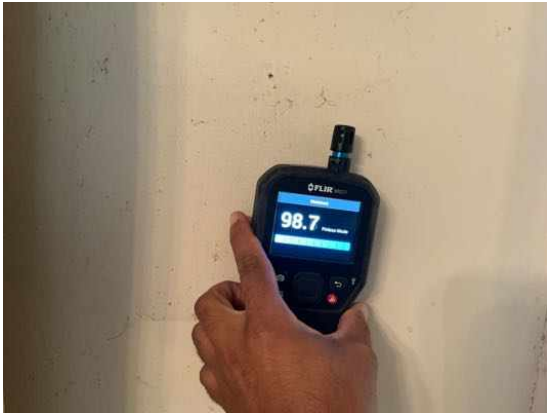
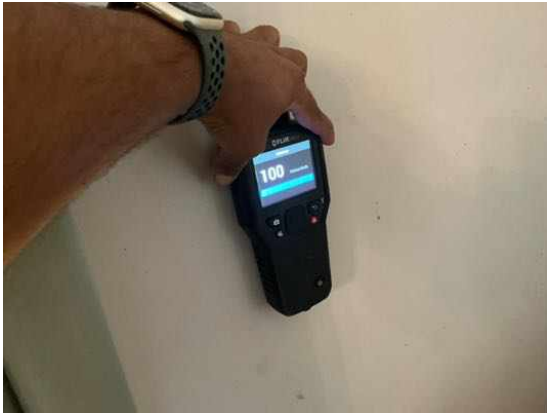
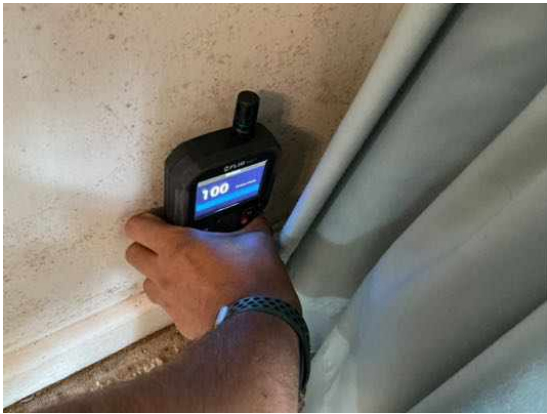
Finding 2.02

Building:	Main Building
Location:	All Areas
Finding:	Excessive Moisture Throughout Internal Walls
Information:	At the time of inspection, elevated moisture readings were recorded to multiple internal wall areas throughout the dwelling using a moisture meter. Readings were noted to be significantly high in several locations, particularly along lower wall sections and adjacent to external walls and window areas.

The property was reported by the real estate agent to have been vacant and closed for an extended period. Lack of ventilation in unoccupied homes can contribute to moisture build-up and condensation internally. However, additional contributing factors were observed externally and within the subfloor area. These include deteriorated roof mortar, gutters filled with debris, evidence of water ponding to eaves areas, inadequate surface drainage around the perimeter of the dwelling, and inadequate subfloor drainage. Poor drainage within the subfloor can allow moisture to accumulate beneath the dwelling, contributing to rising damp conditions and elevated moisture readings internally.

Prolonged elevated moisture levels can result in paint deterioration, mould growth, material breakdown and potential timber decay if not addressed.

- Engage a licensed roofer to inspect the roof covering and ridge capping mortar and carry out necessary repairs and/or resurfacing works.
- Arrange for thorough cleaning of all gutters and ensure ongoing regular maintenance.
- Improve surface drainage around the dwelling and rectify subfloor drainage issues to prevent water accumulation beneath the structure.
- Consider installation of mechanical subfloor ventilation to improve airflow and reduce moisture build-up beneath the dwelling.
- Repaint affected internal areas once above sources have been rectified.
- Increase ventilation internally by opening windows periodically to allow airflow through the home.
- Engage a qualified damp-proofing or moisture specialist to further assess and provide recommendations for rectification if moisture levels remain elevated after external issues are addressed.

Addressing both the building envelope defects, subfloor conditions and ventilation improvements will be necessary to reduce moisture levels within the property.

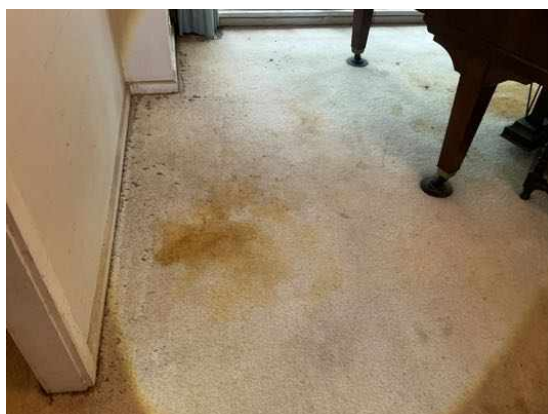
Building: Main Building
 Location: All Areas
 Finding: Carpet - Buckling, Stained & Damaged
 Information: At the time of inspection, the carpet was noted as stained in several areas and also

showing signs of buckling, creating uneven surfaces. Some damaged areas were also noted. These conditions detract from the overall appearance of the flooring and may present a trip hazard if left unaddressed.

It is recommended that a professional carpet cleaner be engaged to treat and clean the stained areas. In addition, a qualified carpet specialist should be engaged to re-stretch or otherwise repair the carpet to eliminate the buckling and restore a safe, even surface. A client is advised to get quotations on new carpet which can be expensive.

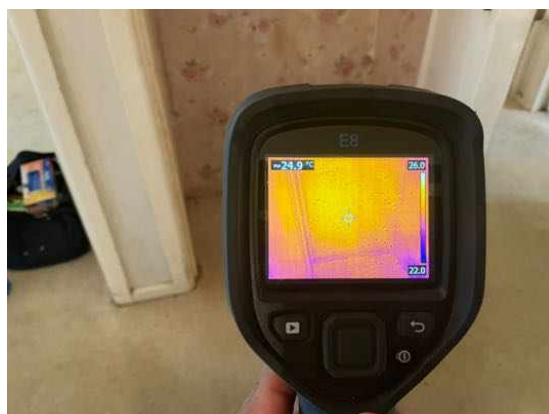
Finding: Stains (Dry) - Wall

Information: At the time of inspection, stains were noted on the internal wall surfaces; however, the areas were dry and no active moisture ingress was detected. These stains are likely the result of a previous moisture event, such as an historic roof leak or past water penetration during heavy rain, which may have since been repaired. The affected areas appear cosmetic at this stage, but the client is advised to monitor the walls over time, particularly after periods of heavy rainfall, and if staining worsens or moisture reappears, a roofing or waterproofing specialist should be consulted to further investigate. Repainting may be considered once it is confirmed that the issue is no longer active.

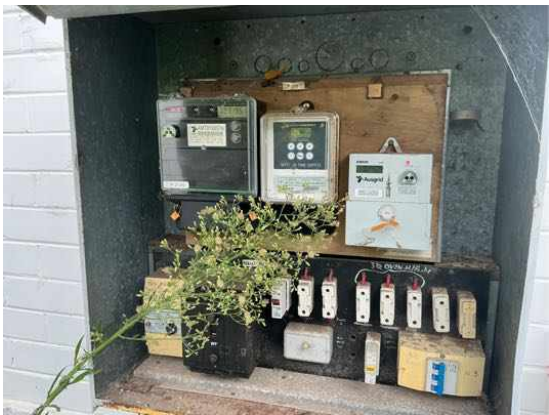
Noted Item

Building: Main Building
 Location: Meter Box
