Building and Timber Pest Inspection Report

Inspection Date: Wed, 1 Apr 2026

Property Address: 7 Manor Grn, Macleod VIC 3085, Australia

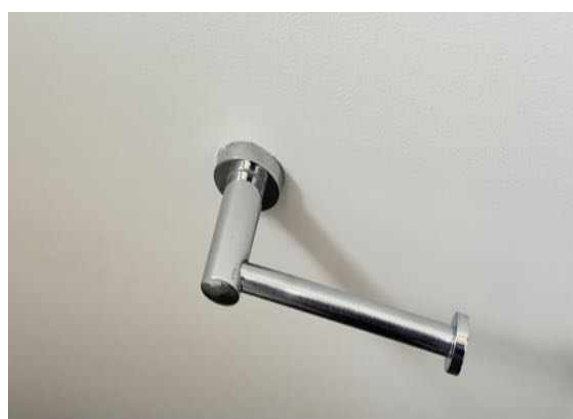
Building: Main Building
 Location: Toilet (WC)
 Finding: Fittings - Loose
 Information: Fittings were observed to be loose and inadequately secured to walls in this area,

moving when light pressure was applied. This reduces usability and may cause further damage if not addressed.

Common causes include incorrect or inadequate fixings, use of anchors unsuitable for the wall type, movement of the wall or timber substrate, wear from repeated use, or improper installation.

If left unresolved, loose fittings may detach, damage wall finishes, or cause progressive deterioration of both fittings and surrounding surfaces.

When practical, a qualified carpenter or experienced handyman should be engaged to securely refix or replace all loose fittings using appropriate fixings and methods for the wall type. The fittings should be monitored over time to ensure they remain secure.

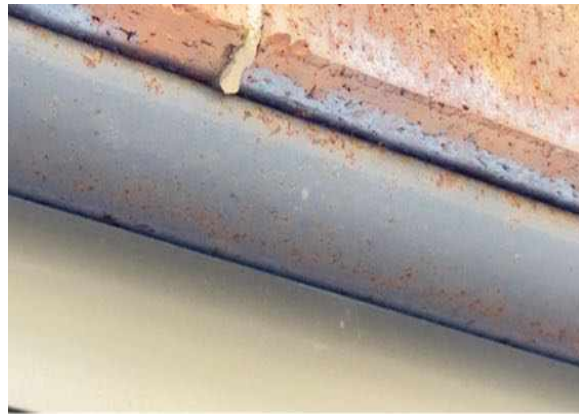
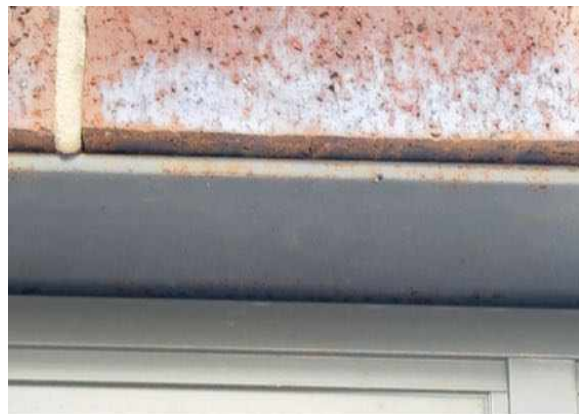
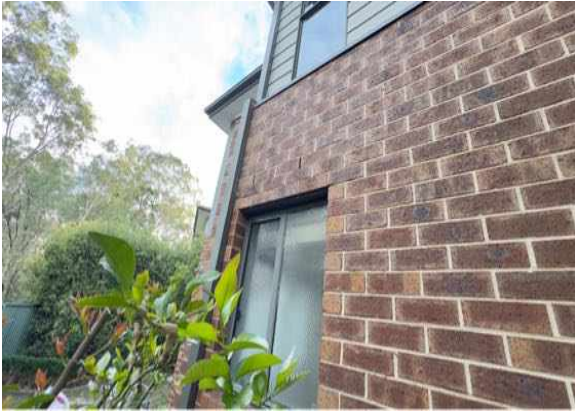
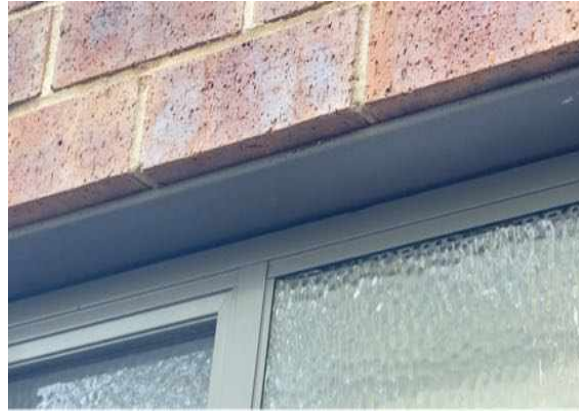
Building: Main Building
Location: All External Window Lintel Areas
Finding: Building Element Hardware - Rust & Corrosion
Information: This building element shows evidence of rusting and corrosion, which is likely to have developed as a result of excessive exposure to moisture and or inadequate coatings. As surface rust provides no protection to the underlying iron, the deteriorating condition is likely to worsen if not addressed in the short-term future.

These items can sometimes be treated but more than likely will require replacement. Where possible, the use of galvanized (treated) metals or aluminium coated metals aid in rust prevention, as does regular general maintenance. Rust formation can be controlled with coatings, such as paint, that isolate the iron from the environment.

Rusting and corrosion should be managed by ideally removing or limiting the affected surface from exposure to moisture. A qualified handyman or carpenter may be appointed to replace any building elements that have been affected by rust or water damage.

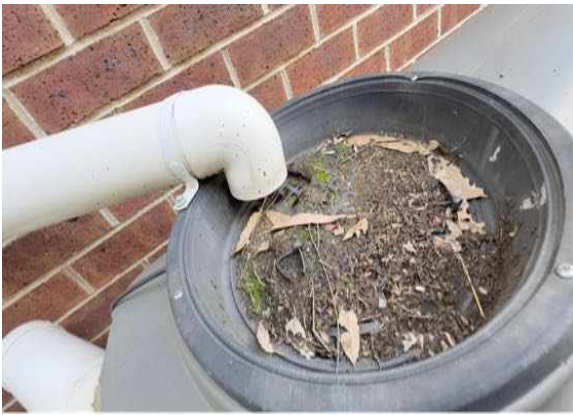
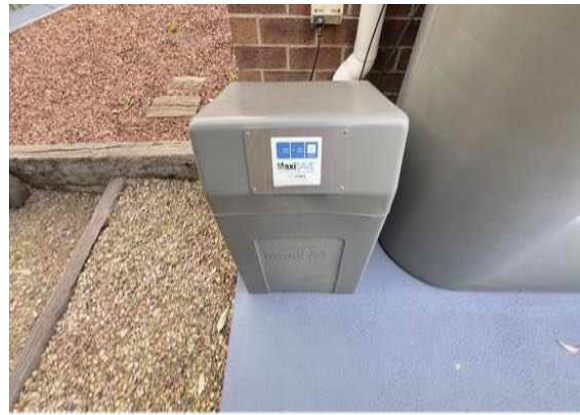
This has likely occurred due to a build-up of leaves and debris from the roof and gutters. A blocked leaf strainer may cause water to overflow, back up into gutters, or discharge uncontrolled around the tank and building.

A licensed plumber or competent hand man is required to clean and clear the leaf strainer. This should be attended to immediately to allow proper water flow and prevent overflow or damage.

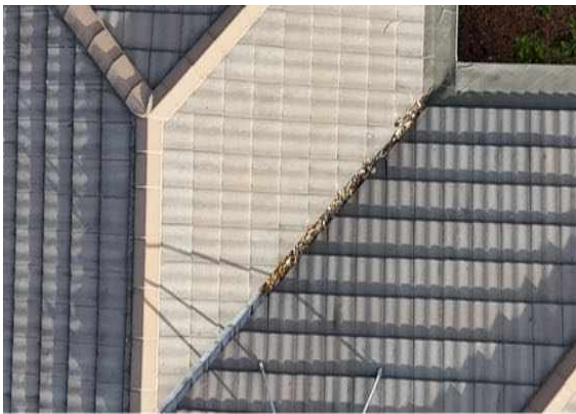
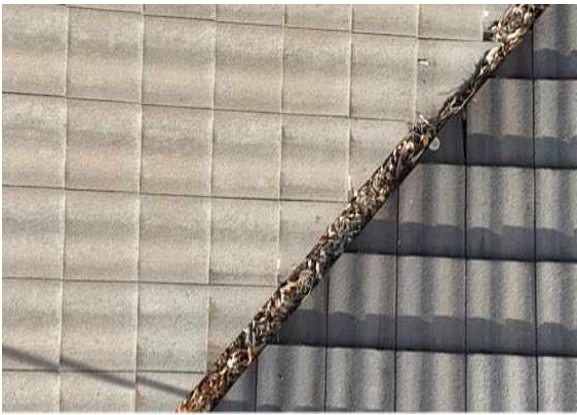
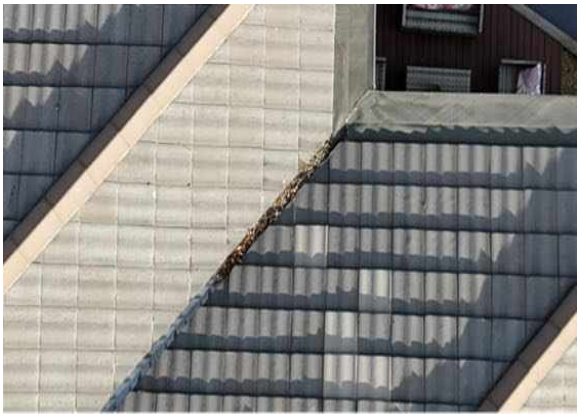
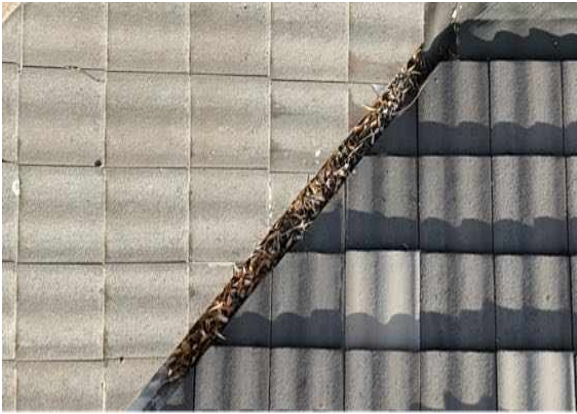
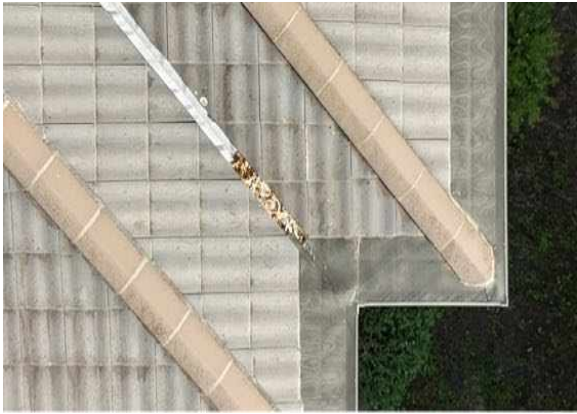
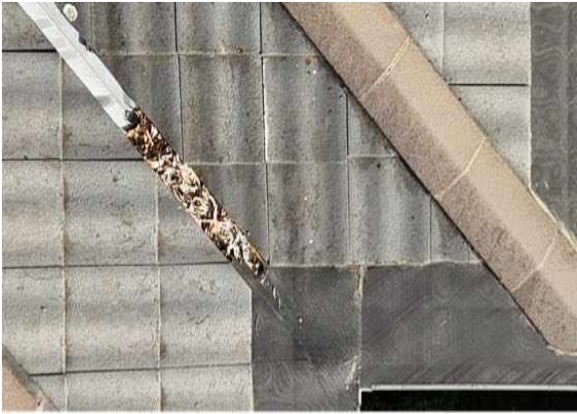
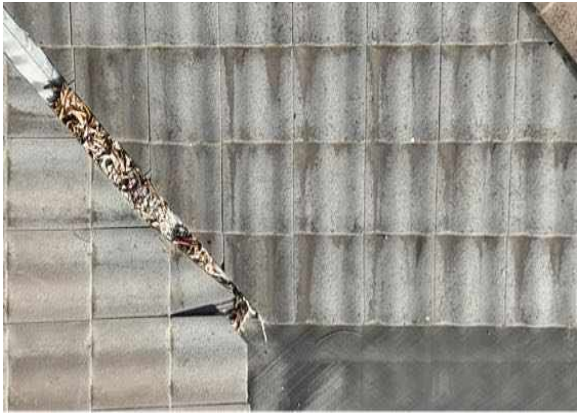
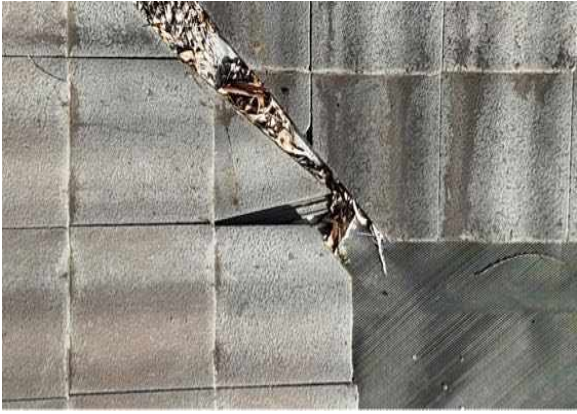
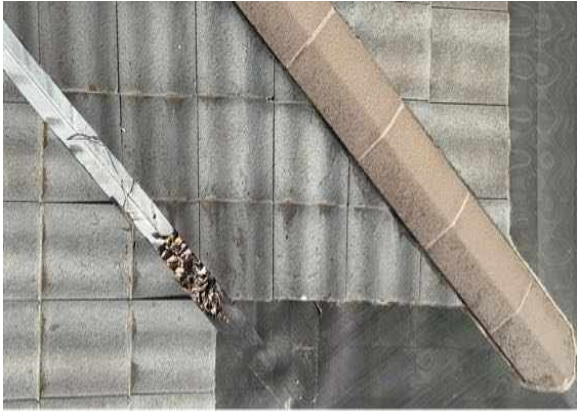
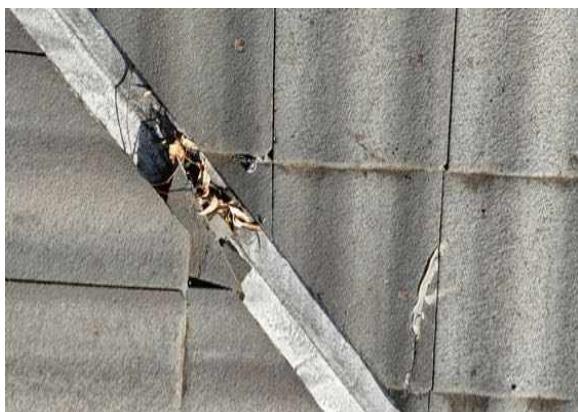
This has likely occurred due to lack of maintenance or build-up of debris over time. Blocked gutters may cause water to overflow, damage the roof, walls, or foundations, and increase the risk of erosion or water ingress.

A licensed roof plumber or competent handy man is required to inspect and clear the blocked gutters in this area. This should be rectified immediately to ensure water drains correctly and to prevent potential damage to the building.

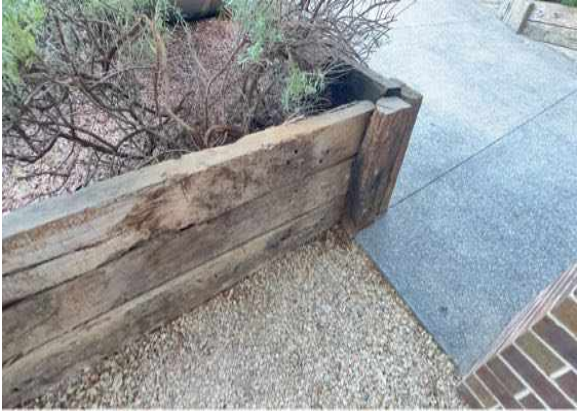
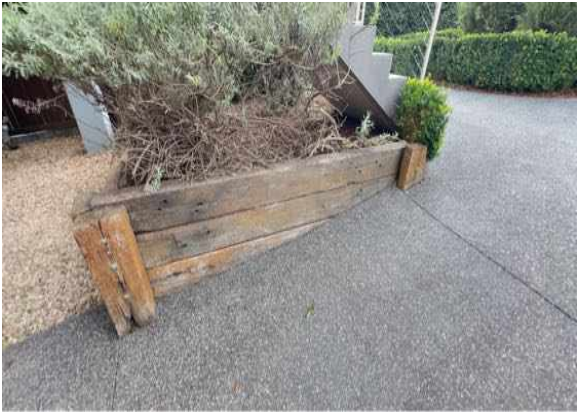
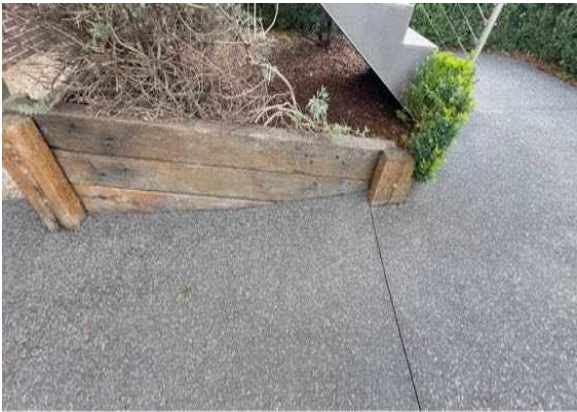
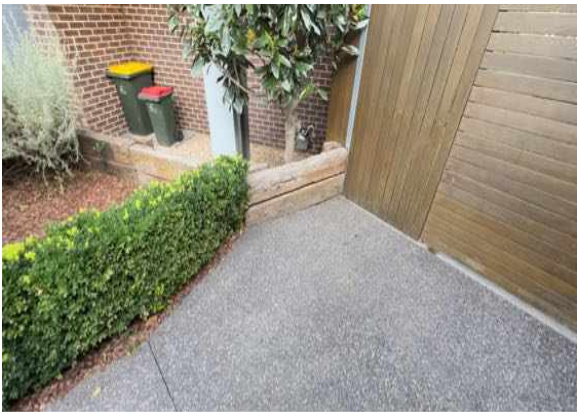
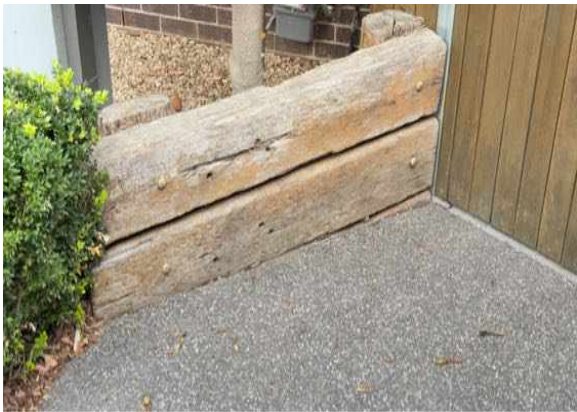
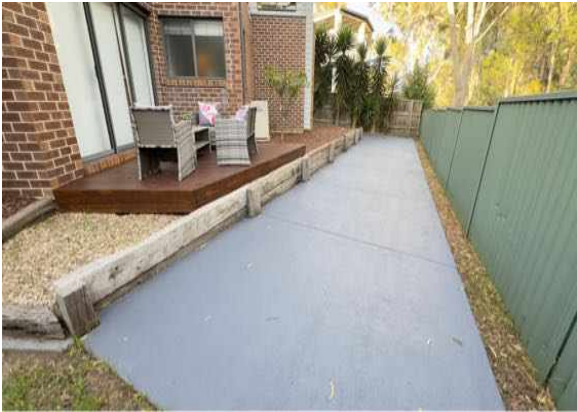
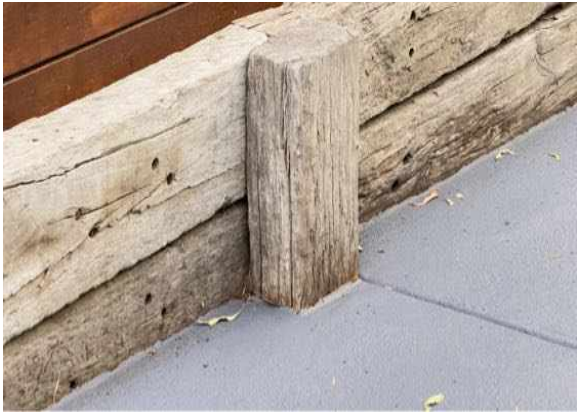
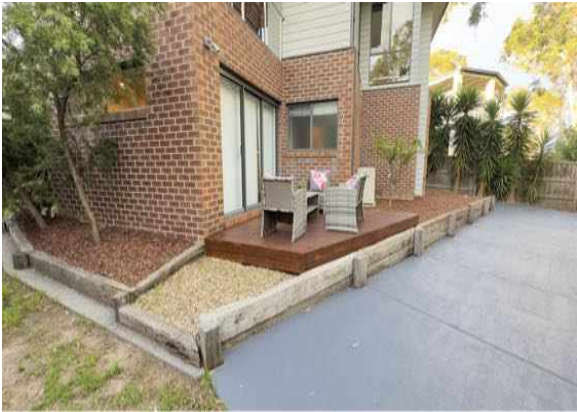
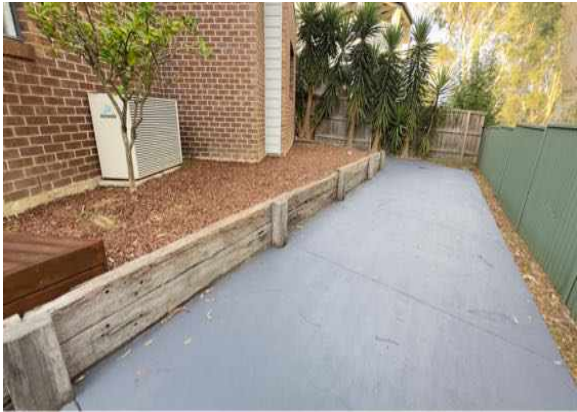
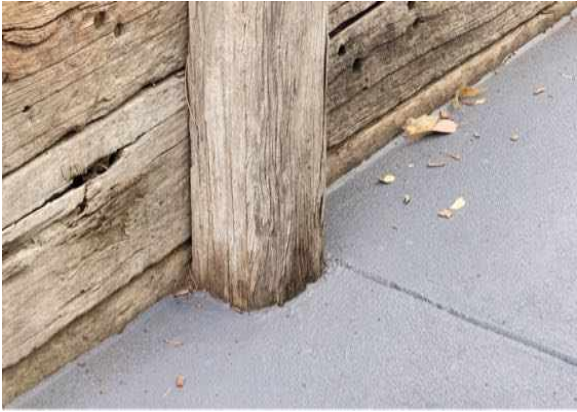
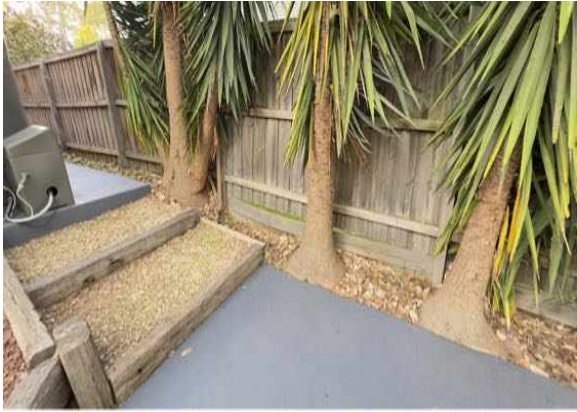
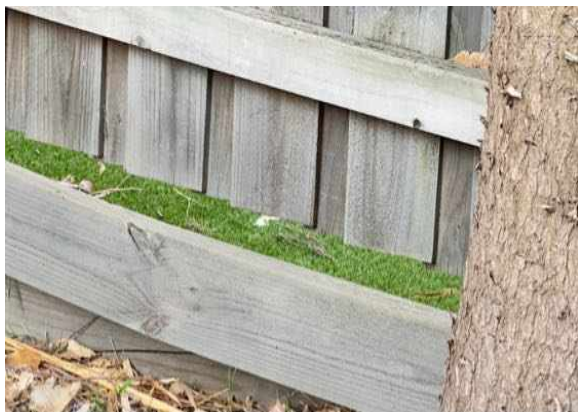
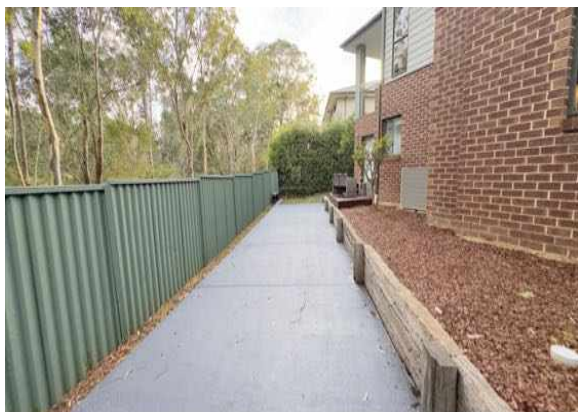
Finding 6.04

Building:	Main Building
Location:	All External Areas
Finding:	Timber Pests - Conducive Conditions - External Exposed Timbers
Information:	During the inspection, external exposed timbers were observed in this area. Timber that is in direct contact with soil, landscaping, or exposed to weather conditions such as rain and humidity is highly susceptible to termite attack and other timber pests. Moisture and environmental exposure can soften timber and make it more attractive and accessible to pests.

It is recommended that a registered builder or qualified carpenter assess all external timbers and undertake necessary remedial works. This may include repairing or replacing deteriorated timbers, applying protective coatings, ensuring adequate clearance from soil or vegetation, and preventing timber from coming into direct contact with moisture-prone areas.

A licensed pest management technician should also inspect the property to assess the potential risk of timber pests and determine whether additional preventative measures, such as termite barriers or monitoring systems, are required. Regular maintenance, moisture control, and pest inspections are essential to protect exposed timbers and maintain the safety and durability of the building.

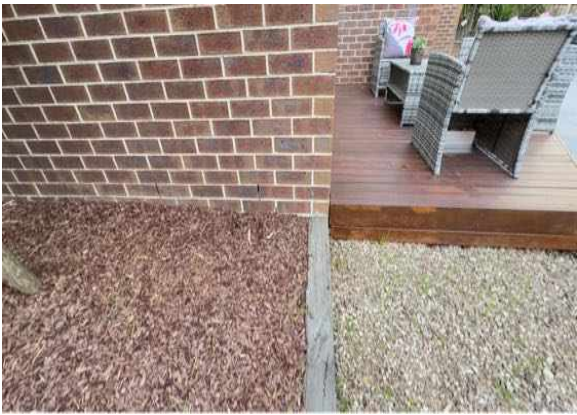
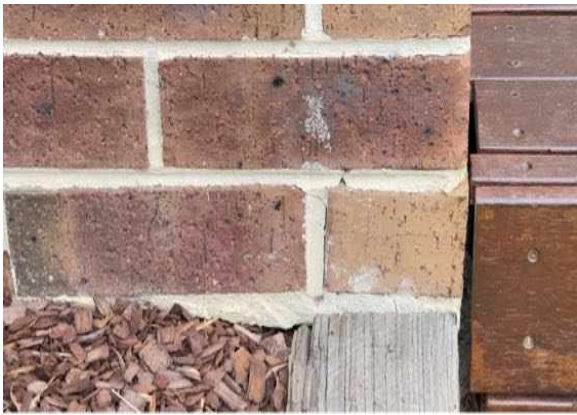
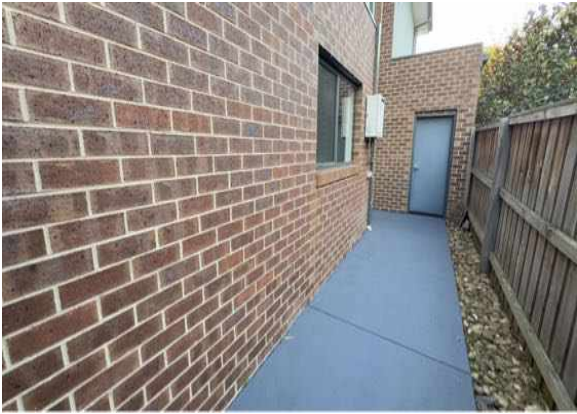
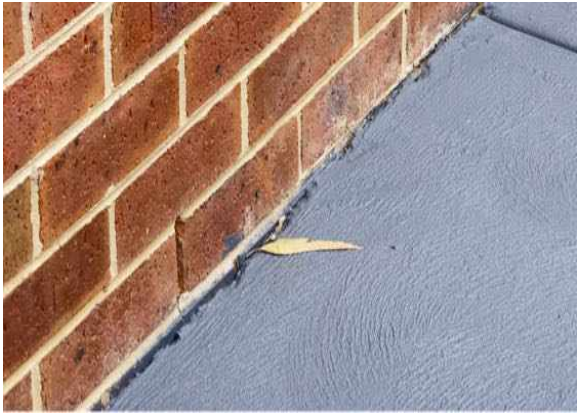
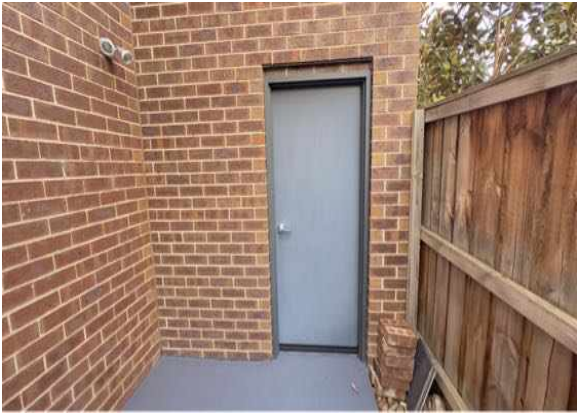
Finding 6.05

Building:	Main Building
Location:	All External Areas
Finding:	Timber Pests - Conducive Conditions - No Slab Edge Exposure
Information:	During the inspection, it was noted that there is no exposed slab edge in this area. While this may initially seem positive, the absence of visible slab edges can create conditions where termite activity goes undetected. Without slab edge exposure, concealed entry points for termites may exist beneath flooring or along hidden wall junctions, reducing the ability to monitor and inspect for potential infestations.

Additionally, a registered builder should be engaged to advise on methods to improve visibility and access to slab edges where practical. Regular inspections, maintenance of clear zones around walls, and ongoing termite management are essential to mitigate concealed timber pest risks and ensure the structural safety of the building.

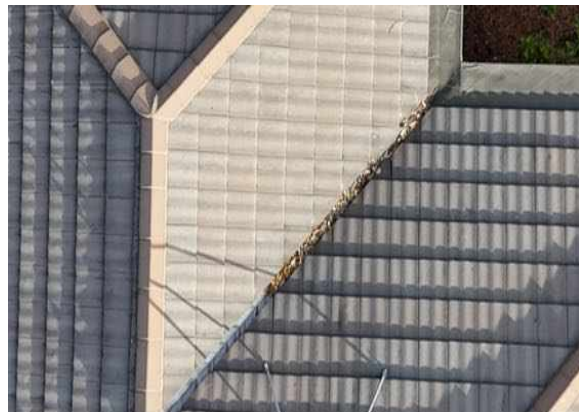
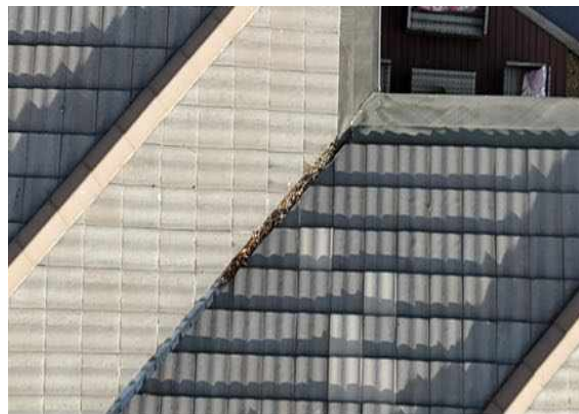
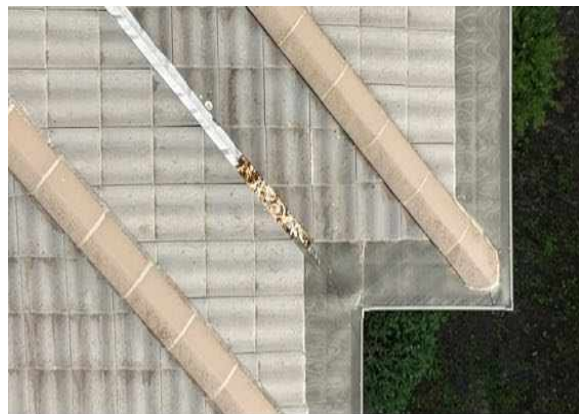
Building: Main Building
Location: All External Areas
Finding: Timber Pests - Conductive Conditions - Gutters Blocked
Information: During the inspection, gutters were observed to be blocked, resulting in water overflow and poor roof drainage. Blocked gutters are a significant concern as they can cause moisture to accumulate around roof edges, fascia boards, wall cavities, and subfloor areas. Persistent moisture in these locations creates conditions highly conducive to timber pest activity, including termites, borers, and fungal decay.

Moisture-related conditions of this nature substantially increase the risk of timber pest infestation and can accelerate deterioration of structural timbers if left unaddressed, potentially leading to progressive damage and higher repair costs.

It is recommended that a qualified roofing contractor or competent handyman be engaged promptly to clear and service all gutters and downpipes and ensure effective drainage away from the building. Ongoing gutter maintenance, in conjunction with regular timber pest inspections, is essential to reduce moisture-related risks and protect the long-term integrity of the structure.
