Building and Timber Pest Inspection Report

Inspection Date: Thu, 19 Mar 2026

Property Address: 19 Peter Cl, Hornsby Heights NSW 2077, Australia

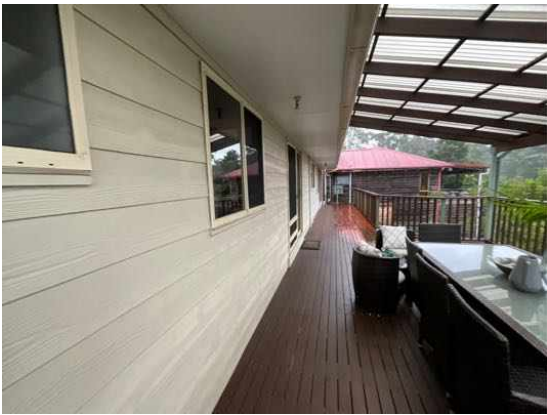
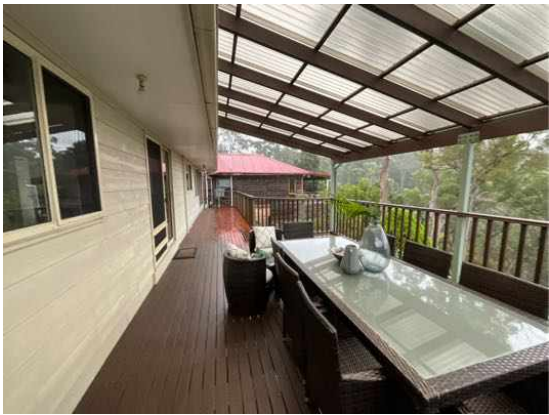
Building:	Main Building
Location:	All Areas
Finding:	Asbestos - Suspected ACM Identified on Site
Information:	Reporting on Asbestos is outside the Scope of this Report. This suspected defect is highlighted as a caution only. We suspect, based on our experience in the building industry, that there is a higher risk of the identified building element containing asbestos.

As Asbestos Reporting is outside the scope of this report, we advise that you consider a separate Asbestos Inspection and Condition Audit, which can include the taking of samples for definitive confirmation of the presence of Asbestos.

In the interim, the client is advised to act with caution, especially when considering any damage to building materials general wear and tear renovations extensions demolition and general maintenance activities due to the suspected presence of Asbestos.

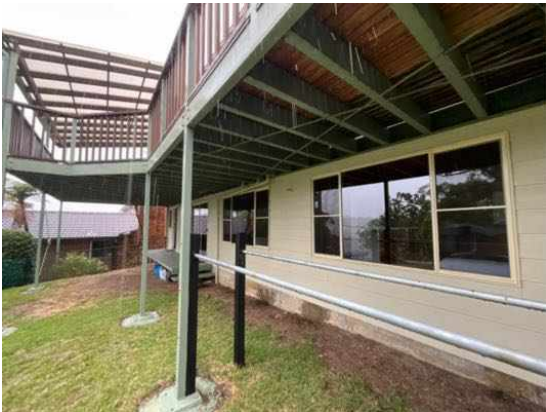
External timber structures are also constantly exposed to weather deteriorates in an exhilarate manner, ongoing assessments are required.

It is highly recommended that a structural engineer further, assess the external timber balcony or a deck to inform the client of its load capacity.

Regular maintenance inspections by competent practitioners is needed.

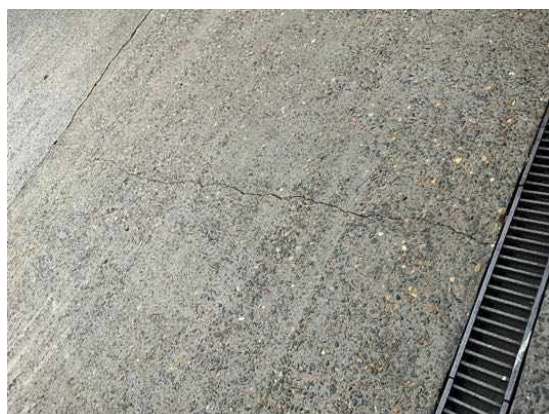
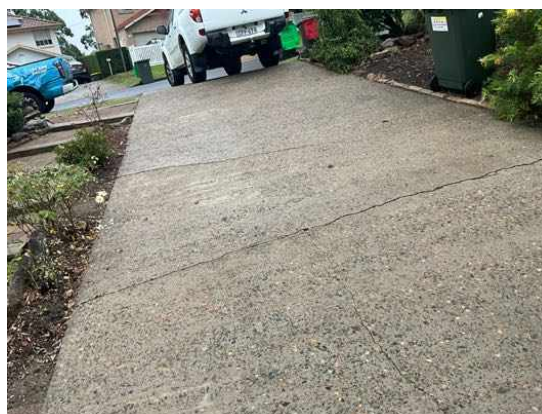
Finding 3.02

Building: Main Building
 Location: All Areas
 Finding: Crack in concrete slab - Category 0
 Information: A crack coded as Category 0 was identified in the slab. A Category 0 crack is described as a hairline crack, representing insignificant movement of slab from level.

The approximate width of the crack to be considered Category 0 is 0.3mm, or change in offset of less than 8mm when a 3m straight edge is placed over the defect.

No rectification is required at this time. However, all cracking should be monitored over a 12 month period to identify any further damage in the area.

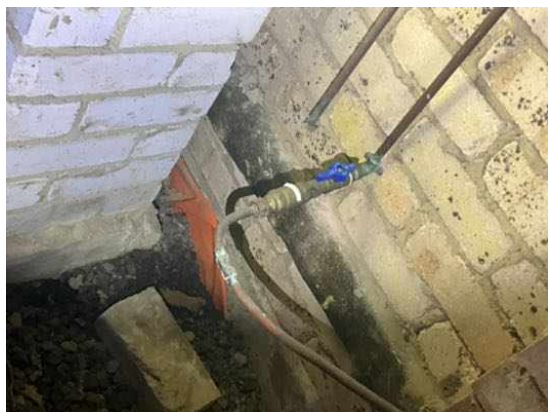
Finding 3.03

Building:	Main Building
Location:	Subfloor
Finding:	HWS Overflow - Not Connected
Information:	The Hot Water System (HWS) overflow was found to be disconnected from storm water drainage and is creating excessive moisture in the surrounding area.

These damp conditions can lead to secondary defects such as rot, rust or corrosion of associated building elements, the formation of fungal decay, or even the creation of potential slip hazards. When coupled with poor site drainage, pooling of water may also attract termite activity to this area.

It is highly recommended that a licensed plumber be appointed to connect the HWS overflow in order to prevent such an environment from being created. These minor works should be carried out as soon as possible.

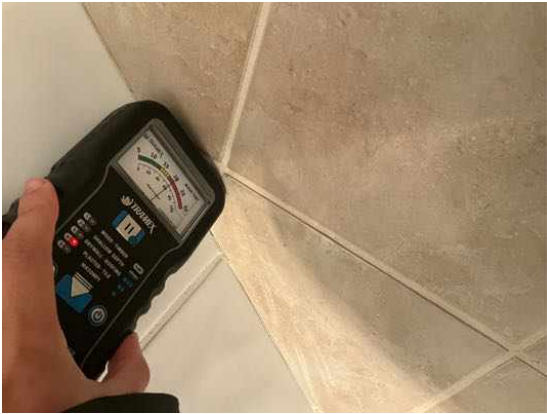
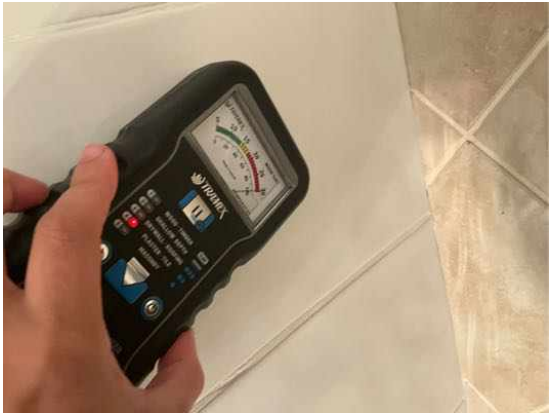
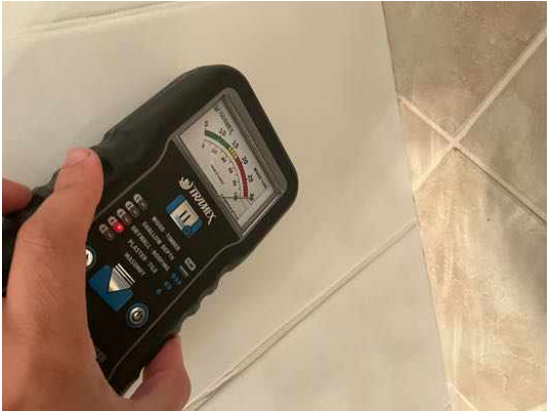
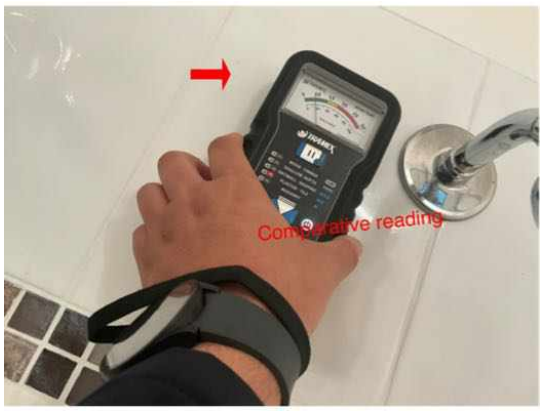
Finding 3.04

Building:	Main Building
Location:	Bathroom
Finding:	Evidence of excessive moisture was present at the time of inspection
Information:	Excessive moisture is present behind the bathroom tiles, indicating a potential water leakage issue within the wall.

The prolonged presence of moisture can lead to mold growth, deteriorate the structure, and create an environment conducive to health hazards. Additionally, it may compromise the adhesive holding the tiles, leading to their detachment.

A licensed plumber or a qualified contractor specializing in water damage remediation should investigate the source of the moisture, fix any leaks, and address the damage. Additionally, replacing affected tiles and ensuring proper waterproofing are crucial to preventing future issues.

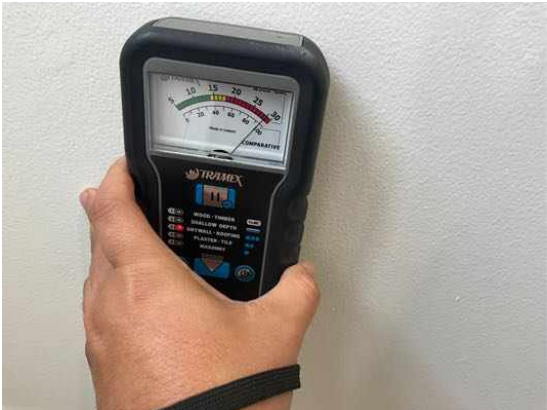
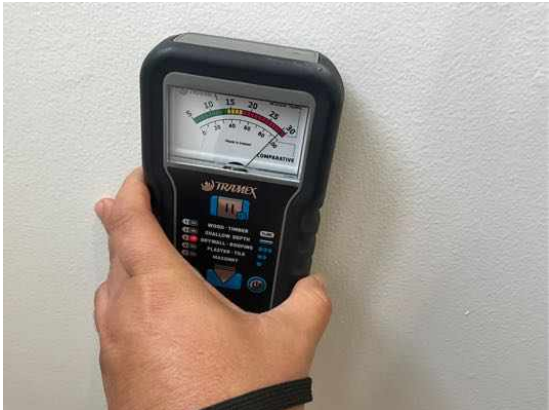
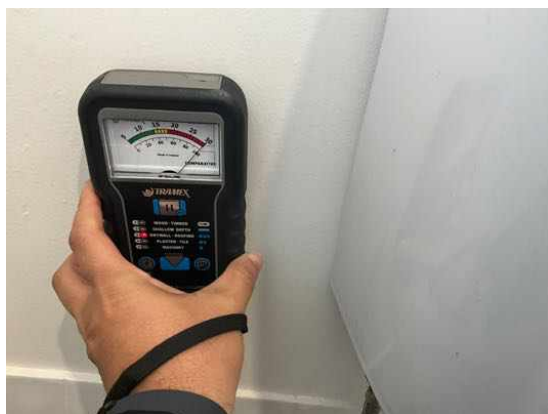
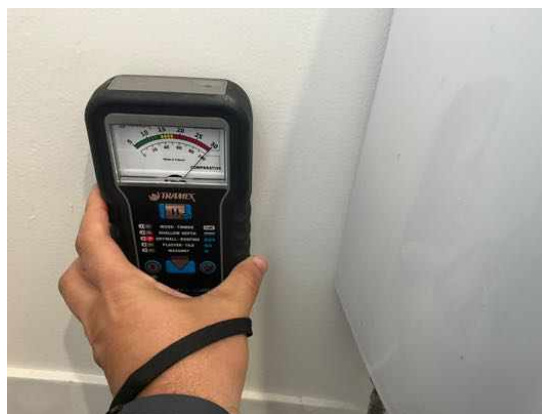
Finding 3.05

Building: Main Building
Location: Toilet (WC)
Finding: Evidence of excessive moisture - Drywall
Information: Excessive moisture is present at the time of , indicating a potential water leakage issue within the wall.

The prolonged presence of moisture can lead to mold growth, deteriorate the structure, and create an environment conducive to health hazards. Additionally, it may compromise the adhesive holding the tiles, leading to their detachment.

A licensed plumber or a qualified contractor specializing in water damage remediation should investigate the source of the moisture, fix any leaks, and address the damage. Additionally, replacing affected tiles and ensuring proper waterproofing are crucial to preventing future issues.

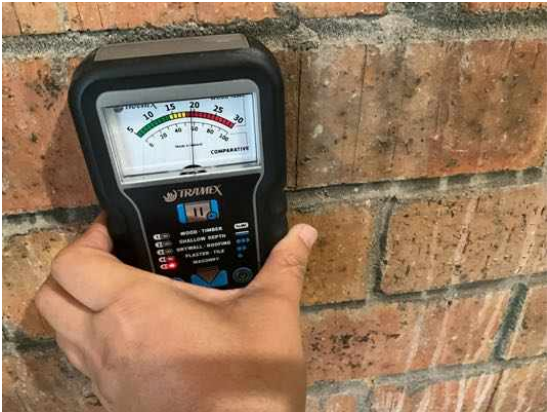
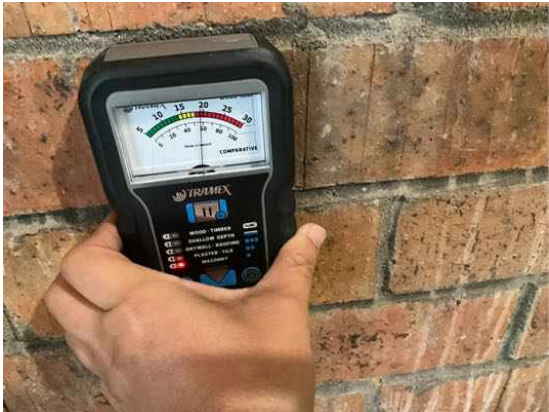
Finding 3.06

Building:	Main Building
Location:	Laundry / Toilet downstairs
Finding:	Evidence of excessive moisture was present at the time of inspection
Information:	Excessive moisture is present behind the bathroom tiles, indicating a potential water leakage issue within the wall.

The prolonged presence of moisture can lead to mold growth, deteriorate the structure, and create an environment conducive to health hazards. Additionally, it may compromise the adhesive holding the tiles, leading to their detachment.

A licensed plumber or a qualified contractor specializing in water damage remediation should investigate the source of the moisture, fix any leaks, and address the damage. Additionally, replacing affected tiles and ensuring proper waterproofing are crucial to preventing future issues.

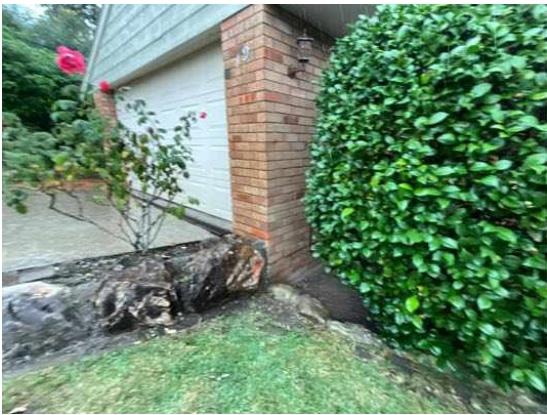
Finding 6.02

Building: Main Building
Location: All Areas
Finding: Dense vegetation around a property can increase the risk of termite infestation
Information: The presence of dense vegetation around a property can increase the risk of termite infestation, as it provides a conducive environment for them. To address this, consider maintaining a clear space between the vegetation and your home. If you suspect a termite issue, it's advisable to consult with a licensed pest control professional for inspection and treatment.

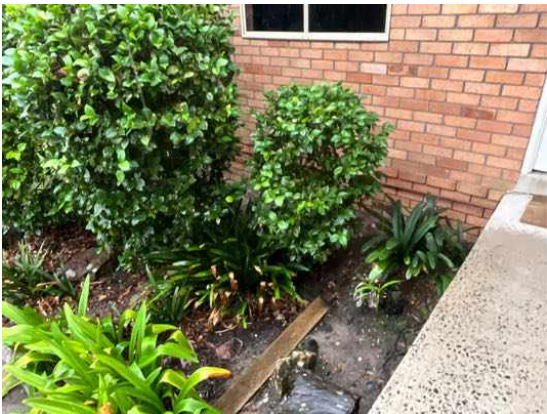
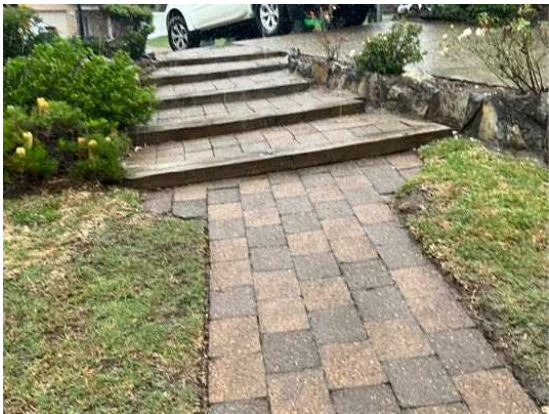
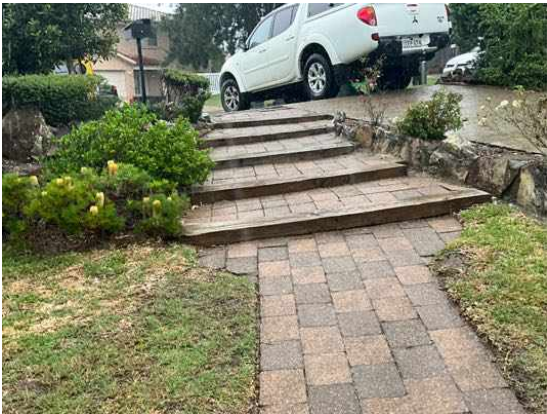
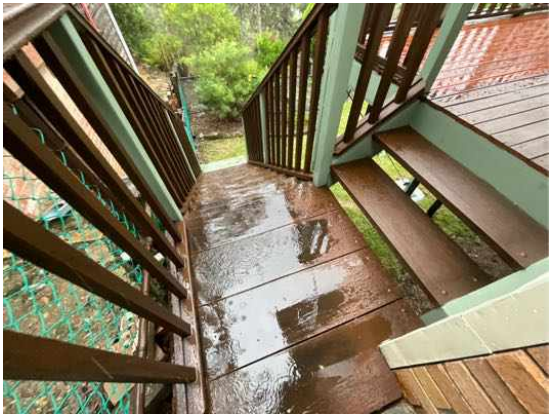
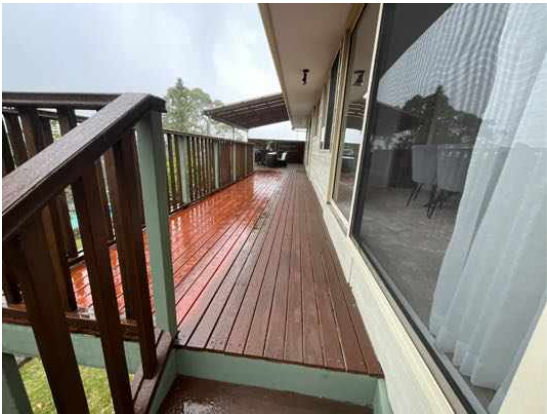
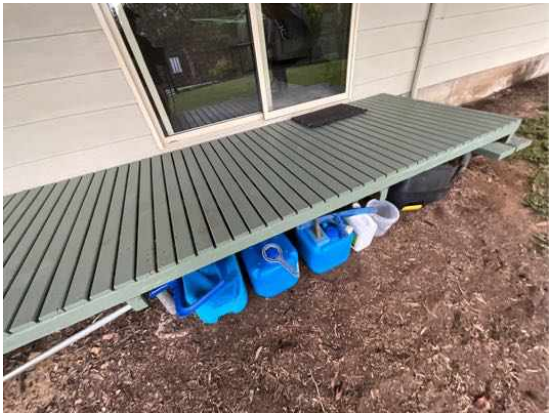
Finding 6.03

Building: Main Building
Location: All Areas
Finding: Timber on ground / conducive conditions to termite damage
Information: Timber on the ground is indeed conducive to termite damage. Termites are known to thrive in moist environments, and wood in contact with soil or moisture is more susceptible to infestation.

To prevent this, it's important to keep timber elevated and away from direct ground contact. Regular inspections and proper termite control measures are also essential to protect your wooden structures from termite damage.

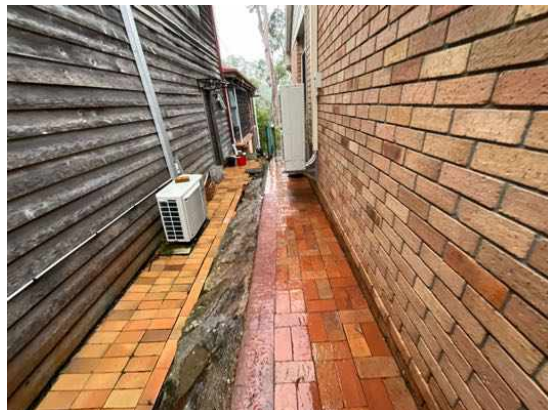
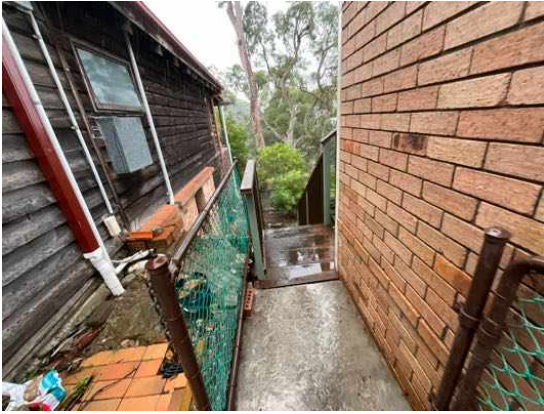
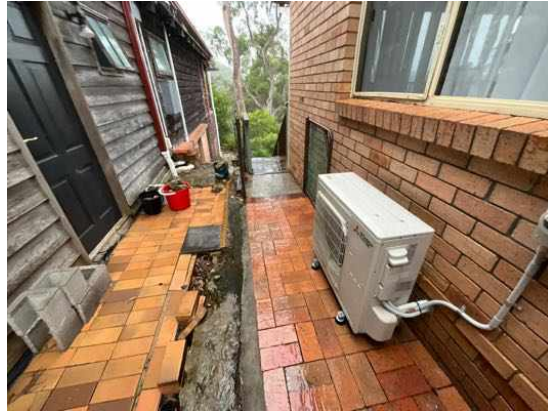
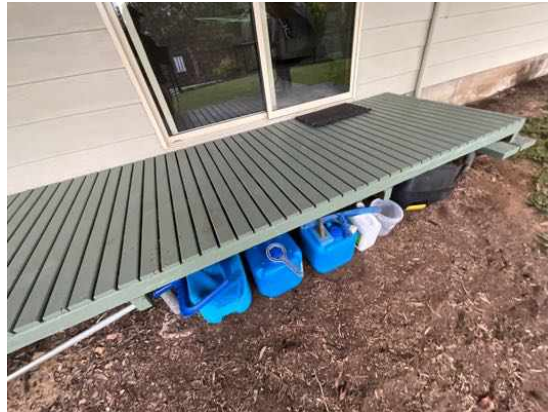
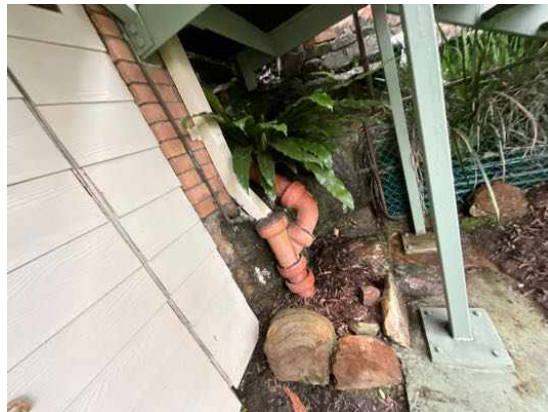
Finding 6.04

Where bridging has occurred full inspection is prevented and termites may enter a property in a concealed or undetected manner.

Recommended moving obstructions away from the external walls for further and future inspections.

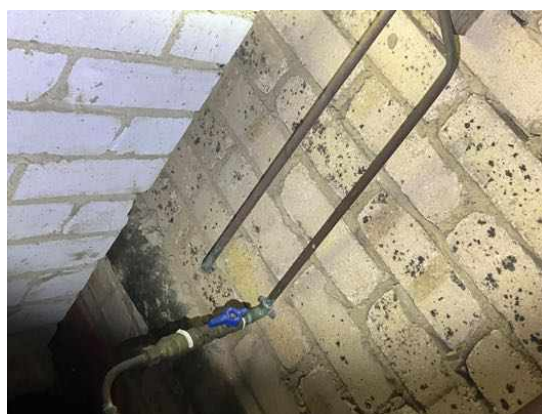
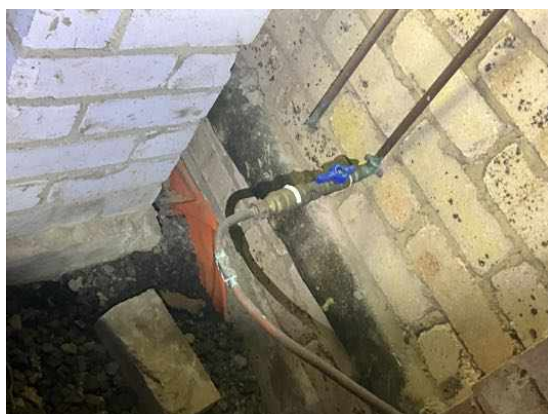
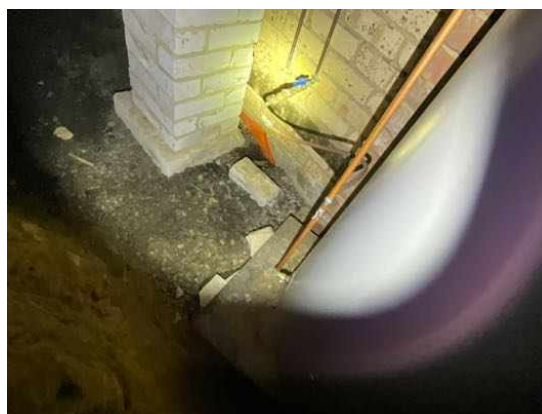
Finding 6.05

Building:	Main Building
Location:	Subfloor
Finding:	HWS not connected - conducive conditions for timber pest attacks
Information:	The hot water system (HWS) is not connected, leaving exposed pipes and creating conducive conditions for timber pest attacks.

Risk of Timber Pest Attack: The risk of timber pest attack is heightened when the hot water system is not connected. Exposed pipes provide easy access points for timber pests like termites and ants to infiltrate the building structure. These pests are attracted to moisture, and the absence of flowing water through the system can lead to moisture buildup, creating an ideal environment for pests to thrive and cause

damage to timber components within the building.

A licensed plumber or qualified plumbing technician should be engaged to reconnect the hot water system. They will assess the existing plumbing infrastructure, determine the appropriate connection points, and ensure proper installation and functionality of the HWS. Additionally, they may inspect for any signs of timber pest activity and recommend preventive measures, such as installing physical barriers or implementing moisture control measures, to deter pest infestations and protect the building from damage. Regular maintenance and inspections by homeowners or property managers are also essential to detect and address potential issues before they escalate.

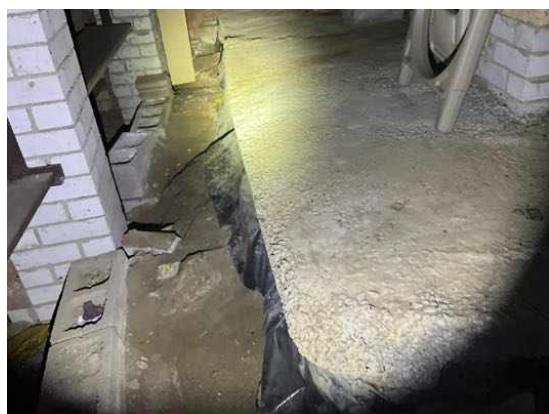
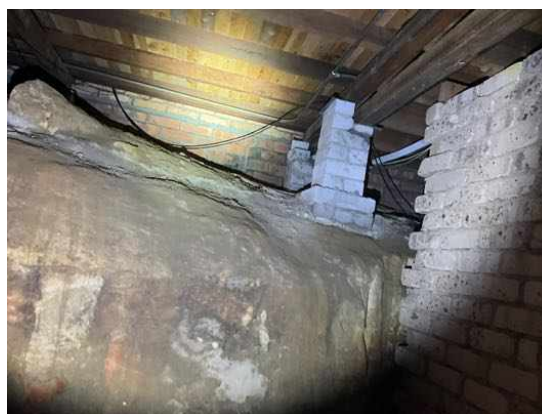
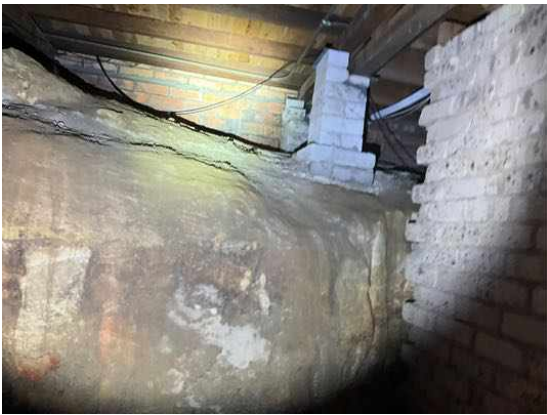
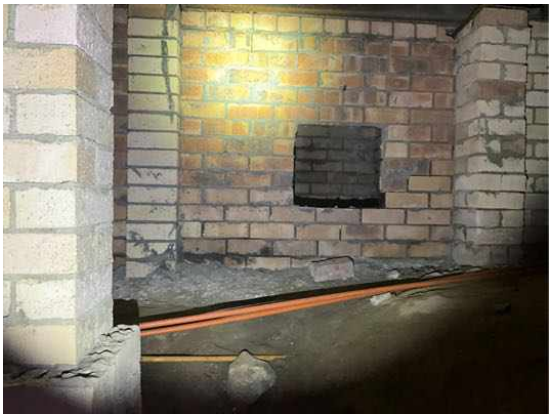
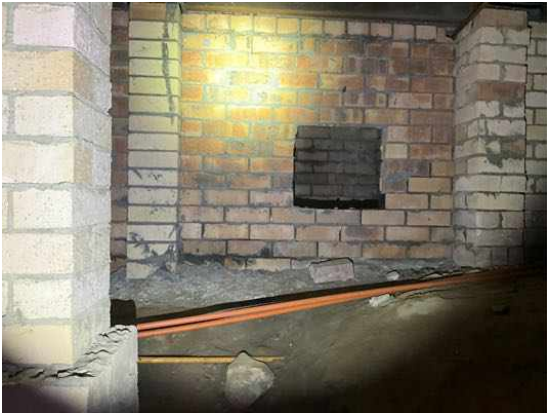
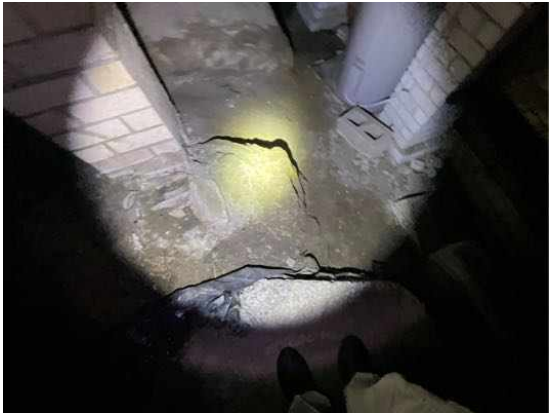
Finding: Subfloor - poor ventilation, inadequate site drainage, water stains
Information: The subfloor lacks adequate ventilation, suffers from inadequate site drainage, exhibits water stains, creating conducive conditions for timber pests such as termites.

Risk: The combination of poor ventilation, inadequate drainage, water stains significantly increases the risk of timber pest infestations. Termites are attracted to moist environments and can thrive in subfloors with high humidity levels and water damage. The lack of proper ventilation and drainage exacerbates moisture retention, providing an ideal habitat for timber pests to establish colonies and cause extensive damage to the subfloor structure. Additionally, water stains indicate previous or ongoing moisture issues, which further attract timber pests and contribute to the deterioration of timber materials.

A licensed pest control professional specializing in timber pest management should be consulted to assess the extent of the infestation and develop a comprehensive treatment plan. They can implement strategies to eliminate existing timber pests, such as termites and prevent future infestations by addressing underlying moisture issues. Additionally, a qualified plumber or builder may be needed to improve subfloor ventilation, enhance site drainage, repair water-damaged areas. Regular inspections and maintenance are essential to ensure ongoing protection against timber pests and maintain the structural integrity of the subfloor.

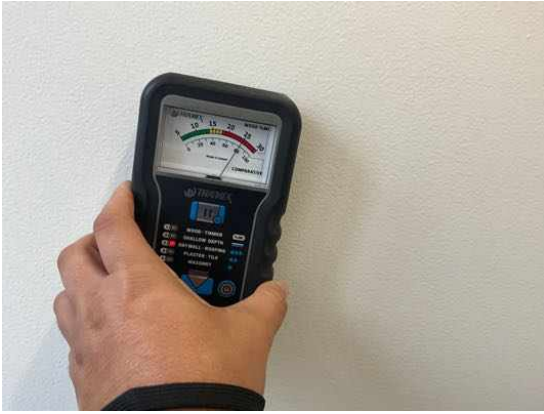
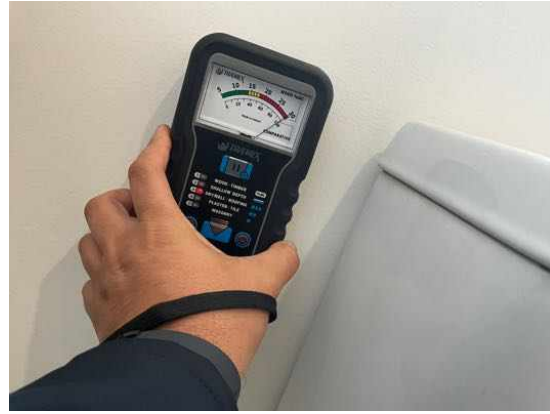
Building:	Main Building
Location:	Toilet (WC)
Finding:	Excessive moisture - Conducive to Timber pest
Information:	Excessive moisture can attract termites and produce conditions that promote fungal growth and wood decay.

Excessive moisture is generally caused by deteriorated inadequate or missing roof drainage leaking plumbing pipes or fixtures poorly plumbed HWS overflows or condenser units and poor site drainage.

Prior to any remedial works being performed a qualified plumber should be appointed to further inspect the property and to identify the cause of the excessive moisture. Works to remove affected building elements may then be necessary and should be performed by an appropriate tradesperson.

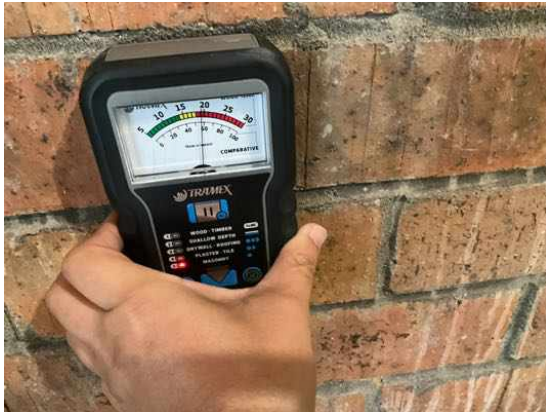
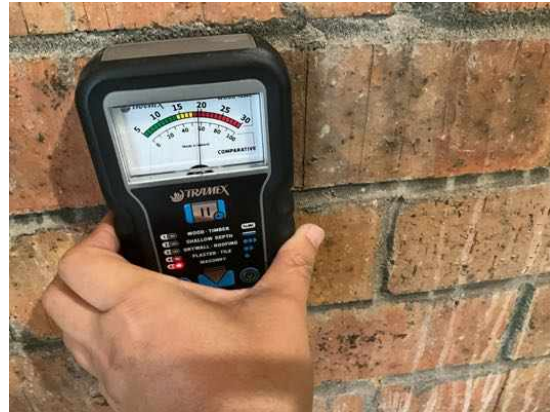
Finding 6.10

Building:	Main Building
Location:	Laundry / Toilet downstairs
Finding:	Excessive moisture - Conducive to Timber pest
Information:	Excessive moisture can attract termites and produce conditions that promote fungal growth and wood decay.

Excessive moisture is generally caused by deteriorated inadequate or missing roof drainage leaking plumbing pipes or fixtures poorly plumbed HWS overflows or condenser units and poor site drainage.

Prior to any remedial works being performed a qualified plumber should be appointed to further inspect the property and to identify the cause of the excessive moisture. Works to remove affected building elements may then be necessary and should be performed by an appropriate tradesperson.
