# Building and Timber Pest Inspection Report

Inspection Date: Sat, 21 Feb 2026

Property Address: 16 Caritta Ct, Parklea NSW 2768, Australia

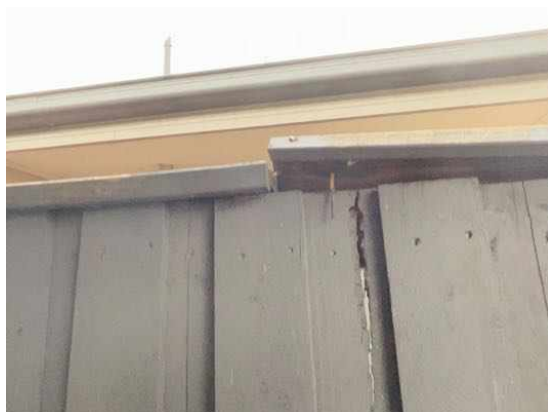
Building:	Main Building
Location:	All Areas
Finding:	Deteriorated fence
Information:	The fence along the property boundary has deteriorated significantly, showing signs of rot, rust, and structural weakness. Several sections are leaning or have become detached, compromising the integrity of the fence and its ability to perform its intended function.

The deteriorated fence poses multiple risks:

1. **Safety Hazard:** The unstable fence may collapse, posing a risk of injury to residents, visitors, and passersby.
2. **Security Concern:** The compromised fence may allow unauthorized access to the property, increasing the risk of theft, vandalism, or trespassing.
3. **Property Damage:** Falling sections of the fence could damage nearby structures, plants, or other property features.

- **Licensed Fencing Contractor:** A professional fencing contractor should be hired to assess the extent of the damage and either repair or replace the deteriorated sections.
- **Handyman Services:** For minor repairs, a qualified handyman could be engaged to reinforce or repair specific sections of the fence.
- **Landscaper (if the fence is part of a larger garden feature):** If the fence is integrated into the landscape design, a landscaper with experience in fencing could be involved in the repair or replacement process.

It's important to ensure that whoever is hired is experienced and qualified to ensure the fence is restored to a safe and functional condition, compliant with local regulations.

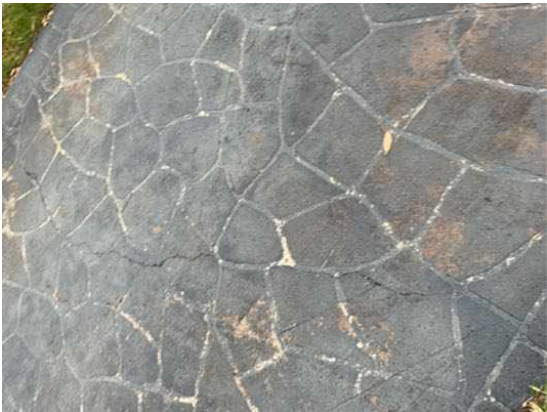
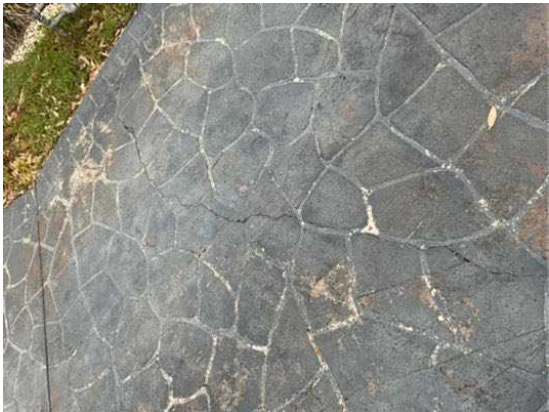
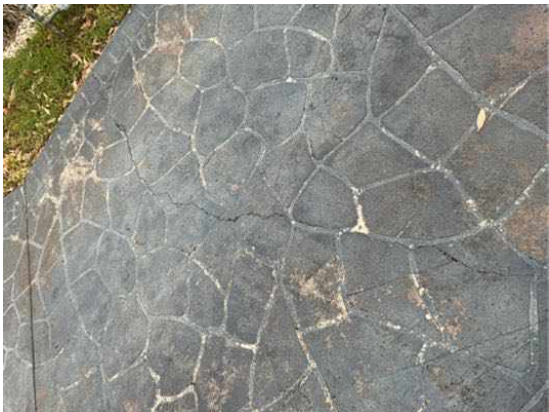
Building:	Main Building
Location:	Driveway
Finding:	Noticeable Cracking in Concrete Slab
Information:	Noticeable cracking has been observed in the concrete slab, failing to meet the required construction and quality standards.

- Cracks are visible on the surface and may extend through the depth of the slab.
- Evidence of improper curing or inadequate reinforcement leading to cracking.

The presence of noticeable cracks in the concrete slab can result in:

- Compromised structural integrity of the slab, potentially leading to failure under load.
- Water ingress through cracks, causing corrosion of reinforcement and further weakening the structure.
- Potential trip hazards and aesthetic issues, reducing the overall value and safety of the property.
- Increased maintenance and repair costs due to ongoing deterioration.

- A structural engineer should be engaged to assess the extent of the cracking and recommend appropriate repair methods.
- A licensed contractor or concrete repair specialist should carry out the recommended repairs under the guidance of the structural engineer.

A detailed inspection should be conducted post-repair to confirm compliance with the required standards and to ensure that the structural integrity of the concrete slab has been restored.

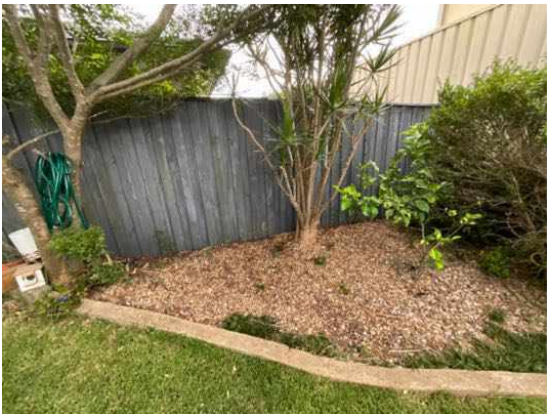
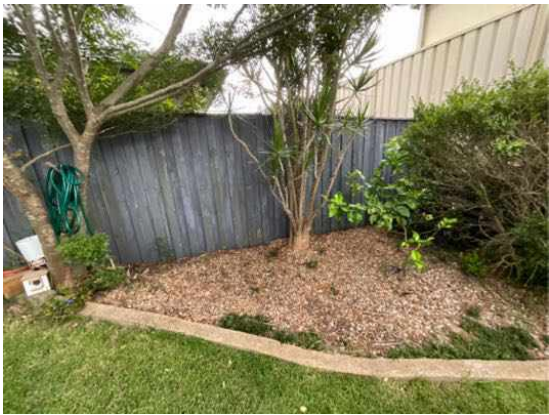
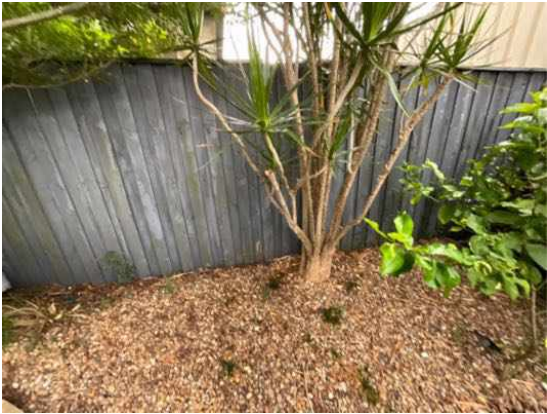
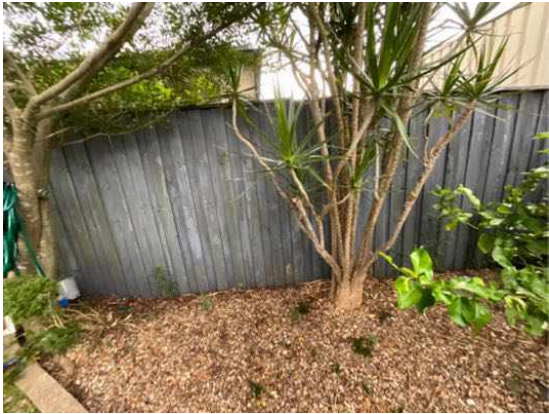
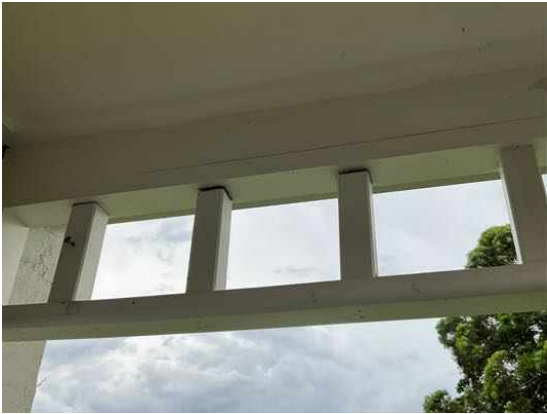
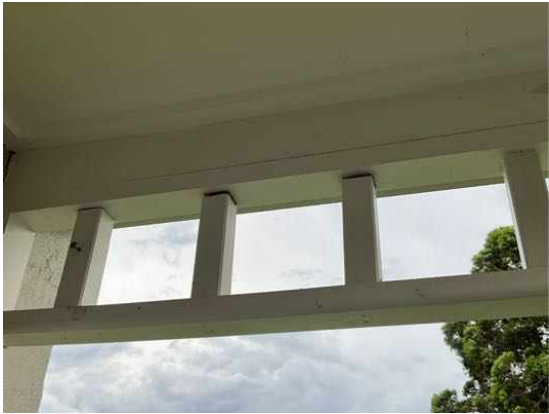
**Finding 3.03**

Building: Main Building  
Location: All Areas  
Finding: Timber - exposed to weather  
Information: External timbers that are frequently exposed to harsh weather conditions require adequate protection in order to maintain their condition. Where timbers have not been painted or treated adequately, general deterioration is likely to occur at an accelerated rate.

If left unattended, replacement of these timbers is likely to be necessary in the short-term future. Adequate treatment of these timbers is required as soon as possible by a painting contractor or general handyman.

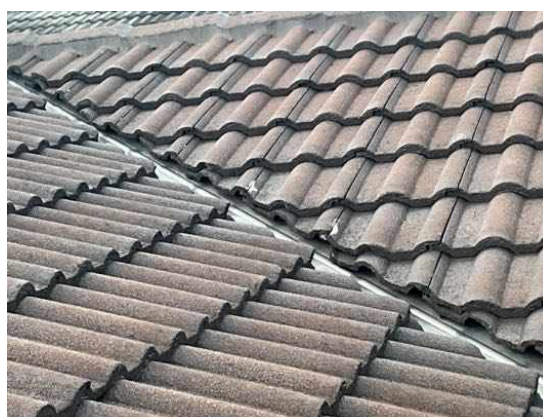
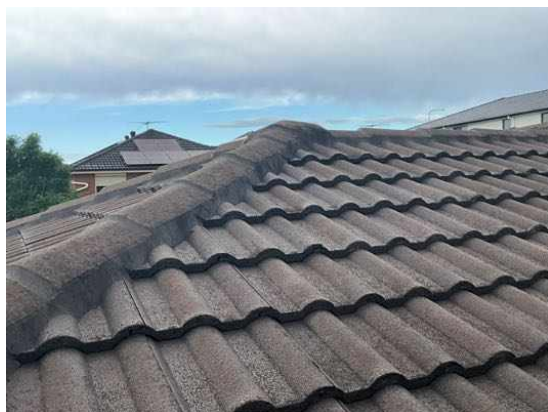
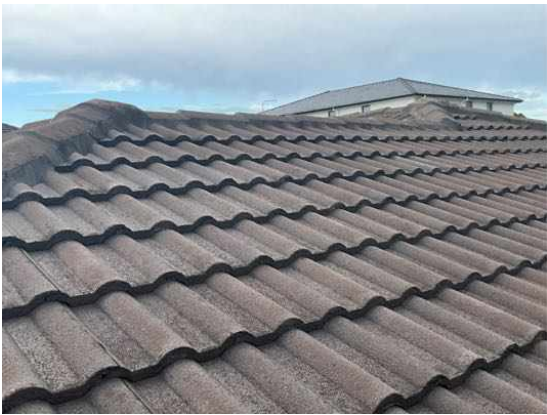
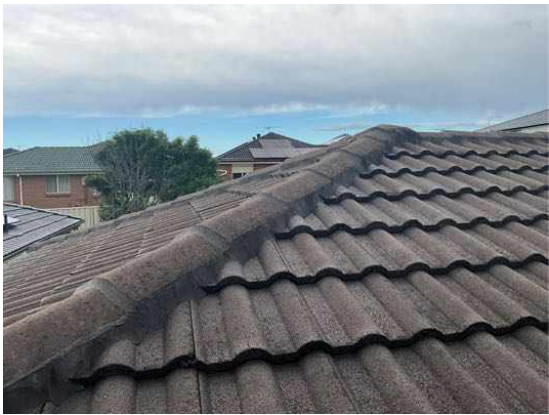
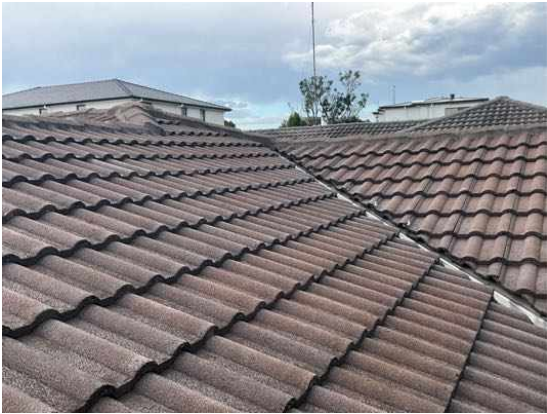
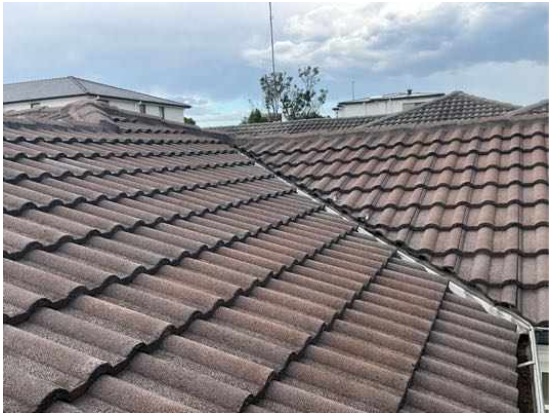
Finding 3.04

Building: Main Building  
Location: All Areas  
Finding: Roof Weathered  
Information:

Inspection of the roof revealed widespread weathering to the tiled roof surface. The tiles show loss of surface finish, colour fading, and age-related deterioration typical of older roof coverings. Although no significant cracking was noted, weathering can lead to increased porosity, reduced water-shedding capability, and a higher risk of future cracking or displacement during adverse weather conditions.

A licensed roofer should be engaged to undertake a closer inspection, carry out routine maintenance, and replace any tiles that may be compromised. Ongoing monitoring is recommended due to the age and condition of the roof covering.

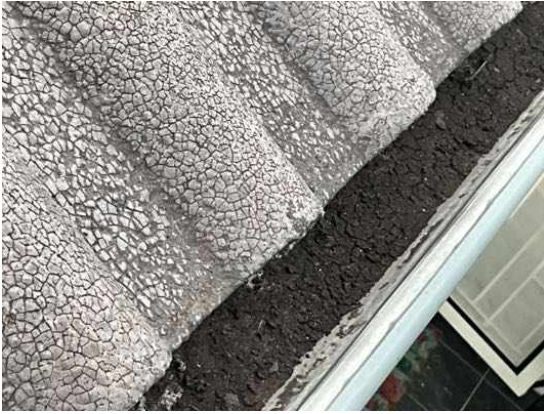
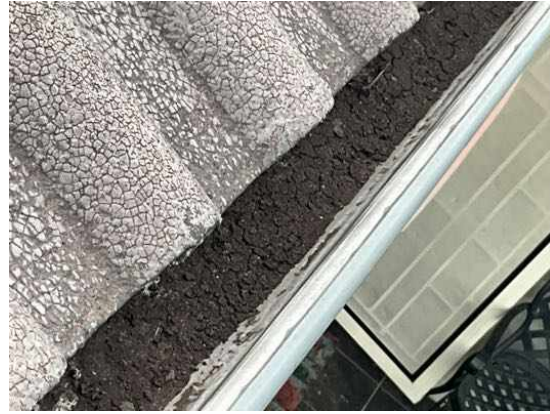
Finding 3.05

Building: Main Building  
Location: All Areas  
Finding: Blocked gutters - organic debris  
Information: The roof gutter system was observed to be blocked with organic debris and moss growth, as evident in the provided images.

- Water ingress into the eaves or walls,
- Timber rot or deterioration of fascia and soffits,
- Accelerated moss and algae growth, promoting further blockages,
- Potential foundation issues if water pools near the base of the structure.

A licensed roofing contractor or qualified gutter cleaning service should be engaged to remove the debris and inspect the system for any further issues.

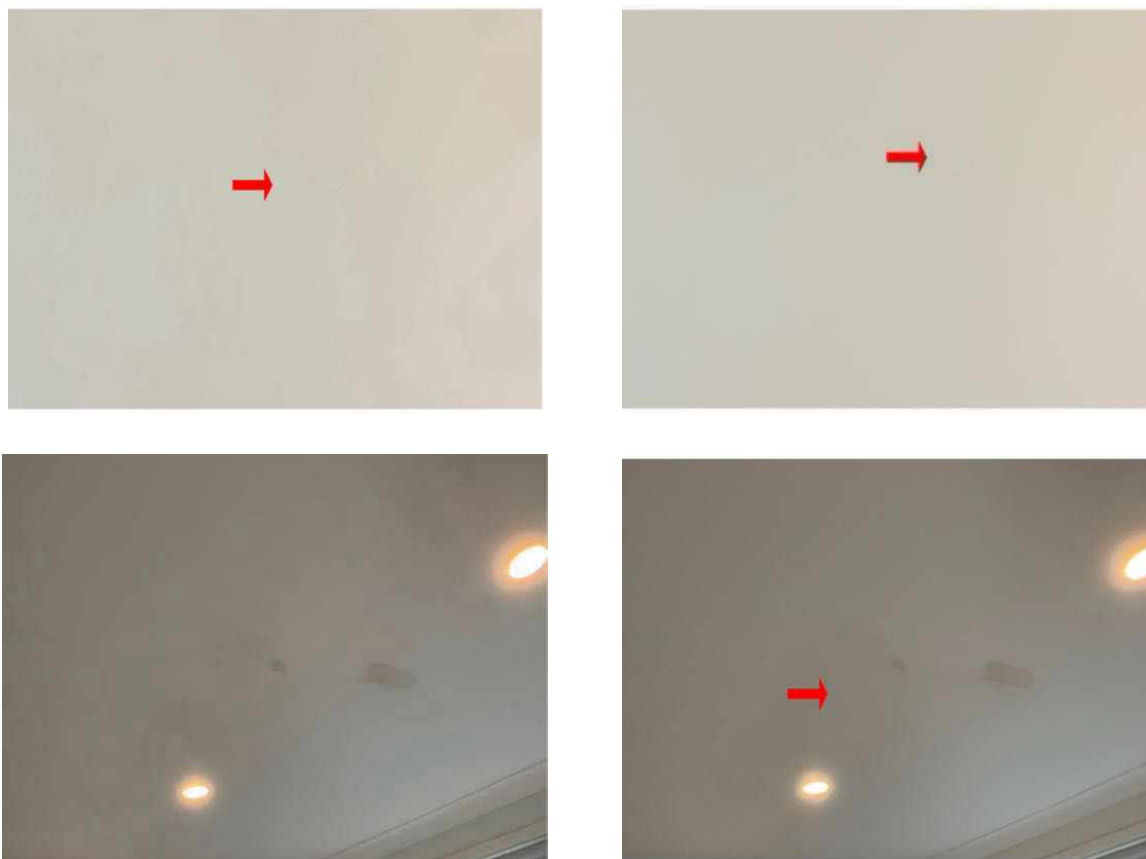
### Finding 3.08

Building: Main Building  
 Location: All Areas  
 Finding: Paint surface deteriorated  
 Information: Sections of the paint in this area was found to have bubble and deteriorated. Paint bubbling is generally an indication of excessive moisture in the area that is currently hidden by the painted surface.

The presence of excessive moisture can have major implications on associated building elements if left unattended. While only seemingly minor at this stage, the damage cannot be determined due to the paint, obstructing any further inspection of the damage.

It is highly advised that the affected paint to be cleaned to allow a further, more invasive inspection by a licensed builder/painter. Failure to act on this defect may necessitate major works in the future.

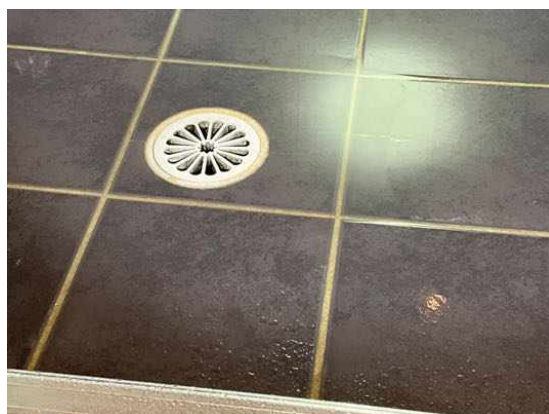
### Finding 3.09

Building:	Main Building
Location:	Bathroom
Finding:	Shower base - Water pooling
Information:	Evidence of water pooling around the floor waste in the shower recess was noticed at the time of inspection. It is suspected that this excessive moisture is attributed to insufficient fall in the shower floor tiles.

This pooling is minor overall but is still considered unsatisfactory, as standard tiling practices would not permit this situation to occur. Pooling water around floor wastes can create a slip hazard in extreme cases and create conditions that are conducive to mould growth over time. Where left unmanaged, the degradation of sealant and grouting is also likely to occur, possibly necessitating further repair works.

Remedial works may involve some sections of tiling and flooring repair and replacement. A tiling contractor or bathroom specialist should be appointed to provide further advice on reparation options and to perform works as necessary.

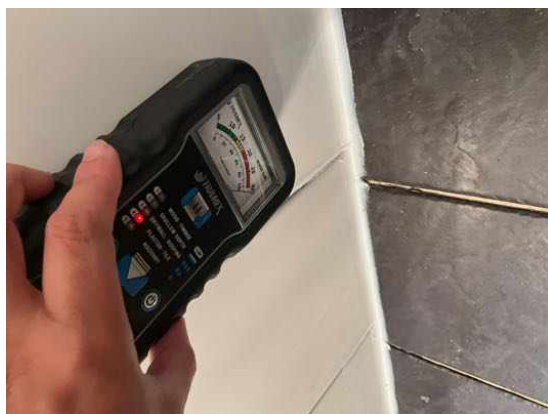
Finding 3.11

Building:	Main Building
Location:	Ensuite
Finding:	Shower - Damp
Information:	Damp is evident to the lower 300mm of wall to the shower alcove. This defect is quite common, and is suspected to have been caused by moisture permeating through the grouting in this area, which shows evidence of deterioration. Leaking pipes within the adjoining wall is also a possible cause.

Damp (or structural damp) refers to the presence of unwanted moisture in the structure of a building, either as the result of intrusion from outside, or condensation from within the structure. In the shower area, internal water leaks or other sources of excessive moisture are generally the cause of damp.

Unmanaged damp in the shower recess is likely to facilitate the formation and development of mould and fungi growth, decaying associated building materials and compromising their structural integrity. It is important to address damp conditions, as the World Health Organisation notes that excess moisture leads - on almost all indoor materials - to growth of microbes such as moulds, fungi and bacteria, which subsequently emit spores and other matter into the indoor air. Exposure to these contaminants is associated with a wide range of respiratory and other health-related problems.

Consultation with a qualified plumber or bathroom specialist is advised immediately to identify the cause of damp and to perform remedial works as required. Where excessive mould growth is present, further inspection by a specialist environmental health inspector should also be considered.

Always ensure that sealant and grout is in good condition to prevent any moisture issues occurring in the future.

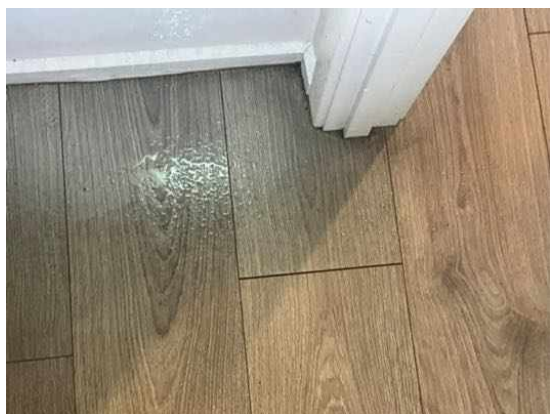
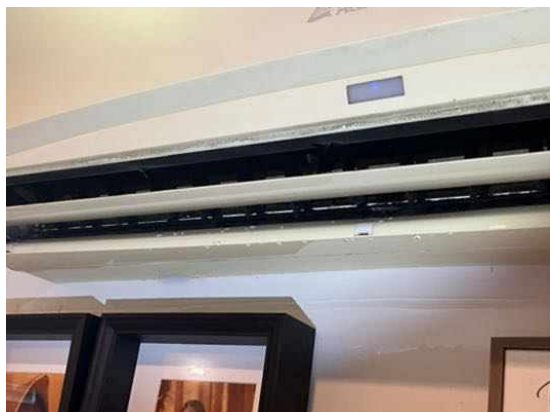
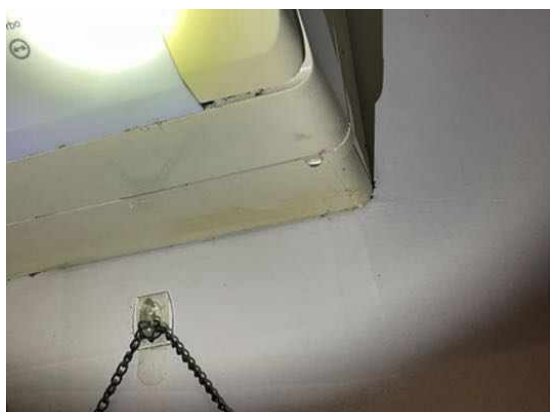
### Finding 3.12

Building:	Main Building
Location:	Dining Room
Finding:	Aircon Unit (Water Leakage)
Information:	Water leakage was observed from the internal wall-mounted split system air conditioning unit at the time of inspection. Active moisture droplets were visible along the lower casing of the unit, with associated moisture staining to the wall surface below and water discharge onto the flooring.

This condition is commonly caused by a blocked or improperly connected condensate drain line, damaged or misaligned drip tray, or inadequate servicing of the unit.

Ongoing leakage may result in damage to wall linings, skirting boards and flooring finishes, and may promote mould growth if not addressed.

A licensed air-conditioning technician is required to inspect, rectify and test the unit's condensate drainage system as a matter of priority.

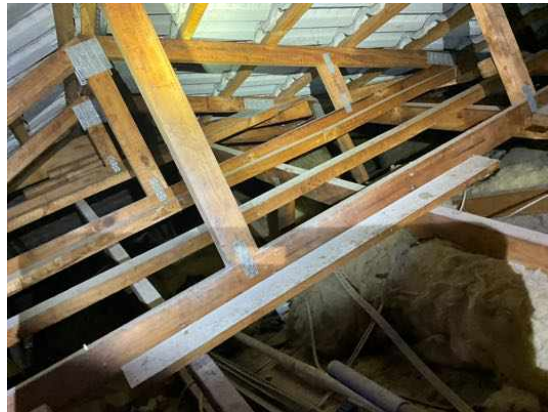
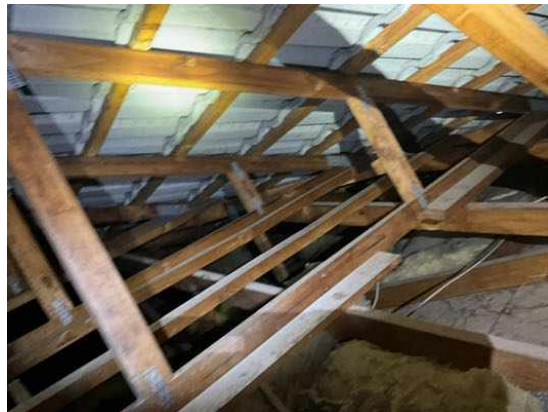
### Finding 3.13

Finding: Sarking - Missing

Information: Sarking is missing under the roof sheeting. Sarking acts as an insulator that helps with noise reduction and protects against water penetration. Sarking plays a key role in the operation and function of the overall roofing structure and its performance.

Although not a requirement at the time of construction, replacement of any missing building element is advisable (although this can be quite expensive to do after the time of construction). Where sarking is missing, regular inspections of the roof tiles for cracking and potential moisture penetration is required.

Sarking may be retrospectively fitted by a registered builder at the discretion of the client.

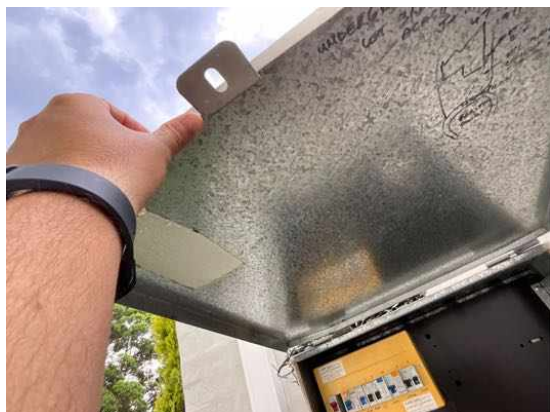
Building: Main Building  
Location: Exterior walls - right side  
Finding: No Evidence of Termite Management System - Durable notice / Legible Sticker  
Information: The application of a pre & post-construction chemical termite barrier is highly recommended for all properties. Such barriers are highly effective in preventing termite attack on any timber building elements throughout the property.

Client must seek further information from the vendor or real estate agent if the conditions of termite management systems were maintained.

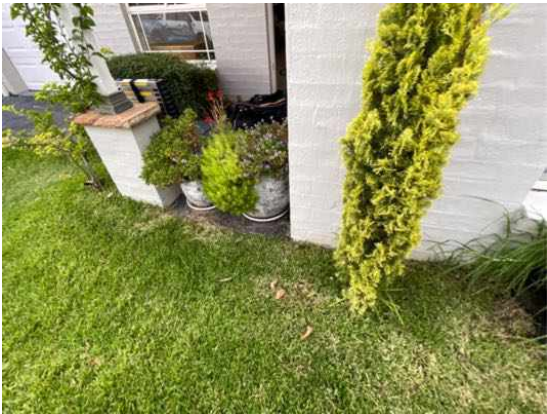
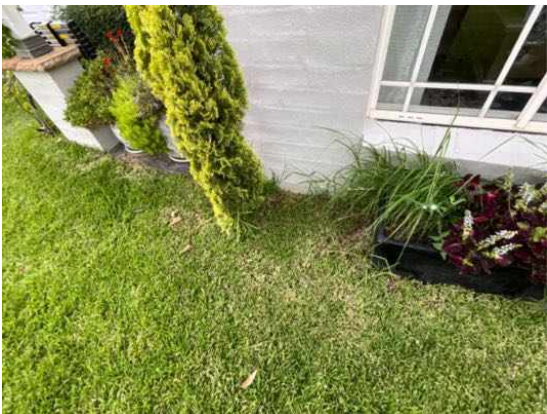
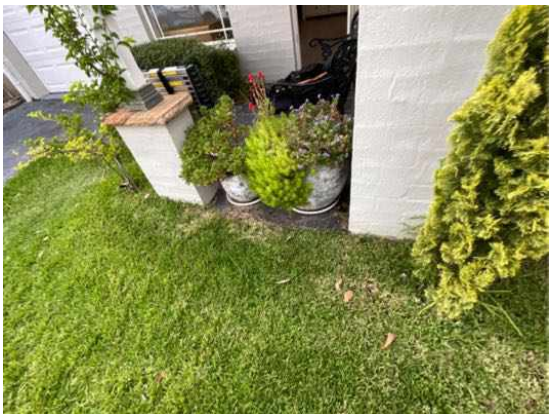
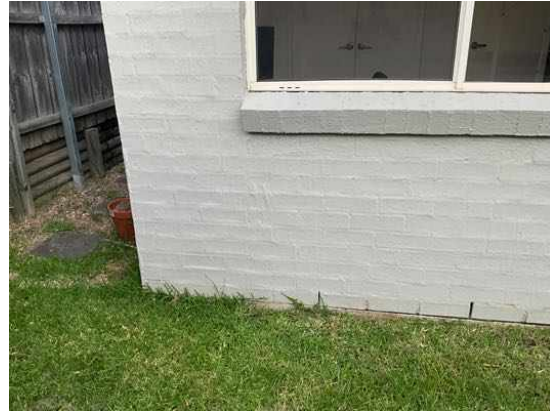
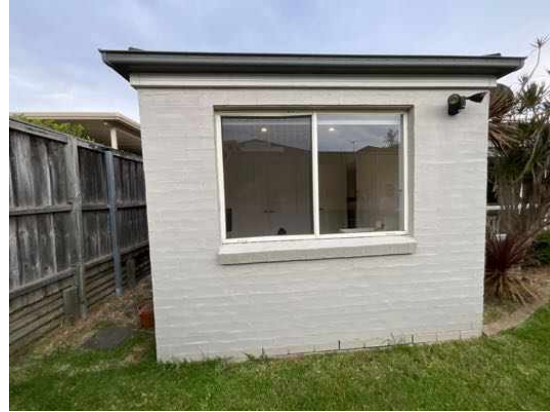
If the slab edge is not properly exposed there is a high risk of termite attack. Sometimes, in order to determine the type of slab, a suitably qualified person such as an architect or builder may be required to consult the construction plans.

Where the slab edge cannot be properly inspected, it is highly recommended that termite or timber pest inspections be carried out every 6-12 months to aid protection of the property against infestation.

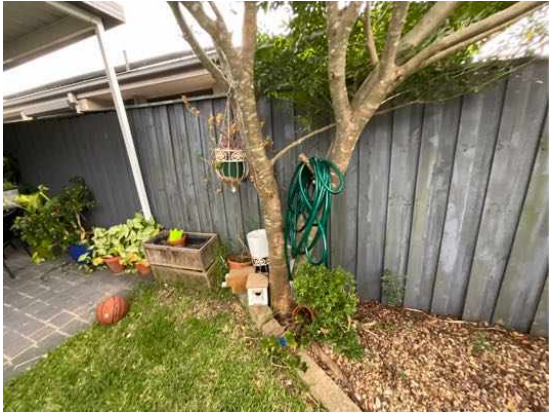
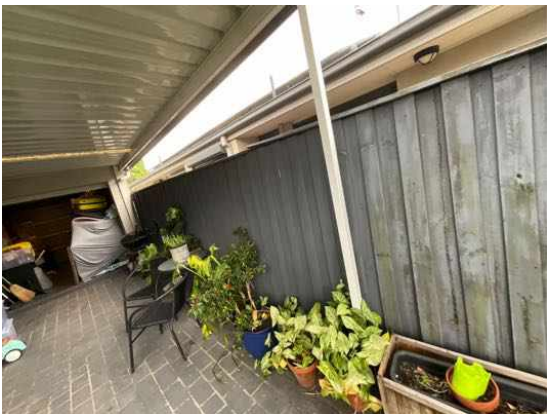
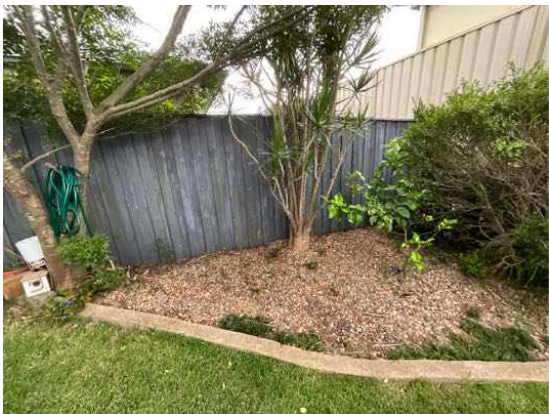
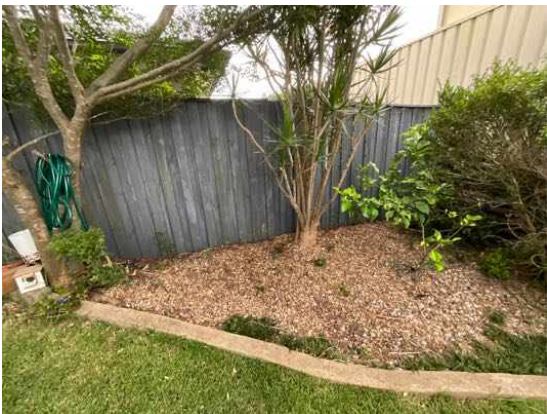
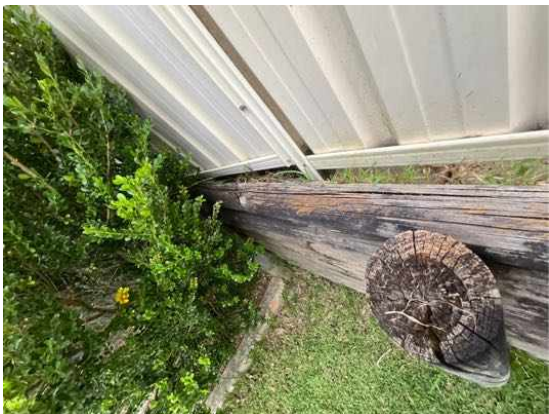
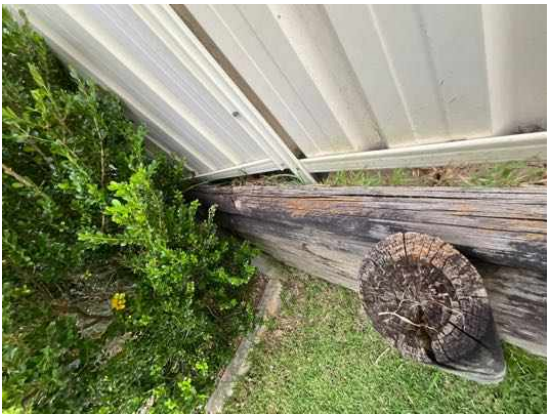
### Finding 6.05

Building:	Main Building
Location:	All Areas
Finding:	Timber on ground / conducive conditions to termite damage
Information:	Timber on the ground is indeed conducive to termite damage. Termites are known to thrive in moist environments, and wood in contact with soil or moisture is more susceptible to infestation.

To prevent this, it's important to keep timber elevated and away from direct ground contact. Regular inspections and proper termite control measures are also essential to protect your wooden structures from termite damage.

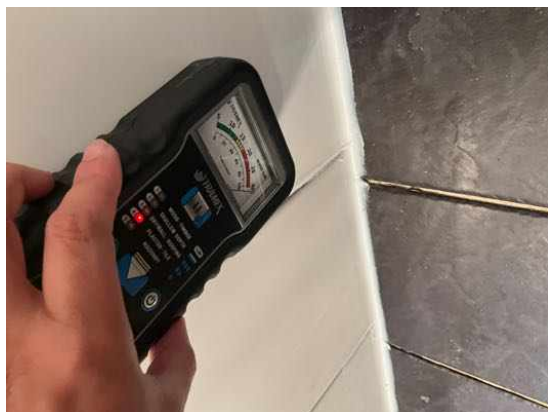
Building:	Main Building
Location:	Ensuite
Finding:	Excessive moisture - Conducive to Timber pest
Information:	Excessive moisture can attract termites and produce conditions that promote fungal growth and wood decay.

Excessive moisture is generally caused by deteriorated inadequate or missing roof drainage leaking plumbing pipes or fixtures poorly plumbed HWS overflows or condenser units and poor site drainage.

If mould growth has been found there may be environmental biological or health issues involved. In these cases an appropriately qualified inspector should also be contacted.

Prior to any remedial works being performed a qualified plumber should be appointed to further inspect the property and to identify the cause of the excessive moisture. Works to remove affected building elements may then be necessary and should be performed by an appropriate tradesperson.

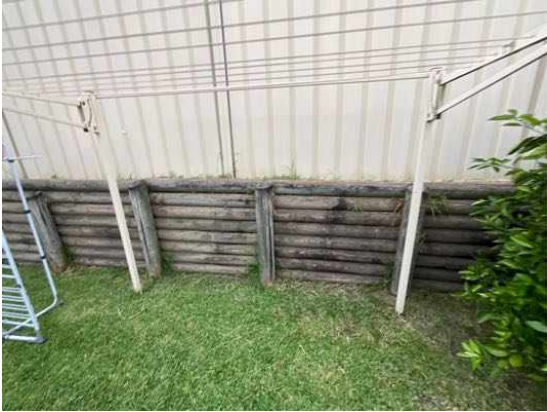
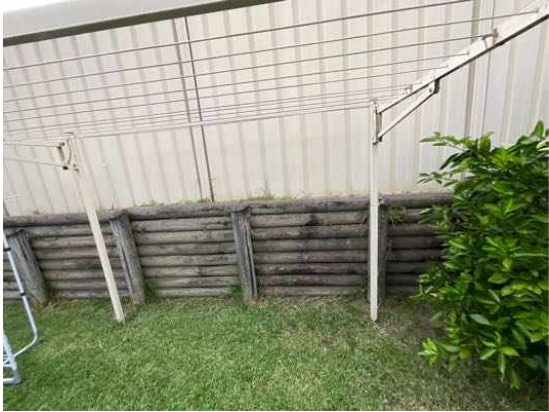
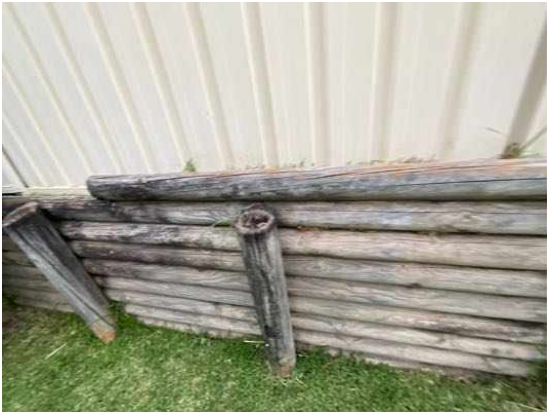
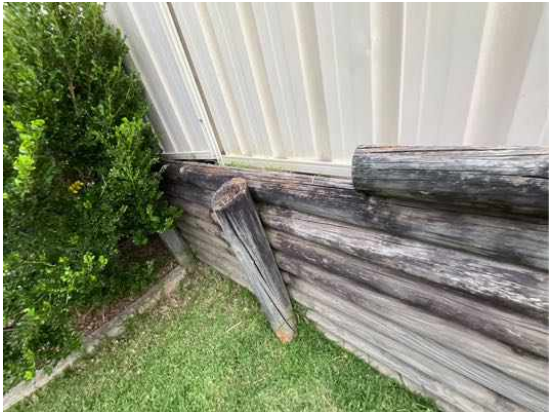
### Finding 7.01

Building:	Main Building
Location:	All Areas
Finding:	Wood rot
Information:	This building element shows evidence of wood rot. Wood rot, also known as Fungal Decay, occurs when timbers and other cellulose building materials are exposed to damp conditions on an ongoing basis. This could be the result of exposure to weathering over a prolonged period of time, or the attraction of excessive moisture from other abutting building materials. Contributing factors also include poor air ventilation in the area.

Wood rot is often associated with general damp problems and is evidenced by a 'musty' smell or mould and mildew occurring on surfaces. If left unmanaged, damp conditions can lead to further health problems and the decay of timbers will continue.

A qualified plumber may be appointed to assess the cause of excessive moisture and to provide advice on any remedial works as required. A qualified carpenter or registered builder may also be required to replace affected building materials.
