## Building Inspection Report

Inspection Date: Tue, 3 Feb 2026

Property Address: 14 Riberry St, Melonba NSW 2765,  
Australia

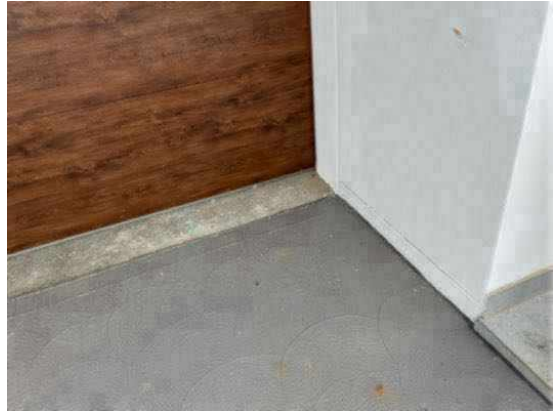
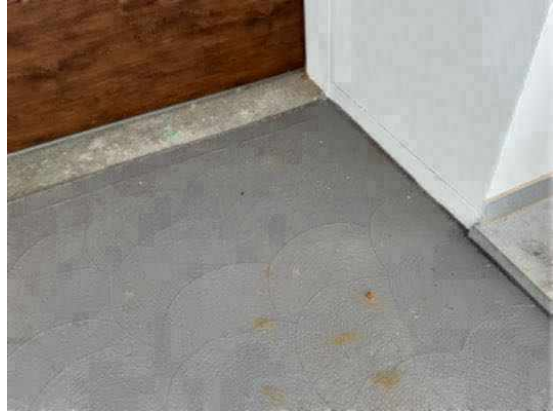
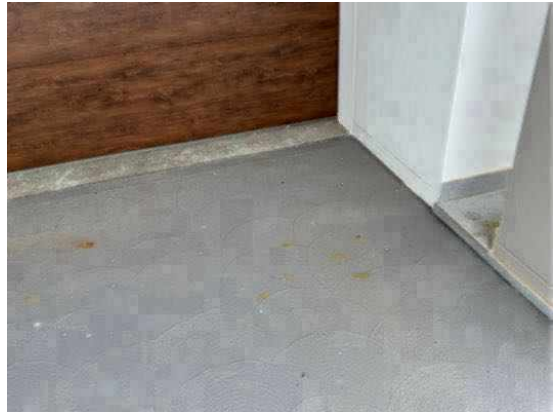
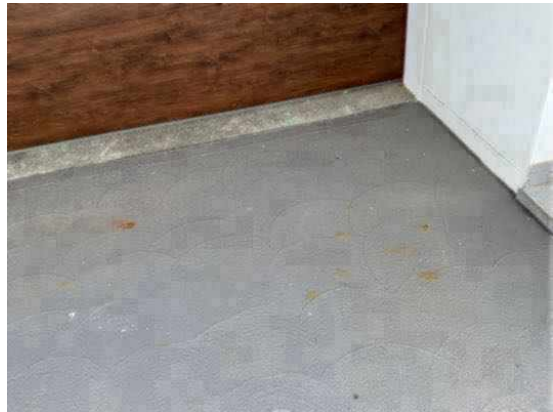
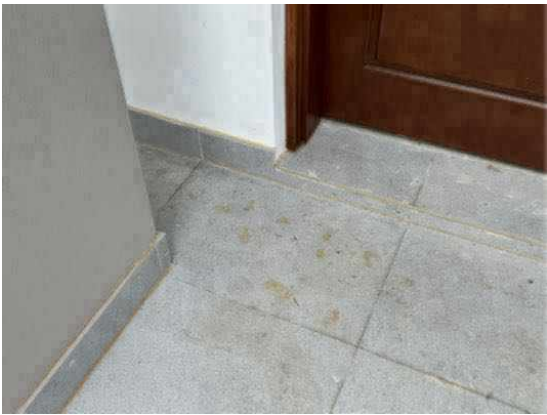
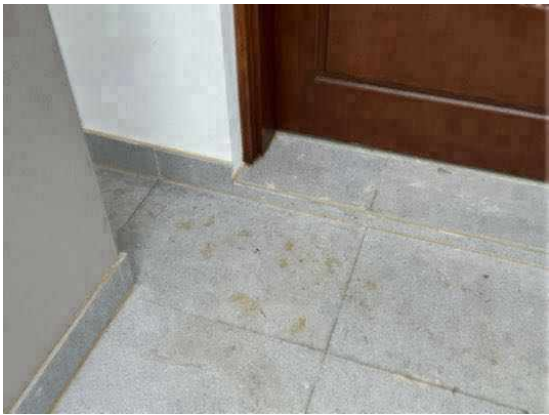
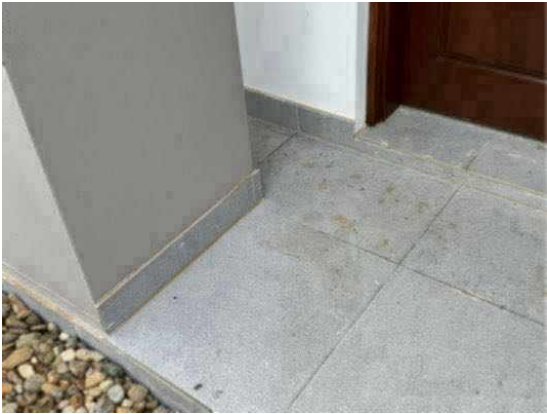
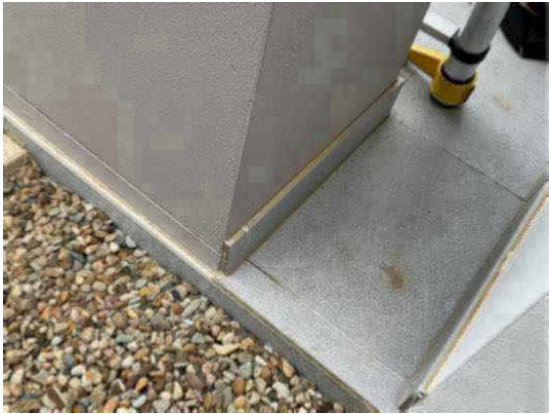
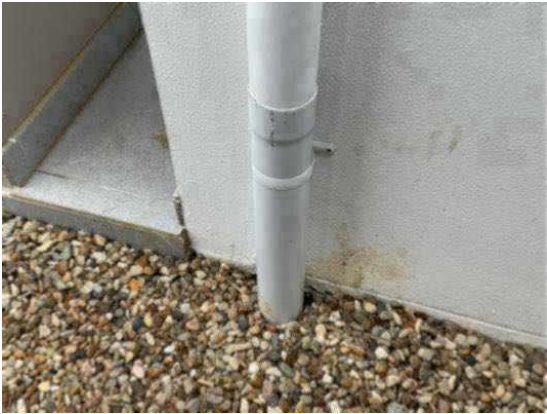
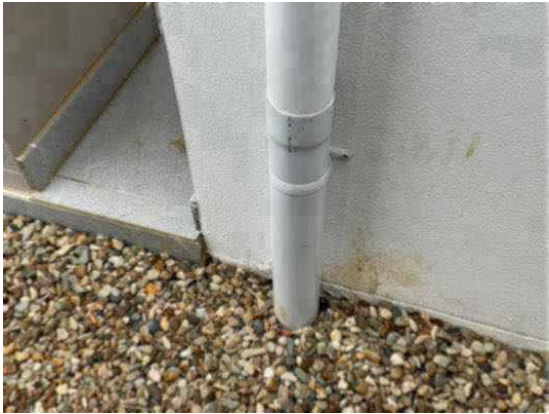
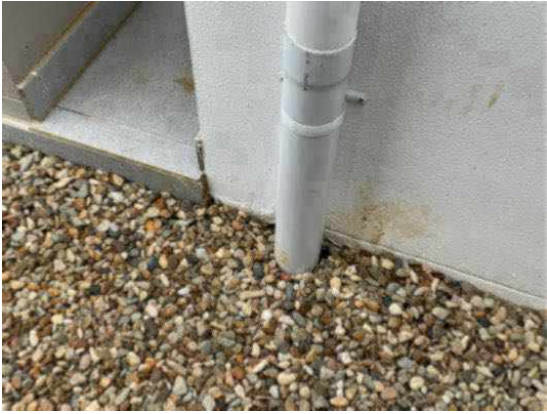
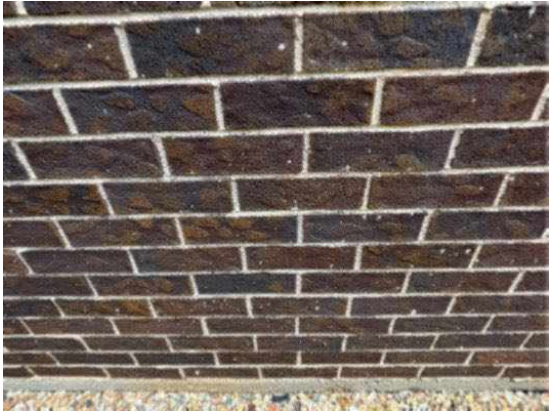
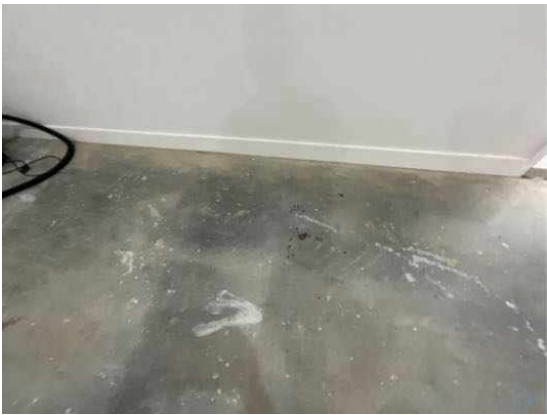
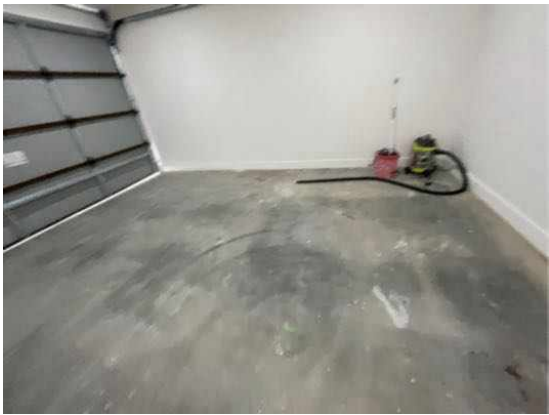
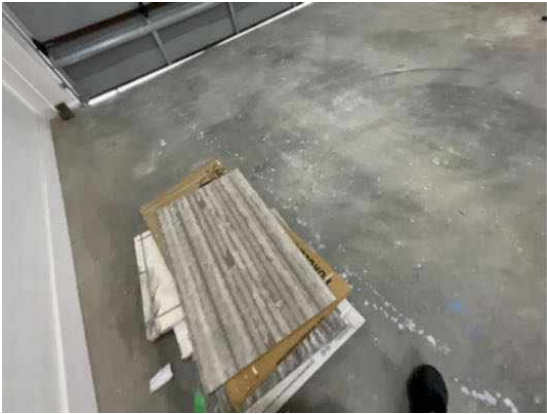
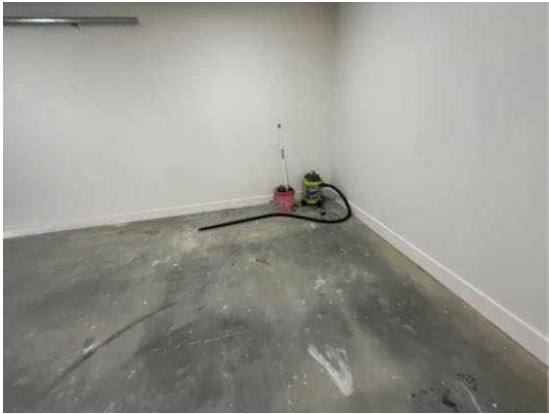
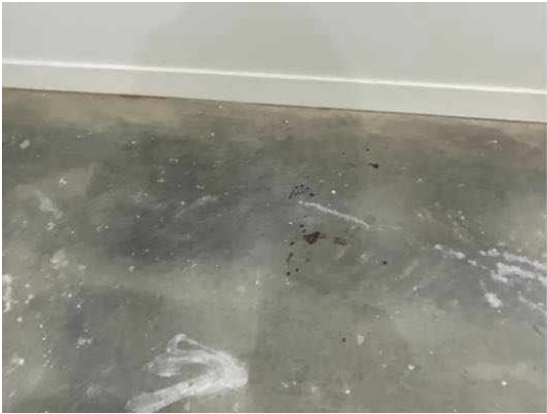
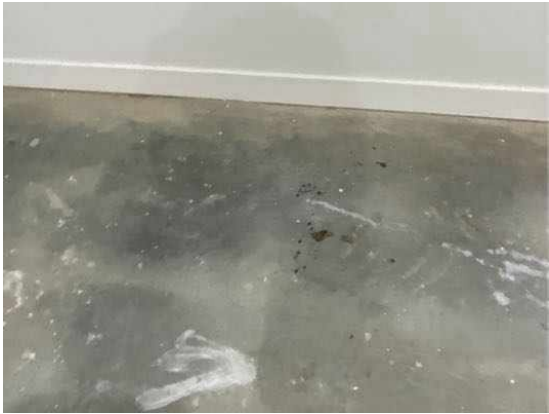
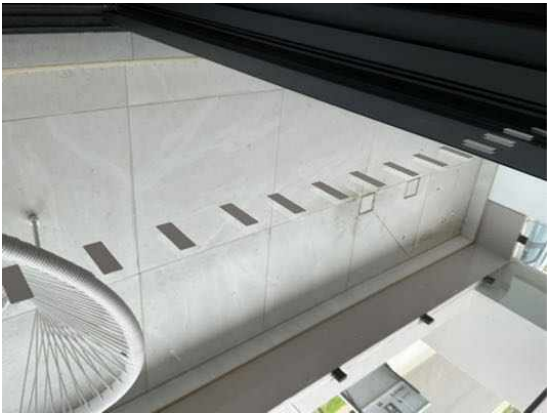
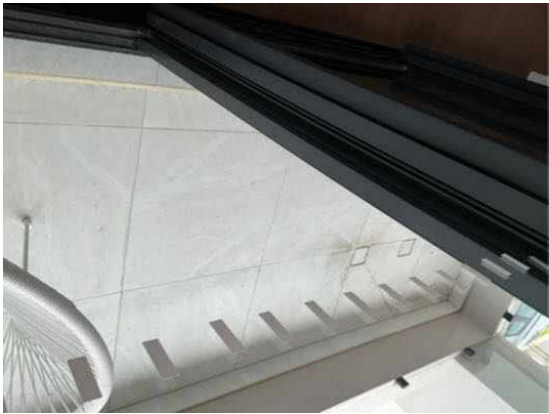
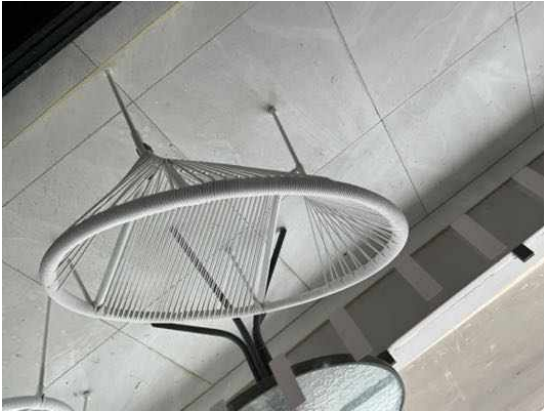
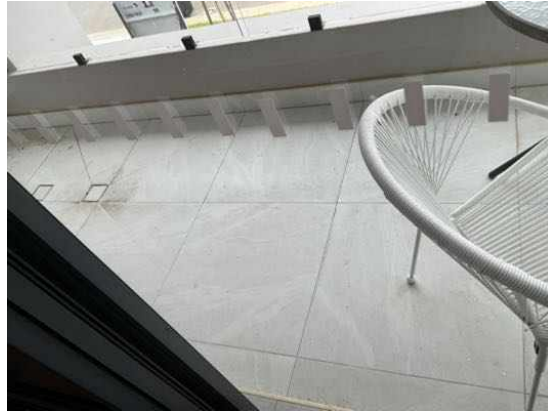
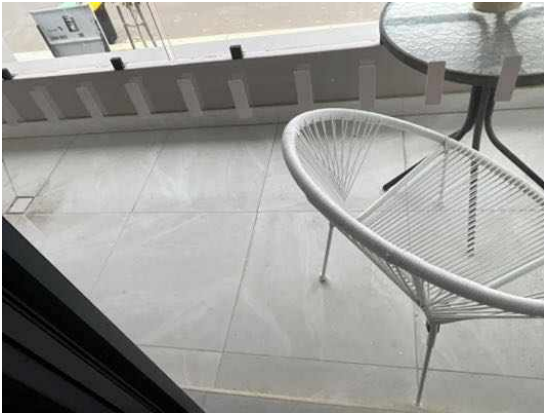
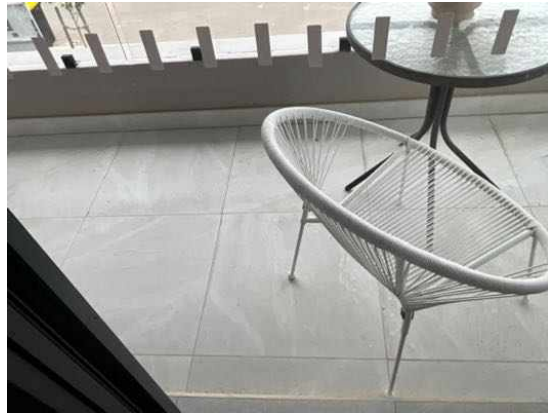
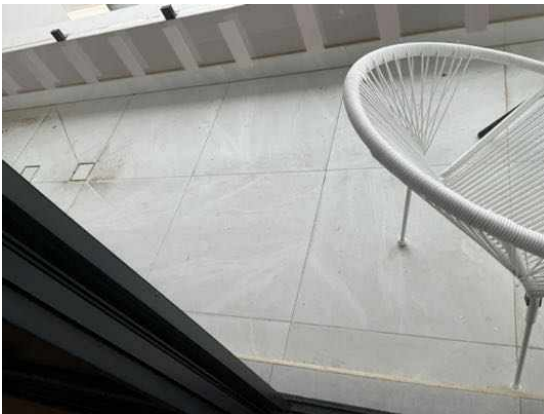
#### Defects 3.01

Building:	Main Building
Location:	All Areas
Finding:	Cleaning required
Information:	It was observed that the house requires cleaning.

Works are defective where windows are not clean, floors are not swept, mopped or vacuumed as appropriate, tiles, sinks, basins, baths, windows or any other area throughout the property are not cleaned, and shelving, drawers and cupboards are not ready for use not cleaned and ready for use at handover.

This is to be referenced against the Australian Standards & Tolerances clause 19.8 Cleaning.

This is to be addressed prior to handover.

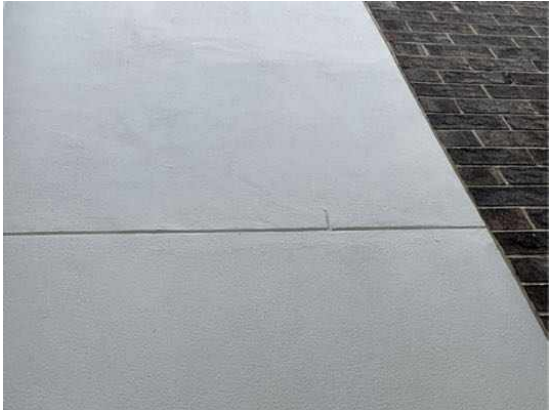
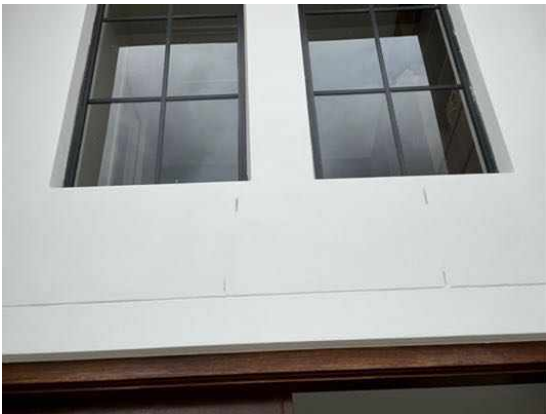
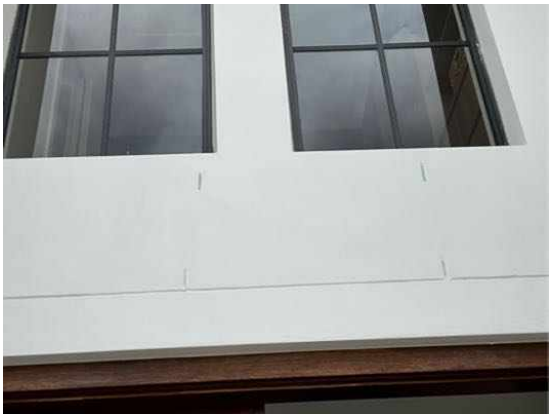
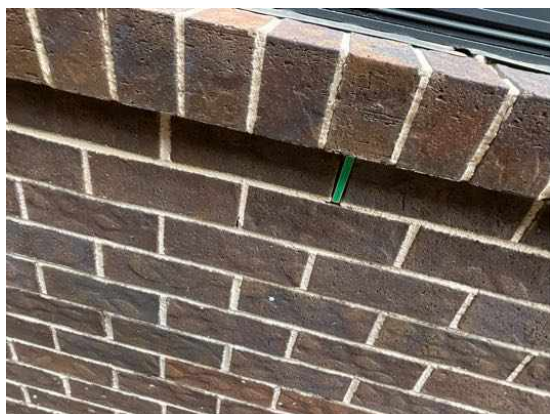
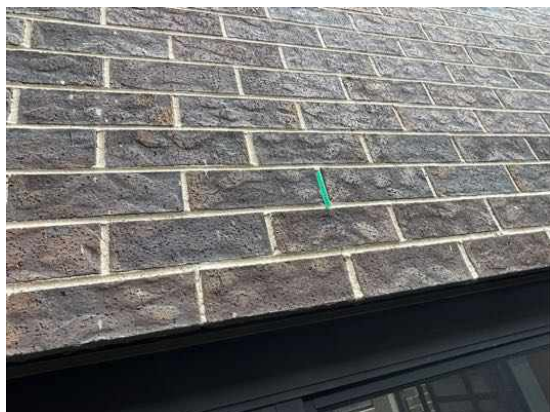
### Defects 3.02

Building: Main Building  
 Location: All Areas  
 Finding: Weep holes - Blocked  
 Information: Weep holes observed at the base of the external masonry walls are blocked or obstructed, preventing adequate ventilation and moisture drainage from the cavity.

Blocked weep holes can lead to a buildup of moisture within the wall cavity, increasing the risk of damp issues, mould growth, internal water ingress, and long-term structural deterioration.

As per the NSW Guide to Standards and Tolerances 2017, Clause 5.06, weep holes must be installed and remain unobstructed to ensure moisture drainage from cavity masonry walls.

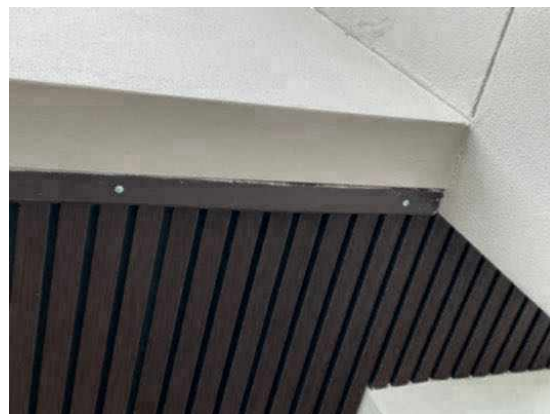
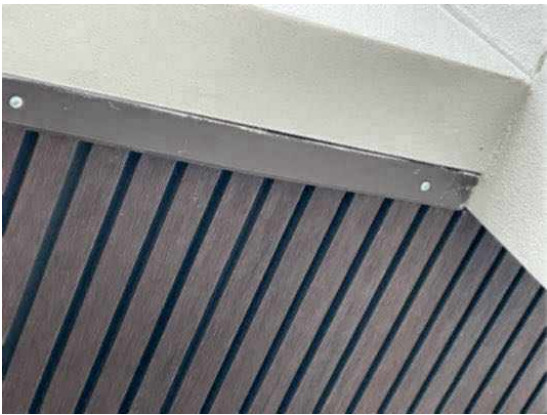
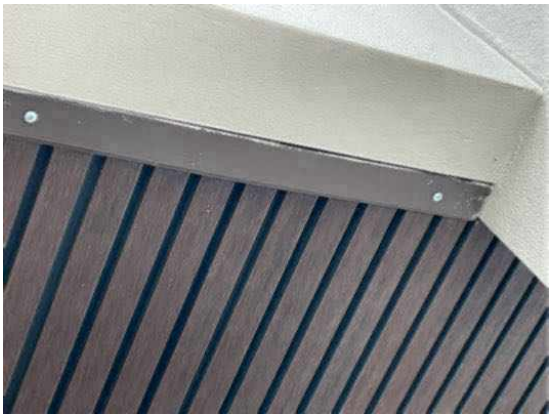
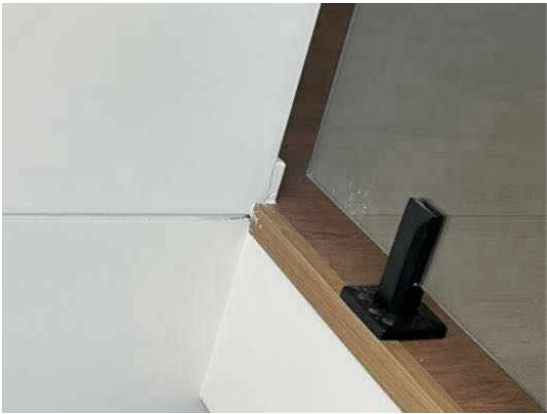
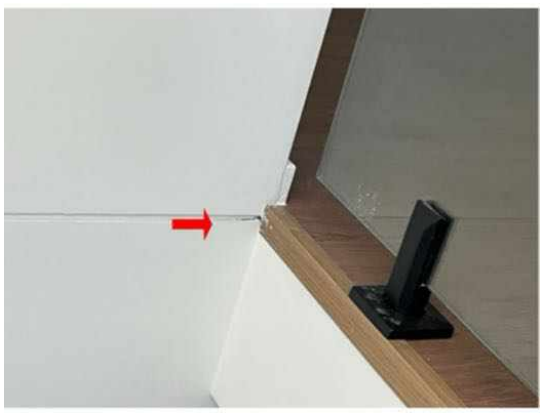
**Defects 3.04**

Building:	Main Building
Location:	All Areas
Finding:	Substandard Work- Various Areas of the Building...
Information:	Substandard work has been identified in multiple areas throughout the building, failing to meet the requirements specified by Australian Guides and Tolerances.

- **\*\*Paint Application:\*\*** Inconsistent and incomplete paint coverage on walls, ceilings, and downpipes, with visible brush marks, drips, and streaks.

- **\*\*Surface Preparation:\*\*** Poor surface preparation resulting in inadequate paint adhesion and flaking.

- **\*\*Fixtures and Fittings:\*\*** Misaligned or improperly installed fixtures and fittings, not meeting the standard requirements for level and alignment.

- Repainting surfaces with proper surface preparation and uniform application.
- Realigning and properly installing fixtures and fittings.

A comprehensive inspection should be conducted post-repairs to ensure all rectifications comply with the required standards.

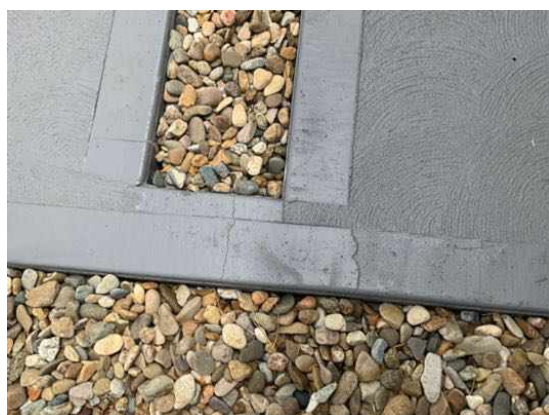
Defects 3.05

Building: Main Building  
 Location: Yard - Front  
 Finding: Crack in concrete slab - Category 0  
 Information: A crack coded as Category 0 was identified in the slab. A Category 0 crack is described as a hairline crack, representing insignificant movement of slab from level.

The approximate width of the crack to be considered Category 0 is 0.3mm, or change in offset of less than 8mm when a 3m straight edge is placed over the defect.

No rectification is required at this time. However, all cracking should be monitored over a 12 month period to identify any further damage in the area.

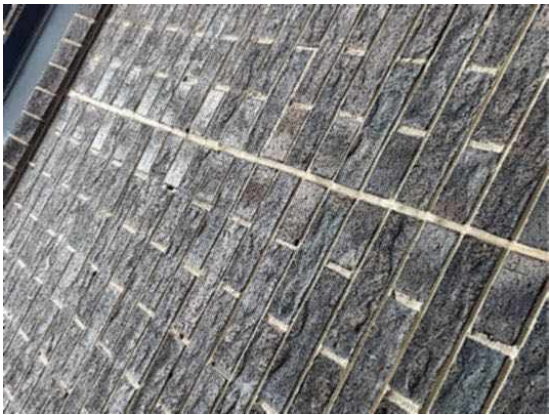
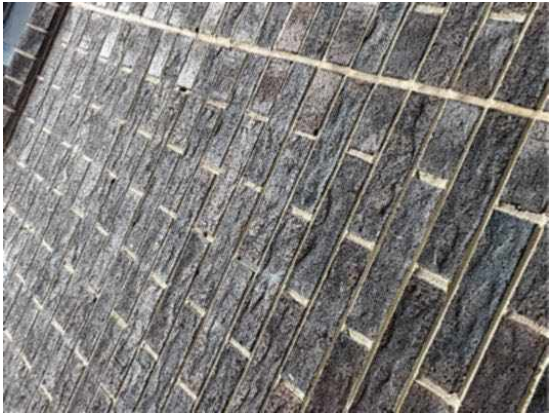
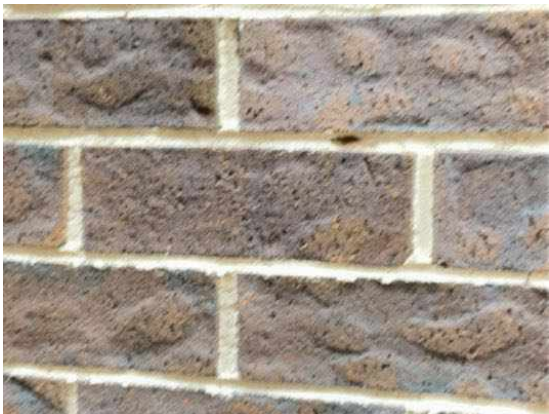
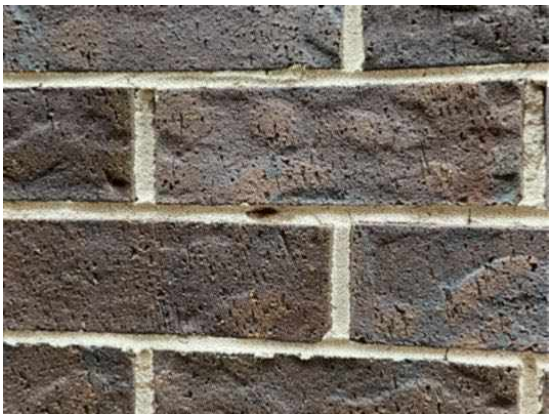
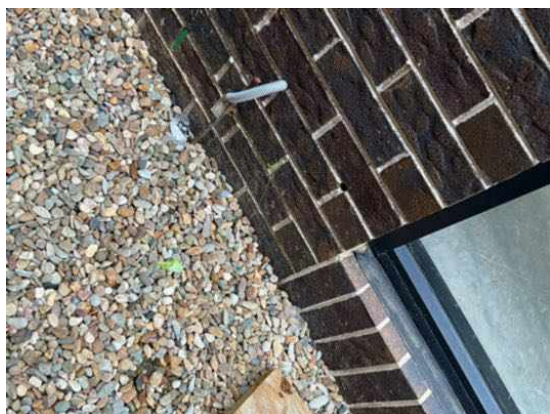
### Defects 3.07

Building:	Main Building
Location:	All Areas
Finding:	Mortar joints - Filling required
Information:	Instances of voids and holes affecting the masonry mortar have been identified. Excepting weep holes and vents voids and holes are defects if they are visible from a normal viewing position.

Where a building element is installed in such as way that it fails to achieve the required minimum standard or level of finish at the time of the inspection, the builder needs to rectify the defect as soon as possible and m complete works to the required standard prior to handover.

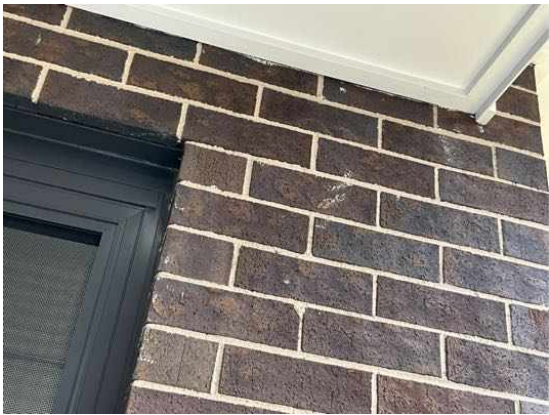
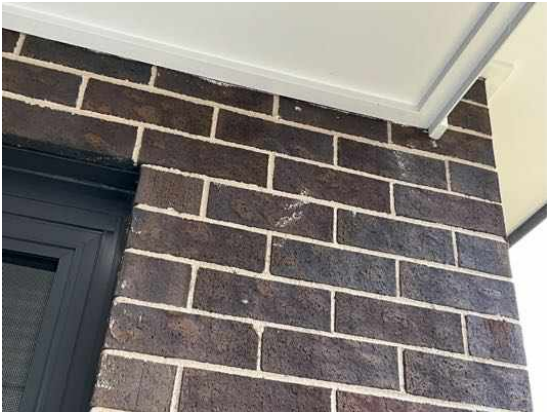
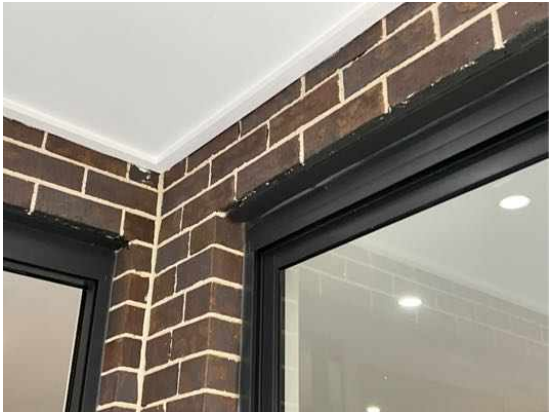
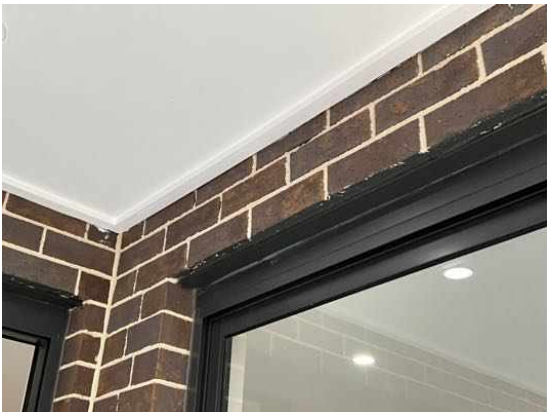
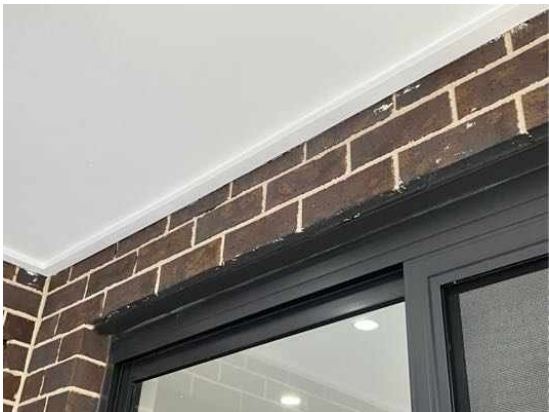
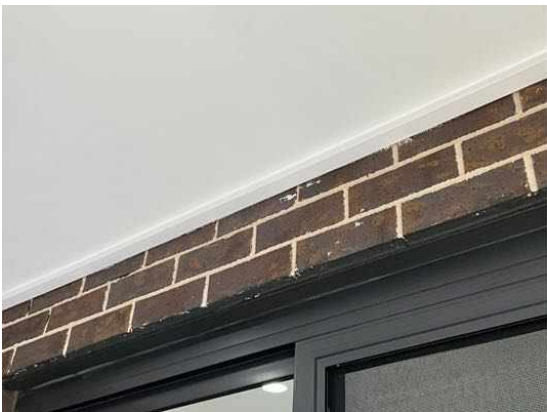
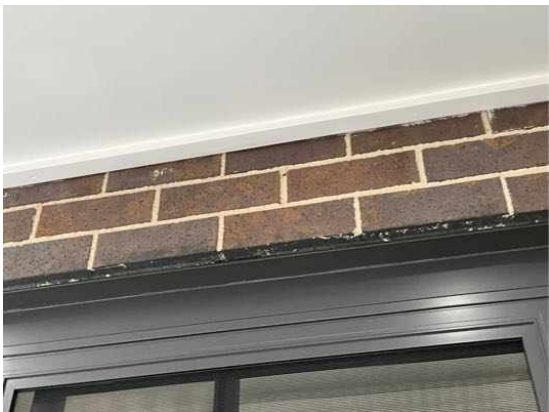
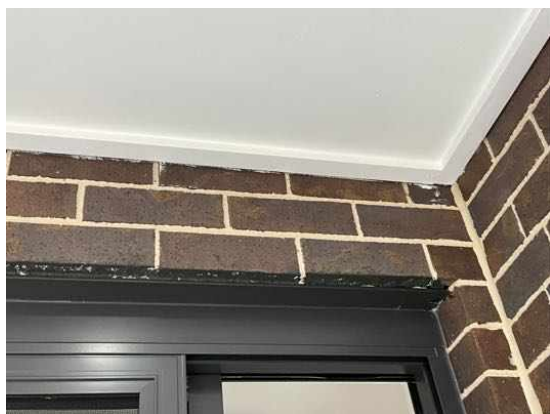
### Defects 3.10

Building:	Main Building
Location:	All Areas
Finding:	Paint - Substandard
Information:	Areas were identified where the surface finish of the painting is substandard and this is considered a defect.

Any irregularity in the surface which is visible from a normal viewing position is considered a defect. Marks may also be a result of fault by other tradespeople throughout the construction process.

Defective surface finish of paintwork is marked with an arrow to the below photos in the following locations.

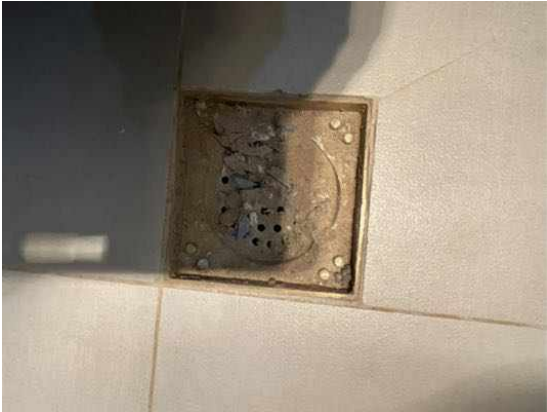
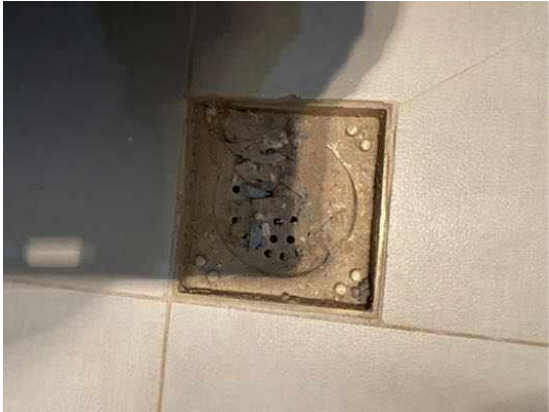
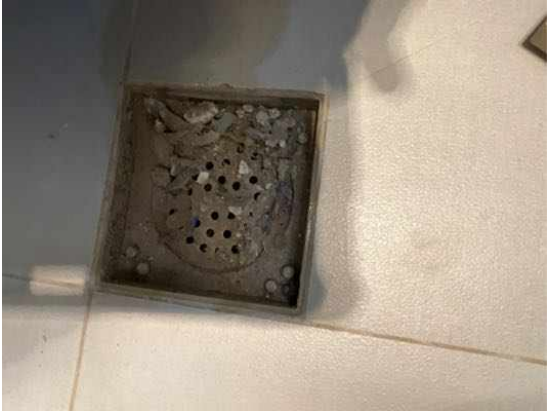
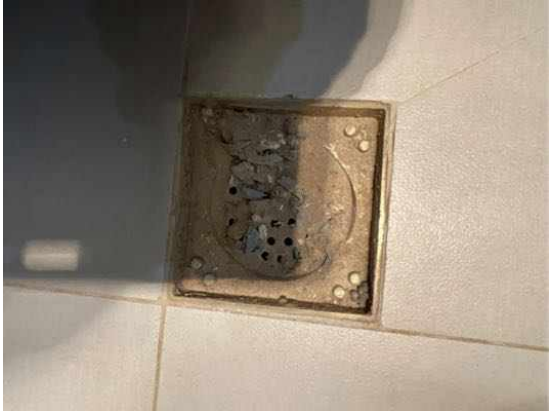
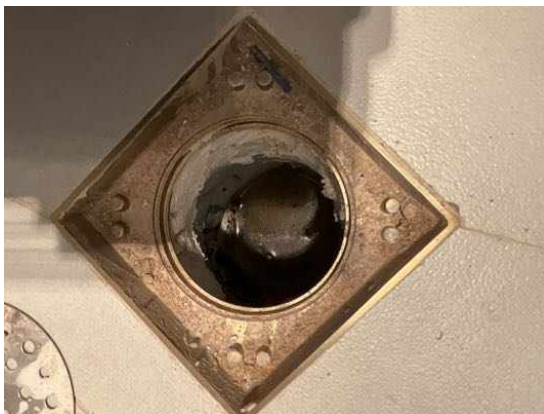
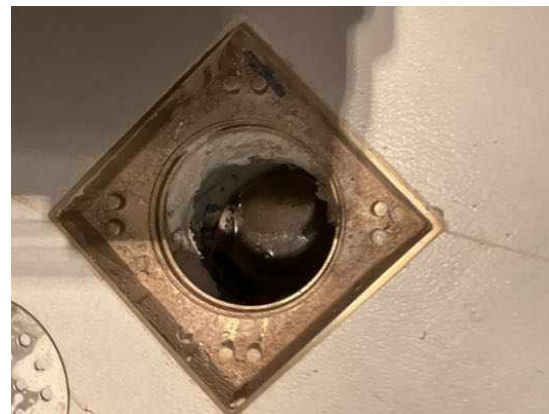
### Defects 3.12

Building:	Main Building
Location:	All Areas
Finding:	Floor waste Debris
Information:	It was noted that there is builder debris in the floor waste drainage. Debris in the plumbing system may lead to blockages in the future.

Building sites are defective if they are not clear of building debris. All floor wastes need

to be checked and cleared prior to handover.

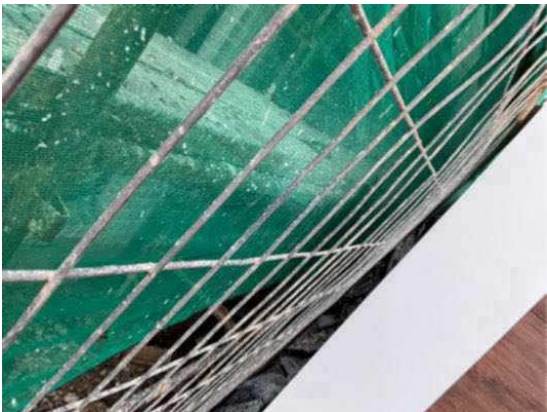
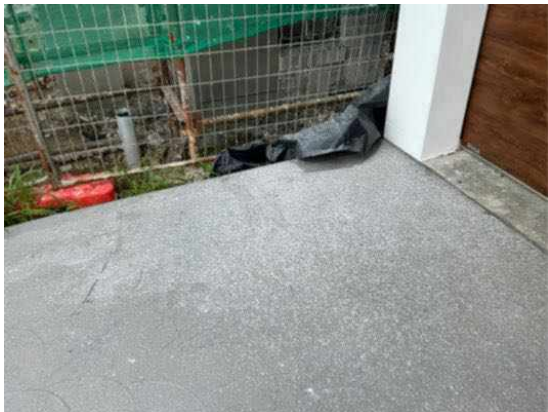
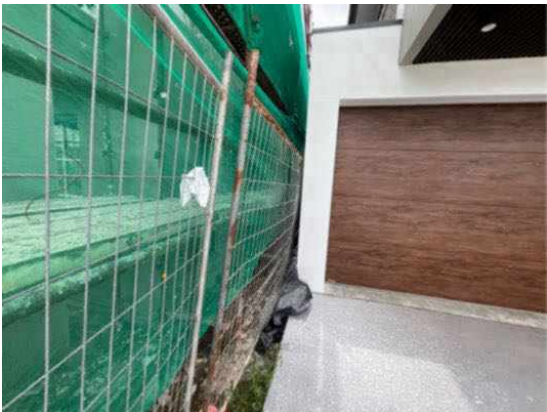
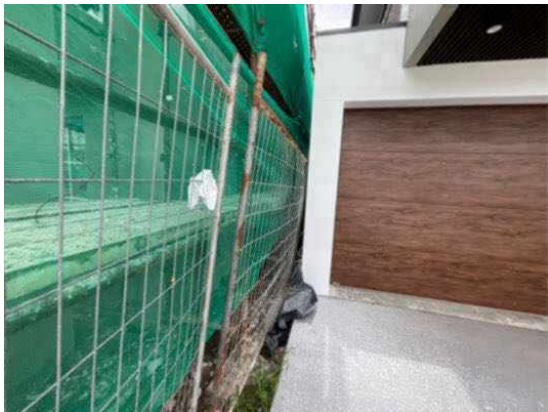
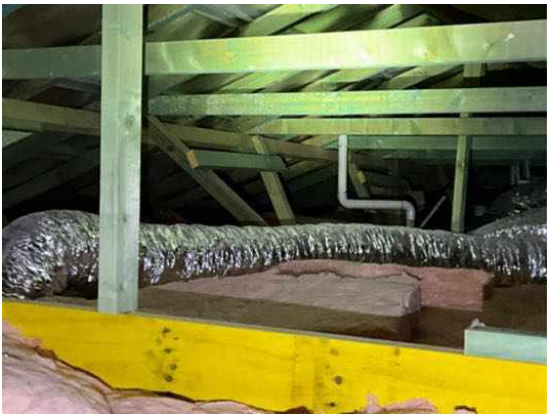
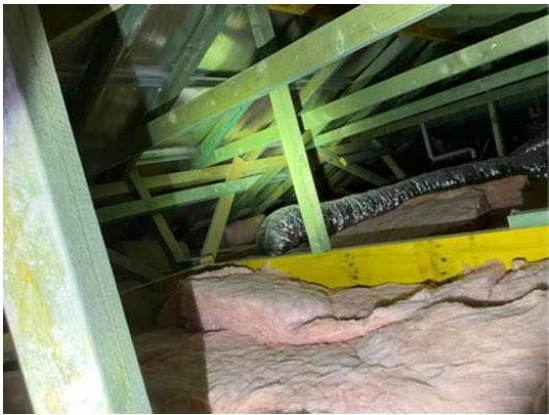
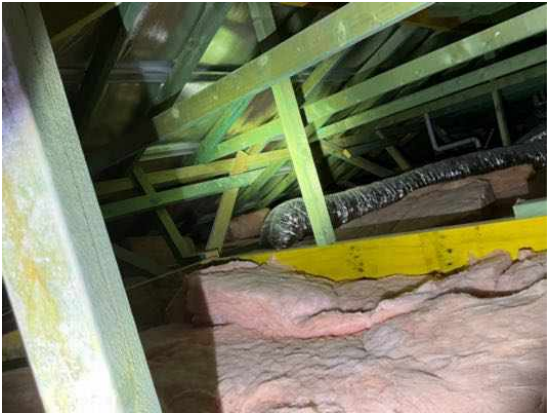
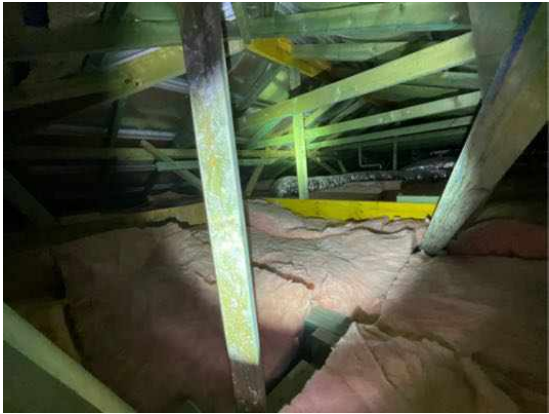
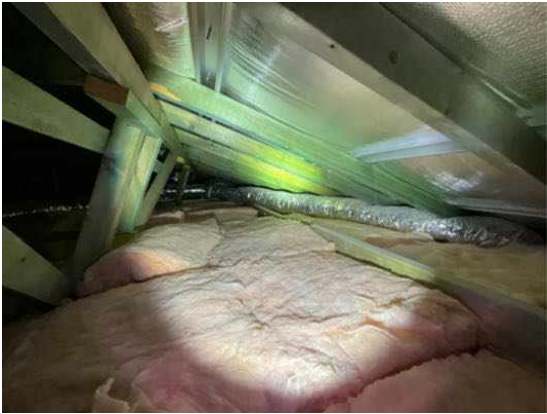
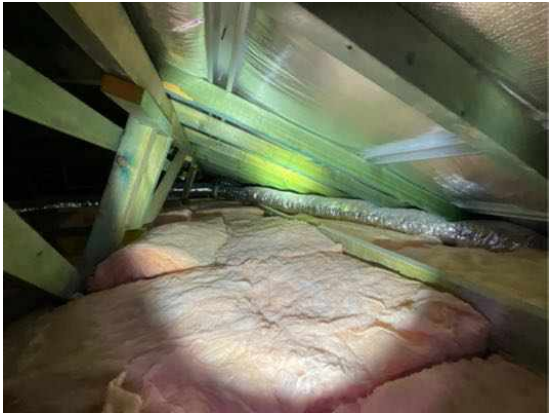
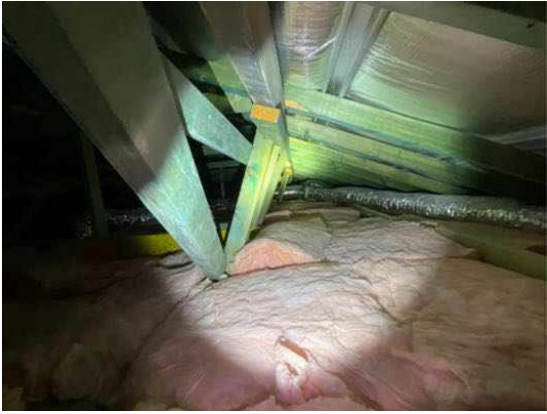
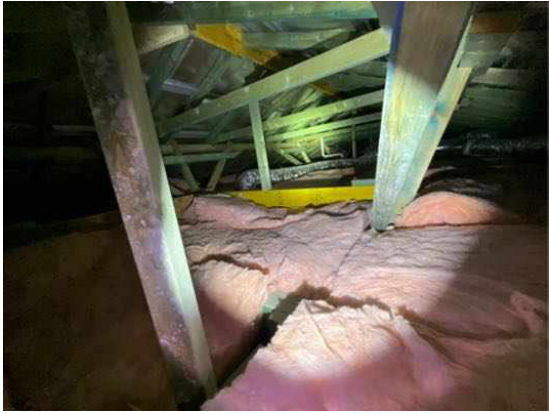
Defects 3.15

Building: Main Building  
Location: All Areas  
Finding: Additional Photos - Obstructions and Limitations  
Information: These photographs are an indication of the obstructions and limitations which impeded full inspection of the property at the time of inspection. These obstructions can hide an array of defects and should be removed to allow full inspection to be carried out. A re-inspection is recommended once the areas are made accessible.
