Building Inspection Report

Inspection Date: Fri, 30 Jan 2026

Property Address: 4 Hatcher Pl, Eumemmerring VIC 3177,
Australia

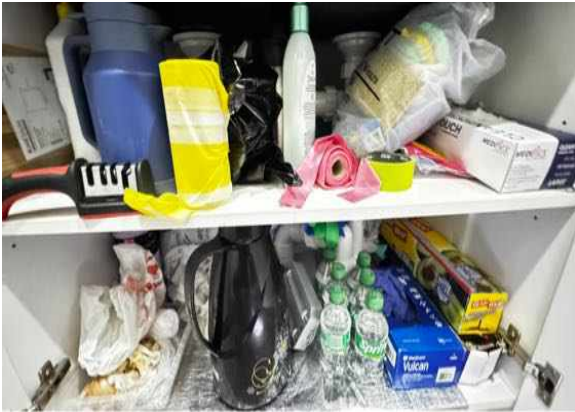
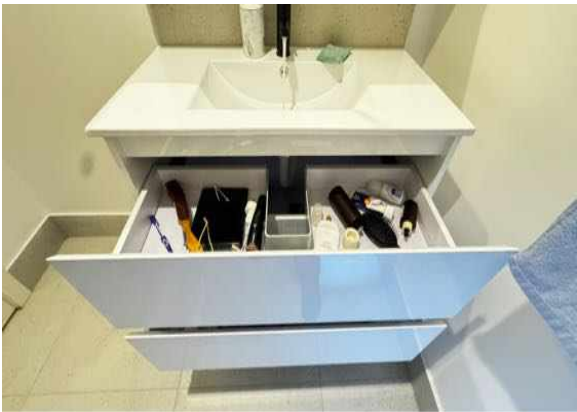
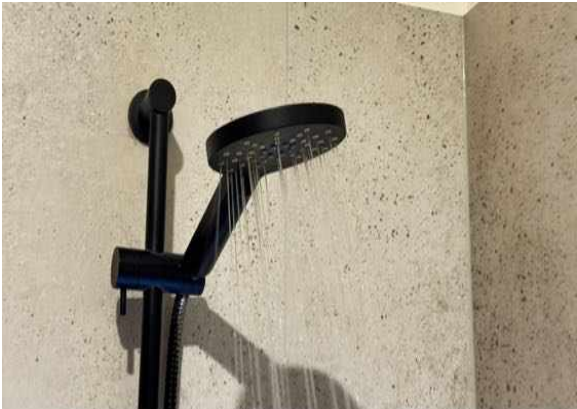
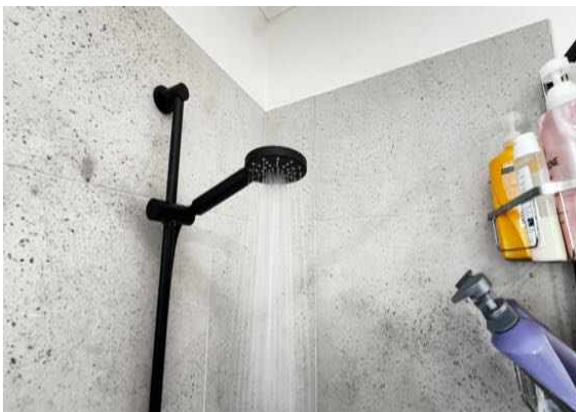
Noted Item

Building: Main Building
 Location: All Internal Areas
 Finding: Water Supply & Drainage - Shower, Basins, Toilets, & Plumbing Fixtures
 Information: The shower recess was tested, and no visible water penetration to surrounding areas was observed at the time of inspection, except where noted as a separate defect elsewhere in this report. Water appeared to flow freely toward the floor waste. Moisture detected to the shower walls is documented separately in the report. The shower floor waste appeared clear during inspection.

Flushing the toilet revealed no visible leaks, and the fixture appeared to operate normally unless otherwise noted as a separate defect. No water damage was observed to the vanity unit unless specifically stated elsewhere in the report. Basins, bathtubs, laundry tubs, vanities, and sinks were tested and inspected with no evidence of leaks, blockages, or drainage issues at the time of inspection unless otherwise noted. All internal taps and shower heads were tested with no leaks observed, unless documented as a separate defect.

This inspection provides a snapshot of performance at the time of testing. Water leaks or drainage issues may not become apparent until the fixtures are used consistently over time and surrounding areas are monitored.

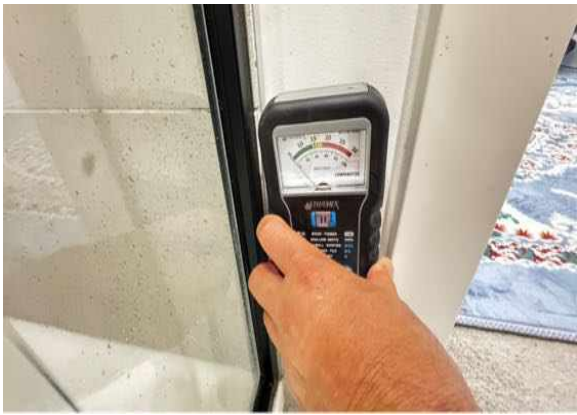
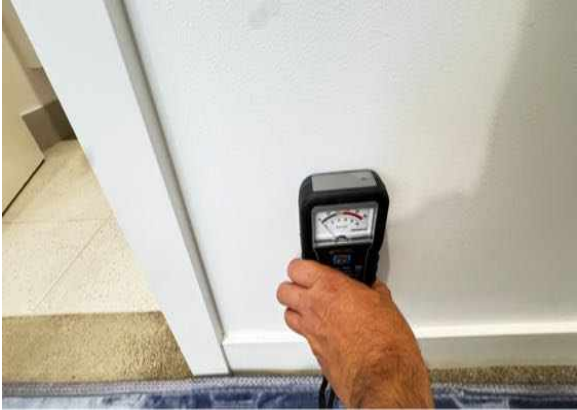
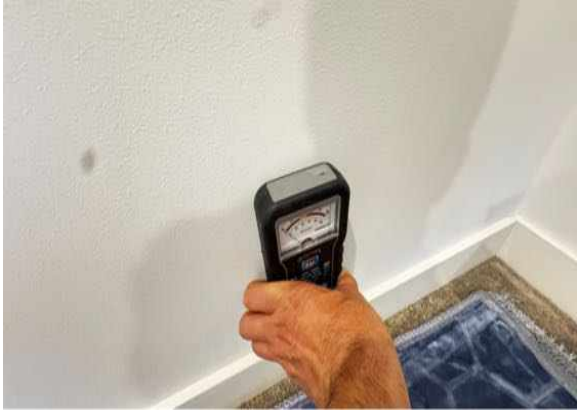
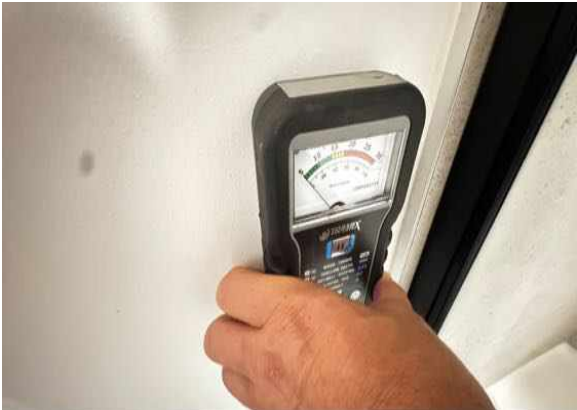
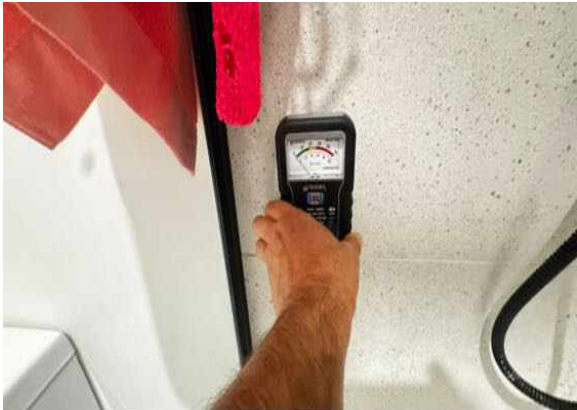
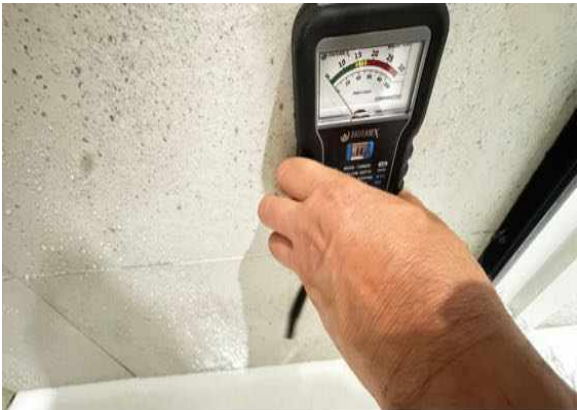
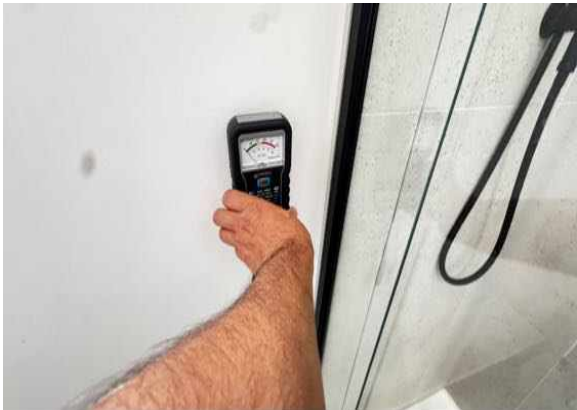
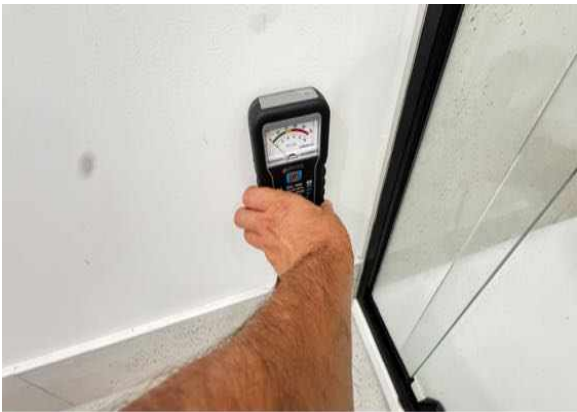
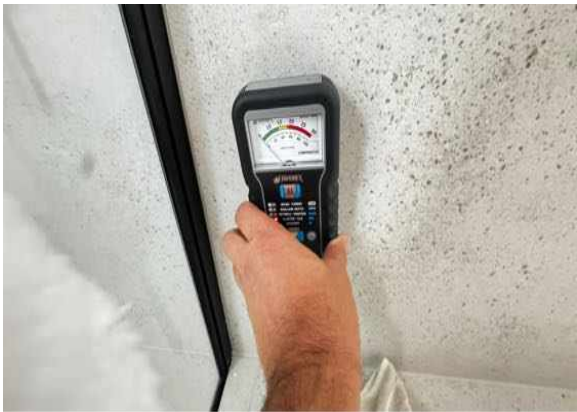
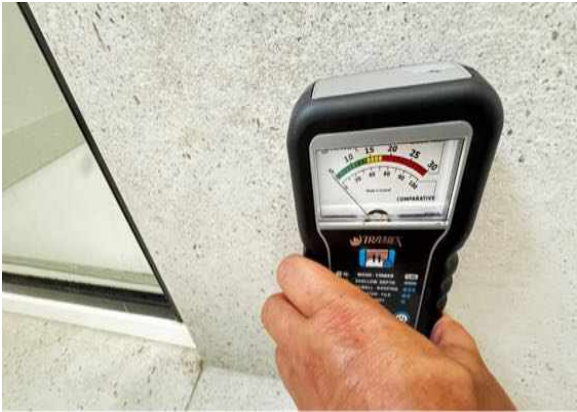
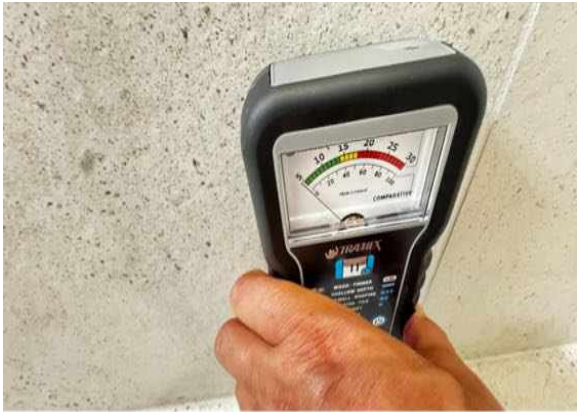
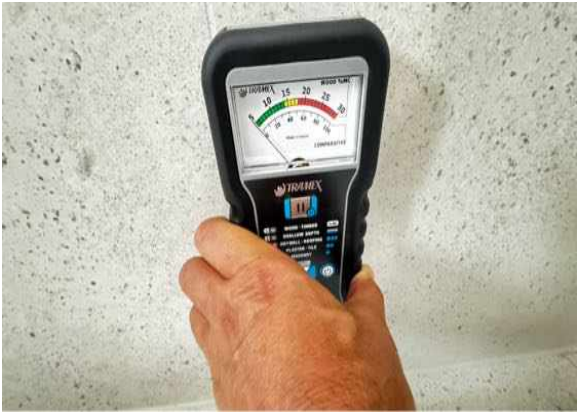
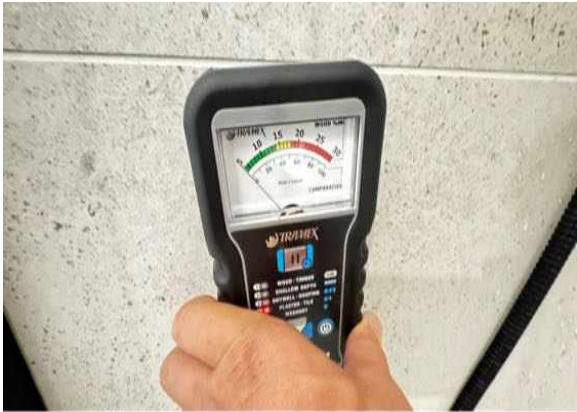
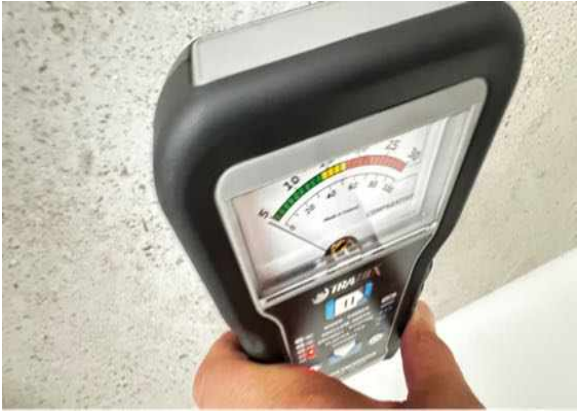
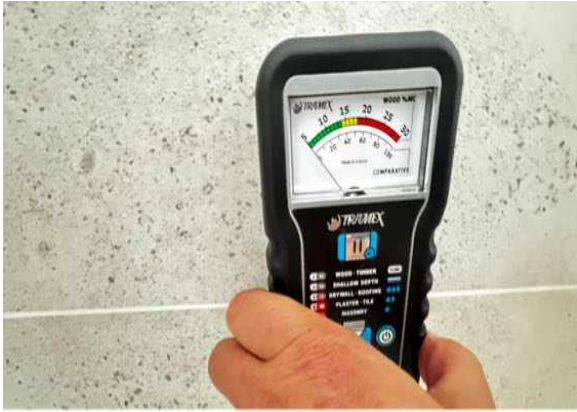
Noted Item

Building: Main Building
 Location: All Areas Interior & Exterior
 Finding: Moisture Levels - Advisory - No Elevated Moisture Levels Present
 Information: At the time of inspection, no elevated moisture levels were detected in these areas. Moisture readings were taken (using a Tramex Moisture Meter) and non-invasive testing methods and reflect conditions present at the time of inspection only. This item is noted for advisory purposes and should not be relied upon as a guarantee that moisture issues are not present elsewhere or may not occur in the future.

It is important to note that moisture levels can fluctuate due to weather conditions, plumbing usage, seasonal changes, or intermittent leaks. Concealed moisture within wall cavities, subfloor areas, or other inaccessible locations may not be detected during a visual or limited moisture assessment.

Ongoing monitoring of the property is recommended, and further investigation by a qualified tradesperson should be considered if signs of water ingress, dampness, staining, mould growth, or material deterioration become apparent.

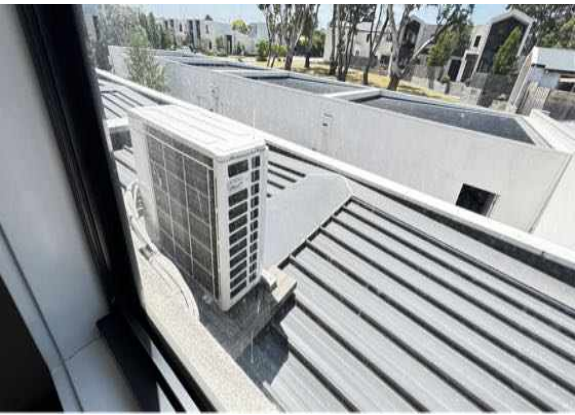
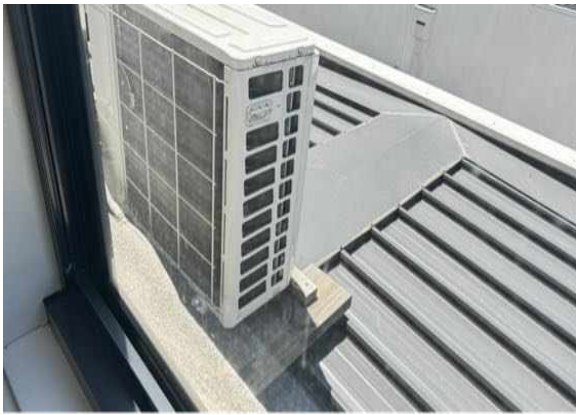
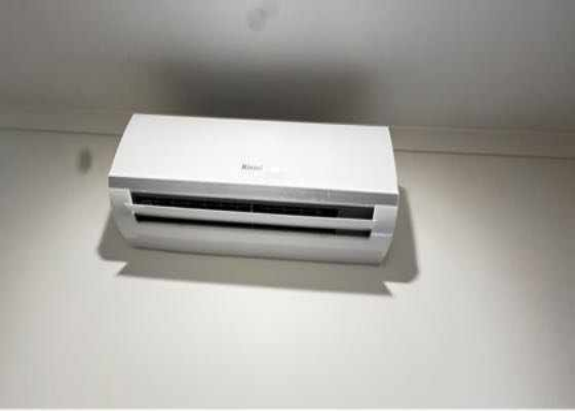
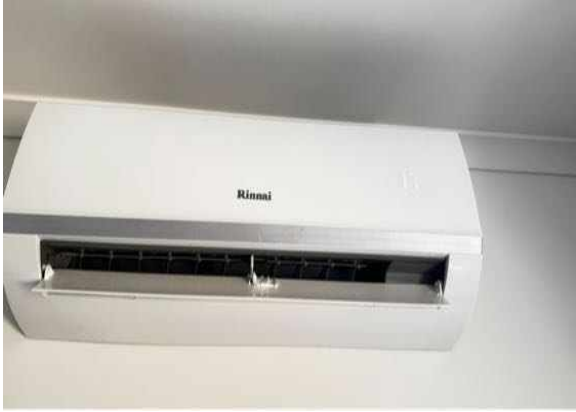
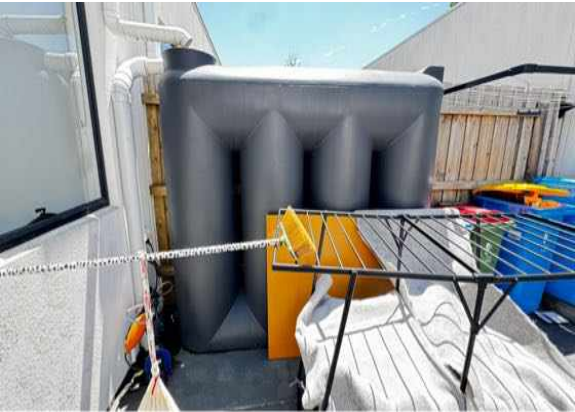
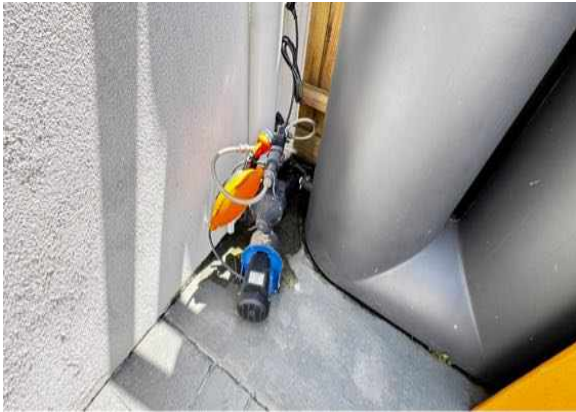
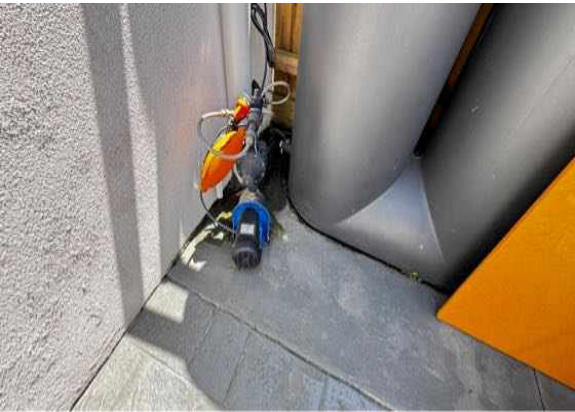
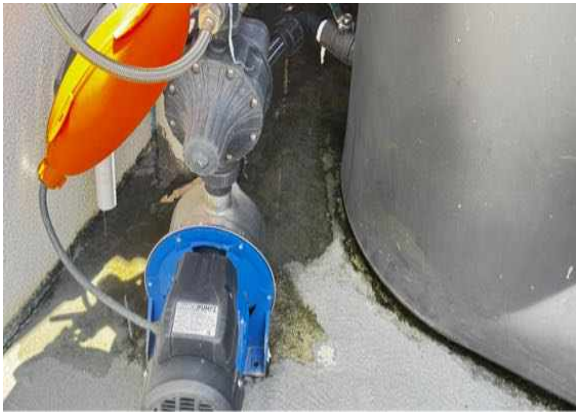
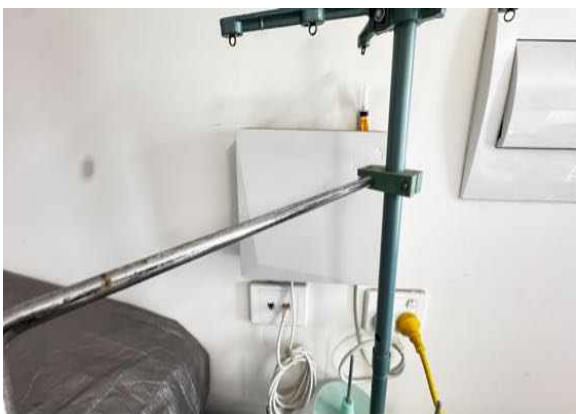
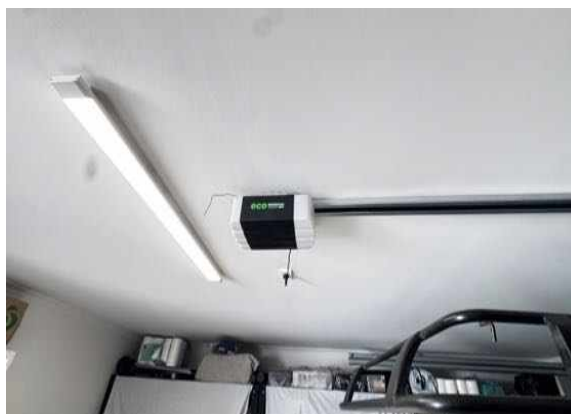
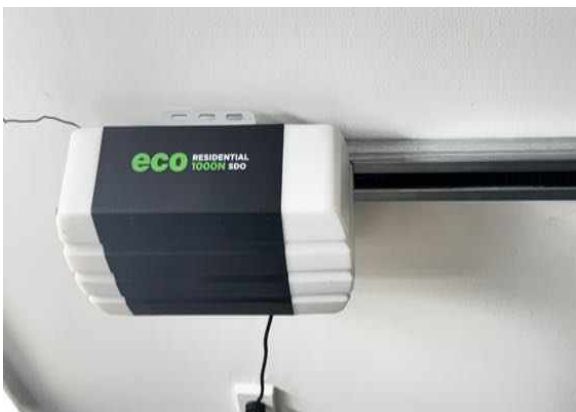
Noted Item

Building: Main Building
 Location: All Areas, Interior & Exterior
 Finding: Appliances, Heating & Cooling Systems, Mechanical Systems, Plumbing, Electrical, Fireplaces - Advisory
 Information: The inspection did not include testing, operation, safety, or assessment of any installed or portable appliances or mechanical systems. This includes, but is not limited to, ovens, cooktops, microwaves, rangehoods, dishwashers, ducted vacuum systems, air-conditioning units, heating systems, hot water services, ceiling fans, exhaust fans, intercoms, security systems, fireplaces, and solid fuel heaters.

Where appliances are beyond their warranty period, the owner should be prepared for potential costs of repair or replacement at any time. The operation of these appliances cannot be guaranteed, and further inspection by a licensed tradesperson may be required. Many appliances are only covered by limited manufacturer or installer warranties. Confirming warranty status is strongly recommended prior to purchase, as out-of-warranty items may require servicing, replacement, or certification by a qualified technician.

Appliances may be worn, damaged, or malfunctioning. Electrical or gas appliances can pose serious safety hazards if incorrectly installed or maintained.

Service, repair, or replace equipment as necessary, particularly where service history or warranty coverage is unknown.

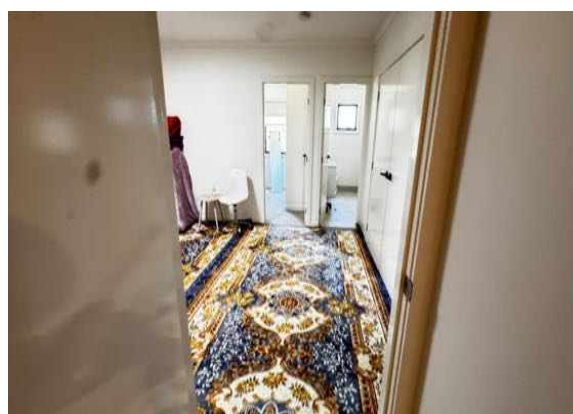
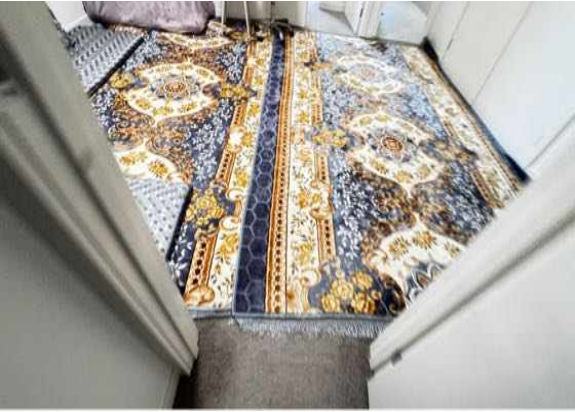
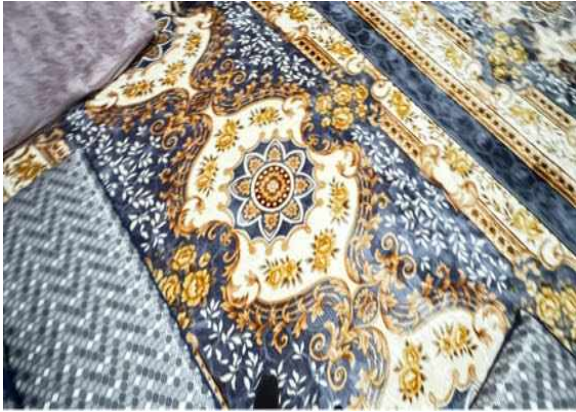
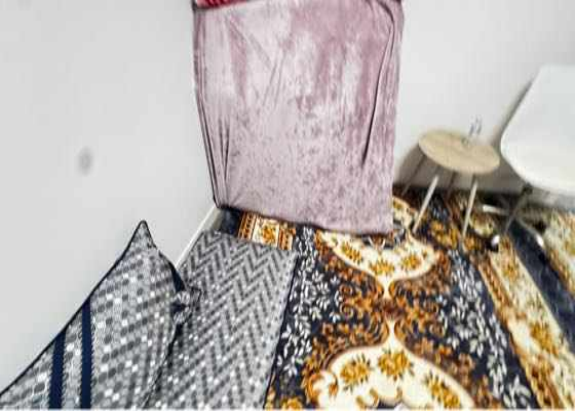
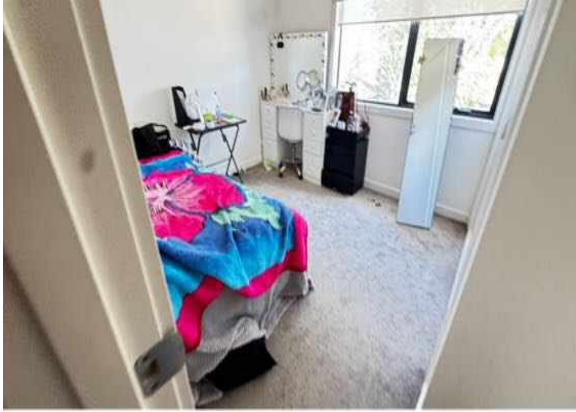
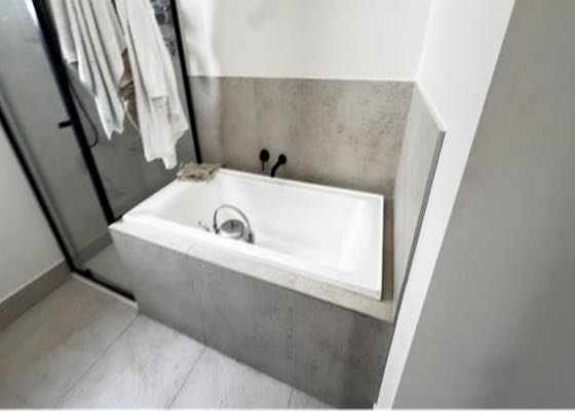
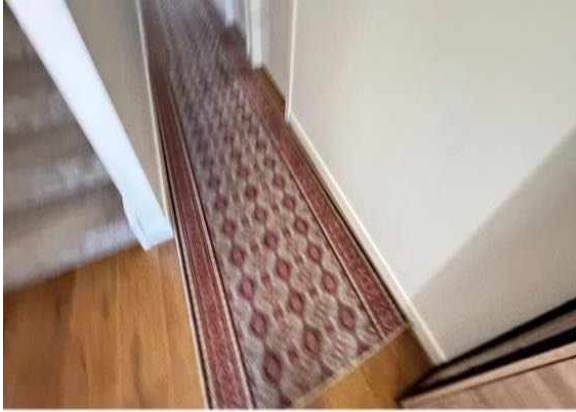
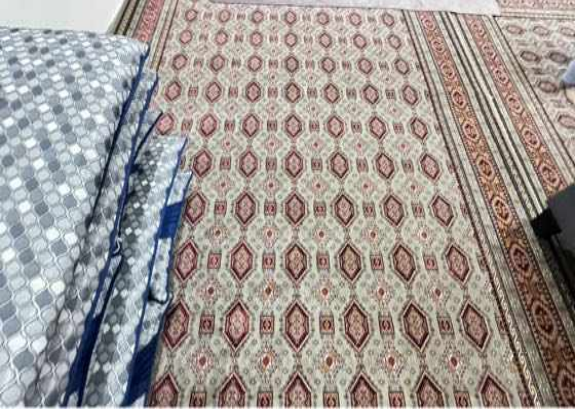
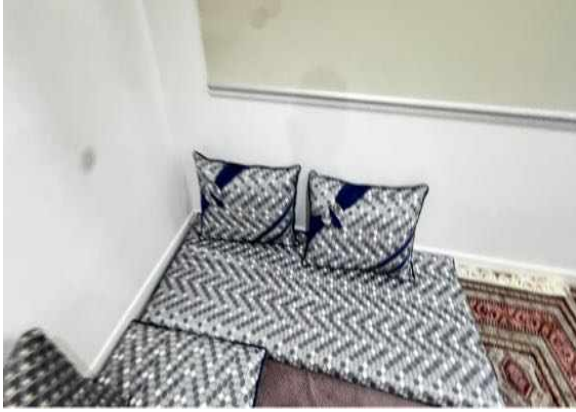
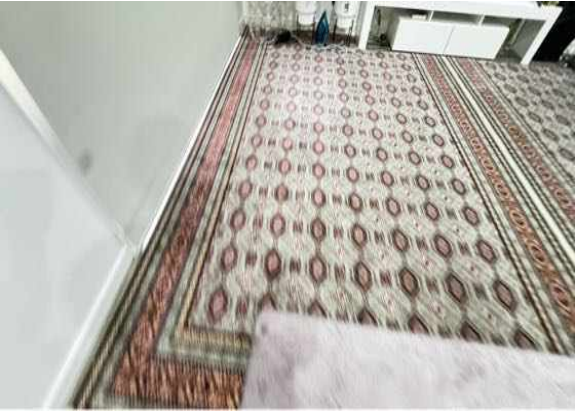
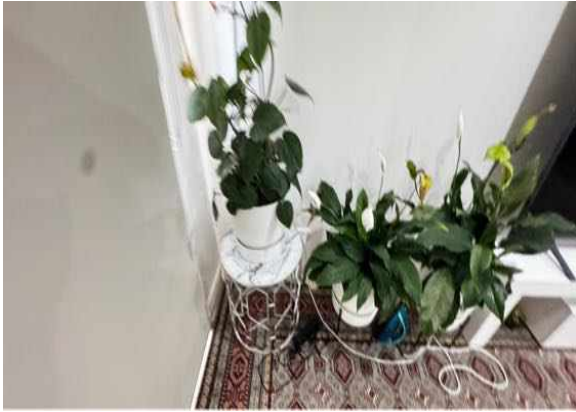
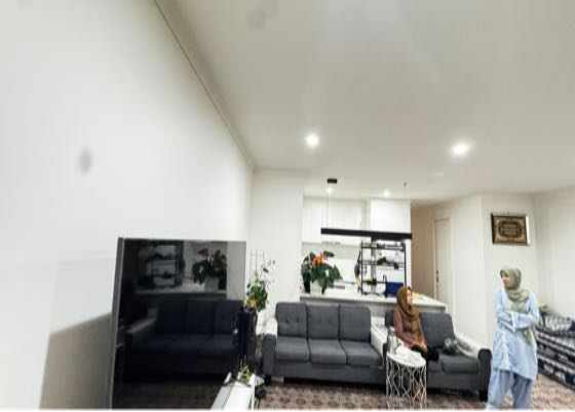
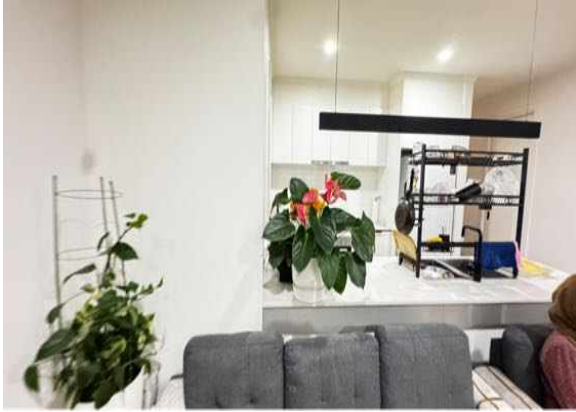
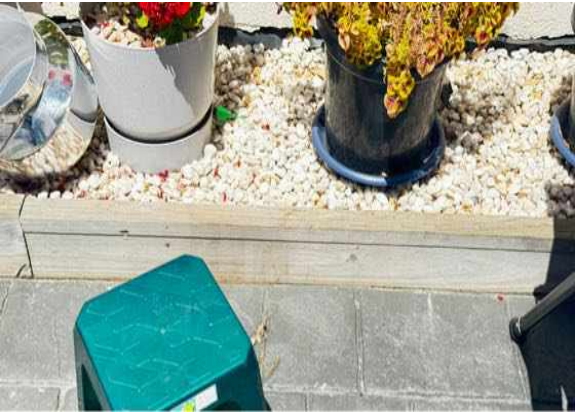
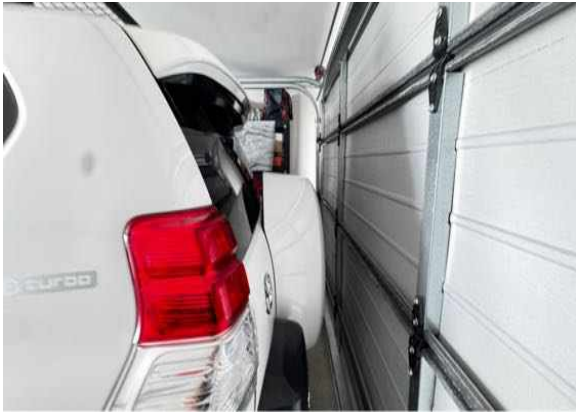
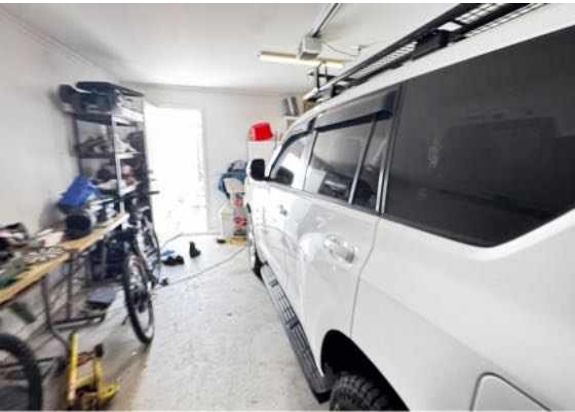
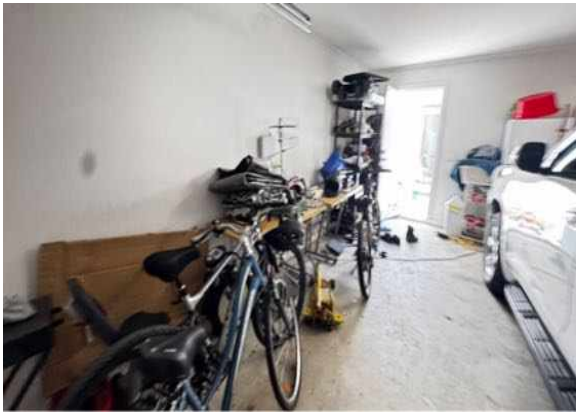
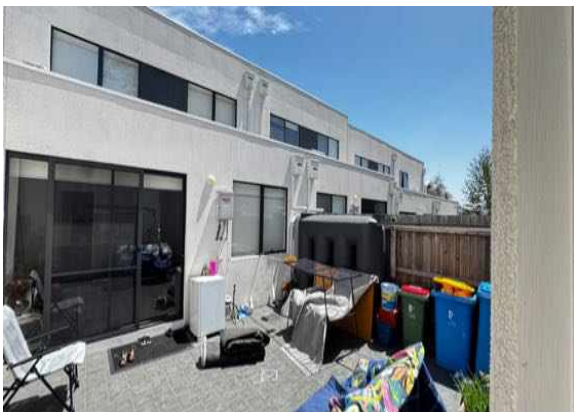
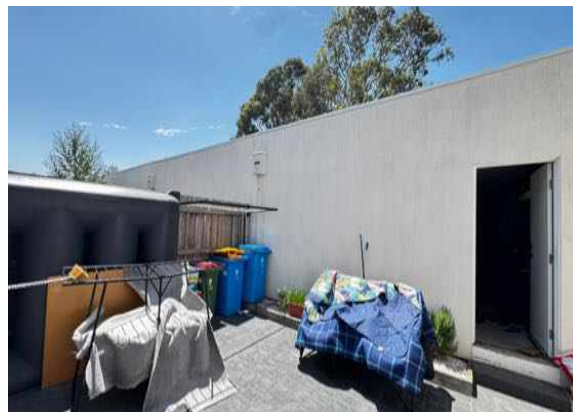
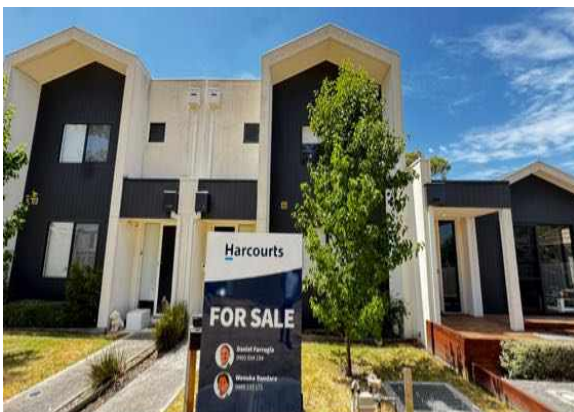
Noted Item

Structural damage such as cracking or movement in walls, floors, or ceilings.

It is strongly recommended that obstructions be removed and concealed areas made fully accessible immediately. A re-inspection should then be carried out to allow a complete assessment of the property's condition. This is particularly important prior to purchase, as defects in concealed areas can carry significant rectification costs.
