Building and Timber Pest Inspection Report

Inspection Date: Fri, 6 Mar 2026

Property Address: 1A Harpur Cres, South Windsor NSW 2756,
Australia

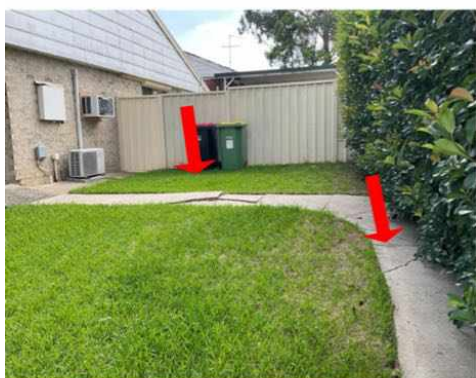
Building:	Building 1
Location:	Yard - front
Finding:	Crack in concrete slab - Category 4
Information:	Cracks of up to 48mm coded as Category 4 was identified in the slab. A Category 4 crack is described as a crack that appears as a gap in the slab, with disturbing curvature or change in level affecting the slab.

Category 4 cracking to slabs exceeds allowable Standards and Tolerances, and this is considered safety defects from trips and falls requiring urgent rectification.

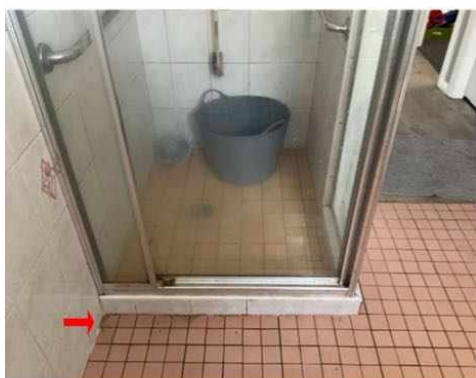
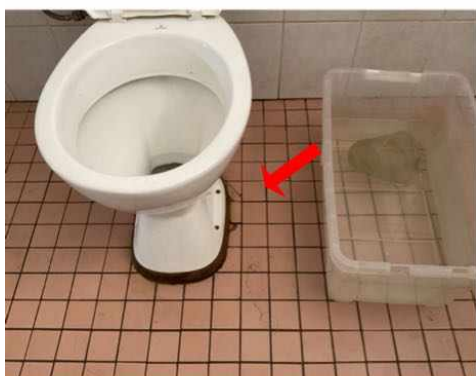
Building:	Building 1
Location:	Bathroom areas
Finding:	Tiles cracked

Information: Cracked tiles were evident in these pictured two bathroom areas at the time of inspection. It is suspected that this cracking has occurred as a result of installation damage.

Cracked tiles throughout the household detract from the overall appearance of the affected areas. In wet areas of bathrooms, it can lead to water damage of adjoining walls and floors.

Replacement of cracked tiles is recommended as soon as possible. A tiling contractor may be appointed to perform these works. Where cracks become more numerous, contact a licensed building inspector for further investigation.

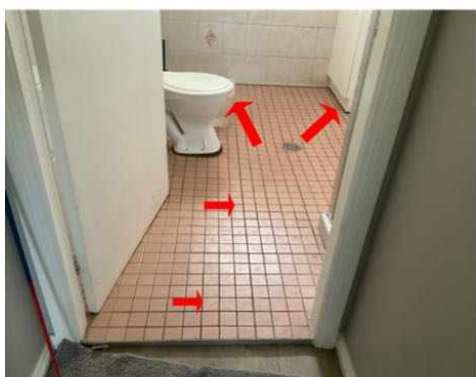
Finding 3.05

Information: Drummy tiled areas were identified at the time of inspection. The term 'drummy' refers to tiles that have become detached from their fixing, despite otherwise being in relatively good condition. Such defects are generally caused by physical or moisture damage to the area. Drummy tiled areas may also be a direct result of poor workmanship during the construction process.

Tiled areas may swell and shrink with changes in air humidity if the area has sustained moisture damage. Any exposure to moisture is capable of causing tiled areas to become drummy and/or cracked over a prolonged period of time. Drummy tiled areas generally require removal and replacement of affected tiles, with adequate sealant and grouting.

Specialist trades are available for these types of services. A registered builder may be required to undertake works if damage is extensive or if secondary building defects have resulted. Otherwise, it is advised that a tiling contractor be appointed to perform works as necessary.

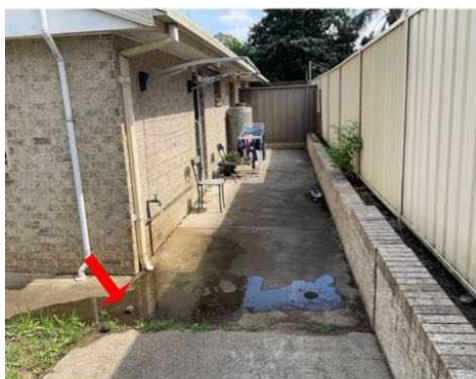
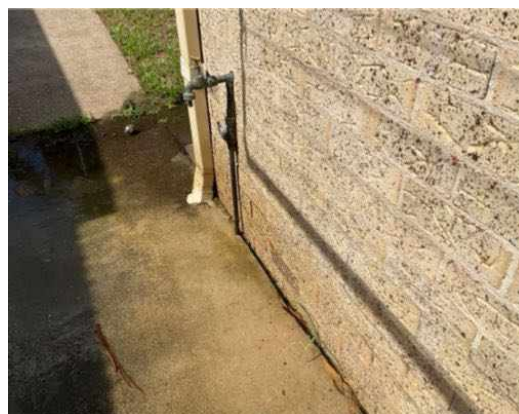
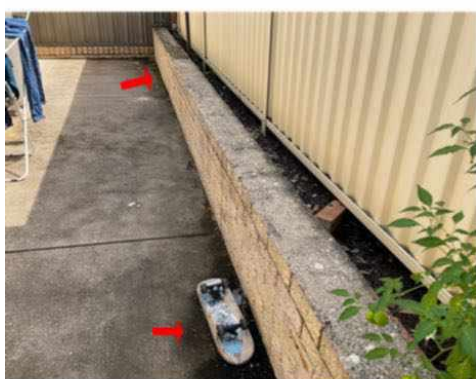
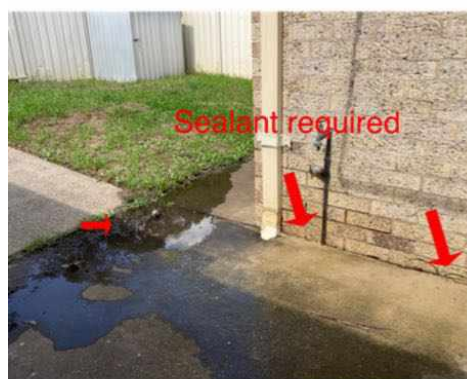
Finding 3.06

Building:	Building 1
Location:	Walls
Finding:	Site drainage - Inadequate
Information:	The site drainage in this rear area was found to be inadequate at the time of inspection, creating potential for subsequent water damage to associated building elements.

Some water pools in 3 areas, evidenced by concrete staining and running the rear tap. A small amount of water disappeared between the wall and the slab. The perimeter walls required sealant to stop water flowing under the slab.

It is important that water does not lie against the base of walls; surrounding paths and ground levels should be sloped to drain water away from walls. Downpipes should not discharge stormwater onto lower walls or plinths. Stormwater should be carried away by large, regularly cleaned drains. Ground levels may need to be lowered to expose a buried DPC.

Where site drainage is inadequate, installation of an Agricultural (Aggie) Drain may be required. A qualified plumber should be appointed to further inspect the property and perform any remedial works as necessary. Secondary defects are likely to occur if left unmanaged.

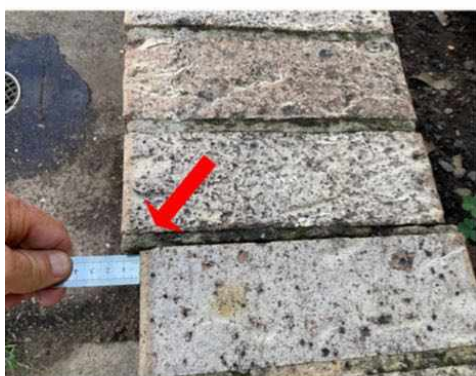
Finding 3.07

Building:	Building 1
Location:	Exterior retaining wall
Finding:	Step cracking and movement to brickwork (minor)
Information:	Step cracking and 10mm of movement was identified to the 675mm brick retaining wall in this rear area at the time of inspection. Step cracking, which is similar to other forms of cracking, has a variety of possible causes. However, the most common is the subsidence of adjacent footings.

Step cracking is a relatively common defect, and is most likely to occur adjacent to windows, doors and other openings. Mortar failure in the gaps between affected bricks indicates the stresses and tensions affecting the wall.

This wall has drainage behind it evidenced by a lower protruding drain.

Where step cracking is extensive or severe, the client is advised to consult a structural engineer. This minor step cracking can be used as a warning sign to address factors causing stress to the wall, which can include the effect of surrounding trees, water leaks, soil erosion, or even the presence of reactive soils in the surrounding area.

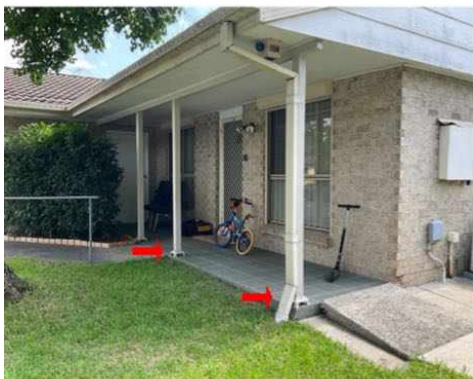
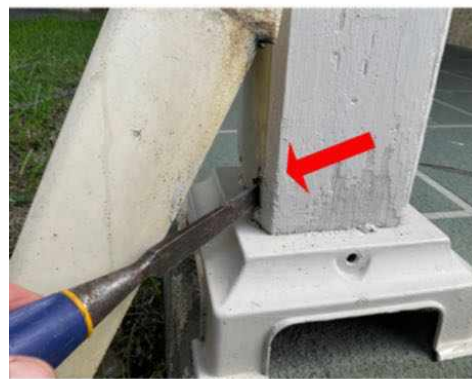
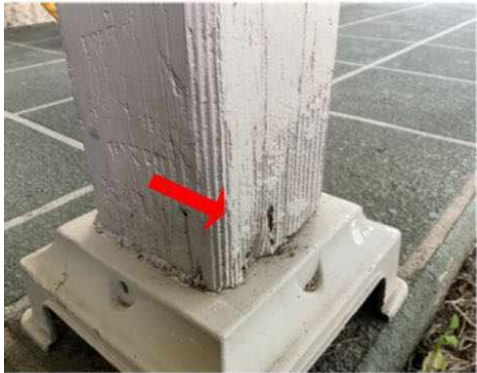
Building:	Building 1
Location:	Verandah, rear door
Finding:	Wood rot to posts and other areas
Information:	Two front posts and the laundry door show evidence of wood rot. These front posts may be repaired if the wood rot is fully removed, bogged and adequately painted protected in the next few months. Wood rot, also known as Fungal Decay, occurs when timbers and other cellulose building materials are exposed to damp conditions on an ongoing basis. This could be the result of exposure to weathering over a prolonged period of time, or the attraction of excessive moisture from other abutting building materials.

Early intervention and regular maintenance, particularly of exterior timbers, will prolong the useful life of these building elements. Replacement of affected timbers may then be a necessary step in protecting surrounding building elements from such deterioration.

A qualified carpenter or registered builder may also be required to replace affected building materials.

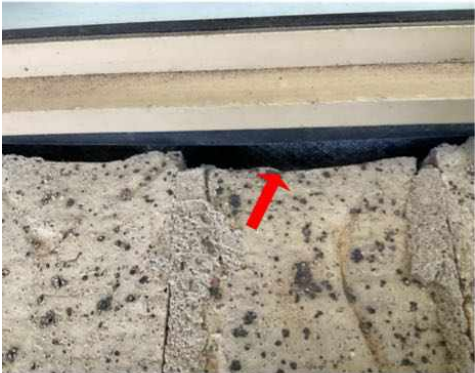
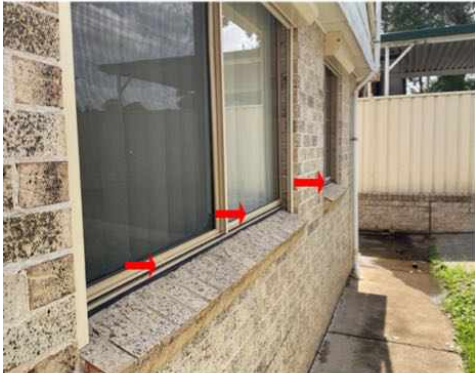
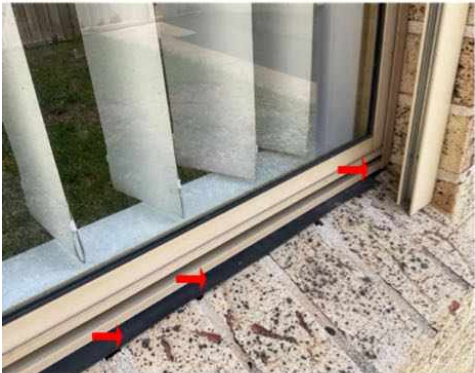
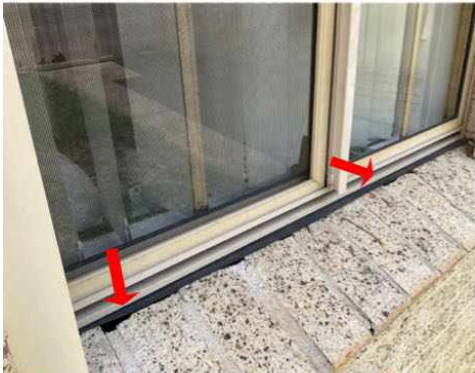
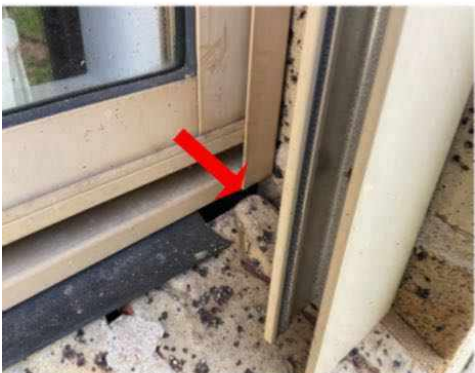
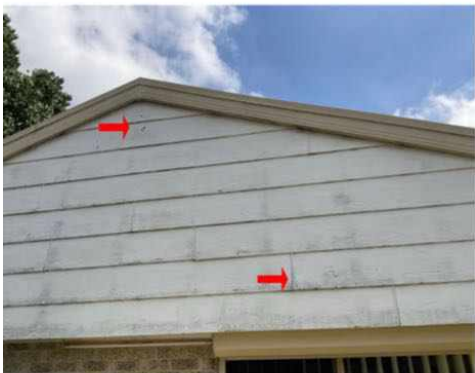
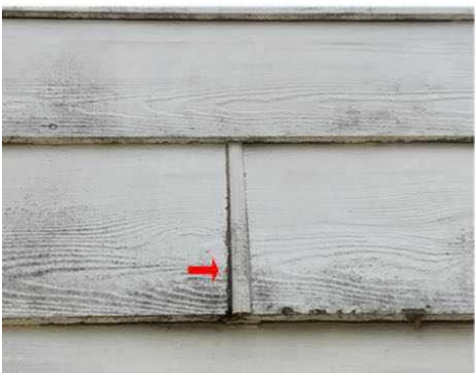
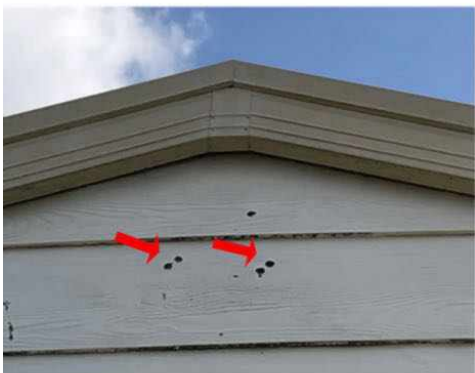
Finding 3.10

Building: Building 1
Location: Exterior walls and windows
Finding: Sealant (external) - missing
Information: It was noted on inspection that areas of external sealant was missing to small areas of the external walls and windows.

A sealant specialist or skilled handy person should be appointed to complete these works as soon as possible

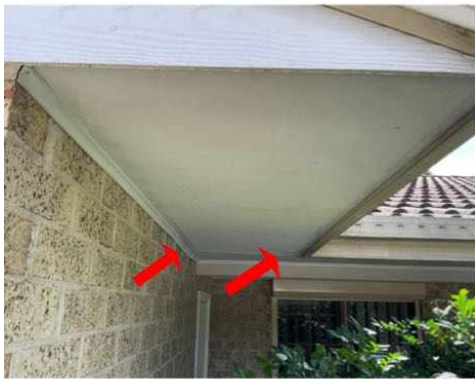
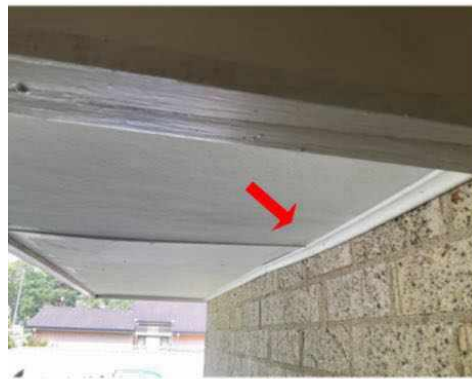
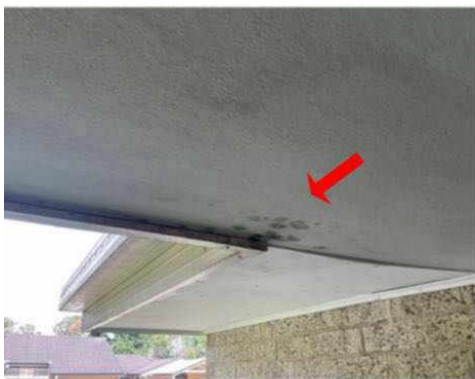
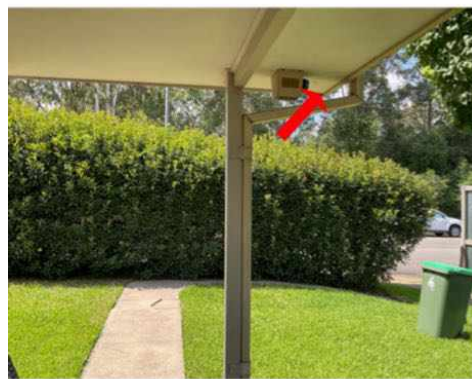
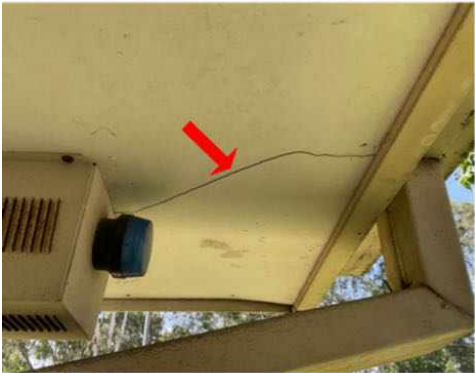
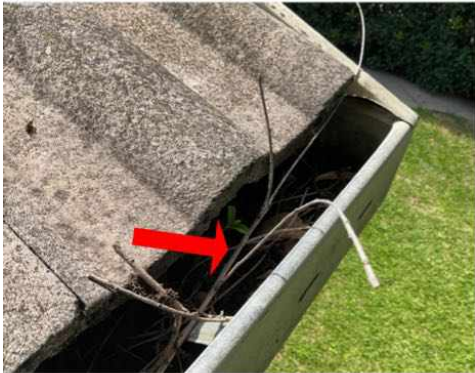
Finding: Eaves - Sagging, water stained, mouldy, cracked.
Information: Sagging and a small crack was found in two areas of the front eaves at the time of inspection. This type of defect is generally consistent with older properties, where the eave sheeting has worn over time.

Eaves are important in preventing water ingress to associated walls by promoting adequate water run-off from roofing structures. Their secondary function is to prevent shelter to adjoining structures from excessive moisture and hence prevent water damage. It is suspected a lack of gutter cleaning has lead to rainwater overflowing into these areas.

A roofing plumbing or general handyman is recommended to perform rectification works as soon as possible. Subsequent water damage is likely to result over time if left unattended.

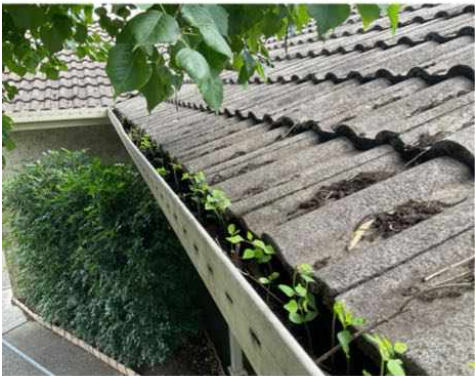
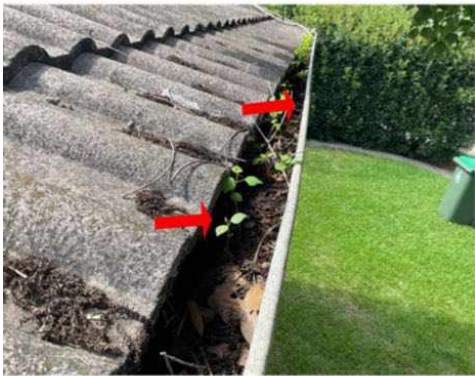
Finding 3.13

Building: Building 1
 Location: Roof exterior
 Finding: Gutters and flashing - Full and blocked
 Information: The guttering and skylight flashing on around the roof was found to be blocked at the time of the inspection. Roof plumbing structures, such as guttering and downpipes, should be free of all debris to prevent blockages. Blockages of the guttering and downpipes will lead to pooling and accumulated water overflows, which is likely to subsequently flood eaves and exterior walls.

Blocked gutters are likely to lead to high levels of moisture in the affected areas which can cause rust and decay of the gutters and downpipes and wood rot to adjoining timber areas. Blockages in gutters should therefore be removed immediately to ensure dry conditions are maintained.

It is highly advised that gutters be cleaned by the homeowner or a general handyperson as a matter of urgency. If this is not undertaken regularly, these gutters will start to sag and cause more eave damage.

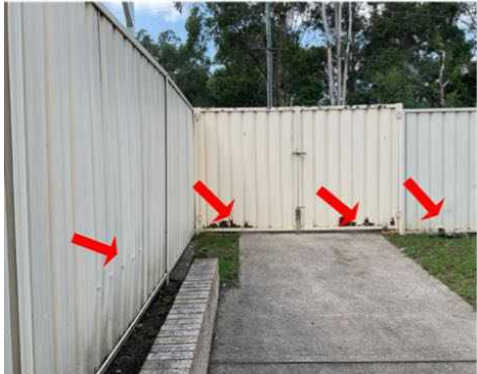
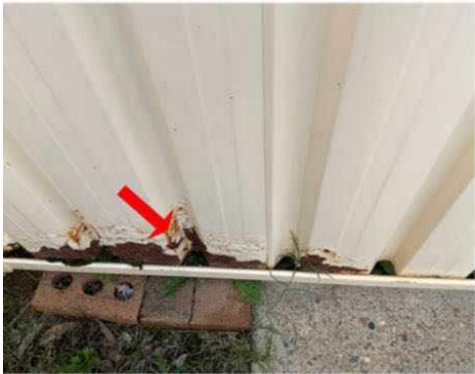
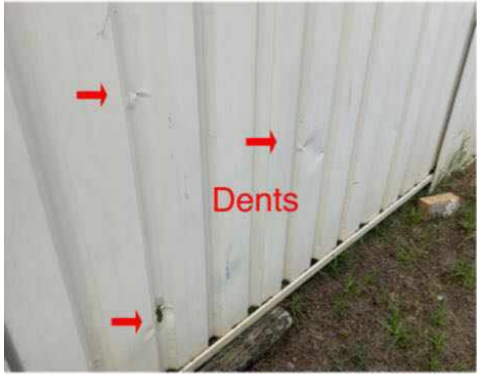
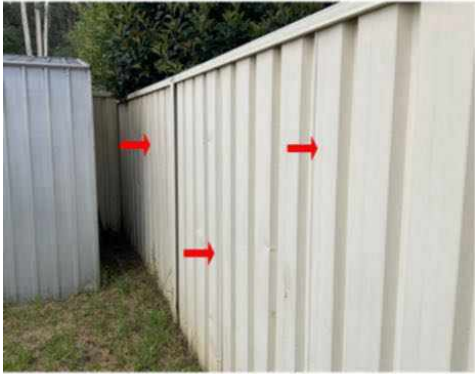
Finding 3.14

Building: Building 1
 Location: Pictured fences & gate
 Finding: Fences damaged - rust and dents
 Information: Evidence of damage to the pictured fences was identified at the time of the inspection. These fences show dents and rusted gates.

It is suggest a fencing contractor be engaged for rectification when convenient.

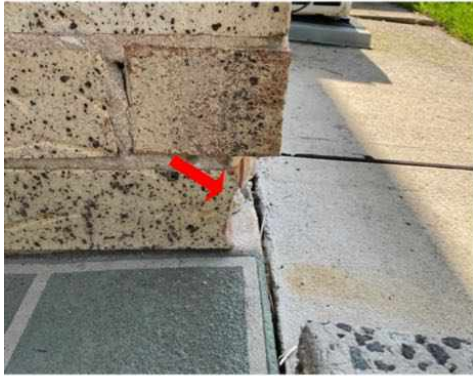
2. The right rear corner has minor mortar damage due to damp conditions from the nearby tap, not requiring rectification at this time.

A bricklayer would be the trade responsible for rectification of these areas when convenient.

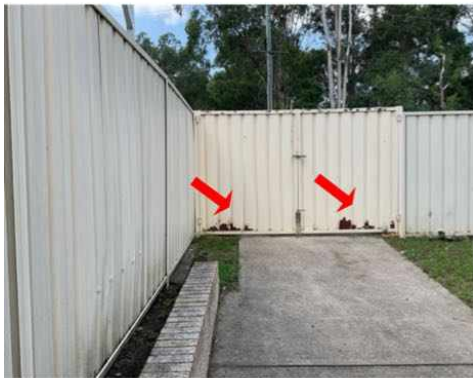
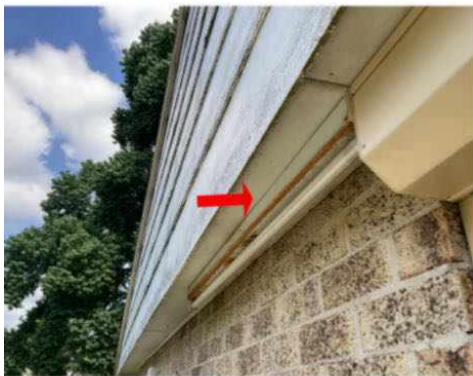
Where possible, the use of galvanized (treated) metals or aluminium coated metals aid in rust prevention, as does regular general maintenance. Rust formation can be controlled with coatings, such as paint, that isolate the iron from the environment.

Rusting and corrosion should be managed by ideally removing or limiting the affected surface from exposure to moisture. A registered builder may be appointed to replace any building elements that have been severely affected by rust or water damage.

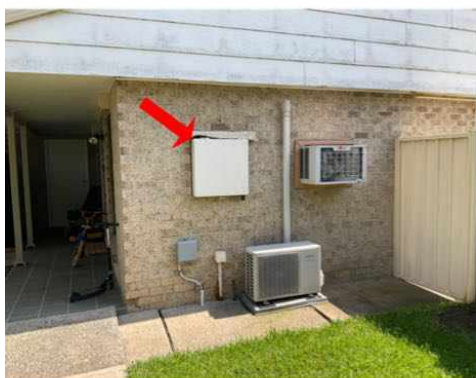
A durable notice should be placed in the switchboard unit to indicate current termite barriers. At the time of inspection, no durable notice was evident and it appeared as though no chemical termite management system has been installed, with no evidence to suggest preventative works taking place since the property was built.

The client may consider gaining further advice from a pest controller as to the costs and procedures involved with a 'chemical' application. It is recommended that obtaining such advice be a short-term priority.

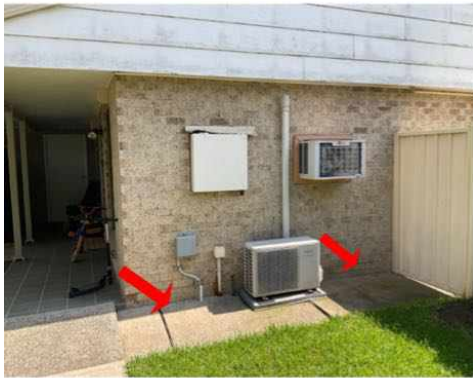
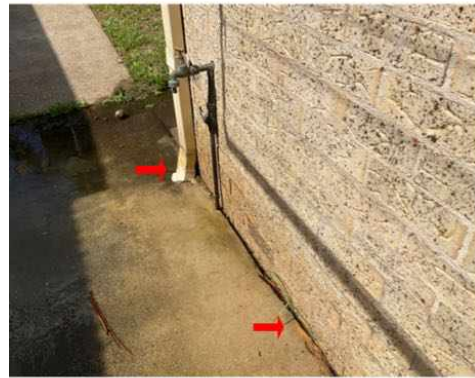
Finding 6.02

Building:	Building 1
Location:	Exterior walls
Finding:	Slab Edge - Exposure
Information:	An inspection zone of at least 75mm in relation to the exposed slab edge, between the bottom brick and the perimeter pavement, is required. This inspection zone should be maintained in order to force termites into the open where they can be detected more readily during regular inspections. The slab edge should not be concealed by anything that may prevent inspection of the area, including render, landscaping, soil, turf, paving, concrete cladding or other structures.

Where the slab edge cannot be properly inspected, it is highly recommended that termite or timber pest inspections be carried out every 6-12 months to aid protection

of the property against infestation.

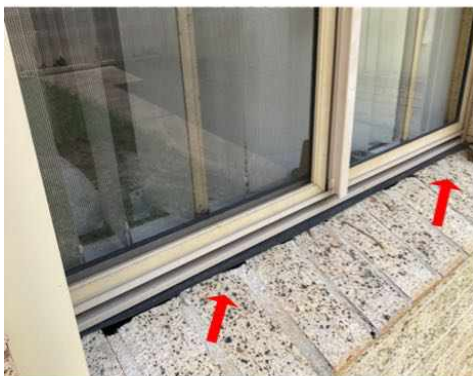
Finding 6.03

Building: Building 1
 Location: Pictured areas
 Finding: Sealant (external) - missing and attractive to termites
 Information: It was noted on inspection that areas of external sealant was missing to small areas of the external walls. A flexible sealant or flashing is required to protect the associated building materials from rainwater ingress. Any moisture ingress into the property is very attractive to termites.

A sealant specialist or skilled handy person should be appointed to complete these works as soon as possible.

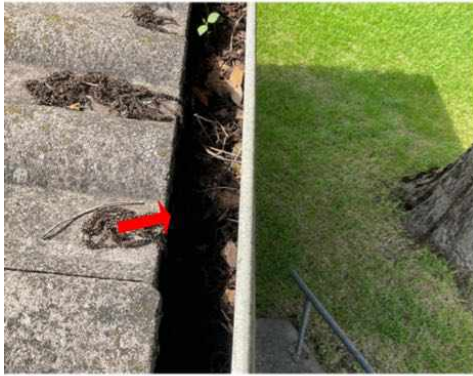
Finding 6.04

Building: Building 1
 Location: Roof - front
 Finding: Trees - Overhanging and filling gutters
 Information: Overhanging trees often result in excessive amounts of leaf debris accumulating in

Blocked gutters are likely to lead to high levels of moisture in the affected areas. Such moisture will not only cause rust and decay of the associated building materials, but can also provide conditions that are conducive to termite and timber pest activity. Blockages in gutters should therefore be removed immediately to ensure dry conditions are maintained.

It is highly advised that gutters be cleaned by the homeowner or a general handyperson as a matter of urgency.

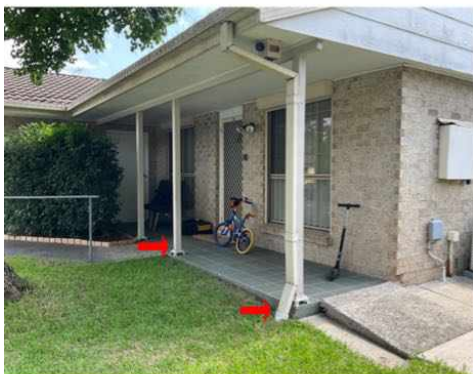
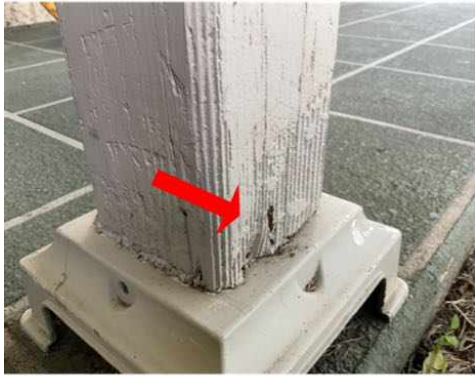
Finding 7.01

The development of fungal decay is accelerated by temperatures in the range of 5degreeC to 40degreeC as well as the presence of oxygen. Generally fungal decay develops on timber elements that are in use in an external environment which are exposed to rain penetration.

In this case although the affected timber element is in a decaying state the extent of any visible damage appears to be localised to a specific area and is yet to spread to other parts of the building element or affect adjoining structures. The fungal decay is therefore likely to be of a relatively superficial nature with minimal impact on the structural integrity or tensile strength of the timber element.
