# Building and Timber Pest Inspection Report

Inspection Date: Tue, 24 Feb 2026

Property Address: 503/31 Smallwood Ave, Homebush NSW  
2140, Australia

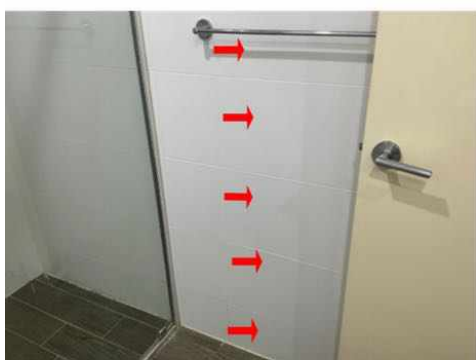
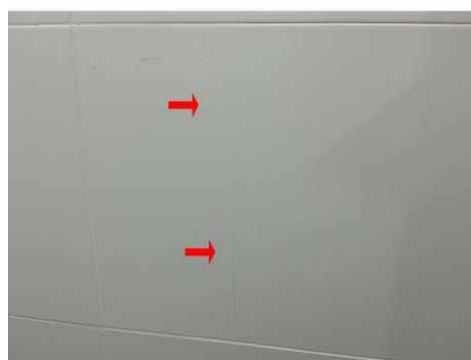
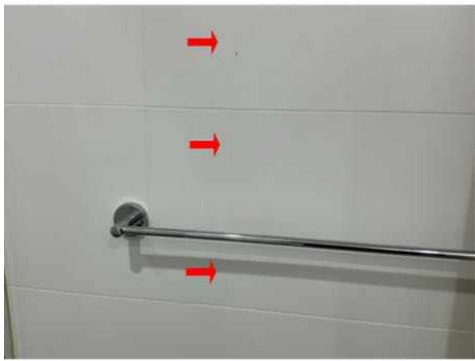
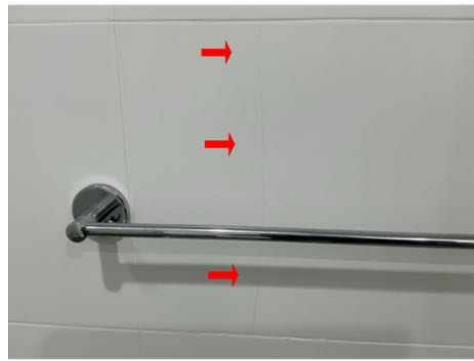
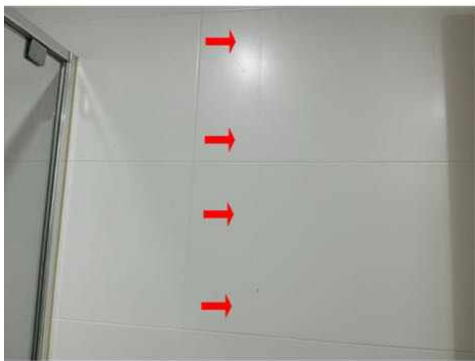
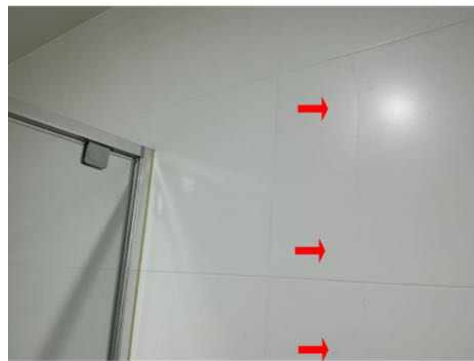
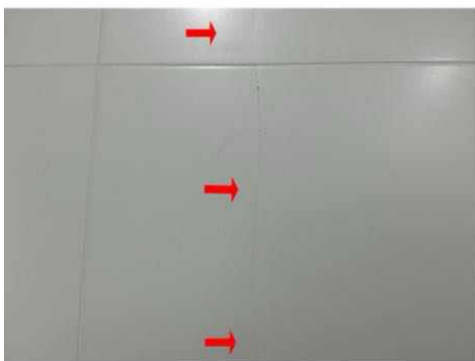
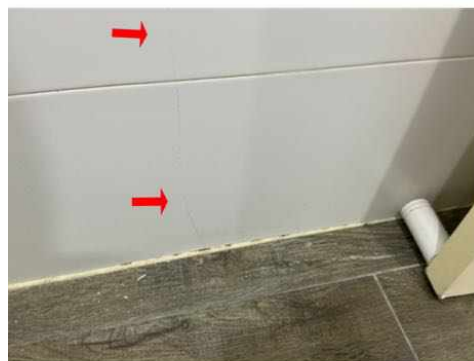
Building: Main Building  
Location: All Areas  
Finding: Tiles cracked or damaged- (wet areas)  
Information: Cracking was evident to the tiling in this area at the time of inspection. While the cracking appears to be minor, this area is frequently exposed to water, allowing potential for water penetration into adjoining sections of walls or flooring.

If left unmanaged, water penetration to these areas may lead to subsequent water damage, which is likely necessitate repair work to affected building elements.

A tiling contractor should be appointed to ensure that no further water damage occurs. The re-application of silicone and grouting throughout remaining tile work is also advised, to further protect the area against water penetration.

Where water penetration has led to water damage, appointment of a relevant tradesperson may be required to repair damaged building elements.

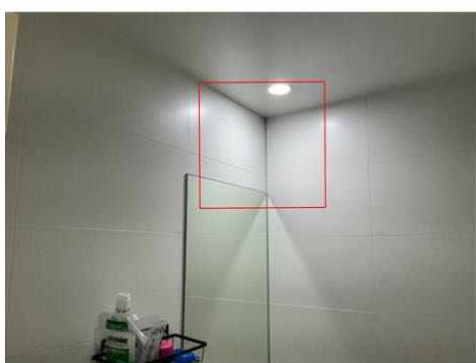
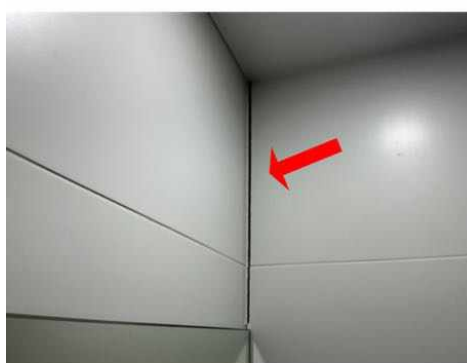
### Finding 3.02

Building:	Main Building
Location:	Ensuite- bathroom
Finding:	Sealant and grouting - Missing or damaged
Information:	It was noted on inspection that sealant or grout is degraded to the tiled shower alcove and or other areas of the bathroom.

Different materials and floor areas move at different rates, generally causing cracking to grout or sealant at this point. A flexible sealant is required to allow for expected expansion and contraction, while keeping the joint water tight and protective of all associated building materials.

There appears to be excessive mould to the sealant and grout which will likely require scraping out and replacement.

Flexible and mould resistant materials should be applied to affected areas to prevent any subsequent water damage that is likely to occur. Regular maintenance and replacement of damage or missing or damaged sealant and grout is highly recommended to the wet areas, as this is a regular wear and tear defect. Sealant and grouting in areas that come into regular contact with water should be maintained for the long term care of your property.

A sealant specialist or tiling contractor should be appointed to complete these works as soon as possible

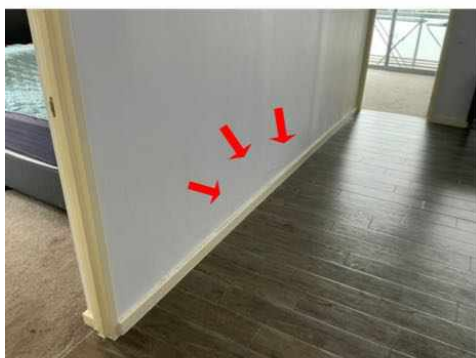
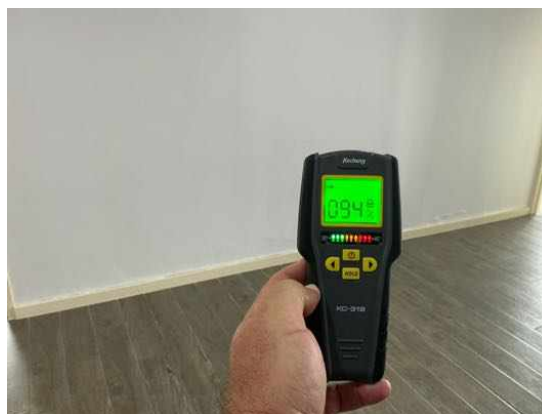
### Finding 3.03

Building:	Main Building
Location:	Lounge/ dining room wall
Finding:	Excessive Moisture Identified.
Information:	Excessive moisture can attract termites and produce conditions that promote fungal growth and wood decay.

Excessive moisture is generally caused by deteriorated, inadequate or missing roof drainage, leaking plumbing pipes or fixtures, poorly plumbed HWS overflows or condenser units and poor site drainage.

If mould growth has been found there may be environmental biological or health issues involved. In these cases an appropriately qualified inspector should also be contacted.

Prior to any remedial works being performed a qualified plumber should be appointed to further inspect the property and to identify the cause of the excessive moisture. Works to remove affected building elements may then be necessary and should be performed by an appropriate tradesperson.

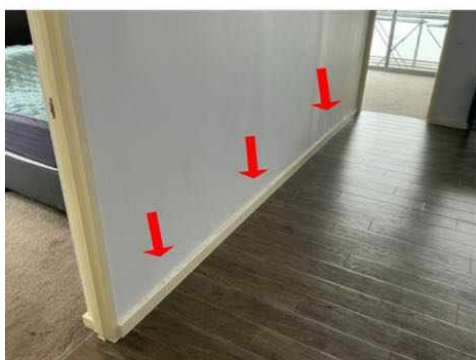
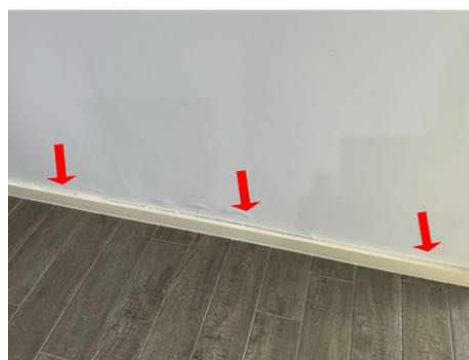
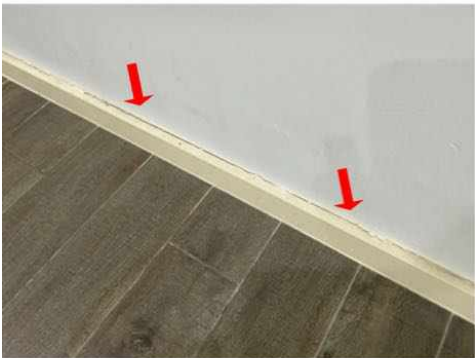
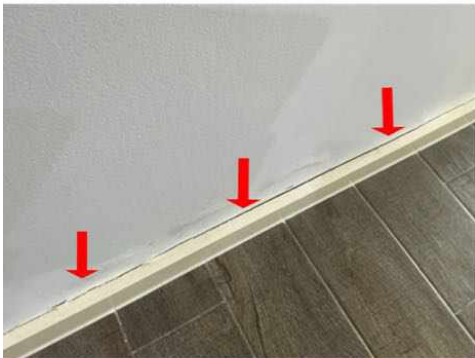
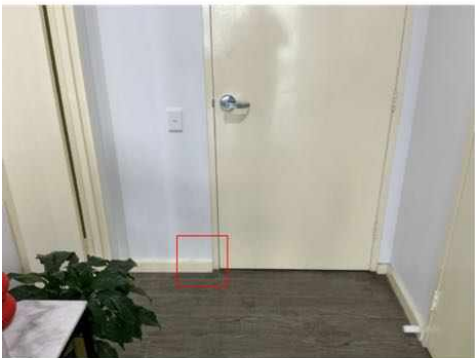
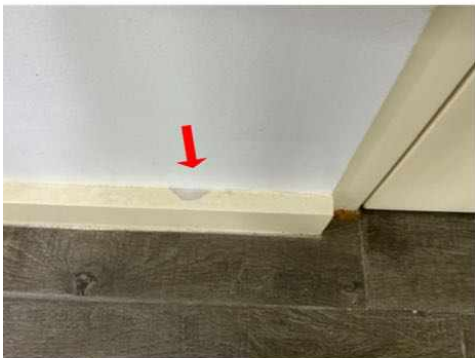
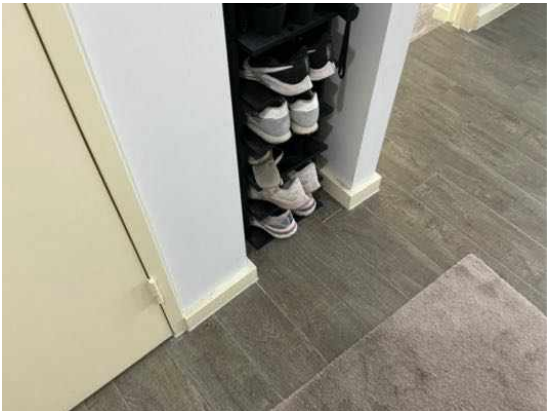
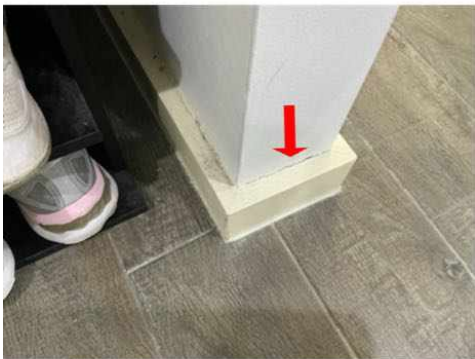
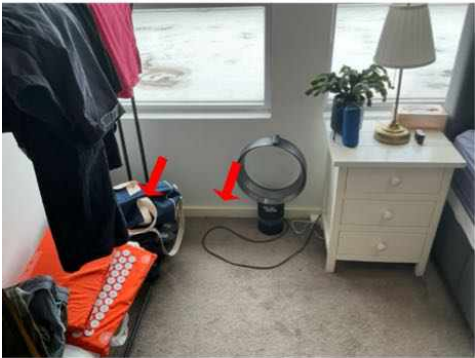
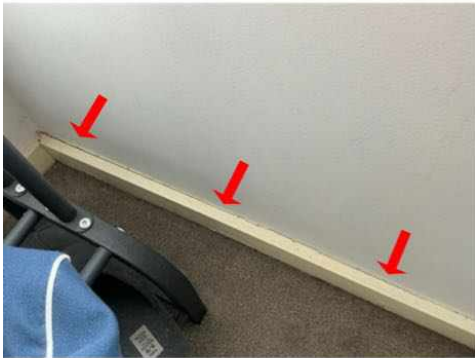
### Finding 3.04

Building:	Main Building
Location:	All Areas- bedroom, lounge room, entrance
Finding:	Paint finish - Substandard
Information:	The paint finish in this area was found to have been completed to a substandard level. Substandard painting is generally classified as an appearance defect. However, the substandard appearance may also be indicative of poor surface preparation and substandard workmanship.

If this applies, further areas of poor and incomplete finishes could develop over time. Furthermore, substandard paint finishes in areas exposed to moisture, e.g. external areas or wet areas, could lead to deterioration of underlying building materials.

Substandard paint finishes should be sanded back, filled, leveled and repainted, as applicable. Where inadequate paint protection has led to the deterioration of the associated building element, repair and/or replacement of this building element may be required.

A painting contractor should be appointed as soon as possible to perform necessary works to aid the appearance of the affected area and to ensure that the area is protected against further deterioration. Alternatively, the homeowner following manufacturer instructions may be able to provide this service.

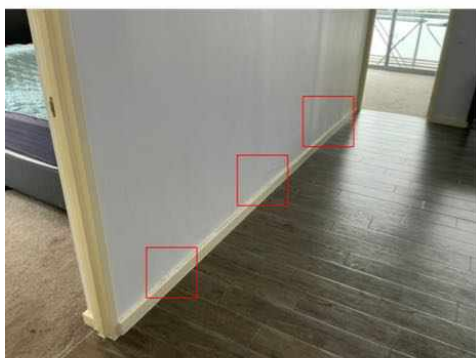
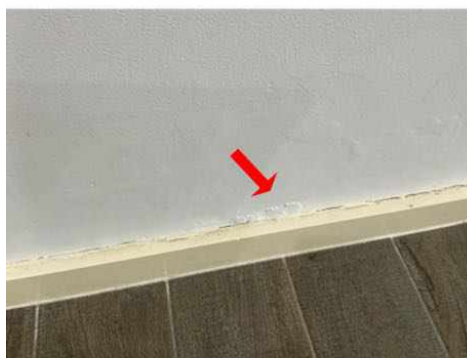
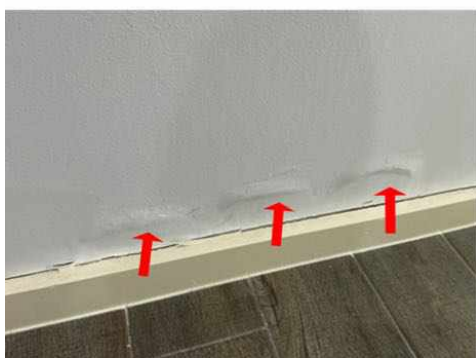
Finding 3.05

Building: Main Building  
 Location: Lounge/ dining room wall  
 Finding: Painted surface - Bubbling  
 Information: Sections of paint in this area was found to have bubbled and deteriorated. Paint bubbling is generally an indication of excessive moisture in the area, that is currently hidden by the painted surface.

The presence of excessive moisture can have major implications on associated building elements if left unattended. While only seemingly minor at this stage, the damage cannot be determined due to the paint obstructing any further inspection of the damage.

It is highly advised that the affected paint be cleaned to allow a further, more invasive inspection by a licensed plumber. Failure to act on this defect may necessitate major works in the future.

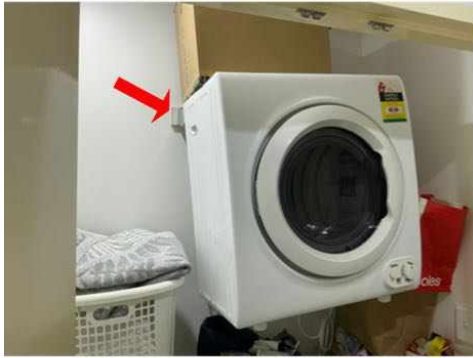
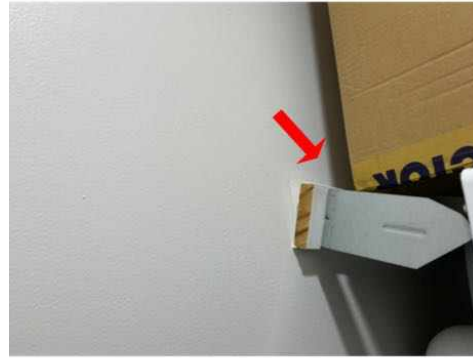
### Finding 3.06

Building: Main Building  
 Location: Laundry  
 Finding: Fitting or fixture - Loose- Wall bracket for dryer loose.  
 Information: The fitting in this area is loose and requires adjustment to tighten.

If left unmanaged, the fitting may further deteriorate, causing potential for the development of other minor secondary defects.

A relevant tradesperson should be appointed to perform these rectification works at discretion of the client.

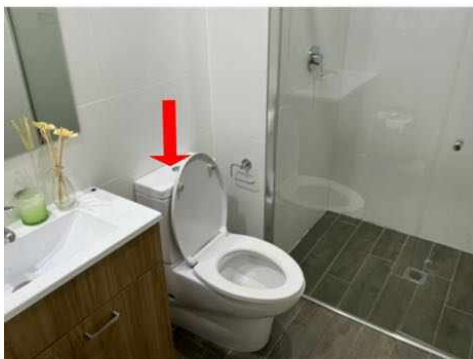
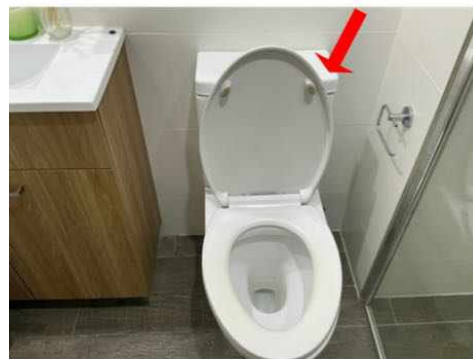
### Finding 3.07

Building: Main Building  
 Location: Main bathroom  
 Finding: Toilet - Not flushing  
 Information: The toilet did not flush at the time of inspection.

Non-operational building elements such as this are vital to the function of the household and must be fixed.

A qualified plumber should be appointed immediately to repair the toilet and return it to an operational state.

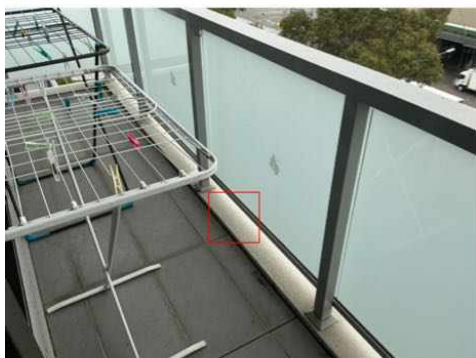
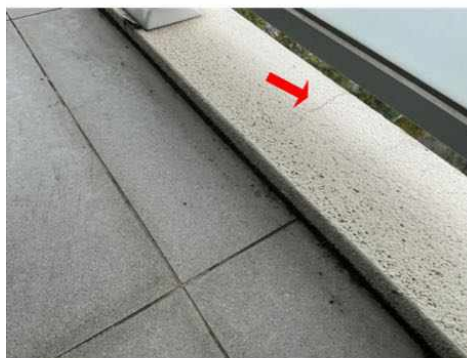
### Finding 3.08

Building: Main Building  
 Location: Balcony

Finding: Cracks to external rendered surface- Category 0  
 Information: It has been observed that cracking to internal rendered surfaces has occurred. The degree of damage falls within Category 0, described as hairline cracks that do not require repair and which are less than 0.1mm in width limit.

Damage of this category is not considered a defect for rectification. Always contact your building inspector should cracks widen, lengthen, or become more numerous.

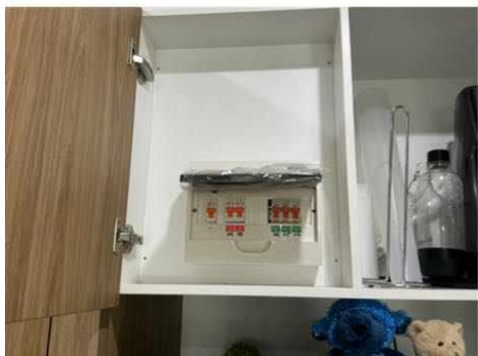
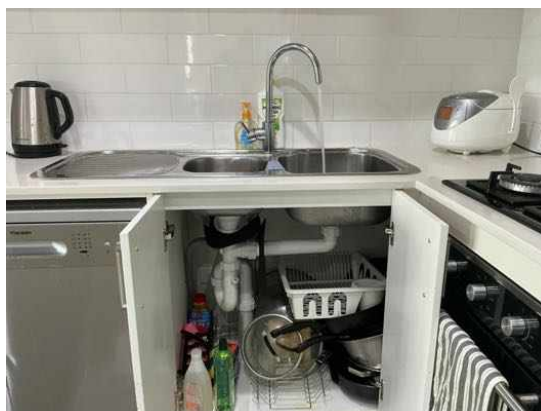
Building: Main Building  
 Location: Switch board- under kitchen sink  
 Finding: Termite Management System - no evidence of a chemical installation  
 Information: The application of a post-construction chemical termite barrier is highly recommended for all properties, particularly if live termite activity has been found on the site previously. Such barriers are highly effective in preventing termite attack on any timber building elements throughout the property.

A durable notice should be placed in the switchboard unit to indicate current termite barriers. At the time of inspection, it appeared as though no termite management system has been installed, with no evidence to suggest preventative works taking place.

The client may consider gaining further advice from a pest controller as to the costs and procedures involved with this application. It is recommended that obtaining such advice be a short-term priority.

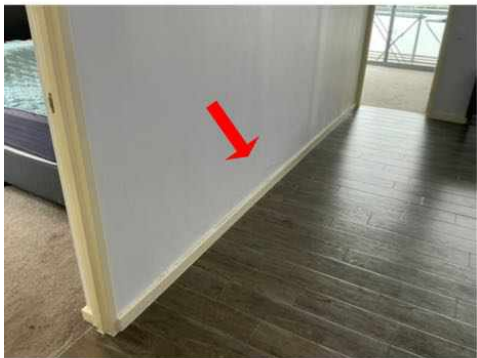
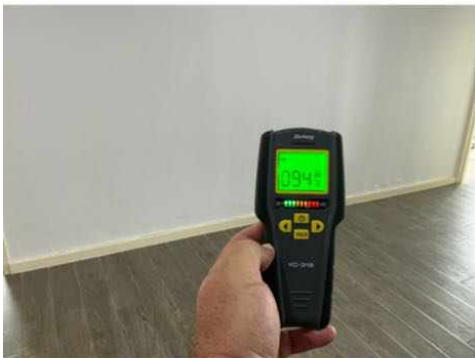
## Finding 6.02

Building:	Main Building
Location:	Lounge/ dining room wal
Finding:	Excessive moisture - identified
Information:	Excessive moisture can attract termites and produce conditions that promote fungal growth and wood decay.

Excessive moisture is generally caused by deteriorated, inadequate or missing roof drainage, leaking plumbing pipes or fixtures, poorly plumbed HWS overflows or condenser units and poor site drainage.

If mould growth has been found there may be environmental biological or health issues involved. In these cases an appropriately qualified inspector should also be contacted.

Prior to any remedial works being performed a qualified plumber should be appointed to further inspect the property and to identify the cause of the excessive moisture. Works to remove affected building elements may then be necessary and should be performed by an appropriate tradesperson.

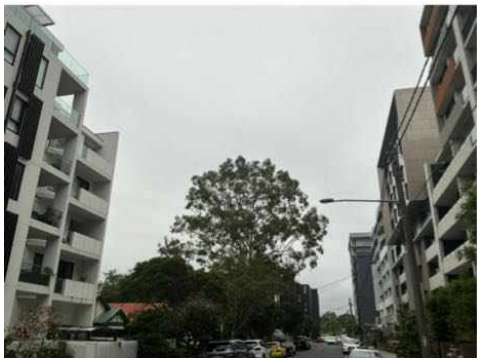
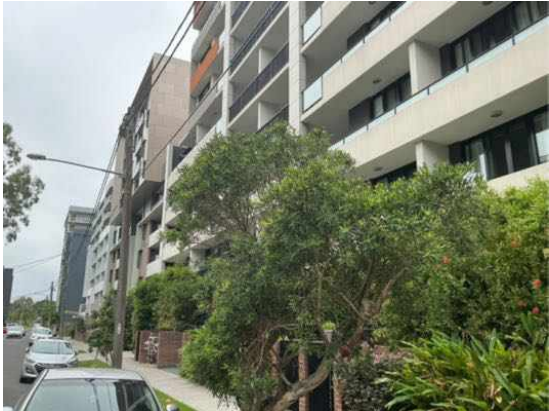
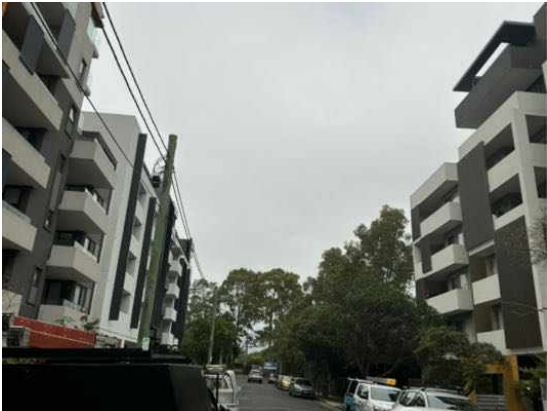
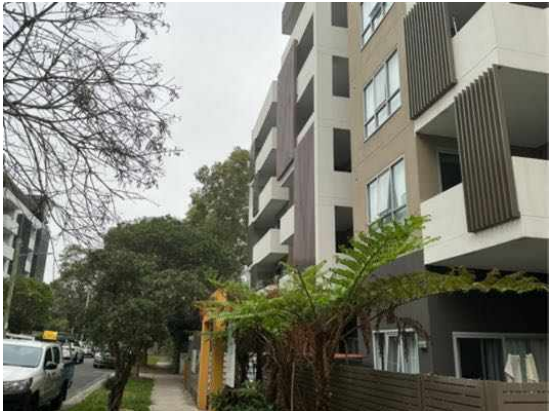
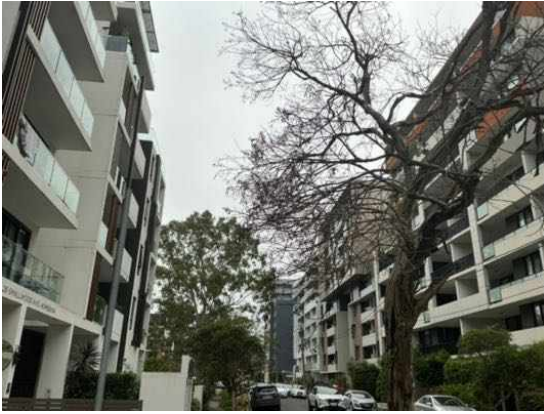
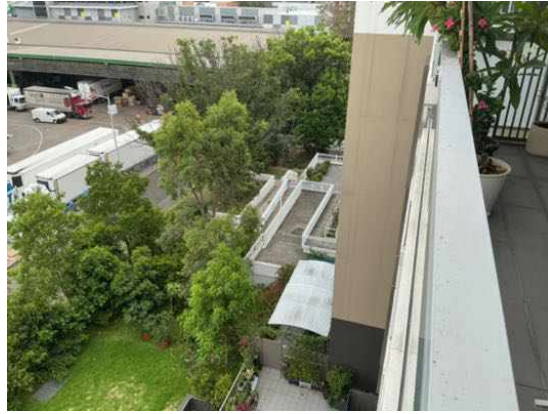
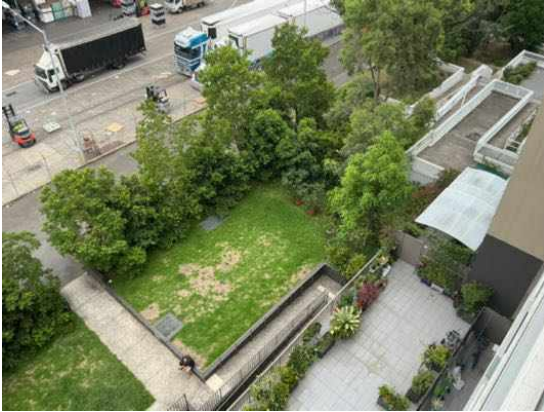
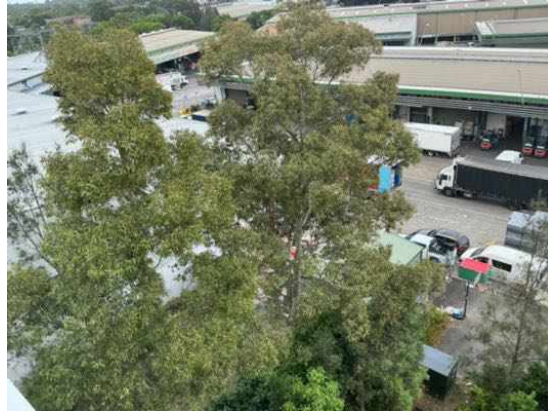
**Finding 6.03**

Building: Main Building  
 Location: All Areas  
 Finding: Trees to be inspected within the property.  
 Information: Trees can be conducive to termite activity and nesting. Trees over 100mm on the property, should be drilled and tested for termite activity.  
 Regular inspections every 6-12 months- or advised by the termite management system installer.

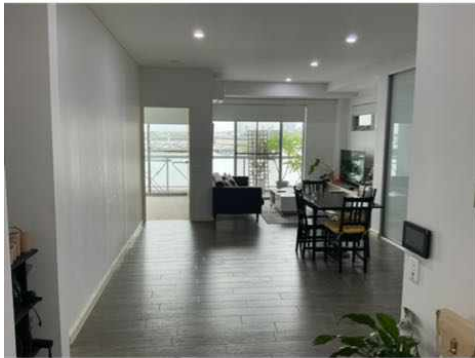
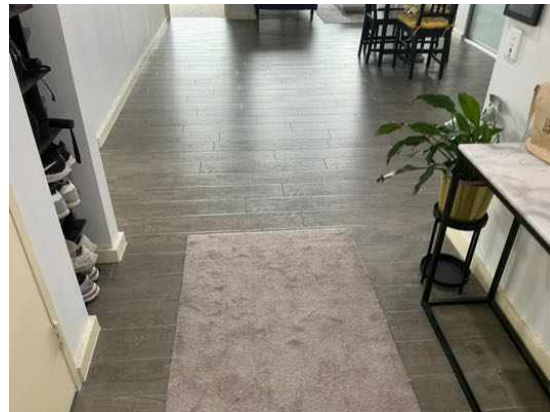
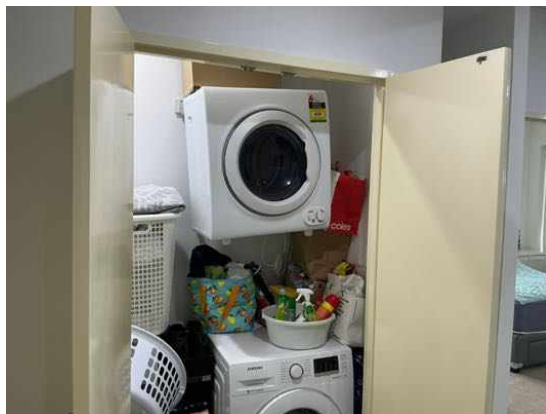
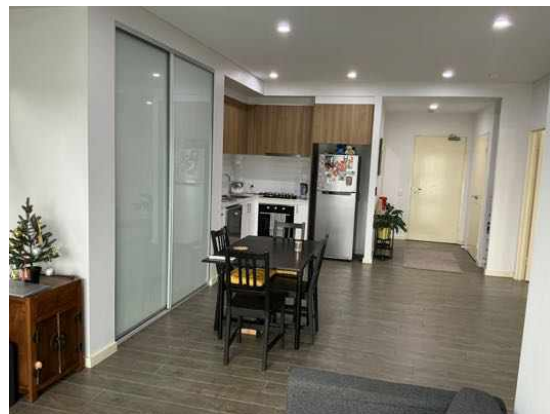
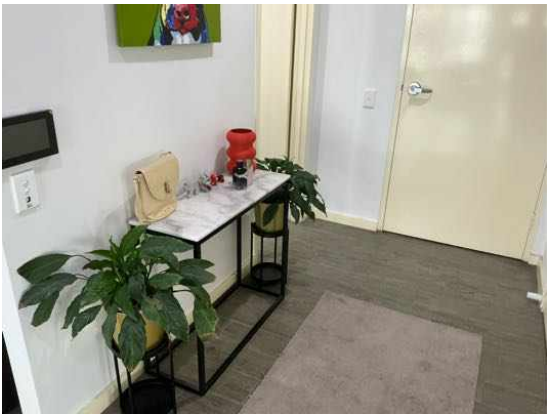
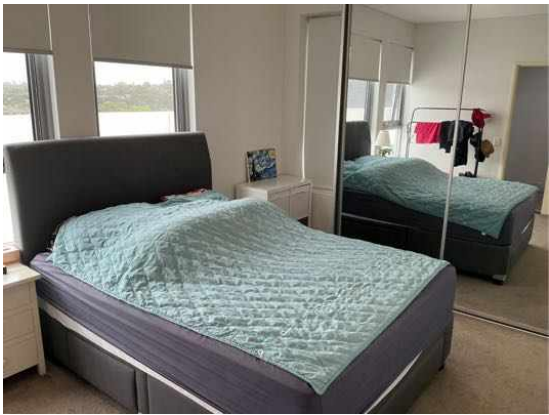
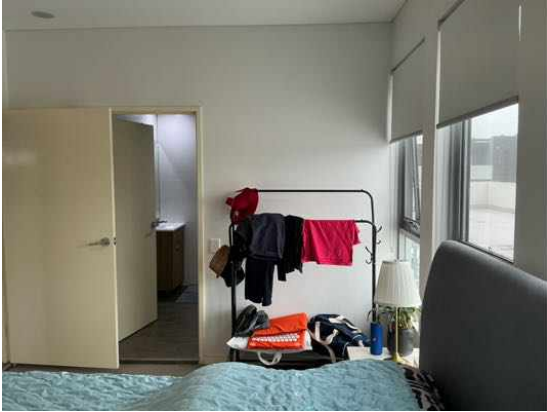
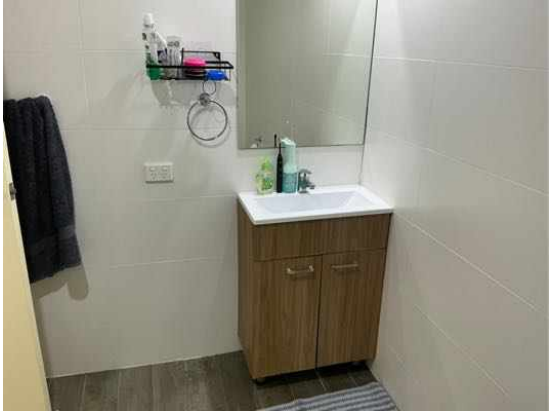
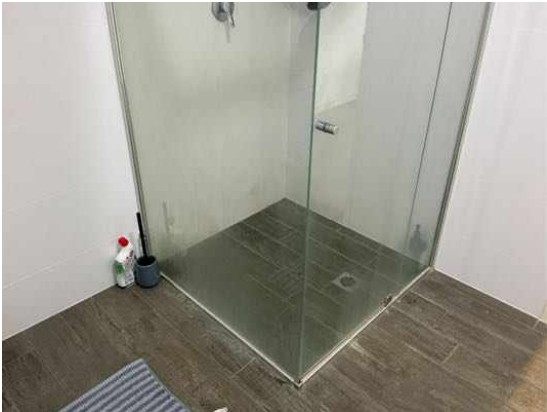
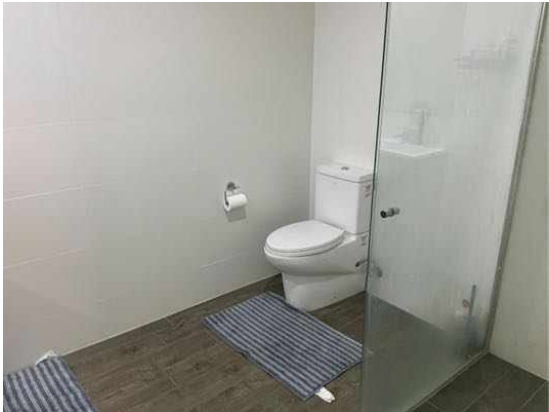
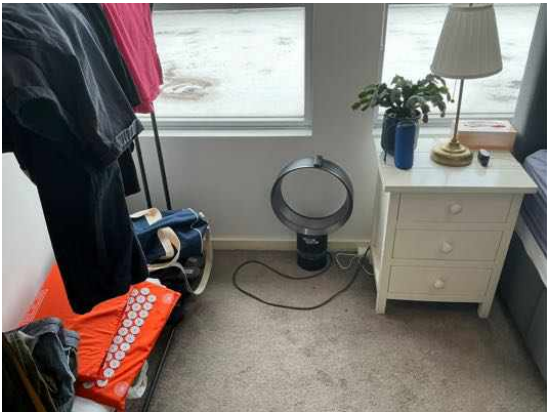
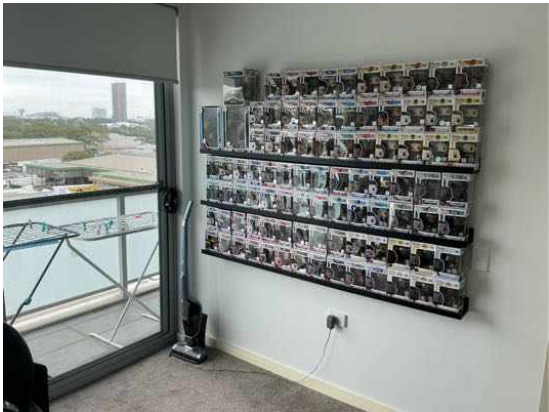
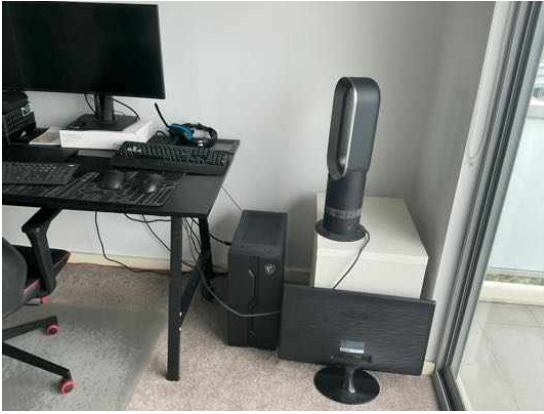
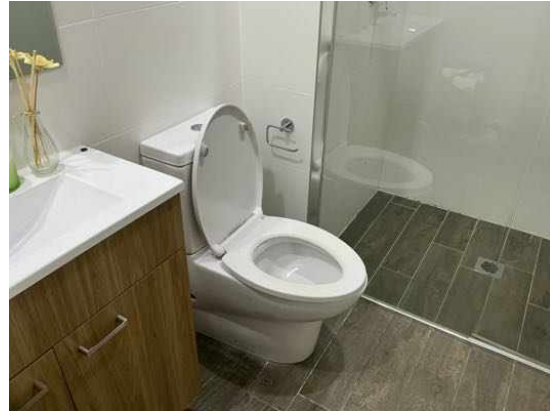
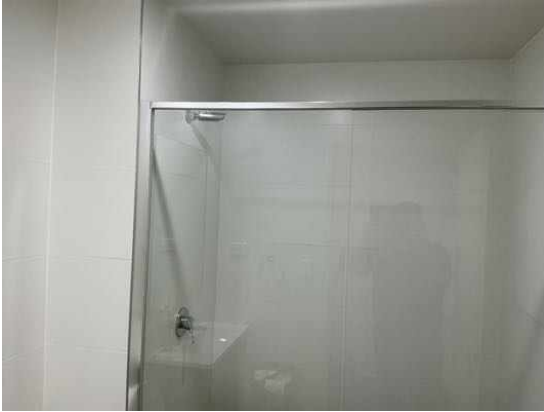
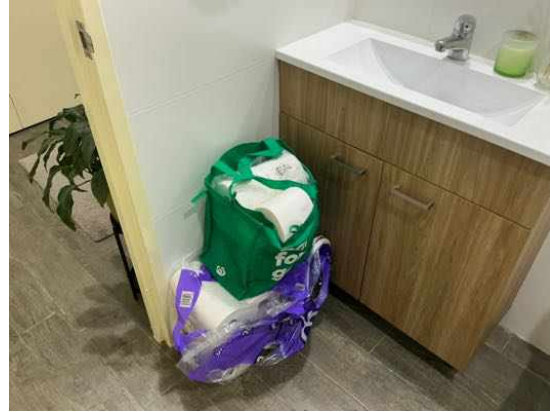
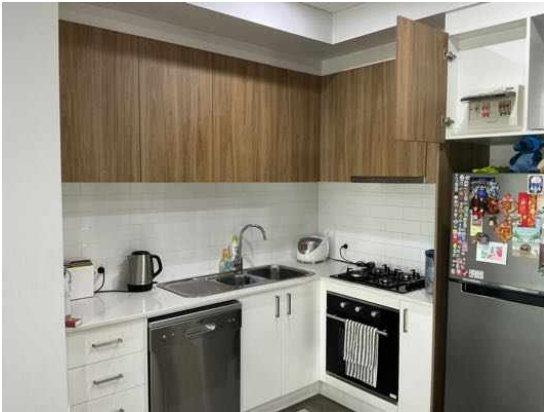
Building: Main Building  
Location: All Areas  
Finding: Additional Photos - Obstructions and Limitations  
Information: These photographs are an indication of the obstructions and limitations which impeded full inspection of the property at the time of inspection. These obstructions can hide an array of defects and should be removed to allow full inspection to be carried out. A re-inspection is recommended once the areas are made accessible.

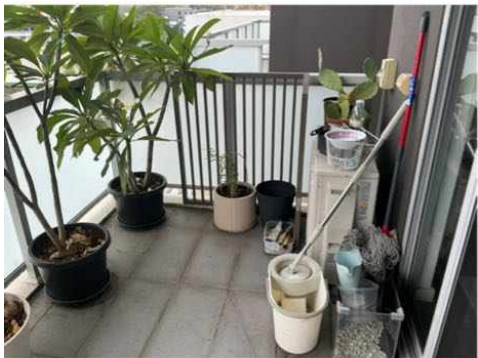
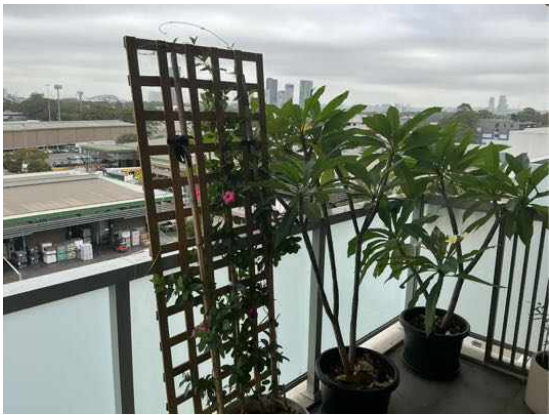
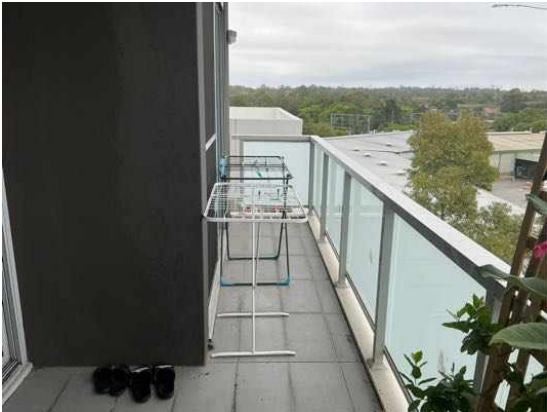
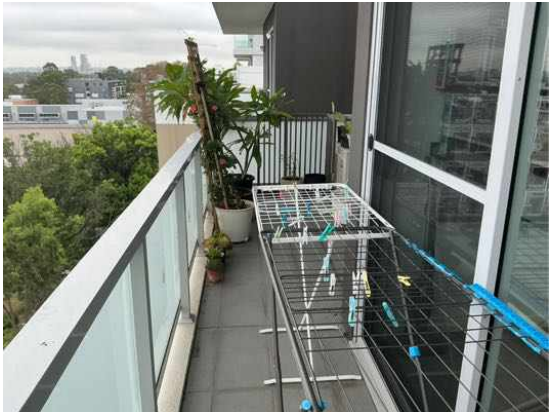
Building: Main Building  
 Location: All Areas  
 Finding: Additional Photos - Obstructions and Limitations  
 Information: These photographs are an indication of the obstructions and limitations which impeded full inspection of the property at the time of inspection. These obstructions can hide an array of defects and should be removed to allow full inspection to be carried out. A re-inspection is recommended once the areas are made accessible.
