Building and Timber Pest Inspection Report VR

Inspection Date: Fri, 23 Jan 2026

Property Address: 15 Togar St, Mansfield QLD 4122, Australia

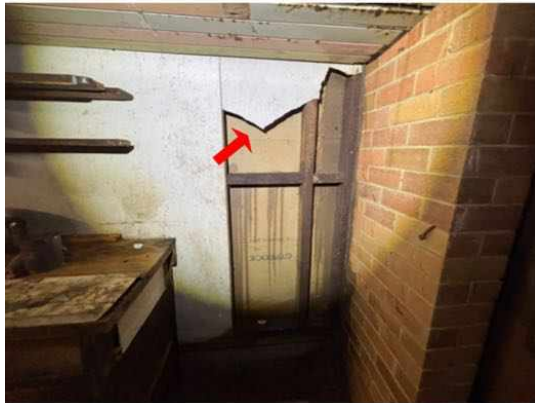
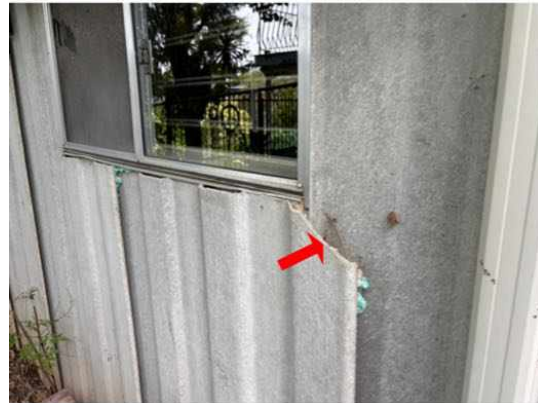
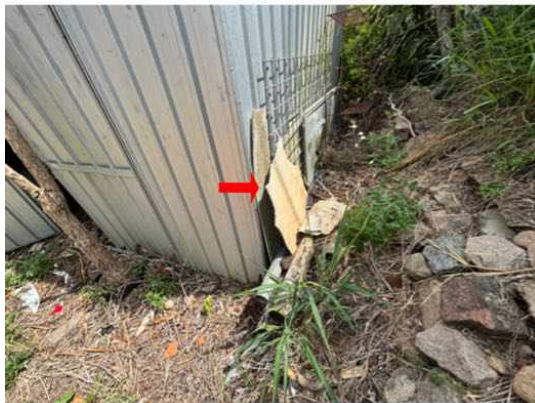
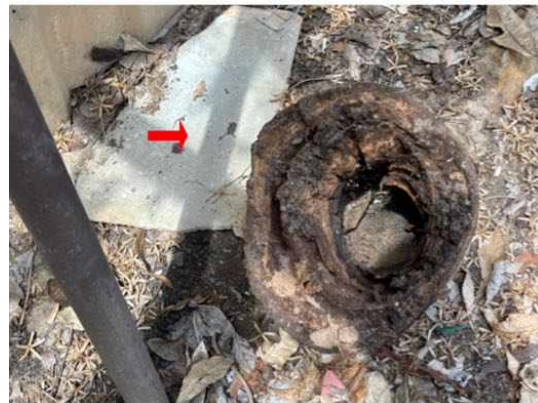
Building:	Main Building
Location:	All Areas
Finding:	Suspected Asbestos Containing Material - damaged and debris
Information:	At the time of the inspection, it was noted that there were damaged fibre cement style products around the dwelling that are suspected as being Asbestos Containing Material. Broken debris was also found in the rear yard.

Broken Asbestos Containing Material is a safety hazard and as such testing should be done to determine what remedial action should be undertaken. This should be done as a matter of urgency.

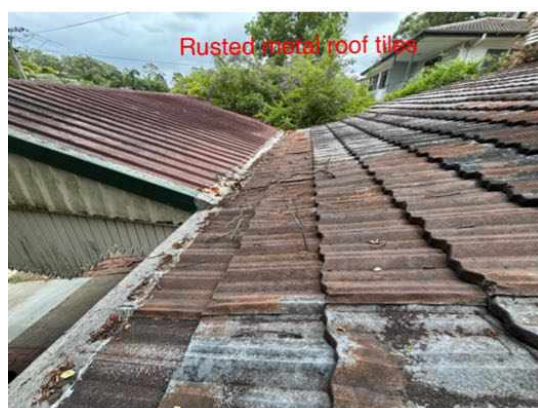
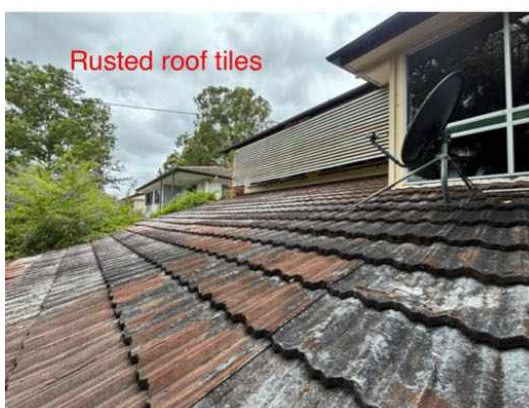
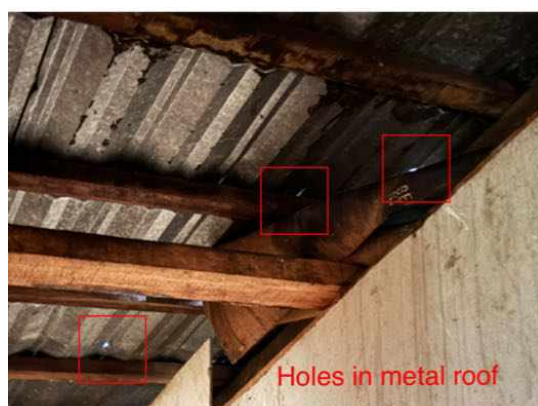
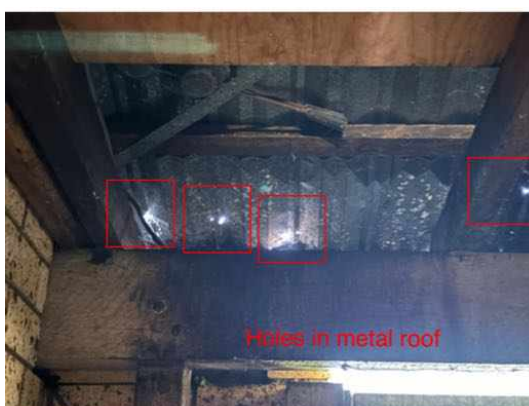
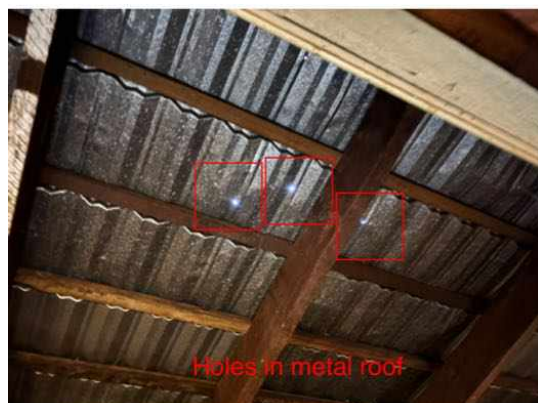
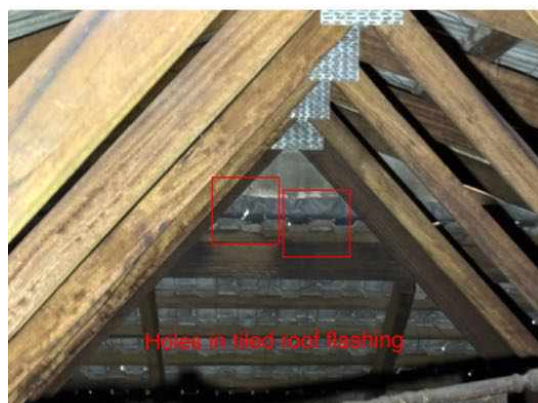
Finding 2.01

Location: Roof Exterior
Finding: Roof covering - deteriorated
Information: At the time of the inspection it was noted that the roof covering to the dwelling has deteriorated resulting in holes in the roof covering.

The front lower section of the roof covering is a metal tile. This metal tile has several holes as a result of the rust found on the metal roof. This allows moisture to penetrate the building. The lead flashings to the gables on either side of the upper tiled roof have holes in them, allowing moisture to enter the roof void.

Moisture entering the roof void will result in undetected damage occurring to the associated building materials.

A roof contractor must be engaged to assess the entire roof covering in order to provide a solution rectify these issue. This should be done as a matter of urgency.

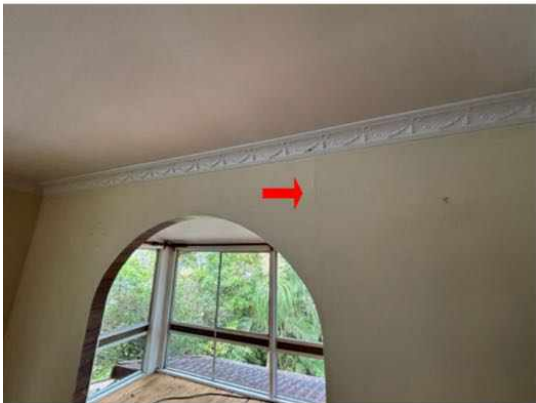
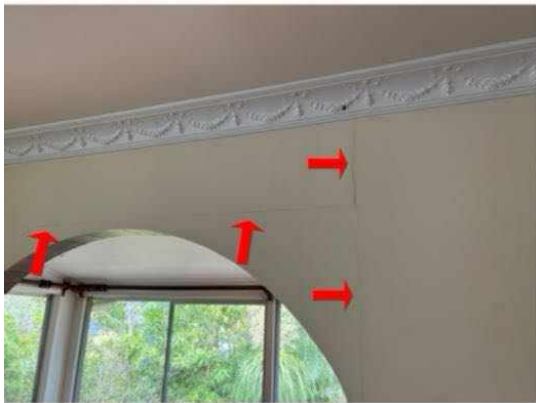
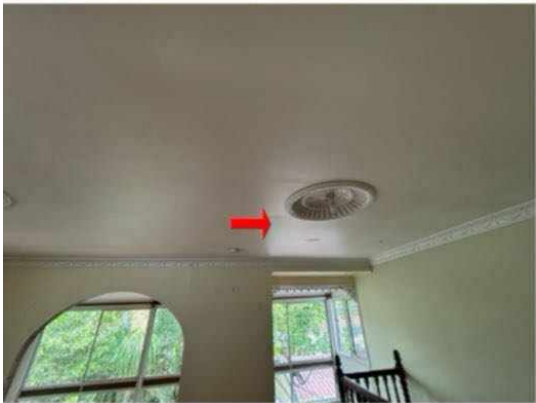
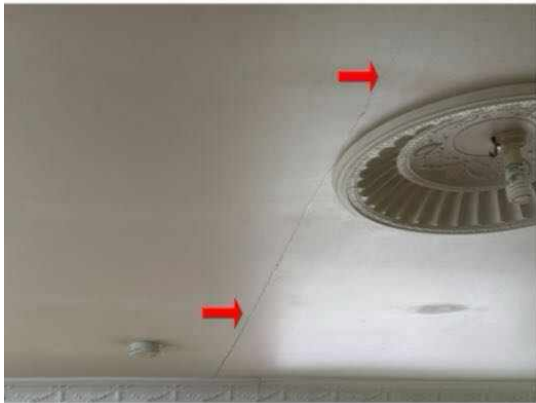
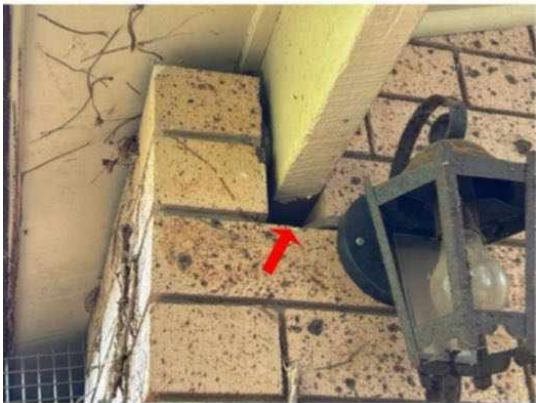
Finding 2.02

Building:	Main Building
Location:	Front right hand side of dwelling
Finding:	Front right of dwelling - suspected movement
Information:	At the time of the inspection, it was noted that the front right hand side of the dwelling has moved. This could be historic damage.

There are cracks to the wall and ceiling linings. The window on the right hand side of the sunroom is misaligned, indicating movement to the building foundations.

On the exterior in this area, there is a large gap under the timber roof beam. The expansion joint in the brickwork is wider at the top than at the bottom.

A structural engineer must be engaged to assess the dwelling and provide a solution to rectify this issue. This should be done as a matter of urgency.

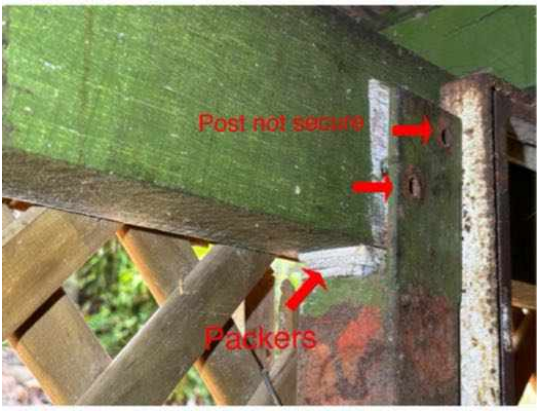
Finding 2.03

Building: Main Building
Location: Rear elevation
Finding: Rear of dwelling - suspected movement
Information: At the time of the inspection, it was noted that movement has occurred to the left and right hand side of the rear of the dwelling.

There is cracking to the wall lining in the sunroom off the bedroom. The floor in the sunroom slopes to the rear of the dwelling. The window above the crack is misaligned. On the exterior of this area, the steel posts supporting the floor framing are rusted. One has a hole in it. Two of the steel posts have packers on top of them and are not secured to the timber bearer. The packers have been used in an attempt to level or raise the floor.

A structural engineer must be engaged to assess the movement at the rear of the dwelling and provide a solution for these issues. This should be done as a matter of urgency.

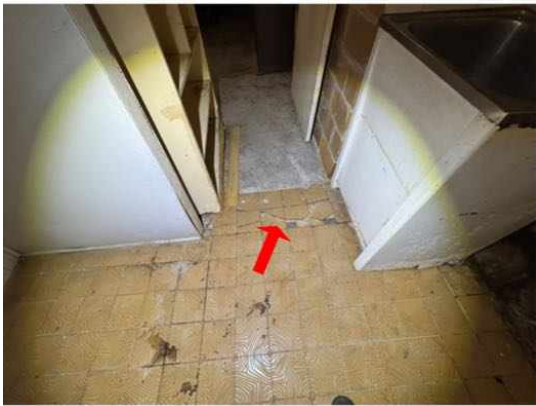
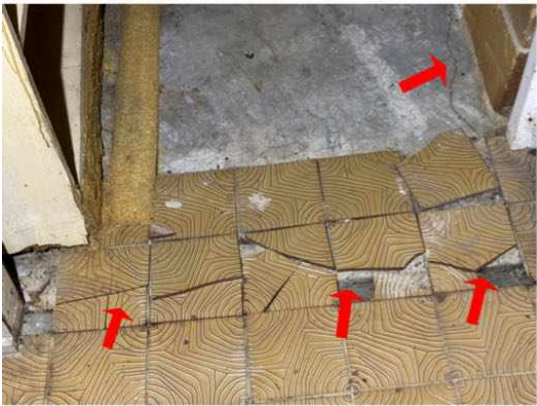
Finding 2.04

Building: Main Building
 Location: Storage area
 Finding: Storage area - concrete cracked
 Information: At the time of the inspection, it was noted that there were several cracks in the concrete floor of the storage area. Movement has occurred in the walkway near the bathroom resulting in the tiles cracking and coming loose.

A structural engineer must be engaged to assess the concrete floor and provide a solution for these issues. This should be done as a matter of urgency.

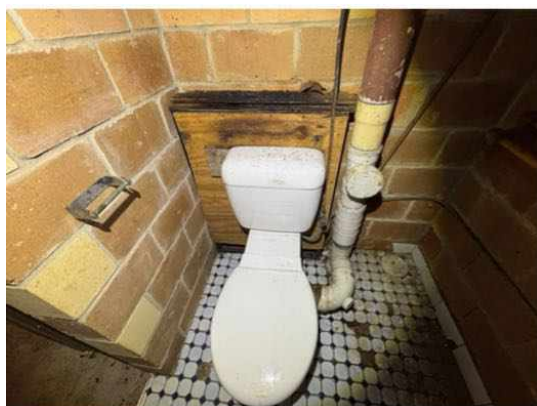
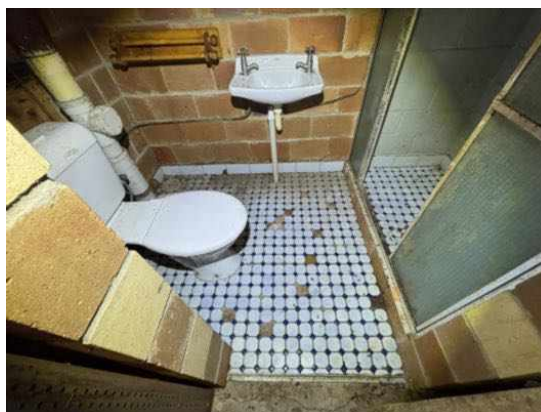
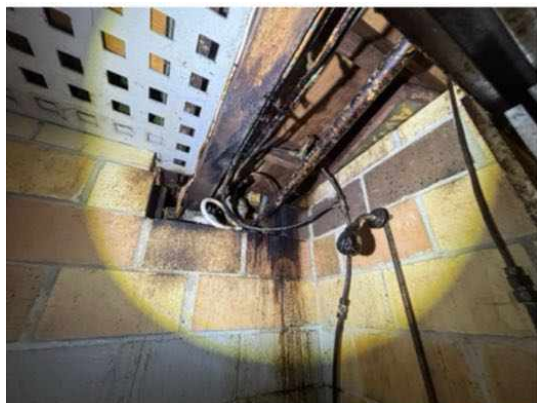
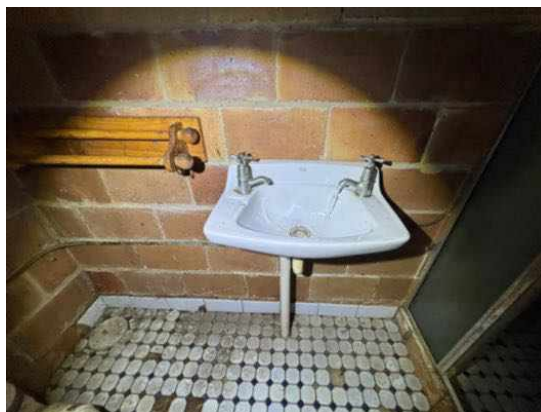
Finding 2.05

Finding: Subfloor - bathroom deterioration

Information: At the time of the inspection, it was noted that the bathroom in the subfloor area has suffered from general deterioration. There is no evidence of waterproofing. It may not be economically viable to perform repairs on this bathroom.

Continued use of this bathroom will result in further damage to the bathroom and potentially the area surrounding it.

A bathroom specialist should be engaged to replace the subfloor bathroom. This should be done as a short term priority.

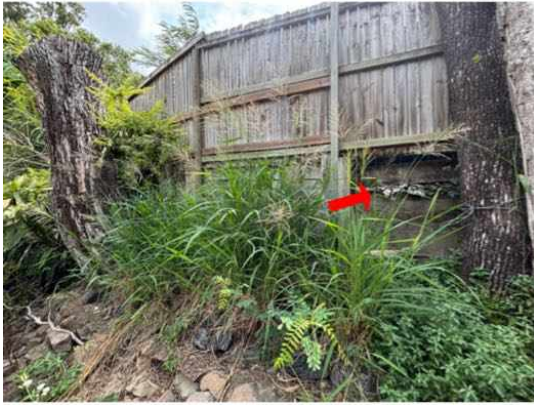
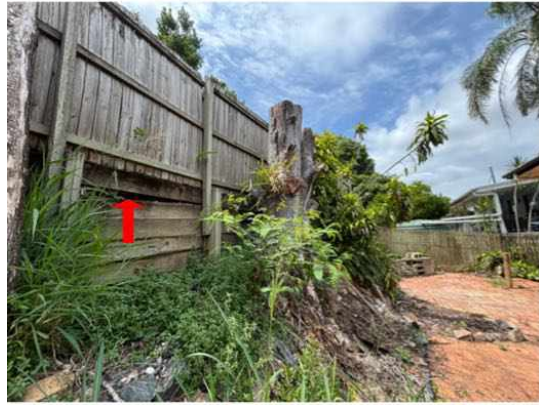
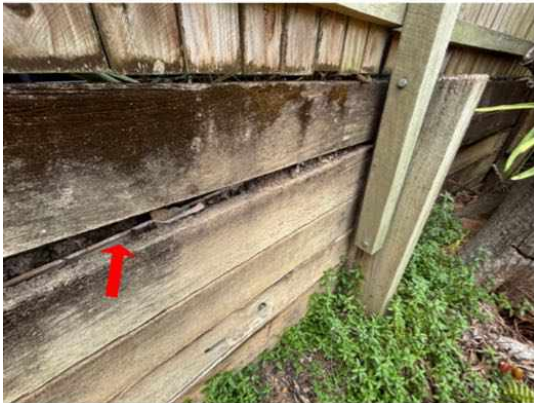
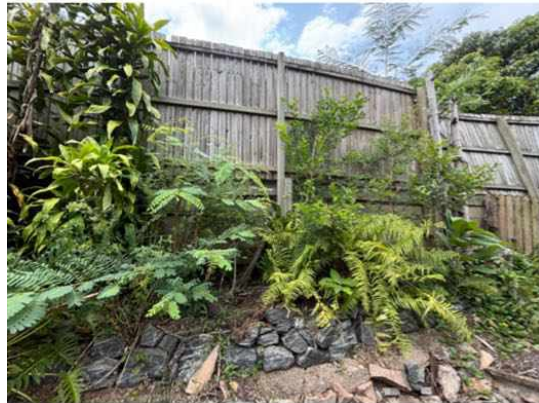
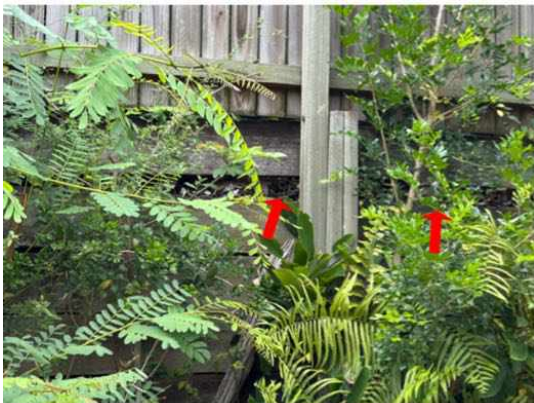
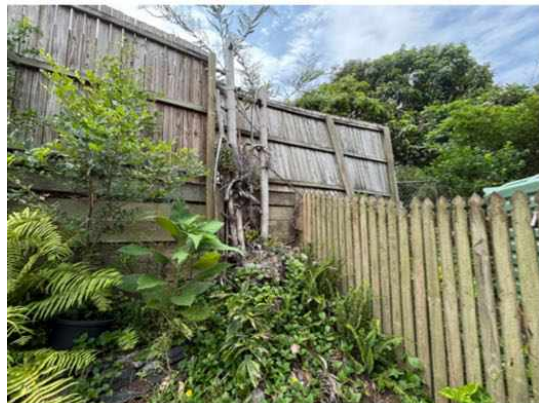
Finding 2.06

Building:	Main Building
Location:	Rear boundary
Finding:	Rear boundary - timber retaining wall deteriorating
Information:	At the time of the of the inspection, it was noted that the timber retaining wall on the rear boundary is deteriorating. Several timber sleepers have moved and as a result the ground that is being retained can be seen through the gaps.

A retaining wall specialist should be engaged to assess the retaining wall and to provide an estimated lifespan of the timber retaining wall. This should be done as a matter of urgency.

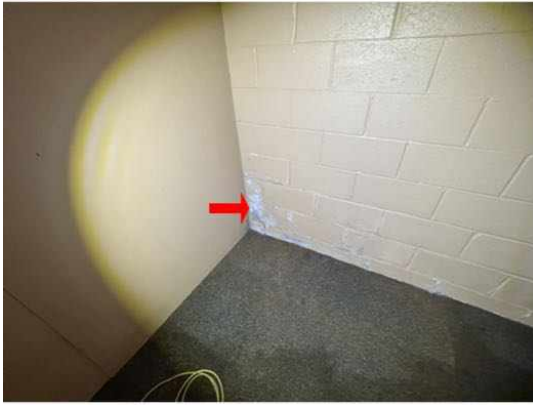
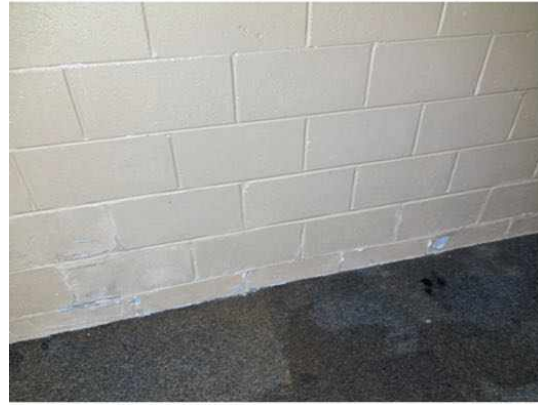
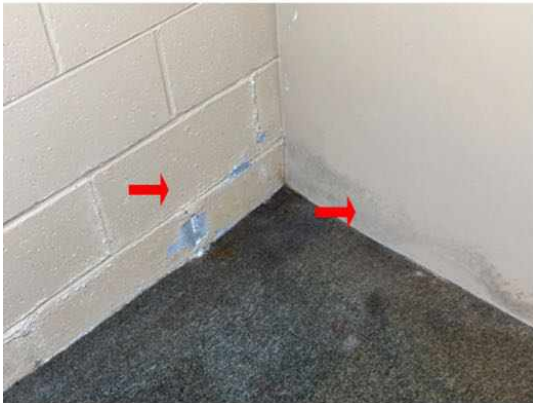
Finding 3.01

Building:	Main Building
Location:	Subfloor
Finding:	Brickwork - Efflorescence
Information:	At the time of the inspection, it was noted that there was evidence of efflorescence in the two rooms on the right hand side of the subfloor or lower level. Normal moisture readings were recorded in the front room. Elevated moisture readings were recorded on the wall in the rear room. Water staining was found on the wall lining. This indicates

that moisture is penetrating the brickwork. The ground level on the exterior is higher than the floor level on the interior. This has been noted as a minor defect as waterproofing can be carried out on the interior to prevent moisture damaging building materials on the interior of these rooms. If left unaddressed this will become a major defect.

While not as affected as exterior waterproofing, the interior side of the brickwork can be waterproofed.

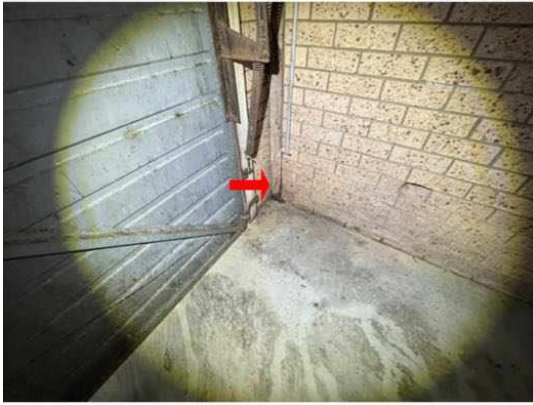
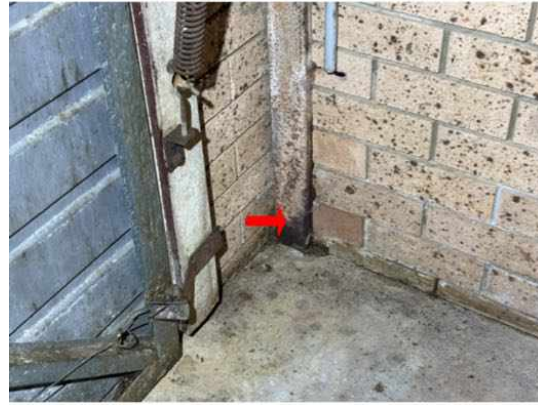
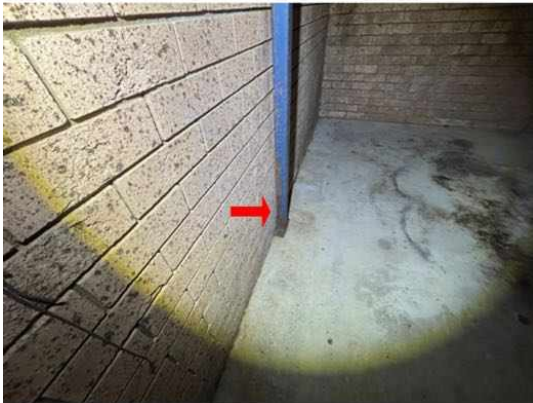
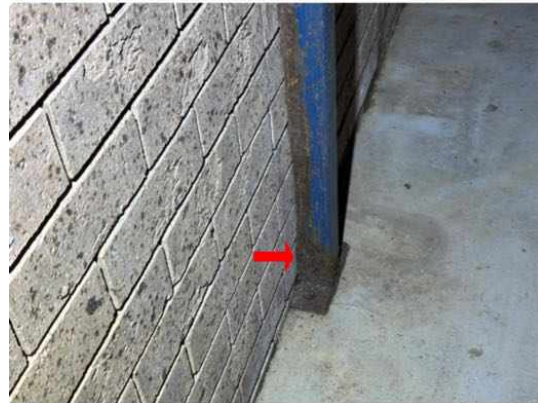
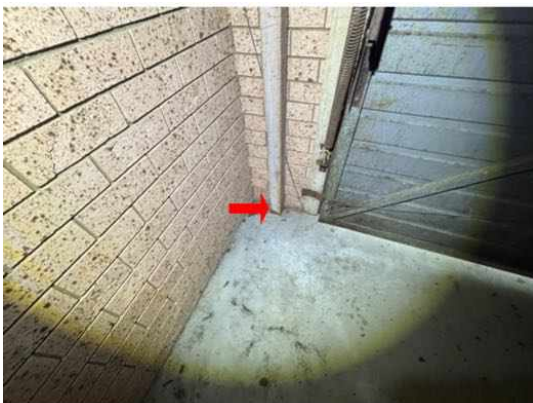
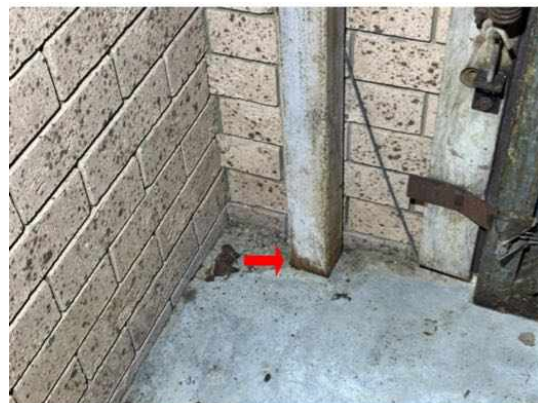
Finding 3.02

Building:	Main Building
Location:	Garage
Finding:	Garage - steel posts rusting
Information:	At the time of the inspection, it was noted that several steel posts in the garage had signs of rusting to them.

If left unaddressed, further rusting may result in holes in the posts which would have an impact on the structural integrity of the steel posts.

A building maintenance professional should be engaged to treat the affected steel posts. This should be done as a short term priority.

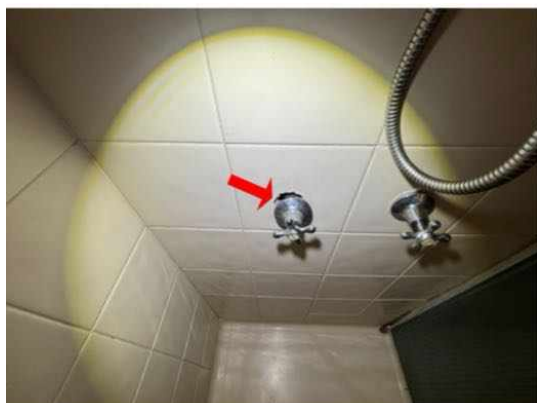
Finding 3.03

Information: At the time of the inspection, it was noted that there was no sealant to the tap/plumbing penetrations in the upper level bathroom. This allows moisture to enter the wall cavity.

Moisture in wall cavities creates a conducive environment for termite activity and can cause undetected damage to the associated building materials.

A building maintenance professional should be engaged to apply sealant to all of the

bathroom wall penetrations. This should be done as a short term priority.

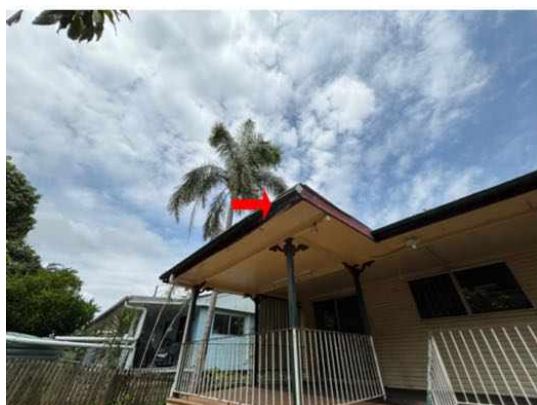
Finding 3.04

Building: Main Building
 Location: Rear elevation
 Finding: Gutters - damaged
 Information: At the time of the inspection, it was noted that the gutter on the rear of the dwelling is damaged. Gutters need to be in good working order to drain the roof properly.

If gutters are leaking, moisture may get to areas of the building that are meant to be kept dry. Damage to building elements may result of moisture ingress.

A licensed roof plumber should be appointed to inspect the gutters and advise on necessary rectification works. This should be done as a matter of urgency.

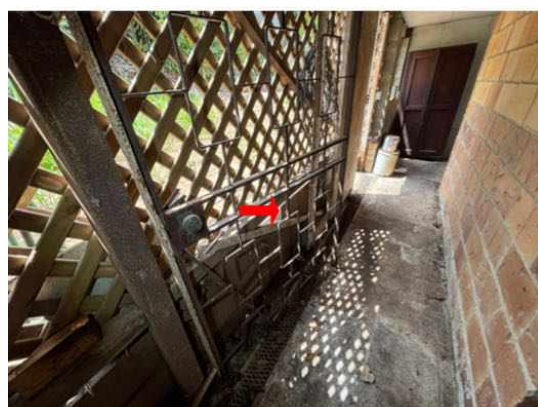
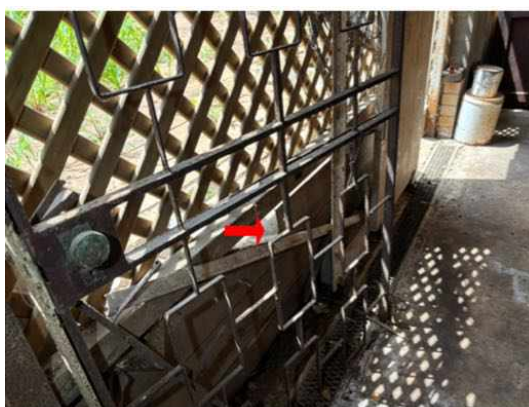
Finding 3.05

Building: Main Building
 Location: Rear elevation
 Finding: Rear elevation - timber retaining wall deterioration
 Information: At the time of the inspection, it was noted that the low timber retaining wall at the rear of the dwelling is deteriorating. This may be due to the age of the materials and

general weathering.

A retaining wall specialist could be engaged to replace the affected sections of the low timber retaining wall. This can be done at the clients discretion.

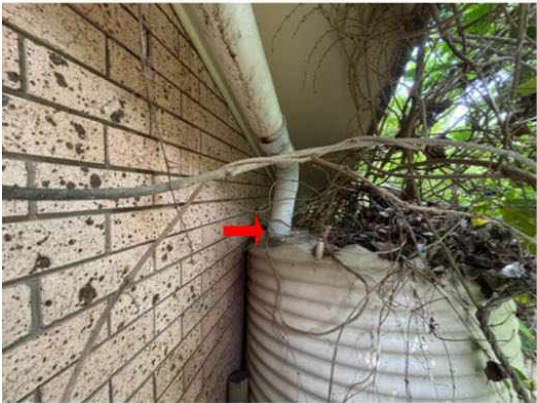
Finding 3.06

Building: Main Building
 Location: Side yard
 Finding: Side yard - water tank movement
 Information: At the time of the inspection, it was noted that the water tank on the left hand side of the dwelling has moved. This may be due to the wood rot that has affected the timber base that the water tank is sitting on. As a result of the movement, the water tank filler does not fill the tank and instead drains next to the foundations of the dwelling.

Excessive moisture next to the foundations of the dwelling creates a conducive environment for termite activity and can cause damage to the associated building materials.

If left unaddressed, further movement of this water tank can be expected.

A building maintenance professional could be engaged to replace the timber base with a more suitable base to ensure that the water tank does not move. This should be done as a short term priority.

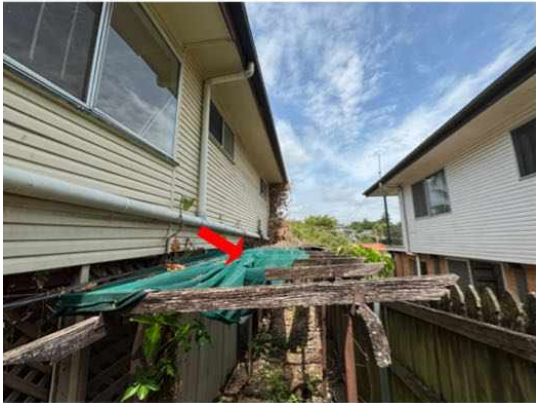
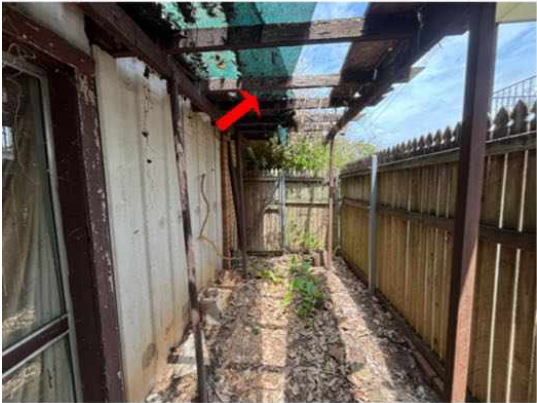
Finding 3.07

Building: Main Building
Location: Side yard
Finding: Side yard - timber structure unstable
Information: At the time of the inspection, it was noted the timber shade structure on the side of the dwelling is unstable and should be removed.

A building maintenance professional should be engaged to remove this structure. This can be done at the clients discretion.

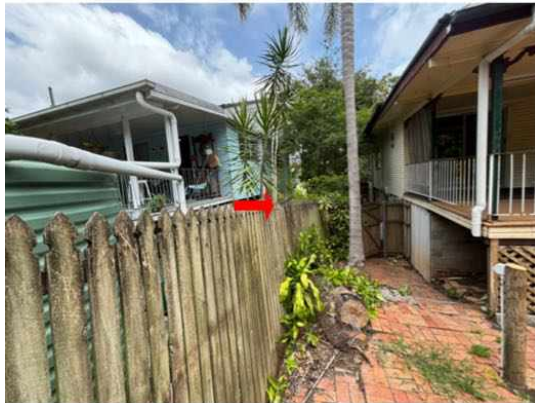
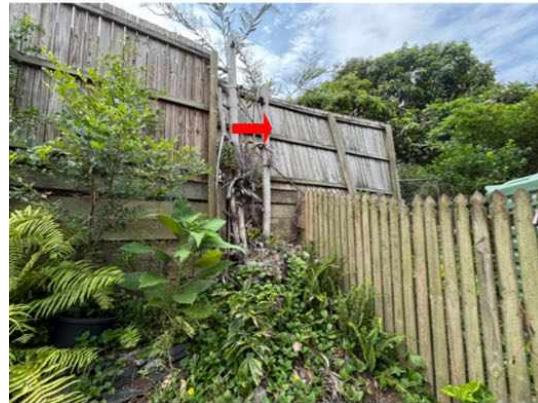
Finding 3.08

Building:	Main Building
Location:	All External Areas
Finding:	Boundary fences - deteriorating
Information:	At the time of the inspection, it was noted that the side and rear timber boundary fences were deteriorating. The fences are currently upright.

A fencing contractor should be engaged to assess the fences and provide a solution to rectify this issue. This can be done at the clients discretion.

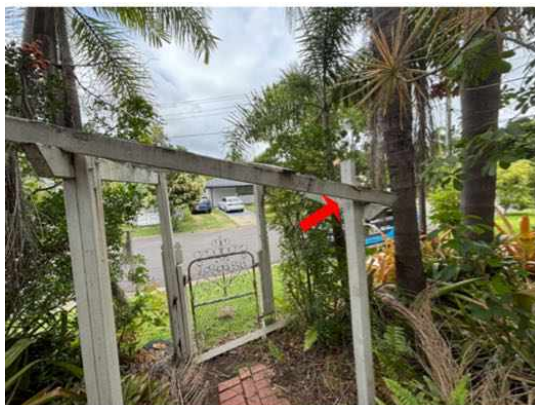
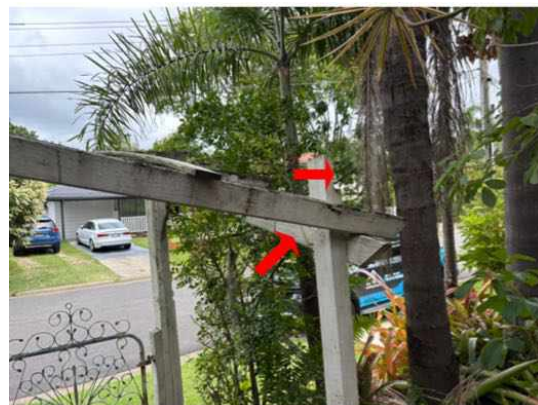
Finding 3.09

Building:	Main Building
Location:	Front yard
Finding:	Front yard - timber structure falling down
Information:	At the time of the inspection, it was noted that the timber structure over the pedestrian gate is falling down. This may be due to the age of the materials and general weathering. Termite damage was also found in this structure.

A building maintenance professional or licensed carpenter should be engaged to replace this structure. This can be done at the clients discretion.

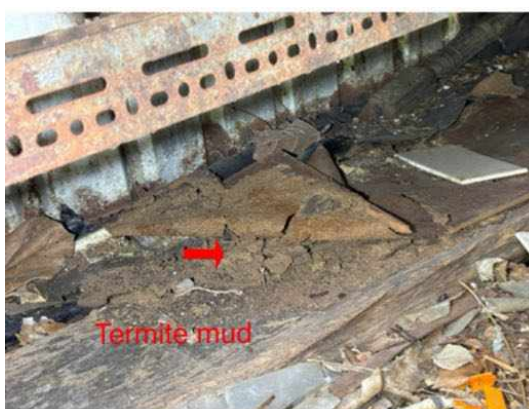
Building:	Main Building
Location:	Shed
Finding:	Shed - evidence of termite activity
Information:	At the time of the inspection, it was noted that there was evidence of termite activity in the shed at the rear of the dwelling. Termite mudding was found in the debris of the shed floor. This appears to be past activity.

A termite and timber pest technician should be engaged to treat the area to eliminate any future activity. This should be done as a matter of urgency.

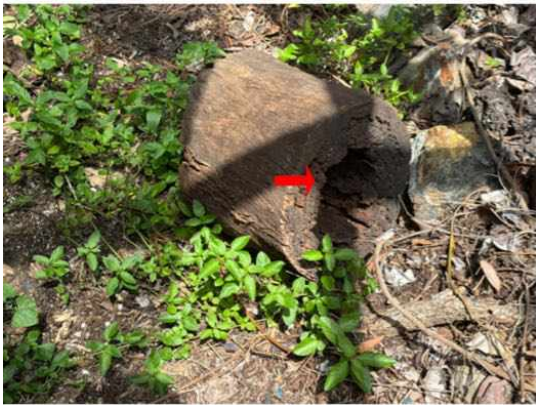
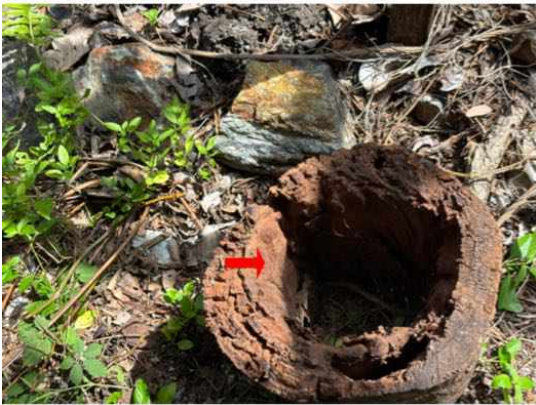
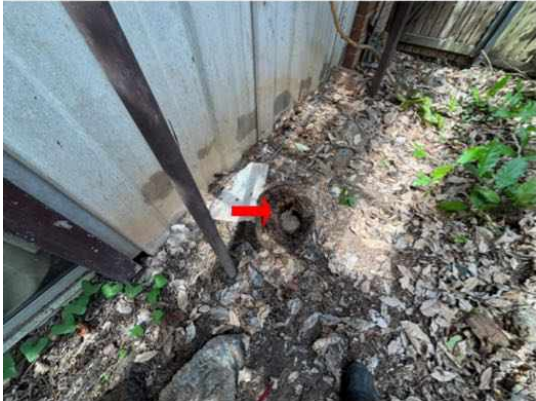
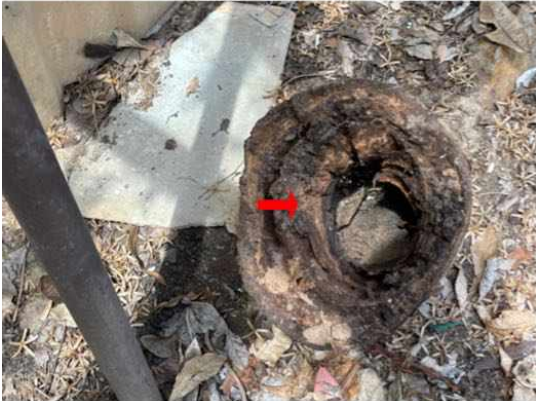
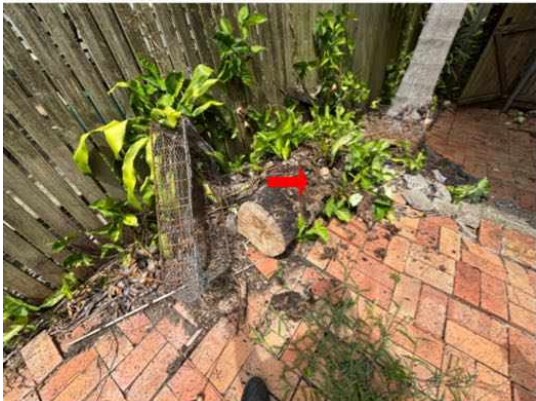
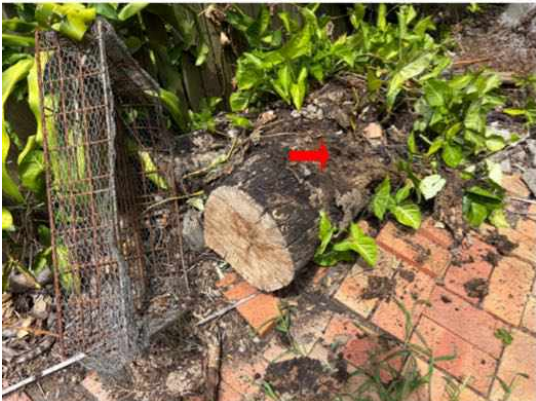
Finding 6.03

Building:	Main Building
Location:	All External Areas
Finding:	Evidence of termite damage
Information:	At the time of the inspection, it was noted that there was termite damage to old timber stumps and the front pedestrian gate structure.

It is advised that the area be visually inspected frequently to ensure that the condition of affected building materials does not worsen and to check for further termite activity.

A building contractor may be appointed to provide a further invasive inspection if further damage is evident.

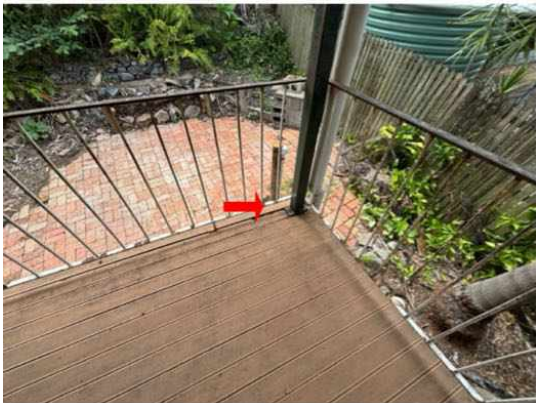
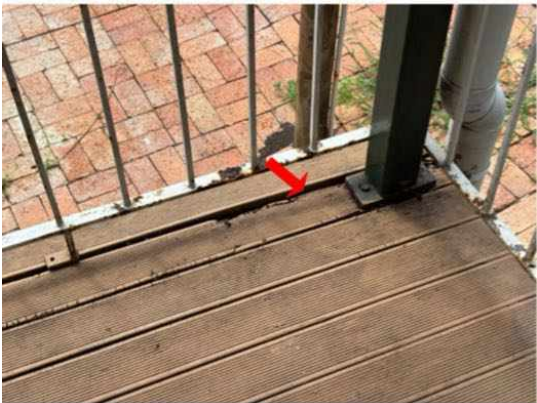
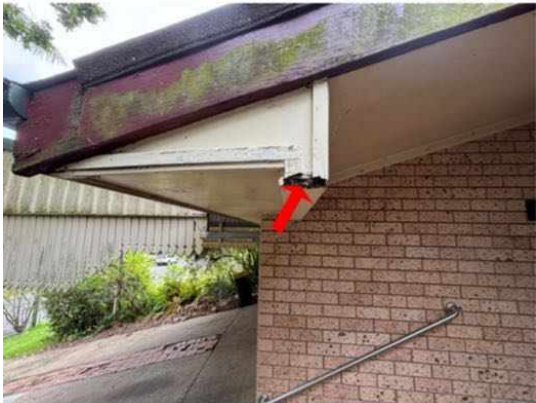
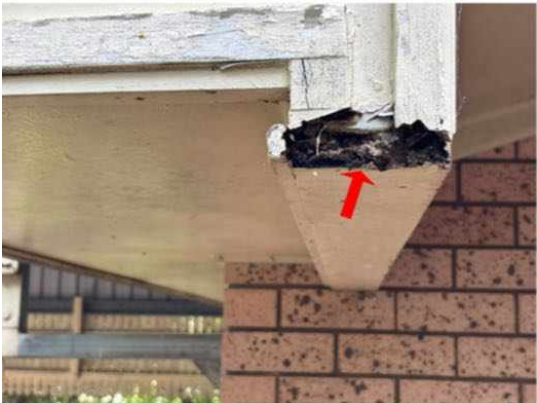
Finding 7.01

Finding: Wood rot

Information: At the time of the inspection, it was noted that there was evidence of wood rot to timber building elements to the dwelling. This may be due to the age of the timber building elements and general weathering.

Early intervention and regular maintenance, particularly of exterior timbers, will prolong the useful life of these building elements. Prior to any works being performed, the cause of the moisture that has created the visible wood rot should be identified and addressed in a suitable manner. Replacement of affected timbers may then be a necessary step in protecting surrounding building elements from such deterioration.

A qualified carpenter or registered builder may also be required to replace affected building materials.

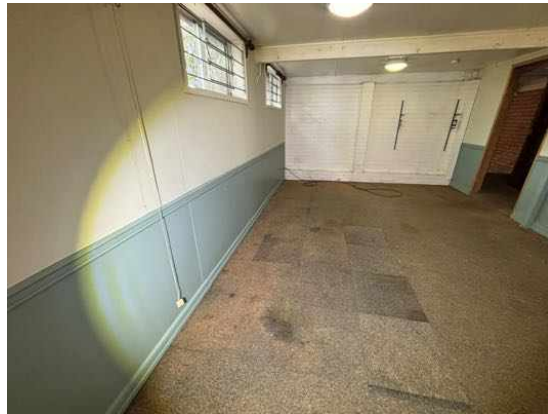
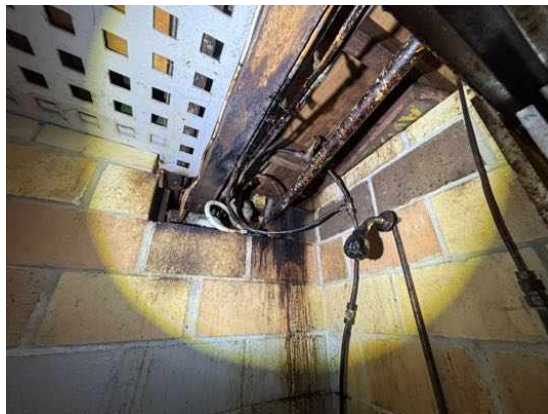
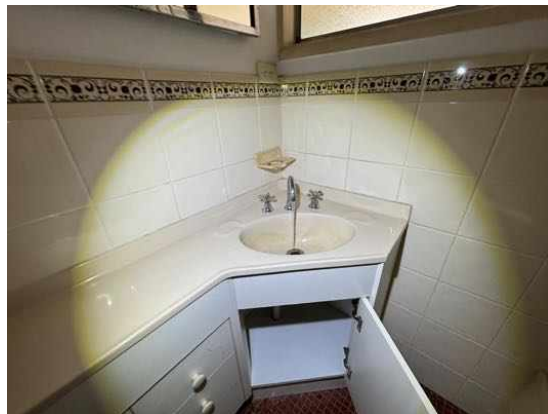
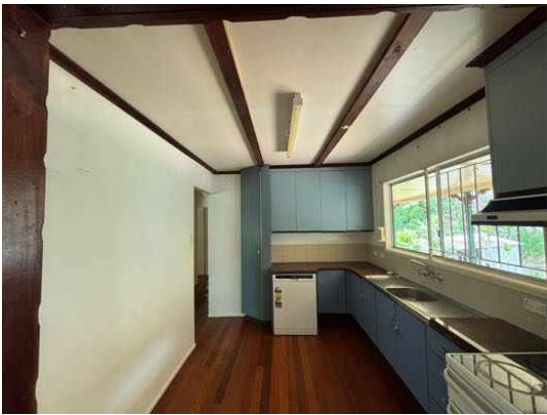
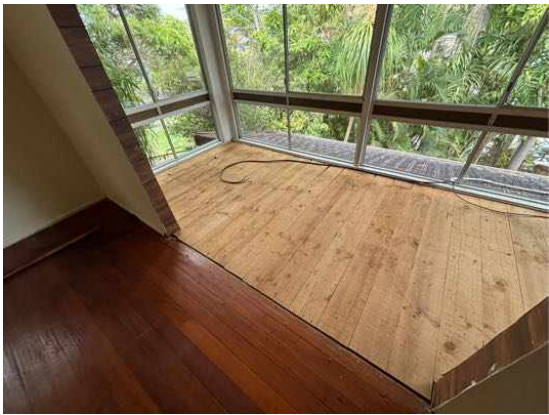
Building: Main Building
Location: All Internal Areas
Finding: Obstructions and Limitations - Internal areas
Information: These photographs are an indication of the obstructions and limitations which impeded full inspection of the property of the internal areas at the time of inspection. These obstructions can hide an array of defects and should be removed to allow full inspection to be carried out. A re-inspection is recommended once the areas are made accessible.

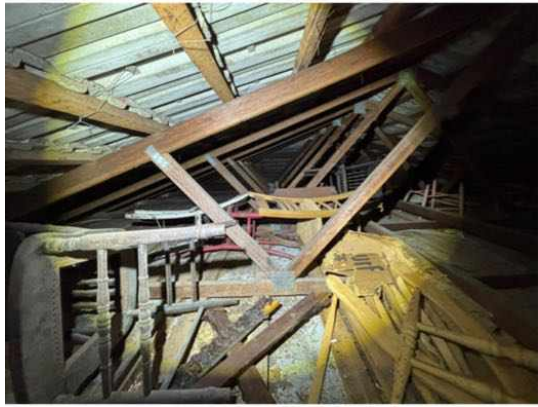
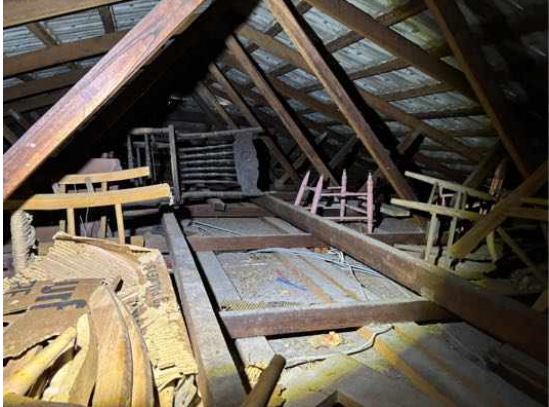
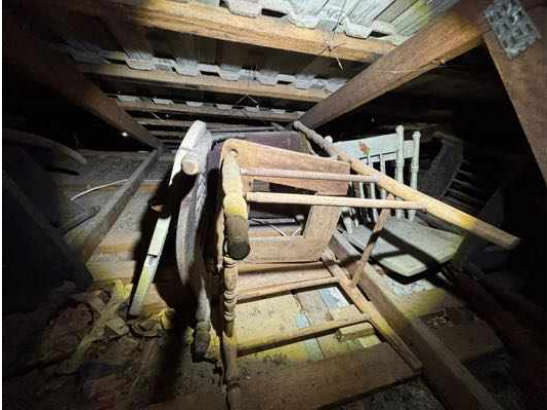
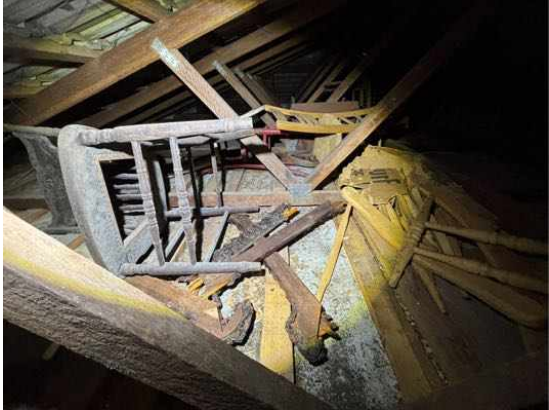
Building: Main Building
Location: Roof Void
Finding: Obstructions and Limitations - Roof cavity
Information: These photographs are an indication of the obstructions and limitations which impeded full inspection of the property of the roof cavity

at the time of inspection. These obstructions can hide an array of defects and should be removed to allow full inspection to be carried out. A re-inspection is recommended once the areas are made accessible.

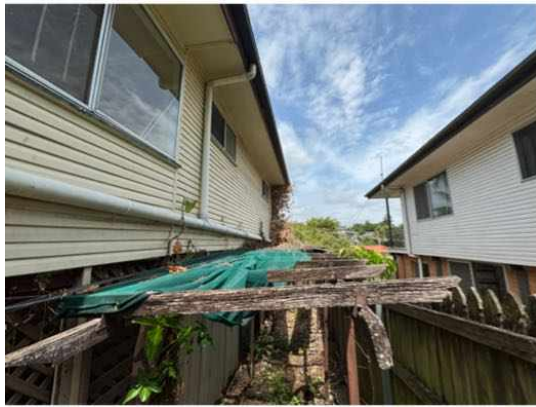
Building:	Main Building
Location:	All External Areas
Finding:	Obstructions and Limitations - External areas
Information:	These photographs are an indication of the obstructions and limitations which impeded full inspection of the property of the external areas at the time of inspection. These obstructions can hide an array of defects and should be removed to allow full inspection to be carried out. A re-inspection is recommended once the areas are made accessible.
