# Building and Timber Pest Inspection Report

Inspection Date: Fri, 27 Mar 2026

Property Address: 9 King St, Berowra NSW 2081, Australia

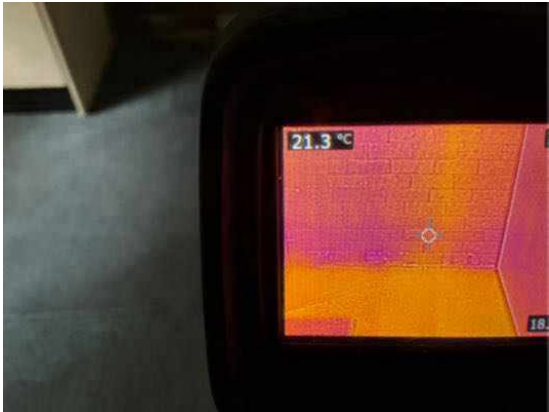
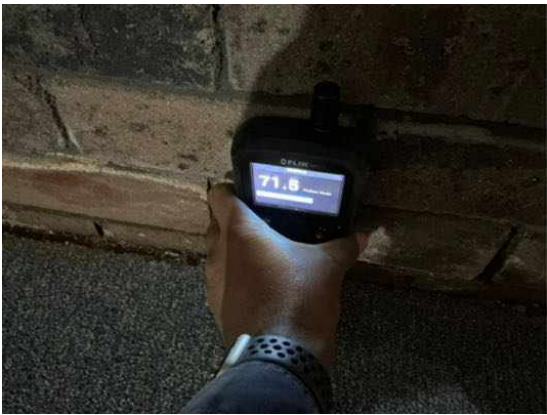
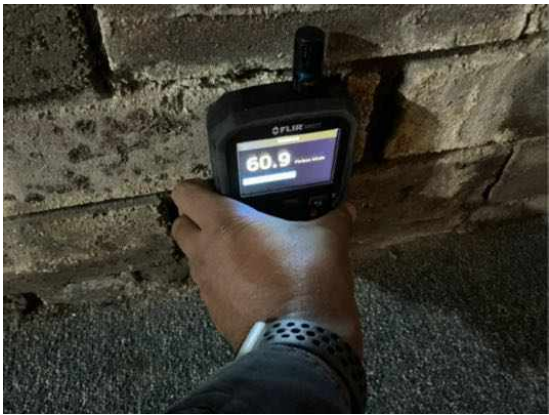
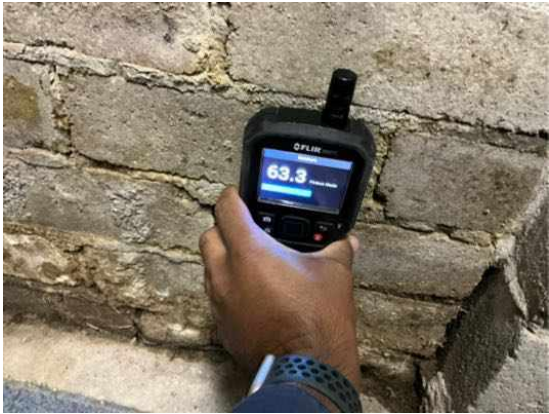
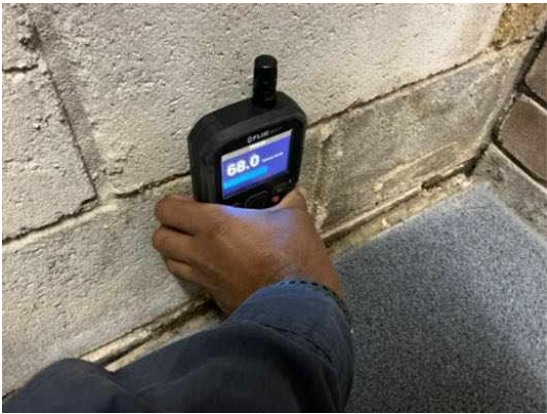
Building:	Main Building
Location:	Workshop, Downstairs Bathroom, Wine Cellar, Kitchenette, Garage
Finding:	Lateral Damp
Information:	Lateral damp was noted on this area at the time of inspection.

Lateral damp refers to moisture entering from the surrounding ground and moving sideways into the base of the wall. This often appears in walls that retain soil or are close to external ground levels. Over time, this can contribute to deterioration of internal finishes such as bubbling or peeling paint.

At this stage, no immediate rectification work is required, but the area should be monitored over the next 12 months. If any signs of bubbling paint, peeling, or further moisture staining appear along the bottom of the wall, the client is advised to engage a damp-proofing specialist to confirm whether a membrane, DPC repair, chemical injection or other moisture management works are required.

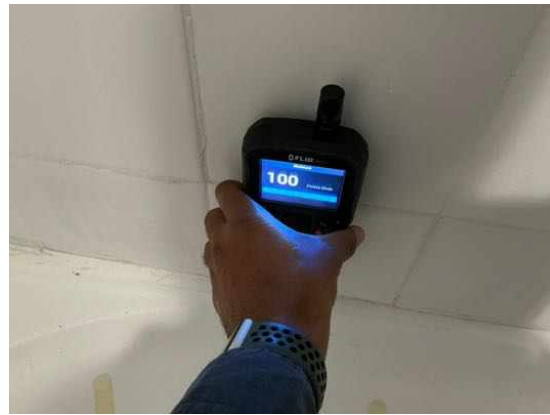
Building:	Main Building
Location:	Both Bathrooms
Finding:	Excessive Moisture - Shower Damp
Information:	At the time of inspection, excessive moisture was noted within the shower area, which is a common issue in wet areas due to the continual exposure to water. This condition is typically caused by moisture seeping through grout lines and settling behind tiles, resulting in localised high-moisture zones. Provided there is no evidence of water staining or elevated moisture readings on the opposite side of the wall, this is considered a minor defect.

However, persistently damp conditions may act as conducive conditions for termite activity, as termites are strongly attracted to moisture-rich environments. It is recommended that the client ensures regular use of the exhaust fan and maintains adequate ventilation after shower use to promote drying and reduce long-term moisture build-up, thereby also reducing the risk of attracting termites.

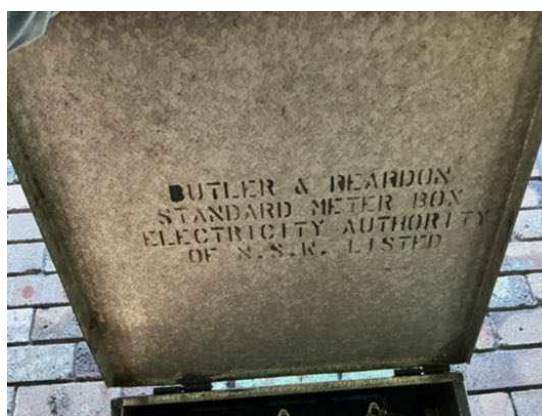
Building:	Main Building
Location:	Meter Box
Finding:	Termite Management System - No Evidence of Installation
Information:	The application of a post-construction chemical termite barrier is strongly recommended for all properties, especially if there has been any history of live termite activity on-site. These barriers are highly effective in protecting timber building elements throughout the property by preventing termite attacks. It is also advisable to install a durable notice within the switchboard unit, indicating the presence of any termite barriers for future reference.

During the inspection, there was no indication that a termite management system had been installed, nor was there any evidence to suggest that preventative measures had previously been undertaken. The client is encouraged to seek further advice from a licensed pest controller regarding the costs and procedures involved in the application of a termite barrier. Prioritizing this step in the short term is strongly advised to ensure long-term protection.

Additionally, the client may want to consult with the vendor to determine whether regular Timber Pest inspections, as per AS4349.3 or AS 3660.2, have been conducted in the past. This will provide further insights into any past termite management practices and help inform the appropriate course of action.

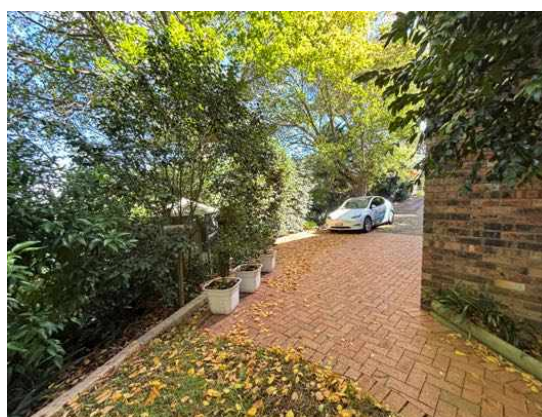
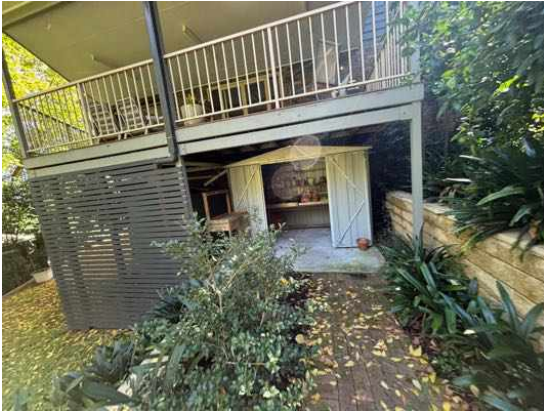
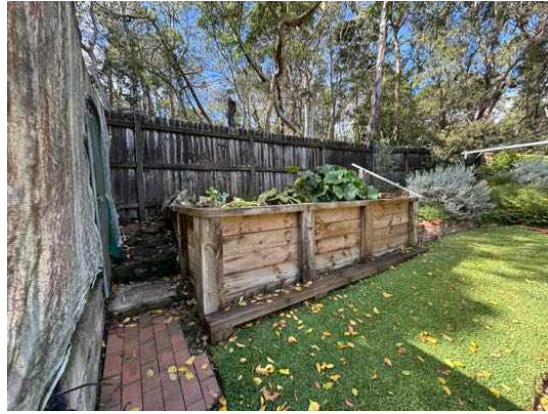
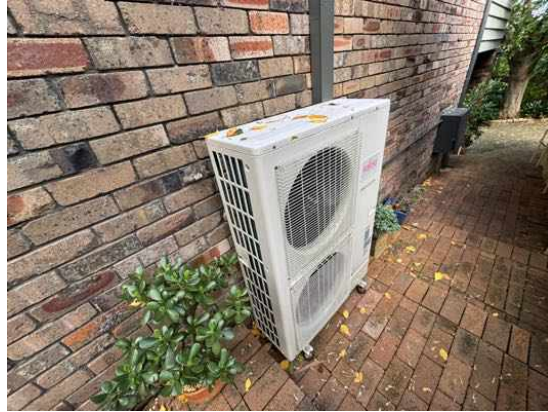
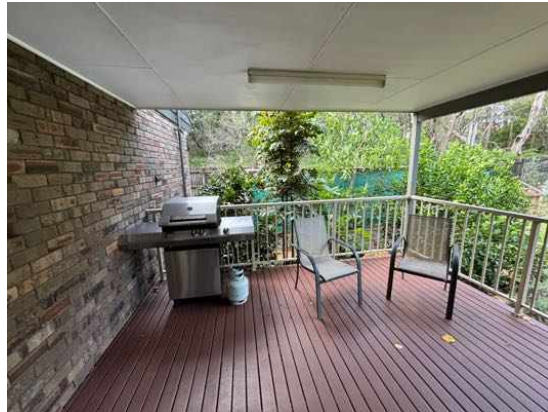
It is essential that these obstructions be cleared to allow for a comprehensive inspection of the external areas. Removing these barriers will enable a more accurate assessment of the property's condition and allow any hidden defects to be identified and addressed promptly. Failure to do so could result in undetected issues worsening over time, potentially leading to more costly repairs in the future.

Therefore, it is strongly recommended that the obstructions be removed and a re-inspection be scheduled once the affected areas are made fully accessible. This will ensure a complete evaluation of the property's exterior and provide the client with a clear understanding of any potential issues that may have been concealed during the initial inspection.

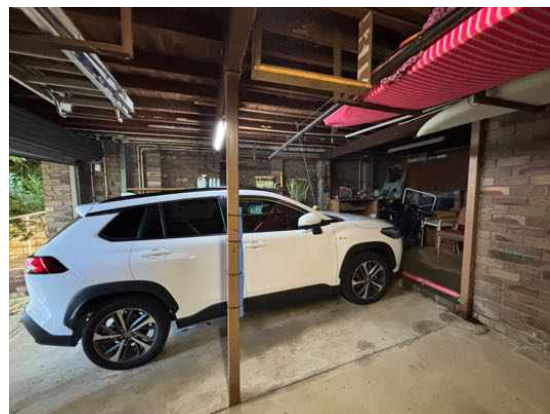
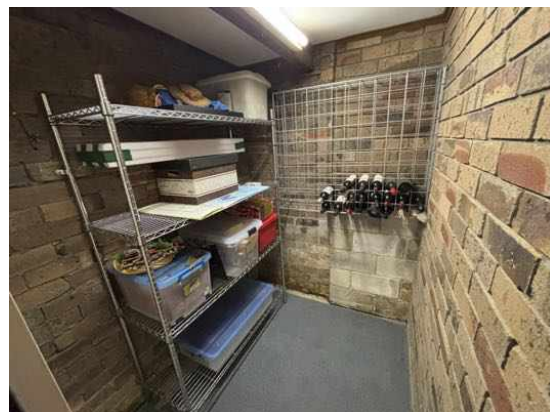
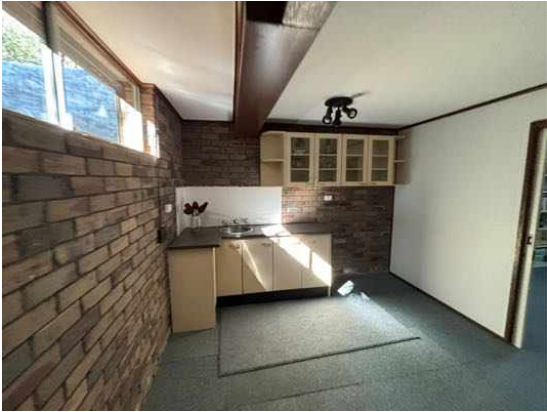
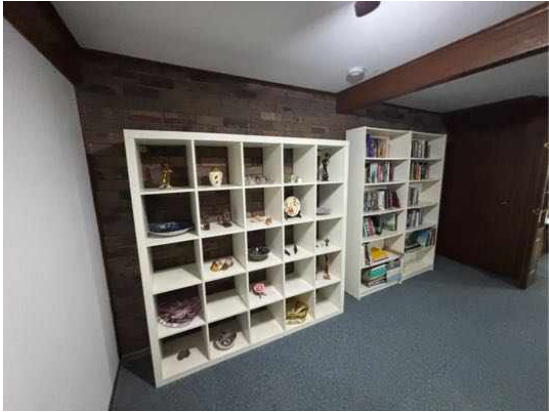
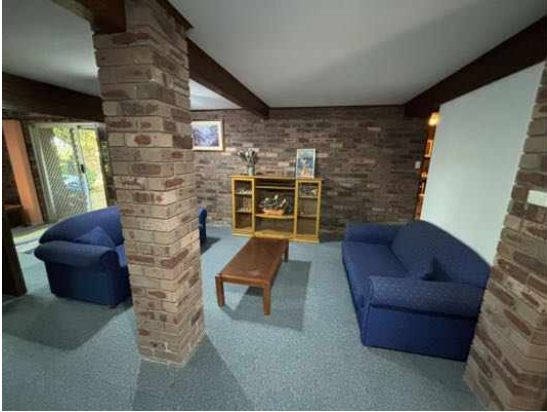
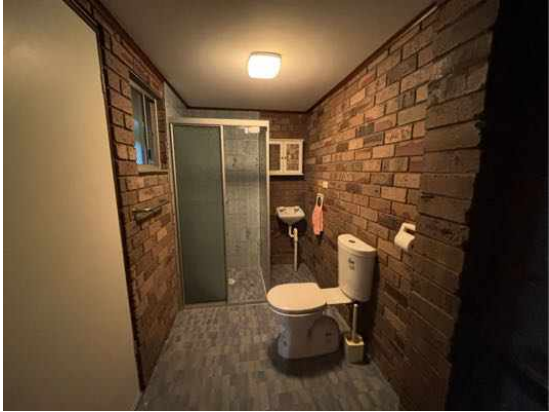
Building:	Main Building
Location:	All Internal Areas
Finding:	Obstructions and Limitations - Internal Areas
Information:	The accompanying photographs provide clear evidence of the obstructions and limitations that restricted a comprehensive inspection of the internal areas of the property at the time of assessment. These obstructions, which may include furniture, personal belongings, stored items, or structural elements such as wall coverings and built-ins, significantly hindered the ability to thoroughly evaluate these areas. It is important to note that such obstructions can potentially conceal a wide array of defects, ranging from hidden structural damage, water leaks, pest infestations, or

It is highly recommended that all obstructions be cleared to facilitate a complete and thorough inspection of the internal areas. Once the obstructions have been removed and full access is available, a re-inspection should be carried out to ensure that any previously concealed issues can be properly identified and rectified. This follow-up inspection will provide a more accurate assessment of the property's internal condition and help the client make informed decisions about any necessary repairs or maintenance.

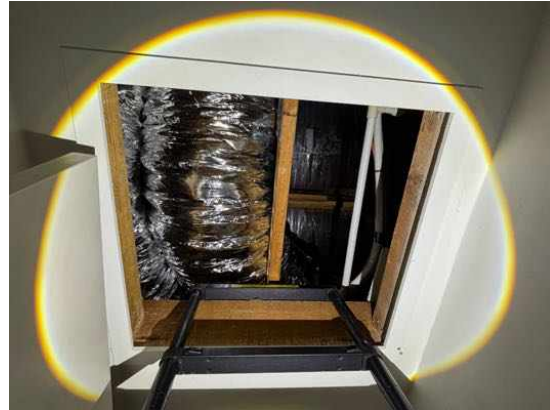
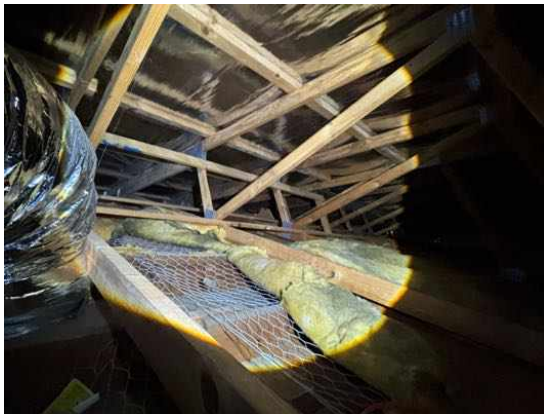
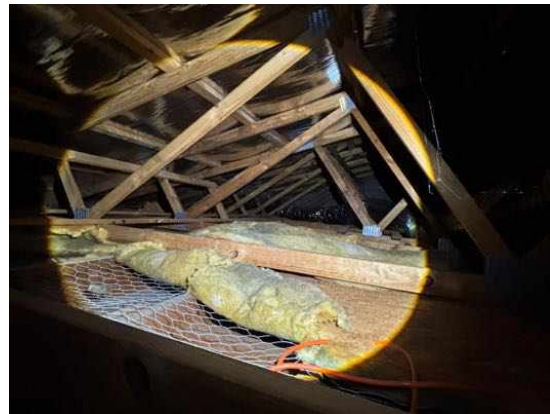
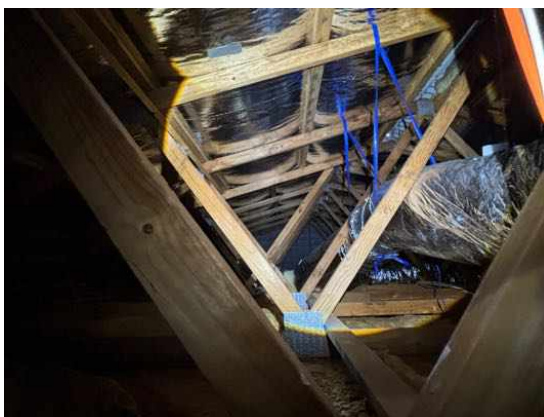
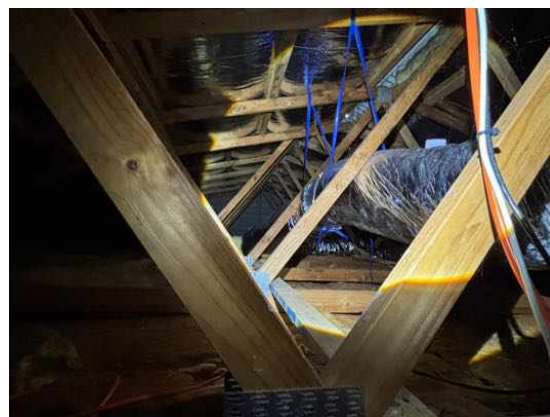
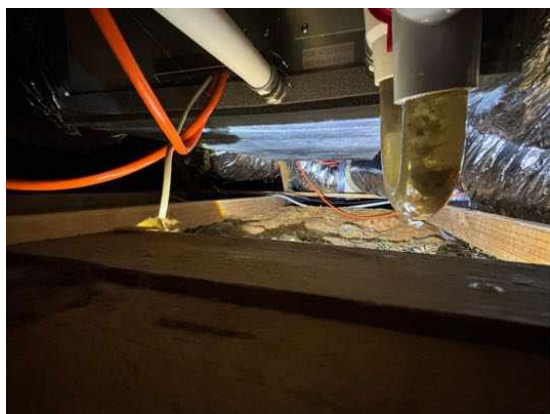
Building: Main Building  
 Location: Roof Void  
 Finding: Obstructions, Limitations, and General Roof Space Condition  
 Information: The photographs provided document both the general condition and the obstructions and limitations that were present in the roof cavity of the main building at the time of inspection. These obstructions—such as insulation materials, stored items, structural elements, or electrical wiring—restricted safe and adequate access to key areas within the roof space. As a result, a comprehensive inspection of all components could not be completed.

damaged framing, compromised insulation, evidence of moisture ingress, pest activity, or electrical hazards. While no major issues were observed in the visible areas, the presence of these limitations means that some defects may remain undetected.

It is recommended that these barriers be removed or repositioned to facilitate full and safe access to the roof space. Once clear, a follow-up inspection should be conducted to allow for a thorough assessment of all concealed areas. This will help ensure that the condition of the roof cavity is accurately evaluated and any hidden issues are appropriately identified and addressed.

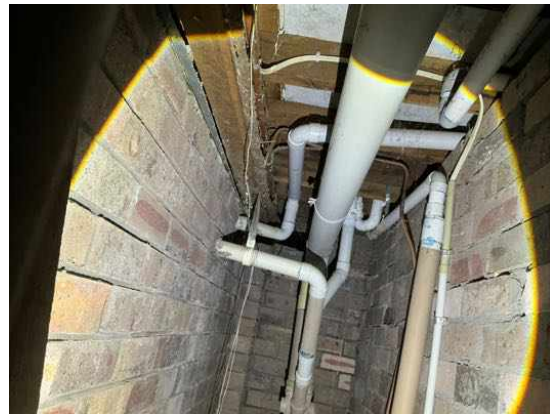
Building: Main Building  
 Location: Subfloor  
 Finding: Obstructions, Limitations, and General Subfloor Condition  
 Information: The attached photographs illustrate the obstructions and access limitations that restricted a full inspection of the subfloor area of the main property at the time of assessment. Items such as stored materials, construction debris, low-hanging services, and insulation impeded movement and visibility within key sections of the subfloor. In addition, the limited crawl height further restricted safe access to inspect critical structural components.

Restricted access and confined spaces can significantly hinder the ability to evaluate important elements such as floor joists, bearers, stumps, drainage, subfloor ventilation, and signs of moisture or pest activity. These obstructions may also conceal defects such as timber decay, water ingress, termite damage, inadequate support, or ventilation issues that are not immediately visible during a limited inspection.

While no major concerns were identified in the accessible areas, a full and unobstructed inspection is necessary to properly assess the overall condition of the subfloor. It is recommended that obstructions be removed and access improved where possible. Once adequate clearance is provided, a re-inspection should be arranged to ensure that any concealed defects can be identified and addressed accordingly. This will assist in providing a more comprehensive understanding of the subfloor's condition and reduce the risk of unforeseen issues.

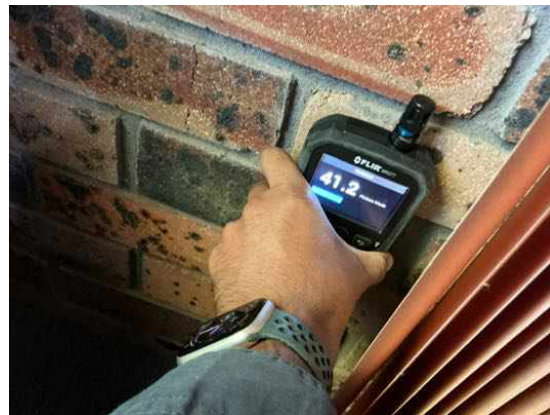
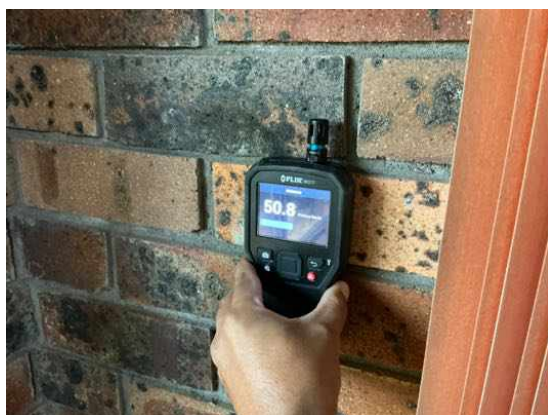
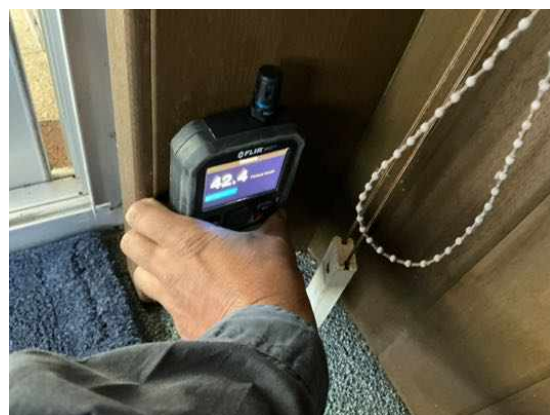
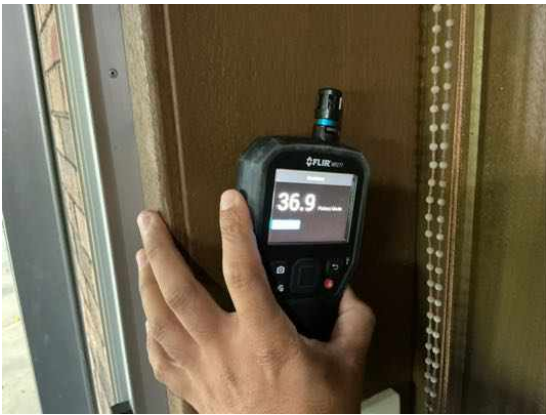
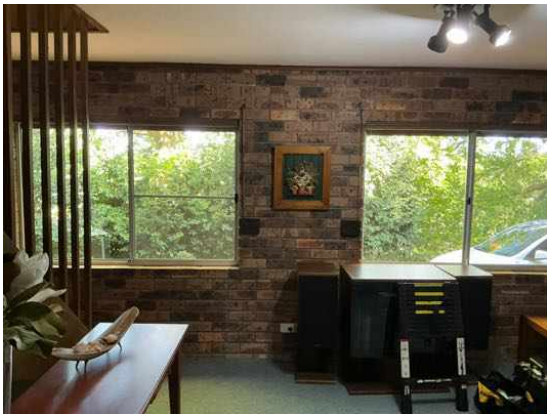
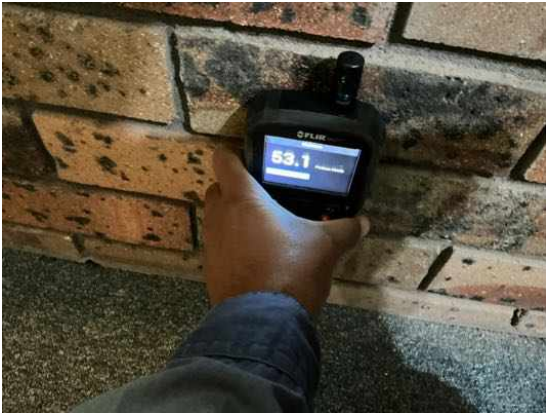
Building: Main Building  
Location: All Areas  
Finding: Additional Photos - Moisture Meter Readings  
Information: Additional moisture meter reading photos have been provided for the property to offer further clarity on areas tested during the inspection. These photos are intended to give a visual reference for the specific locations where moisture levels were measured. These readings were taken at the time of the inspection to assess any potential moisture-related issues within the property. Any defects related to moisture that were identified during the inspection have been separately mentioned in the defect statements within the report.

It is important for the client to understand that moisture levels can fluctuate over time due to various factors, including changes in weather, humidity, and environmental conditions. While the readings reflect the property's moisture levels during the inspection, they may not represent future conditions, and increased moisture could lead to issues such as dampness, mould growth, or deterioration of building materials if left unmonitored.
