Building and Timber Pest Inspection Report

Inspection Date: Tue, 24 Feb 2026

Property Address: 1/2 Hatton St, Ryde NSW 2112, Australia

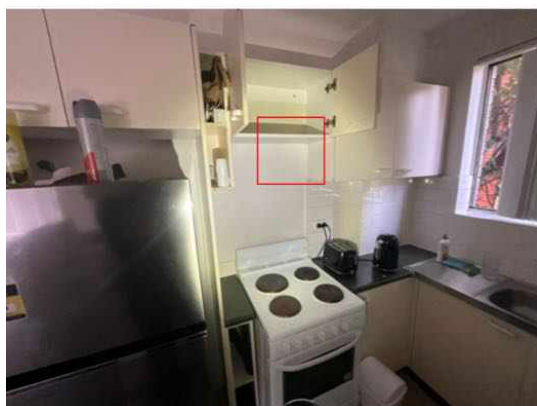
Finding 1.01

Building:	Main Building
Location:	Kitchen
Finding:	Exhaust fan - Missing
Information:	A complying exhaust fan was not installed to this area at the time of inspection.

The kitchen exhaust fan was found to be missing at the time of inspection, requiring urgent works by a licensed electrician.

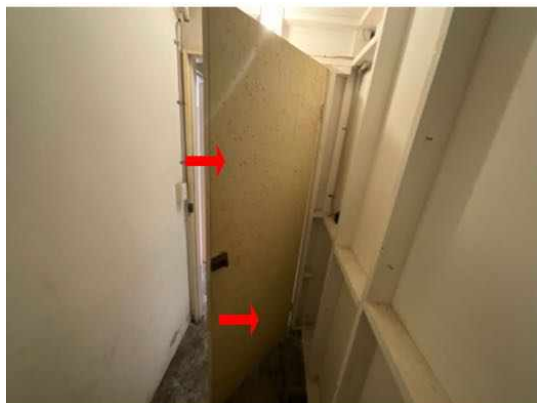
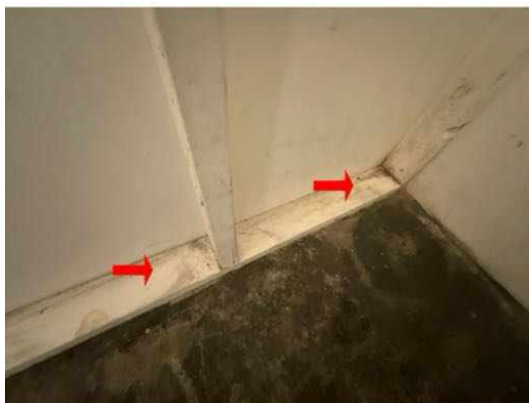
Finding 1.02

Building:	Main Building
Location:	Storage
Finding:	Mould - Present
Information:	Where evidence of mould growth was noted, there may be environmental, biological or health issues associated with the report. A specialist inspection by a suitably qualified environmental health inspector is warranted, where mould is extensive or where any queries regarding air quality spores or other related issues apply.

Another safety hazard is due to mould in the storage downstairs. A mould remediation contractor is required to treat this mould urgently.

Generally, the client is advised to ensure that the general environment is free of

moisture and humidity to aid in the prevention of mould formation and development. Any mould found during the inspection should be cleaned immediately by a cleaning contractor or the homeowner as applicable.

Please note that severely affected building elements may require replacement by a licensed builder.

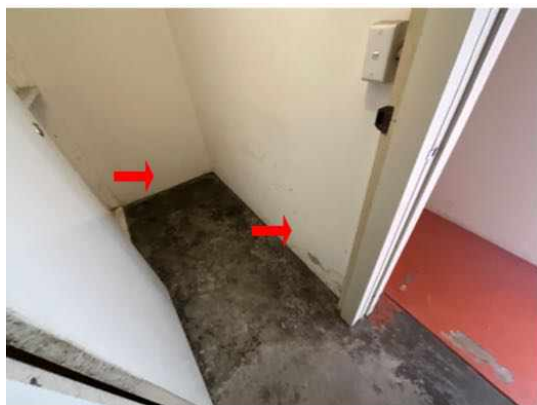
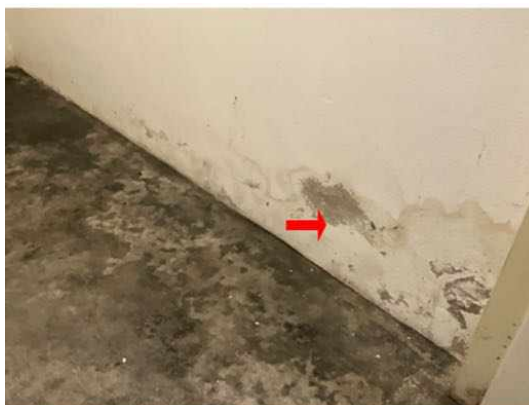
Finding 2.01

Building:	Main Building
Location:	Storage
Finding:	Damp - Rising
Information:	Rising damp describes the upward movement of water in low sections of building elements (e.g. walls) by capillary action - the movement of water through porous materials such as bricks, sandstone or mortar.

Damp rising is suspected to the storage downstairs, requiring immediate works by a licensed builder and plumber.

Consultation with a licensed builder and plumber is advised immediately to identify the cause of the damp and perform remedial works as required.

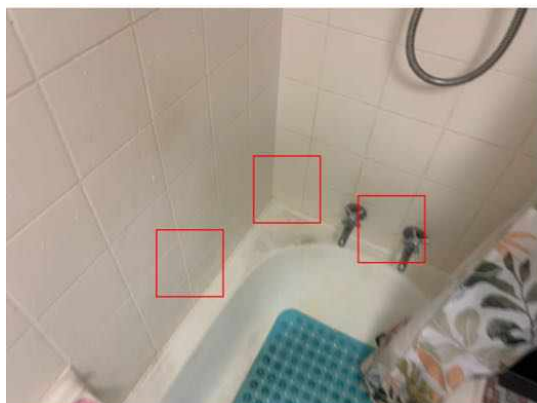
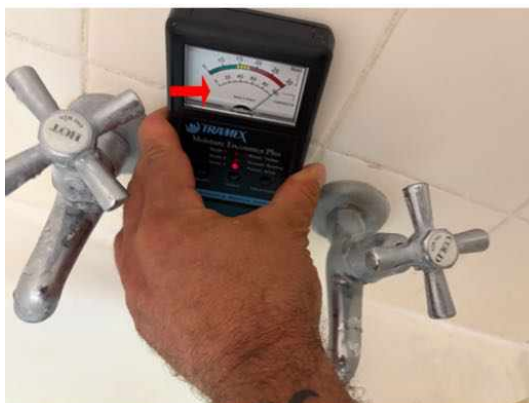
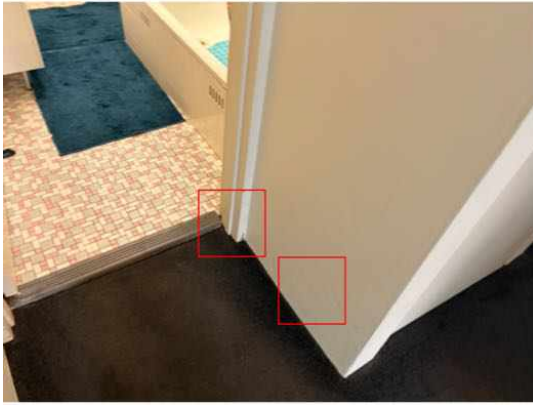
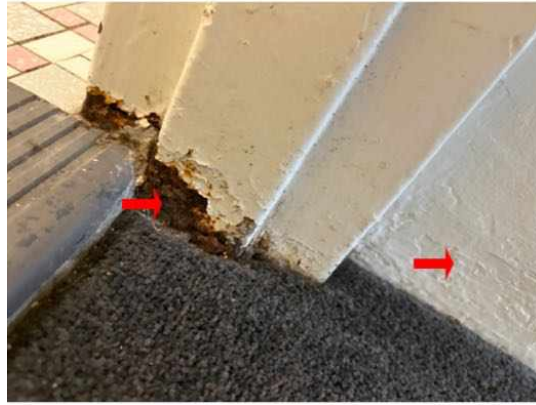
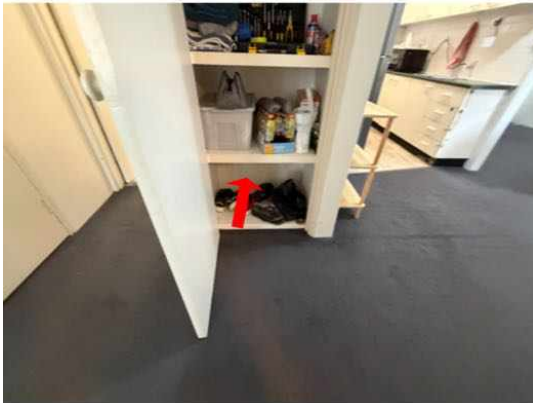
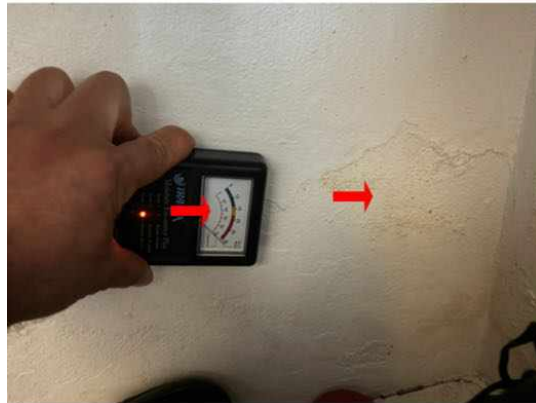
Finding 2.02

Location: Bathroom

Finding: Water leak - Internal

Information: A water leak was found in this area at the time of inspection. Internal water leaks can be detrimental to surrounding building elements; their potential causes include damage to plumbing fittings and fixtures, through to water damage and deterioration of associated building elements.

Internal water leak evident to the shower, with excess moisture and water damages to the surfaces. A bathroom specialist must be appointed urgently for rectifications.

In extreme cases, structural damage may develop due to a prolonged water leak. It is highly advised that a bathroom specialist be appointed urgently for rectifications.

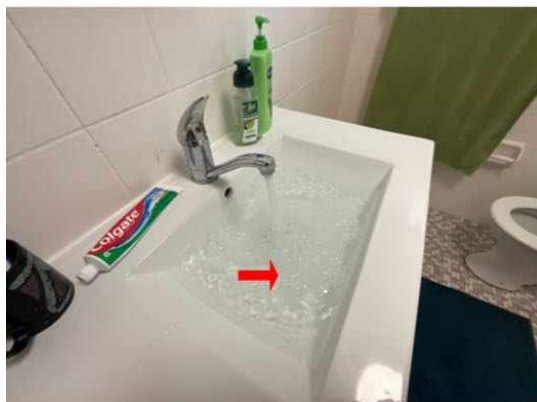
Finding 3.01

Building: Main Building
 Location: Bathroom
 Finding: Sink/basin - slow draining
 Information:

The sink/basin drain appeared to be partially blocked at the time of inspection. Blockages here are usually caused by hair and other debris. If left unmanaged, a lack of general maintenance may lead to the development of more significant defects, such

A licensed plumber should be appointed to remove the blockage at the client discretion.

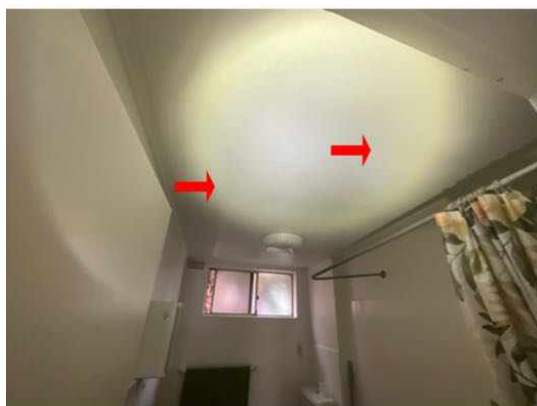
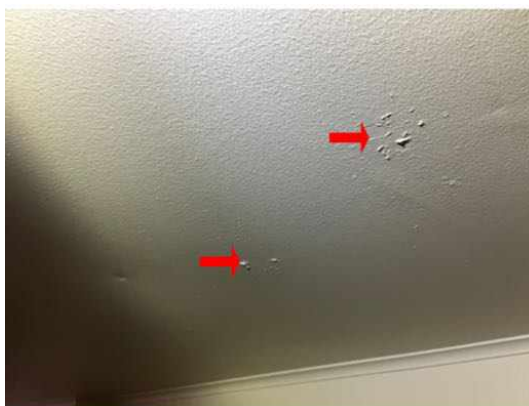
Finding 3.02

Location: Bathroom

Finding: Paint cracking and peeling

A qualified painter should be appointed to rectify the problem.

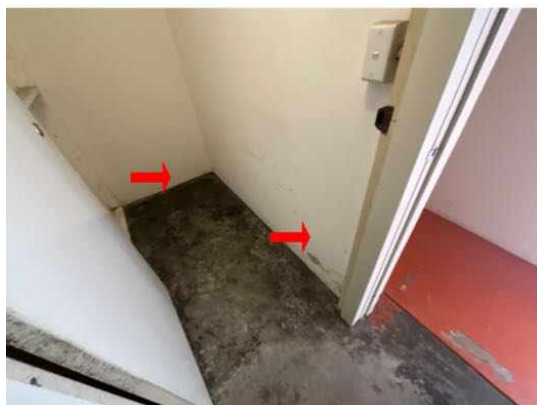
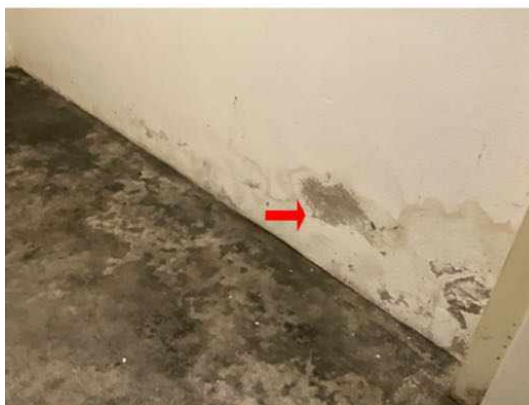
Finding 6.01

Building:	Main Building
Location:	Storage
Finding:	Damp - Rising
Information:	Rising damp describes the upward movement of water in low sections of building elements (e.g. walls) by capillary action - the movement of water through porous materials such as bricks, sandstone or mortar.

Consultation with a licensed builder and plumber is advised immediately to identify the cause of the damp and perform remedial works as required.

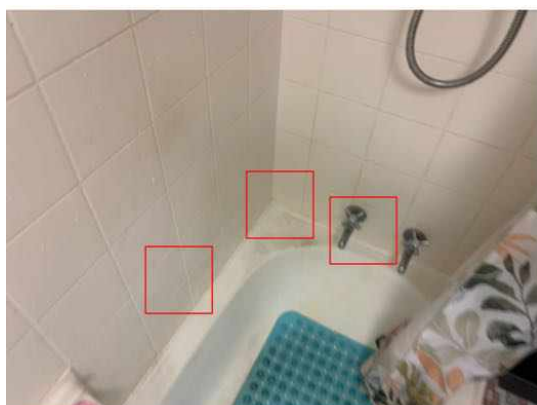
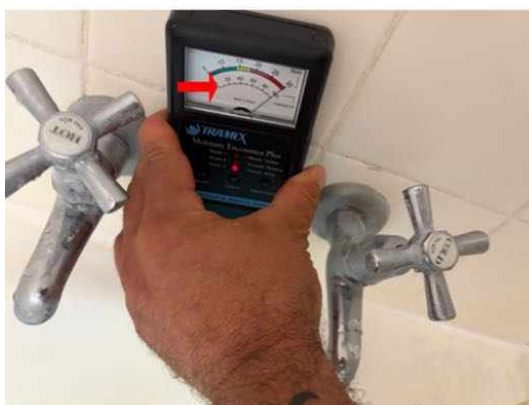
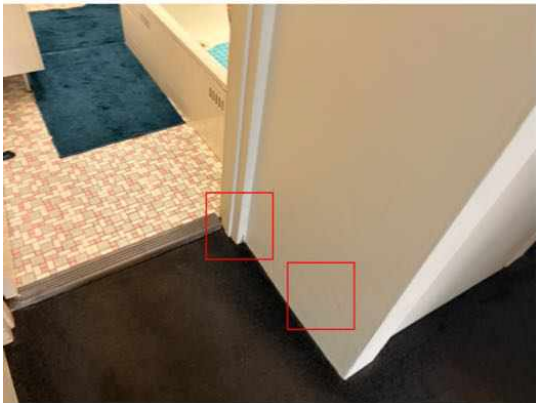
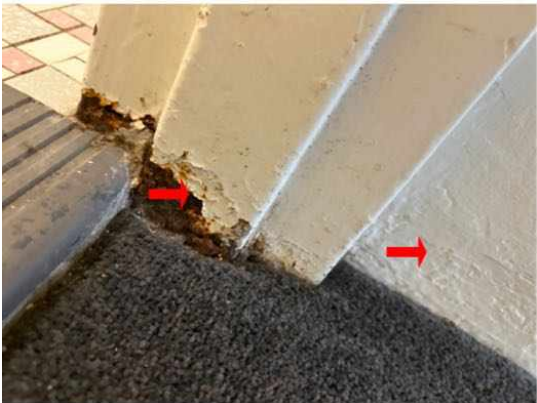
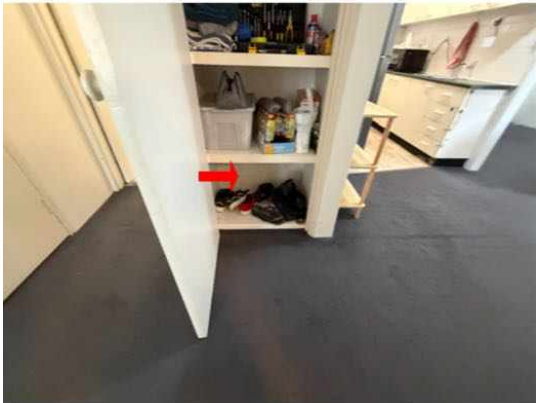
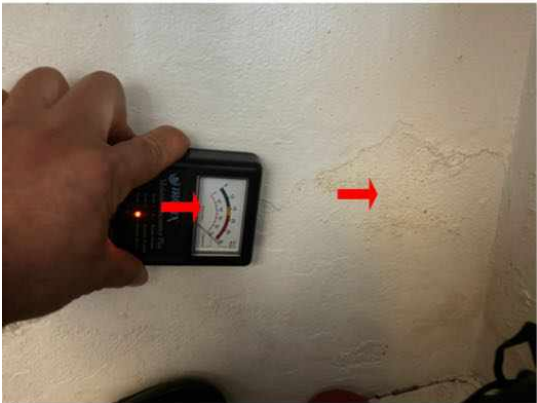
Finding 6.02

Location: Bathroom

Finding: Water leak - Internal

Information: A water leak was found in this area at the time of inspection. Internal water leaks can be detrimental to surrounding building elements; their potential causes include damage to plumbing fittings and fixtures, through to water damage and deterioration of associated building elements.

In extreme cases, structural damage may develop due to a prolonged water leak. It is highly advised that a bathroom specialist be appointed urgently for rectifications.

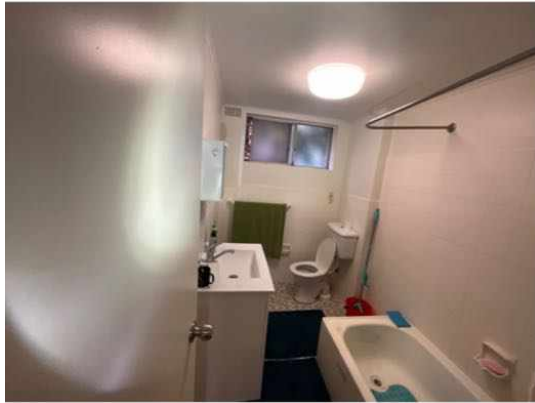
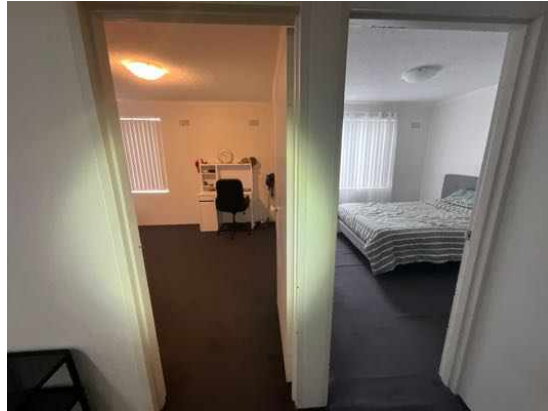
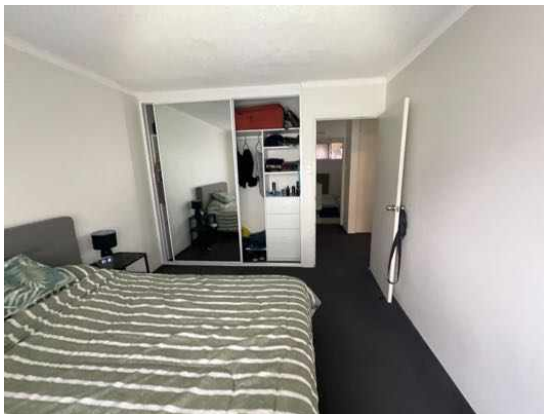
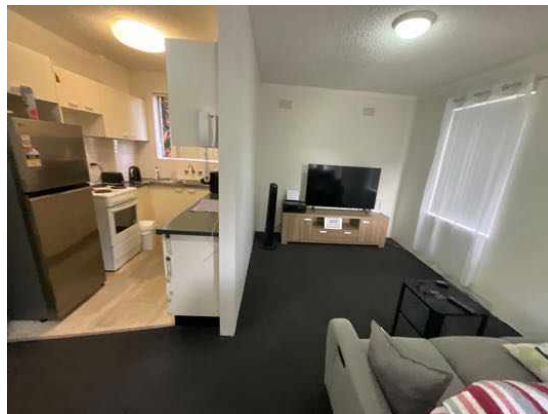
These photographs are an indication of the obstructions and limitations which impeded full inspection of the property at the time of inspection. These obstructions can hide an array of defects and should be removed to allow full inspection to be carried out. A re-inspection is recommended once the areas are made accessible.
