# Building and Timber Pest Inspection Report

Inspection Date: Tue, 17 Mar 2026

Property Address: 40 Edgeware Rd, Aldgate SA 5154,  
Australia

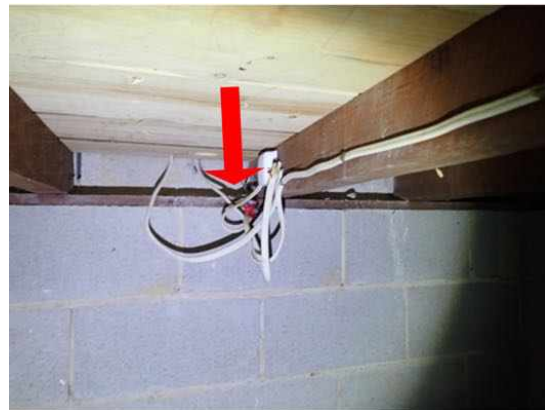
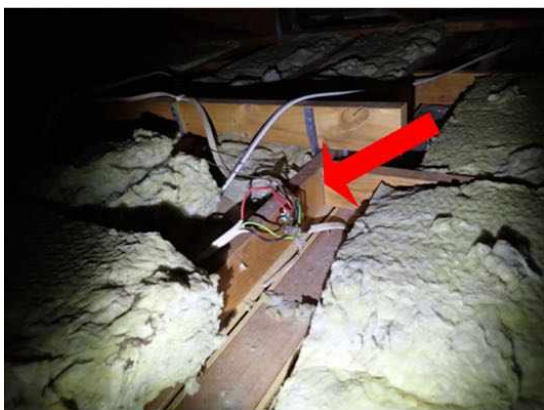
#### Finding 1.01

Building:	Shed
Location:	Subfloor/Roof Void
Finding:	Electrical junction box - Missing
Information:	Several wiring joins in the sub floor and roof space are not adequately protected by a junction box. Junction boxes provide a second insulation barrier to adequately seal off and protect the wires, increasing the safety of the immediate environment and ensuring that the wiring is not damaged.

The absence of junction boxes in the roof space poses as an electrical safety hazard, providing risk of electrocution. It appears as though wiring in this area has been completed to a substandard level of workmanship, evidenced by the lack of adequate wiring protection.

Appointment of a licensed electrician is highly advised to provide additional information on the risks of unprotected wiring and to install junction boxes and any other elements as required. Such works should be carried out as a matter of urgency; until this time, any persons within the sub floor and roof space should exercise a high level of caution.

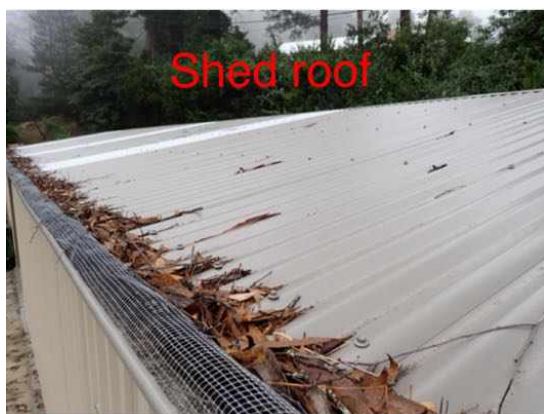
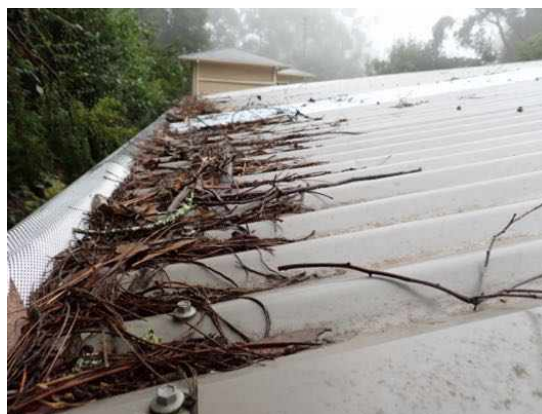
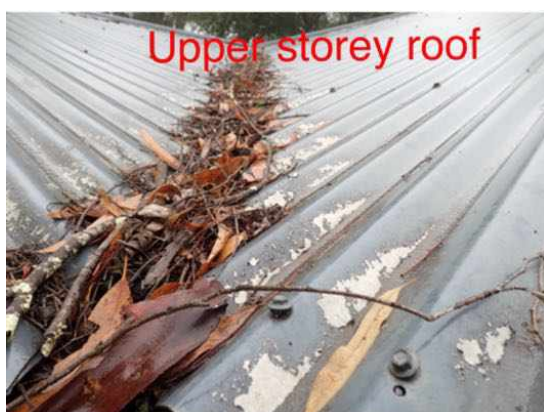
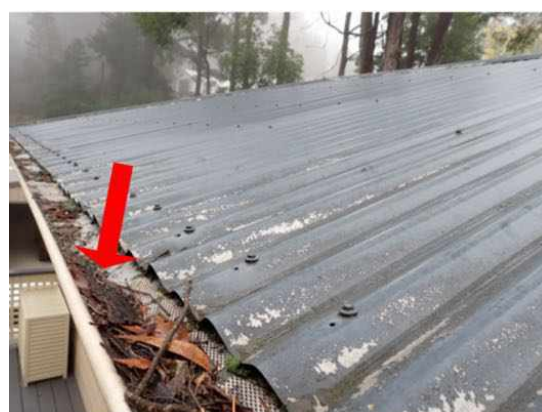
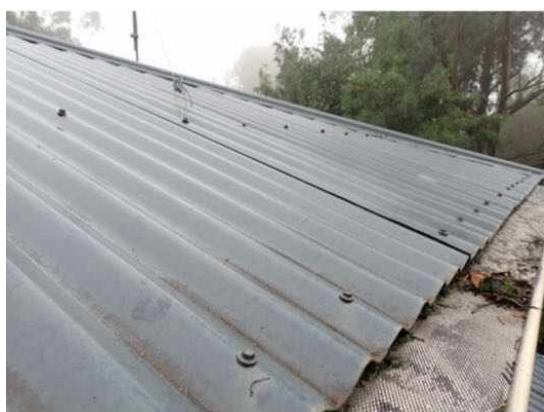
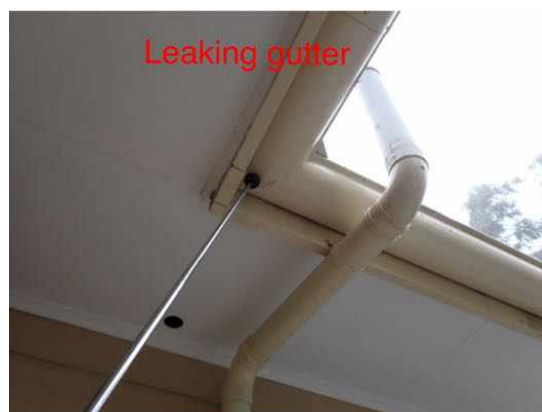
### Finding 3.01

Building:	Main Building
Location:	Roof Exterior
Finding:	Gutters - Blocked
Information:	Roof plumbing structures, such as guttering and downpipes, should be free of all debris to prevent blockages. Blockages of the guttering and downpipes will lead to pooling and accumulated water overflows, which is likely to subsequently flood eaves and exterior walls. Where gutter guard is installed regular maintenance should include cleaning out any debris which may rest on top of or filter through the gutter guard.

Blocked gutters are likely to lead to high levels of moisture in the affected areas. Such moisture will not only cause rust and decay of the associated building materials, but can also provide conditions that are conducive to termite and timber pest activity. Blockages in gutters should therefore be removed immediately to ensure dry conditions are maintained.

Consult a Licensed Plumber for further specific advice on remedial works that may be required. In the interim, it is highly advised that blocked gutters be removed by the homeowner or a general handyperson as a matter of urgency.

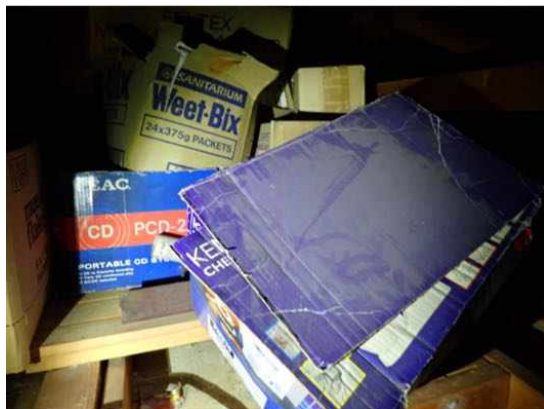
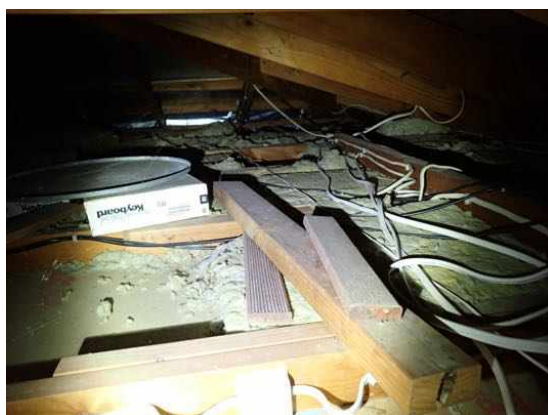
### Finding 3.02

Building:	Shed
Location:	Roof Void
Finding:	Stored Goods/Rubbish
Information:	<p>An array of debris/stored goods was found in the roof void area at the time of inspection. Debris in this area restricts ventilation and creates potential for concealed pest activity , as well as unnecessary strain on the roof structure. Debris in the roof void should be removed as soon as possible. Depending on the location and amount of debris and stored items, the homeowner may elect to undertake this task. Alternatively there are a large number of rubbish removal subcontractors that could undertake these works.</p>

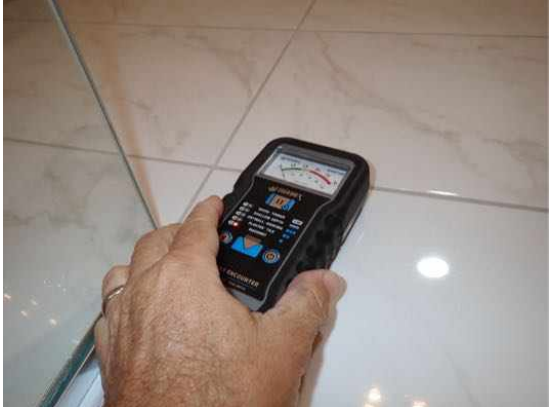
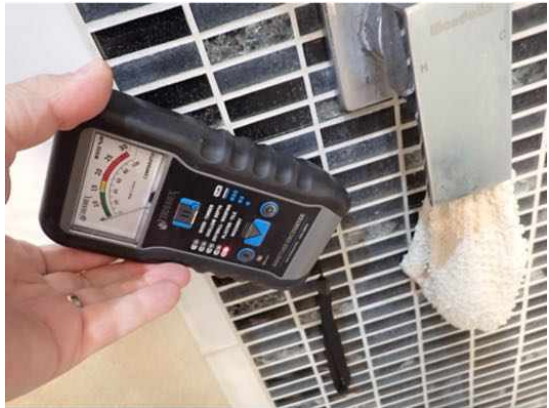
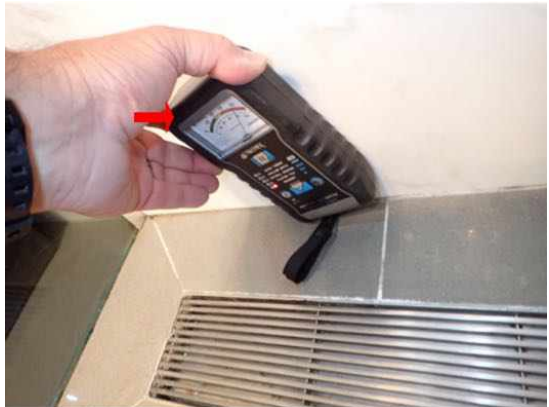
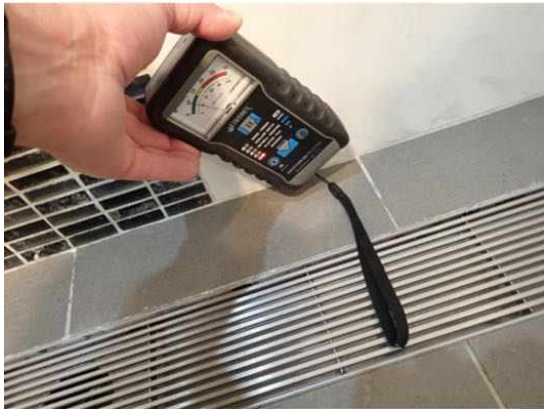
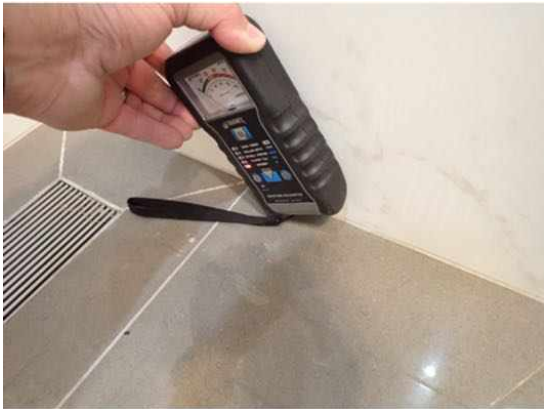
### Finding 3.03

Building: Shed  
 Location: Bathroom  
 Finding: Shower Damp - Monitor  
 Information:

Damp is evident to the lower 400mm of wall to the shower alcove. There is no high reading around the taps nor are there high readings transferring to the other side of the wall. Both sealant and grout appear in poor condition at present and will need to be renewed, as it is suspected that the high moisture readings at the shower base have been caused by moisture permeating or leaching through the grouting and perhaps gaps in the sealant.

Consultation with a qualified plumber or bathroom specialist would be advised to conduct a precautionary pressure test, to identify the cause of damp and to perform remedial works to prevent further deterioration and additional costs.

Always ensure that sealant and grout is in good condition to prevent any moisture issues occurring in the future.

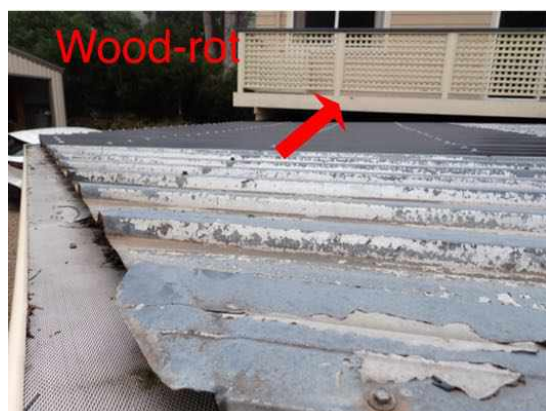
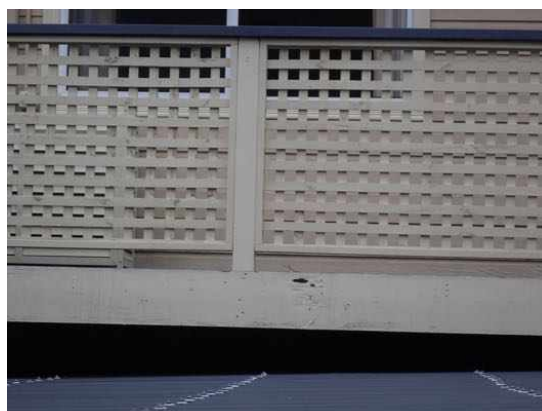
Finding 3.04

Building: Shed  
 Location: Balconies  
 Finding: External Timber Balcony or Deck - Structural Stability  
 Information: The load capacity of the external balconies could not be verified during the inspection. External timber structures are also constantly exposed to weather elements and can deteriorate in an accelerated manner, ongoing assessments are required.

It is highly recommended that a Structural Engineer further assess the external timber balcony or deck to inform the client of its load capacity. Regular maintenance inspections by competent practitioners is needed.

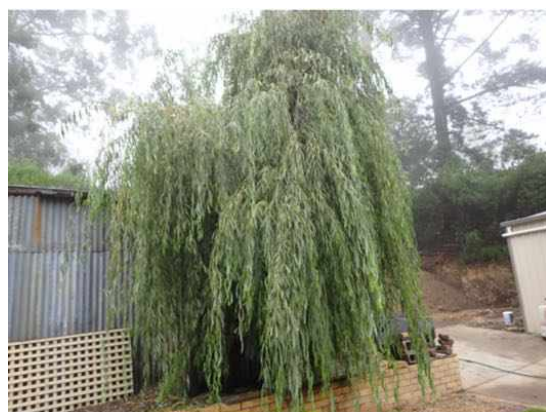
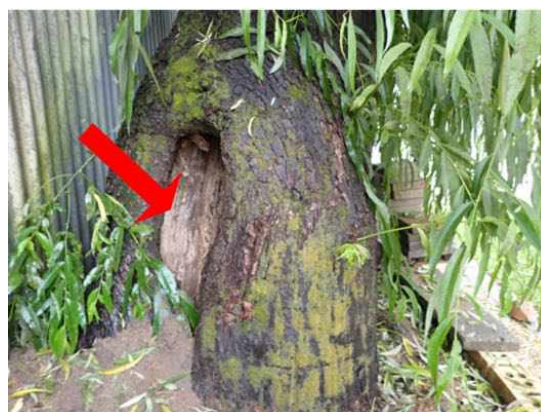
### Finding 5.01

Building: Shed  
 Location: External Areas  
 Finding: Termite Damaged - Suspected Activity Identified

**Information:** Although no evidence of live termite activity was found at the time of the inspection, it is suspected that a termite colony may be present on or near the property. Visible evidence of termite workings was found in timber within the yard. Further inspection of external and internal areas is required in order to correctly identify the presence of termite activity and may include works of an intrusive nature.

It should be noted that where termite activity has occurred in close proximity to the dwelling, the risk of termite activity within the dwelling is greatly increased, particularly where inspection is restricted or obstructed due to inaccessible areas.

It is strongly recommended also that an internal invasive inspection/treatment of the dwelling be conducted as soon as possible.

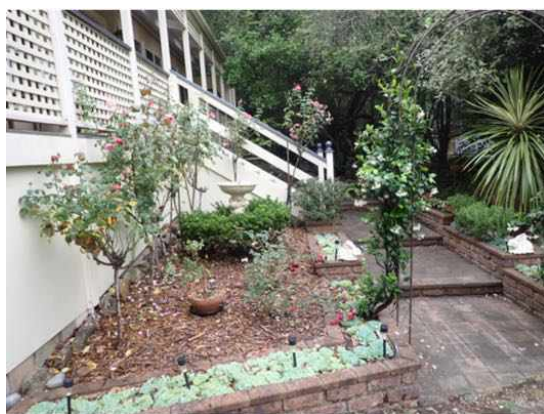
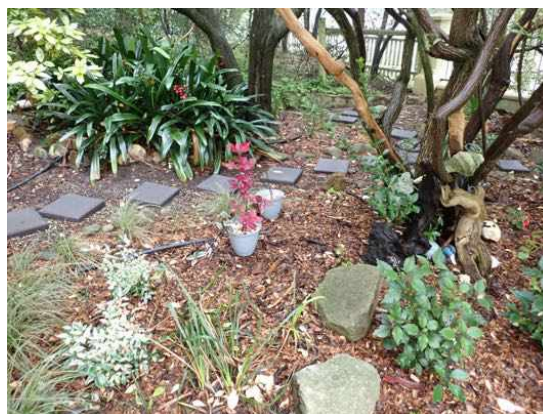
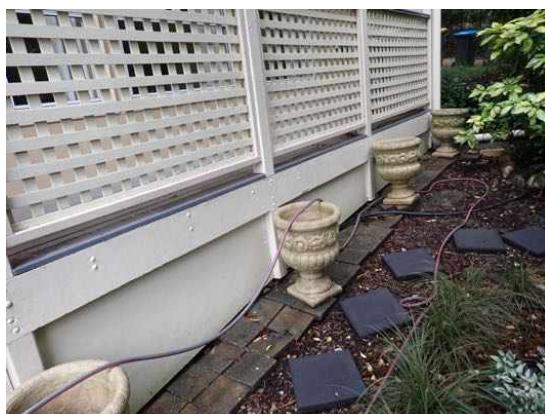
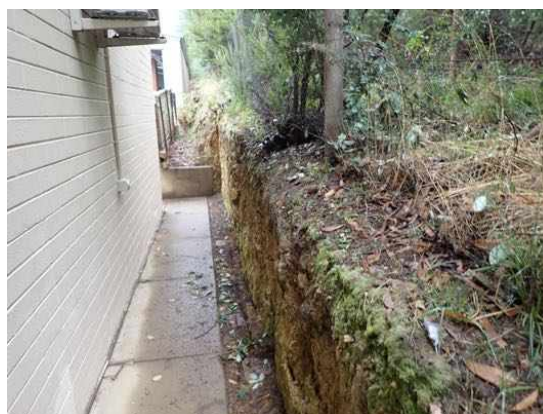
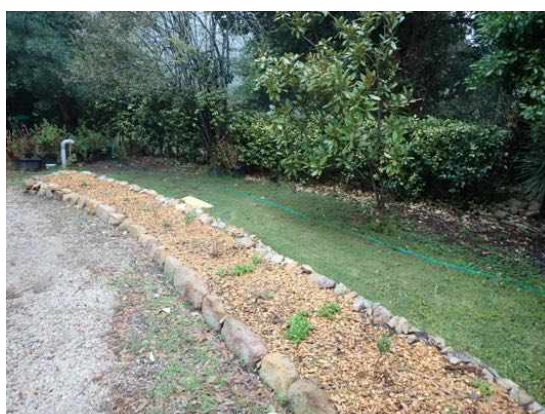
**Finding 6.02**

Building: Shed  
Location: External Areas  
Finding: Garden Beds - Conditions Conducive to Termites  
Information: Garden beds were found to be evident in the garden area. These garden beds can include untreated timber, and with a combination of moisture from watering hosing can make conditions conducive to termite activity and termite ingress.

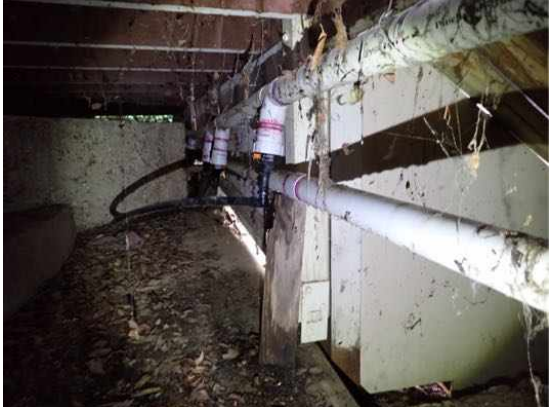
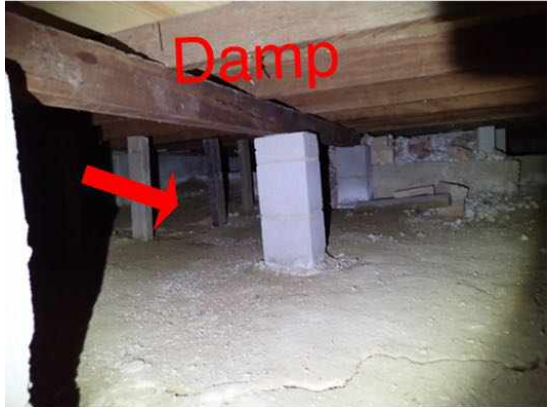
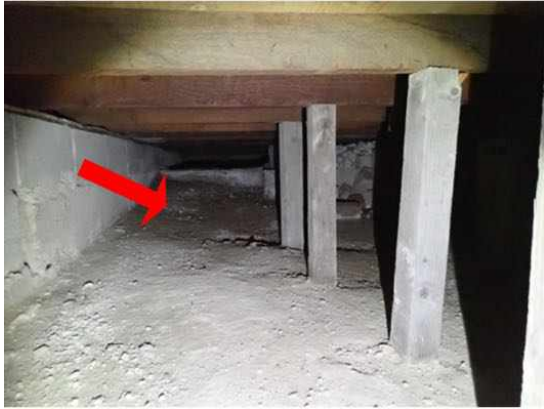
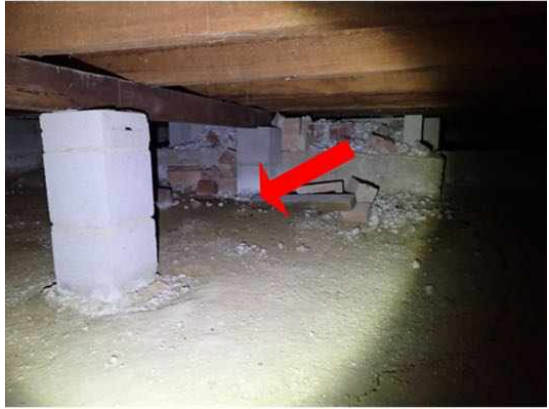
### Finding 6.03

Building:	Shed
Location:	Subfloor
Finding:	Sub Floor - Damp
Information:	Dampness to localised sections of the subfloor area was identified. It is suspected that this dampness has occurred due to poor site drainage and inadequate subfloor ventilation. Dampness in this area is likely to lead to wood rot and general deterioration of structures within the subfloor space. Excessive moisture also creates an environment which is conducive to termite and pest infestation.

A licensed plumber should be appointed to ensure proper subfloor drainage. This will ensure a dry subfloor space.

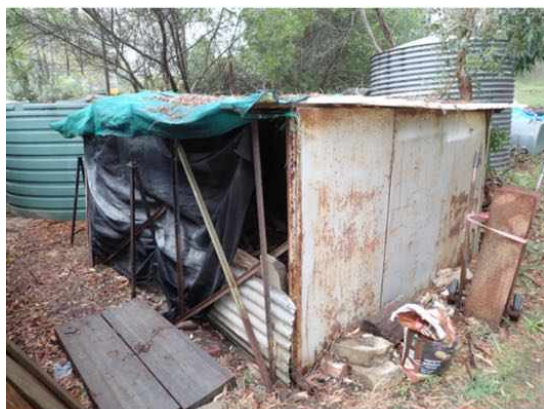
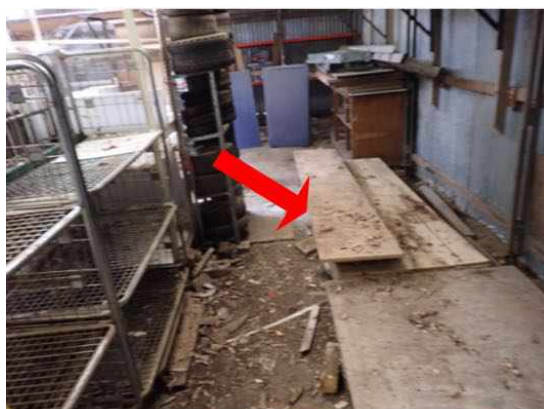
## Finding 6.04

Building:	Shed
Location:	External Areas
Finding:	Stored timbers - subfloor space or external area
Information:	The storing of timbers in the subfloor space or around the external property increases the risk of termite activity being present. As they are likely to come into contact with weather conditions or excessive moisture wood rot is likely to develop on timbers that are not treated.

It is highly recommended that any stored timbers be immediately removed from areas in which they may attract any termite / timber pest attack. Minimisation of risk / prevention of termite attack is far more adequate than dealing with the presence of termite activity.

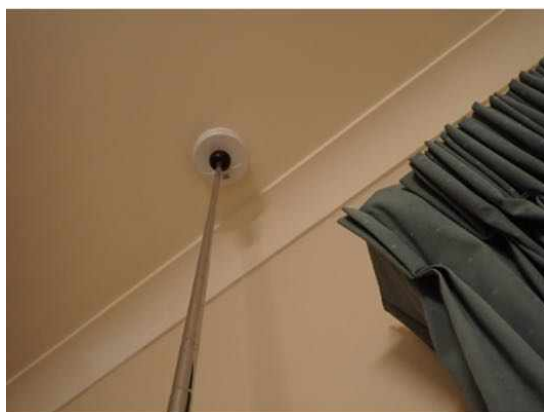
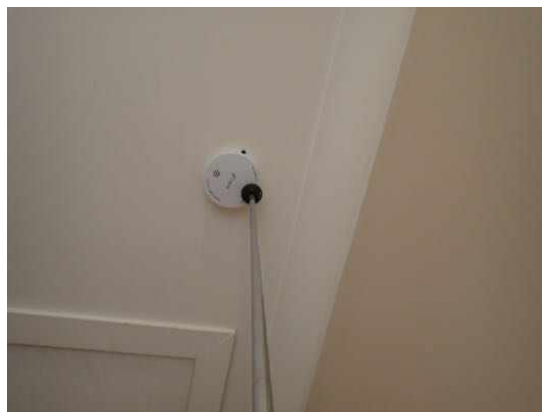
Building: Shed  
 Location: Internal Areas  
 Finding: Smoke Detectors  
 Information:

Reporting on Smoke Detectors or Alarms, including hard wired smoke detection systems and their legislative requirements, is outside the Scope of this Report. (Smoke Alarms activated when tested at the time of the inspection.)

Always ensure sufficient working and suitable smoke detectors are installed prior to occupying any building. Additionally, it is advised that all smoke detectors be tested by the homeowner on a monthly basis.

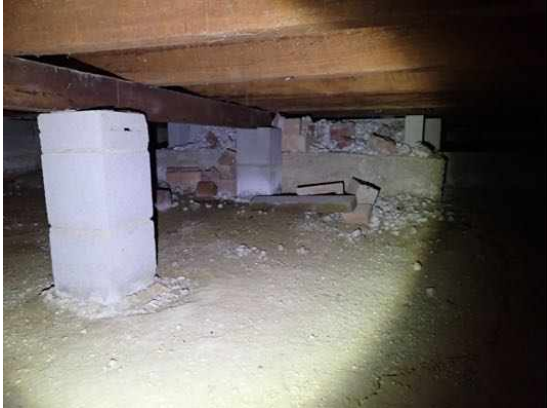
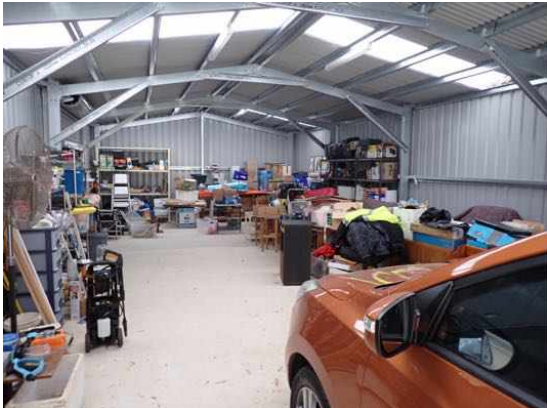
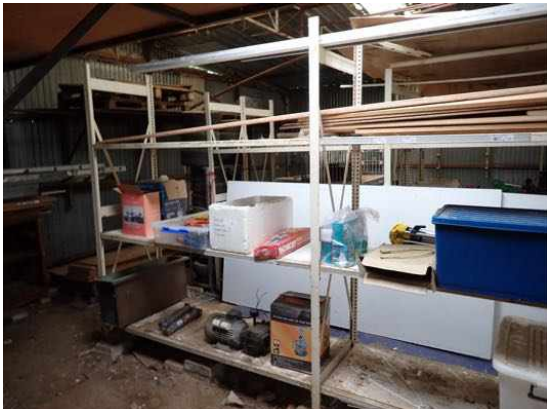
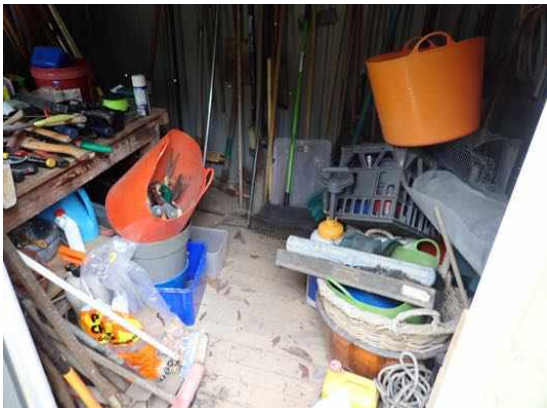
Building: Shed  
 Location: All Areas  
 Finding: Additional Photos - Obstructions and Limitations  
 Information:

These photographs are an indication of the obstructions and limitations which impeded full inspection of the property at the time of inspection. These obstructions can hide an array of defects and should be removed to allow full inspection to be carried out. A re-inspection is recommended once the areas are made accessible.
