Building and Timber Pest Inspection Report

Inspection Date: Thu, 5 Mar 2026

Property Address: 30 White Haven Ave, Magenta NSW 2261,
Australia

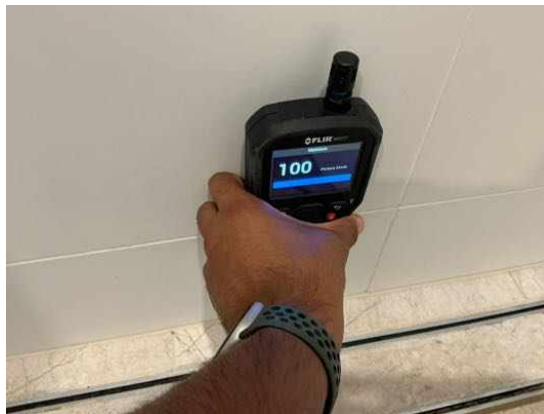
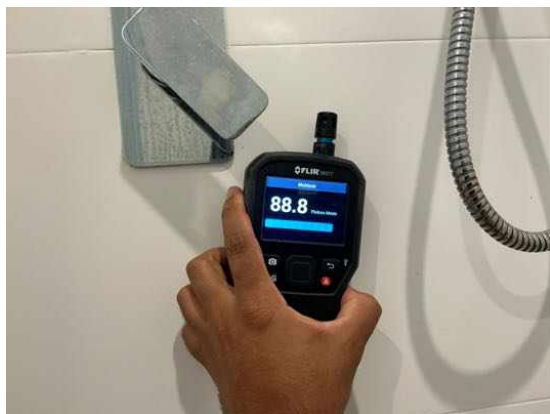
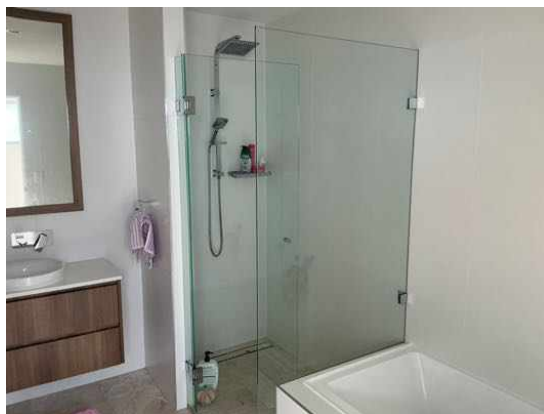
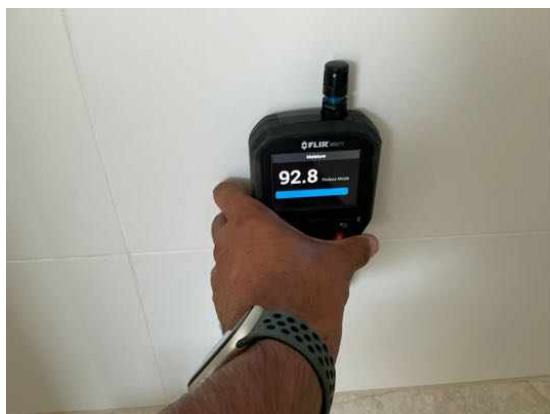
Building:	Main Building
Location:	Both Bathrooms
Finding:	Excessive Moisture - Shower Damp
Information:	At the time of inspection, excessive moisture was noted within the shower area, which is a common issue in wet areas due to the continual exposure to water. This condition is typically caused by moisture seeping through grout lines and settling behind tiles, resulting in localised high-moisture zones. Provided there is no evidence of water staining or elevated moisture readings on the opposite side of the wall, this is considered a minor defect.

However, persistently damp conditions may act as conducive conditions for termite

activity, as termites are strongly attracted to moisture-rich environments. It is recommended that the client ensures regular use of the exhaust fan and maintains adequate ventilation after shower use to promote drying and reduce long-term moisture build-up, thereby also reducing the risk of attracting termites.

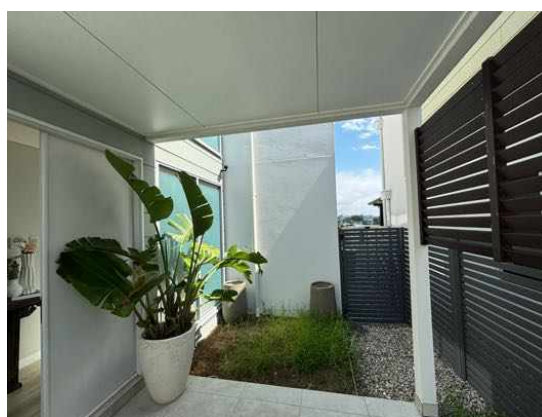
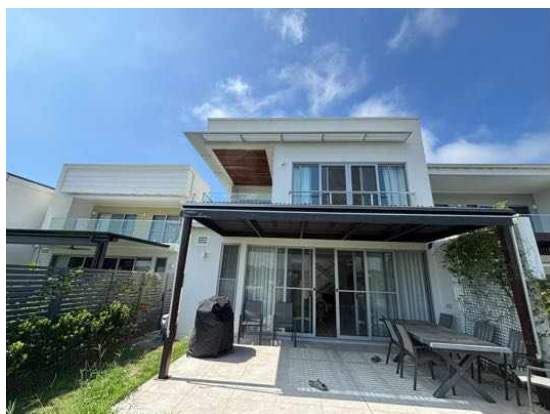
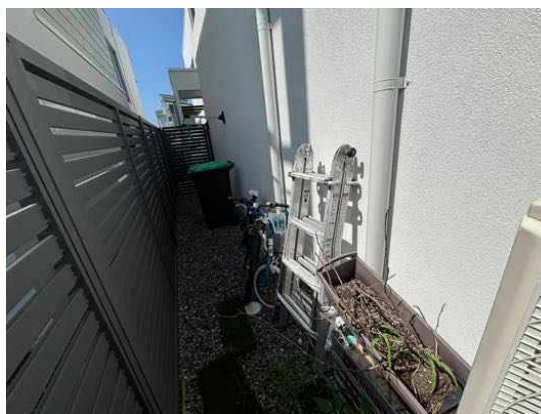
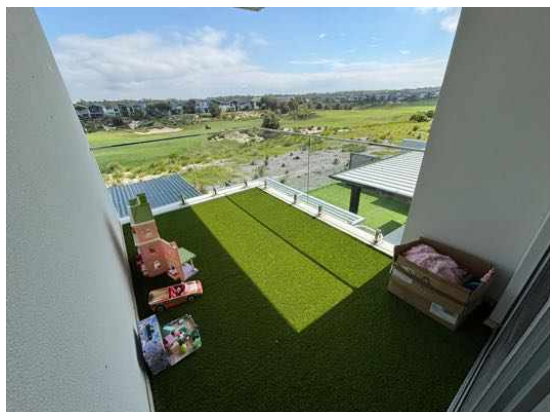
Building: Main Building
Location: All External Areas
Finding: Obstructions and Limitations - External Areas
Information: The attached photographs provide a visual representation of the obstructions and limitations that impeded a full inspection of the external areas of the property at the time of assessment. These obstructions, which may include vegetation, stored items, debris, or other physical barriers, can obscure potential defects and prevent a thorough evaluation of the property's condition. Obstructions of this nature can conceal a wide range of issues, such as structural damage, water ingress, pest infestations, or deteriorating building materials, which may not be visible during the initial inspection.

It is essential that these obstructions be cleared to allow for a comprehensive inspection of the external areas. Removing these barriers will enable a more accurate assessment of the property's condition and allow any hidden defects to be identified and addressed promptly. Failure to do so could result in undetected issues worsening over time, potentially leading to more costly repairs in the future.

Therefore, it is strongly recommended that the obstructions be removed and a re-inspection be scheduled once the affected areas are made fully accessible. This will ensure a complete evaluation of the property's exterior and provide the client with a clear understanding of any potential issues that may have been concealed during the initial inspection.

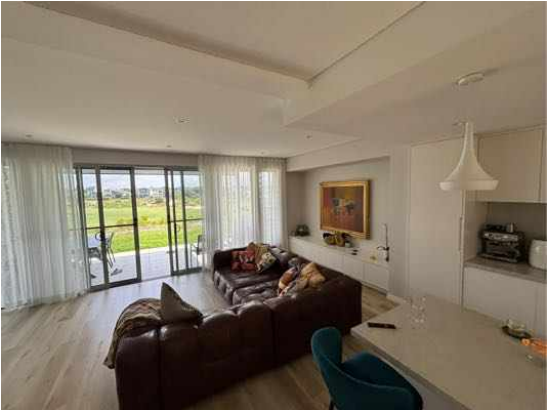
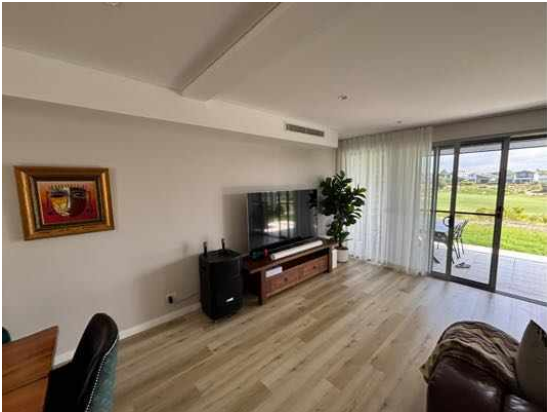
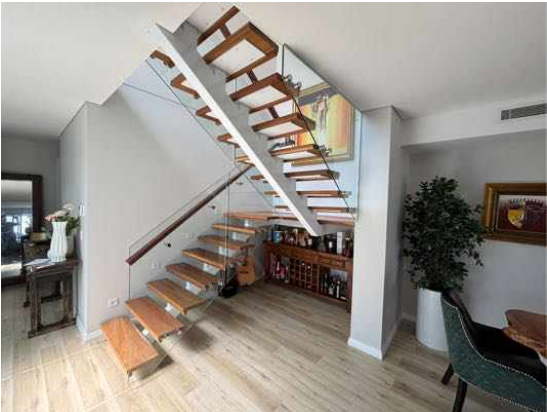
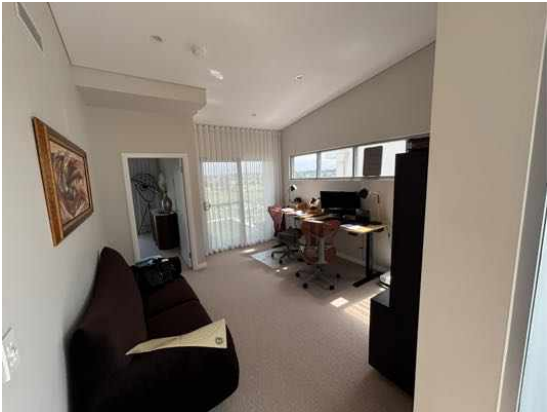
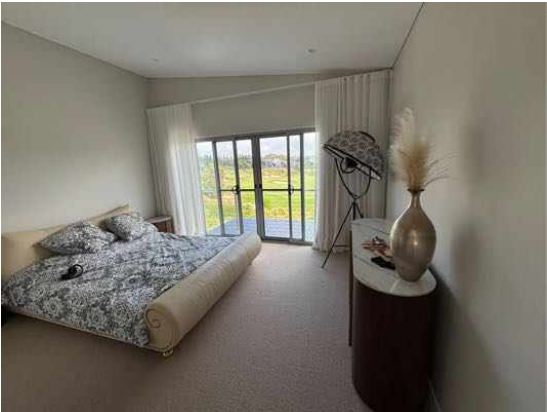
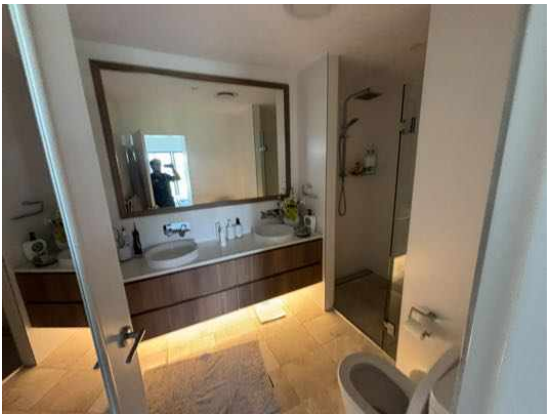
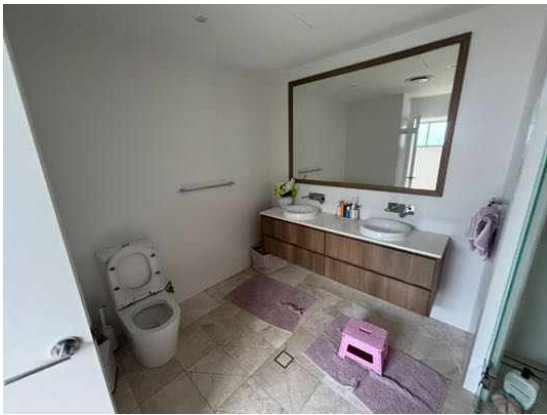
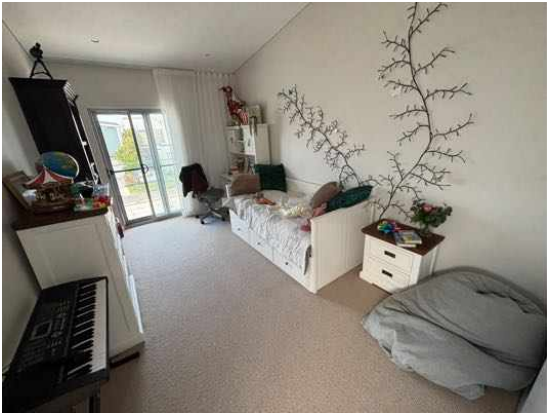
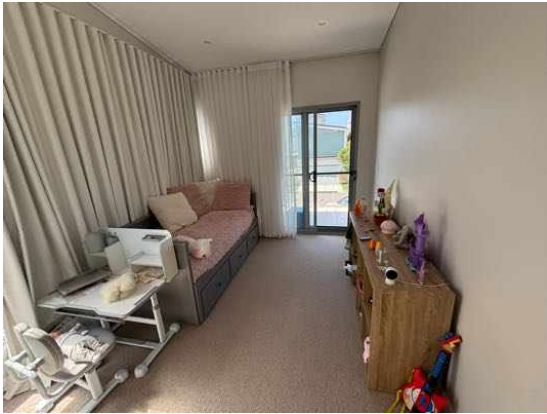
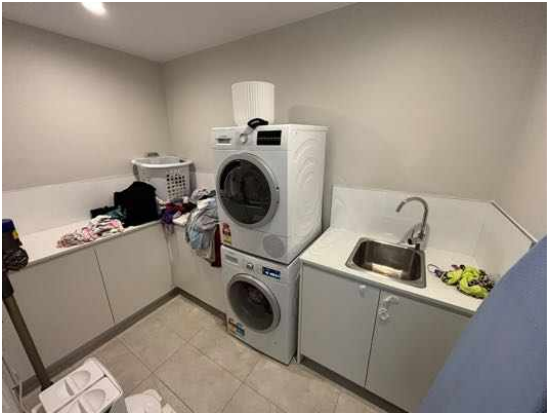
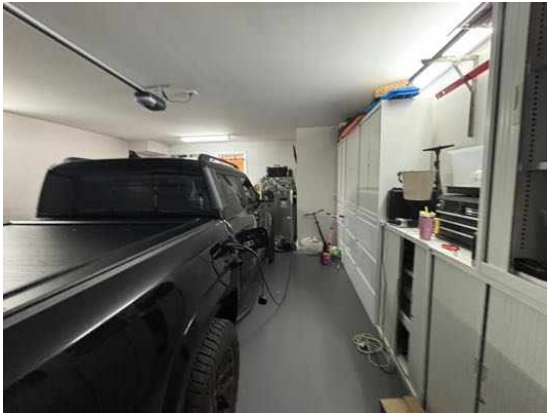
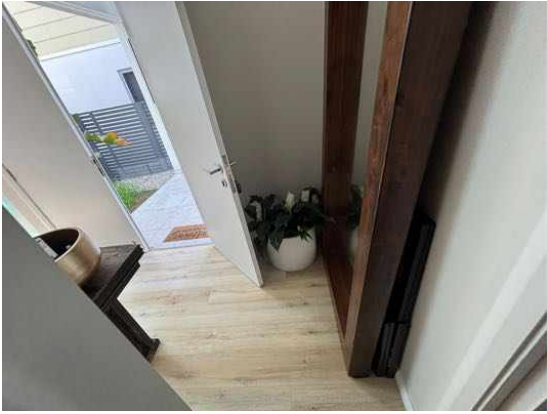
Information: The accompanying photographs provide clear evidence of the obstructions and limitations that restricted a comprehensive inspection of the internal areas of the property at the time of assessment. These obstructions, which may include furniture, personal belongings, stored items, or structural elements such as wall coverings and built-ins, significantly hindered the ability to thoroughly evaluate these areas. It is important to note that such obstructions can potentially conceal a wide array of defects, ranging from hidden structural damage, water leaks, pest infestations, or electrical issues, to deteriorating materials that may not be visible during the initial inspection.

The presence of these impediments means that critical areas of the property were not accessible, and therefore, any underlying defects that may affect the integrity and safety of the property could remain undetected. These hidden defects, if left unaddressed, could worsen over time and may result in costly repairs or pose potential safety hazards to the occupants.

It is highly recommended that all obstructions be cleared to facilitate a complete and thorough inspection of the internal areas. Once the obstructions have been removed and full access is available, a re-inspection should be carried out to ensure that any

previously concealed issues can be properly identified and rectified. This follow-up inspection will provide a more accurate assessment of the property's internal condition and help the client make informed decisions about any necessary repairs or maintenance.

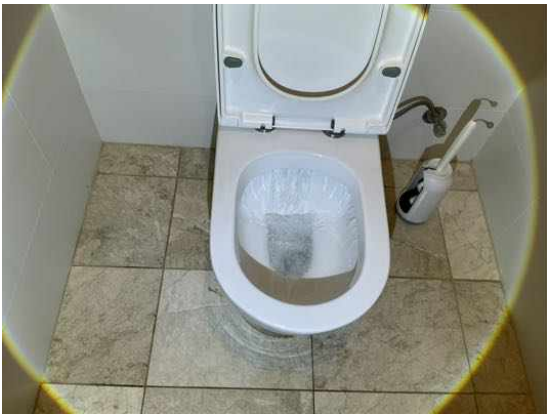
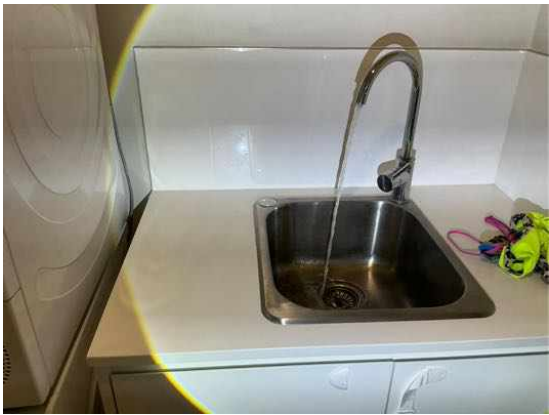
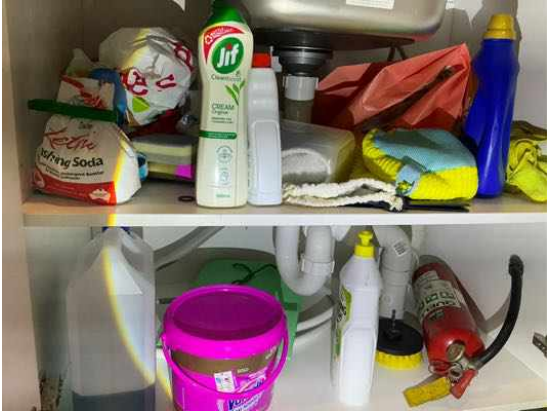
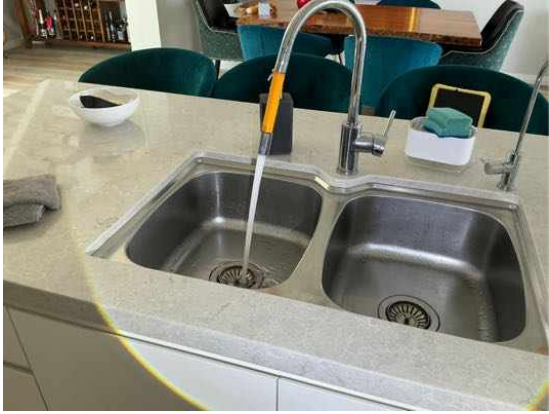
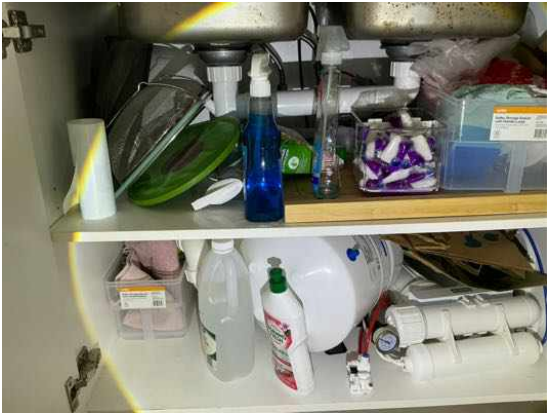
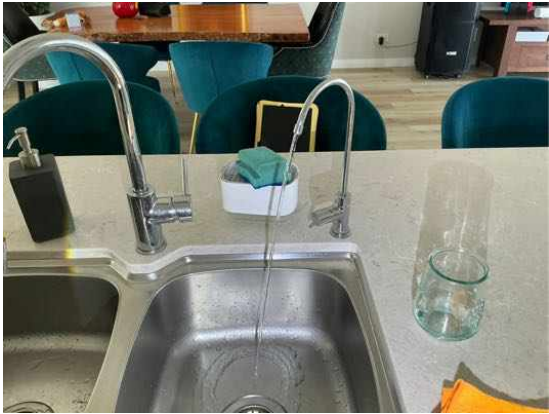
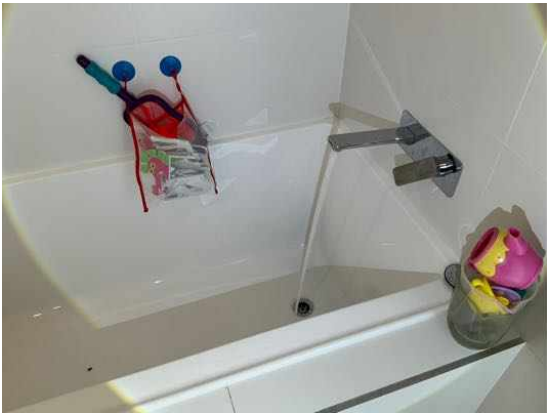
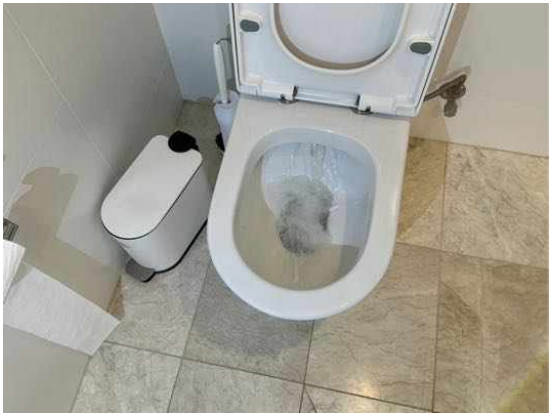
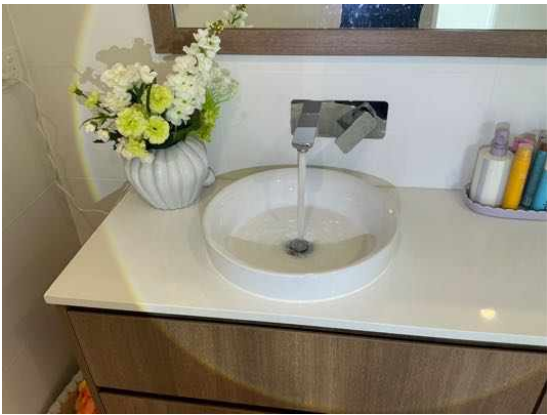
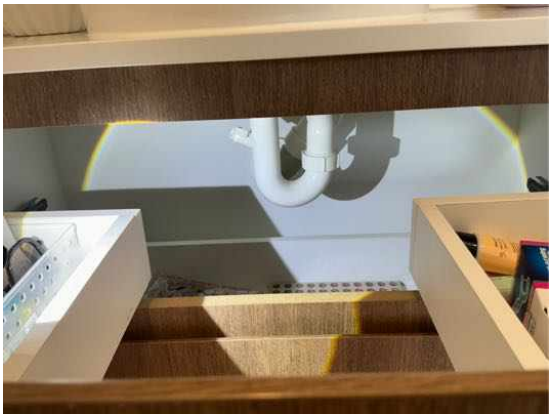
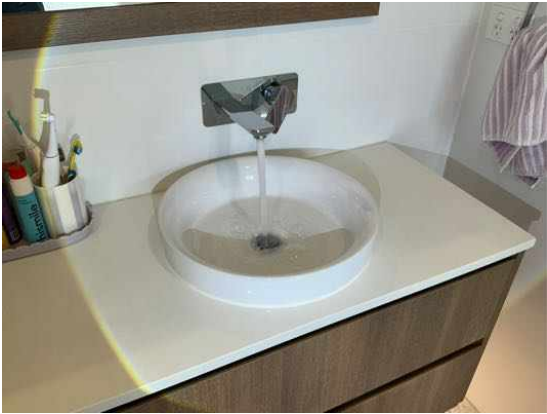
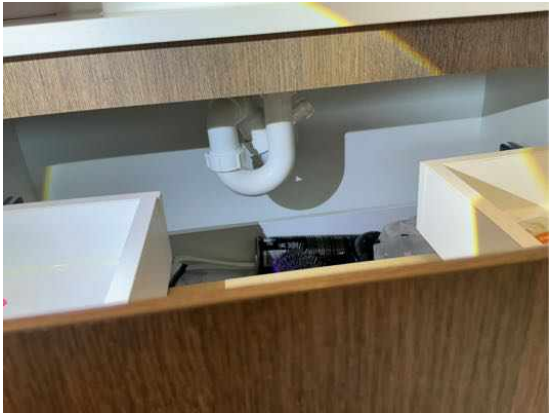
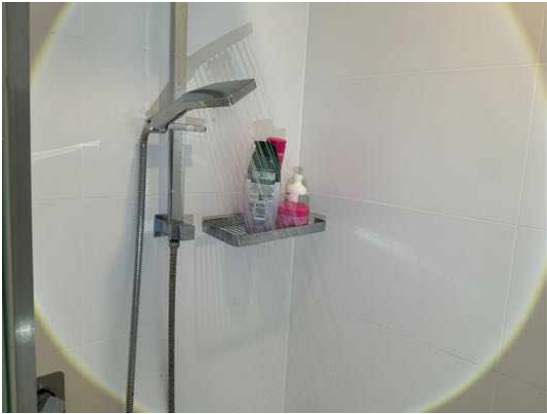
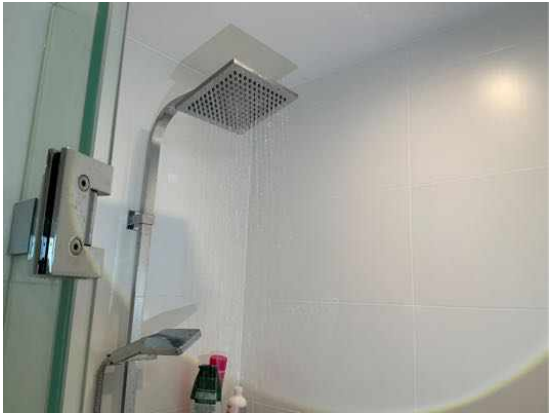
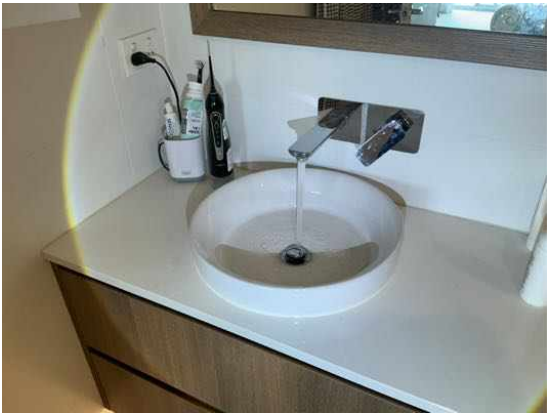
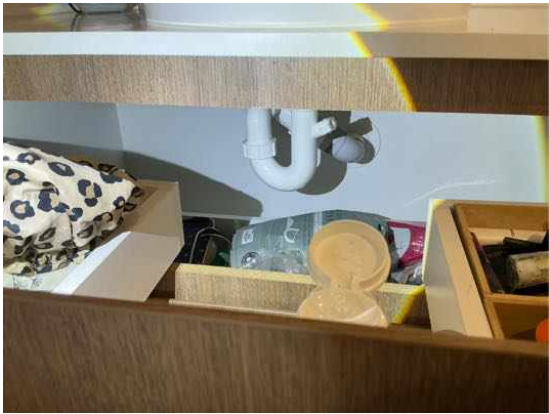
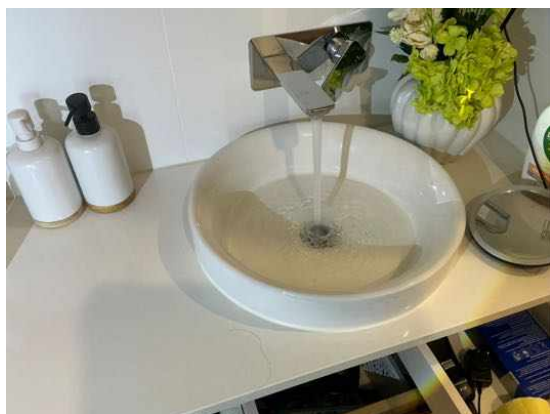
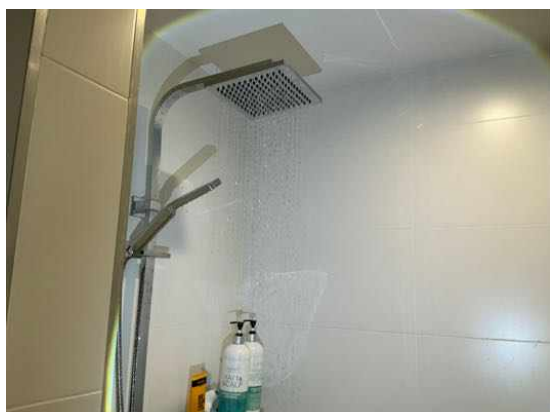
Building:	Main Building
Location:	All Areas
Finding:	FYI - Taps, Drainage & Toilets Tested and Cabinetry Obstructions
Information:	During the inspection, all accessible taps, drainage systems, and toilets were tested for water flow and drainage efficiency, and checked for any visible signs of leakage. At the time of the inspection, no issues were noted in these areas. Unless highlighted in a separate defect statement, no immediate remedial work appears necessary. Supporting images may be found in the additional photos section for reference.

It is important to note that while a visual inspection of cupboards and cabinetry beneath sinks and vanities was undertaken, stored personal items and fixtures presented obstructions that limited full visibility of the internal areas. As per standard inspection practices, inspectors are not permitted to move or disturb personal belongings during the inspection process. Therefore, only visible and accessible sections were inspected, and concealed water damage or plumbing defects may not have been detected.

Given this, a re-inspection is recommended after all obstructions have been cleared to allow for a comprehensive assessment of these areas. Regular maintenance and monitoring of plumbing and drainage systems is also advised to ensure ongoing functionality and early detection of potential issues.

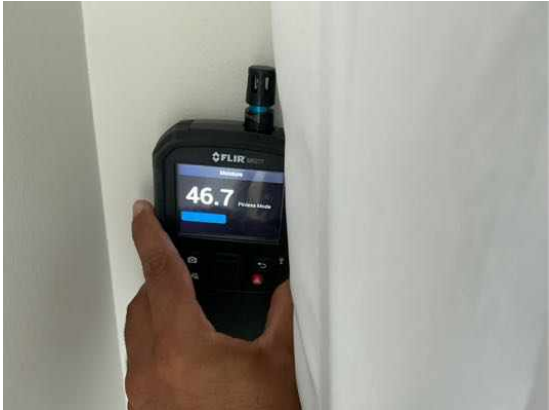
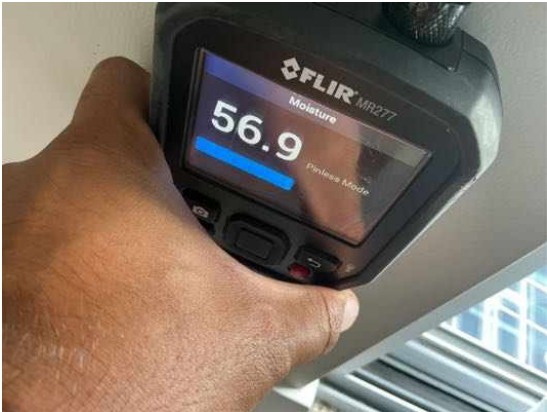
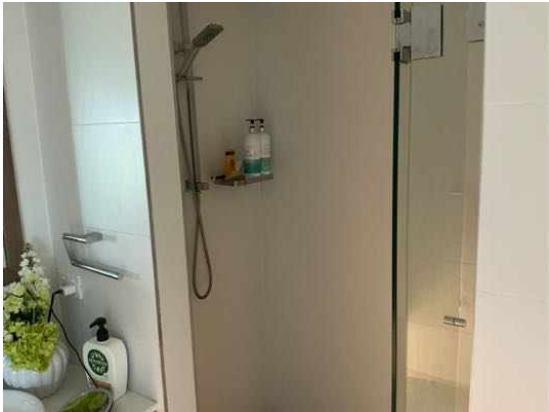
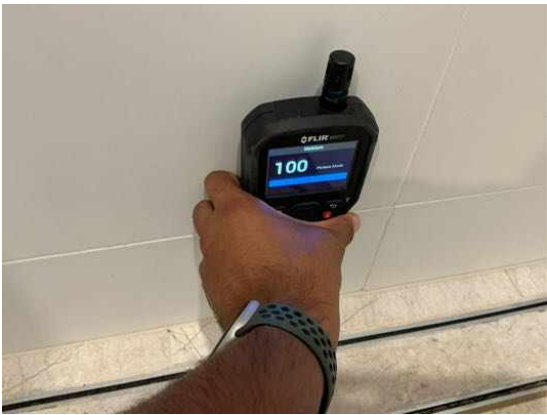
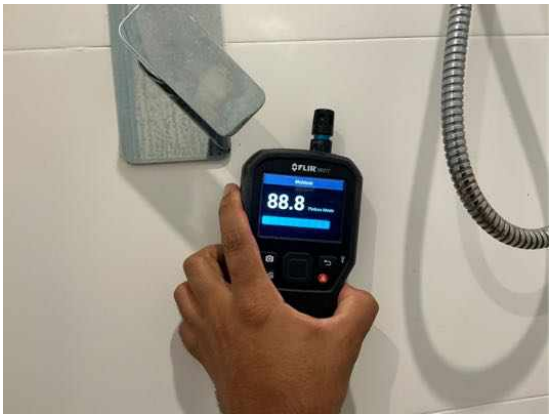
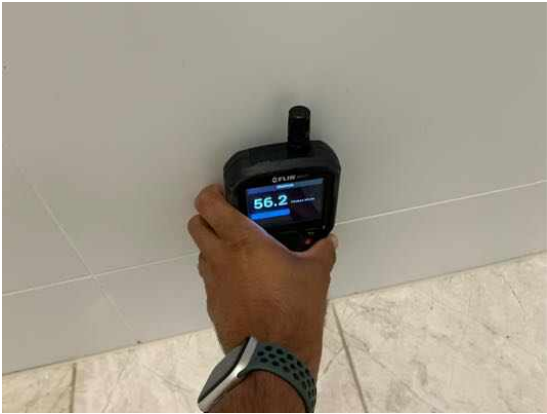
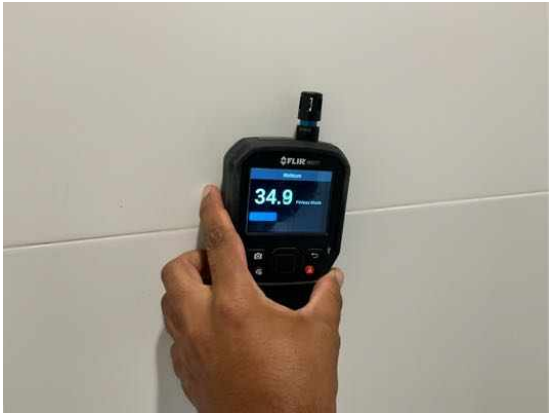
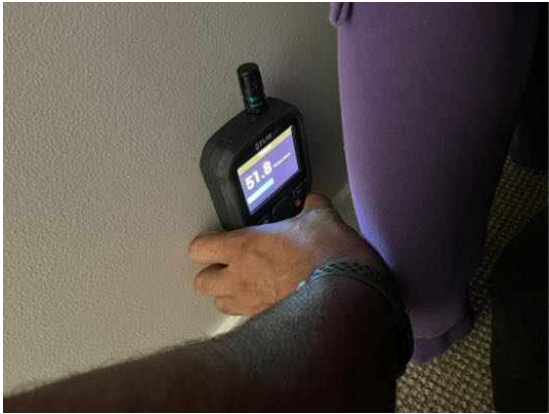
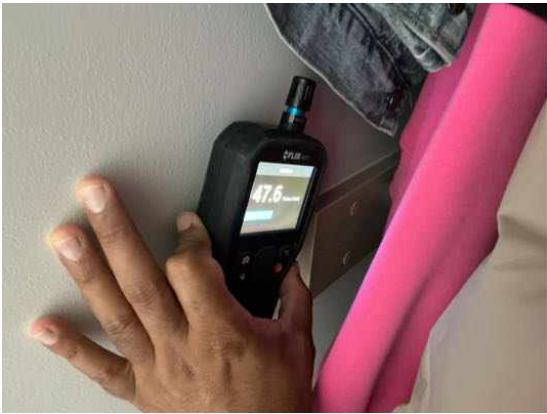
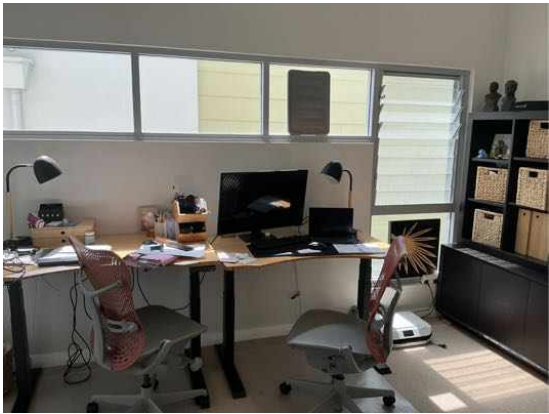
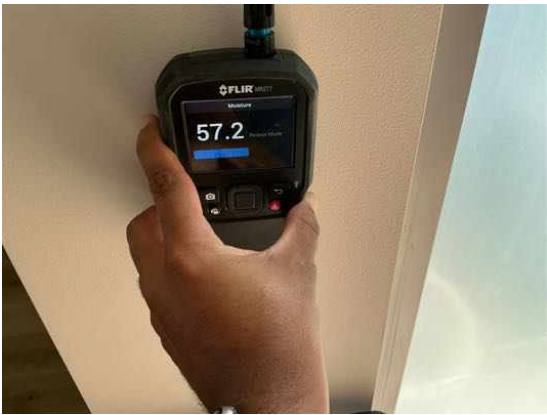
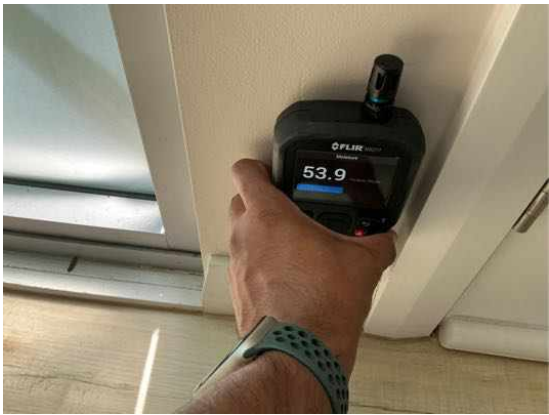
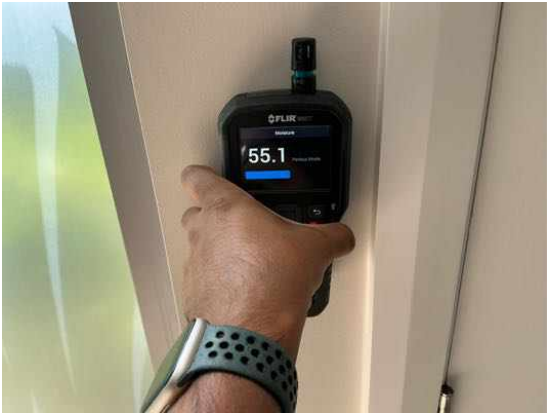
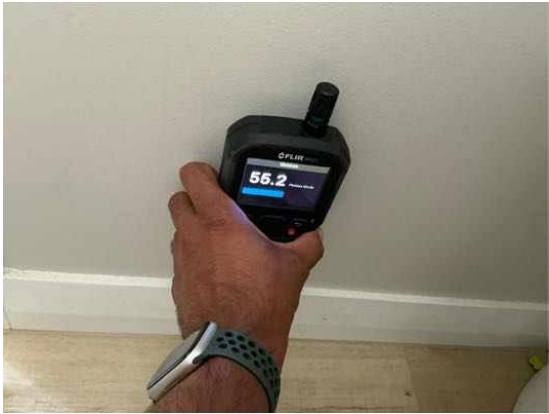
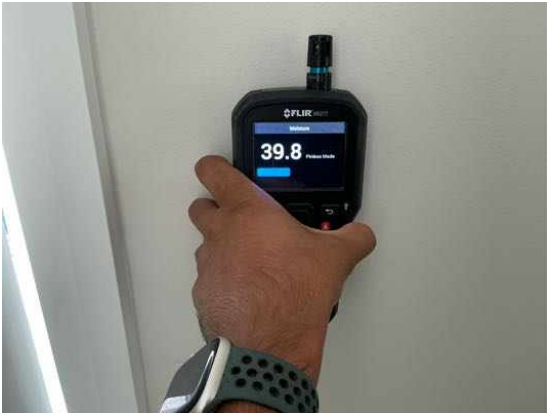
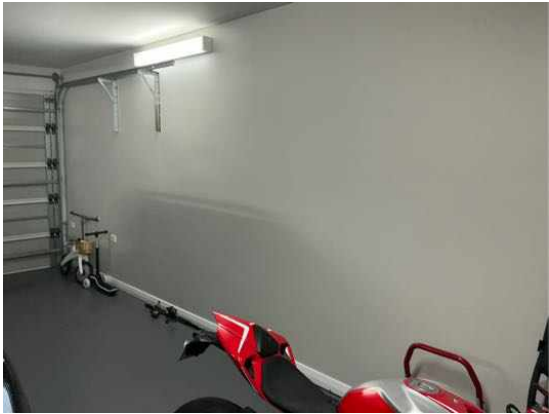
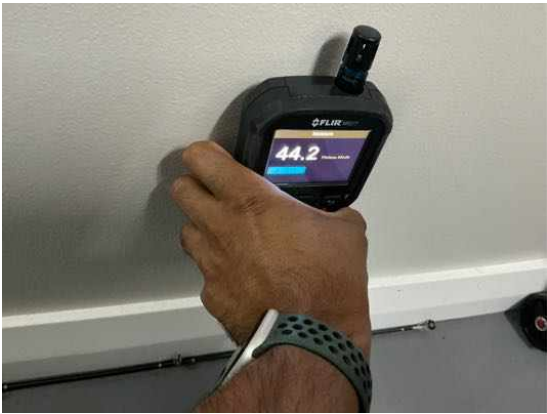
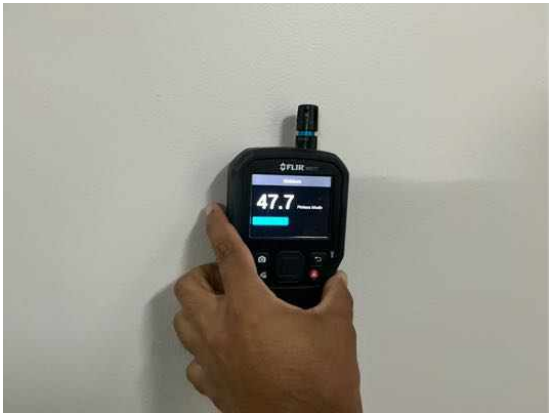
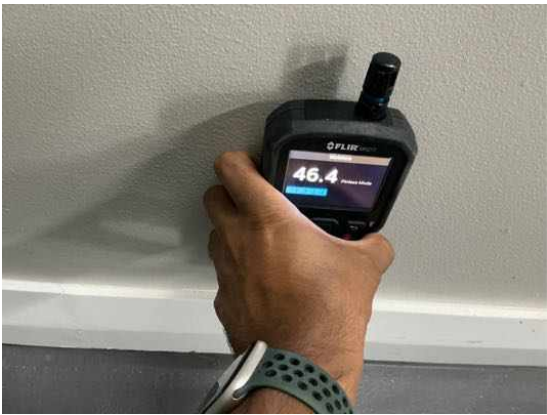
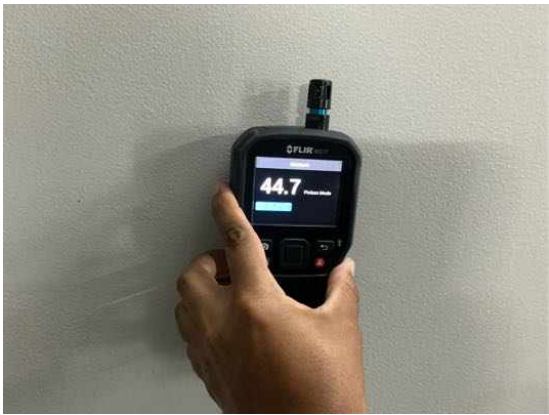
Building:	Main Building
Location:	All Areas
Finding:	Additional Photos - Moisture Meter Readings
Information:	<p>Additional moisture meter reading photos have been provided for the property to offer further clarity on areas tested during the inspection. These photos are intended to give a visual reference for the specific locations where moisture levels were measured.</p> <p>These readings were taken at the time of the inspection to assess any potential moisture-related issues within the property. Any defects related to moisture that were identified during the inspection have been separately mentioned in the defect statements within the report.</p>

It is important for the client to understand that moisture levels can fluctuate over time due to various factors, including changes in weather, humidity, and environmental conditions. While the readings reflect the property's moisture levels during the inspection, they may not represent future conditions, and increased moisture could lead to issues such as dampness, mould growth, or deterioration of building materials if left unmonitored.

For further clarification or additional information regarding the moisture readings, the client is encouraged to contact the building inspector directly. Regular monitoring of moisture-prone areas is recommended to ensure any emerging concerns are addressed promptly, particularly during wetter seasons or in high-humidity conditions.

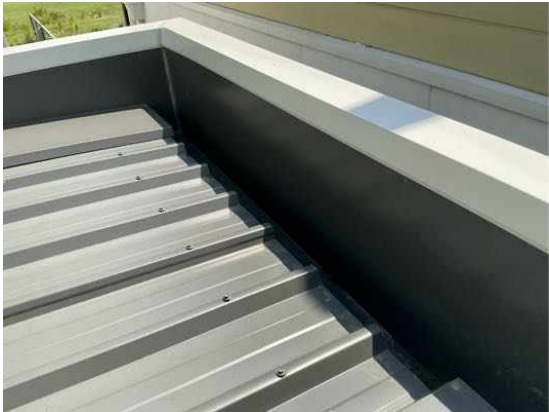
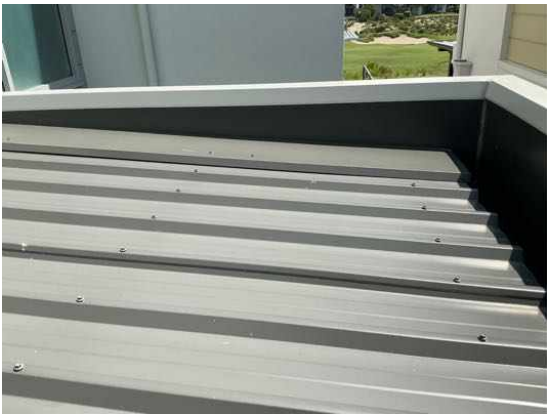
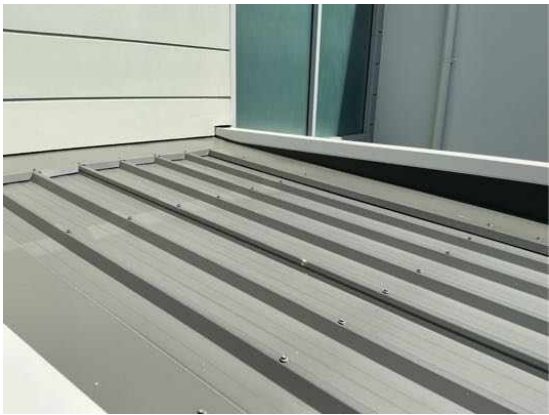
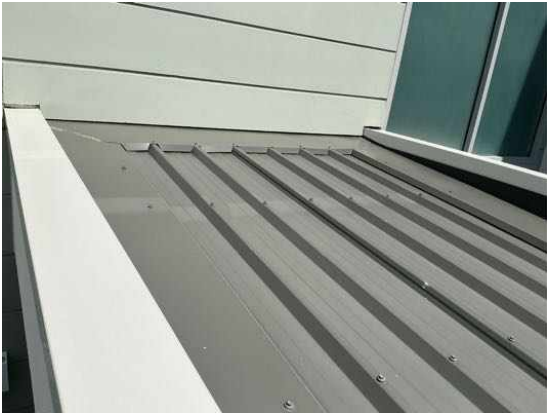
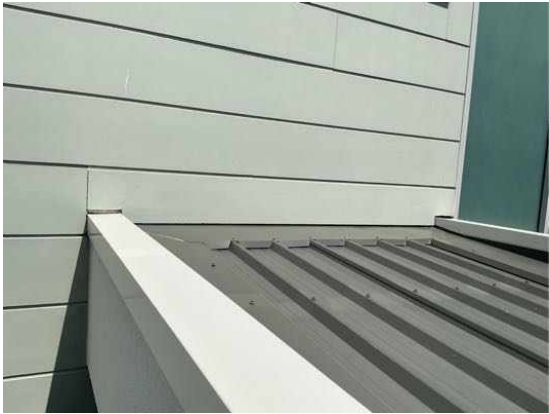
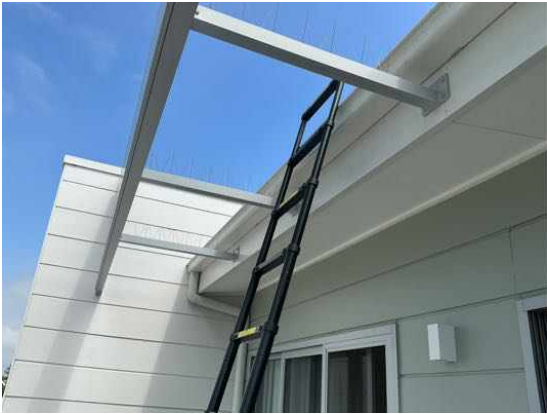
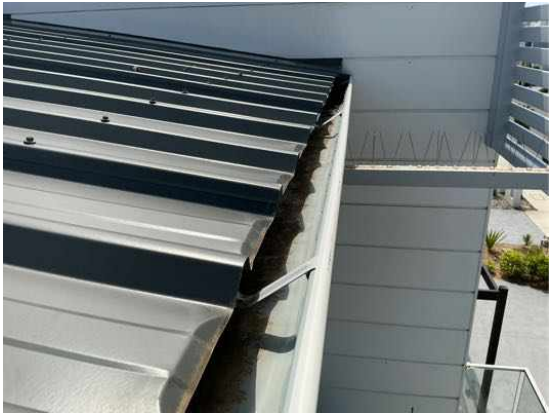
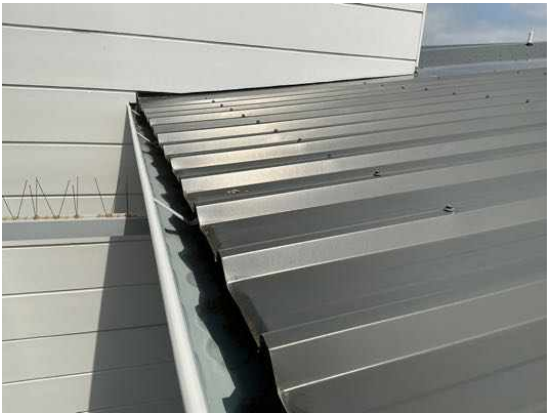
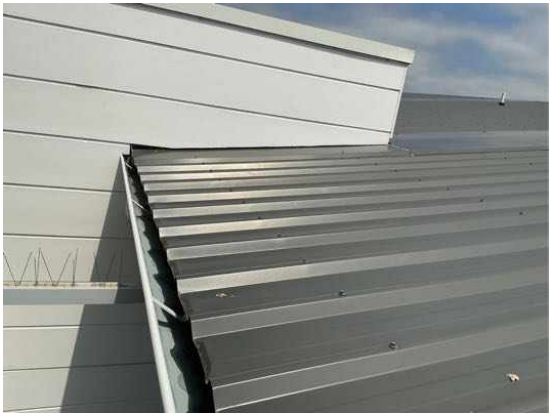
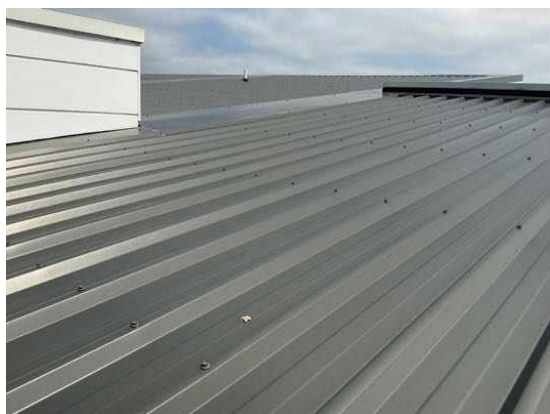
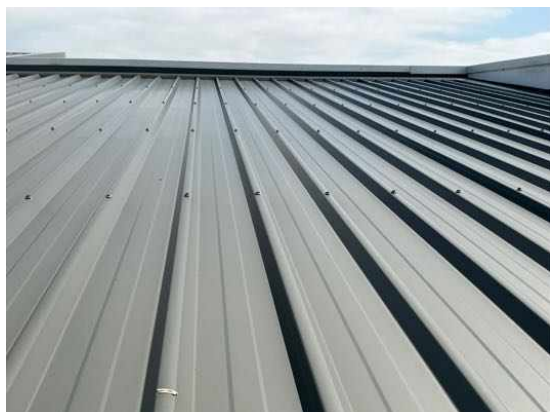
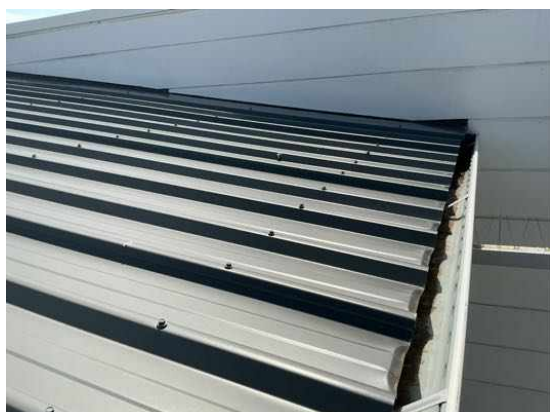
Building: Main Building
Location: Roof Exterior
Finding: Additional Roof Photos
Information:

As part of the information provided, please note that the attached roof photos represent the condition of the roof at the time of inspection. These photos are for visual reference only and do not constitute a detailed roofing assessment. Any defects or issues identified with the roof are mentioned separately in the defect statements. It is strongly recommended that the client engage a qualified roofer to conduct a thorough inspection of the roof, ensuring that any potential issues, such as leaks, structural integrity, or wear and tear, are properly identified and addressed.

Additionally, the condition of the roof may change over time due to weather, natural wear, or other unforeseen factors. Regular maintenance and inspections by a licensed professional are advised to ensure the roof remains in good condition and to avoid costly repairs in the future. The information provided in these photos should be considered a snapshot of the roof's condition during the time of inspection and not a guarantee of its future performance.
